Building Inspection Report and Schedule of Repairs

Inspection Report

Property Address:
231 Margaret St.
Key West Fl. 33040

Historic Half Shell Restaurant

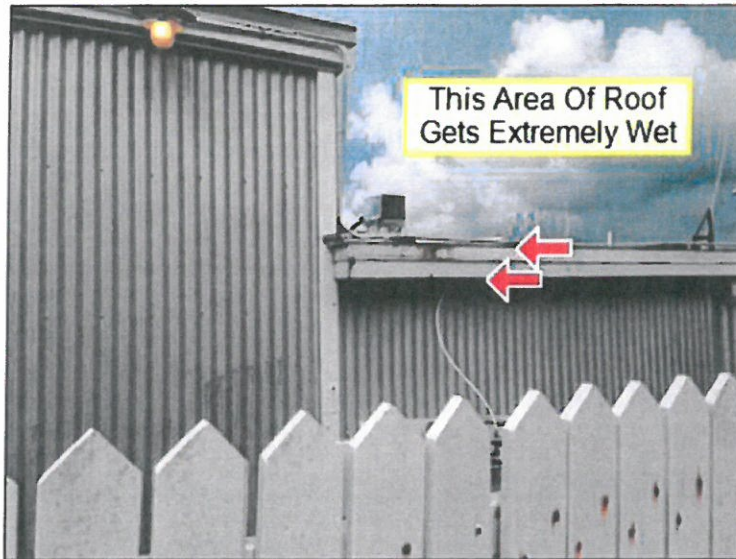
1.1 Picture 1 NE Side Of Building

1.1 The roof flashings on the building was also extremely poor condition. Two areas of the most concern are shown in this report as being extremely wet areas and should be dealt with as soon as possible.

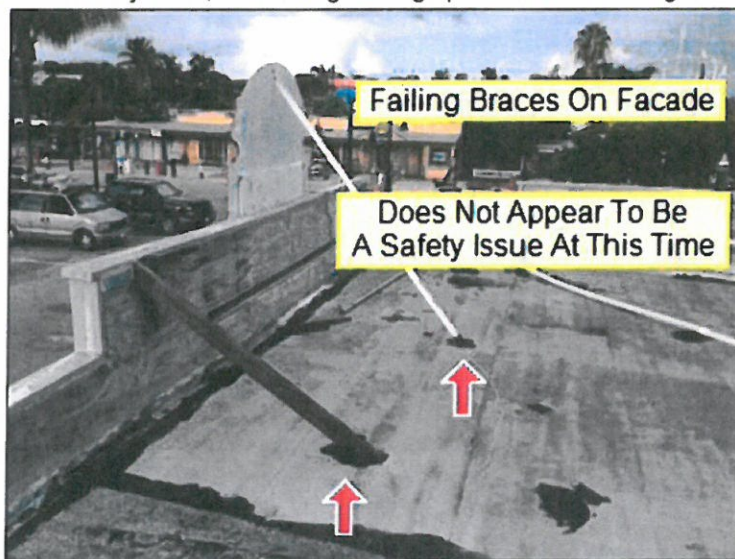
1.3 Picture 1 Facade

1.3 Although I don't believe it's a safety issue, the bracing holding up the facade is failing

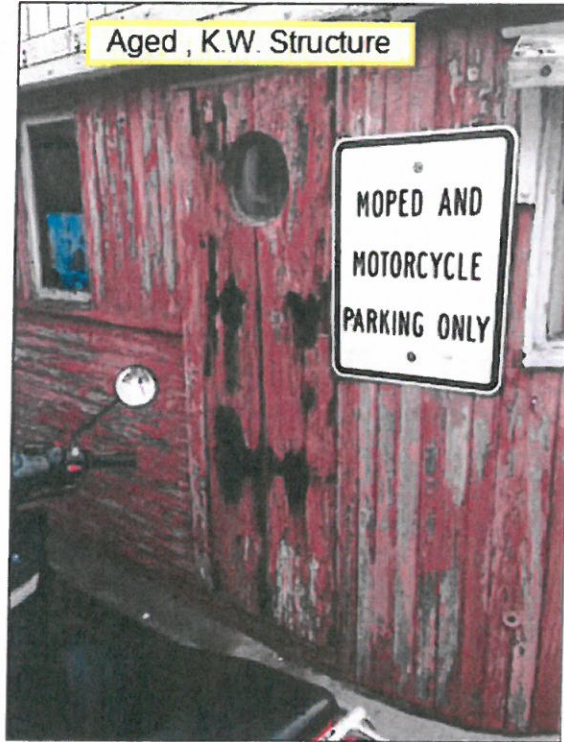
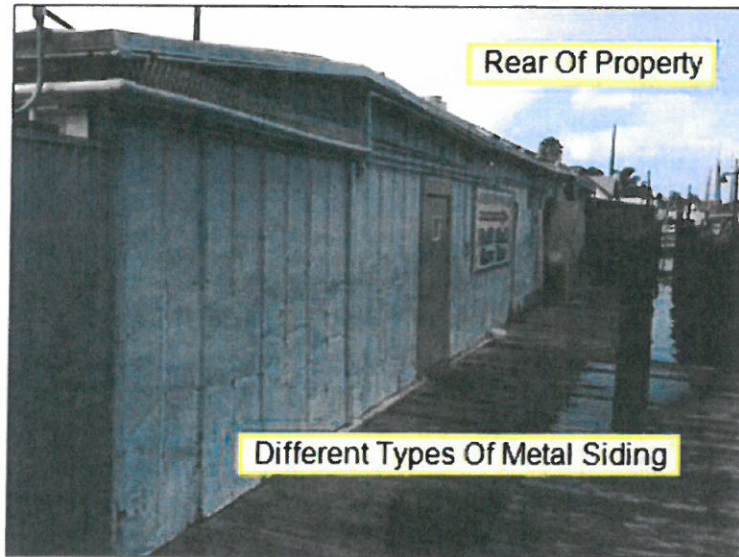
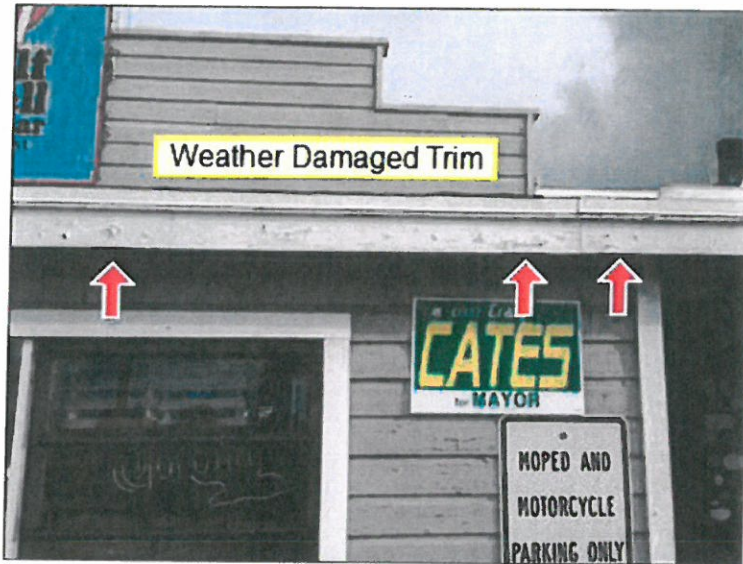
2.0 This is a somewhat typical waterfront historic restaurant in Key West Florida. The exterior of the building is indeed in poor condition but was probably meant to be left that way to some degree.

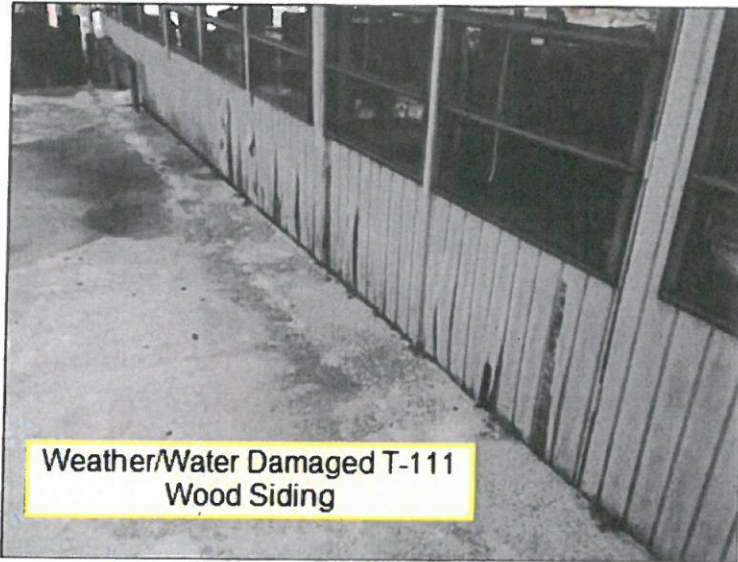
2.0 Picture 5 Wall Cladding

Weather/Water Damaged T-111
Wood Siding

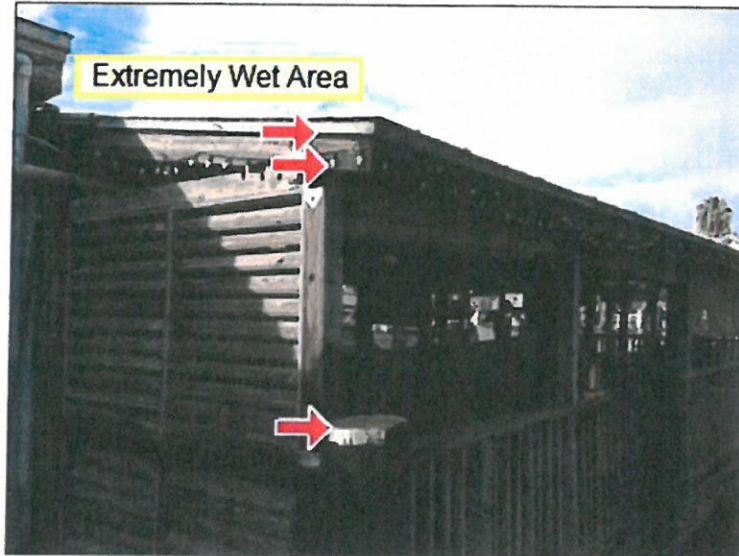
2.0 Picture 6 NW Side Of Building

Extremely Wet Area

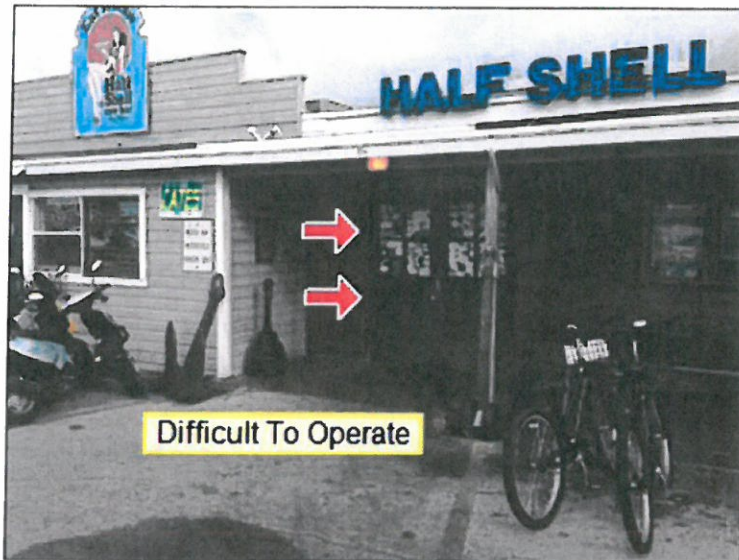
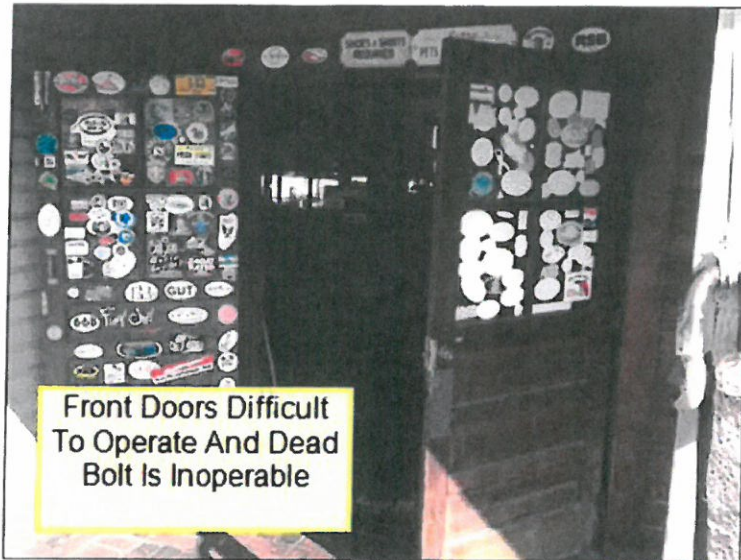
2.1 The double front doors are extremely difficult to operate.

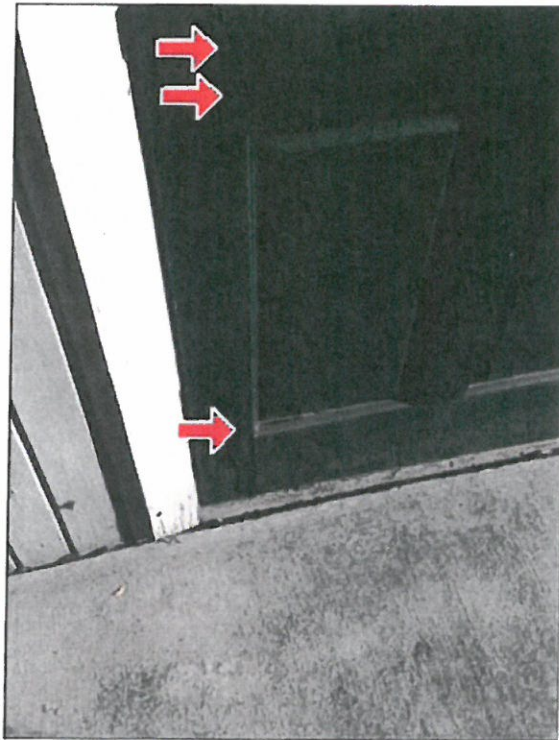
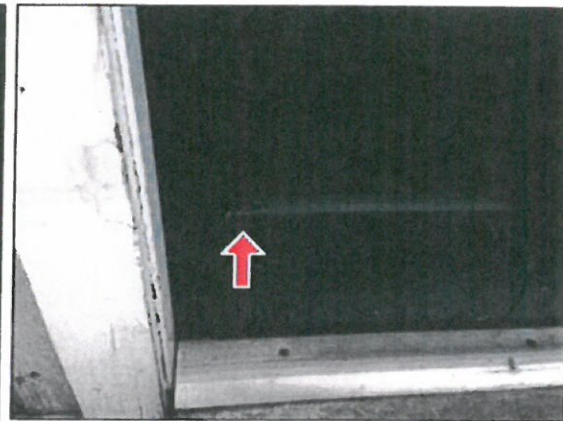
The other doors throughout the building were found to be operable though somewhat aged.

2.1 Picture 2 Weather Damaged Door

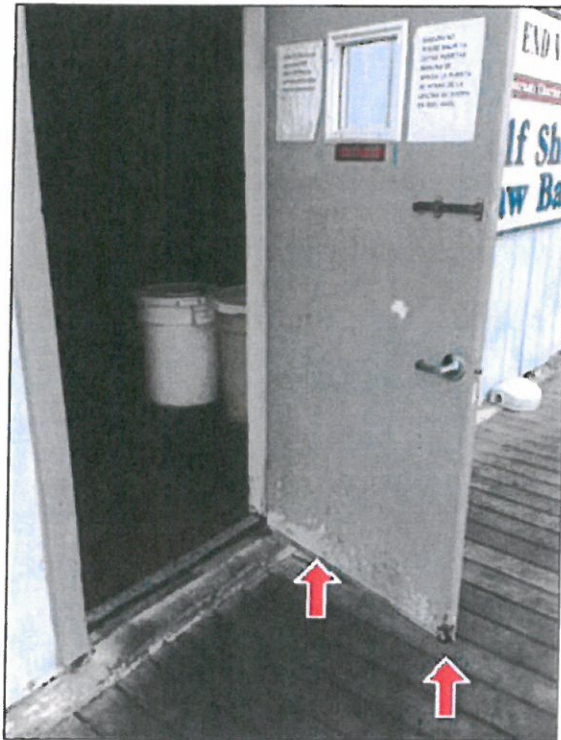
2.1 Picture 5 Typical Damaged Exterior Door

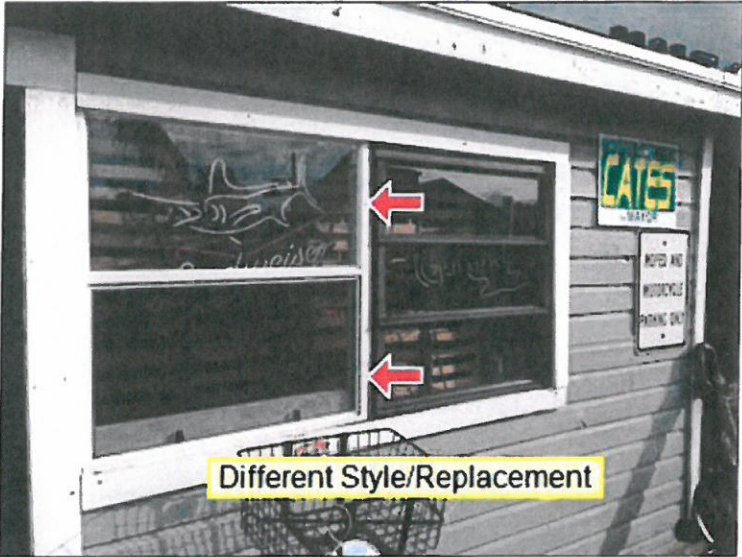
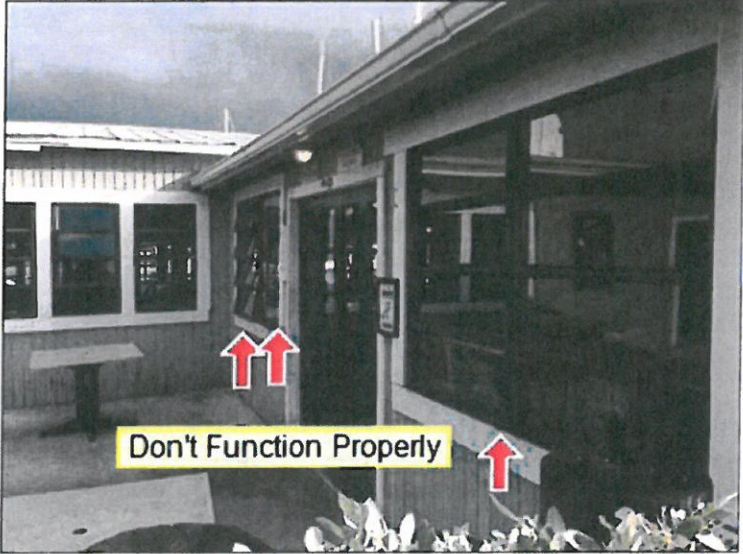
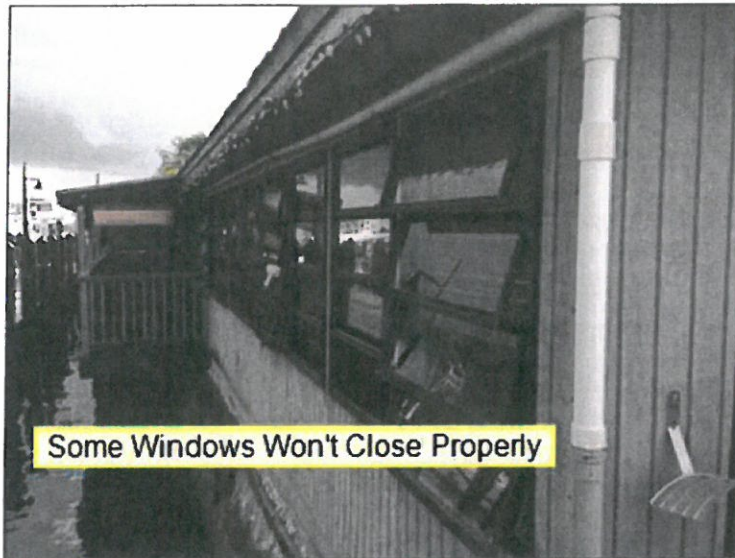
2.2 The windows throughout the restaurant are in poor condition. Most of the hardware is missing or inoperable. A lot of the windows could not be closed. One of the panes of glass out front was actually broken as shown in picture number four.

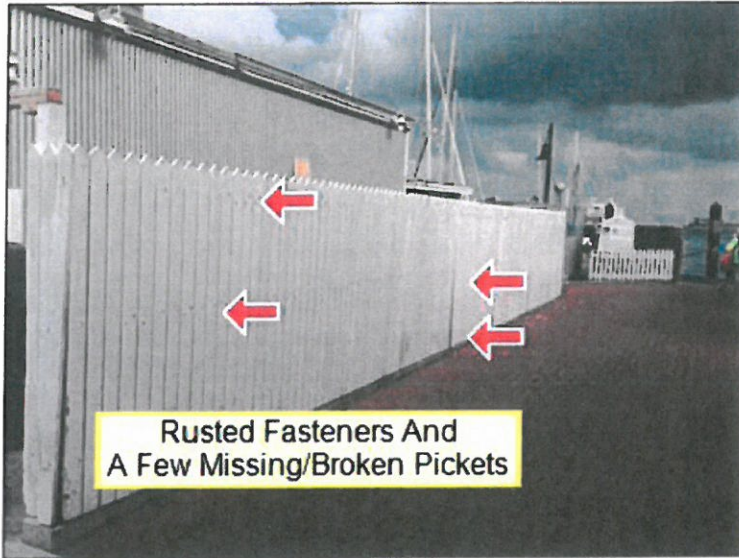
2.3 Picture 2 Fence

The fence along the northeast side of the property was found in fairly good condition although the fasteners are rusted and a few pickets are loose or missing.

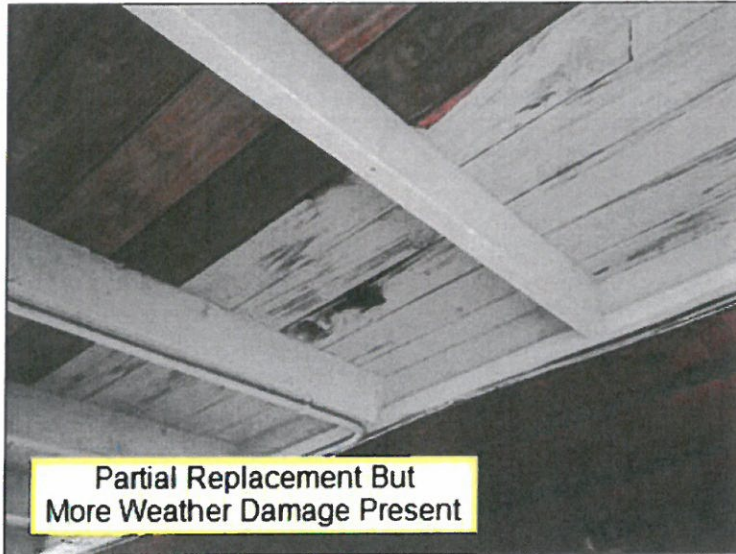
2.3 Although the front porch cover seems to have been repaired recently a lot of rot still remains.

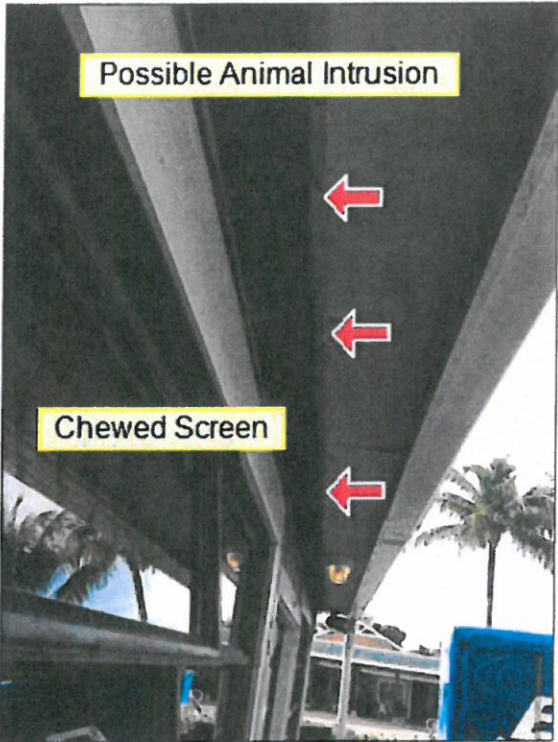
2.5 Picture 1 Soffits

2.5 The soffit around most of the building was found to be in poor condition. Most of the screen has been ripped or chewed which could invite animal activity.

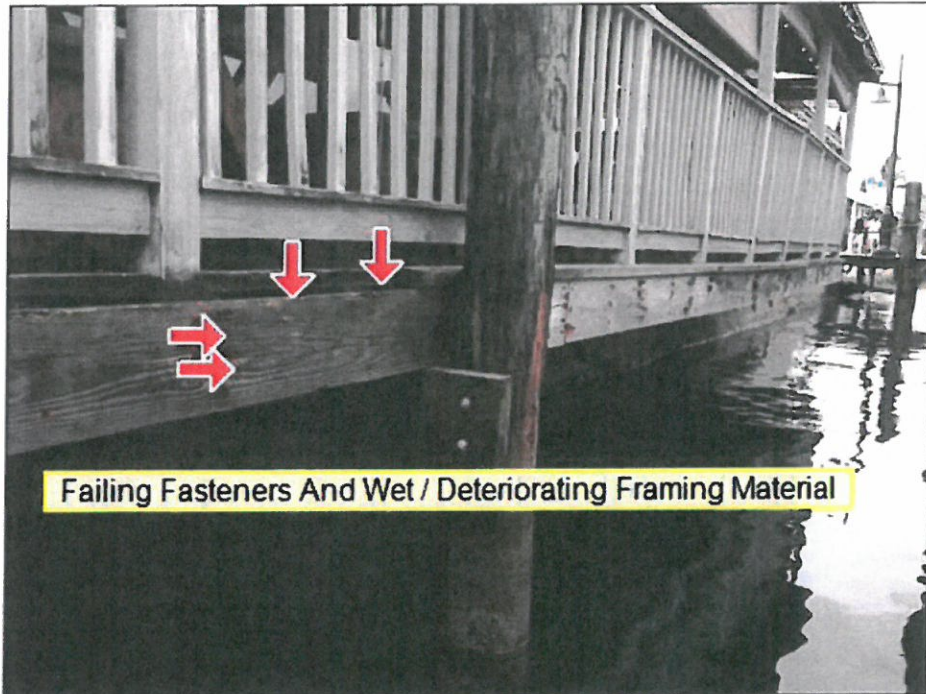
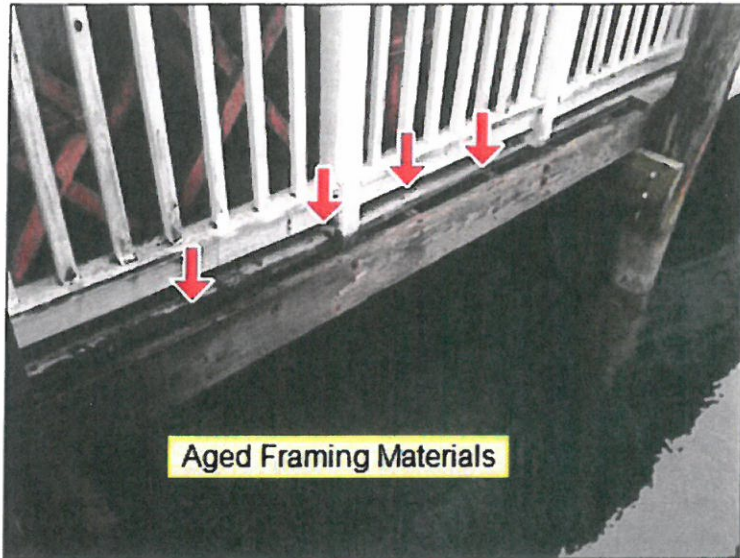
3.2 The cantilever structure of the restaurant appears to be structurally sound at this time. A number of fasteners are rusted and the framing material does show signs of water damage and it is my recommendation a structural engineer be contacted for further evaluation and recommendation.

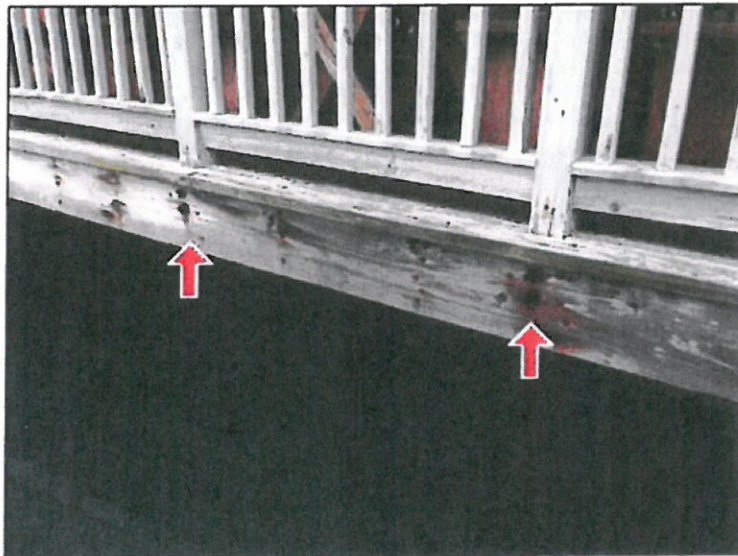
3.2 Picture 2 Failing /Rusting Fasteners

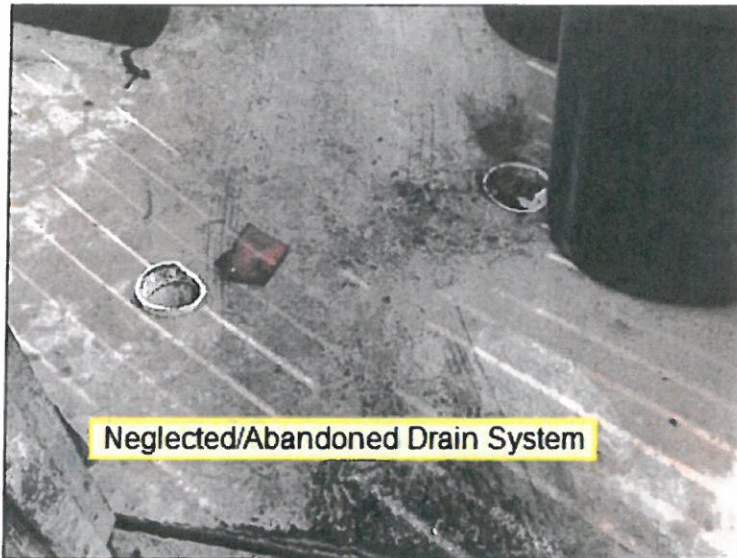
4.0 Picture 1 Drain

4.0 Picture number one shows two PVC drains that appear to have been discarded and left open.

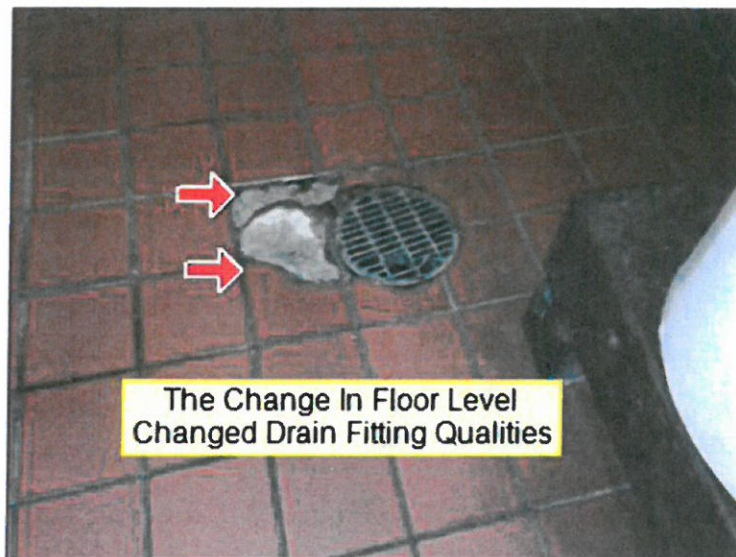
4.0 Picture 2 Kitchen Drain System

The changing of floor heights throughout the kitchen area has made the drain system faulty.

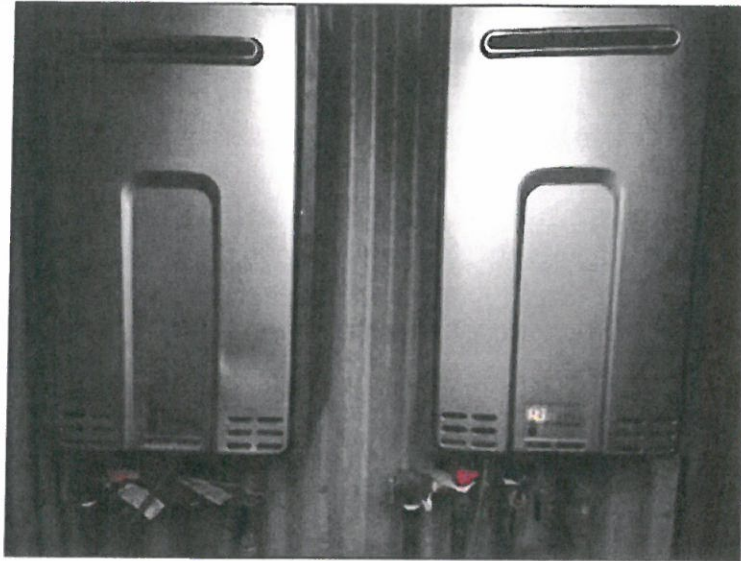
4.2 Picture 1 2 Tankless Units

4.2 The two tankless water heaters shown in picture number one were difficult to access for further inspection due to clutter in the area.

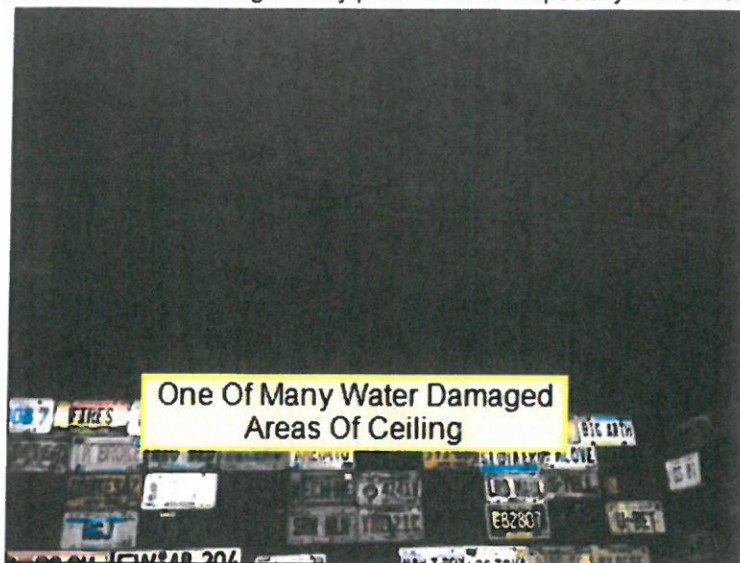
5.0 Picture 1 Ceiling

5.0 The ceilings throughout the restaurant are in generally poor condition especially in the kitchen area..

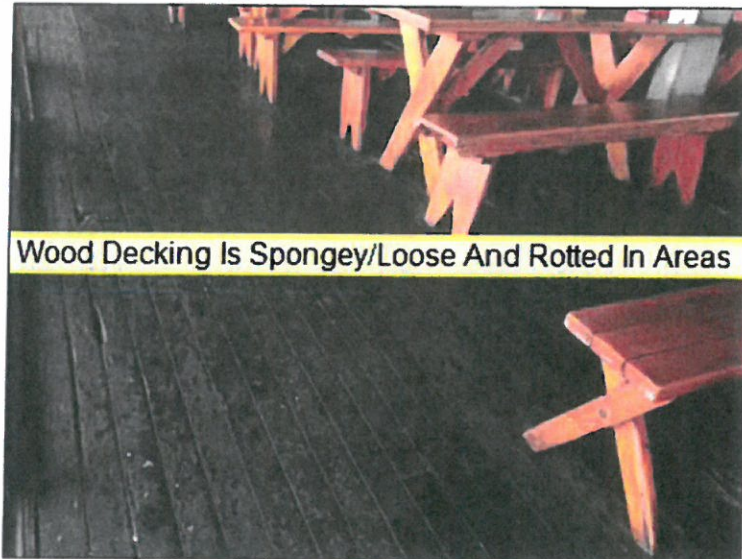
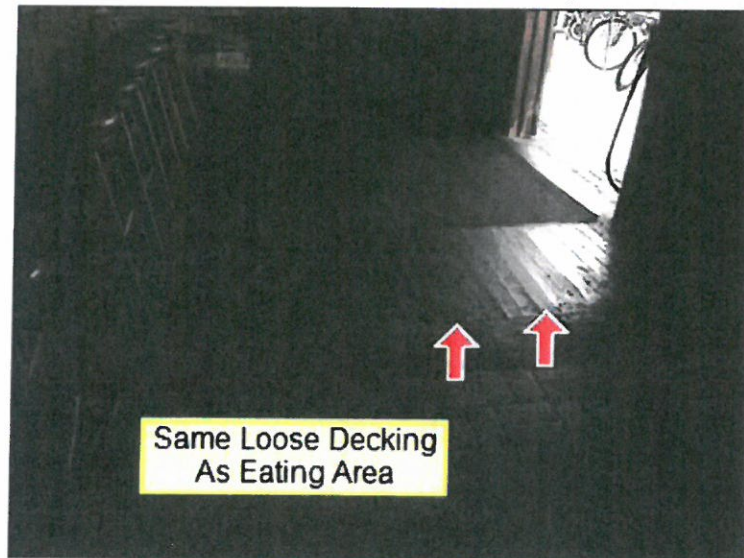
5.2 The floors throughout the restaurant are obviously aged and stand in different degrees of condition. The areas of wood decking painted black are loose and in the process of failure.

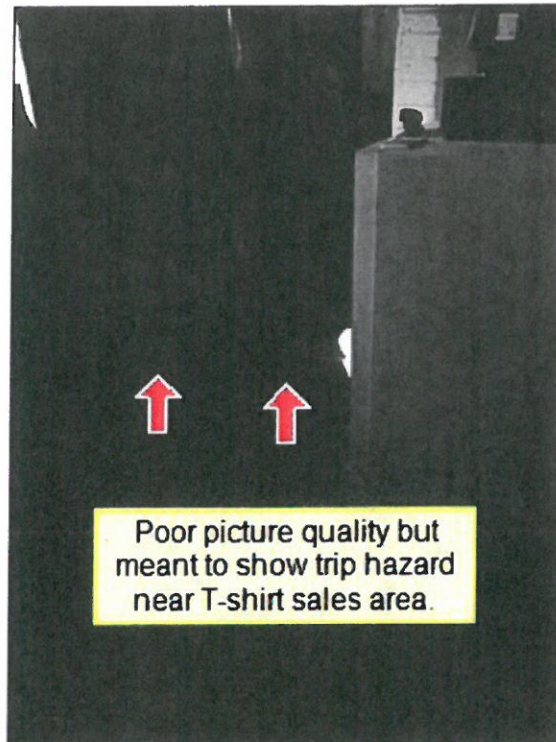
5.2 Picture 3 Trip Hazard

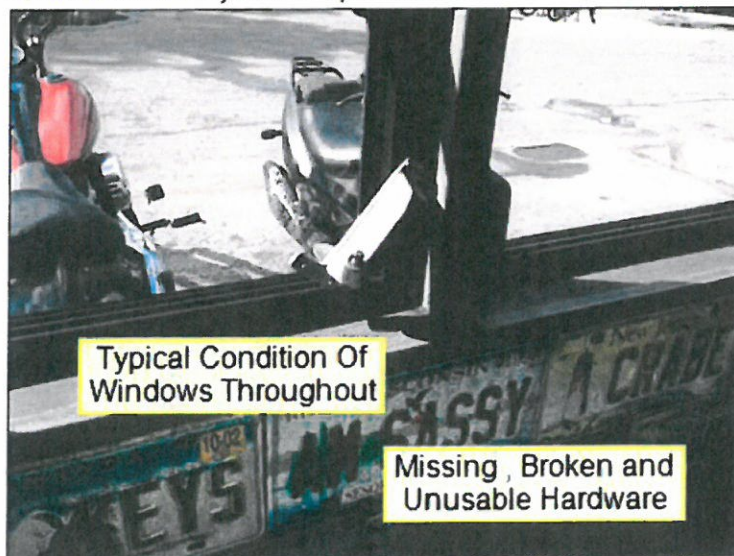
5.4 Picture 1 Windows

5.4 The windows throughout the restaurant are in extremely poor condition. a large percentage are either missing hardware, have hardware that doesn't work or just don't operate at all.

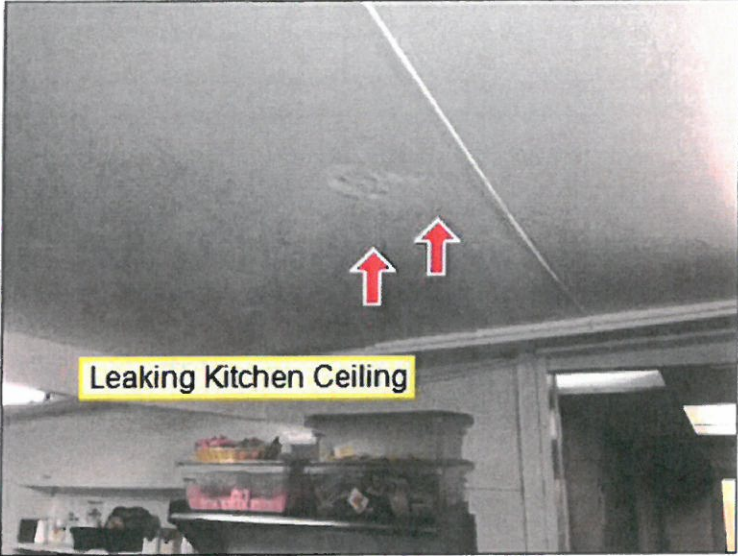
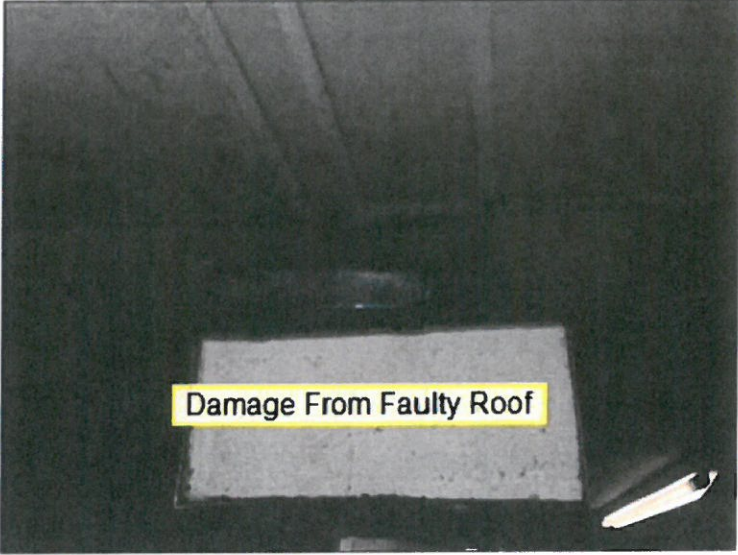
6.0 The kitchen ceilings are in extremely poor condition. There are obviously many areas that leak due to the faulty roof.

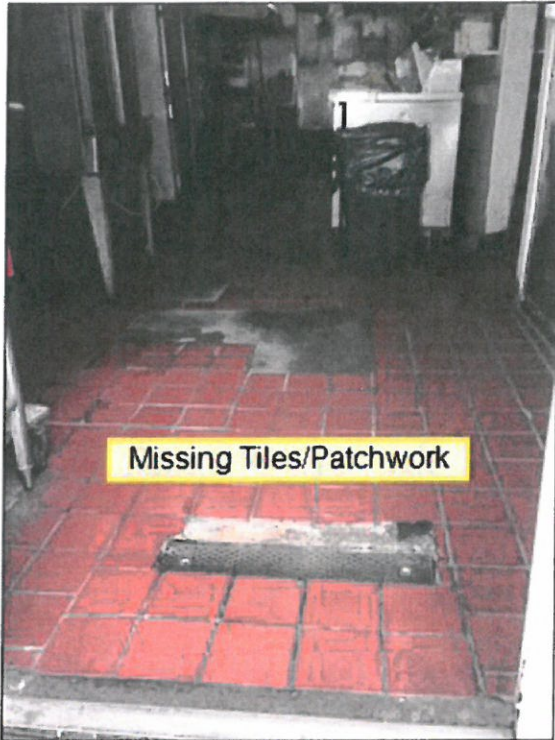
6.2 Picture 1 Kitchen Floor

6.2 The kitchen floor in this aged building has obviously undergone quite a few changes over the years.

Missing Tiles/Patchwork

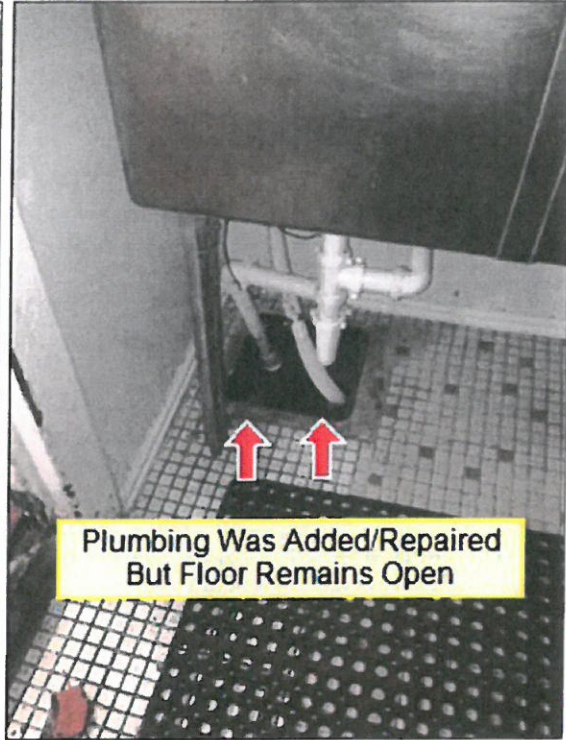
6.2 Picture 2 Kitchen Floor

Plumbing Was Added/Repaired
But Floor Remains Open

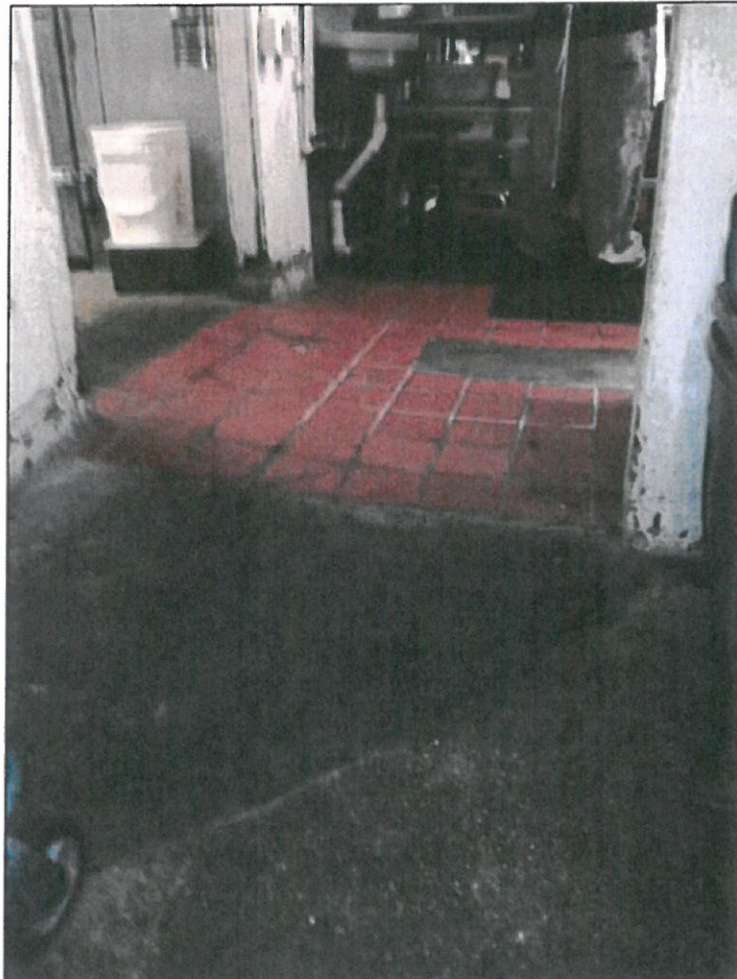
6.2 Picture 5 Typical Flooring Situation

Flooring in this area Does Have Problems
But Some Repairs Have
Been Made

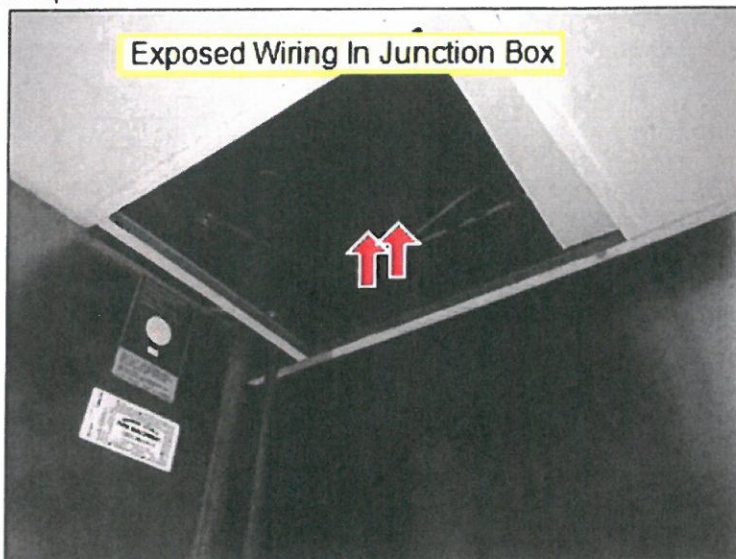
6.8 Picture 1 Kitchen Ceiling

6.8 The outlets and switches throughout the restaurant were in an aged condition and you will notice the exposed wiring in the kitchen ceiling as shown in picture number one.

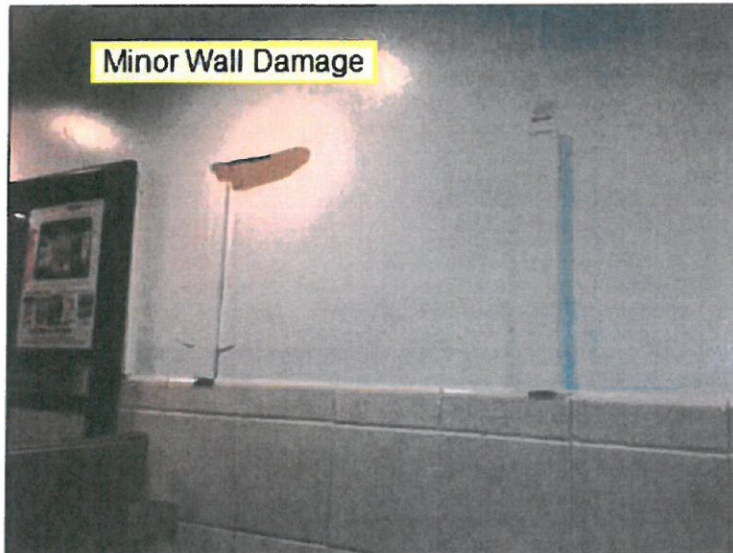
7.1 Picture 1 Mens Bathroom

7.1 Minor damage to the men's bathroom wall as it appears the picture was removed.

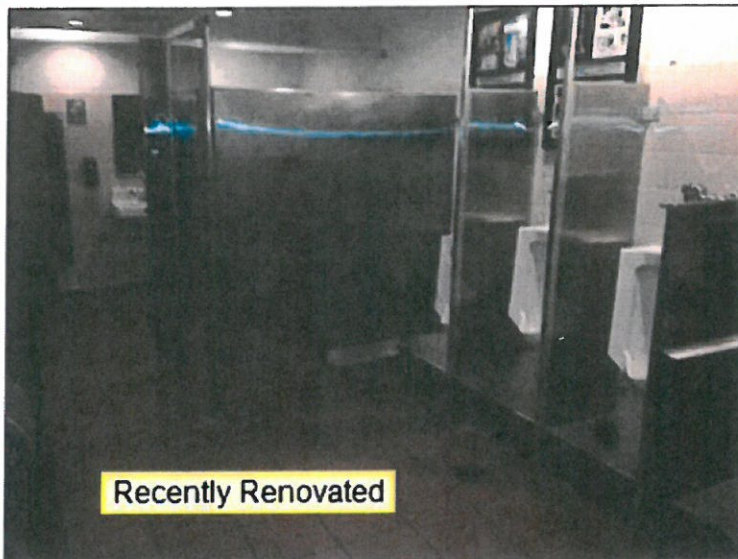
7.5 Picture 1 Mens Bathroom

7.5 The men's bathroom appears to have been recently renovated and was found in good working order with the exception of an open ground at the wall outlet.

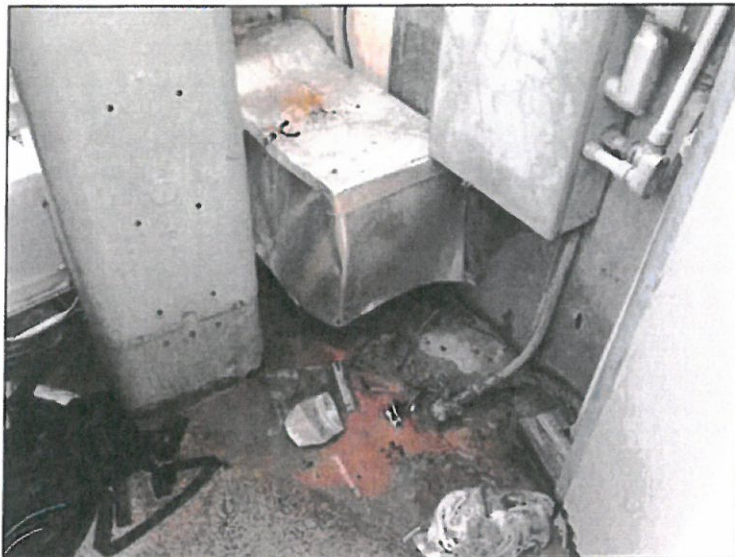
8.0 Picture 1 Service Entrance

8.0 Again, the service entrance is in a poor cluttered , overloaded condition. Consulting a licensed electrical contractor for further evaluation and recommendation is suggested.

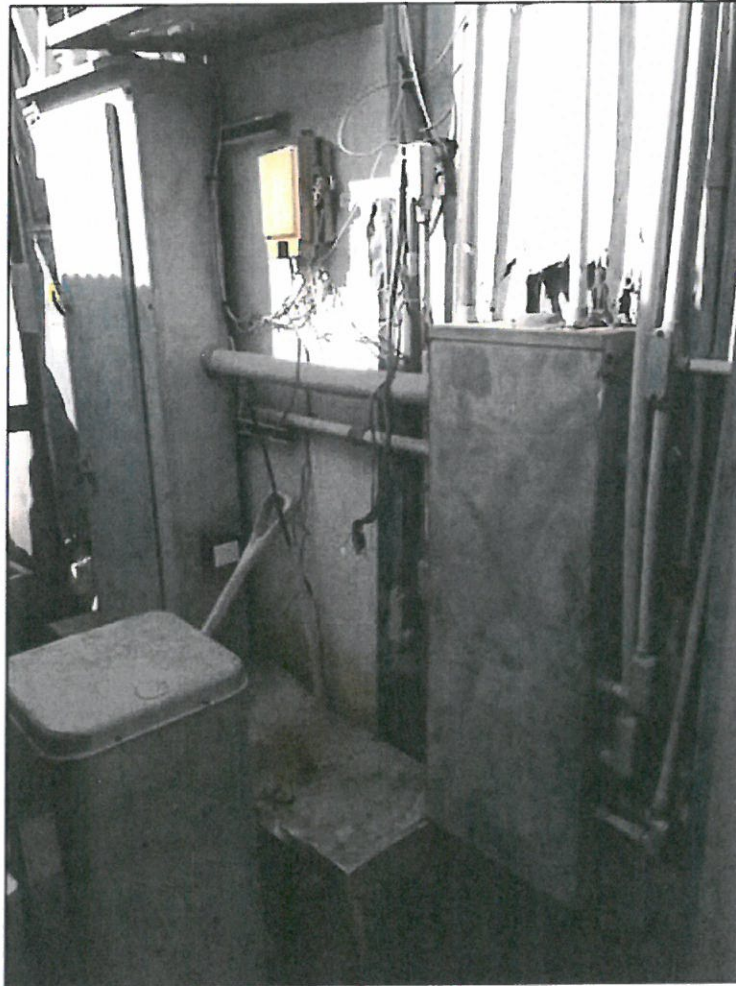
8.1 Picture 1 Underground Service Entrance

8.1 The service entrance as a whole was in poor condition. Loose panels, loose panel covers, overloaded circuits and an extreme amount of moisture in that area makes a poor overall situation.

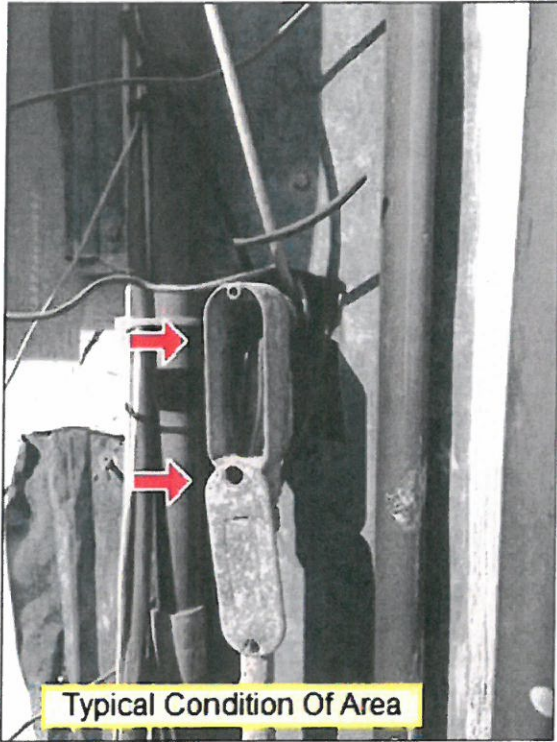
Typical Condition Of Area

8.1 Picture 2 Exposed Wiring

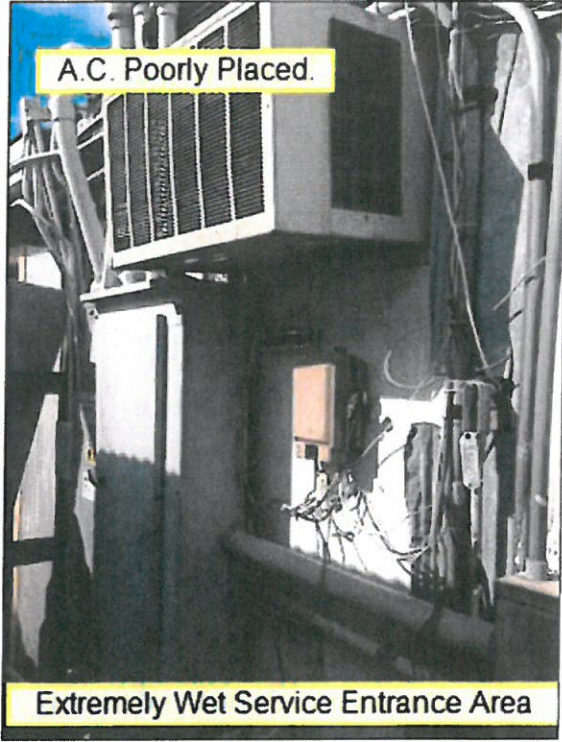
8.1 Picture 3 Main Distribution Panel

A.C. Poorly Placed.

Extremely Wet Service Entrance Area

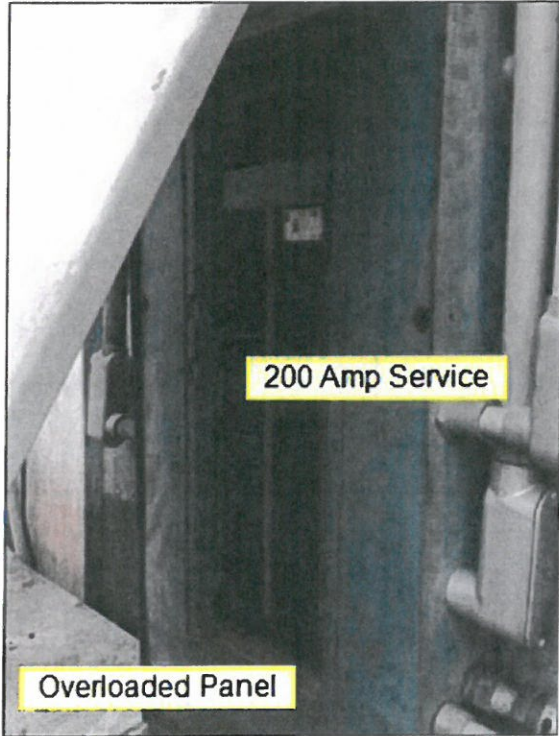
8.1 Picture 4 Distribution Panel

200 Amp Service

Overloaded Panel

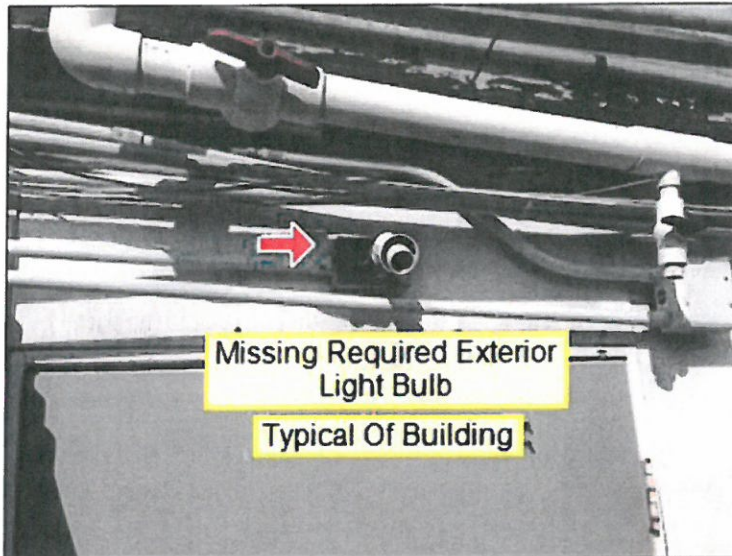
8.3 Picture 1 Maintenance Issues

8.3 This is an old building which made determining functional equipment as opposed to operational equipment very difficult. A lot of the existing conduit/PVC and wiring are obviously obsolete but just left behind. Picture number one shows a typical minor issue at the restaurant.

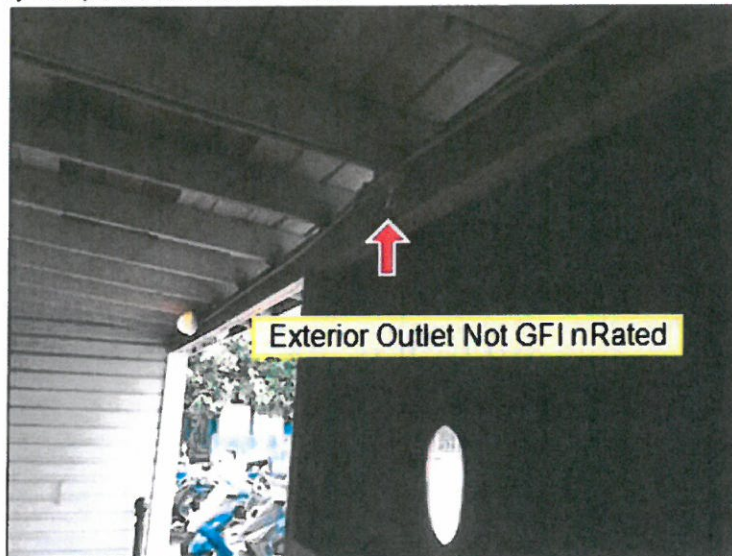
8.4 Picture 1 Front Entry

8.4 The overhead front entry receptacle was not GFI rated.

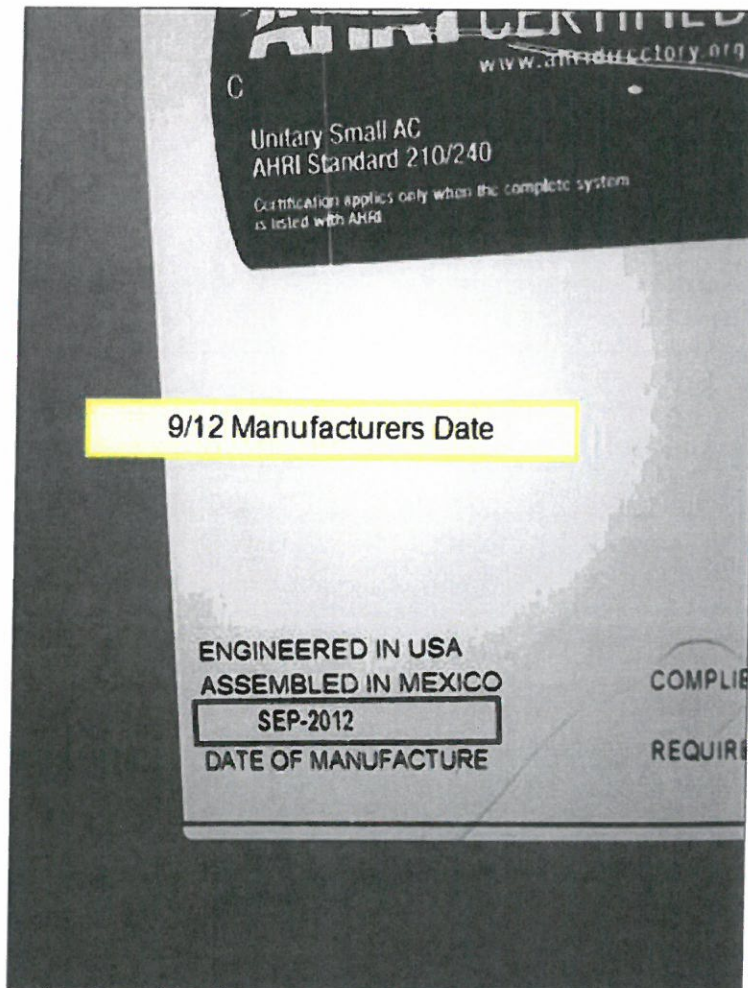
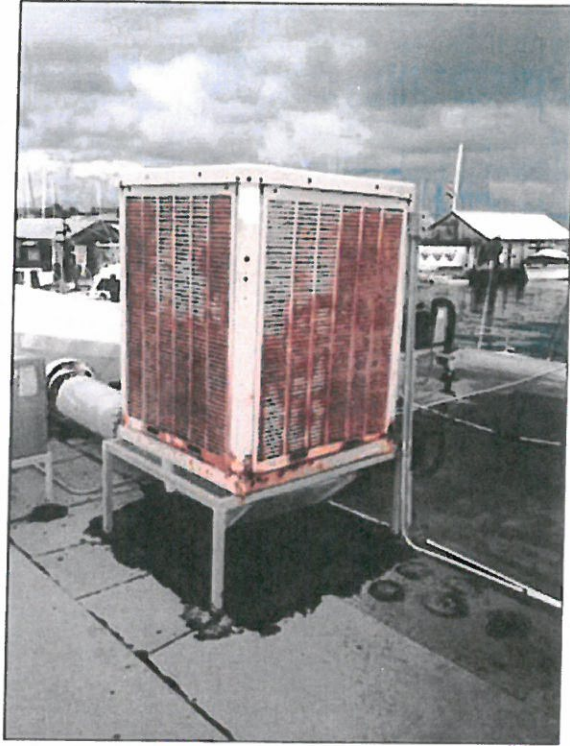
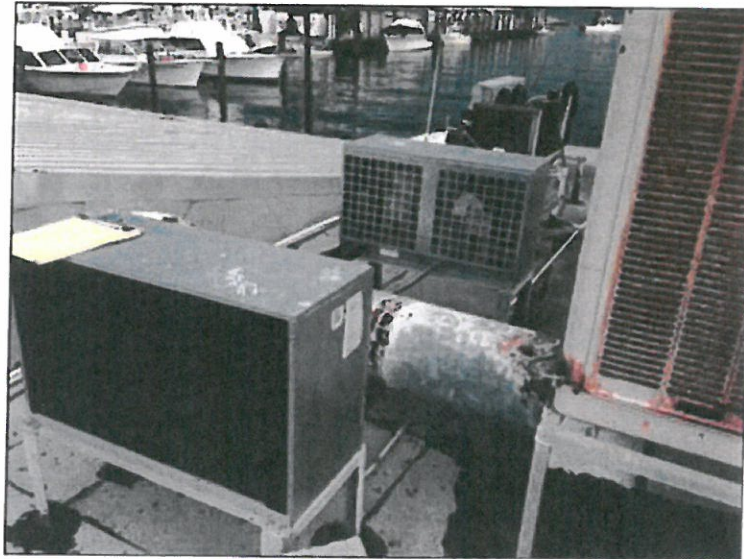
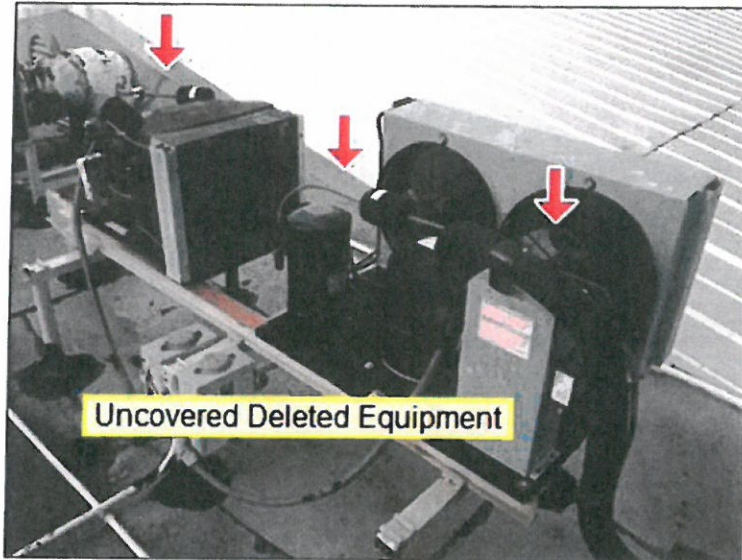
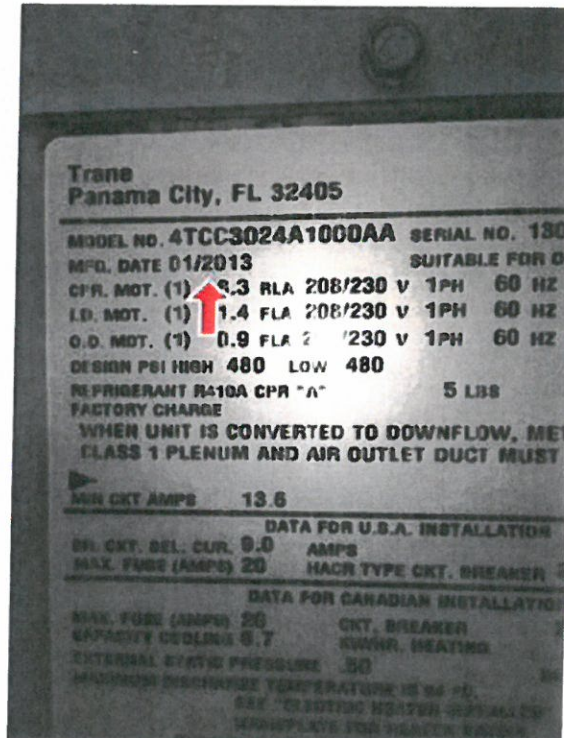
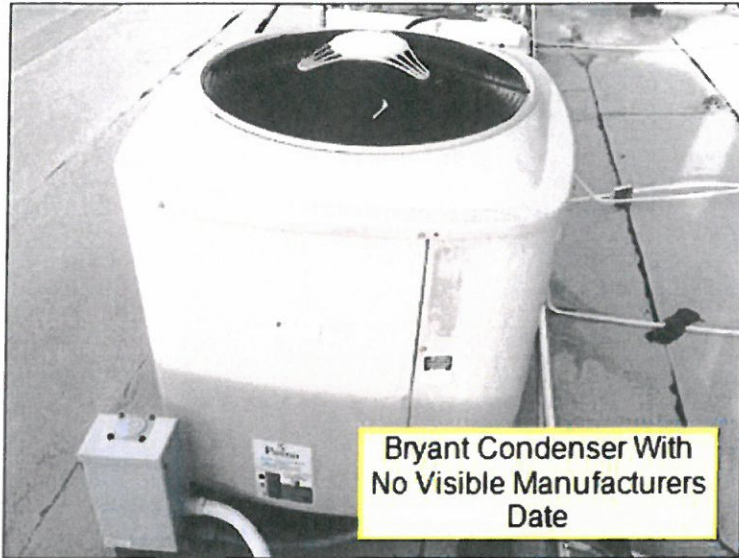
9.0 A lot of the cooling equipment on the property is obsolete. A lot of cooling equipment is in good working order with manufacturer's information present, and a lot of cooling equipment on the property is functional yet no records of manufacturers information could be found.
