**RE: Glynn Archer School
Adaptive Reuse Assessment for us as City of Key West Municipal Offices
Executive Summary**

GLYNN ARCHER ASSESSMENT

BACKGROUND

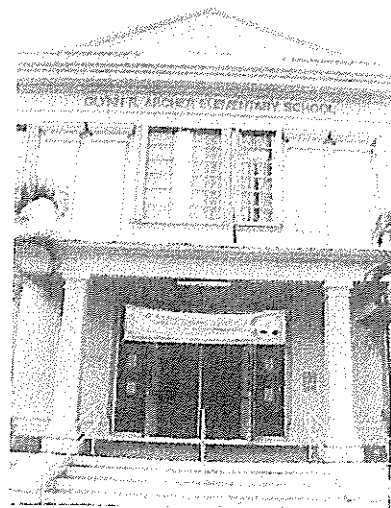
Main entrance to Building A.

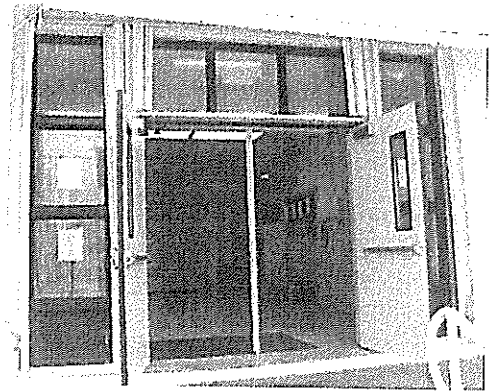
The main entrance doors to the school at the front of Building A. These doors have sidelights and transoms. These doors are contemporary replacements; the original main doors had the configuration of the doors in the photo below.

The contemporary doors of Buildings A and B, while serviceable, are not appropriate to the character of the building, and should be replaced by impact-resistant doors replicating the originals. The historic doors at the rear of the buildings are significant character defining elements, and should be accurately restored.

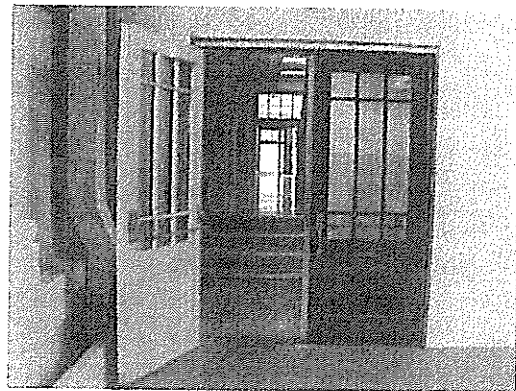
This pair glazed doors at Building A dates from the original construction of the building.

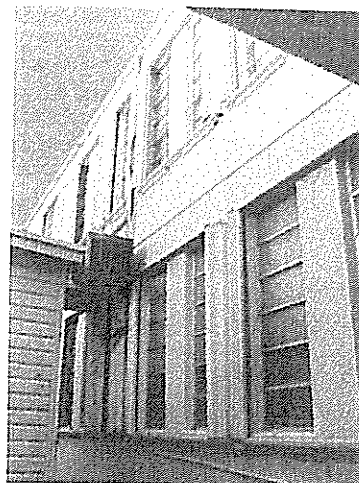
The windows at Buildings A and B consist of 36" wide x 8'-6" tall aluminum 6-lite awning-style windows at the first and second floors. The windows are putty-glazed, and many are deteriorated and non-functional. They are over 30 years old, and are replacements for the original metal windows. All of the windows are covered with accordion style hurricane shutter systems bolted to the exterior of the building, giving the building a haphazard appearance.

Typical aluminum awning-style windows at Buildings A and B. The windows should be removed and replaced with new impact resistant units replicating the originals.

The windows at Buildings A and B are deteriorated and not repairable. They should be removed and replaced with new impact-resistant window units replicating the original windows of the building. This will allow the hurricane shutters to be removed from the face of the building, restoring the clean appearance of the exterior. Additionally,

maintenance staff will not be required to install shutters during each storm event. Energy efficient Low-E glass should be installed to reduce the amount of heat transmission into the buildings. Each of the window openings should be inspected for spalling, and any deteriorated concrete should be repaired before new units are installed.

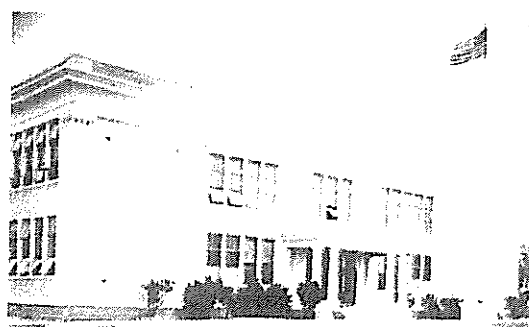
Historic photo of front of Building A, taken in 1926 from White Street. The original metal windows were composed of 3 parts: An operable awning at the top, a stationary window at the center, and another operable awning window at the bottom. New impact resistant windows replicating these originals should be installed in the existing openings.

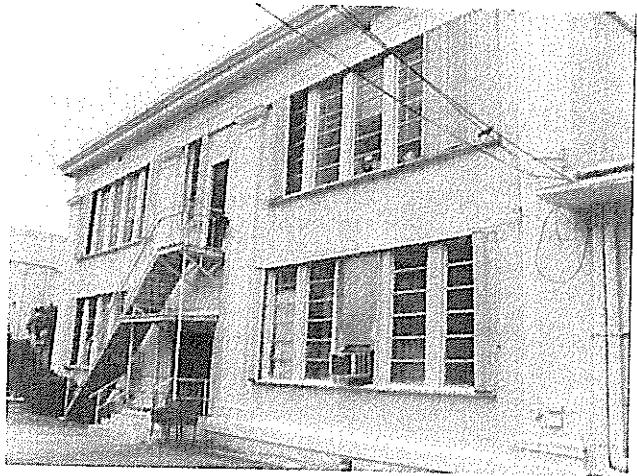
Some peeling paint was found at the exterior of the building, but there are no major signs of spalling concrete. Minor spalling was found around the perimeters of many of the exterior windows, and at the building cornice. There are no signs of settlement or major cracks.

Typical exterior wall at Building A and B. The walls are cluttered by accordion style hurricane shutters, electrical and phone conduit, and air conditioning units.

The exterior penetrations consisting of conduit, wires, panel boards, condensing lines, air conditioning units attached to walls, and accordion shutter systems must be removed to facilitate the exterior envelope restoration. These items are addressed in detail in the applicable sections that follow.

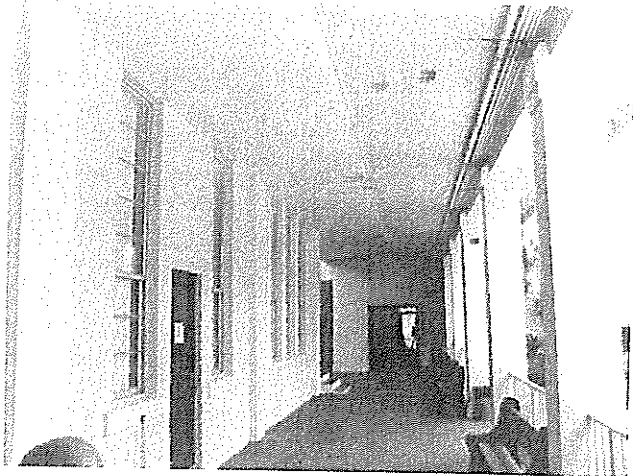
Covered arcade at the north side of the Auditorium.
The north wall of the Auditorium wall is at left.

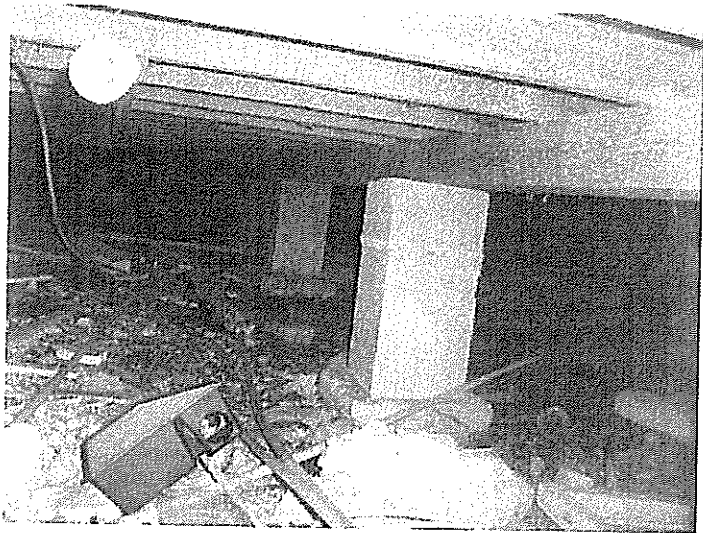
The wood floor framing rests on large wood girders supported by these concrete piers. There was no sign of cracking, settling, spalling or damage to the concrete perimeter footing or the interior concrete piers. According to the Engineering Report by Seatech dated May 5, 2010, the wood floor framing was in good condition, with the exception of some areas "underneath plumbed spaces where rotted wood was observed, but the general condition of the floor joists and sheathing was good"

Typical interior foundations at Building A. The wood framing, seen at top, bears on girders, which in turn bear on concrete pier footings. All debris under the building should be removed, and damaged girders and framing should be sistered with new material, or replaced.

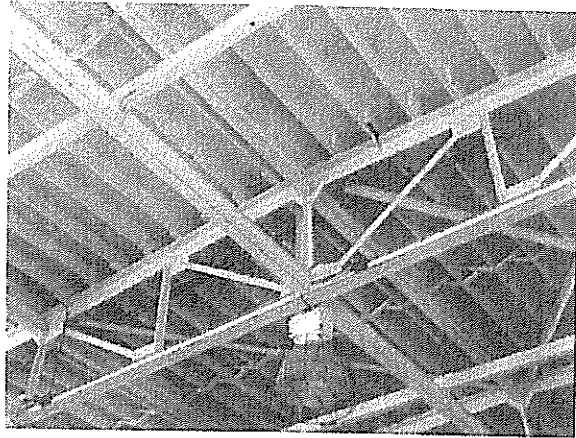
The roofing at the Gym is composed of built-up roofing, with no signs of significant leakage. The roof structure is composed of wood sheathing over wood framing members, which in turn bear on steel trusses spanning the Gym. According to the Engineering Report by Seatech dated May 5, 2010, the roof framing members are in poor condition, with some roof framing members requiring immediate replacement.

Interior view of the Gymnasium, showing the internal roof structure. The roof bears on wood framing, which in turn bears on steel trusses spanning the Gym. Deteriorated wood framing members should be replaced or sistered with new material.

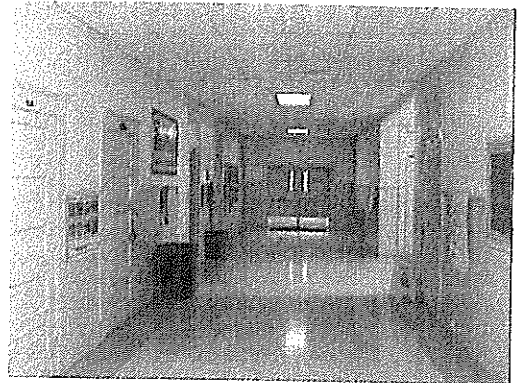
The ceilings at Buildings A and B consist mostly of lay-in acoustic tile systems. At the first floors, the lay-in ceilings have been installed between 1 foot and 4 feet below the original ceiling, to accommodate piping and electrical conduit. The original ceilings consisted of plaster over lath, with an original ceiling height of approximately 13'-4". The original ceilings are deteriorated, and much of the plaster has been removed down to the lath. The existing lay-in ceilings are worn but serviceable, with heights that vary in almost every room.

View of interior hallway at Building A, showing typical lay-in acoustic ceiling systems.

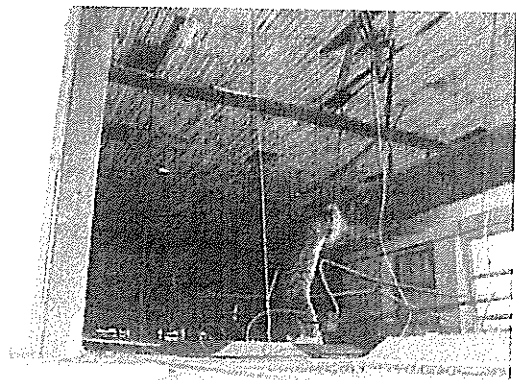
The original ceiling can be seen above the existing lay-in acoustic ceiling. It consisted of plaster over lath, and is at least four feet higher than the current ceiling. The original lath can be seen at the top of the photo. The lay-in ceiling should be removed and the plaster and lath ceiling should be restored.

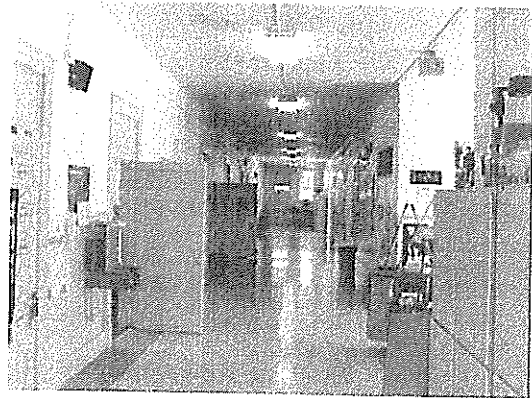
View of hallway at Building A, showing typical finishes at the school: Vinyl tile flooring, stucco walls covered with bulletin boards, and lay-in acoustic ceilings. The original painted wood 5-panel classroom doors can also be seen. These doors originally had transoms above them for air circulation.

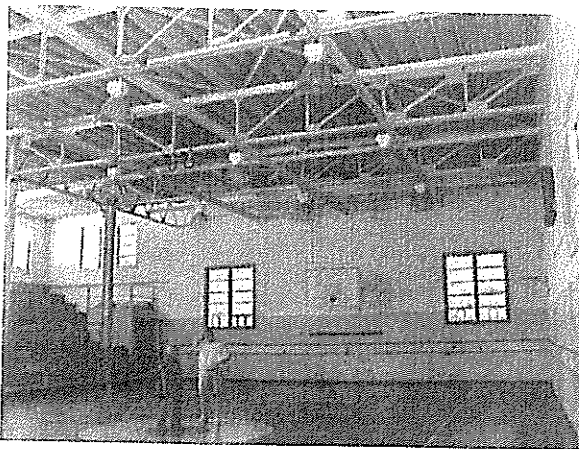
The finishes at the Gymnasium are much more utilitarian in nature, consisting of polished wood floors for basketball, and ceilings exposed to the structure. The reinforced concrete and masonry structure of the walls is currently exposed. It is likely that there was another finish on these walls, which has been removed or has deteriorated. All of the electrical fixtures in the Gym are covered with wire cages to prevent breakage. Additionally, there are locker rooms and showers in the gym, which are deteriorated.

View of interior of Gymnasium Building, showing wood floors marked for a basketball court, stucco walls, and exposed trusses at ceiling.

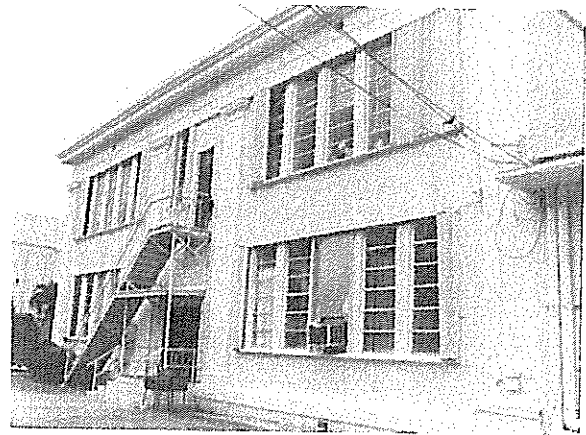
The electrical systems are amalgam of various systems added over the lifespan of the building, with numerous panels, subpanels, and conduit installed as needs dictated. It is outdated and should be replaced.

View of exterior of building A, showing different electrical lines, air conditioners and telephone boxes attached to the building. All of the building exteriors are cluttered with these components, all installed where convenience dictated. Installation of these elements also created multiple penetrations in the building envelope, each of which is a source of water intrusion.

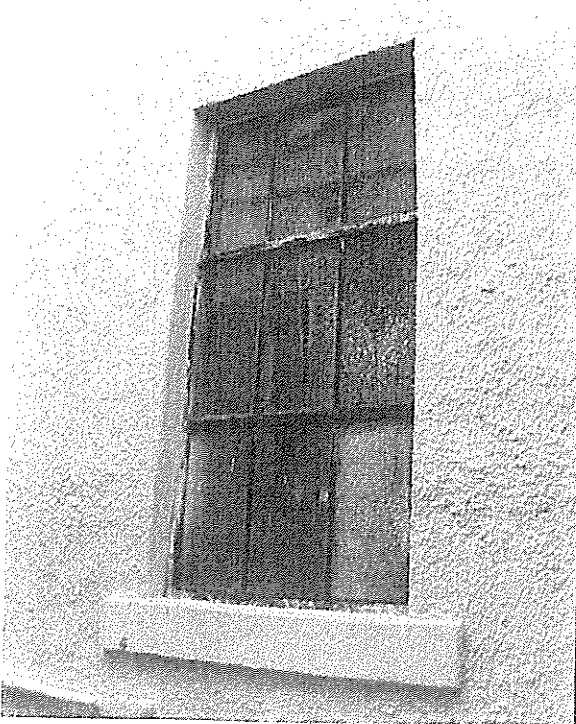
A historic metal window was found at the rear of the Auditorium.

This window can be used as a pattern for the new metal impact resistant windows.

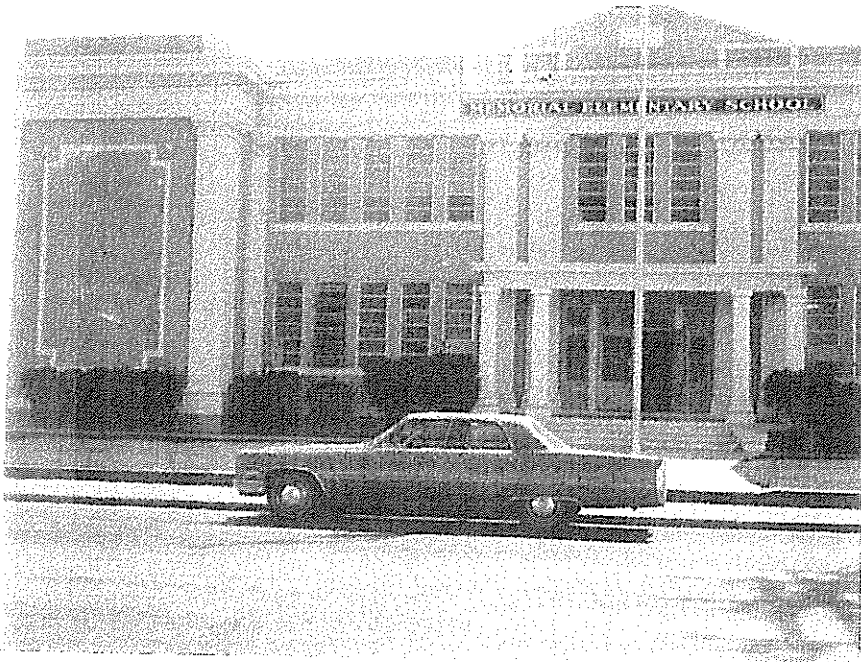
Photo of Building A taken about 1970, when the Building was called Memorial Elementary School. (A 1966 Cadillac sits out front)
The original windows have been removed and replaced with the windows seen today. The front doors of the building are still original.
