REPORT AND
RECOMMENDATIONS

**ARCHITECTURAL CONDITIONS
AT THE CORNISH MEMORIAL
A.M.E. ZION CHURCH**

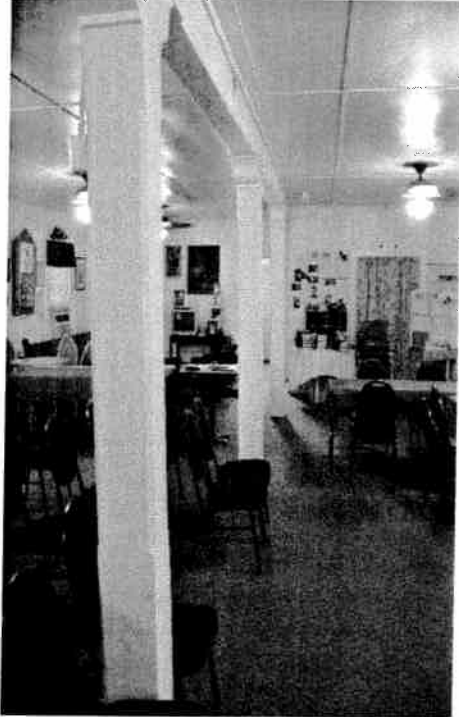
Figure 15 Racked Columns

While the major structural components of the building are in serviceable condition (see the Structural Engineers report), modifications over time have compromised the structural integrity of the church as a whole. This is evident because the building racks (leans) to the Southeast between seven and eight inches (7"-8") to the Northwest from eave to ground at the center of the building side walls (Figure 14) while the front and rear gable walls lean approximately three inches (3"). This is visible from the street and inside the first floor meeting hall where the 8x8 columns are noticeably out of plumb from 1-1/2" to 3-3/4" in ten feet of height (Figure 13).

Wind loads are the most probable cause of the racking.

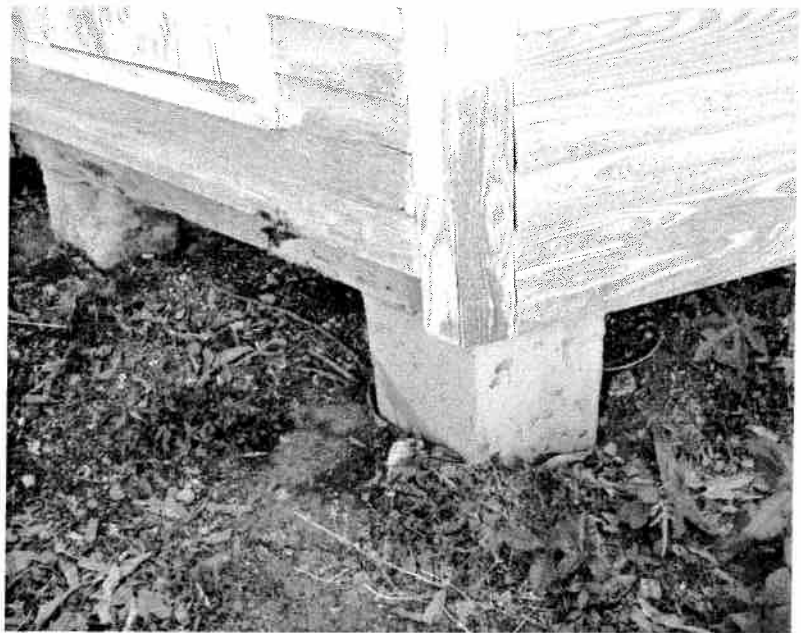
Figure 17 Foundation Piers

The ground floor of the church rests upon the foundation piers, creating an eighteen inch crawl space (Figure 17). Floor framing consists of two central parallel 6"x 9" longitudinal beams 11'-3" apart, traversed with 3"x 10" floor joists spaced eighteen inches apart running from beam to 6"x 7" continuous sills (Figure 18). The floor sheathing, which is also the finish floor and consists of 1x4 (7/8"x 3-7/8") tongue and groove fastened to the floor joists. Intermittently, 2x8s have been added between the floor joists in an effort to stiffen the framing.

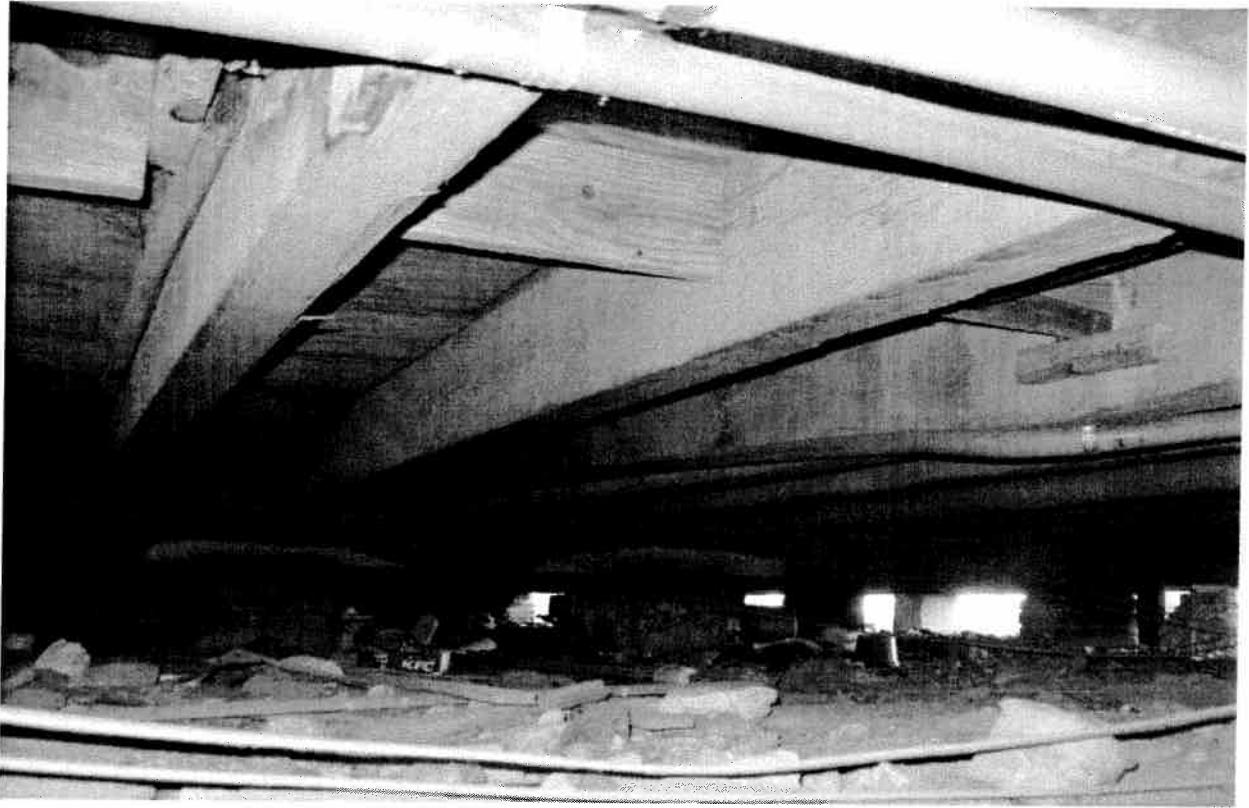
Figure 18 Crawl Space and Ground Floor Framing

Generally, the ground floor framing appears to be dry and in good condition except for what appears to be sill damage at the Southwest corner. It is transversely level at the front

(East) end of the building but progressively settles out of level from the center of the building to the South wall, from 1" at the Southwest corner of the Pastor's office to 6" at South West corner of the building. The building is generally level in the longitudinal axis from the center of the building to the North Wall (Figure 19).

8. Correct the sill and foundation condition at the Southwest Corner to reduce the differential settlement.

Jack and replace the existing sill, and rebuild the foundation below it.

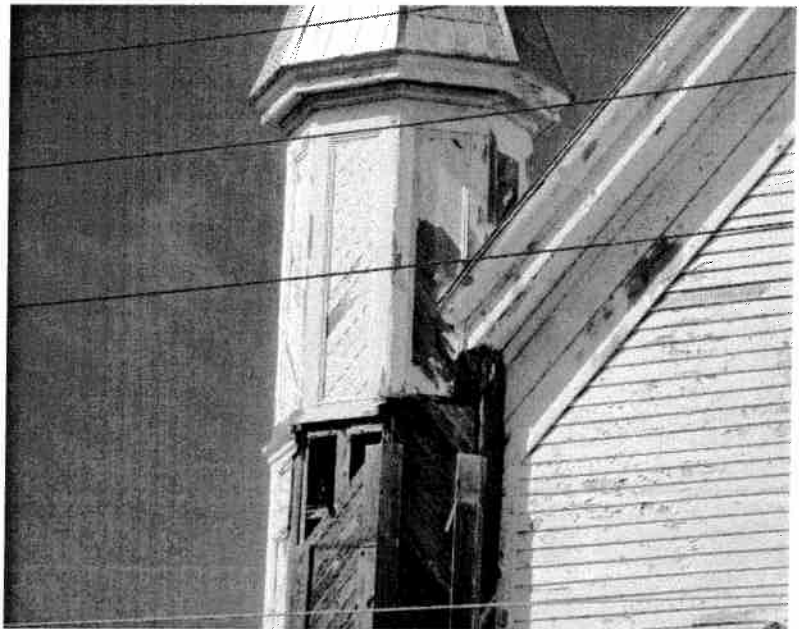
Figure 23 Turret Damage

Turrets are constructed in two ways: the original structure, which was post and beam and, from the 1990 repair work, with pressure-treated 2x4 materials. The 1990 framing has deteriorated significantly more than the original. The turret sheathing consists of 1x6 diagonal boards and is exposed to view as paneling between trim boards. Contemporary sheet metal connectors have been added to some of the timbers. The turrets have suffered deterioration more than any other major building component (Figure 23).

7. Rebuild and repair the corner turrets.

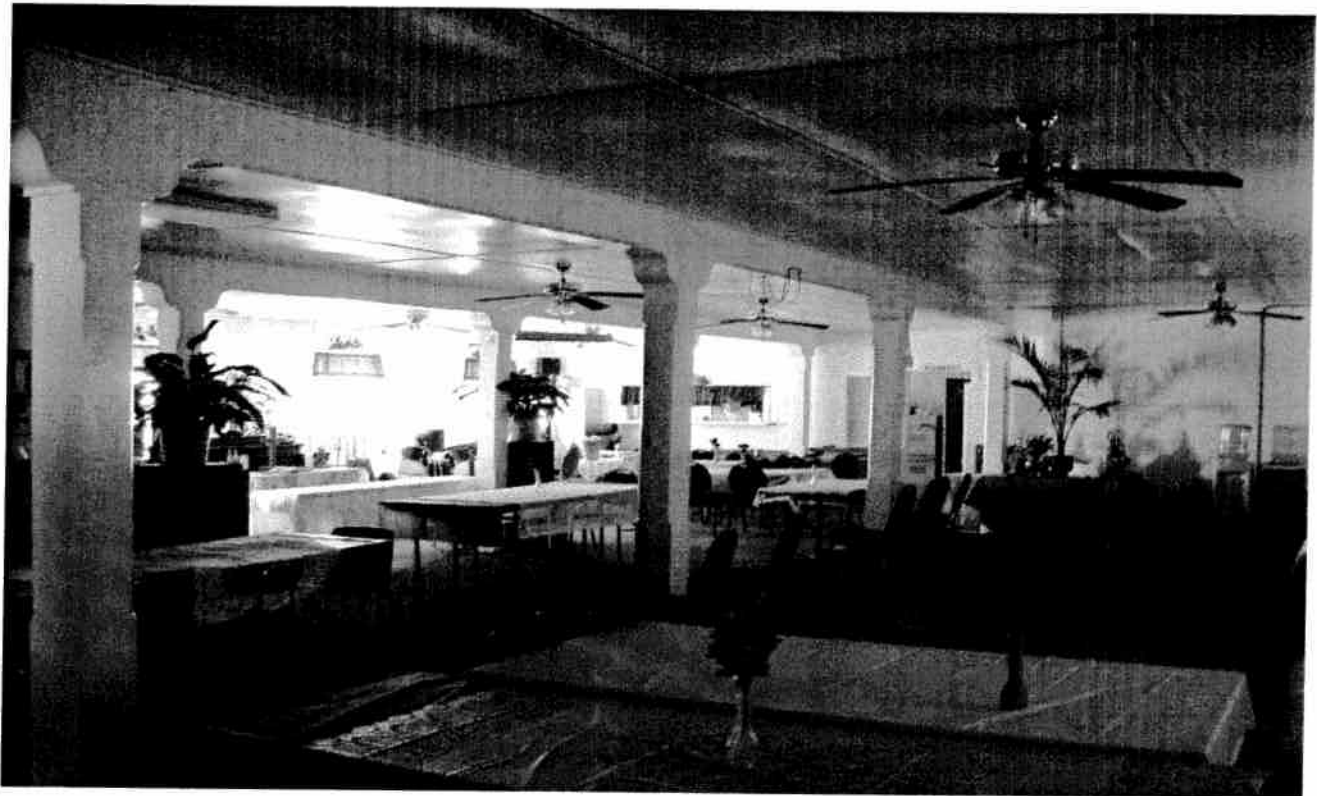
Figure 24 Second Floor Supporting Columns (View of Fellowship Hall)

from beam to exterior wall. The second floor floor sheathing, which is also the finish floor (floor boards), consists of tongue and groove 1x4s (7/8"x 3-7/8"). Their condition is poor, with extensive termite damage.

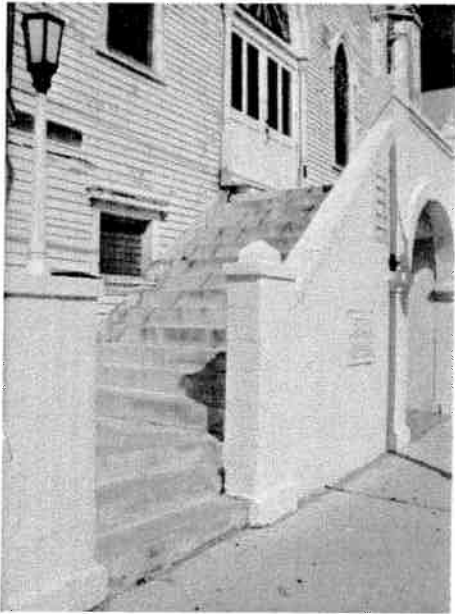
Figure 27 Stairs

Spalling, a sign of corrosion of steel within concrete. The stairs do not meet the Florida Building Code for tread and riser proportions or handrail provision and can be considered hazardous (Figure 27).

The only area explored for damage is the top landing slab and because it is seriously damaged from spalling it can be assumed that other areas could be damaged as well. Thus the repair of the stair could be extensive, even requiring it being partially or completely rebuilt.

10. Repair/rebuild the concrete stair at the front of the church.

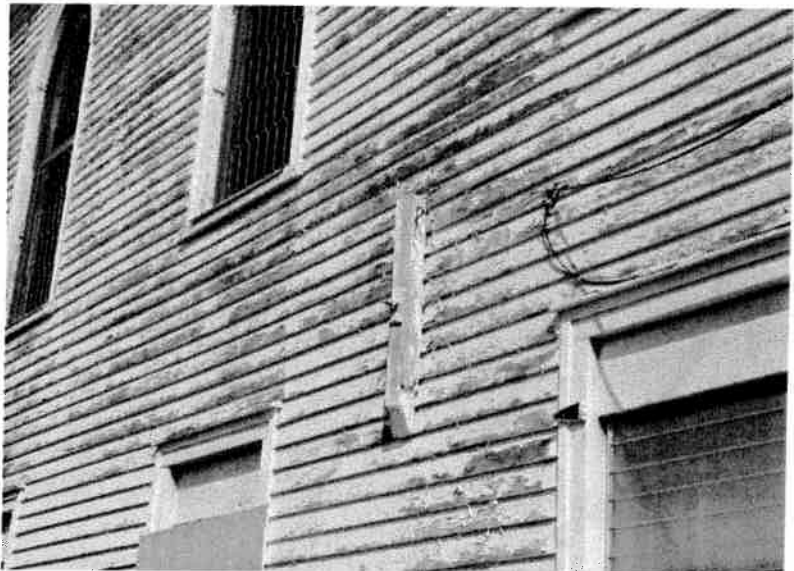
Figure 31 Exterior Wall

There is minor evidence of mildew on the interior walls, but the exterior siding, having lost so much of its paint suffers from dry rot, insect damage, and damage from exposure to the elements (Figure 31).

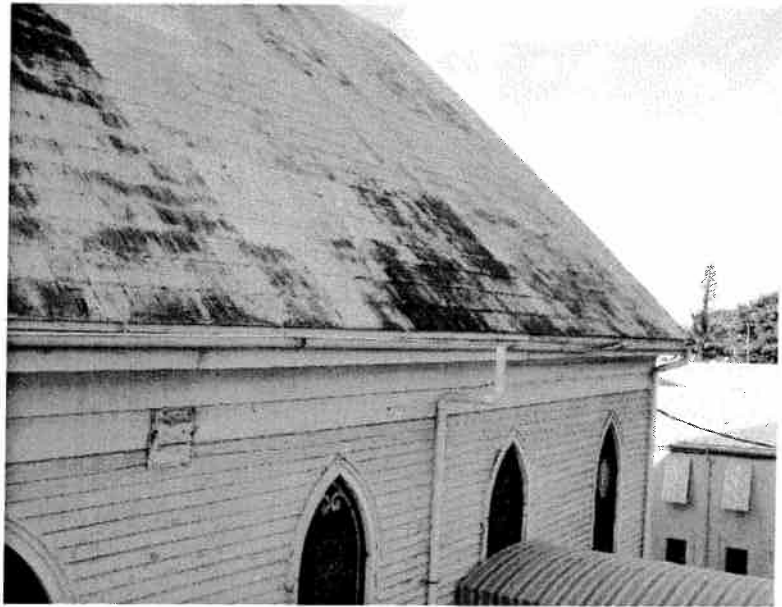
Figure 33 Roof

The roof covering consists of 29 gauge galvanized metal shingles upon rosin paper nailed to the original wood roof sheathing. The shingles are forty to fifty years old and at the end of their useful life. They exhibit extensive rust on the surface and there are many leaks that have damaged the ceiling below. (Figures 33, 34, and 35).

1. Replace the existing roof, gutters, downspouts and flashing.

Repair all rotten and damage areas of the existing roof sheathing.

Replace the existing 29 gauge shingles with 24 gauge shingles.

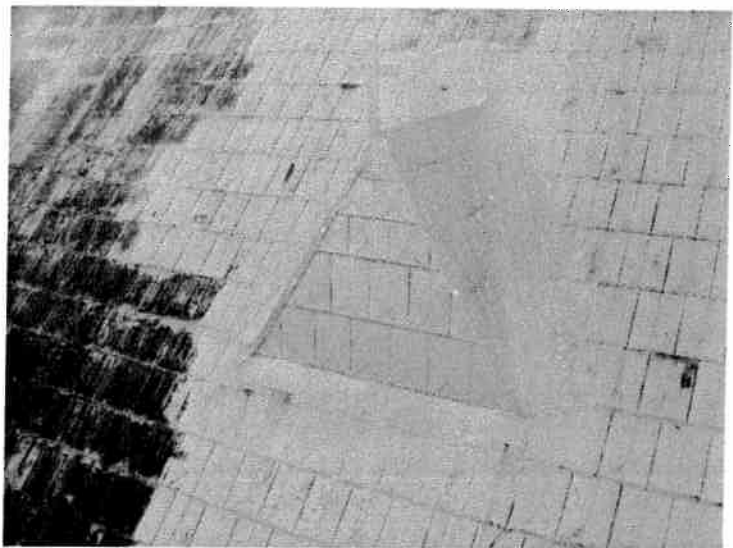
Figure 39 Original Roof Ventilation Dormers (Closed)

The church has four original ventilation dormers high on the roof but they have been closed and covered with roof shingles (Figure 45). The gutters are 6" half-round galvanized steel and the downspouts are 4" diameter galvanized steel round. Some downspouts are missing; others hang loosely from the gutters.

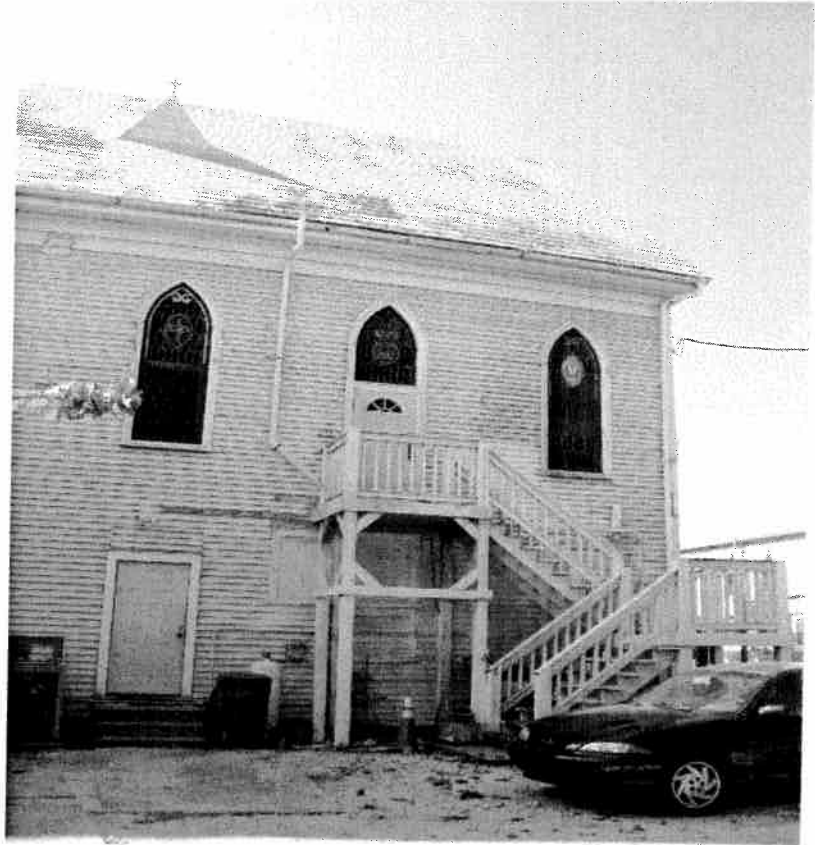
Figure 43 Rear Egress Stair

A wood stair has been constructed at the rear of the church outside the rear egress door to provide emergency egress for the sanctuary. It is approximately twenty years old and shows considerable rot at the ground level where the stringers and supporting posts are in contact with the soil. It is also in violation of the code with respect to tread and riser ratio (Figure 43).

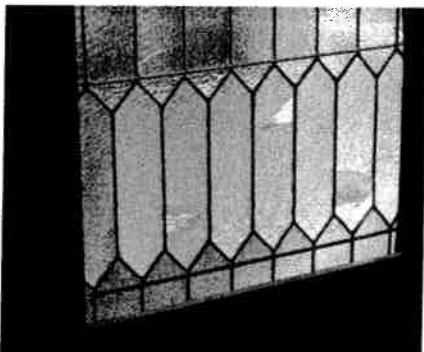
Figure 44 Stained Glass Damage

The stained glass windows are in good condition generally, with few broken panes. The jalousie windows on the ground level are in deteriorating condition, largely non-operational and in some instances sealed with exposed expandable foam insulation (Figure 38). The crescent-shaped window frame is badly deteriorated and allows water to penetrate into the exterior wall.

7. Repair, replace, and protect the stained glass windows.

Repair the broken stained glass windows.

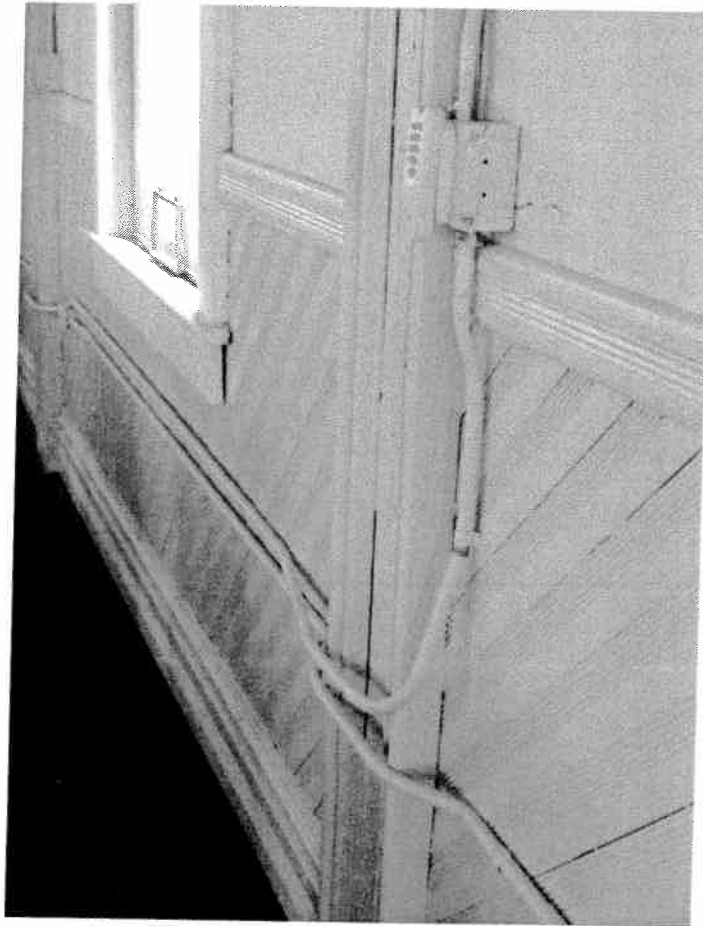
Figure 51 Conduit on Woodwork

Because the church was built before the advent of electricity over time the electrical wiring has been installed on the surface of the walls and ceiling. This has resulted in visible conduit attached to the face of the walls and woodwork (Figure 51), diminishing the woodwork's appearance.

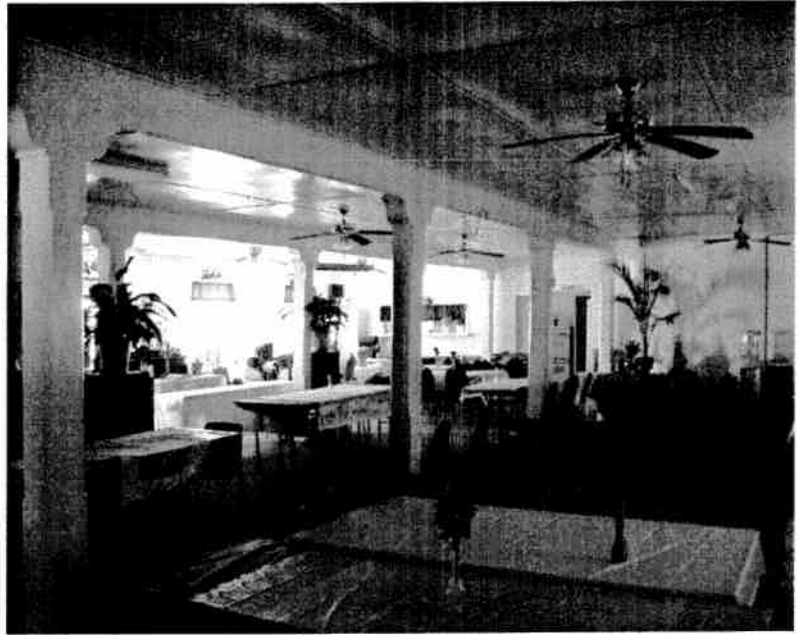
Figure 53 Ground Floor Fellowship Hall

The walls and ceiling framing are covered with a type of "Masonite" wall board and are painted. Considerable sagging was observed. (Figure 53). The columns in the space are 8"x 8" timbers and are painted. They show superficial termite damage.

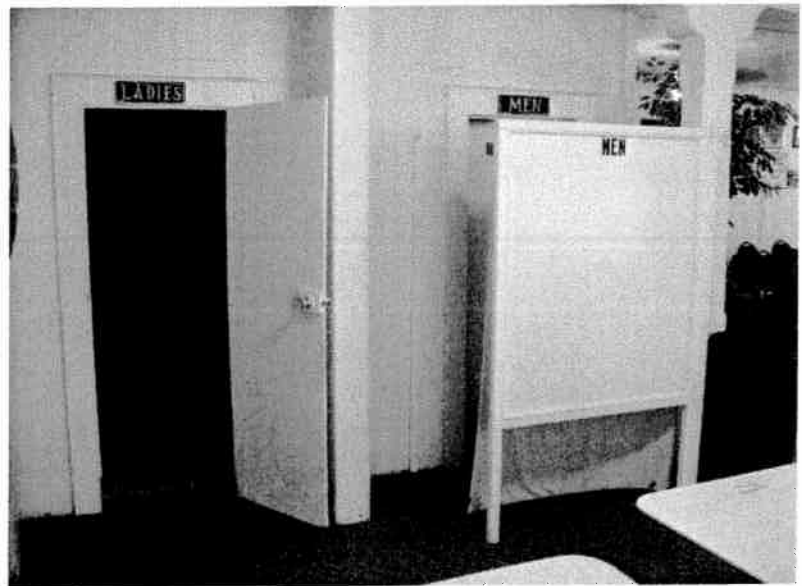
Figure 56 Bathrooms

The bathrooms are located on the ground floor and, while clean, are in aging condition (Figure 56). There are three water closets, one urinal, and three lavatories. They are neither adequate for the occupancy load of the church or are they ADA compliant.

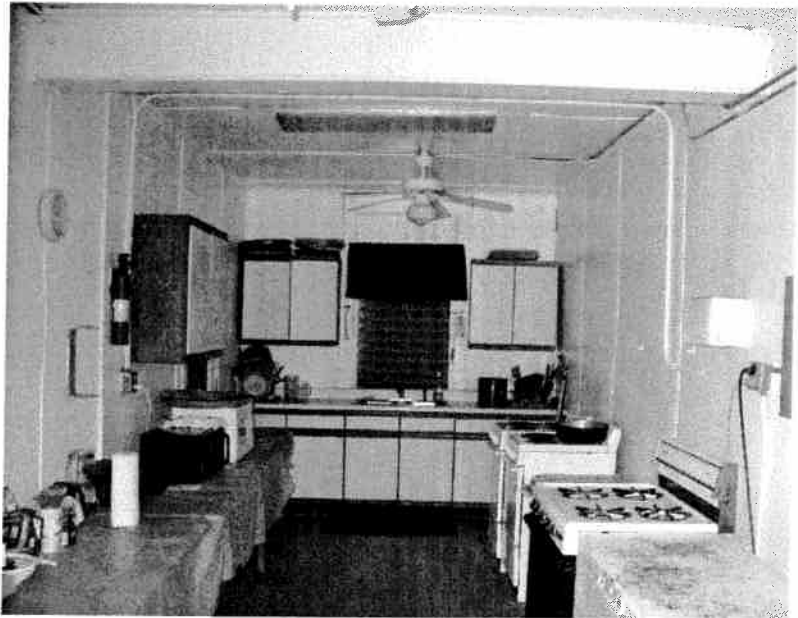
Figure 57 Kitchen

The kitchen is one large room at the back of the ground floor and contains one double sink, two electric stoves, one gas stove, two wall ovens, one microwave oven, one freezer, and two refrigerators. All of the appliances are residential grade in more or less serviceable condition and more or less adequate for volunteers to cater events (Figure 57). It does not meet the state code for its purpose.

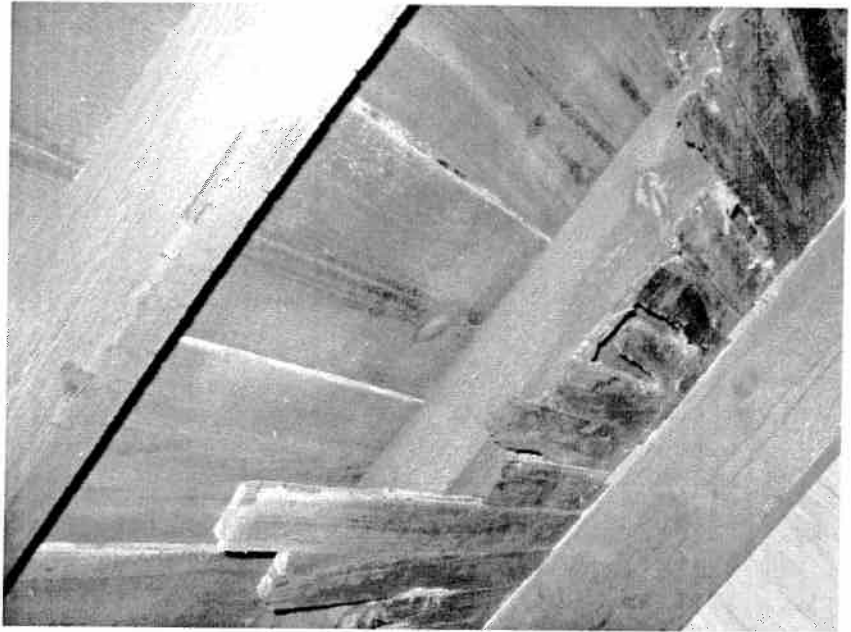
Figure 59 Evidence of 1964 Fire

The church suffered a fire in 1964 in the area of the attic. Part of the roof burned through and some of the exposed structural beams in the attic were charred. The roof was repaired with plywood sheathing—perhaps at the time the current roof was installed—but the charred beams were left intact. These remain to view today (Figure 59).

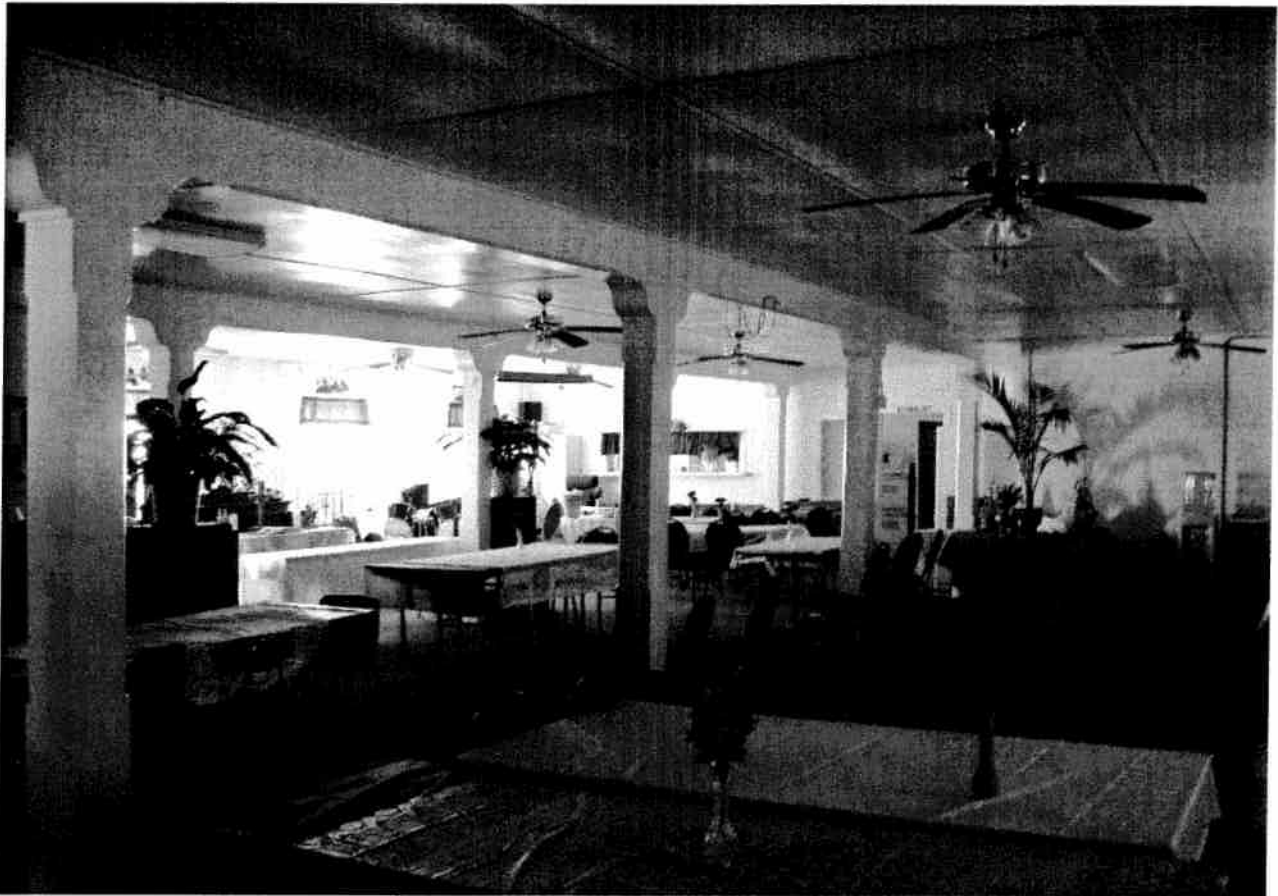
Figure 62 First Floor Interior Lights

First Floor Interior: Lighting on the interior of the ground floor consists of a combination of economy-grade residential ceiling fans with light kits and florescent ceiling fixtures (Figure 62) in the fellowship hall. They are in poor working order.

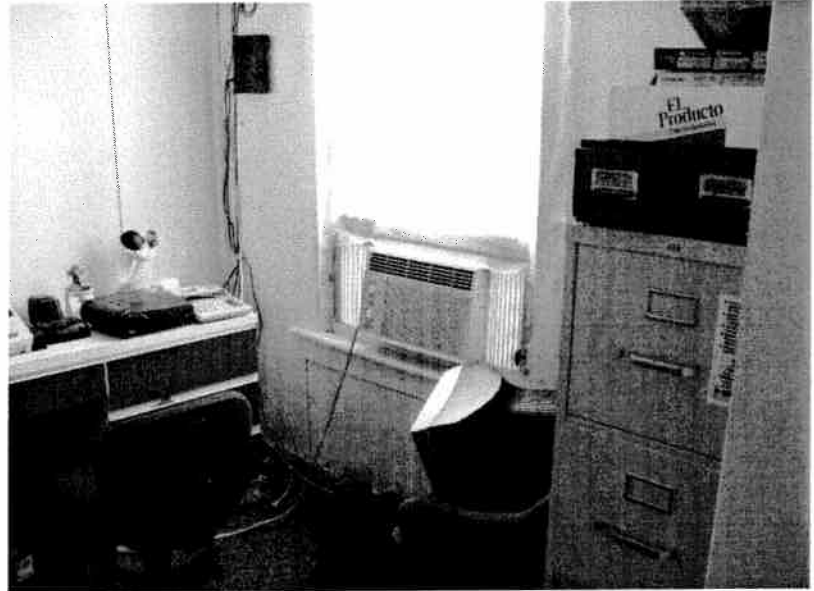
Figure 70 Window Unit

Ground Floor: There are five window units, of 3/4 to 1-1/2 tons (Figure 70). Four are serviceable, the others in varying stages of life. They are used frequently, as the Fellowship Hall is used during the week by different religious groups. They are no doubt inefficient by today's standards and contribute to high energy costs.

3. Replace the window units on the First Floor with high SEER ductless split system air conditioners.
