**TREE COMMISSION TREE REMOVAL REPORT
CITY of KEY WEST**

PROPERTY: 1716 United St

APPLICATION NUMBER: T2025-0279

REQUEST: The applicant is requesting removal of the Sapodilla tree & Strangler Fig.

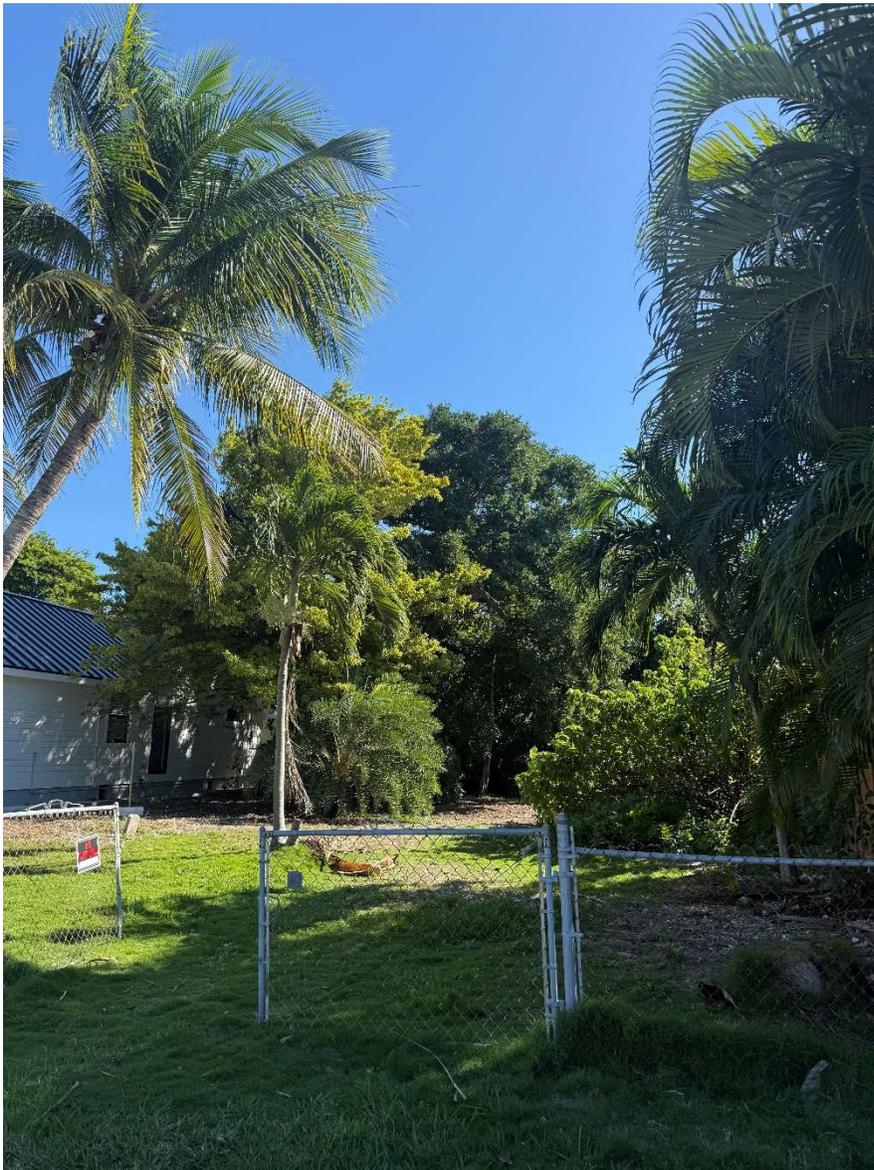
Both trees can be seen from the street due to the lot being undeveloped.

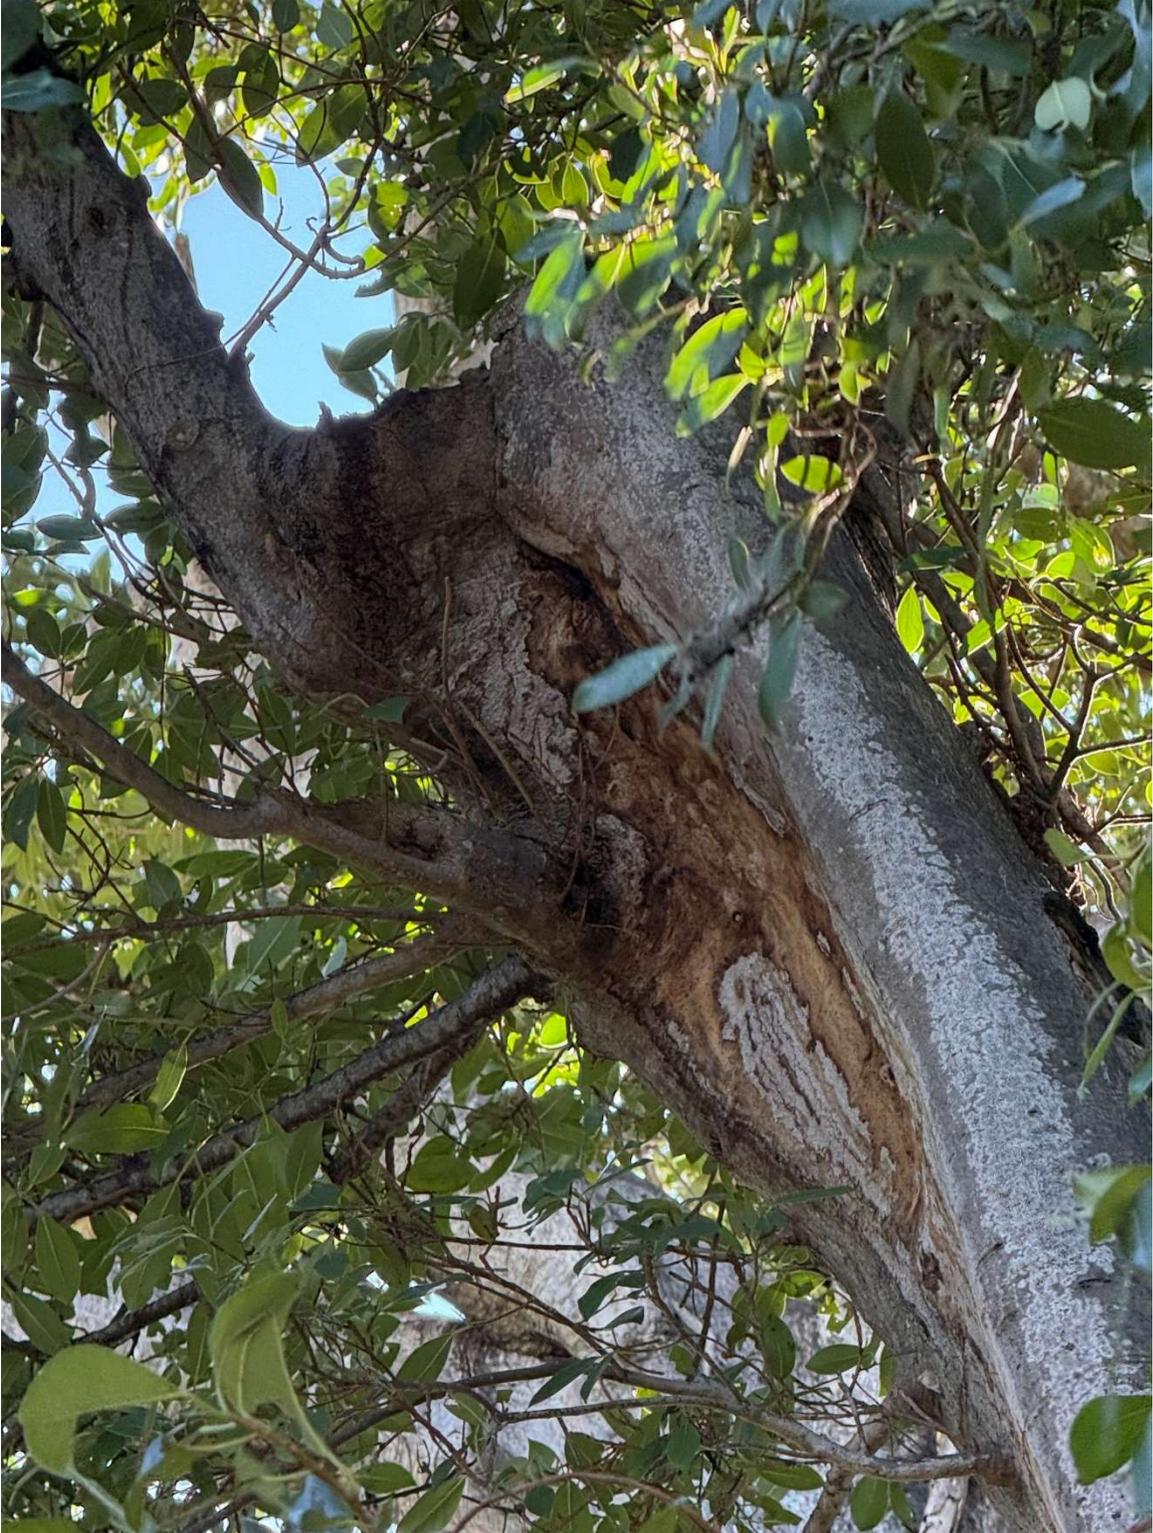
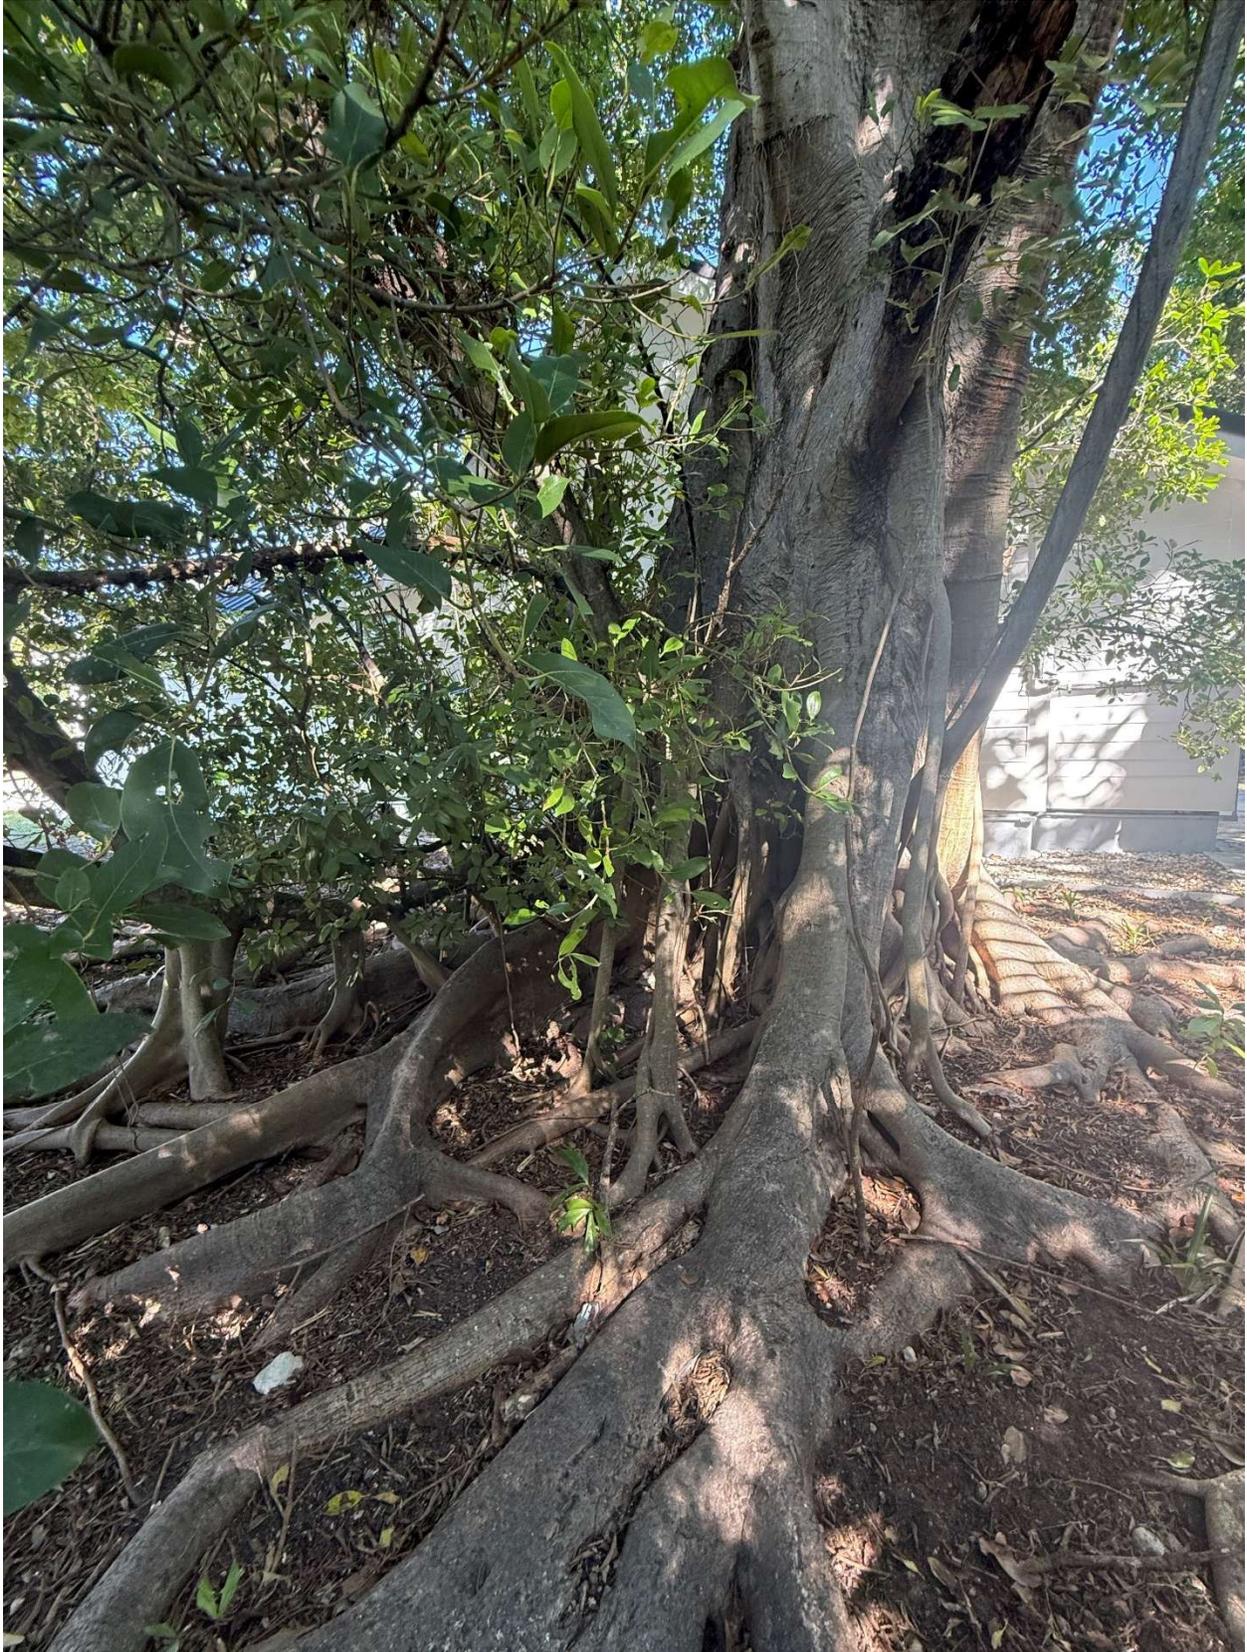
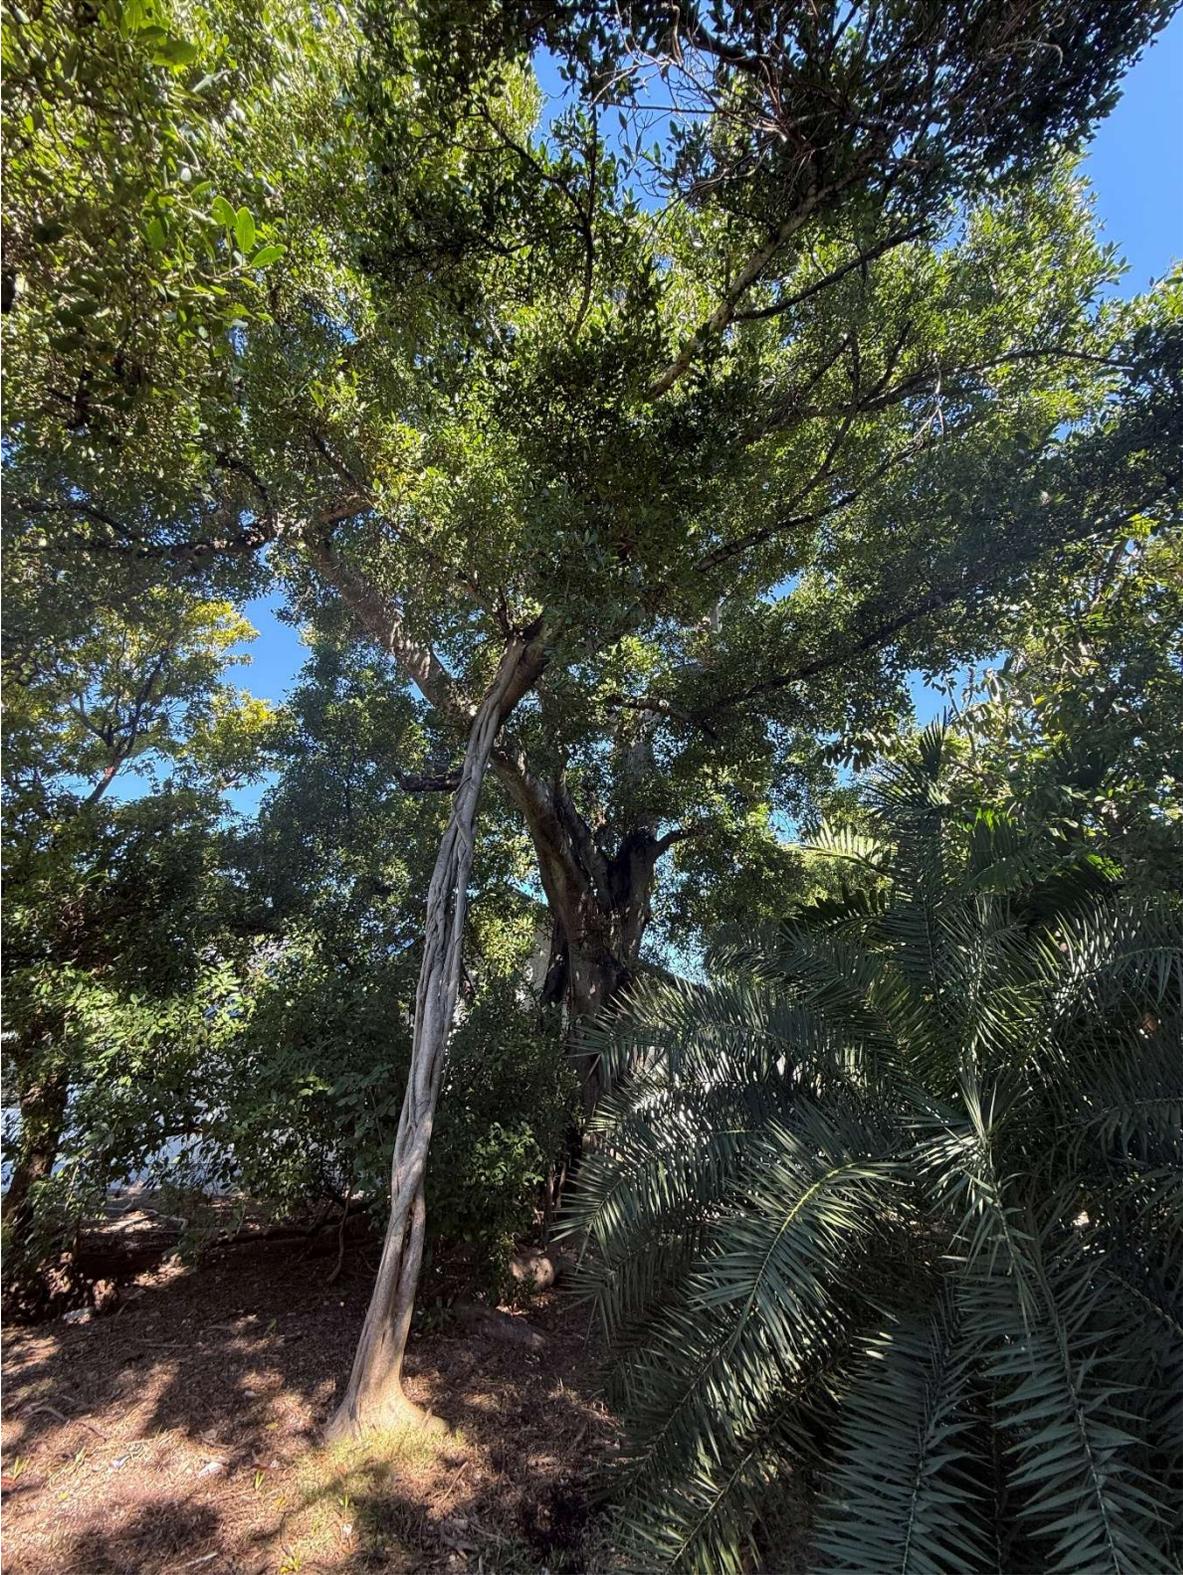
Stangler Fig is quite large but has numerous torn branches from having never been maintained and surviving storms.

When branches are torn off trees outcomes can range from minor setbacks to serious trouble. Outcomes include disease, pests, and decay.

Condition: 60% (numerous torn and decayed branches)

Recommended Mitigation: 46 Caliper Inches

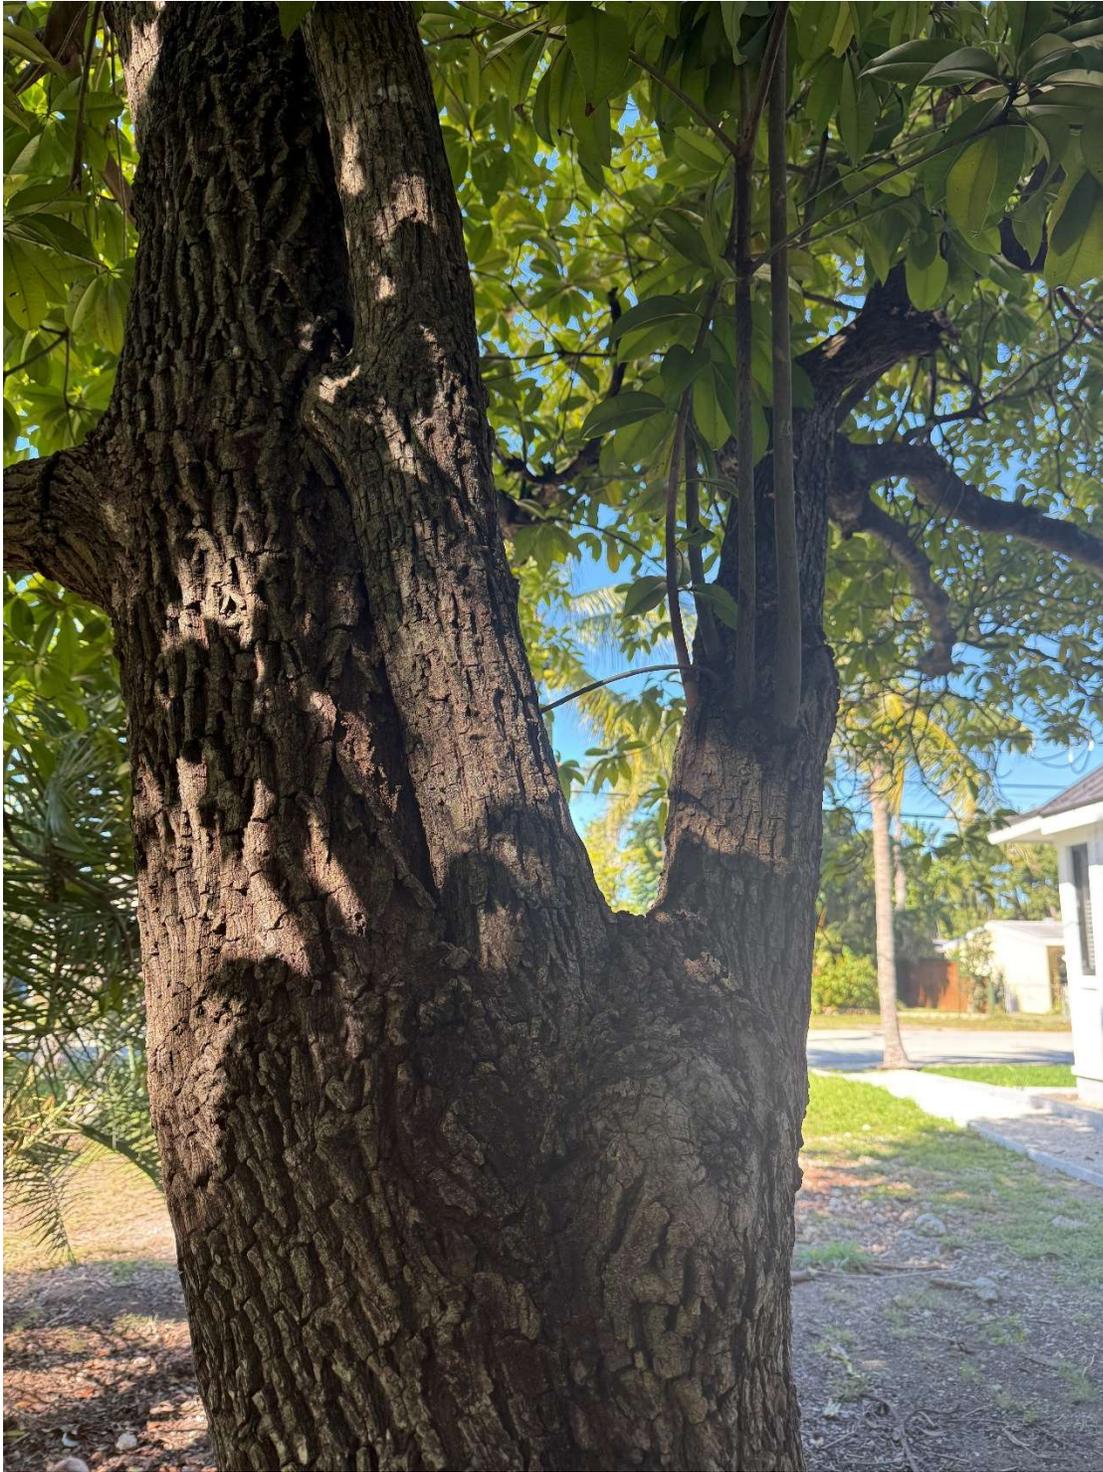
Sapodilla Tree has an unusual growth with multiple stems growing off the trunk. This V shaped junction is weak and often forms included bark.

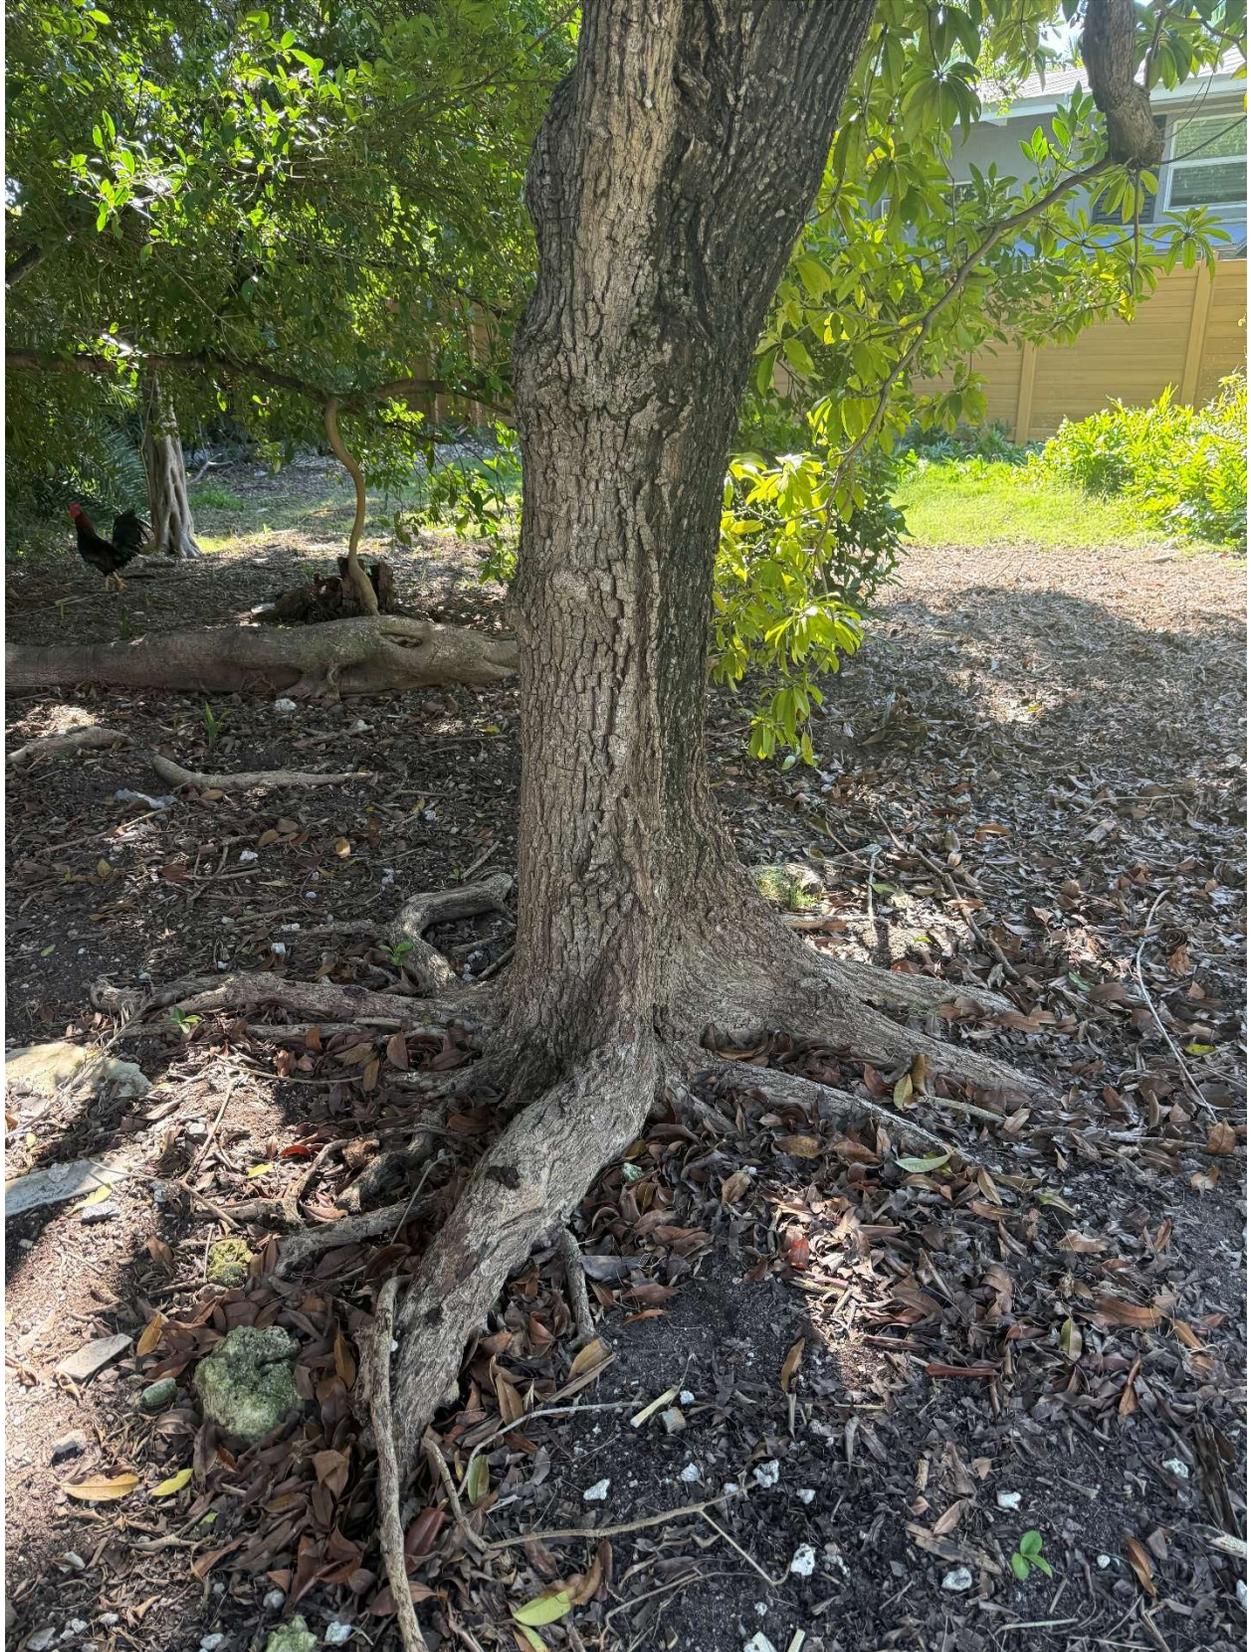
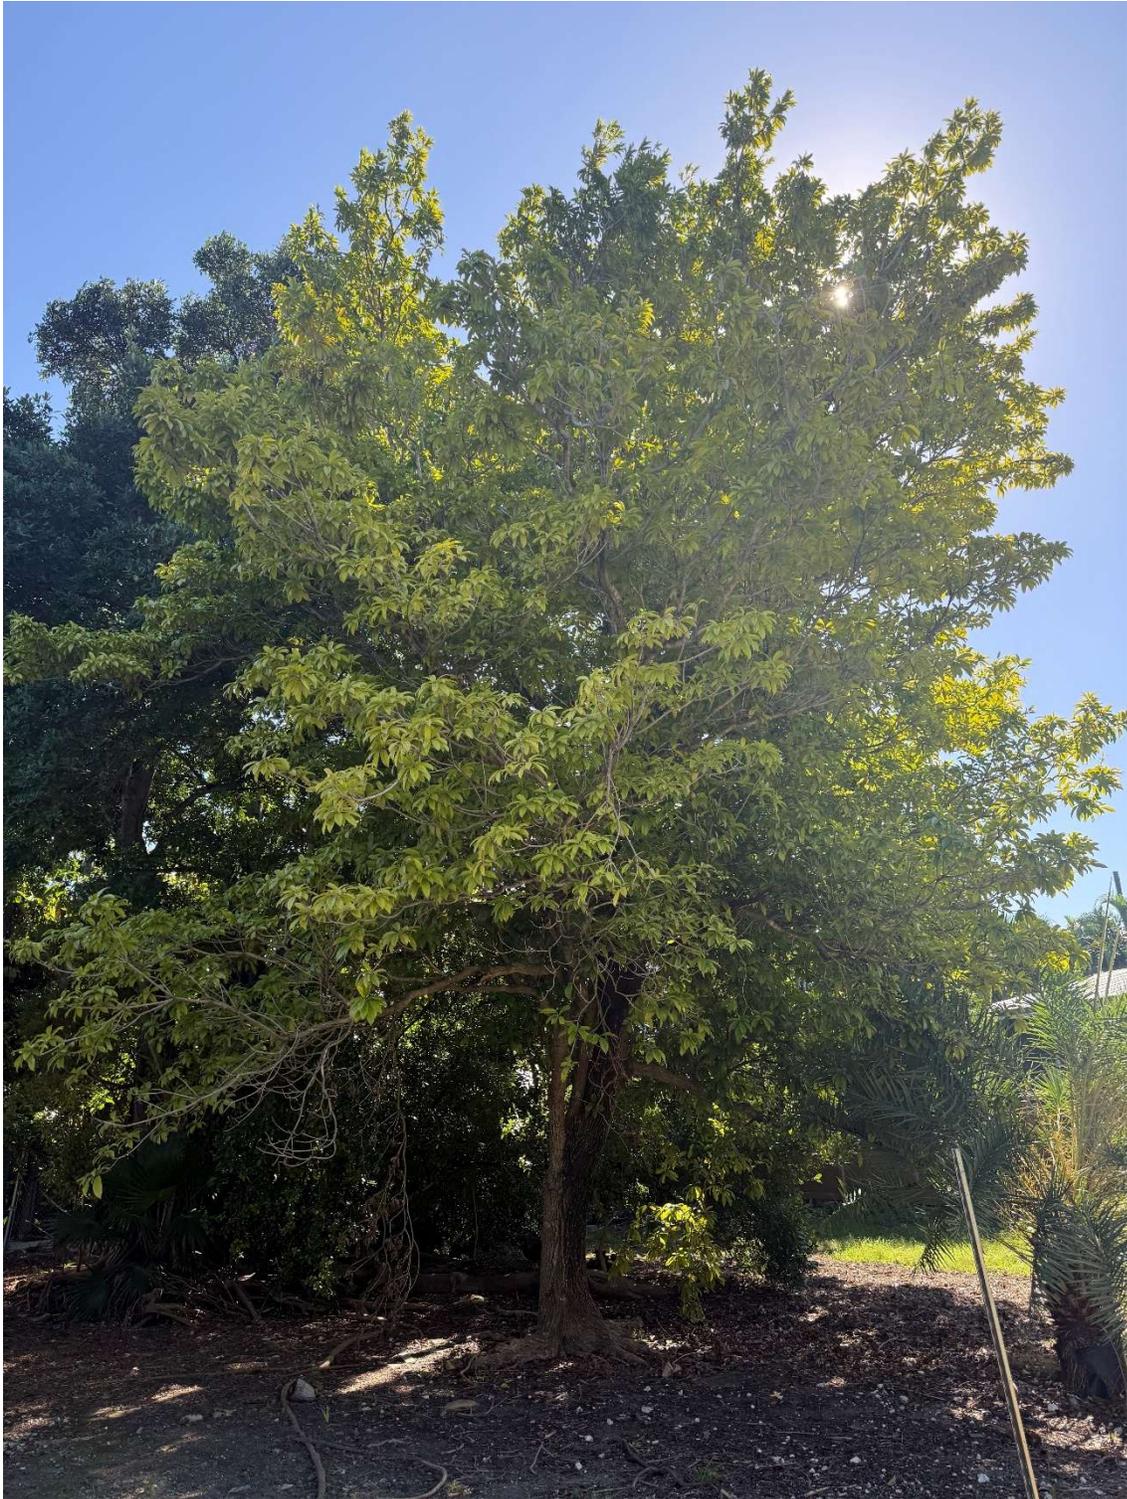
The canopy of the Sapodilla Tree is chlorotic.

Condition: 70% (Canopy is chlorotic)

Recommended Mitigation: 12.4 Caliper Inches
