Repair of 30-Inch HDPE Force Main

PREPARED FOR: City of Key West
PREPARED BY: CH2M HILL
DATE: December 31, 2012
PROJECT NUMBER: 437684.03.33.25

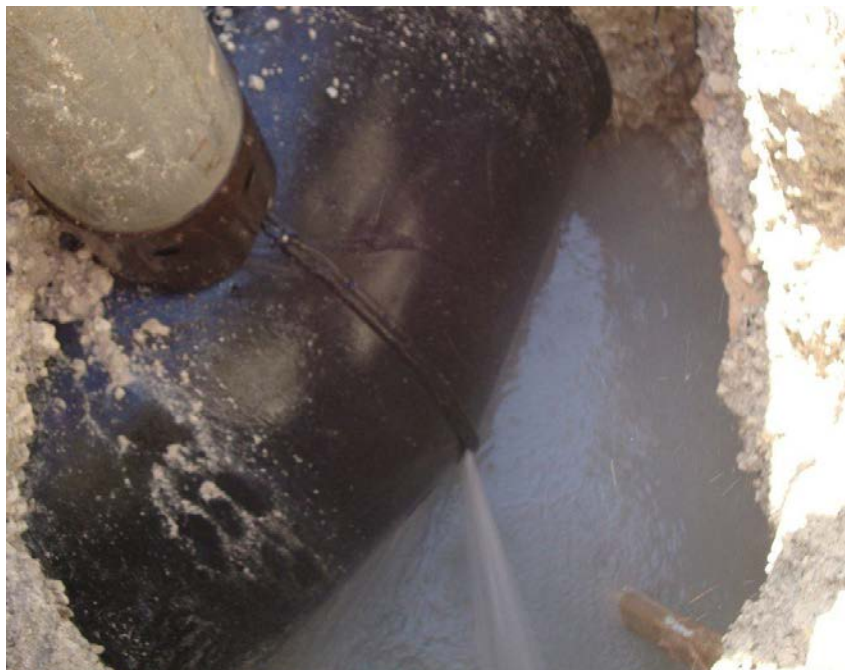
Figure 1: Leak in Fitting Weld

The cause of the leak has not been determined. There is no obvious damage to the pipe however, long-term strain on the weld, could over time result in this type of failure. Induced strain on HDPE pipe is commonly caused by the temperature related shrinkage of the pipe during installation. The location of the leak is on the main previously used to convey treated wastewater from the plant, which at this location is the inside pipe as the main bends to the east (Figure 2).

The recommended methodology for repairing the leak will likely depend on what is actually available and what is constructible considering the site restraints. Given the above discussion, Option 3, with the mechanical coupling may be the only feasible alternative although Option 1 should provide the most reliable, long-term solution. It would also be advantageous from a cost basis if the existing flanged joint could be used for the new fitting if the

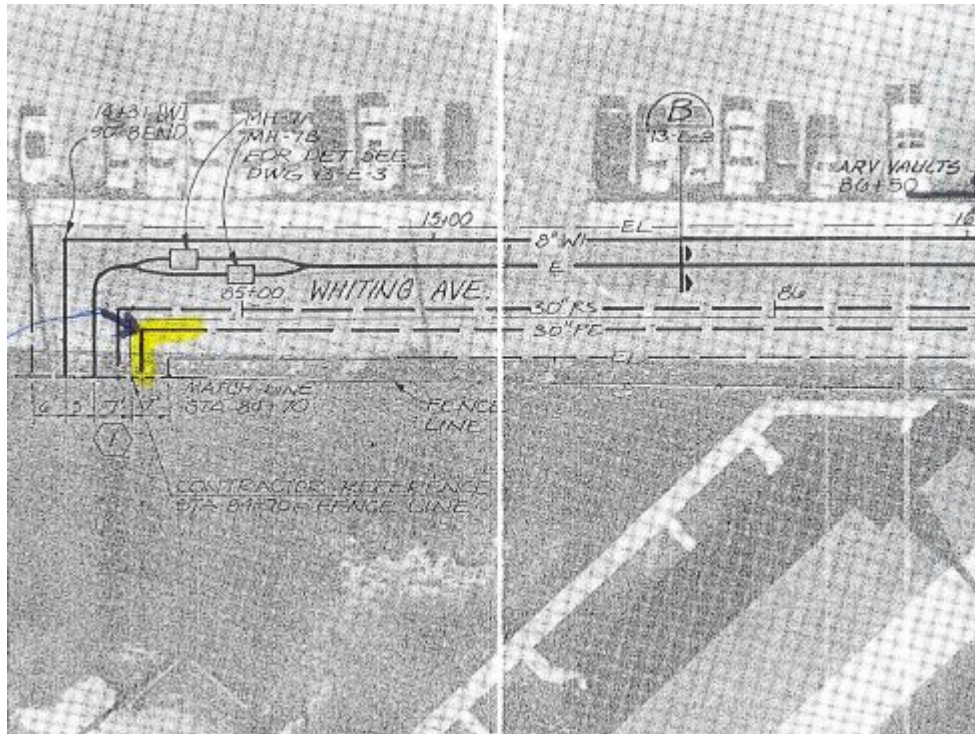
Figure 2: Location of Leak

As the pipes turn from the south to the east, as shown above, the separation between them changes. On the southern, housing side (Figure 3) the separation is 6-8". On the northern, KWNAS side in Whiting Ave. (Figure 4), the separation is 12-14". The south side of the fitting (where the pipes are closer together) is provided with a flanged joint, the other is a butt-welded joint. The flanged joint is a standard Class 125 bolted flanges with a 316-SS backing plate behind the welded (HDPE) flange on the HDPE side.

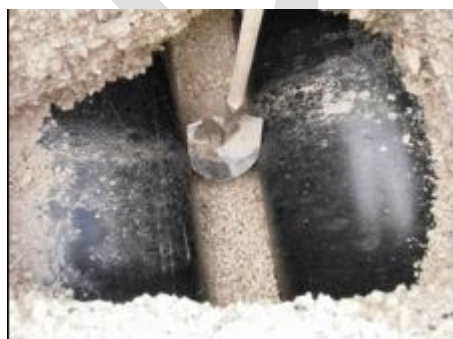
Figure 3: North/South Housing Side

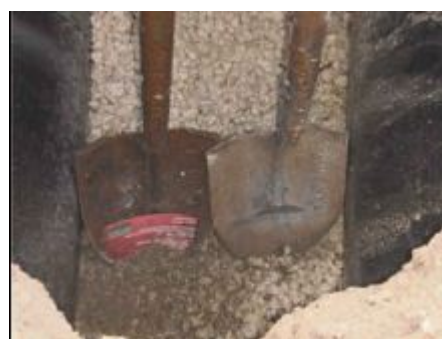
Figure 4: East/West KWNAS Side

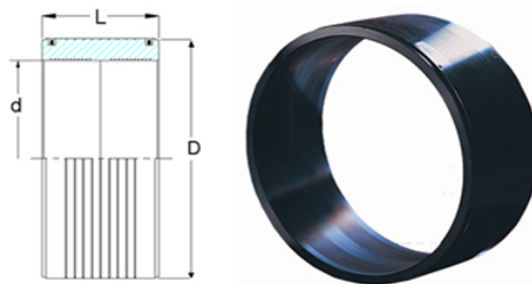
Figure 5: Electrofusion Coupling (Strongbridge/Integrity Fusion)

The EF couplings are external to the pipe being joined as shown in Figure 5 for a DIPS application. The ends of the existing pipe would have to be trimmed and made square enough to be accommodated by the insertion depth of the fitting. The budget level cost for a coupling similar to that shown below is \$5700.

The advantage of this repair method would be a fully welded (essentially no joints) and restrained, non-metallic joint, if it could be constructed. The components of this type of repair would include a fabricated 90° HDPE bend with extensions on each side as necessary to fit and an EF coupling. The repair could be made with one flanged coupling matched to the existing flange or two EF couplings.

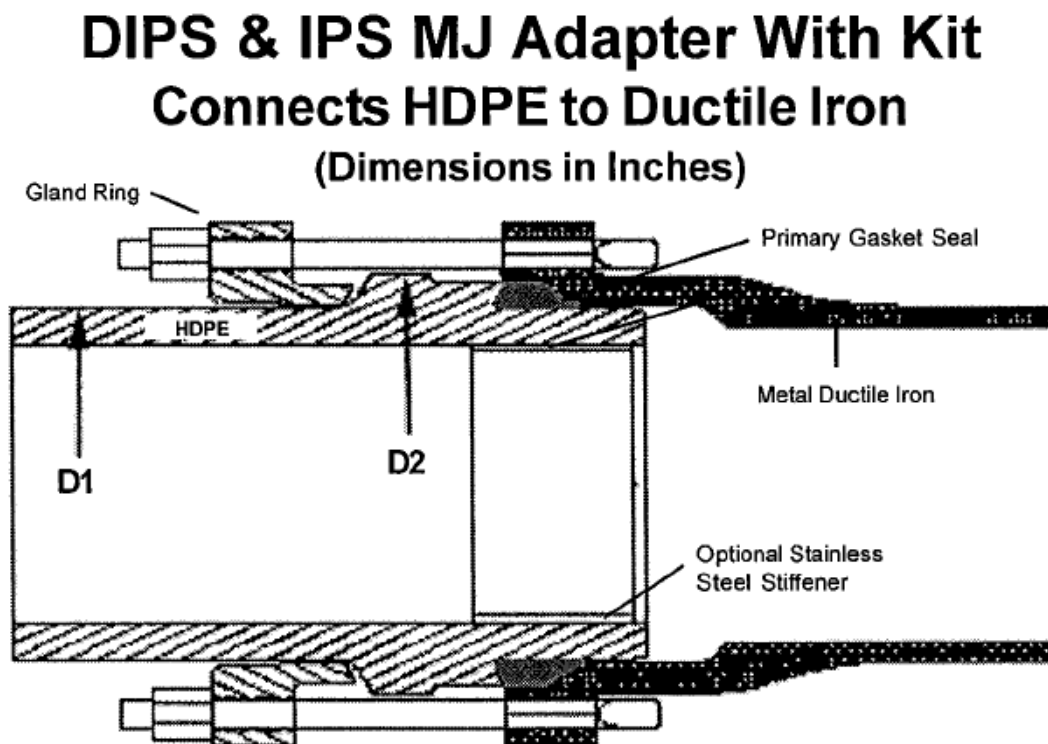
Figure 6: DI to HDPE Coupling

- It will be difficult to work with the mechanical restraints around the pipe given the proximity of the adjacent pipe and groundwater conditions.
- This option will result in two joints for each leg of the fitting
- There will need to be a restrained adaptor coupling on each side to transition from the HDPE to DI. An example of this type of coupling is shown in Figure 6.

The components of this type of repair would include a RJ 90° DI bend with RJ spool piece extensions on each side as necessary to fit, a DI/HDPE adaptor coupling for connection, an internal SS stiffener for each coupling (total of two if the flanged connection is replaced) and whatever form of thrust restraint can be accommodated.

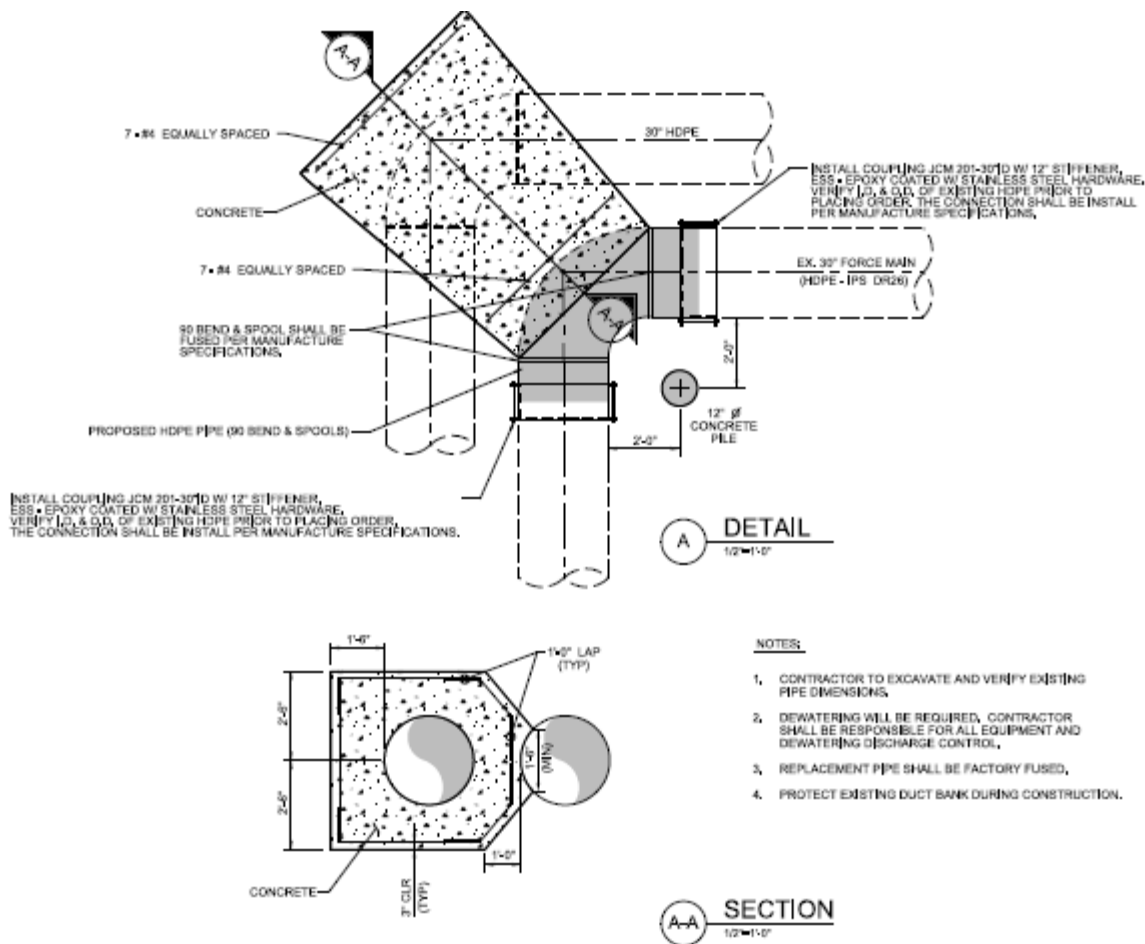
Figure 7: Thrust Restraint Options

This repair will require that the fitting be restrained by some external means since it will not be possible to attach a bead section to the ends of the existing HDPE pipe sections. Possibilities for providing external restraint are shown in Figure 7 and demonstrate the potential difficulties with such and installation.

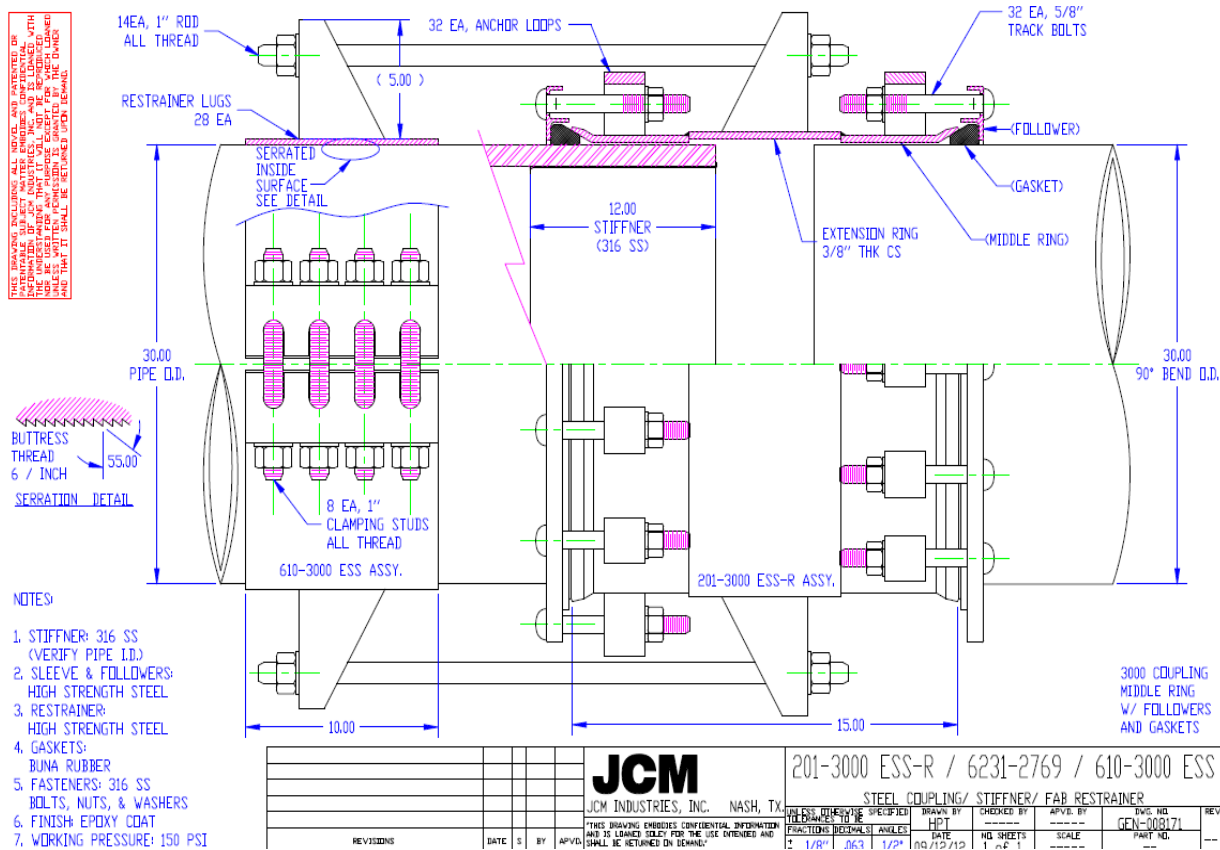
Figure 8: Restraining Coupling (JCM)

The situation was discussed with JCM and they developed a coupling based on their standard components for use on the HDPE pipe and the conditions described above. The proposed coupling is shown in Figure 8. The HDPE pipe manufacturers are comfortable with the restraining JCM couplings and work closely with them on applications. They consider JCM to be in the forefront of HDPE coupling technology. The dimensions of the restraining "ears" will fit in the space between the pipes; however the excavation will have to allow the installation crew to work around the full circumference of the pipe, as would any of the options considered.

1. The restraint ears extend 5" from the restrainer body plate. The plate thickness of the restrainer is .5" (total O.D. = 41")
2. The lower left hand side of the drawing rev shows the serrated I.D. surface that grips the pipe and provides the restraint
3. The components of this type of repair would include a fabricated 90° HDPE bend with extensions on each side as necessary to fit, two (2) 201-3000 ESS -R couplings for connection, two (2) 610-3000 ESS for restraining (as shown in Figure 8) and two (2) 6231-2769 stiffeners for each coupling (total of four if the flanged connection is replaced).
4. All metallic components to be 316 SS
5. The budget level cost for a coupling similar to that shown below is \$
