EXISTING TREE REPORT and ASSESSMENT

CITY of KEY WEST

DATE OF REPORT: March 17, 2026

PROPERTY: 1624 Spalding Court

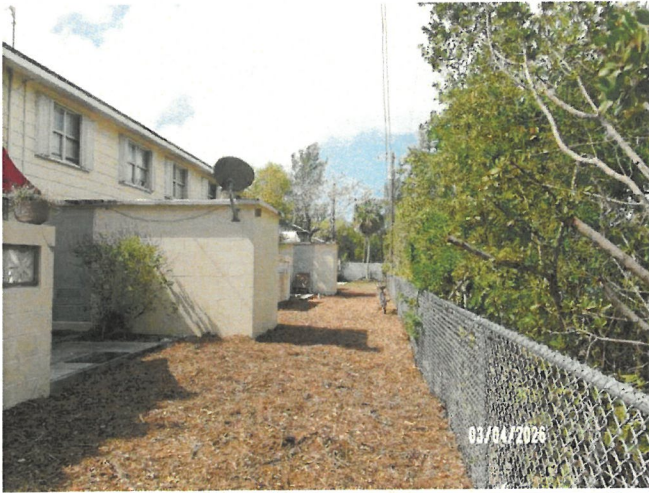
Looking west at the northern boundary area of project. Tree area 5.63 is to the right.

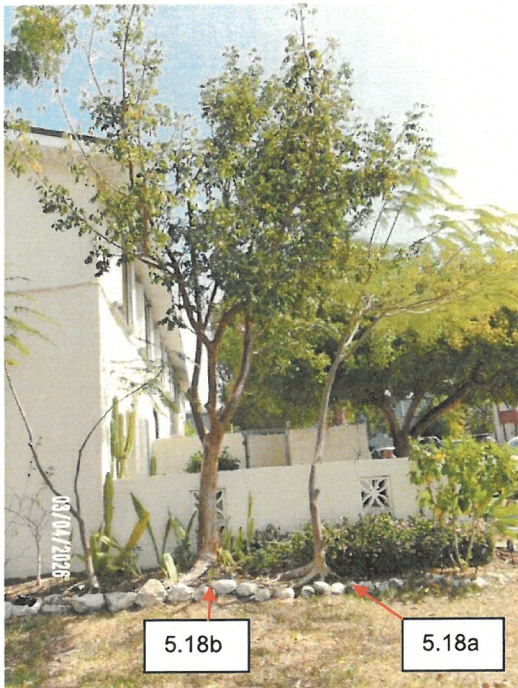
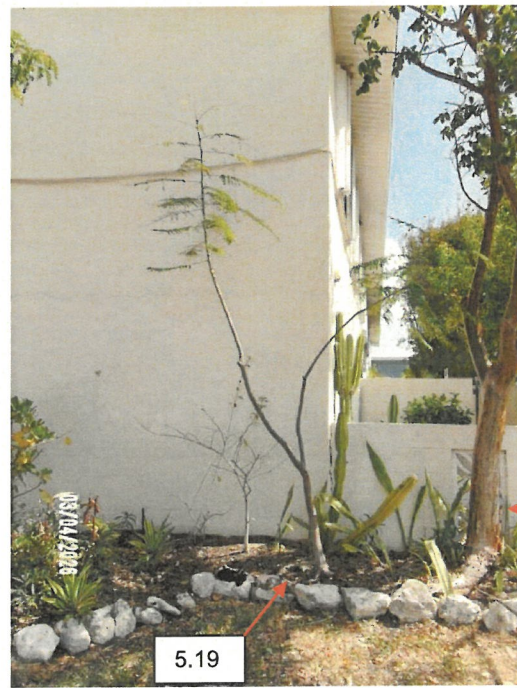
Tree 5.18a: Royal Poinciana (*Delonix regia*)

Diameter: 3.1" dbh

Condition: 40% (poor, base of tree and root crown exposed, poor structure, young tree.)

Location: 70% (growing close to concrete privacy wall, very visible tree)

Species: 100% (on City of KW protected tree list)

Approximated Tree Value: 70%

Potential Required Mitigation: 2.1 caliper inches

Tree 5.18b: Gumbo Limbo (*Bursera simaruba*)

Diameter: 7.3" dbh

Condition: 70% (fair, young tree.)

Approximated Tree Value: 80%

Potential Required Mitigation: 5.8 caliper inches

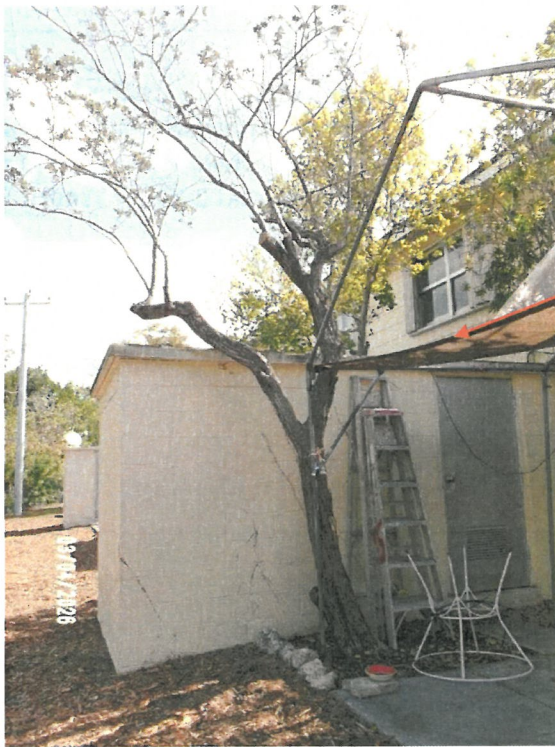
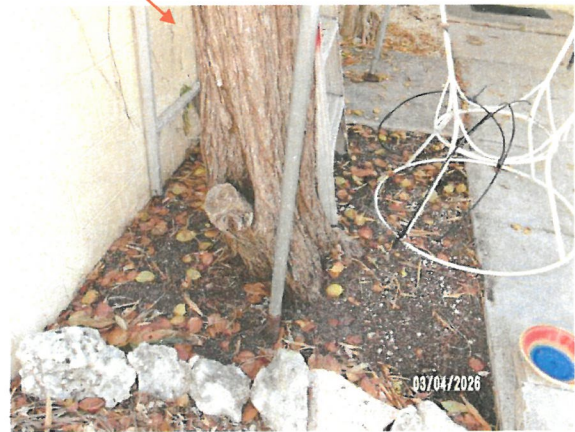
5.23

Tree 5.23: Silver Buttonwood (*Conocarpus erectus sericeus*)

Diameter: 8.5" dbh

Condition: 40% (poor, canopy sparse, old trunk cut near base)

Location: 60% (growing in rear of property near concrete privacy wall)

Species: 100% (on City of KW protected tree list)

Approximated Tree Value: 66%

Potential Required Mitigation: 5.6 caliper inches

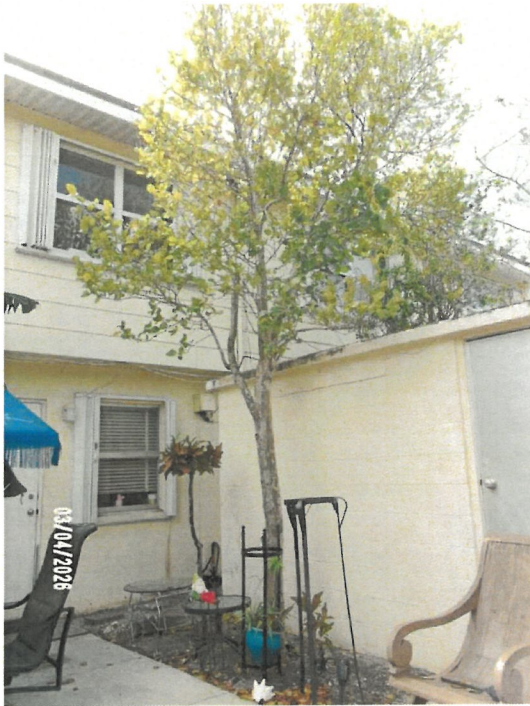
Tree 5.25: Pigeon Plum (*Coccoloba diversifolia*)  
 Diameter: 5.7" dbh  
 Condition: 60% (fair)  
 Location: 60% (growing in rear of property near concrete privacy wall)  
 Species: 100% (on City of KW protected tree list)  
 Approximated Tree Value: 73%  
 Potential Required Mitigation: 4.1 caliper inches

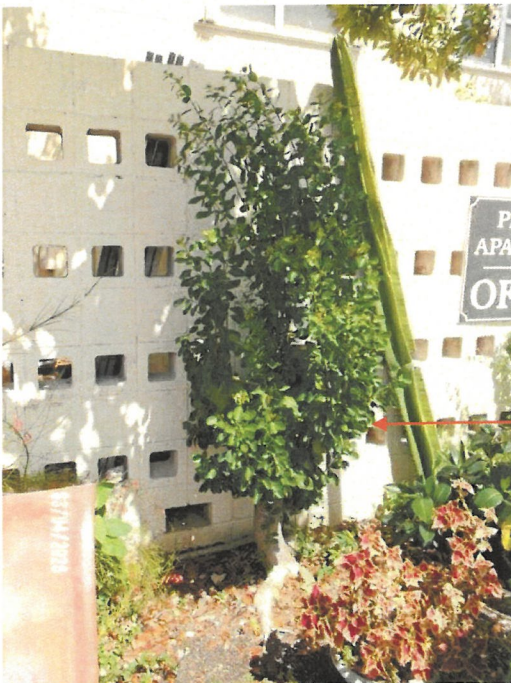
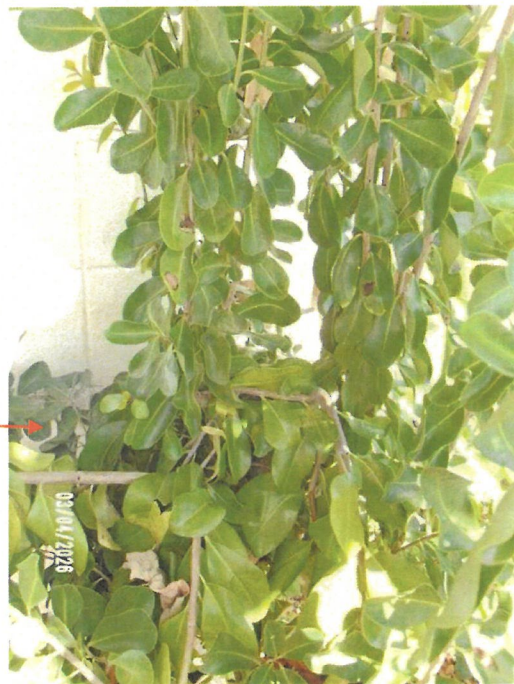
5.40

Tree 5.40: Blolly (*Guapira discolor*)

Diameter: 2.5" dbh at cut

Condition: 40% (poor structure, main trunk has been cut destroying tree shape, "canopy" is resprout branches)

Location: 70% (growing close to privacy wall, very visible tree)

Species: 100% (on City of KW protected tree list)

Approximated Tree Value: 70%

Potential Required Mitigation: 1.7 caliper inches

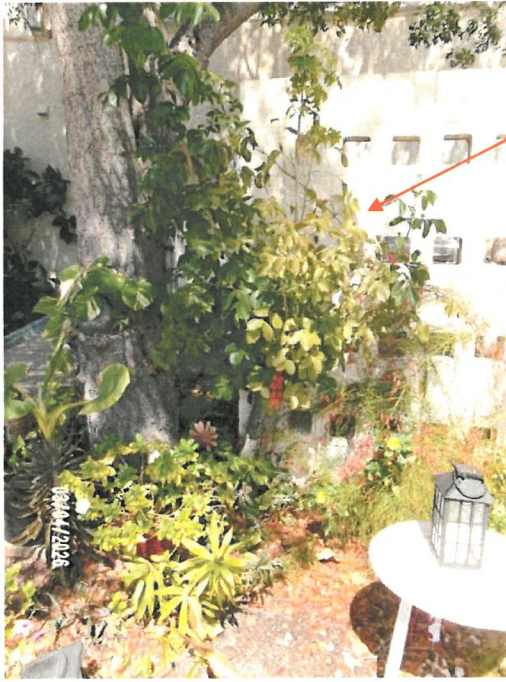
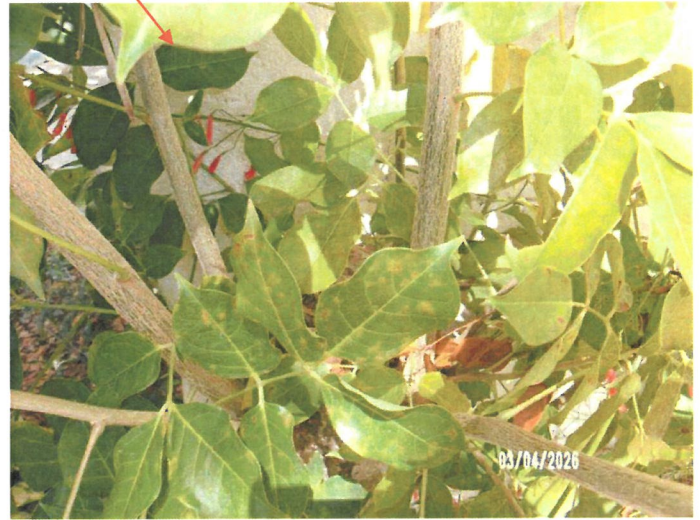
5.41

Tree 5.41: Gumbo Limbo (*Bursera simaruba*)

Diameter: 2.5" dbh at cut

Condition: 40% (poor structure, main trunk has been cut destroying tree shape, "canopy" is resprout branches)

Location: 70% (growing close to privacy wall, very visible tree)

Species: 100% (on City of KW protected tree list)

Approximated Tree Value: 70%

Potential Required Mitigation: 1.7 caliper inches

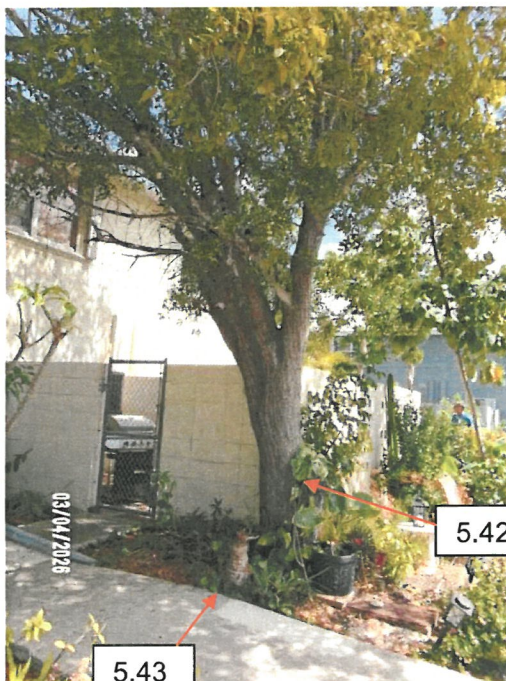
5.42

Tree 5.42: Mahogany (*Swietenia mahagoni*)

Diameter: 16.8" dbh

Condition: 60% (fair, codominant trunks with included bark at crotches of main trunk, canopy needs maintenance)

Location: 70% (growing next to sidewalk, very visible tree)

Species: 100% (on City of KW protected tree list)

Approximated Tree Value: 76%

Potential Required Mitigation: 12.7 caliper inches

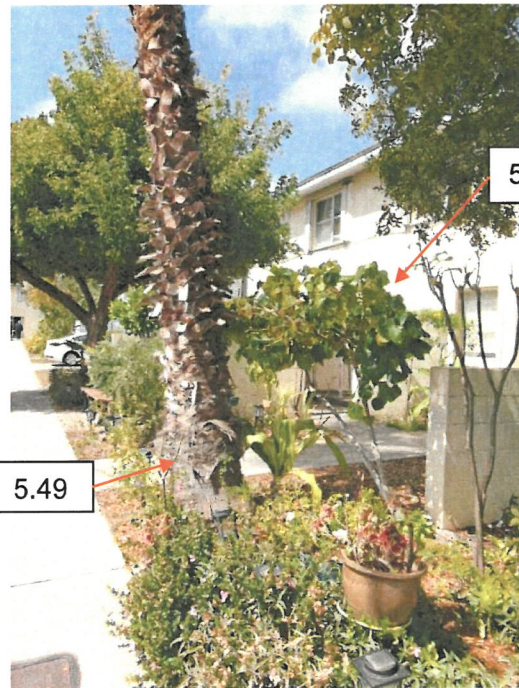
5.49

Tree 5.49: Washingtonian Palm (*Washingtonia robusta*)

Required Mitigation: 1-native palm, 4 ft tall OH minimum

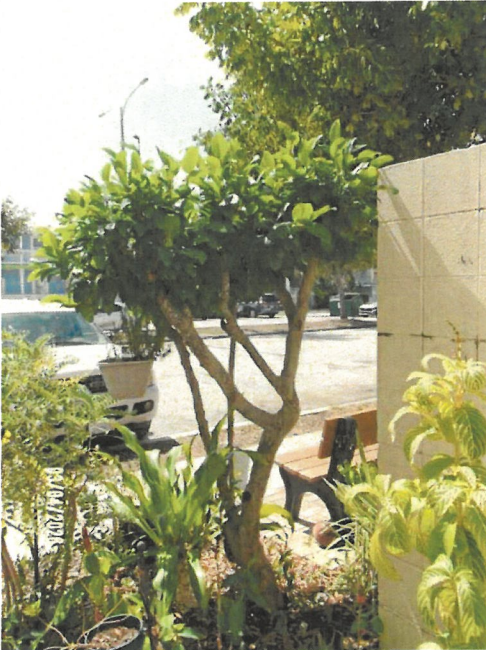
Tree 5.54: Pigeon Plum (*Coccoloba diversifolia*)

Diameter: 8.9" dbh total (multiple trunks at 4 ft height)

Condition: 50% (fair to poor, canopy has been topped/hedged-natural shape of tree damaged)

Location: 80% (growing near sidewalk area, very visible tree)

Species: 100% (on City of KW protected tree list)

Approximated Tree Value: 76%

Potential Required Mitigation: 6.7 caliper inches

| Tree # | Common Name | Scientific Name | Diameter/<br>Height | Condition | City of KW LDR | Action | Notes |
|---|---|---|---|---|---|---|---|
| 5.54 | Pigeon Plum | Coccoloba diversifolia | 8.9" | Fair to poor | Protected | Remove | Multiple trunks. Bad trim/maintenance-canopy branches have been topped/hedged. Cactus growing nearby-not regulated |

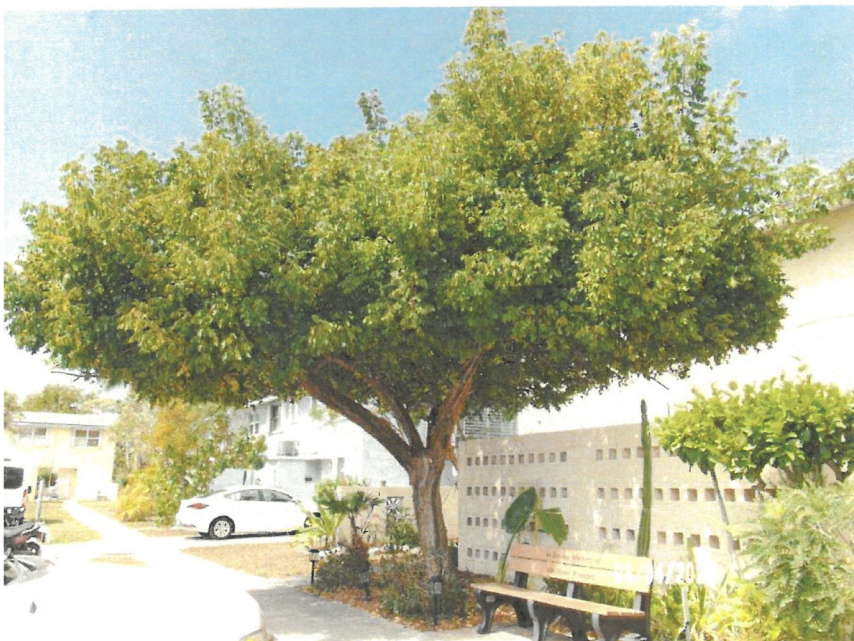
Tree 5.55: Gumbo Limbo

(*Bursera simaruba*)

Diameter: 13.6" dbh

Condition: 80% (good)

Location: 80% (growing near sidewalk area, very visible tree)

Species: 100% (on City of KW protected tree list)

Approximated Tree Value: 86%

Potential Required Mitigation: 11.6 caliper inches
