### Concrete Repair Cost Proposal Form for Fredrick Douglass Gym

**Repair Details SK 1 – 10**

**Frederick Douglas Gym**

**Structural Repairs**

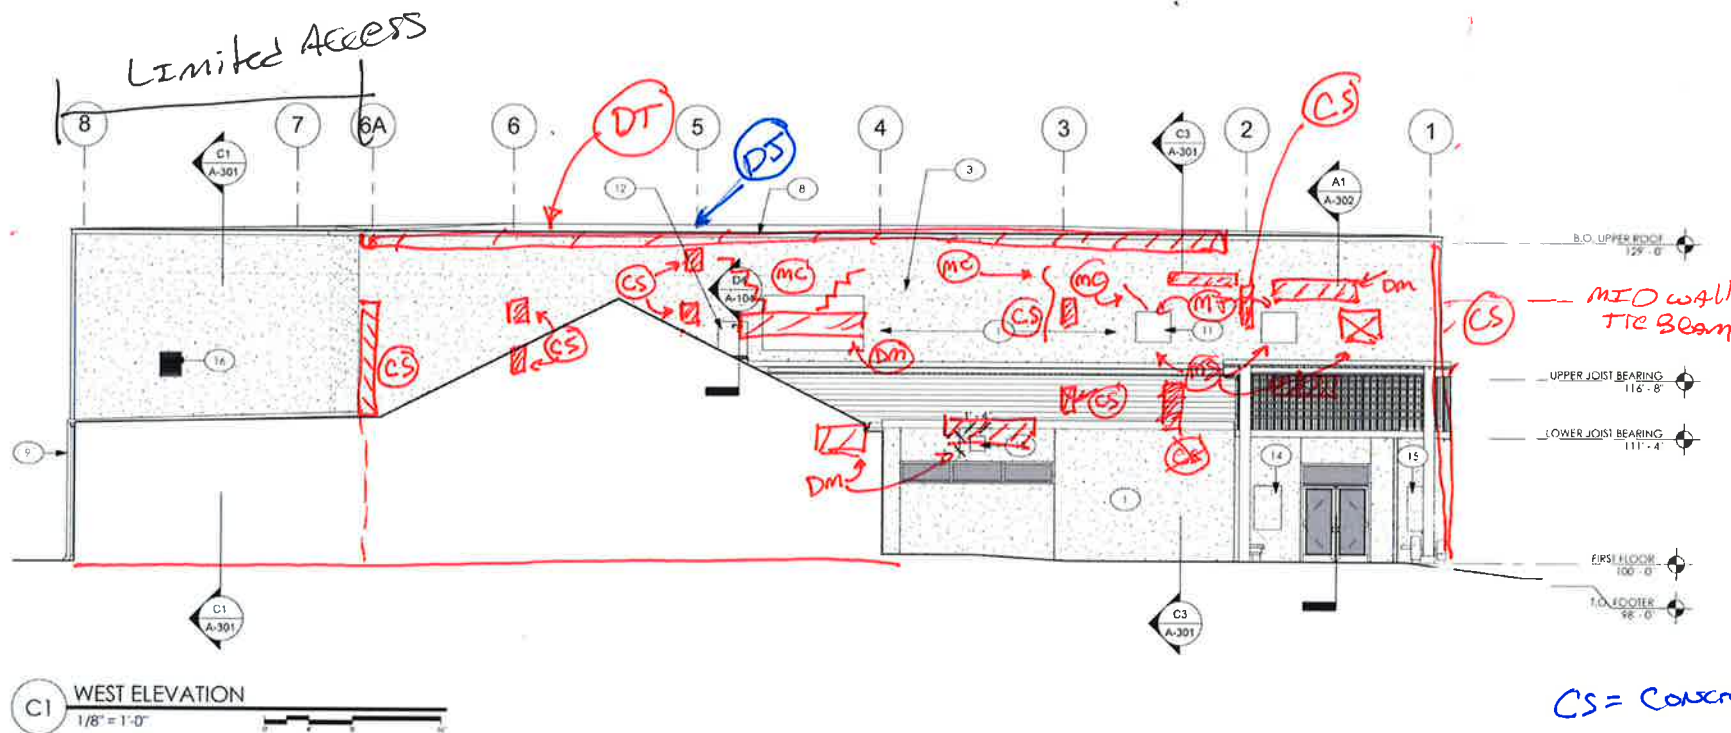
CS = Concrete Sill  
 DH = Damaged Header  
 DS = Damaged Sill  
 MC = Masonry Crack

DJ = Damaged wall at Truss  
 just seat

DT = Damage High Roof  
 Tie Beam

DM = Damaged MED Wall  
 Tie Beam

MH = missing Header

MS = missing Sill

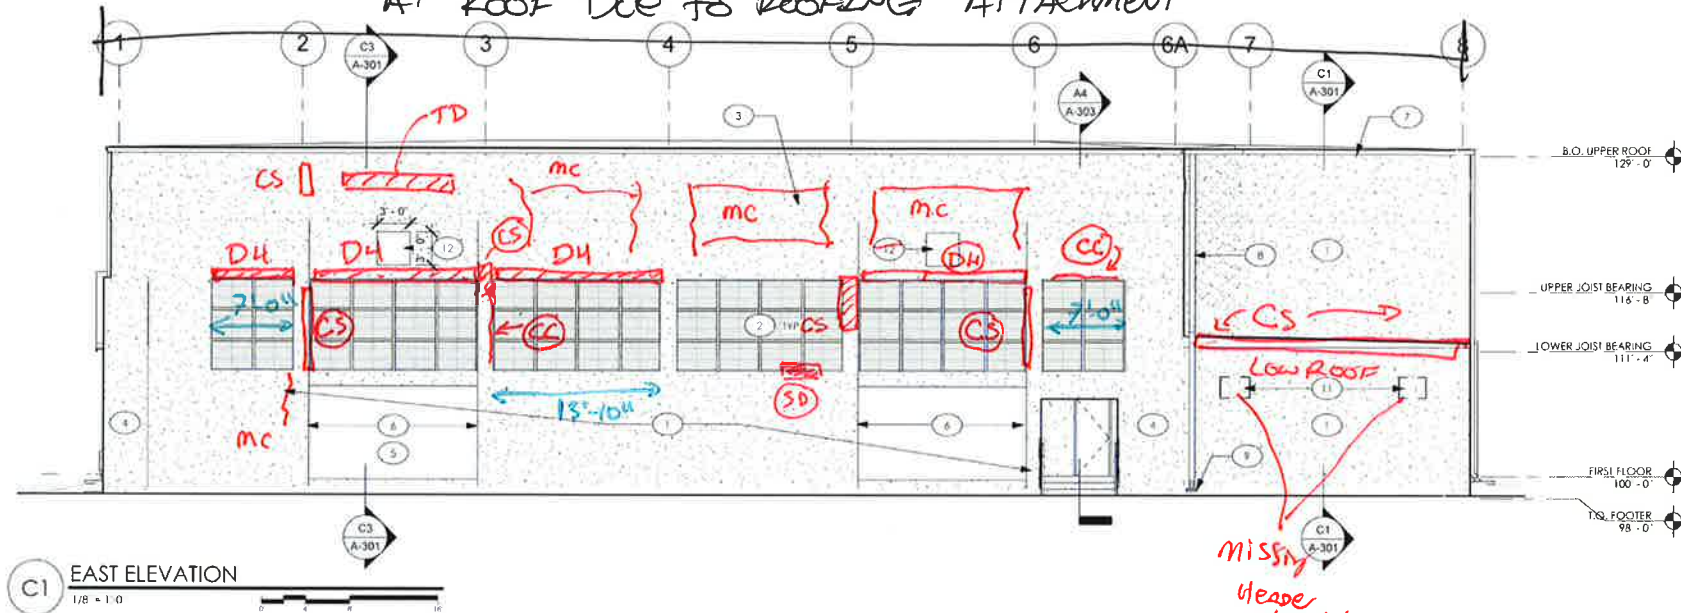
LIMITED ACCESS TO TOP OF WALL  
AT ROOF DUE TO ROOFING ATTACHMENT

LIMITED ACCESS OF TOP  
OF WALL DUE TO ROOFING SYSTEM
