# STAFF REPORT

RE: **5220, 5224, 5228, & 5230 College Road**  
**(permit application # T2019-0135)**

FROM: Karen DeMaria, City of Key West Urban Forestry Manager

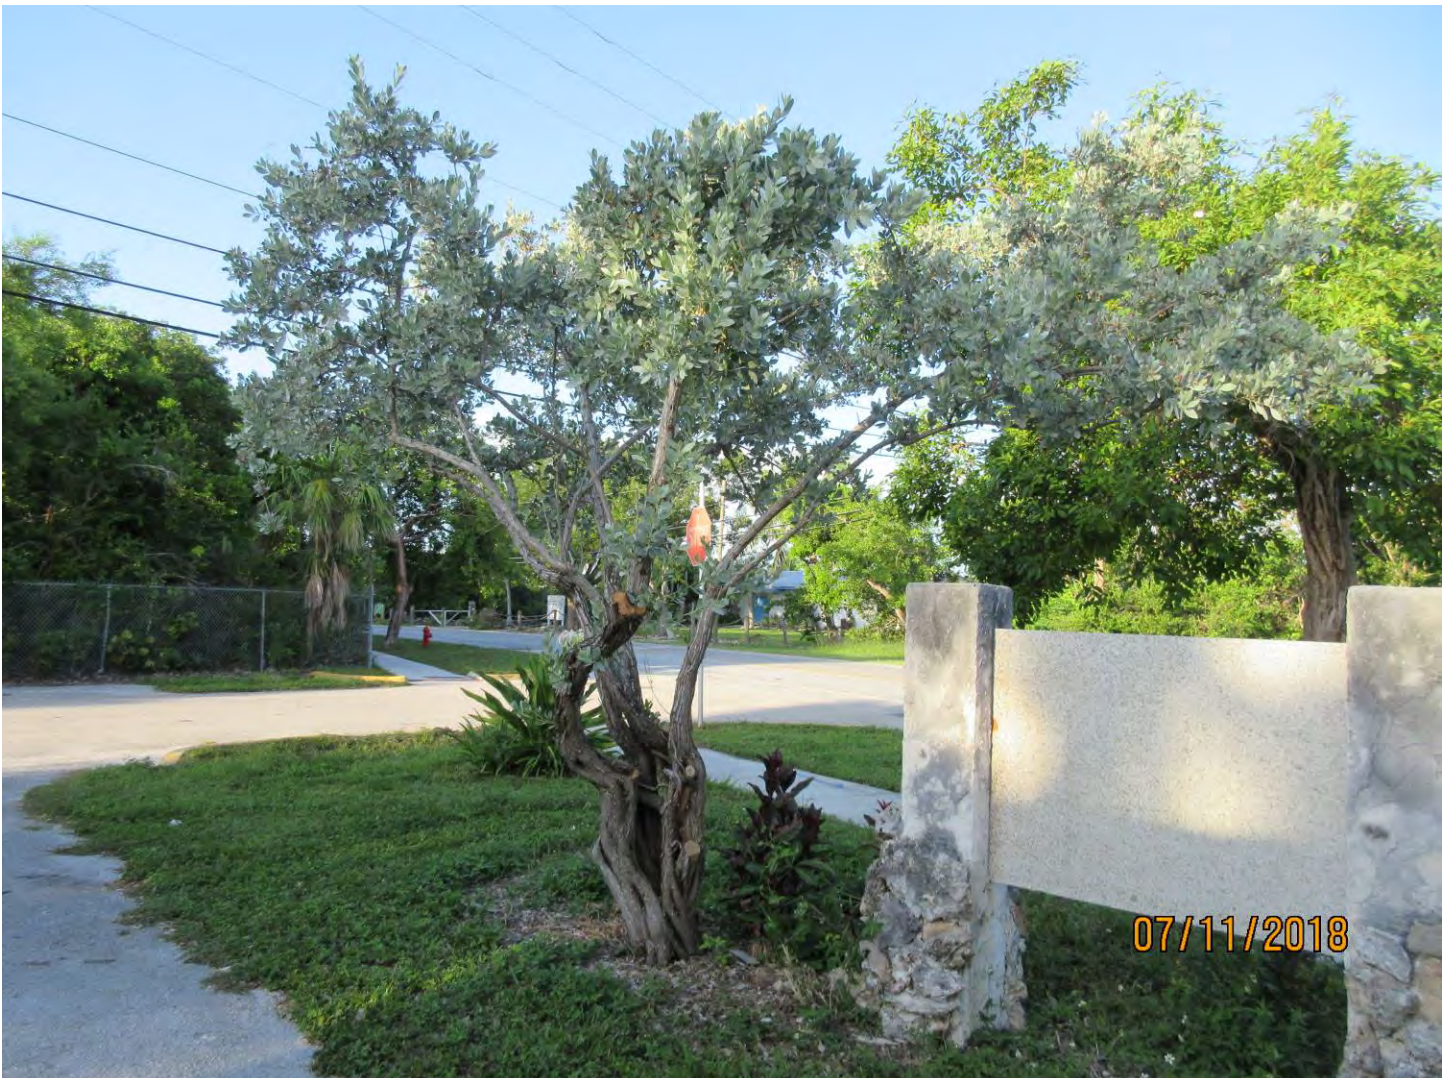
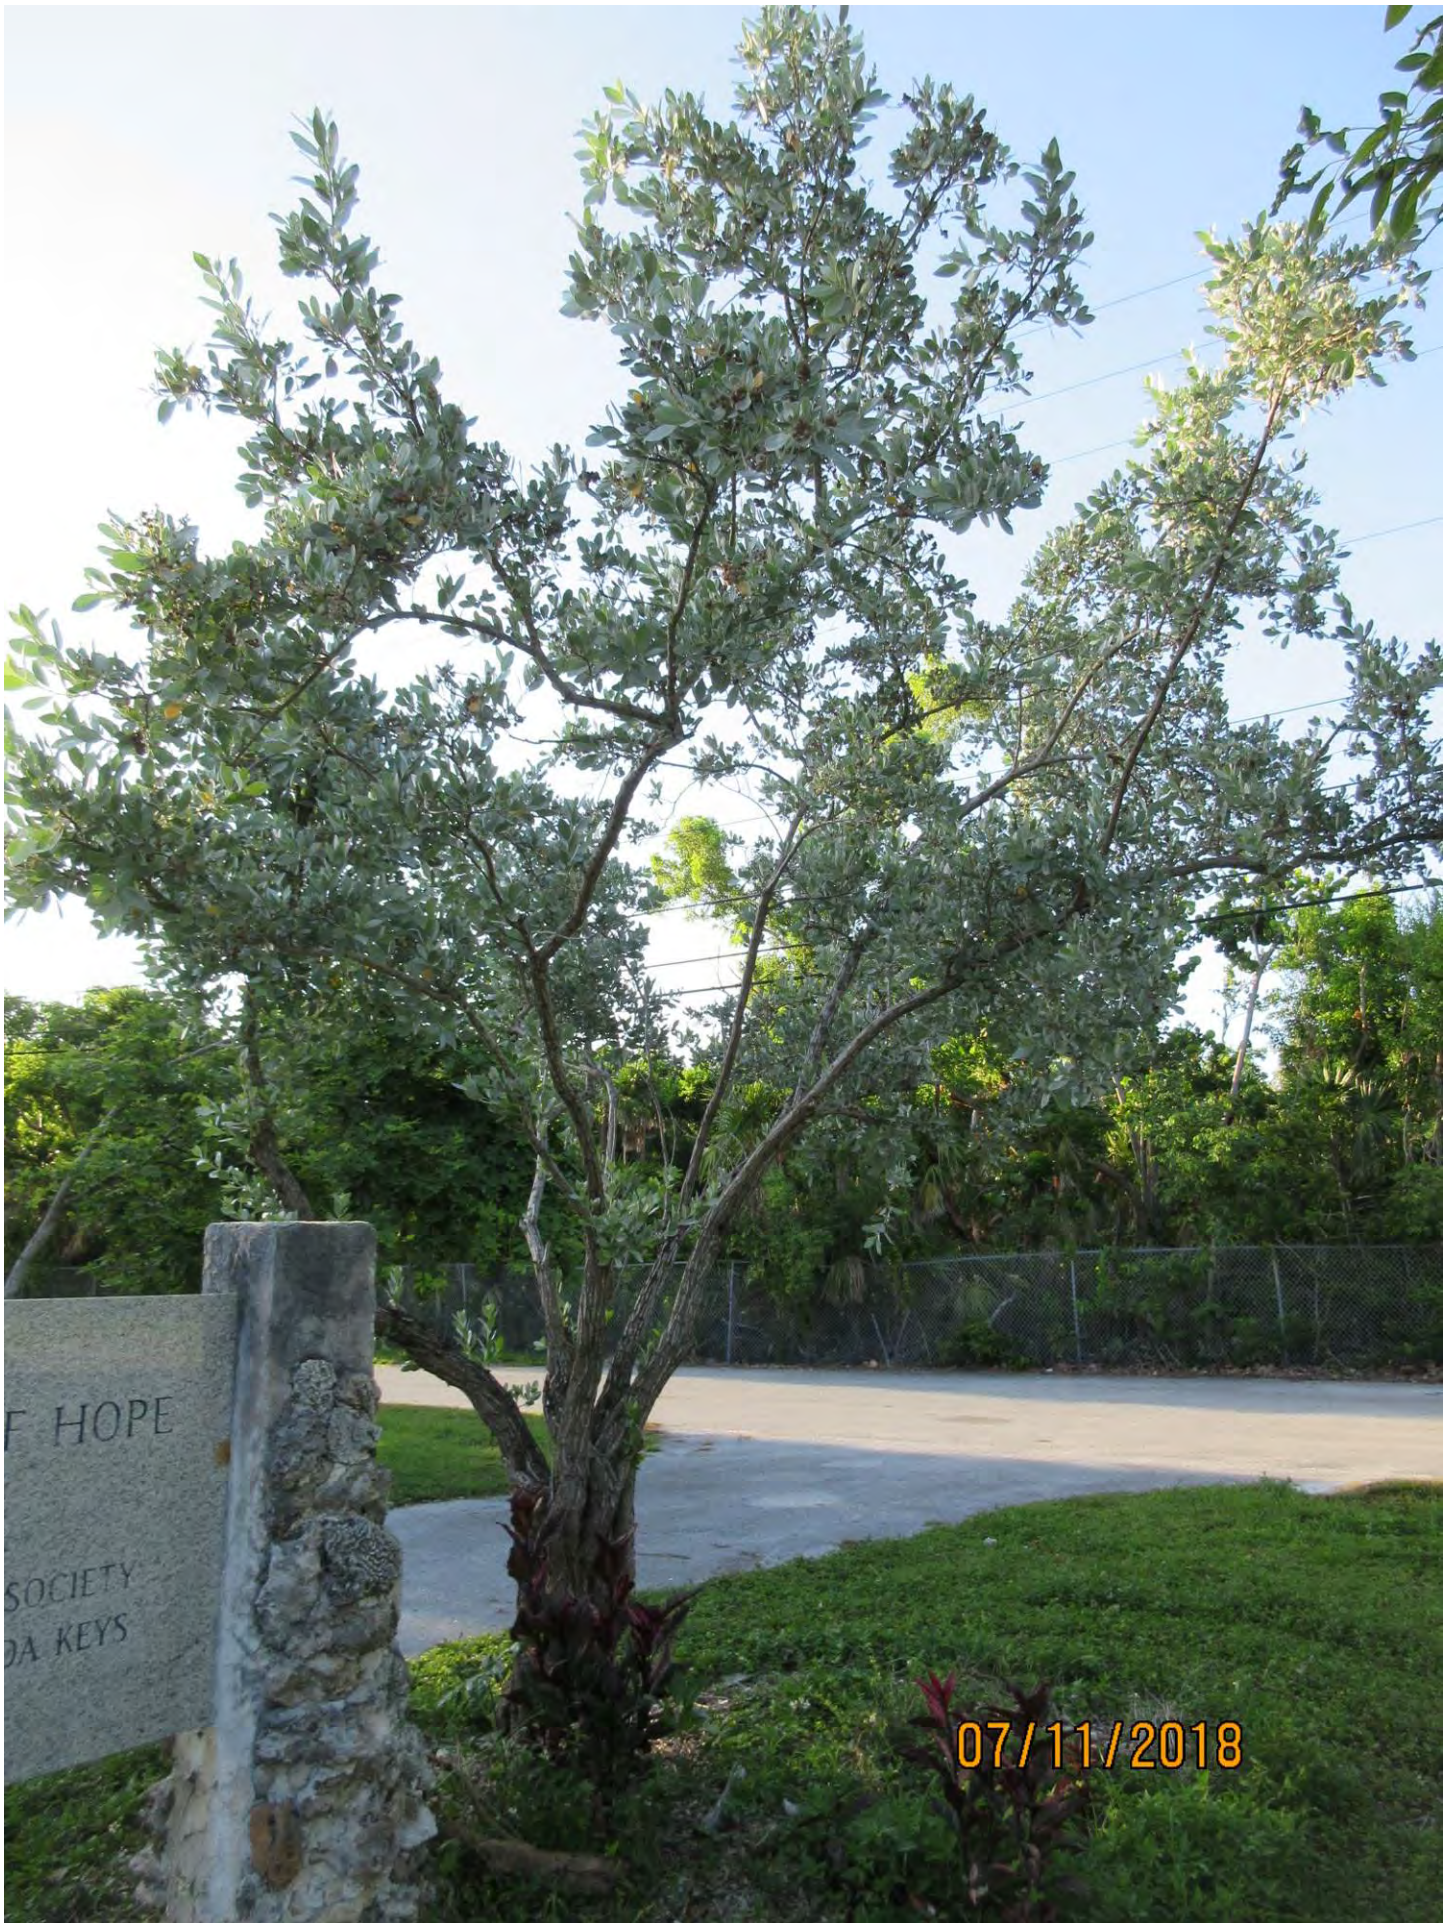
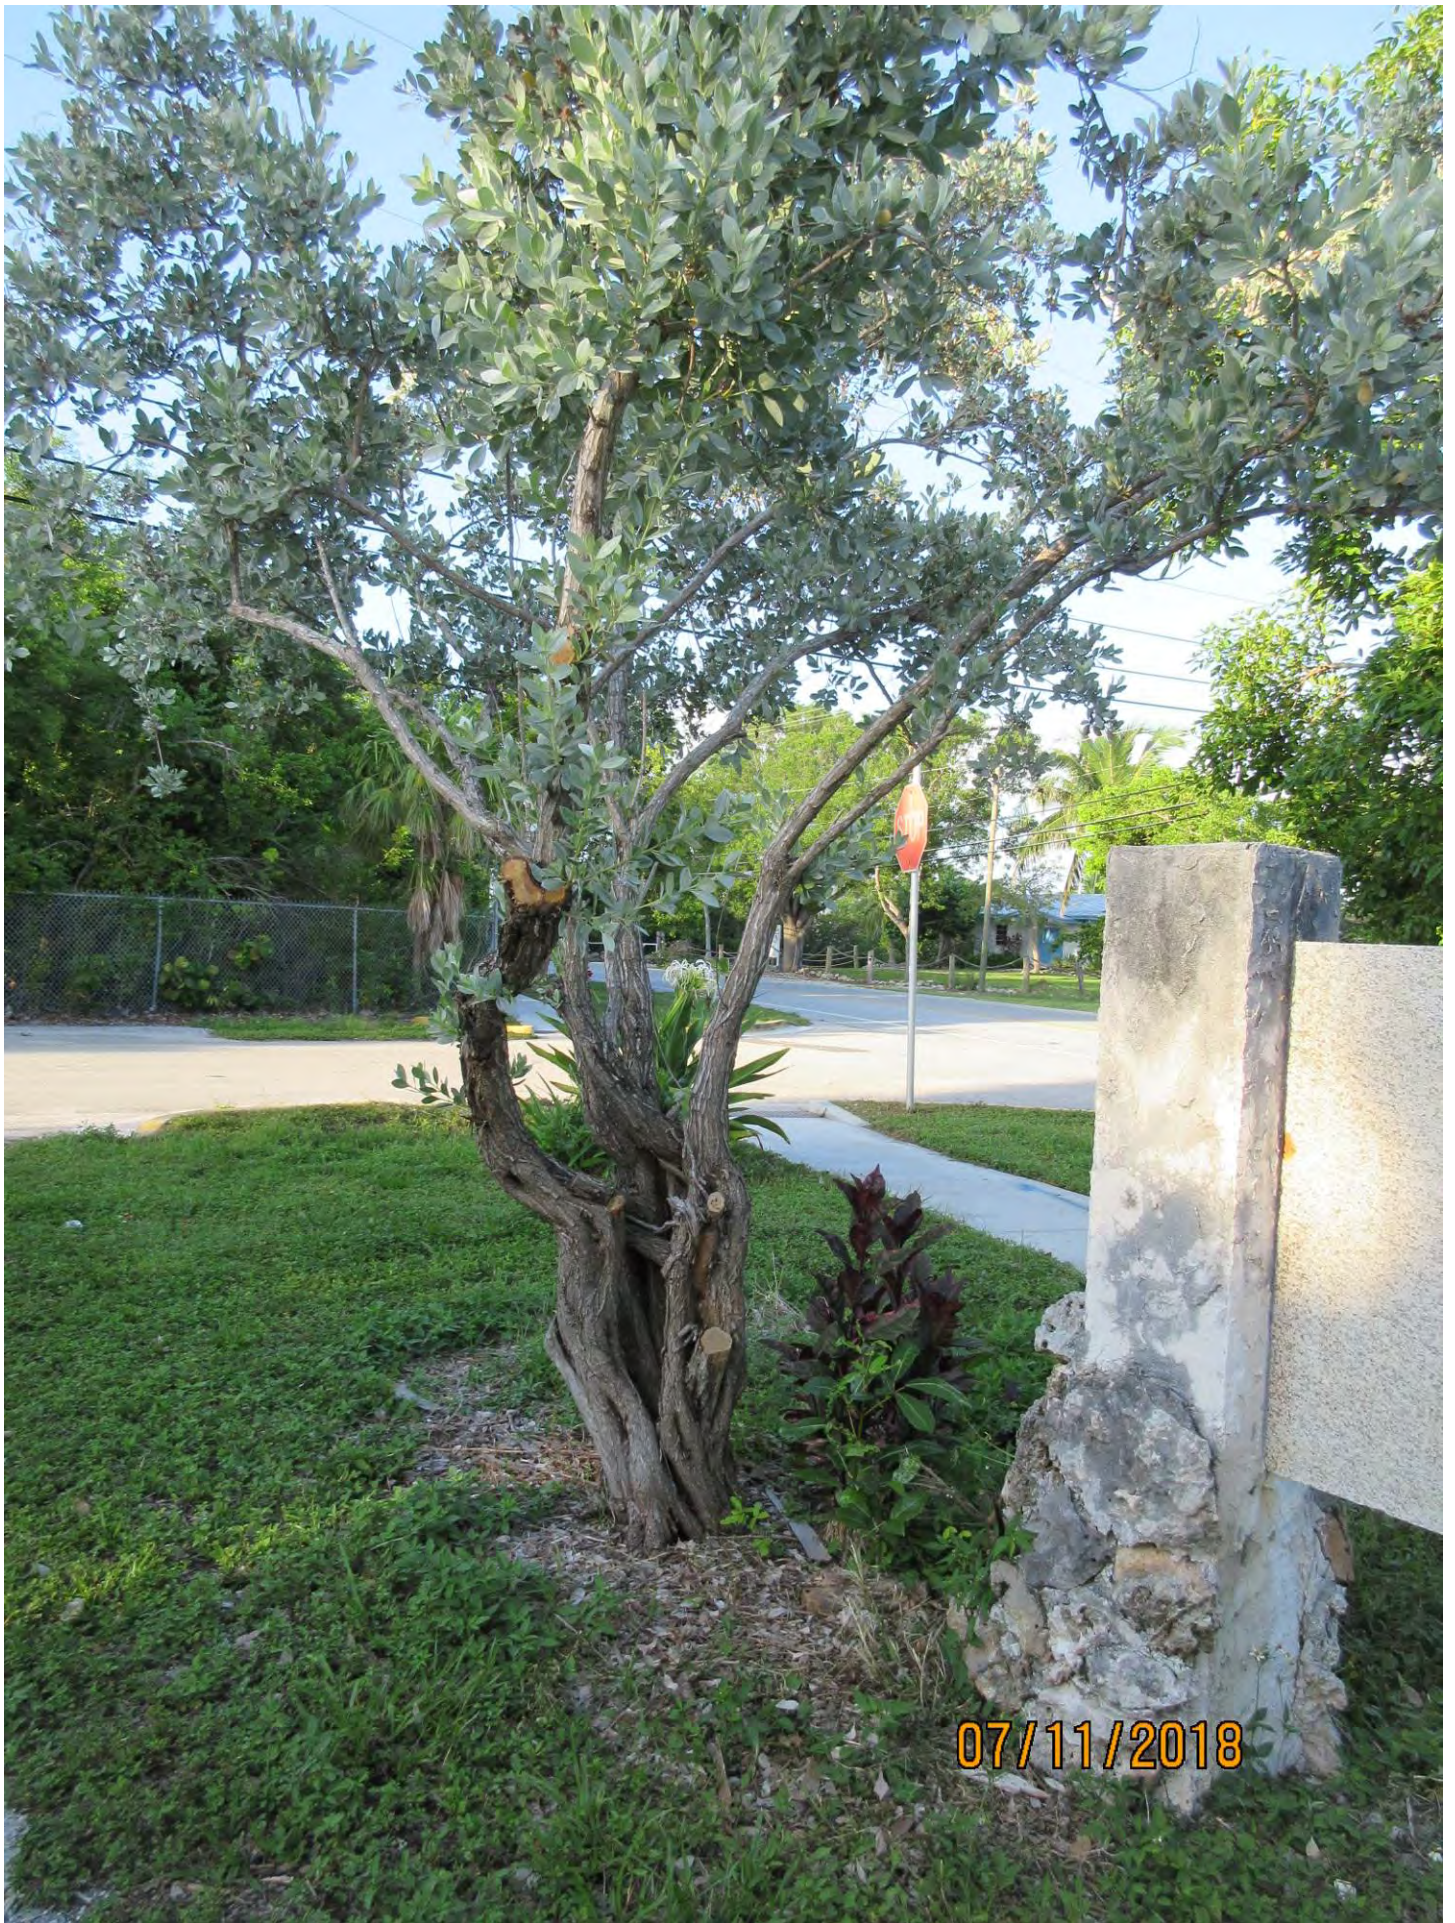
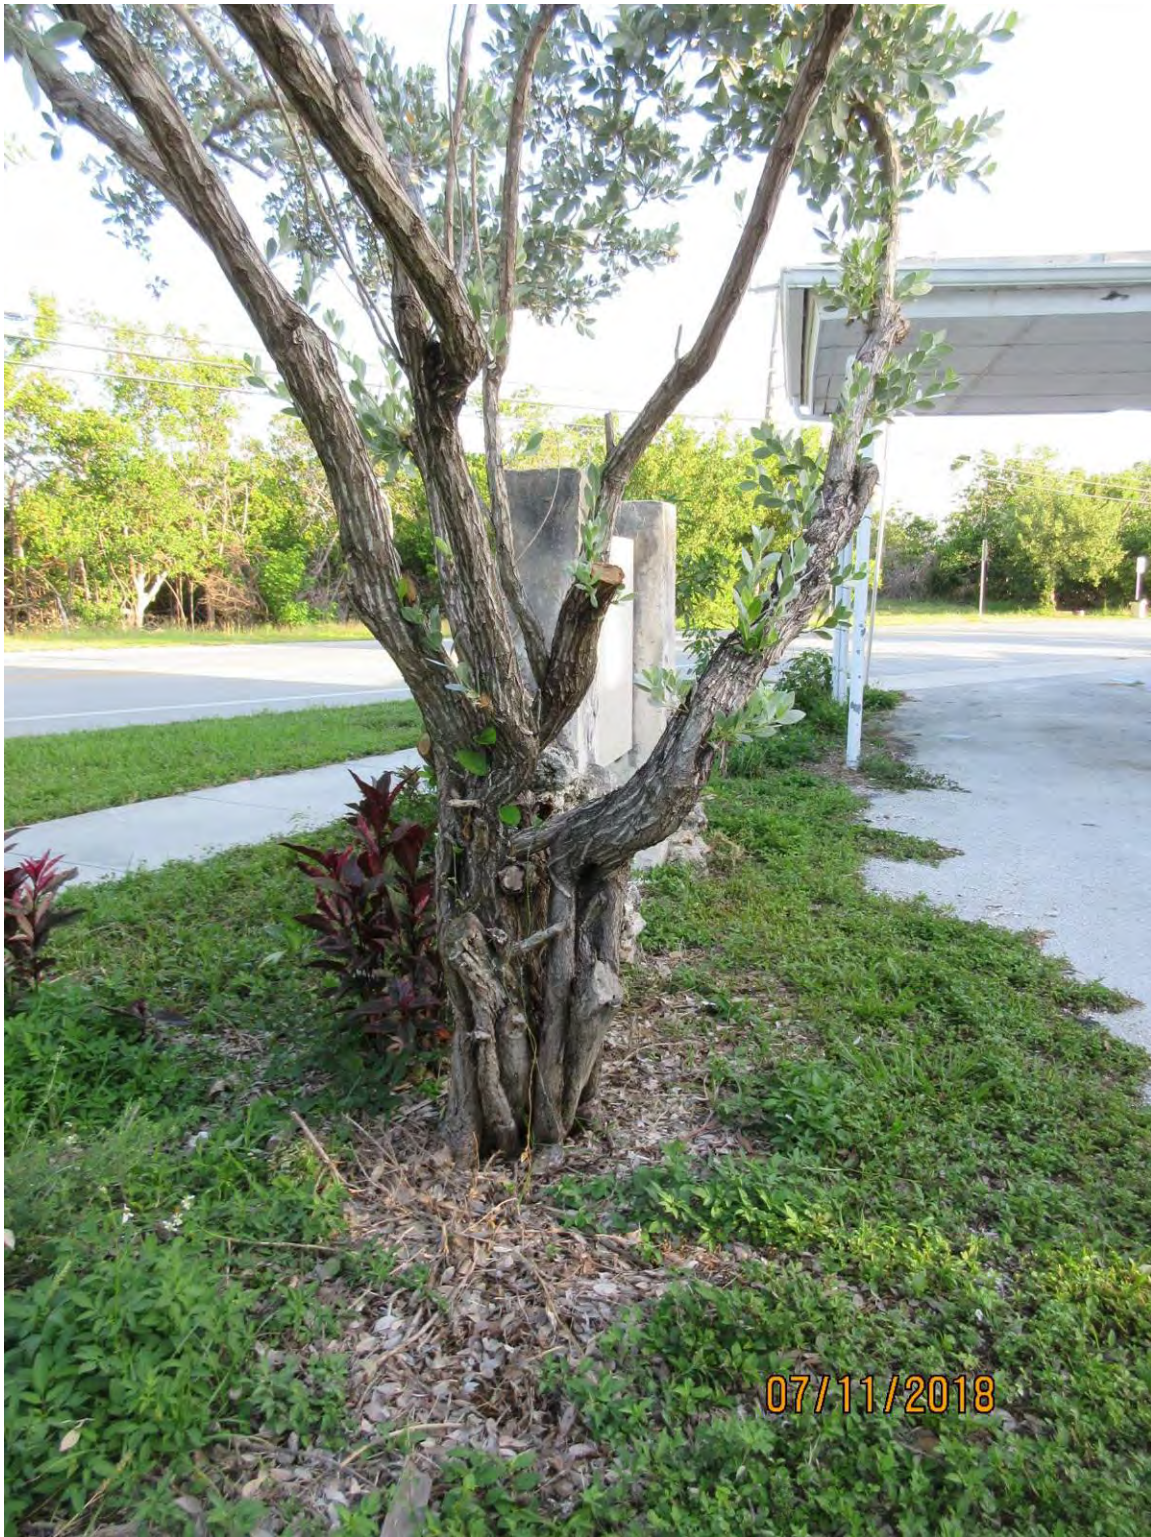
**Tree #2:**

Condition: 60% (fair, low multitrunked, codominant trunks)

**Value x Diameter = 15.2 replacement caliper inches**

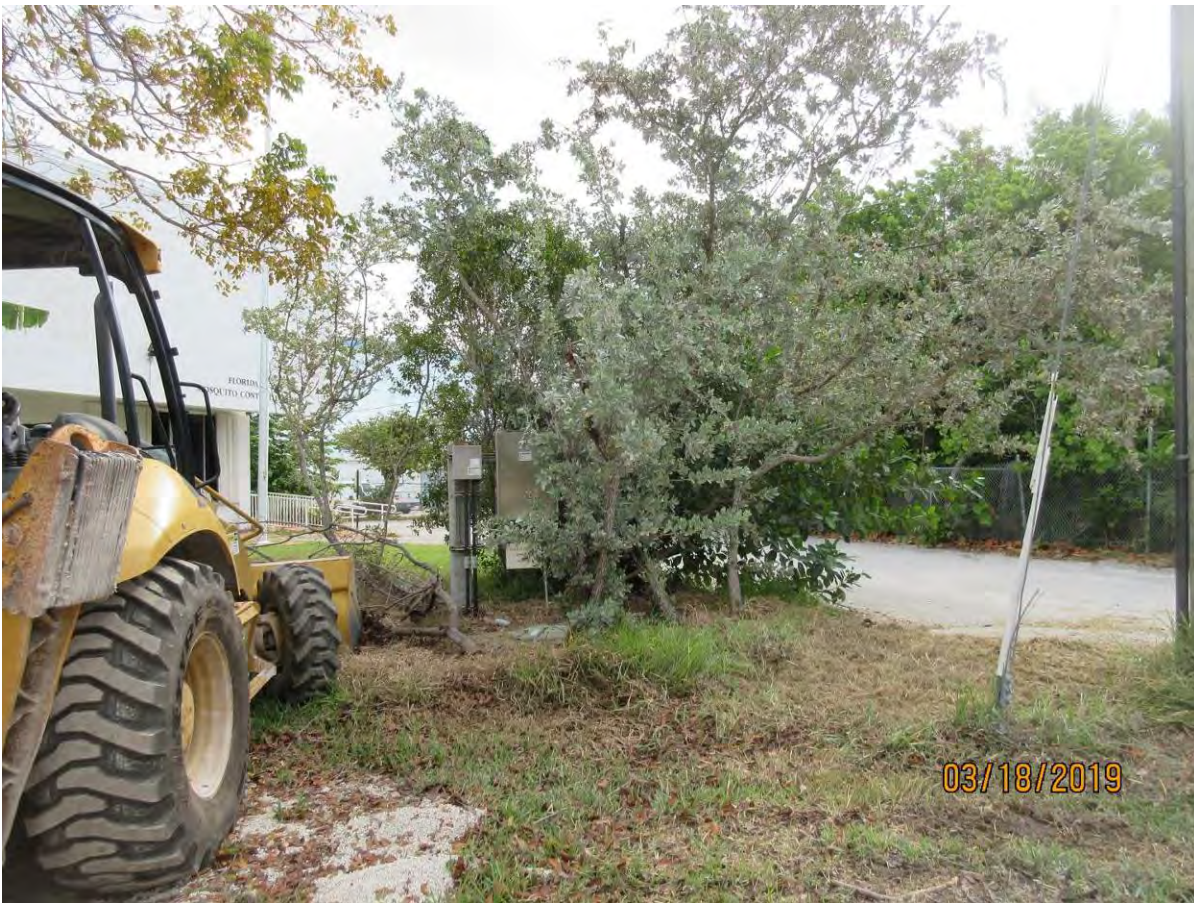
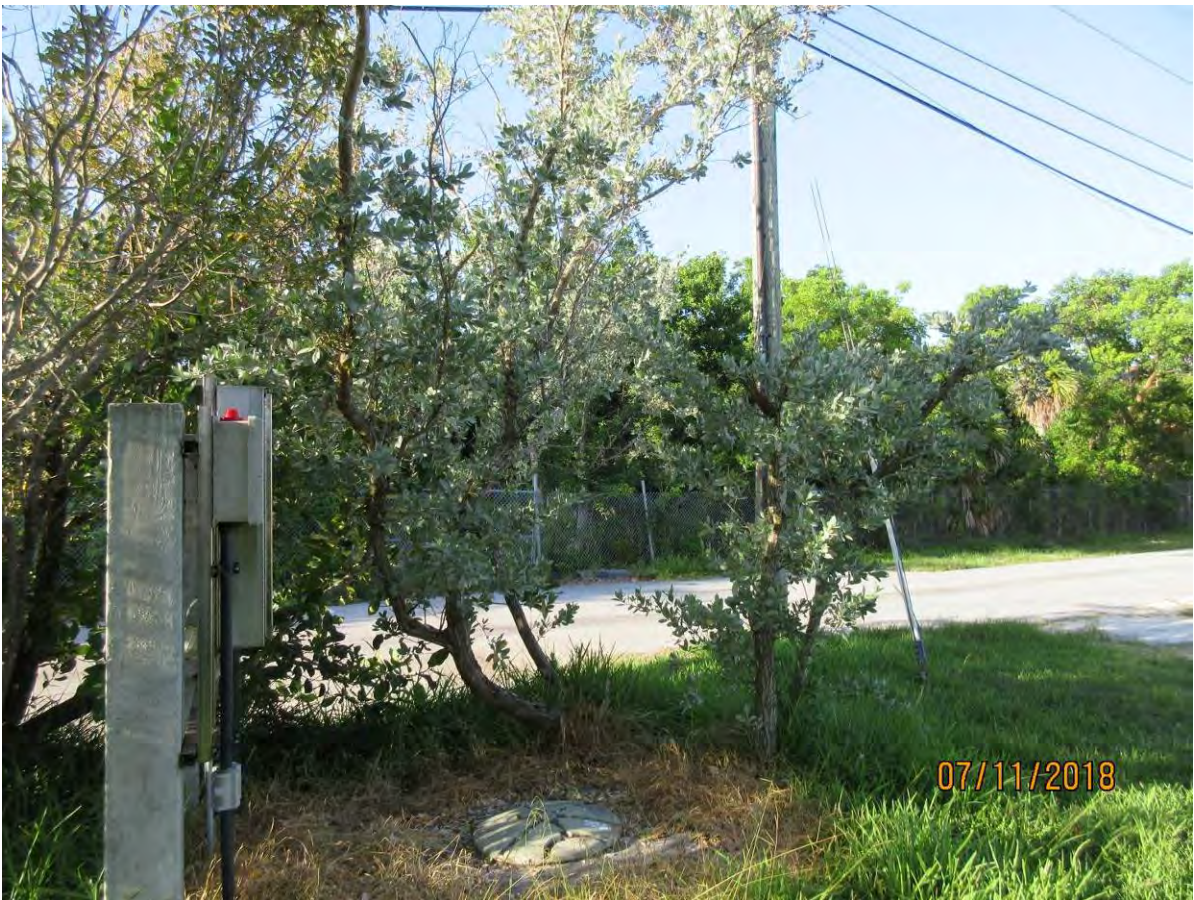
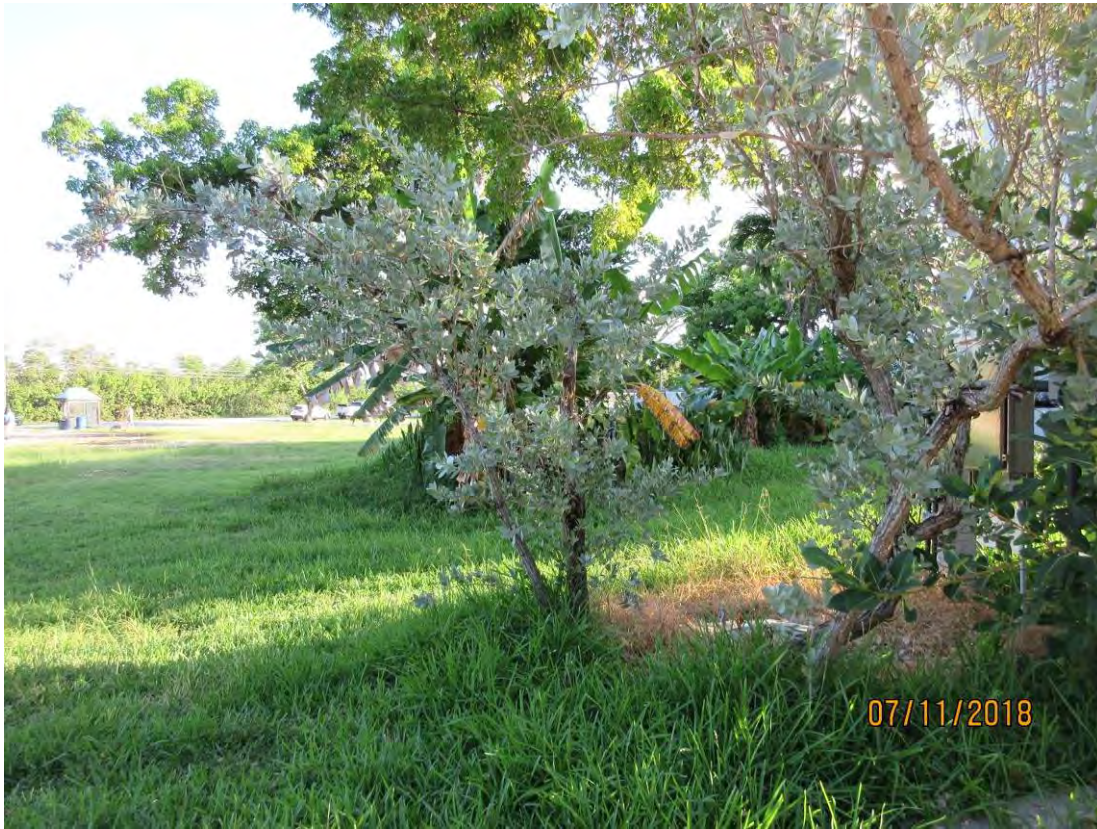
**Tree #9:**

Condition: 40% (poor, multi trunked, was a shrub/hedge)

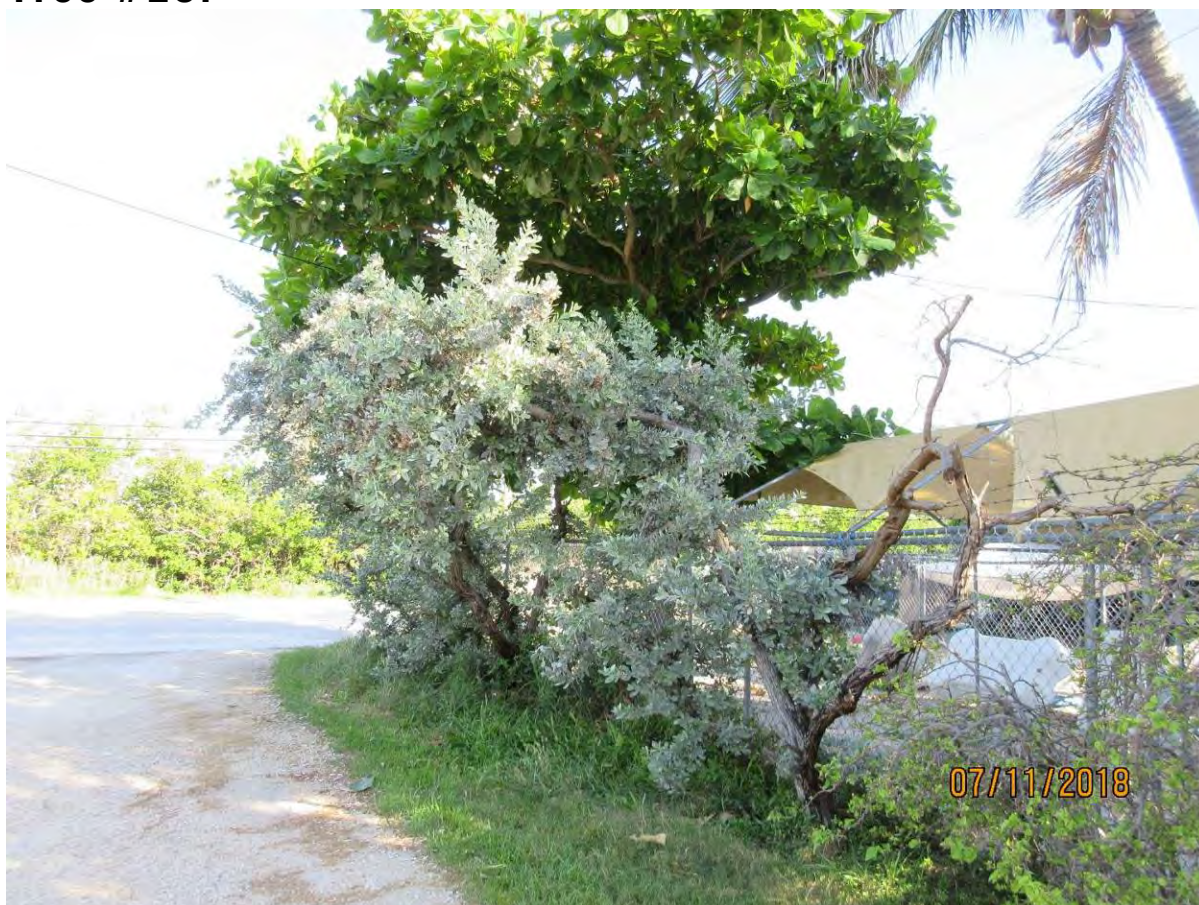
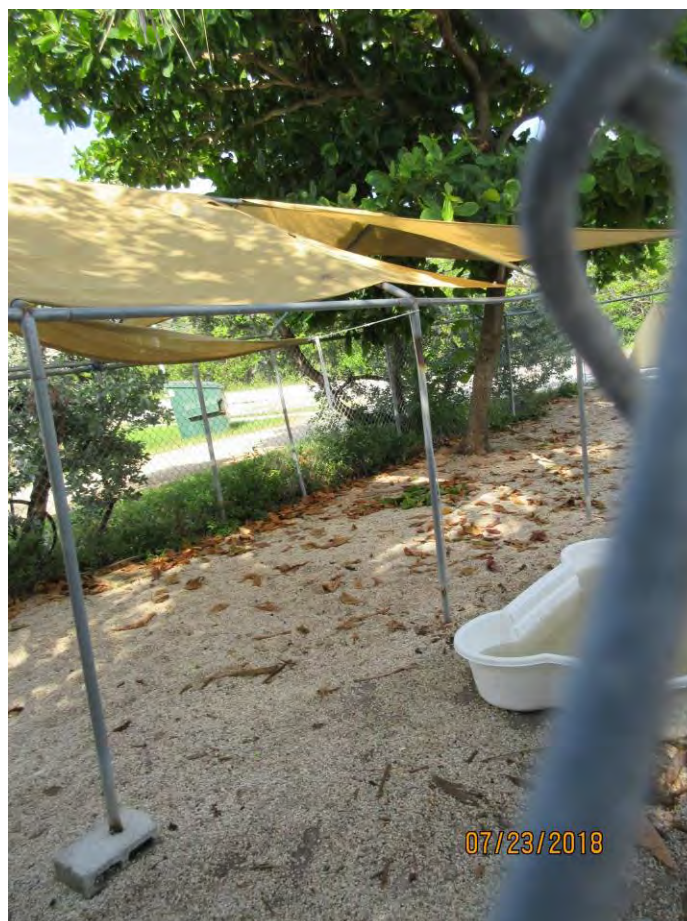
**Tree #25:**

Condition: 40% (poor, overgrown shrub/hedge, part of canopy dead)

Condition: 60% (fair, overgrown shrub/hedge)

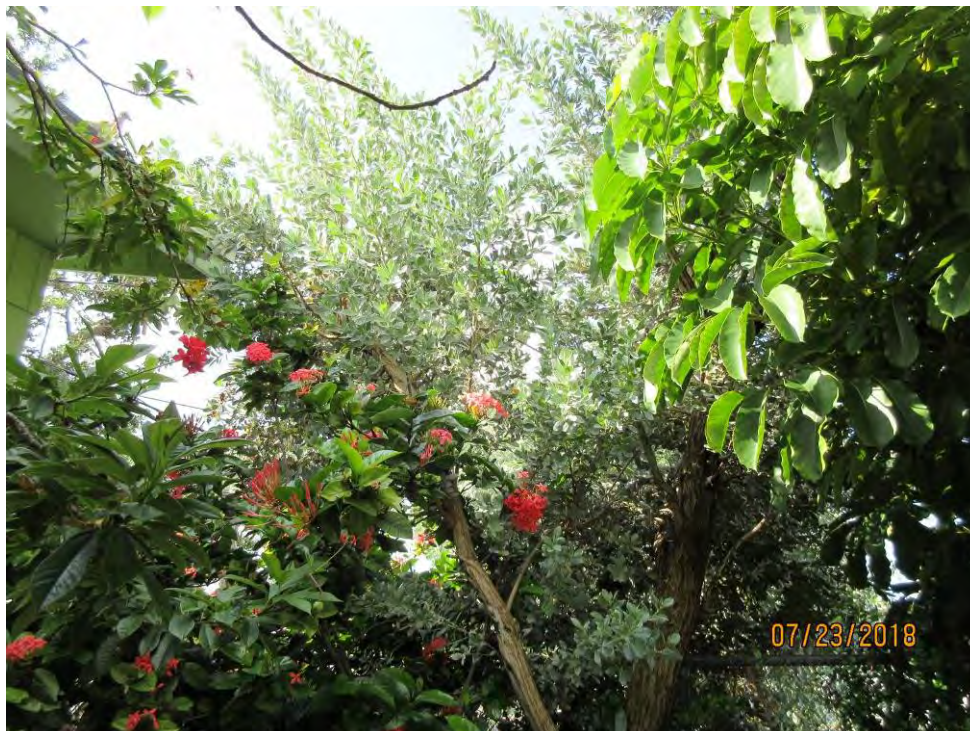
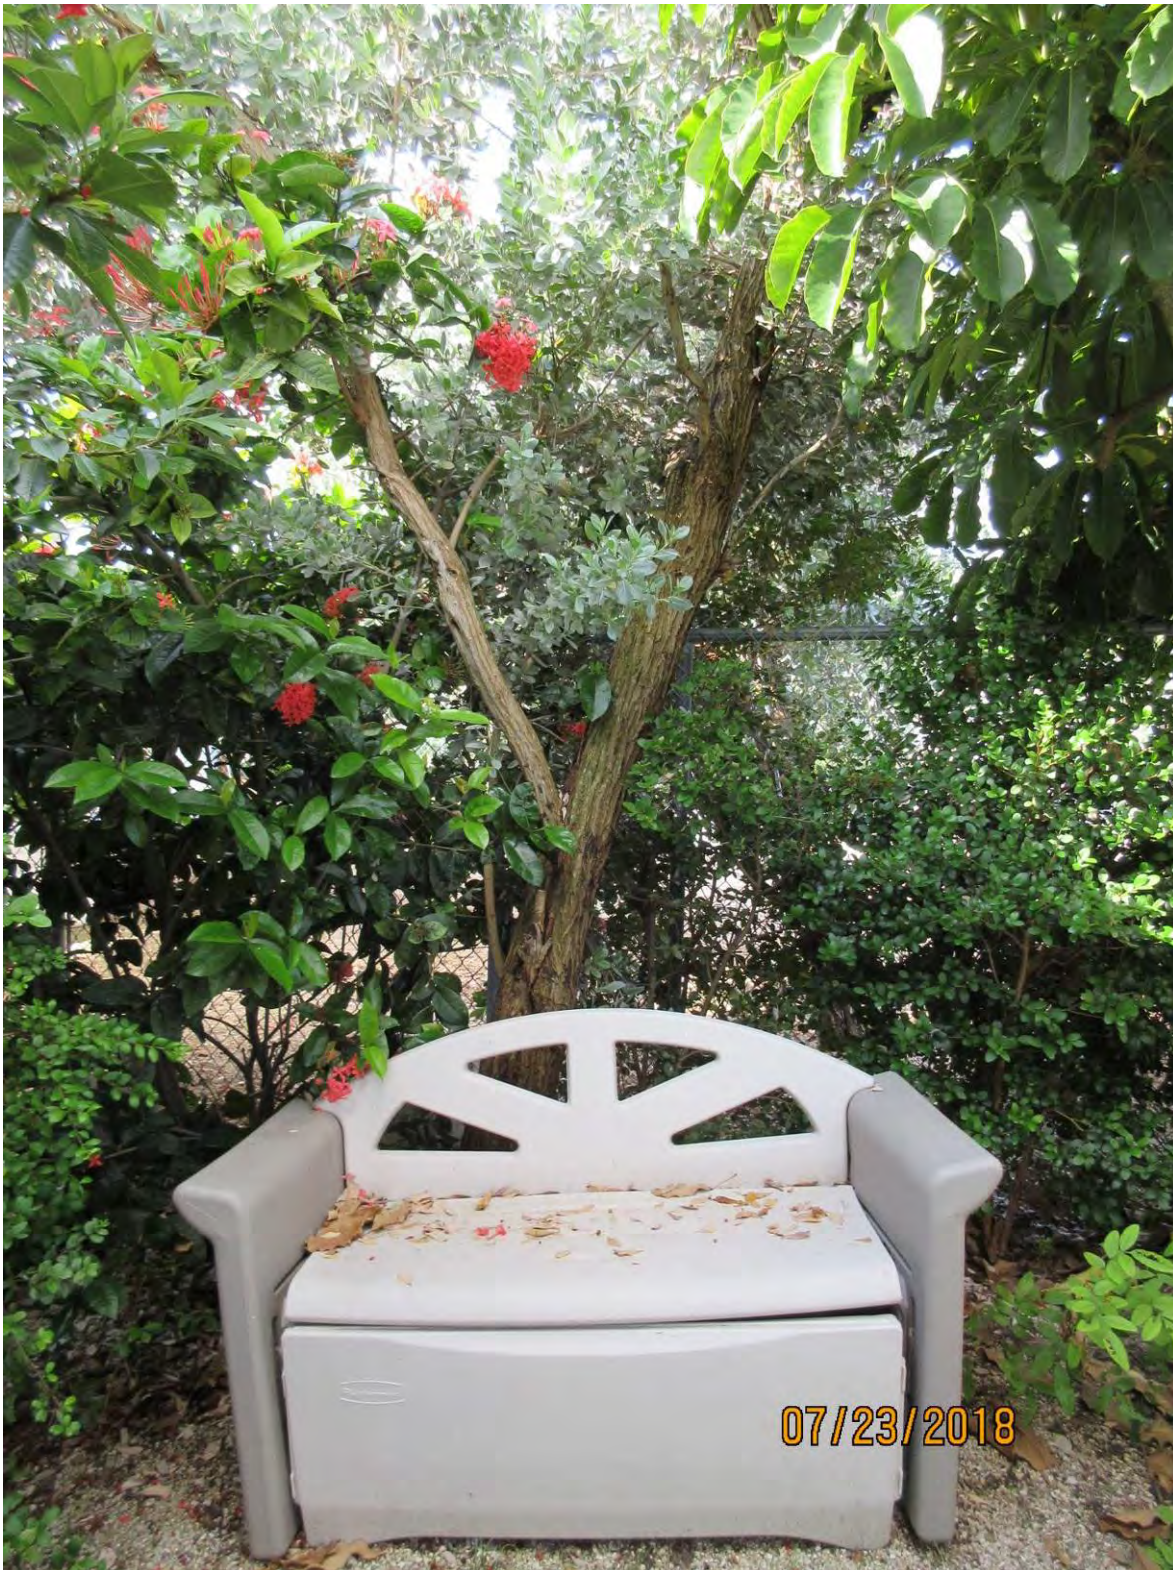
**Tree #46:**

Condition: 60% (fair)

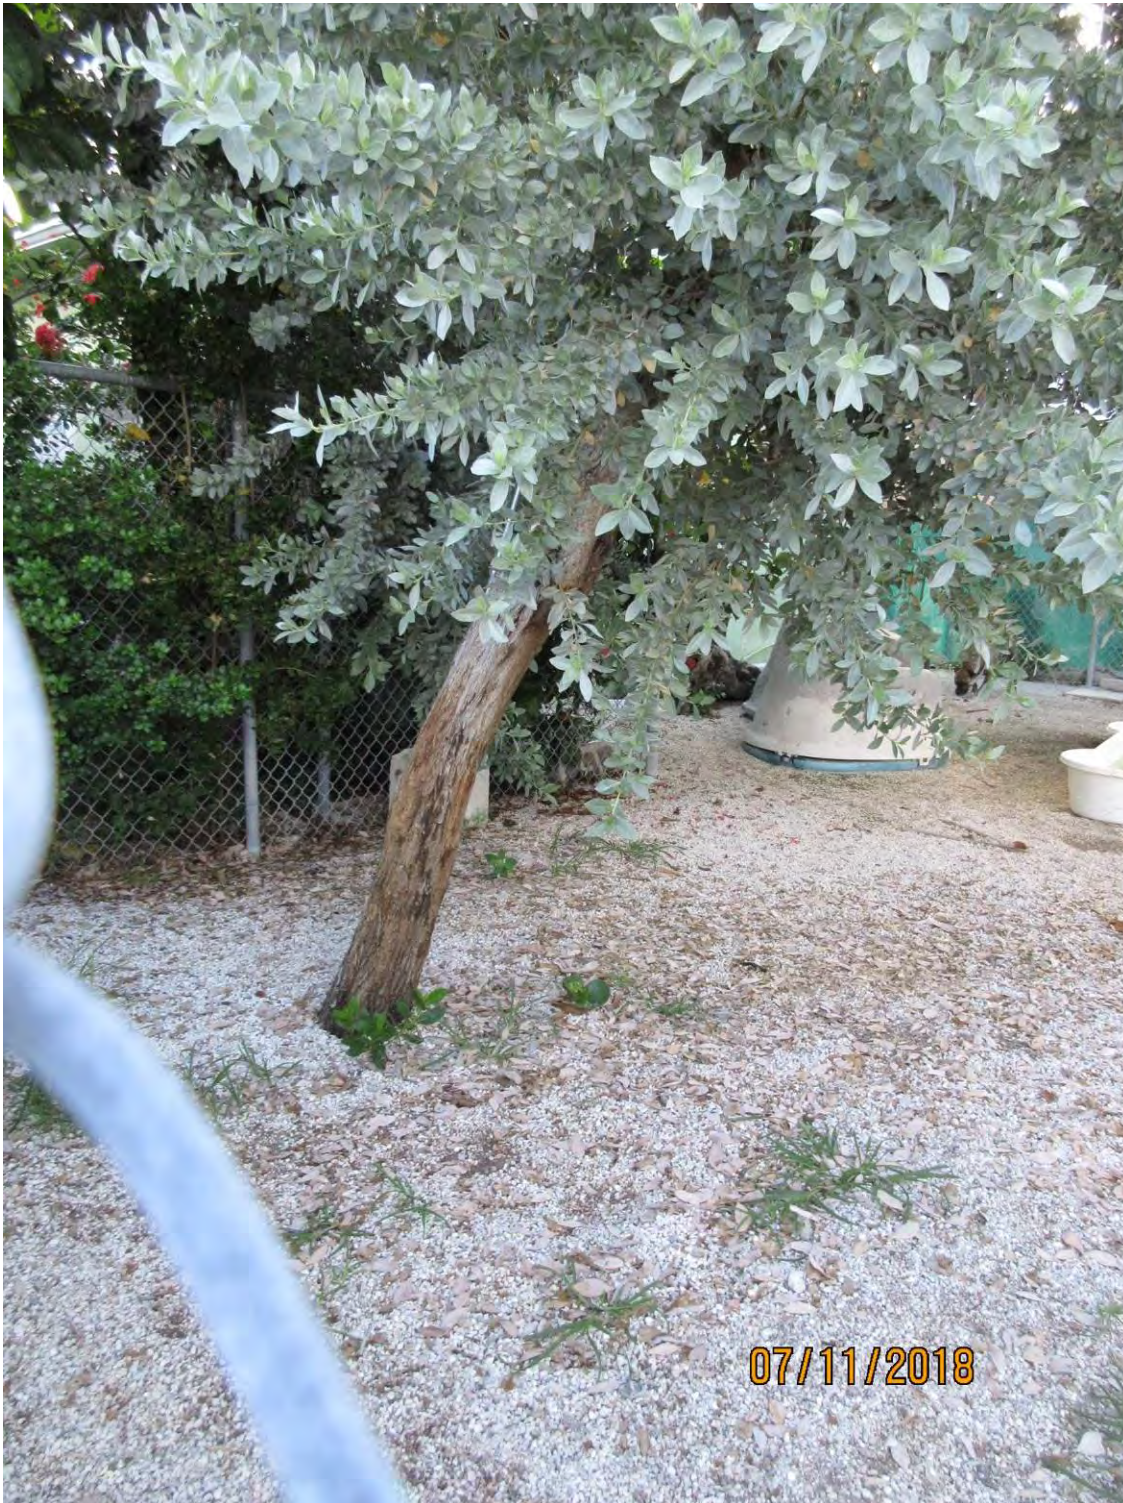
**Tree #48:**

Condition: 60% (fair)

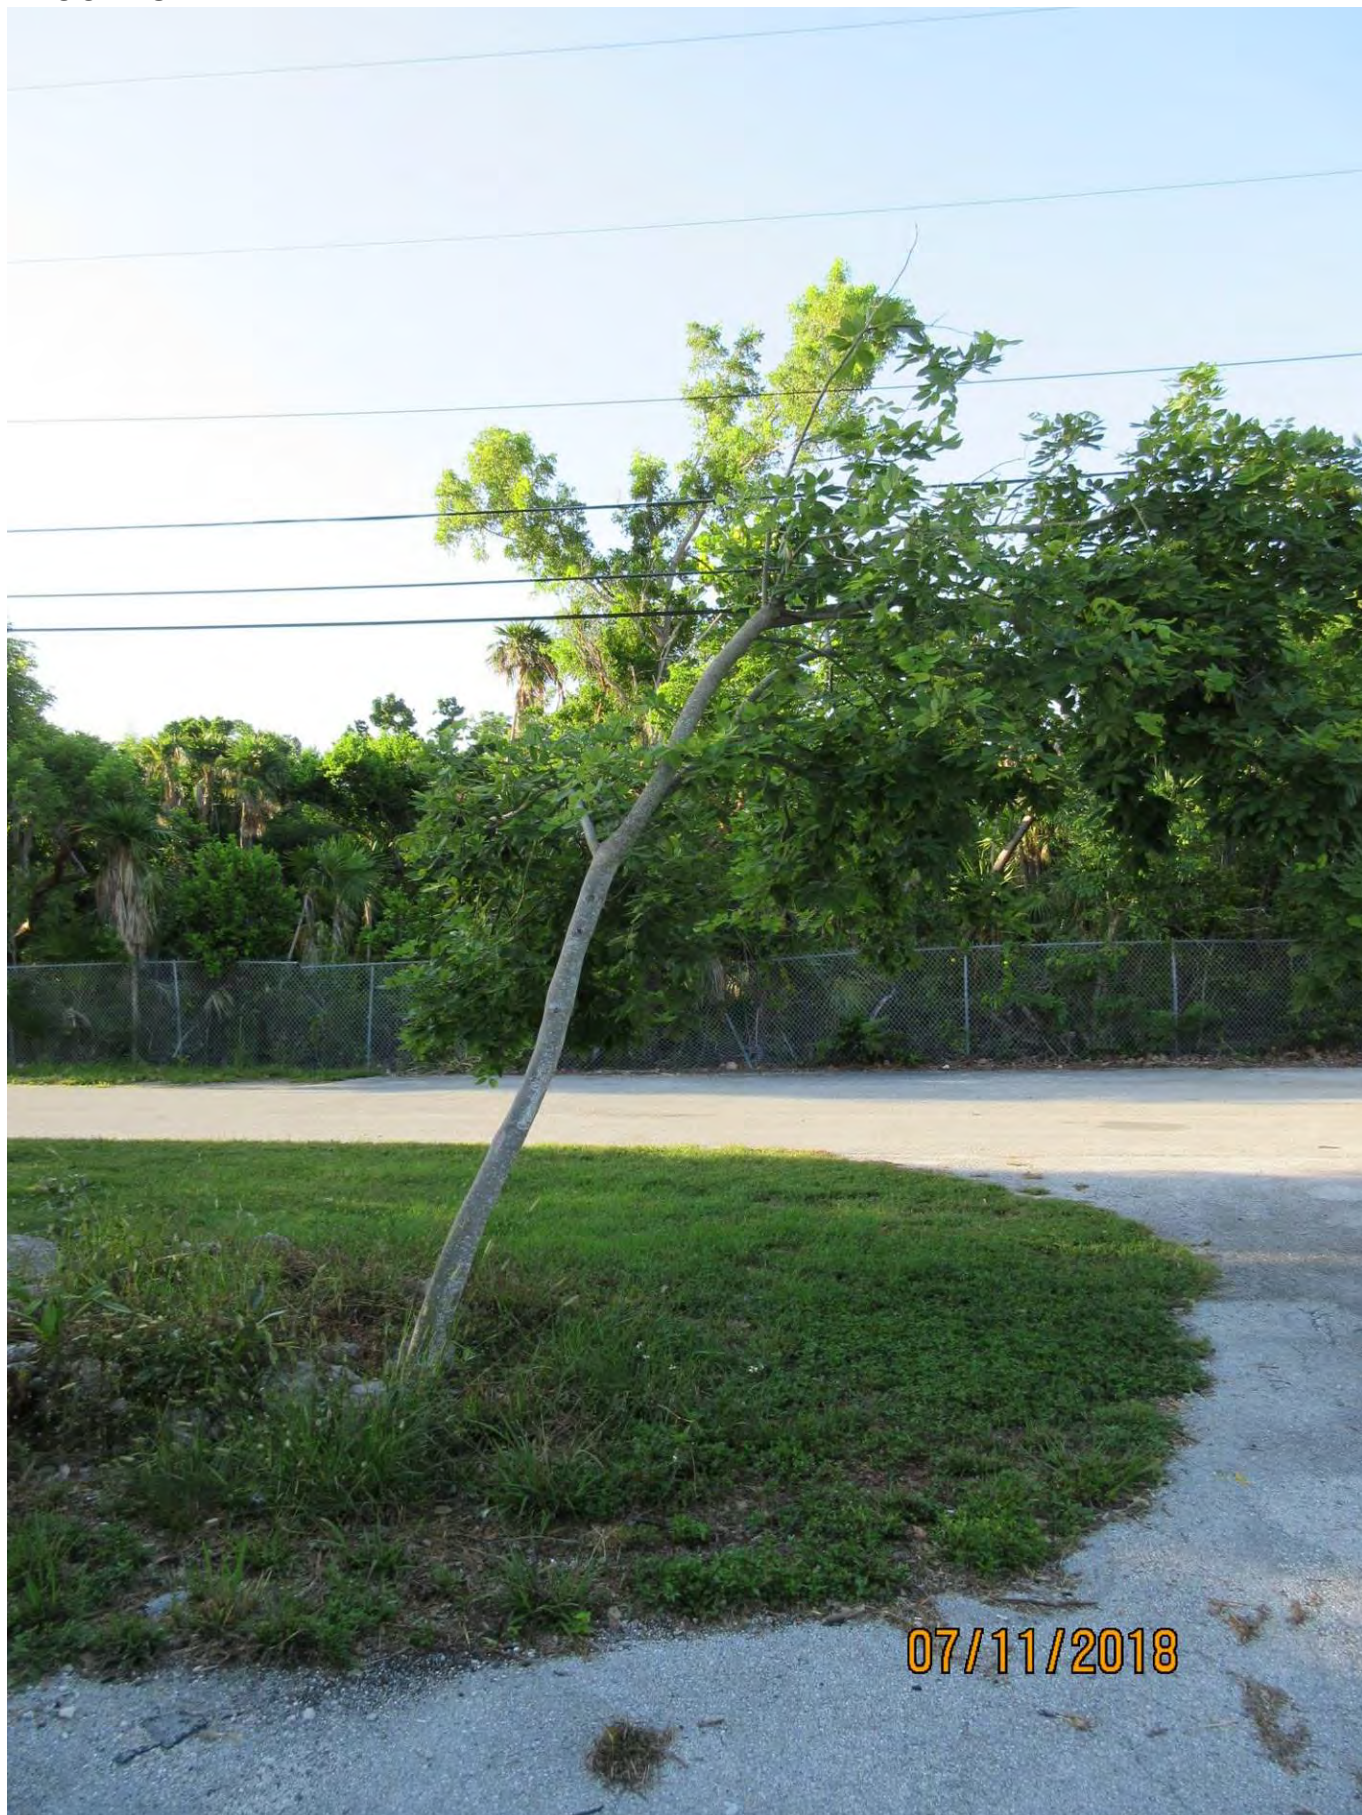
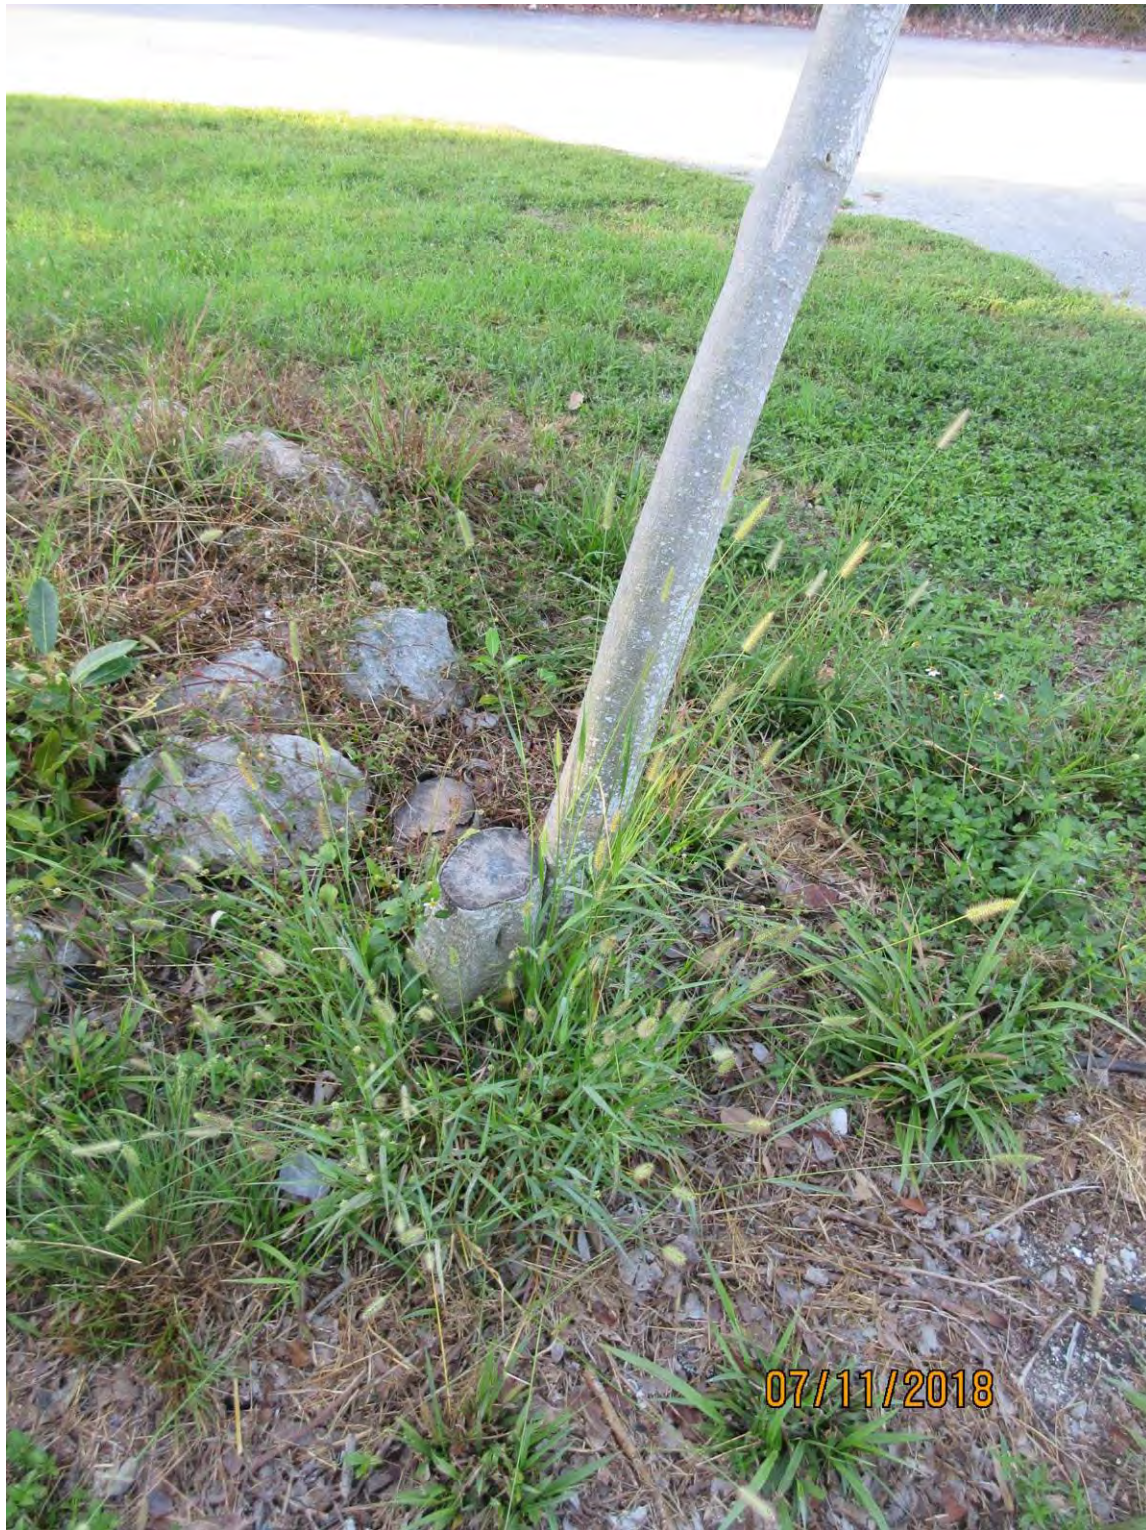
**Tree #5:**

Condition: 40% (poor, strong lean, one codominant trunk previously removed)
