# STAFF REPORT

RE: **5220, 5224, 5228, & 5230 College Road**  
**(permit application # T2019-0135)**

FROM: Karen DeMaria, City of Key West Urban Forestry Manager

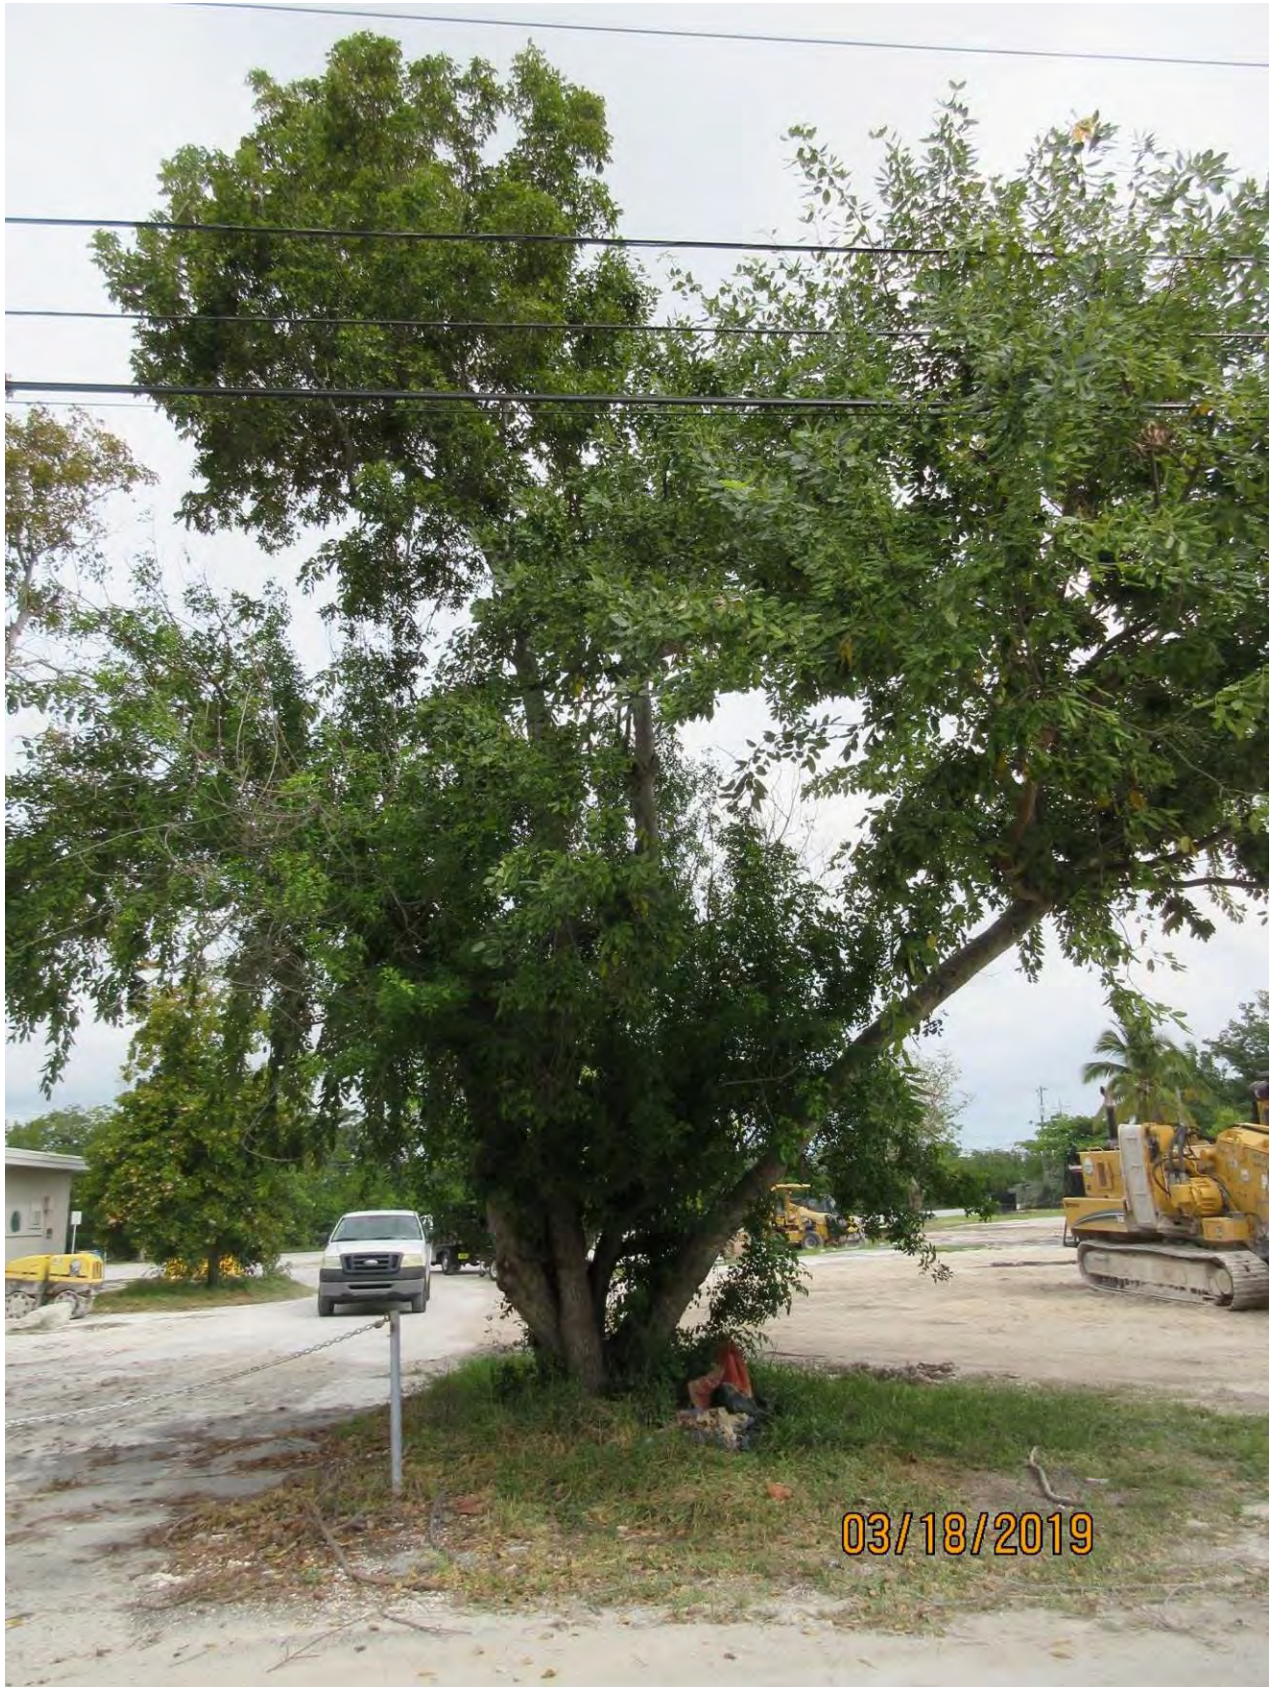
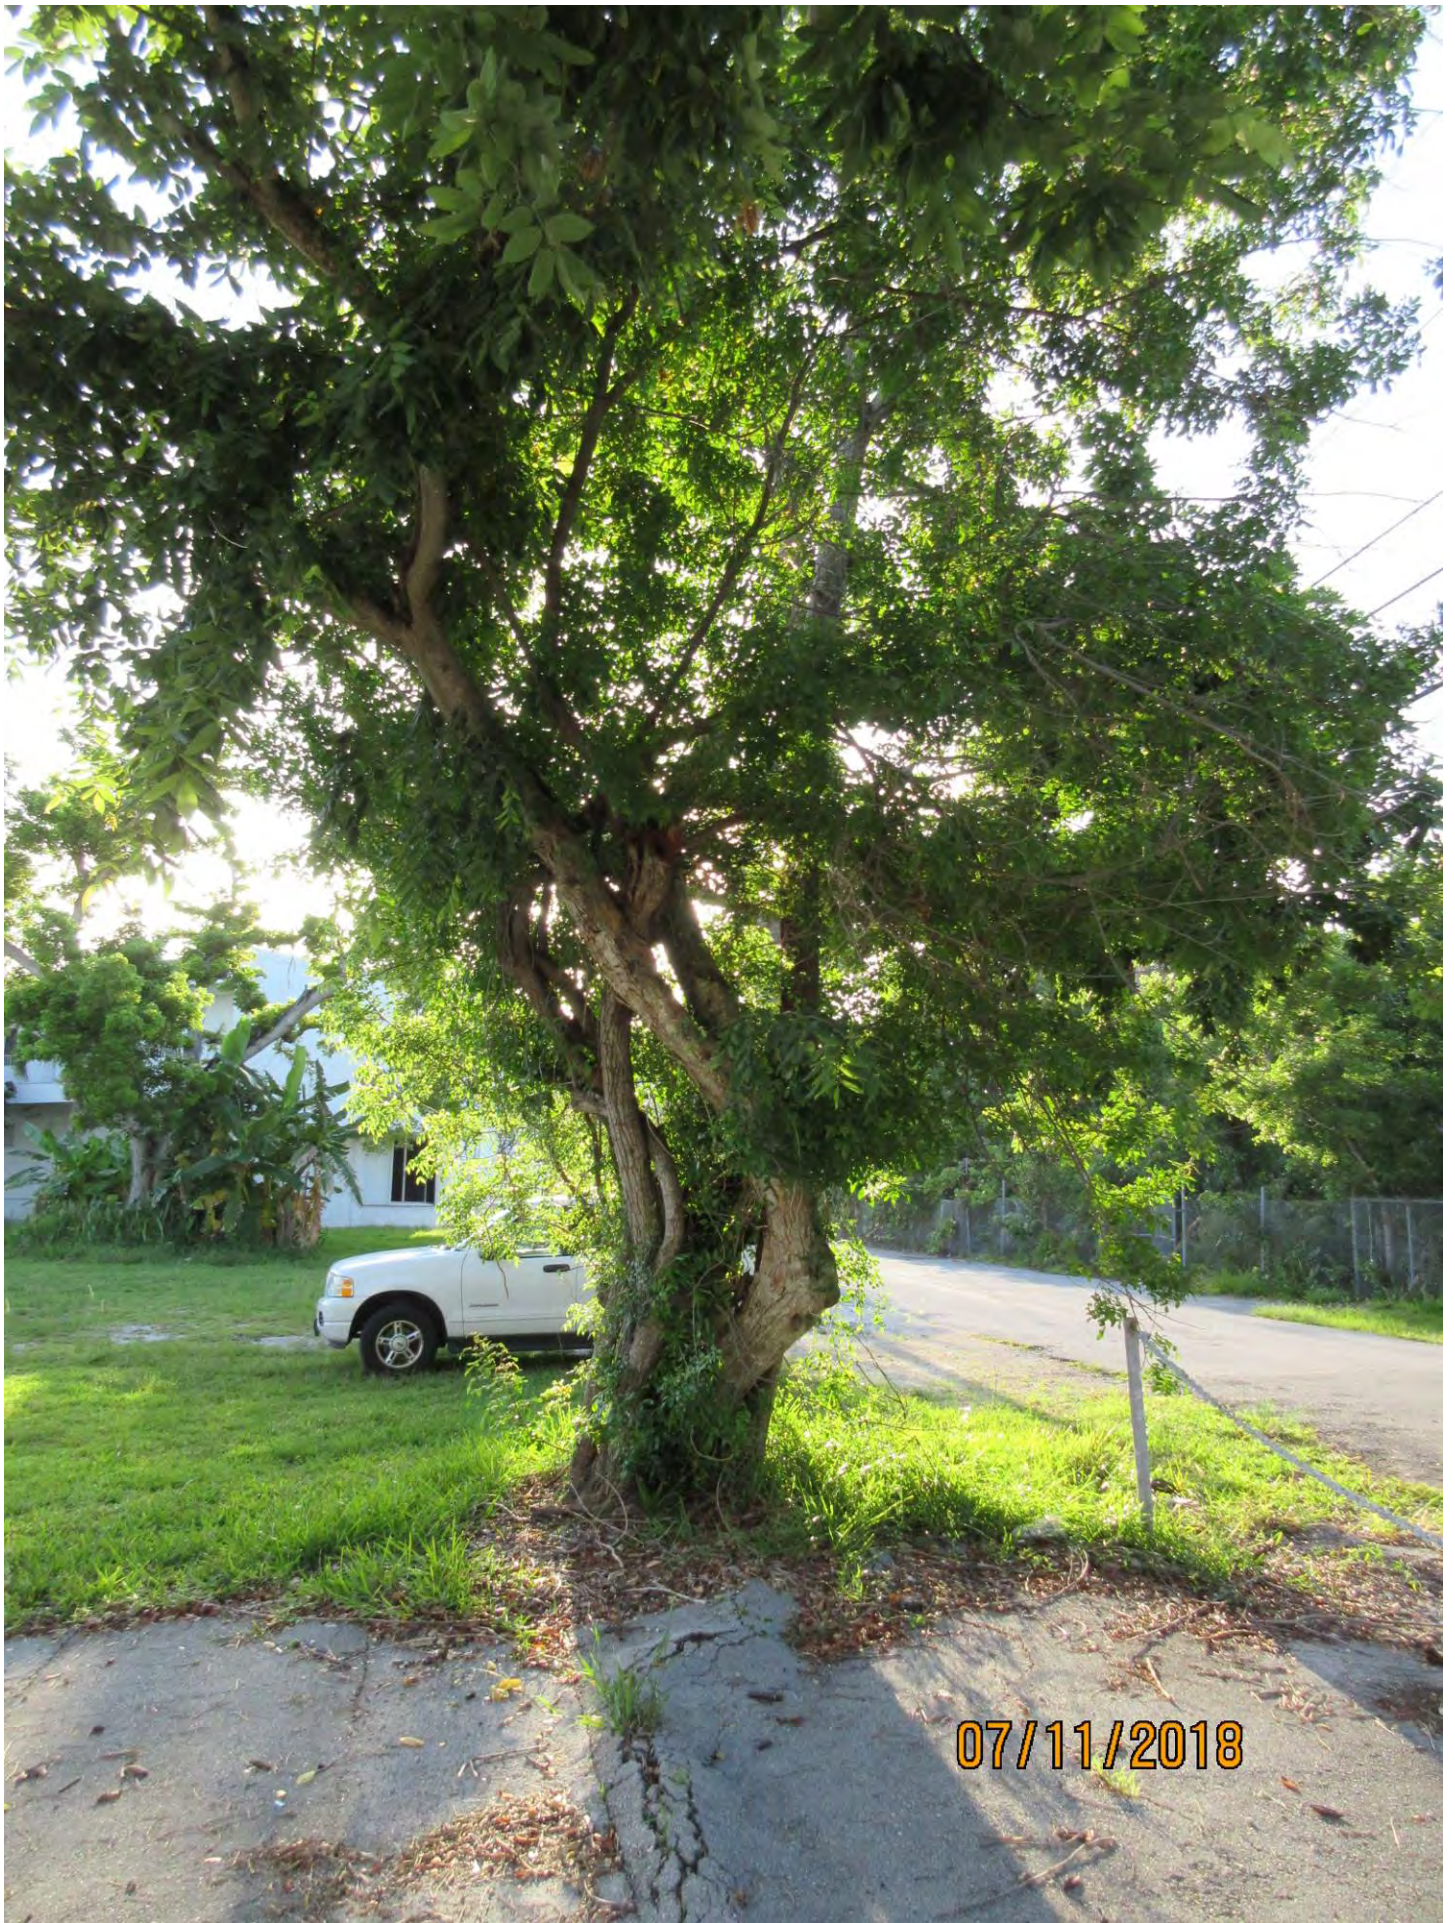
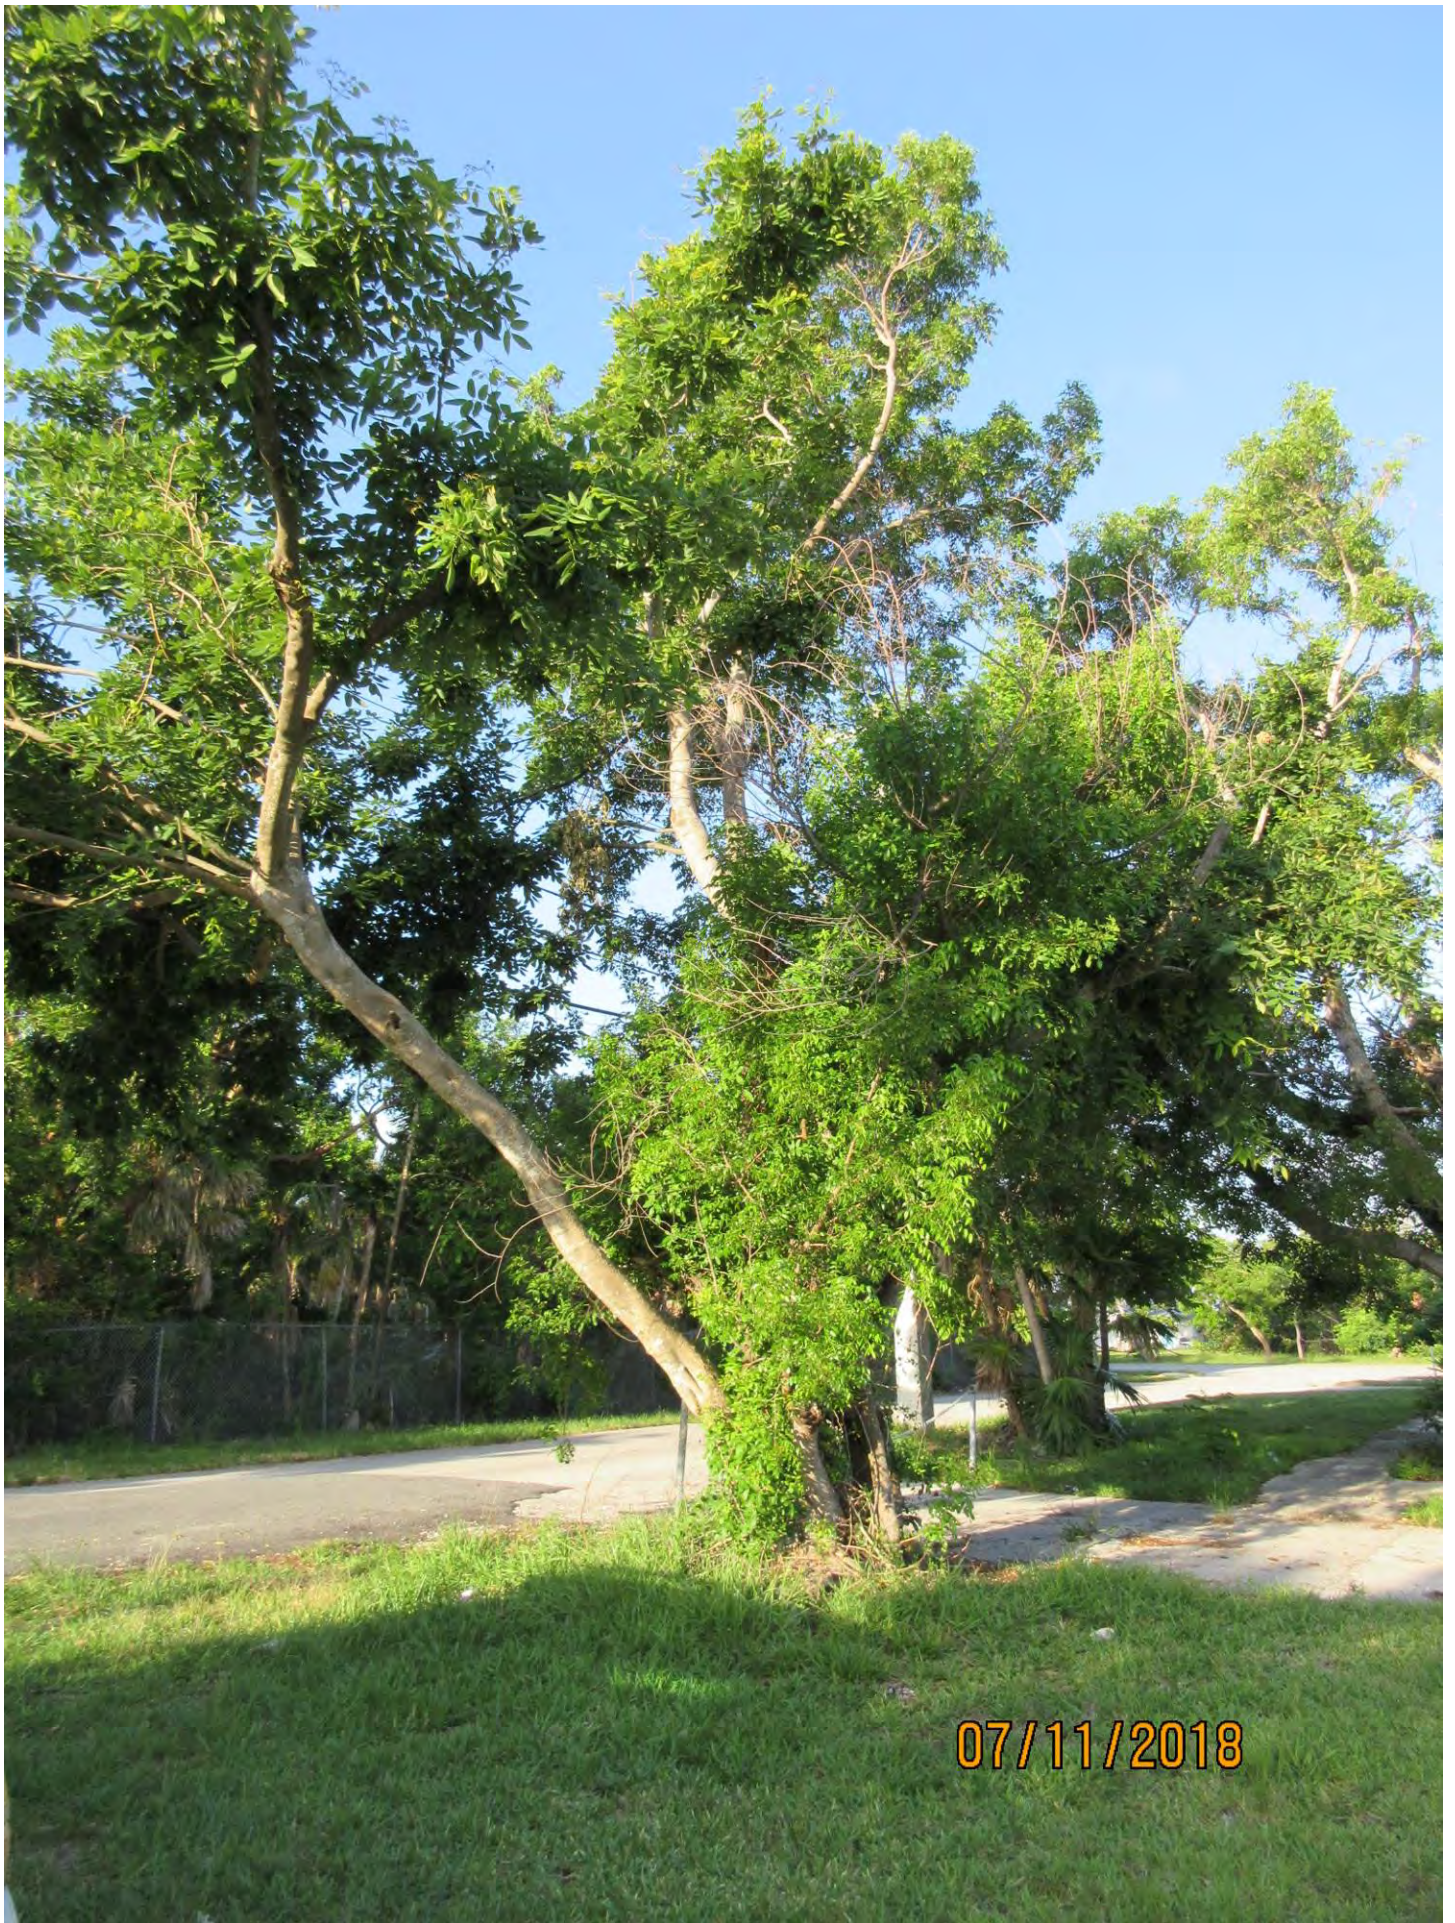
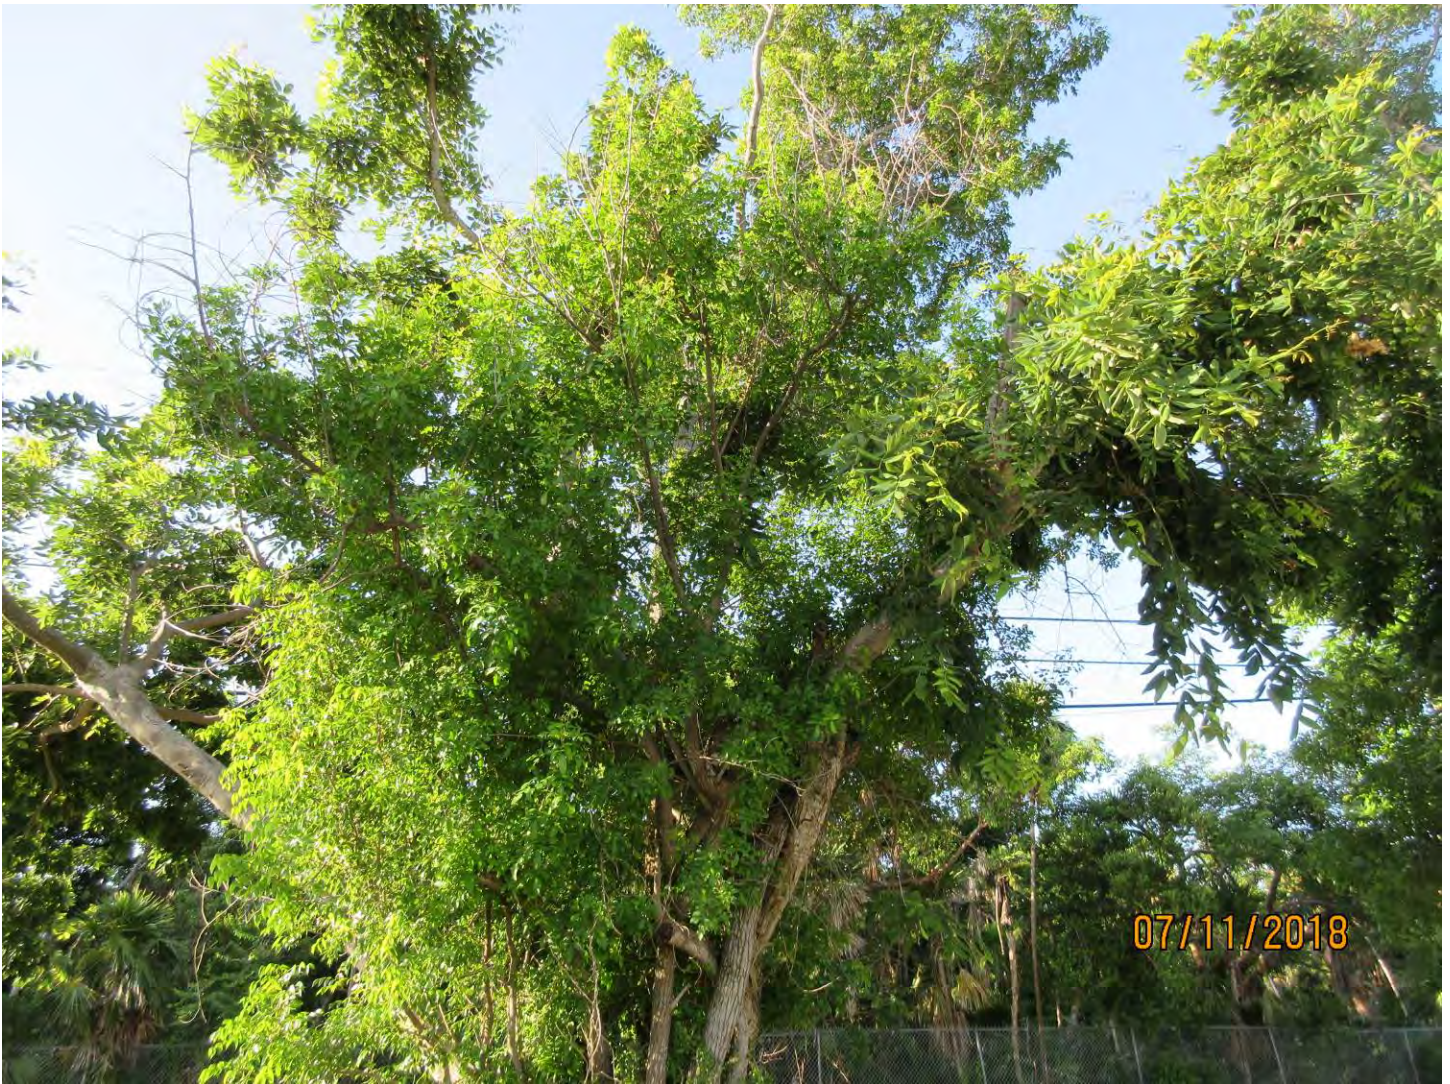
**Tree #8a:**

**Tree lump 8 consists of a large Jamaican Dogwood tree with a Mahogany (tree #8c) and Brazilian pepper tree (invasive exotic) growing with it.**

Location: 60% (growing intertwined with two other trees species)

Condition: 40% (poor, decay in canopy branches and main trunks, poor structure)

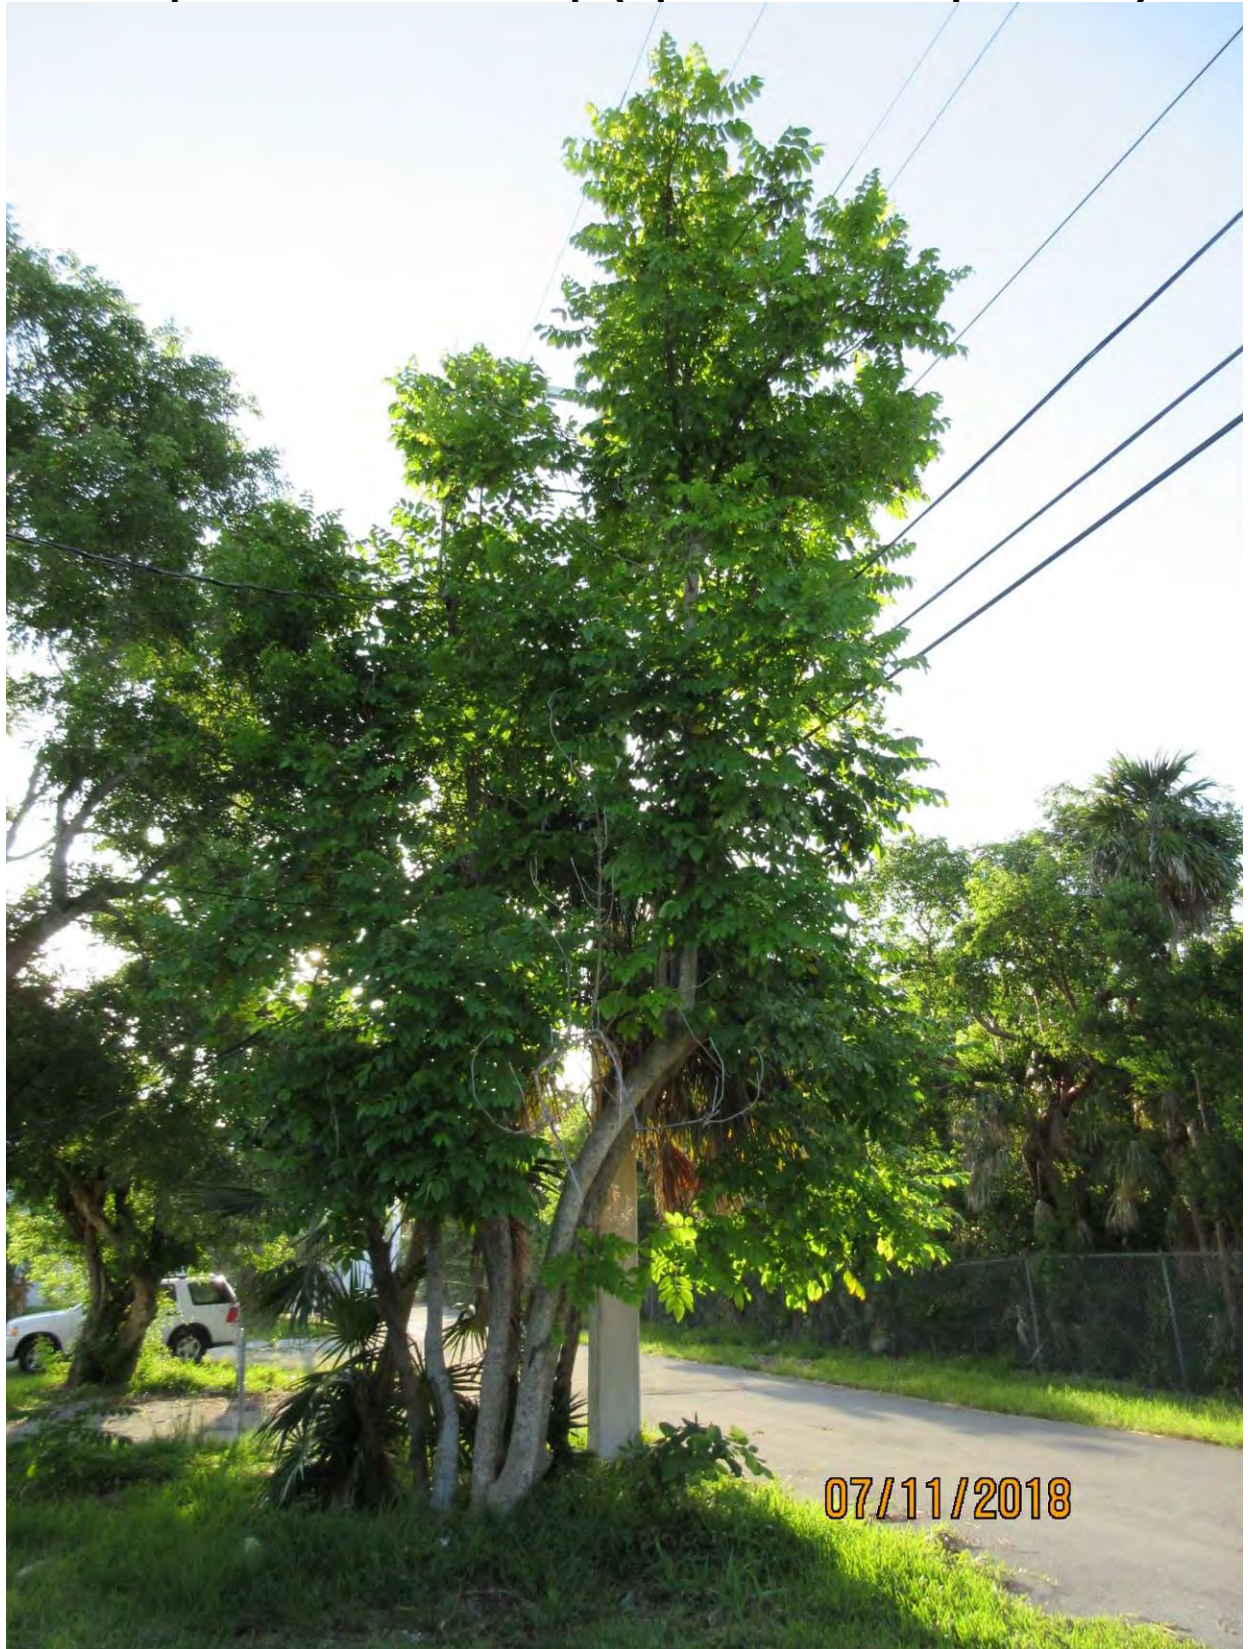
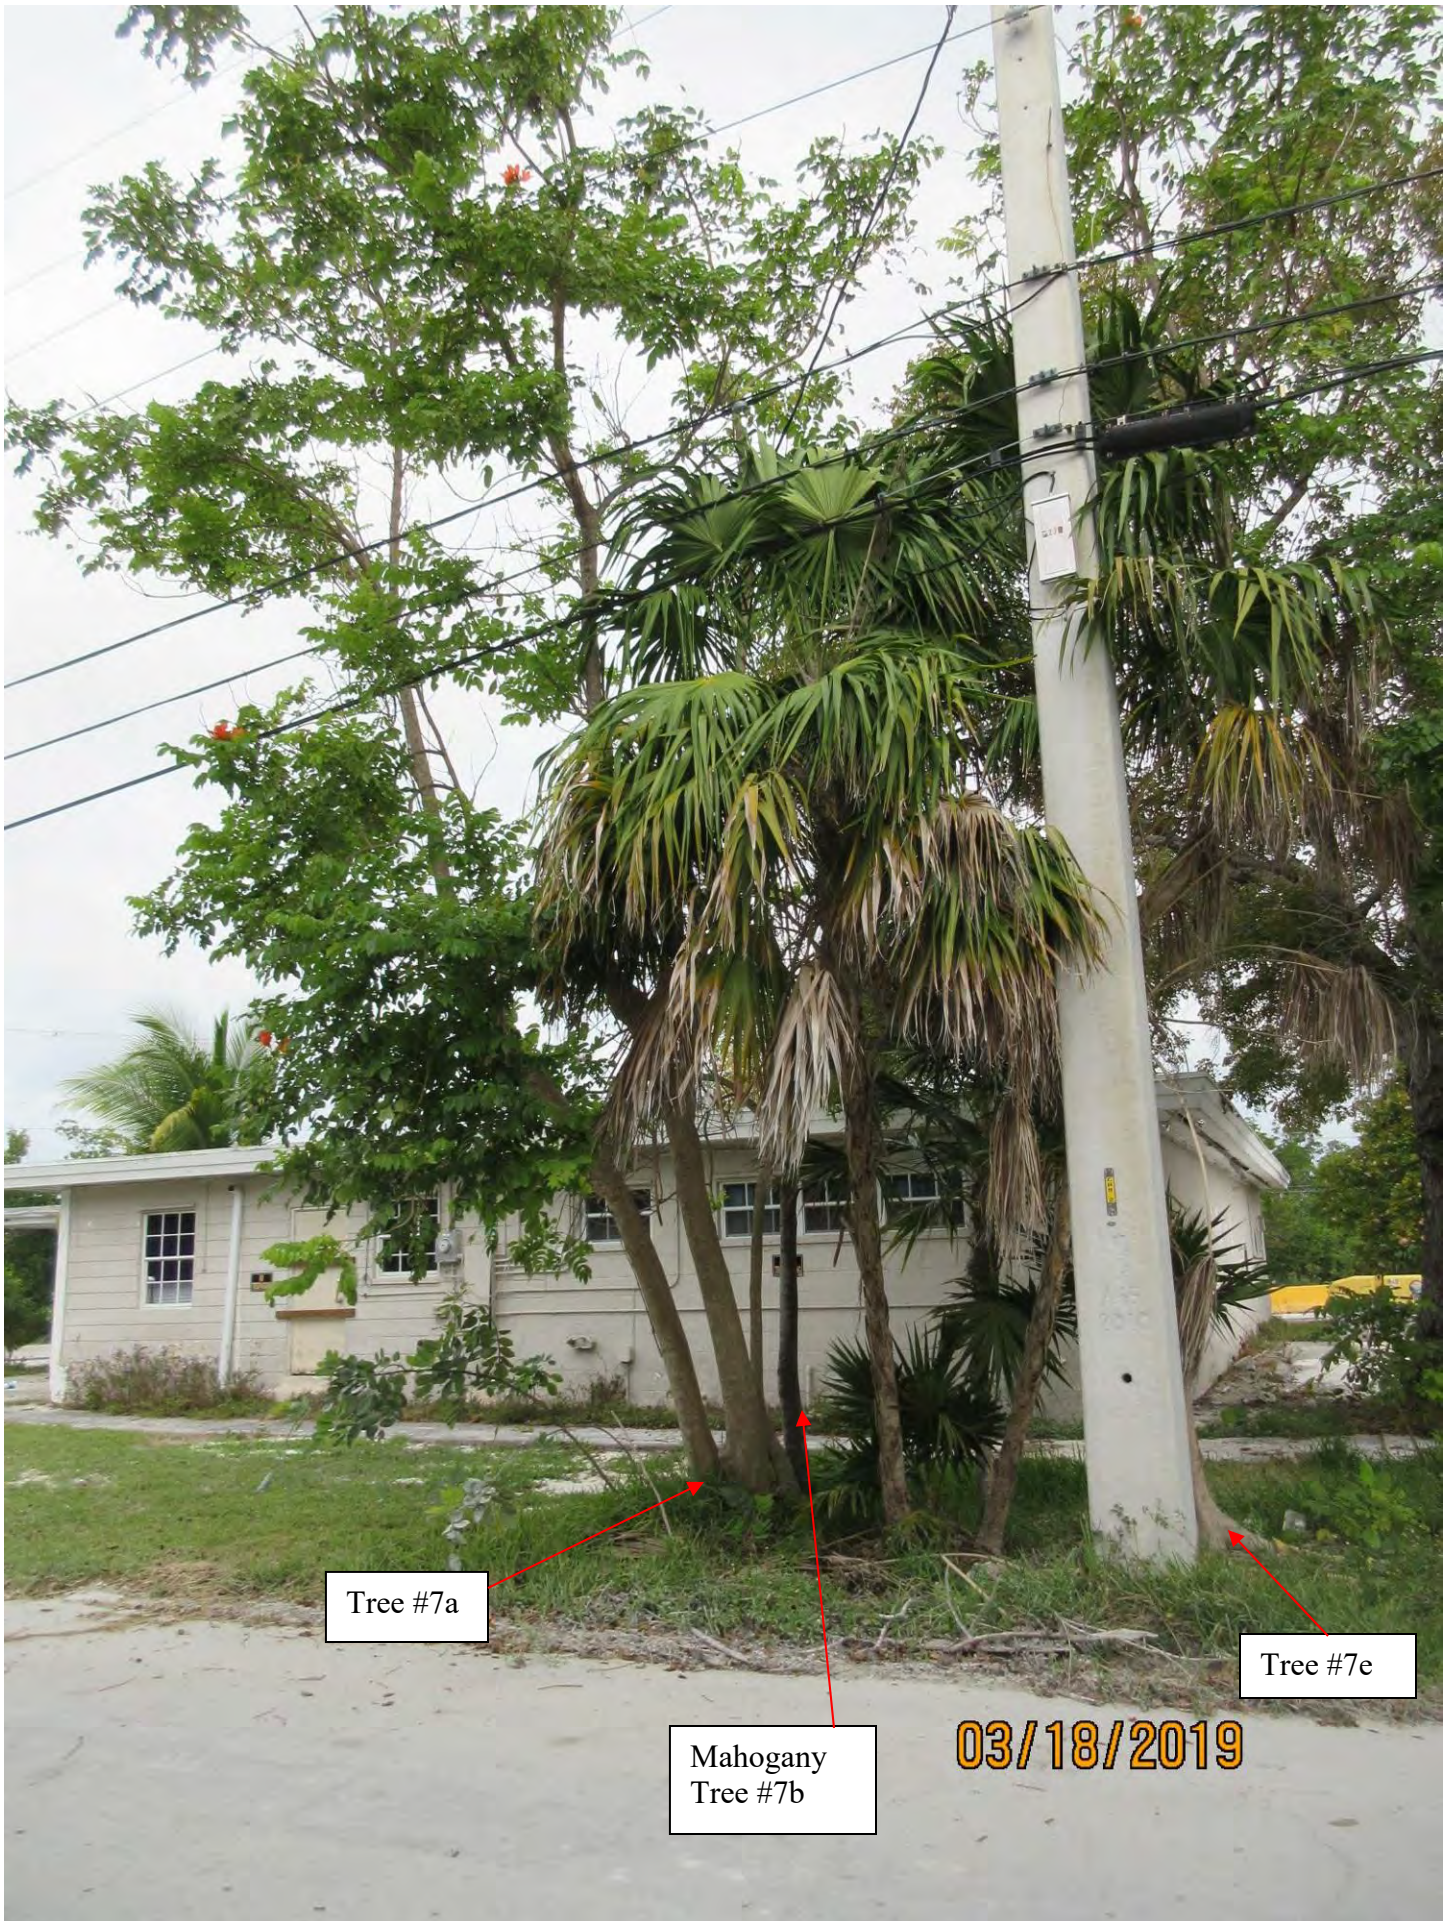
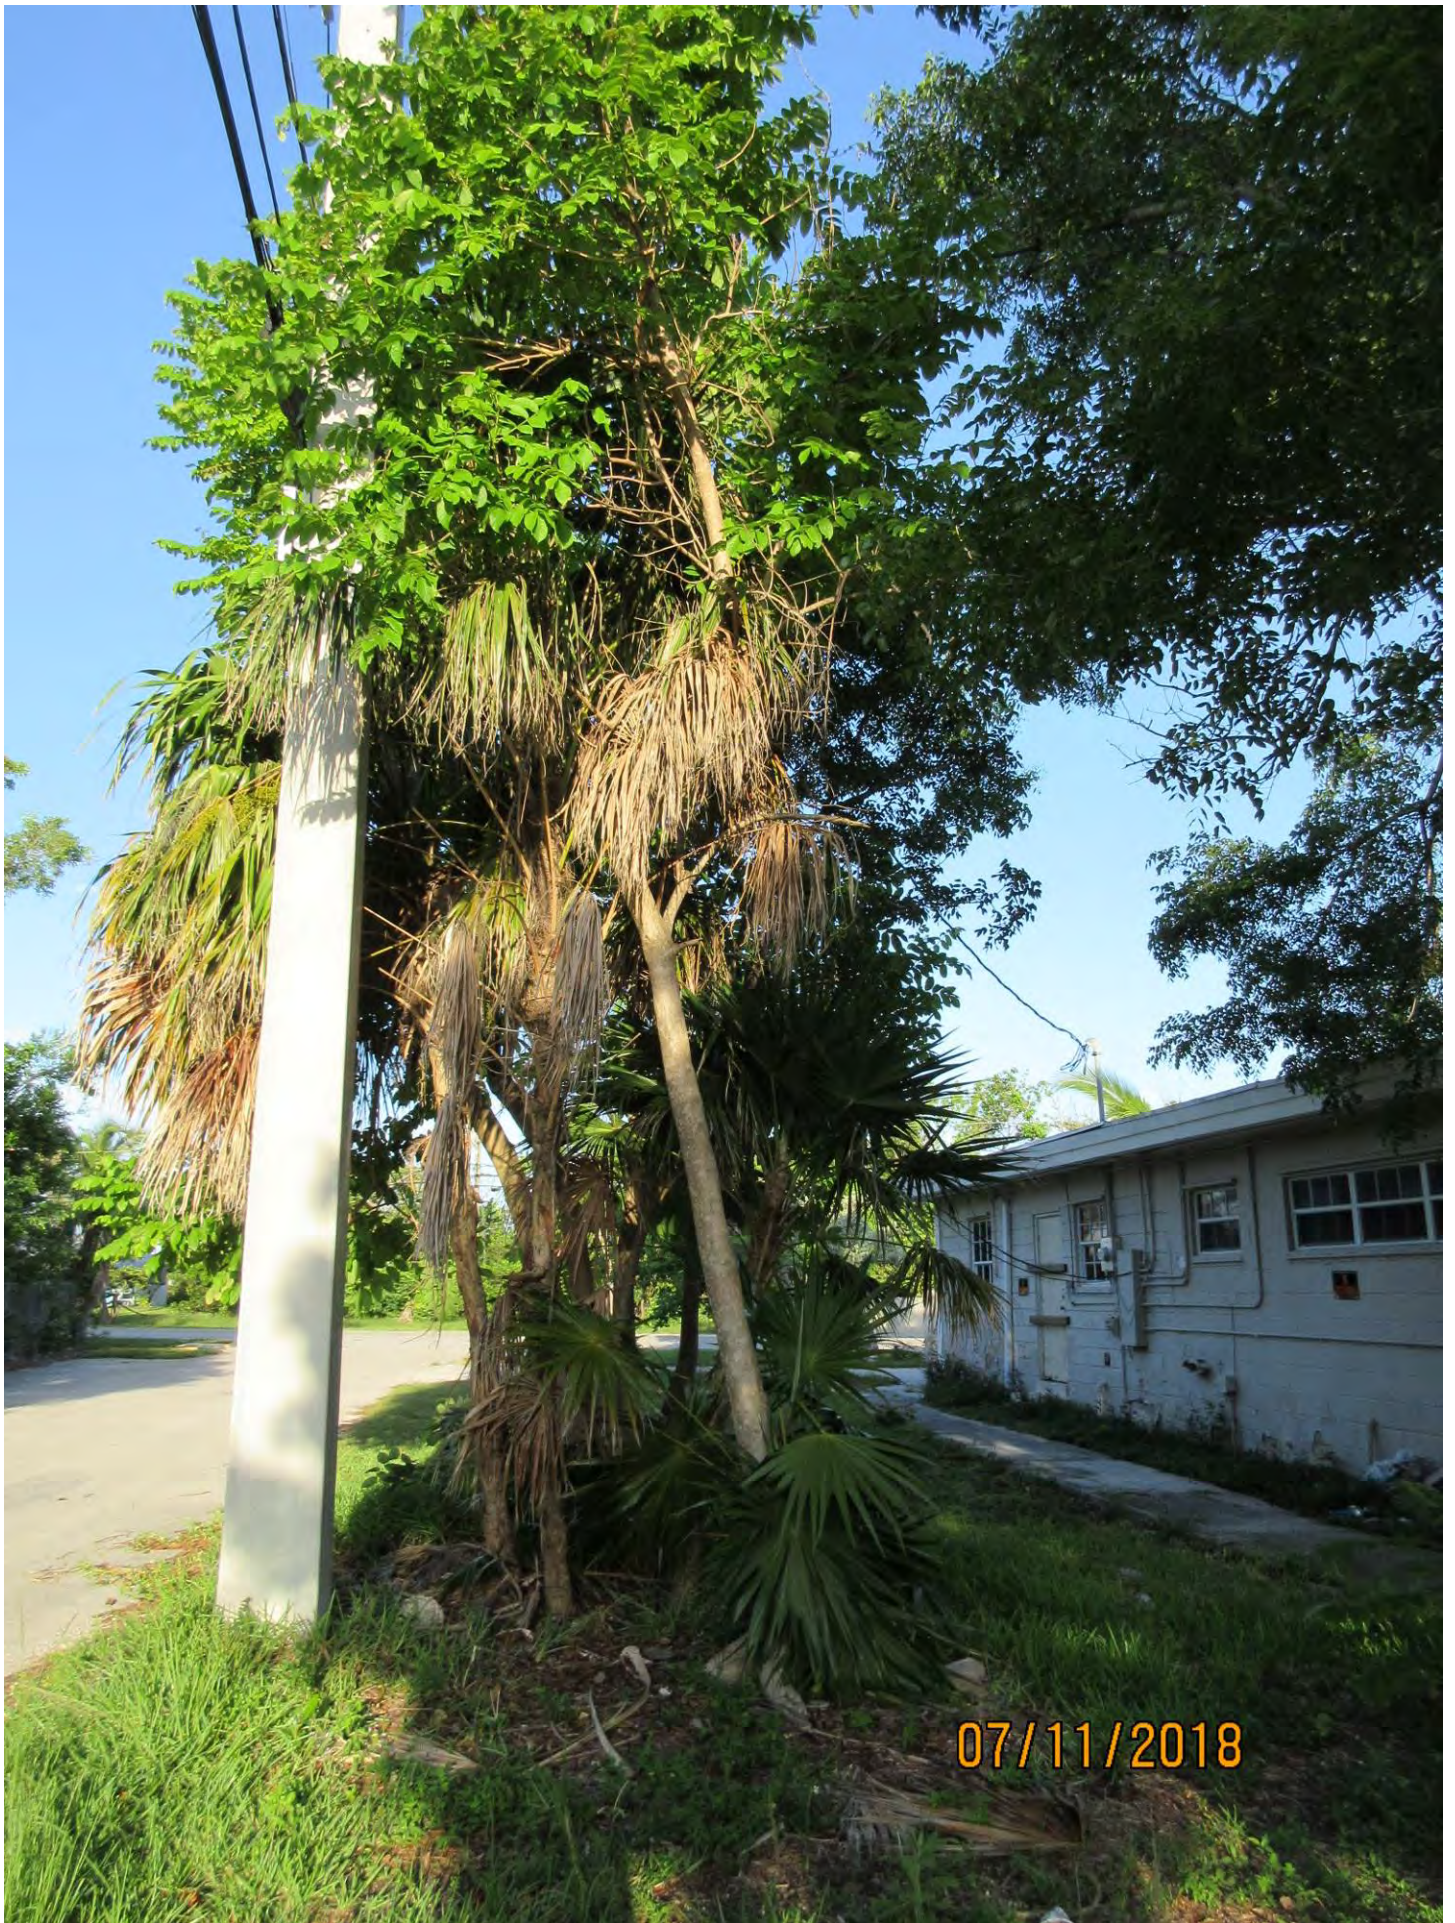
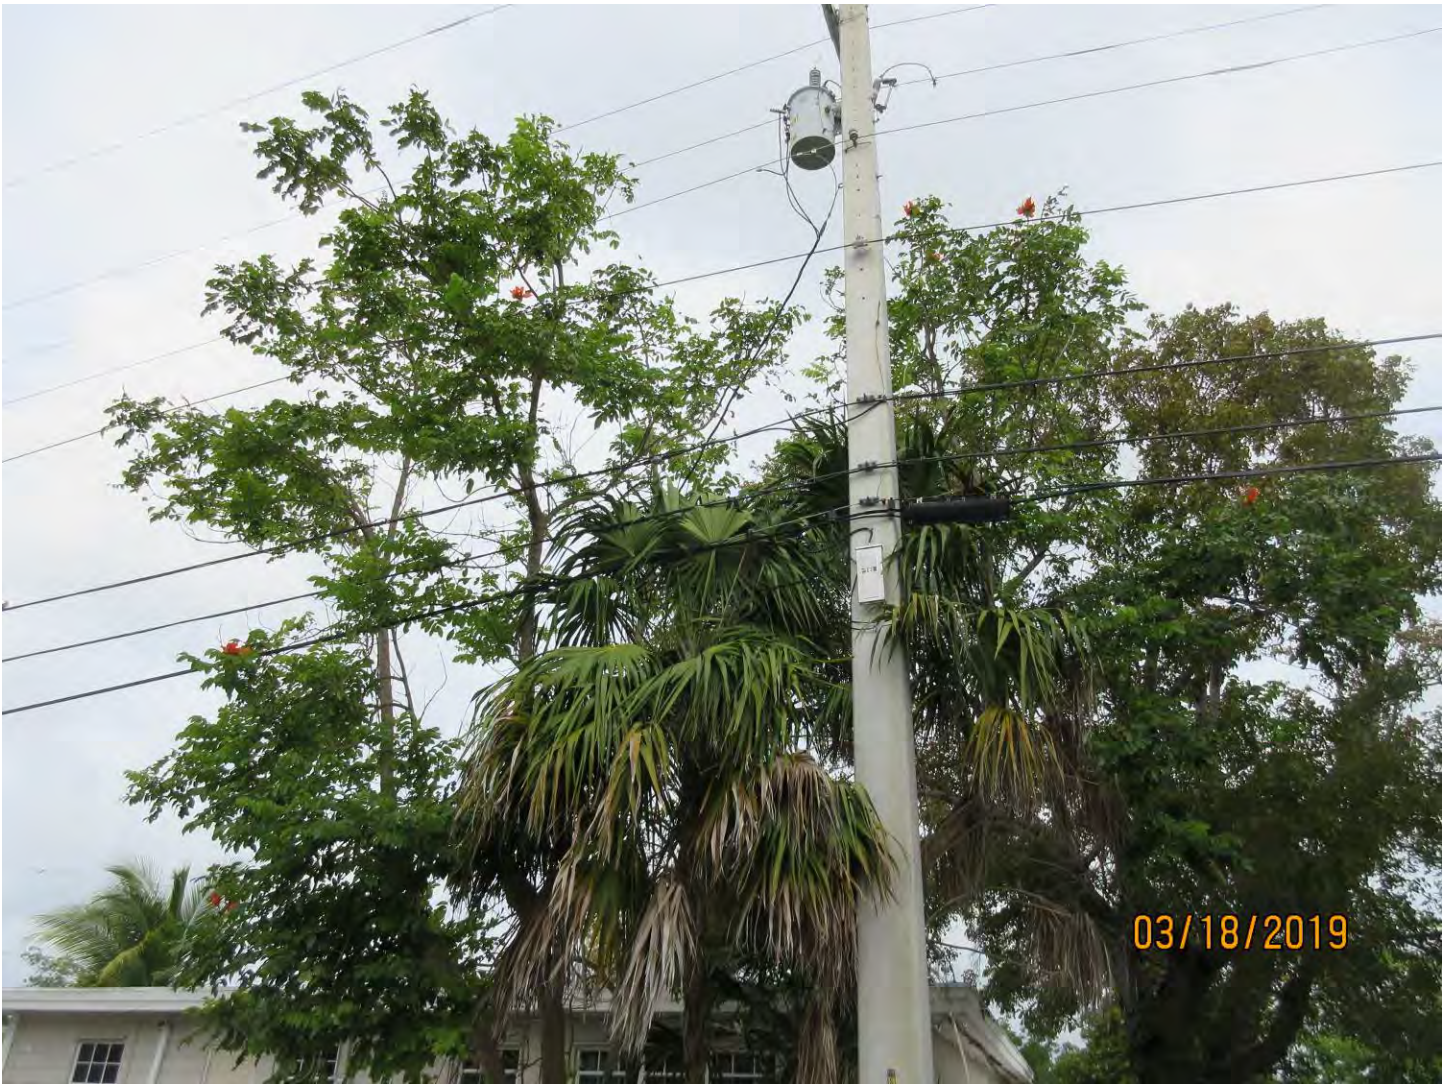
**Tree Clump #7 consists of a large multi trunked African Tulip tree, a young mahogany tree and a clump of thatch palms. The Thatch Palms will be transplanted.**

Location: 50% (in utility lines, roots intertwined with mahogany tree and thatch palms)

Condition: 50% (several trunks, poor structure)

Location: 40% (in utility lines and growing at base of pole, roots intertwined with mahogany tree and thatch palms)
