# STAFF REPORT

RE: **5220, 5224, 5228, & 5230 College Road**  
**(permit application # T2019-0135)**

FROM: Karen DeMaria, City of Key West Urban Forestry Manager

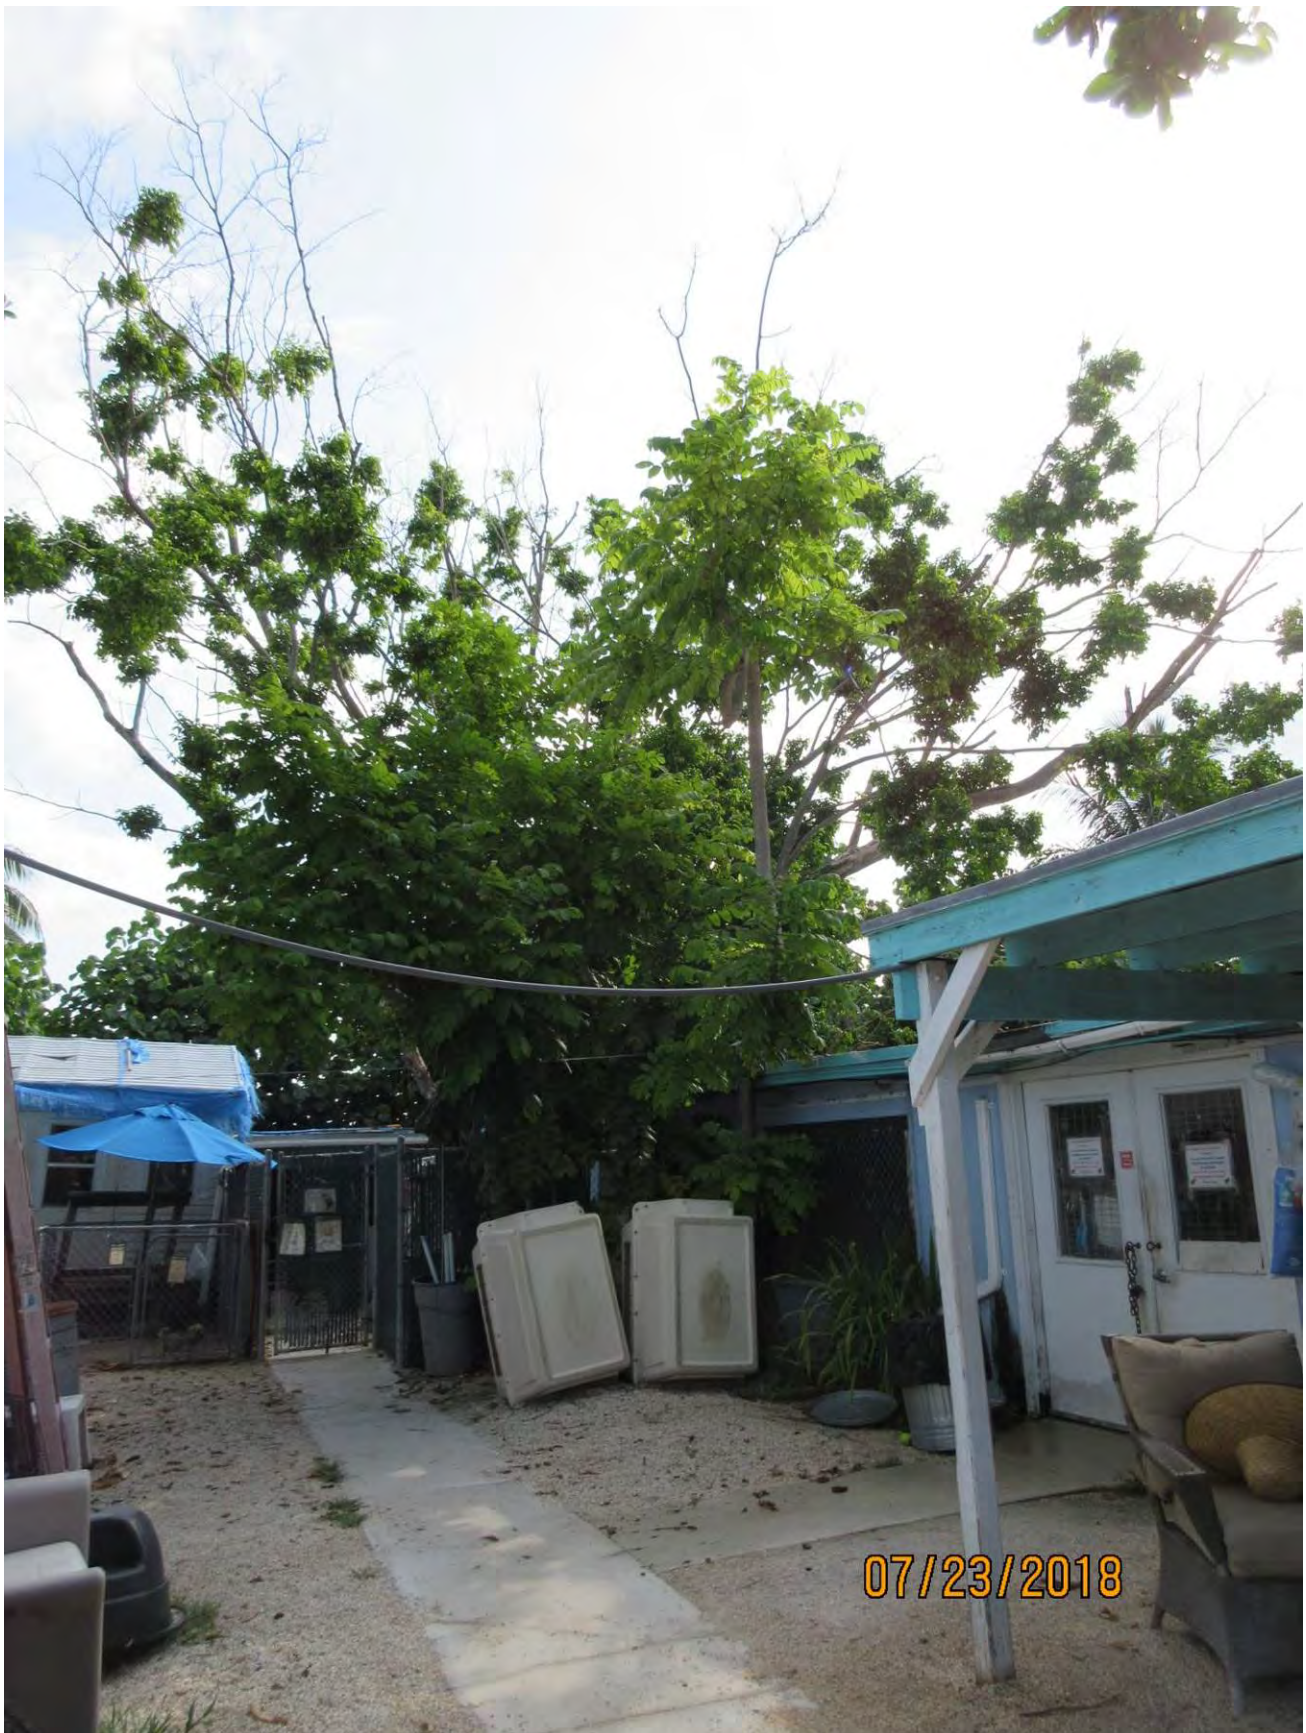
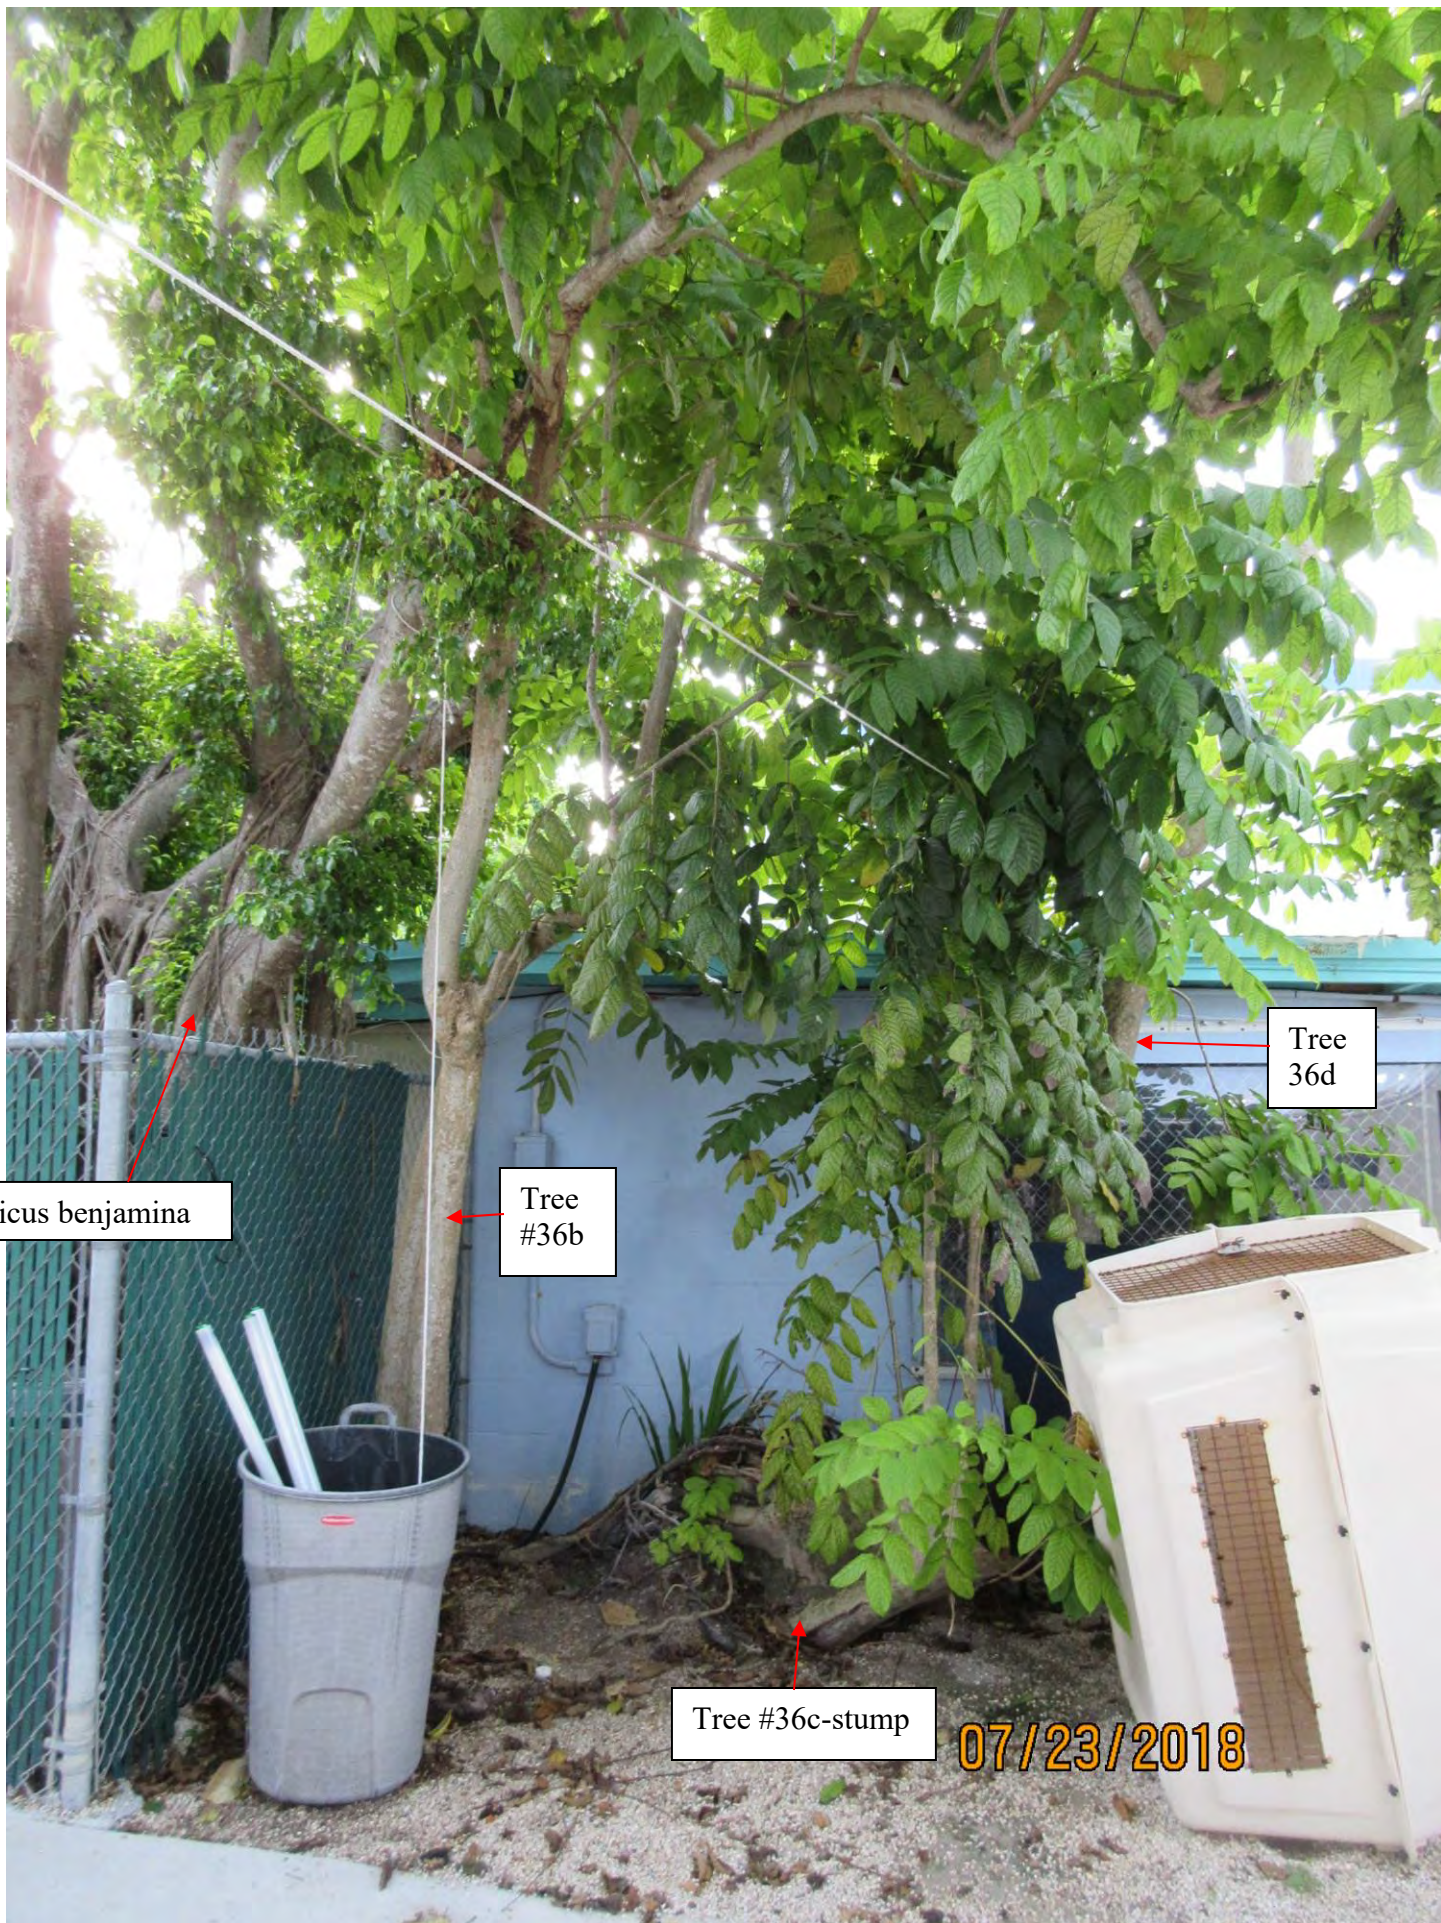
**Tree clump #36 consists of (2) African Tulip trees, (1) African Tulip stump that has resprouted (not regulated), and (1) Ficus benjaminia (not regulated).**

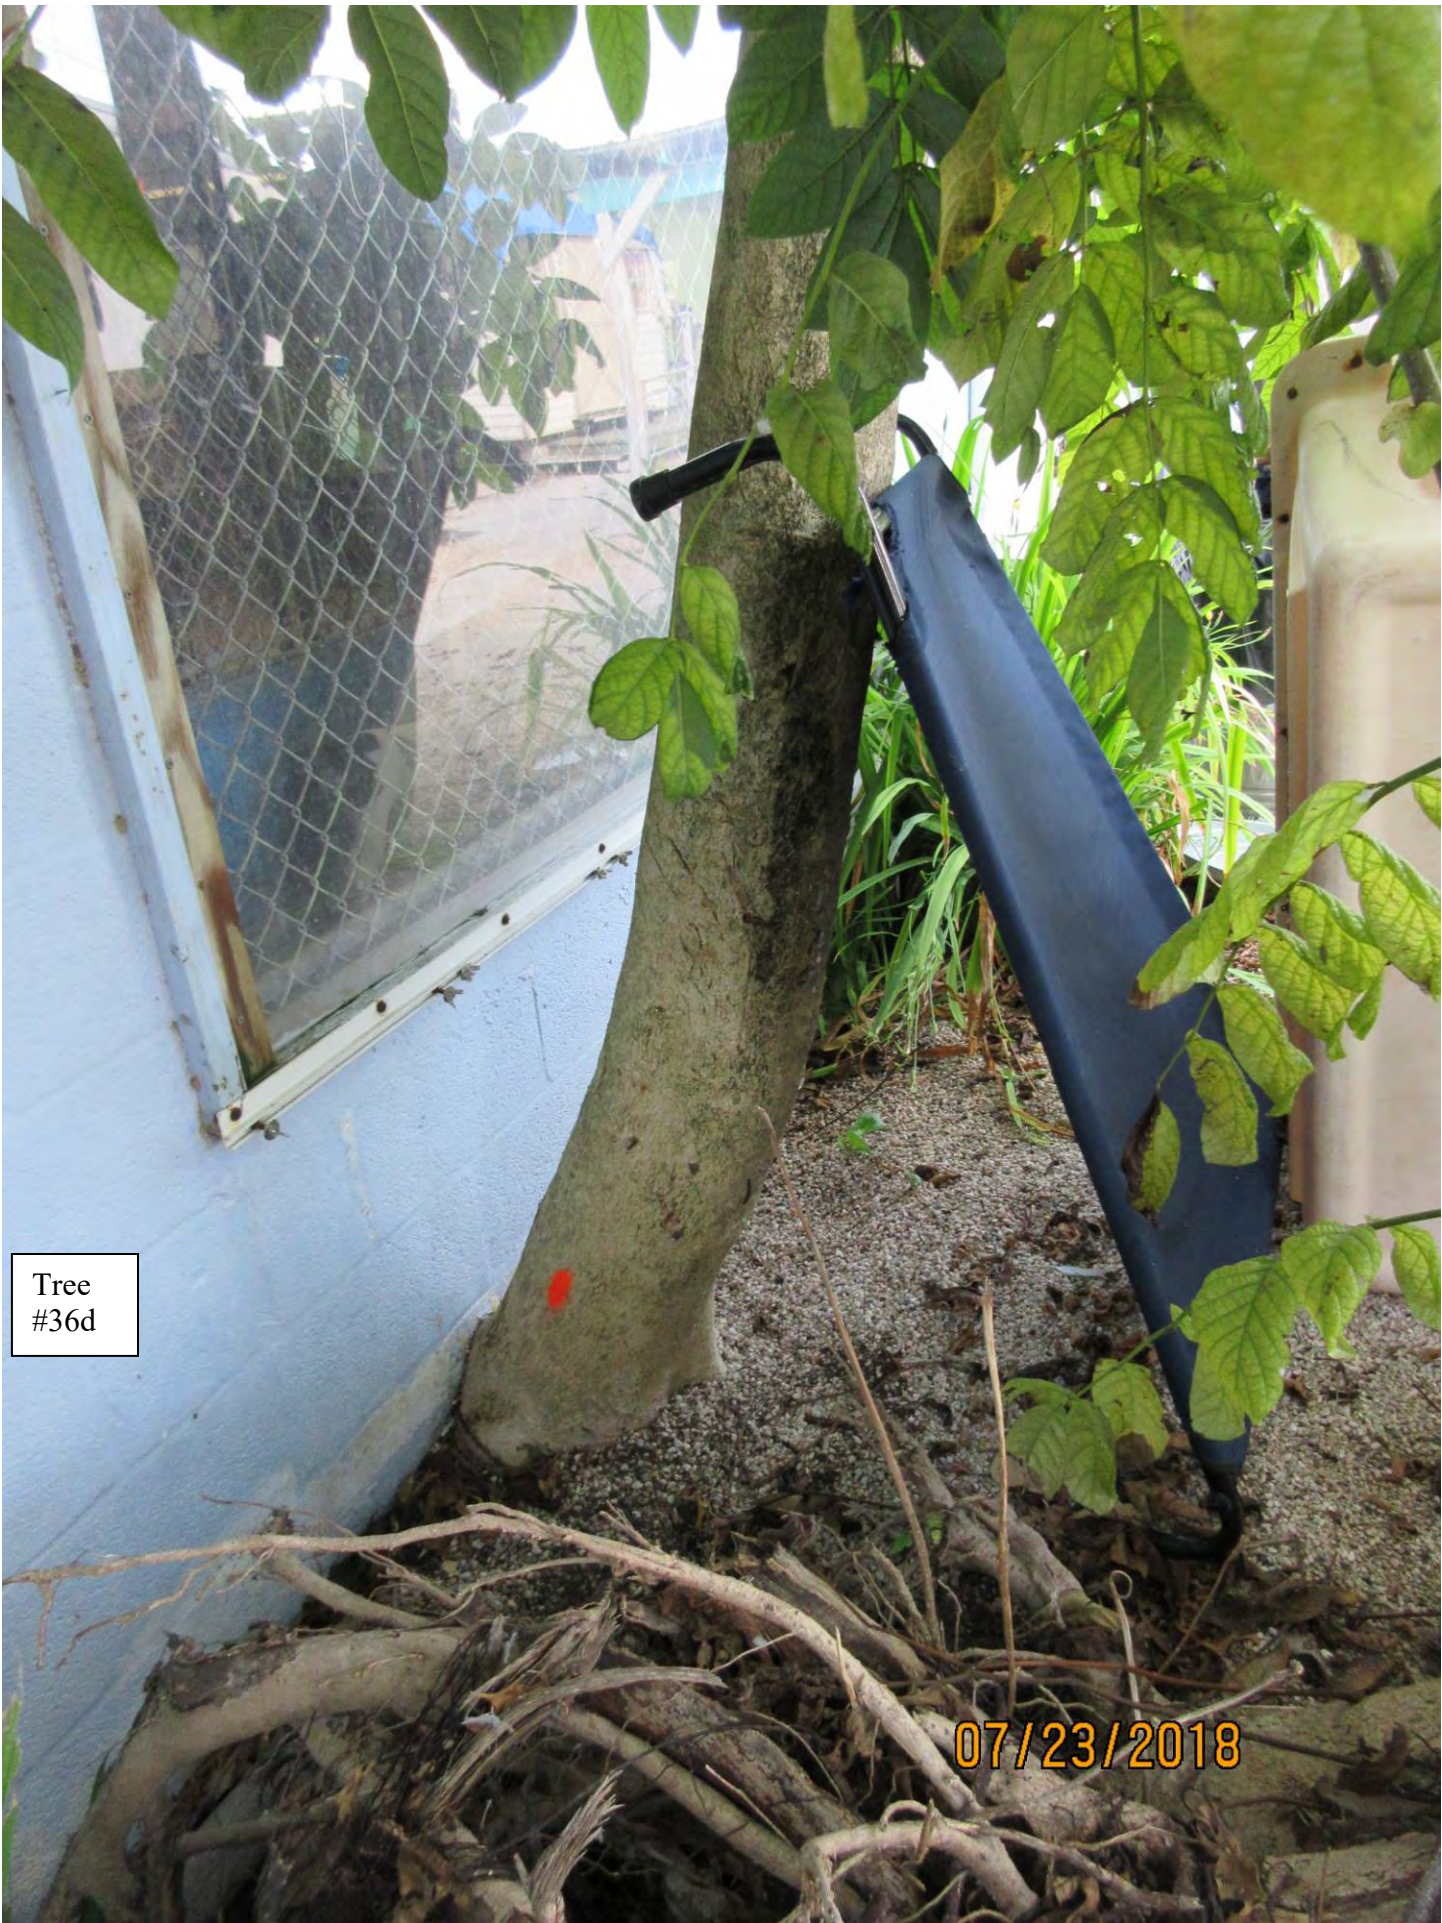
Tree  
#36d

Location: 40% (growing at base of structure)

Condition: 40% (poor structure)

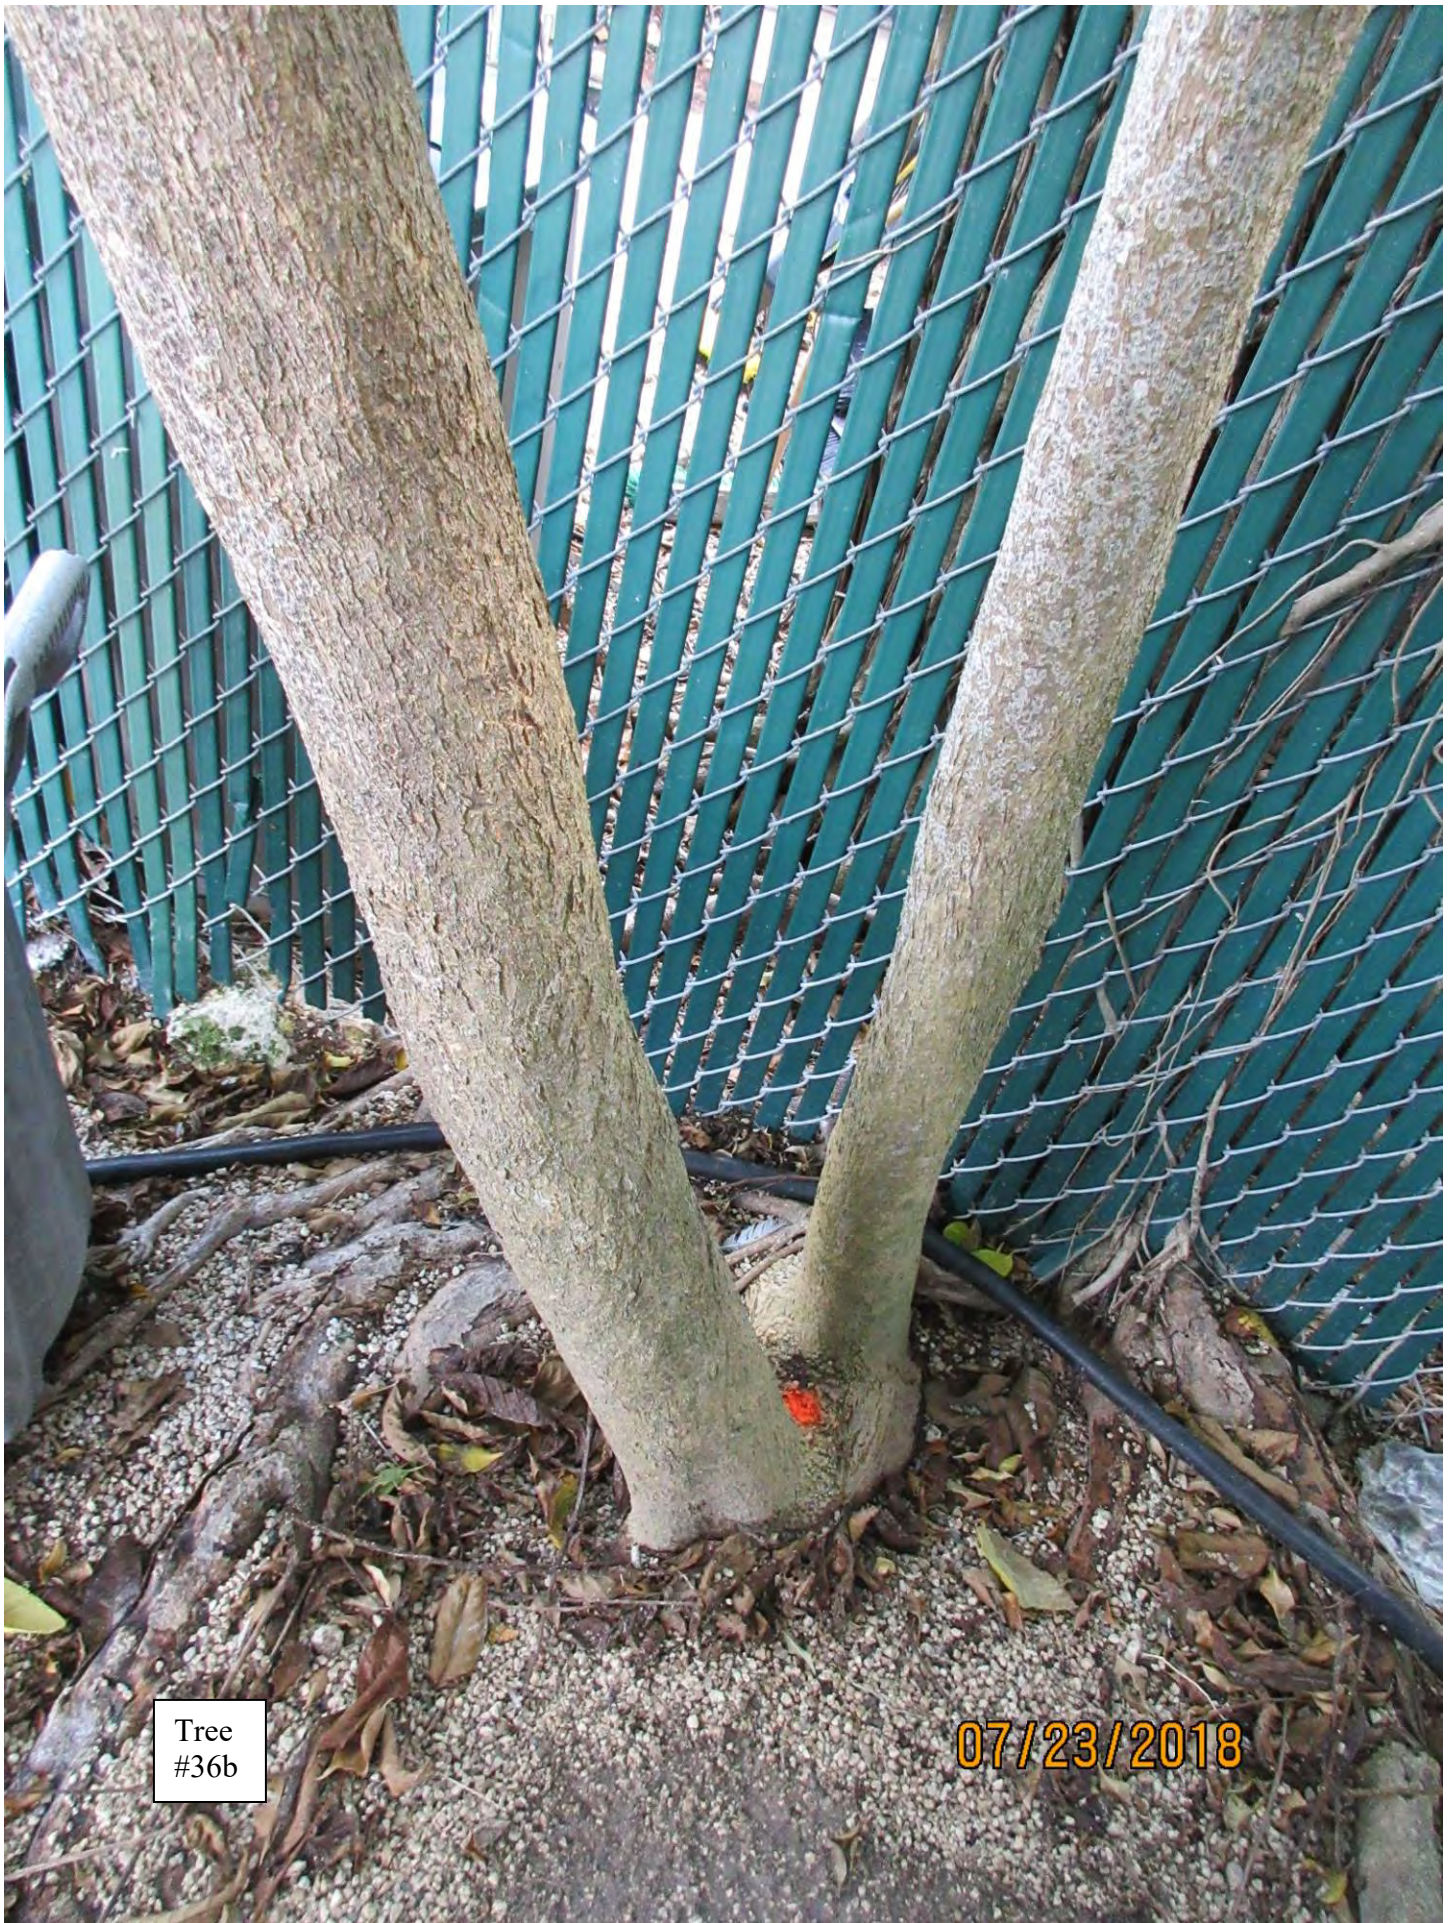
Tree  
#36b

Location: 60% (canopy impacted by adjacent tree)

Condition: 40% (codominant trunks, poor structure)

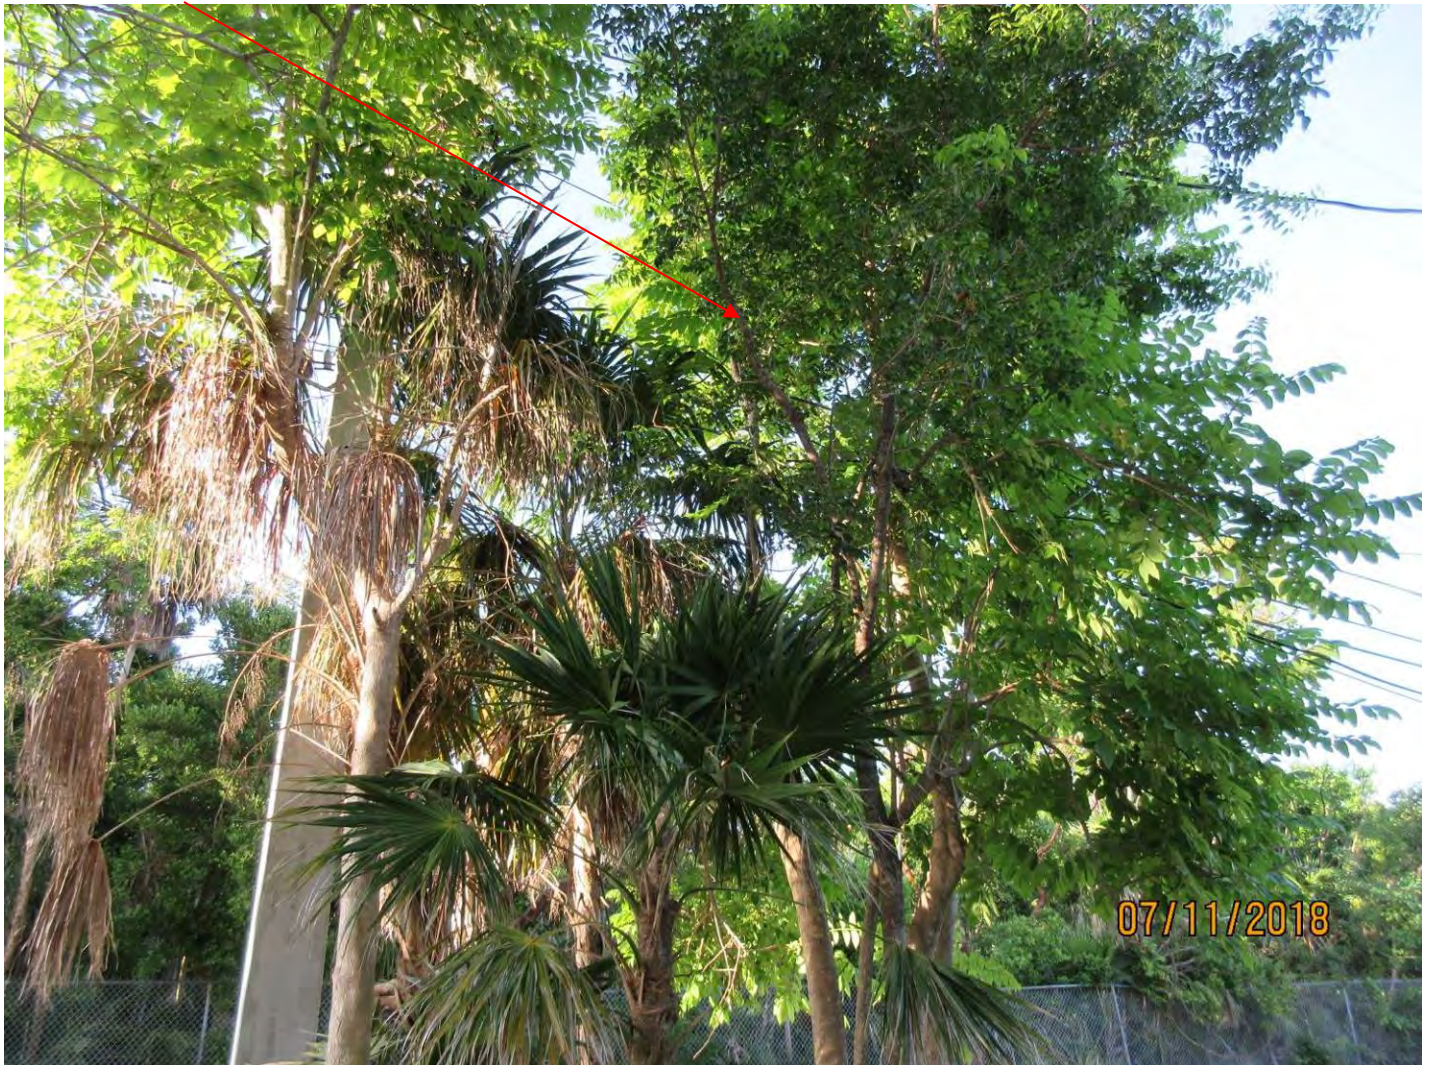
**Tree #7b:**

Location: 50% (canopy in utility lines, roots intertwined with other trees.)

Condition: 50% (fair)

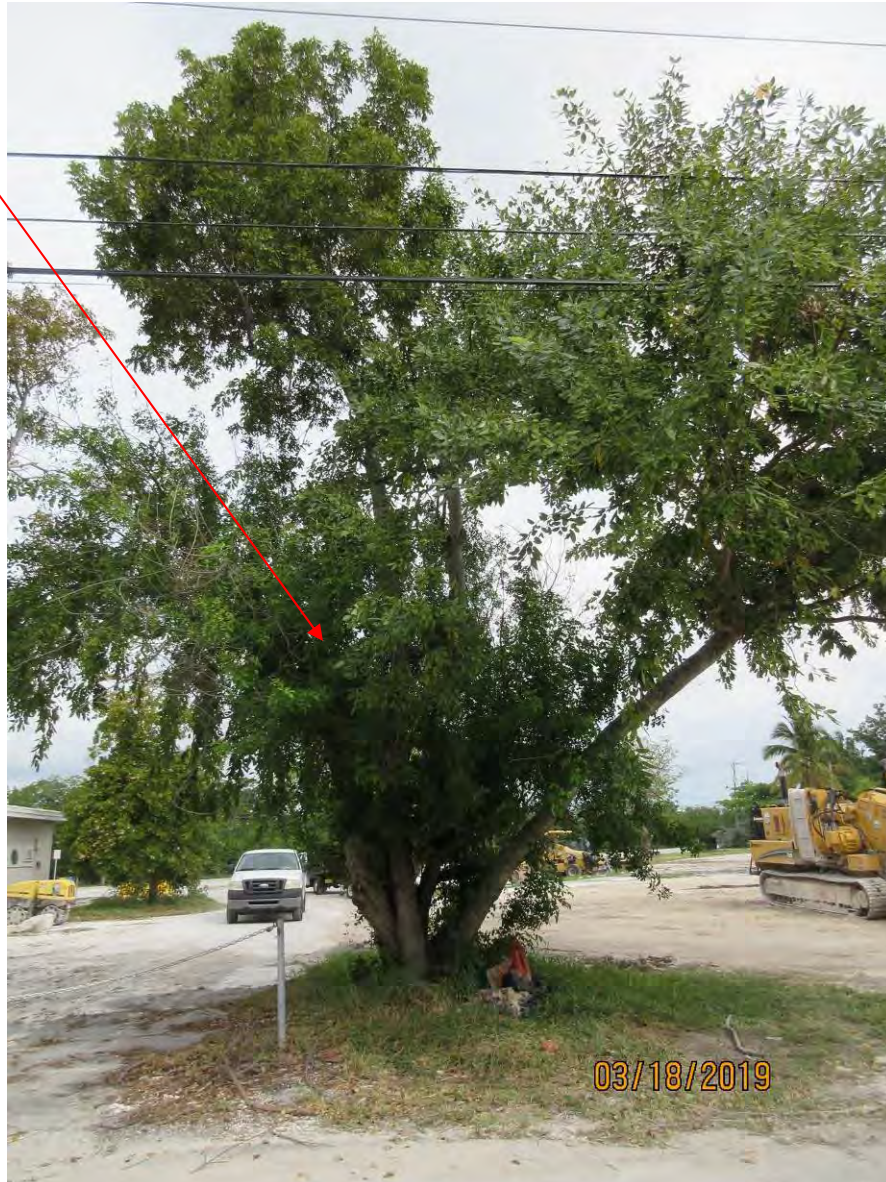
**Tree #8c:**

Location: 40% (growing intertwined in rootball of other trees)

Condition: 40% (poor)
