# STAFF REPORT

RE: **5220, 5224, 5228, & 5230 College Road**  
**(permit application # T2019-0135)**

FROM: Karen DeMaria, City of Key West Urban Forestry Manager

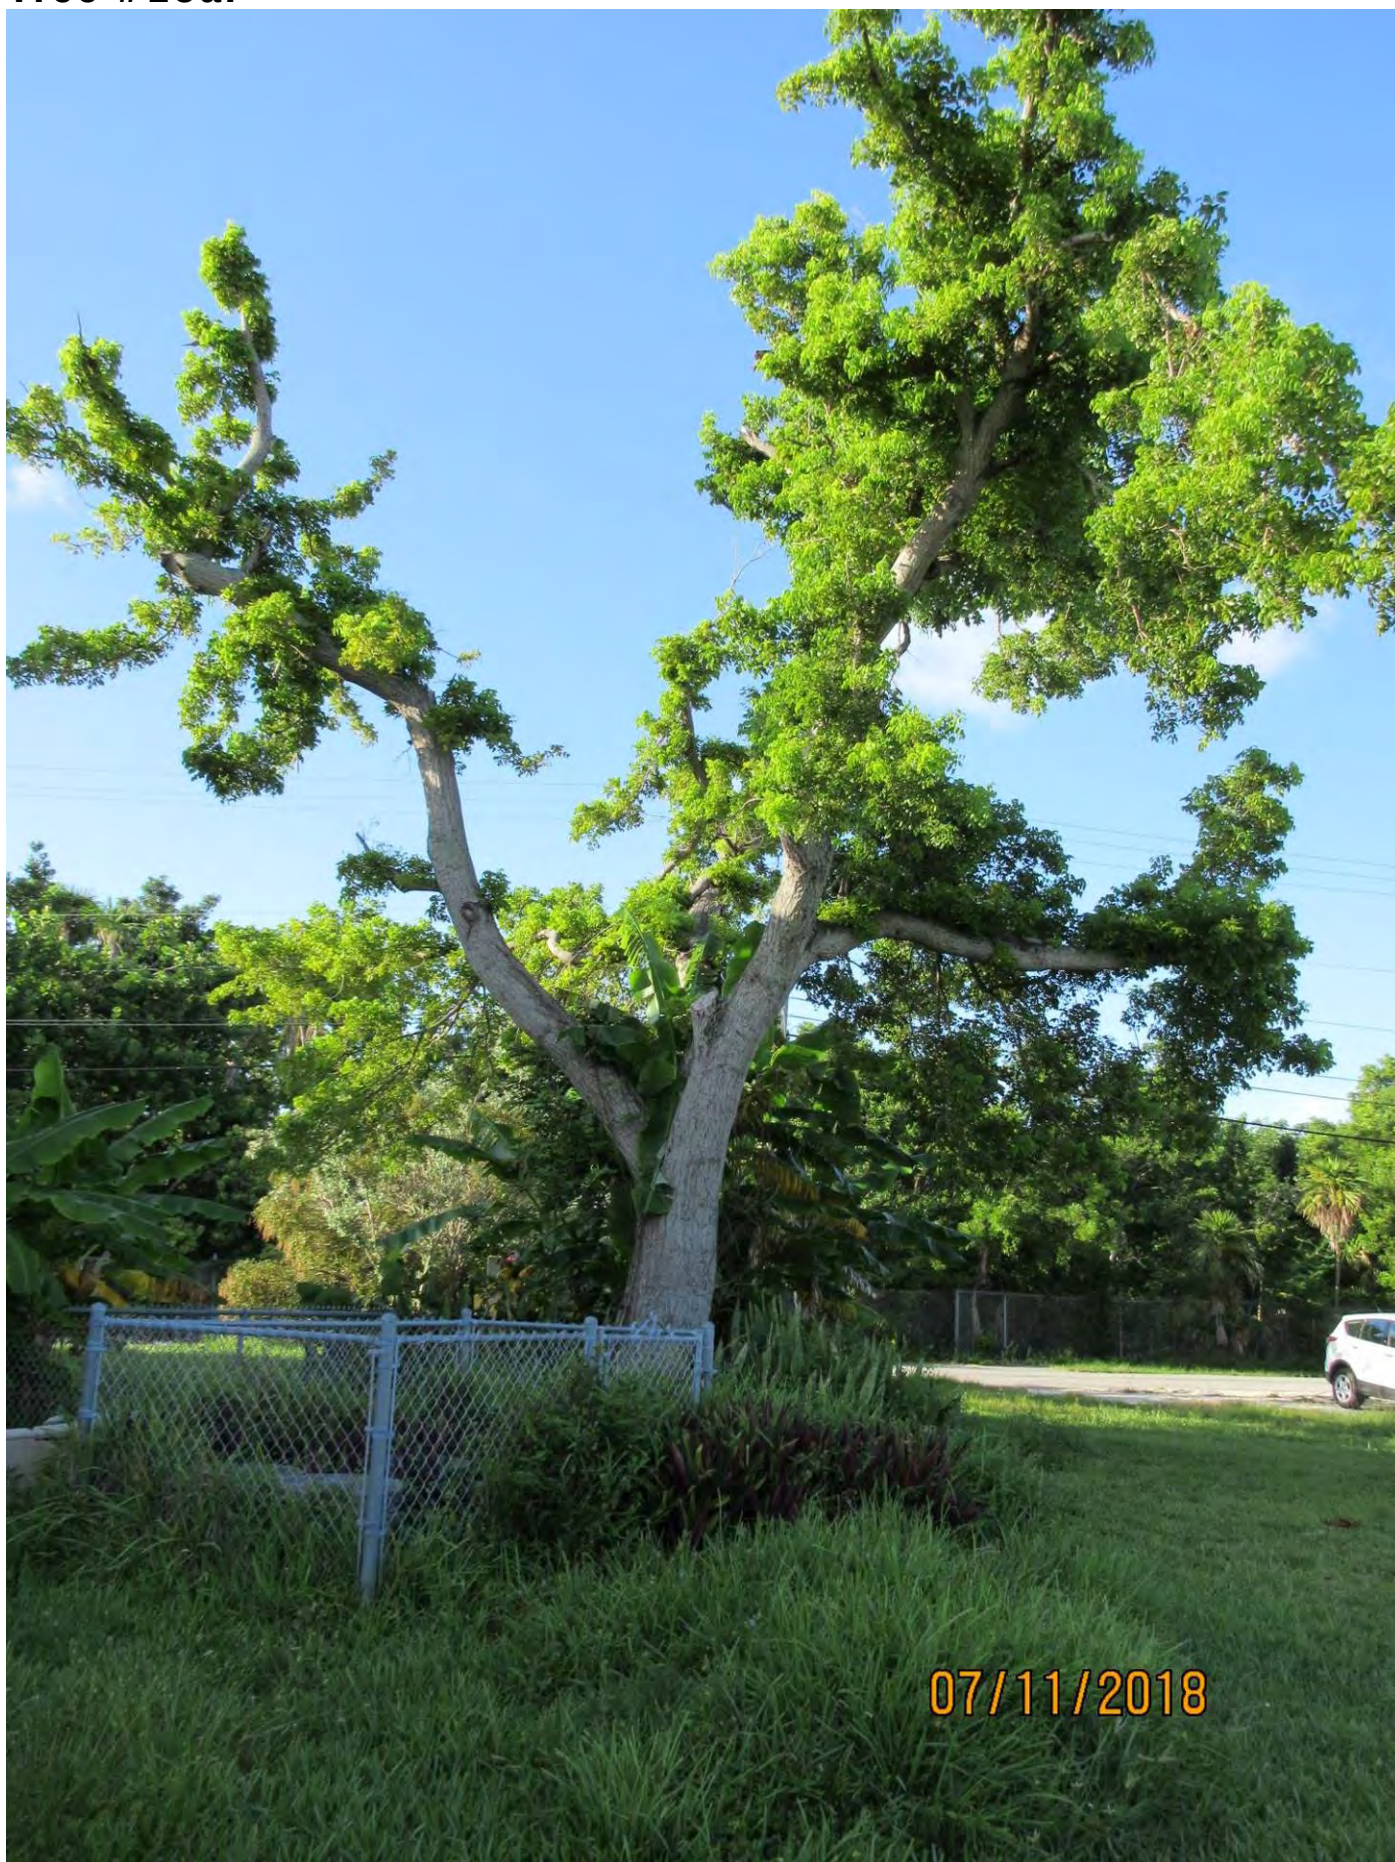
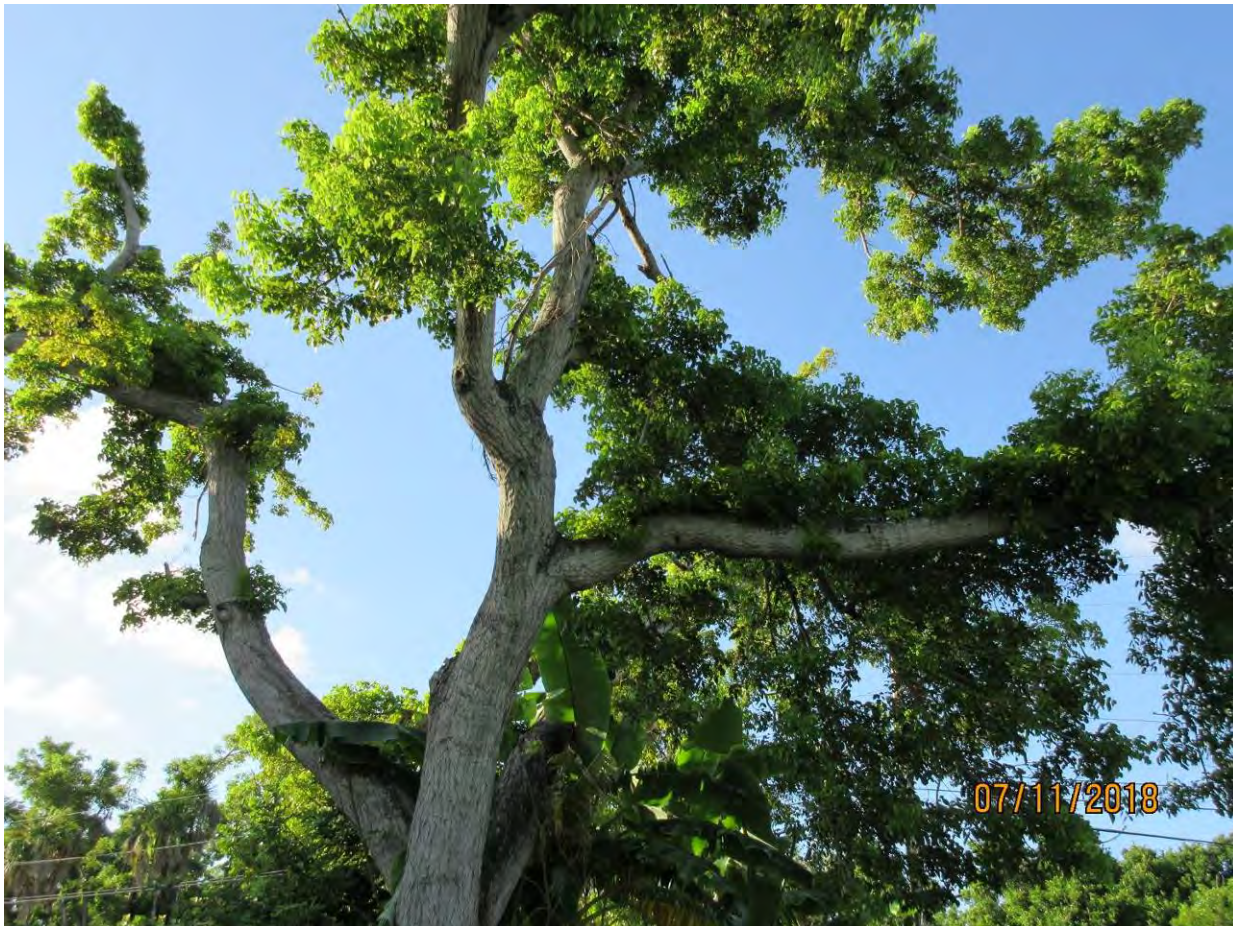
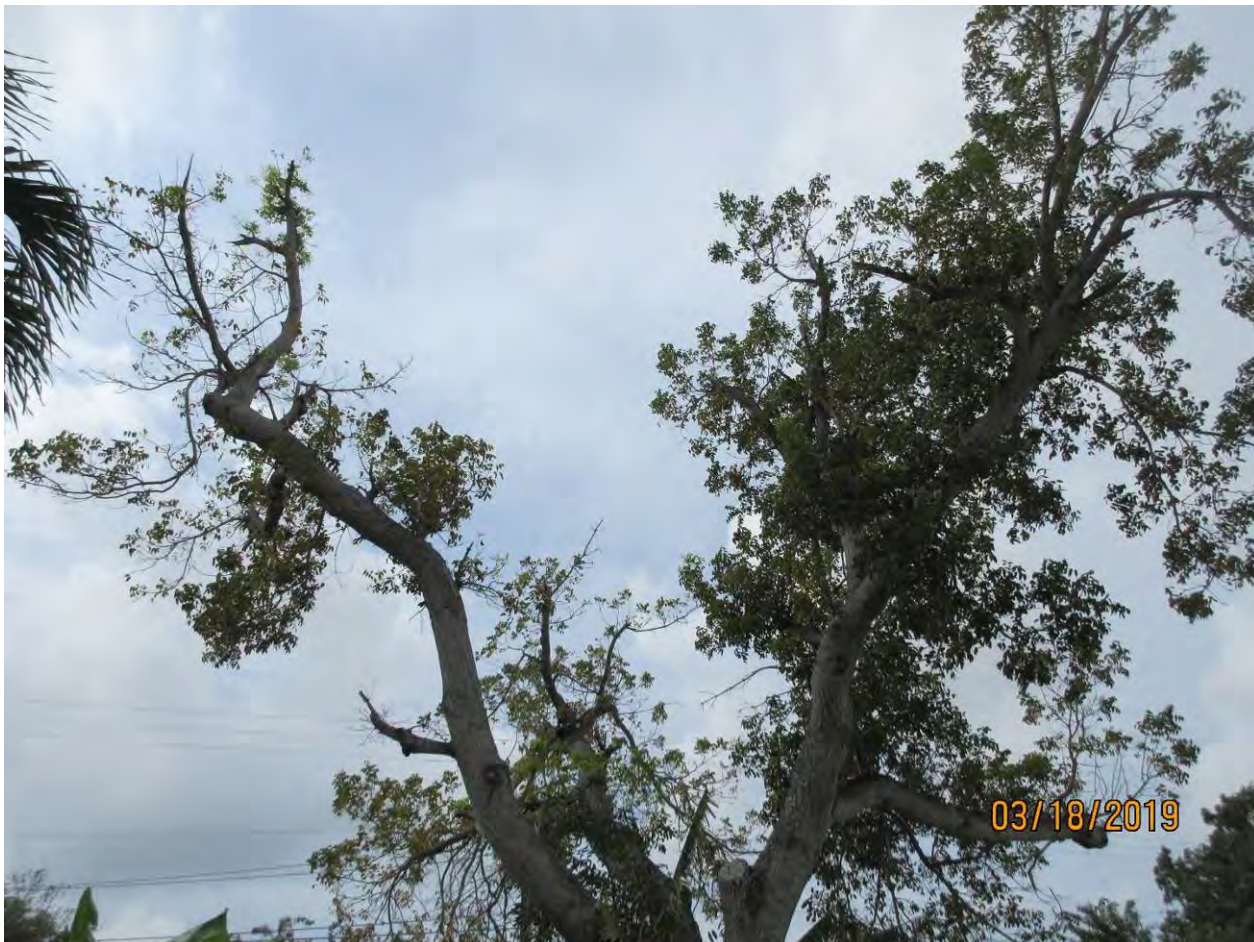
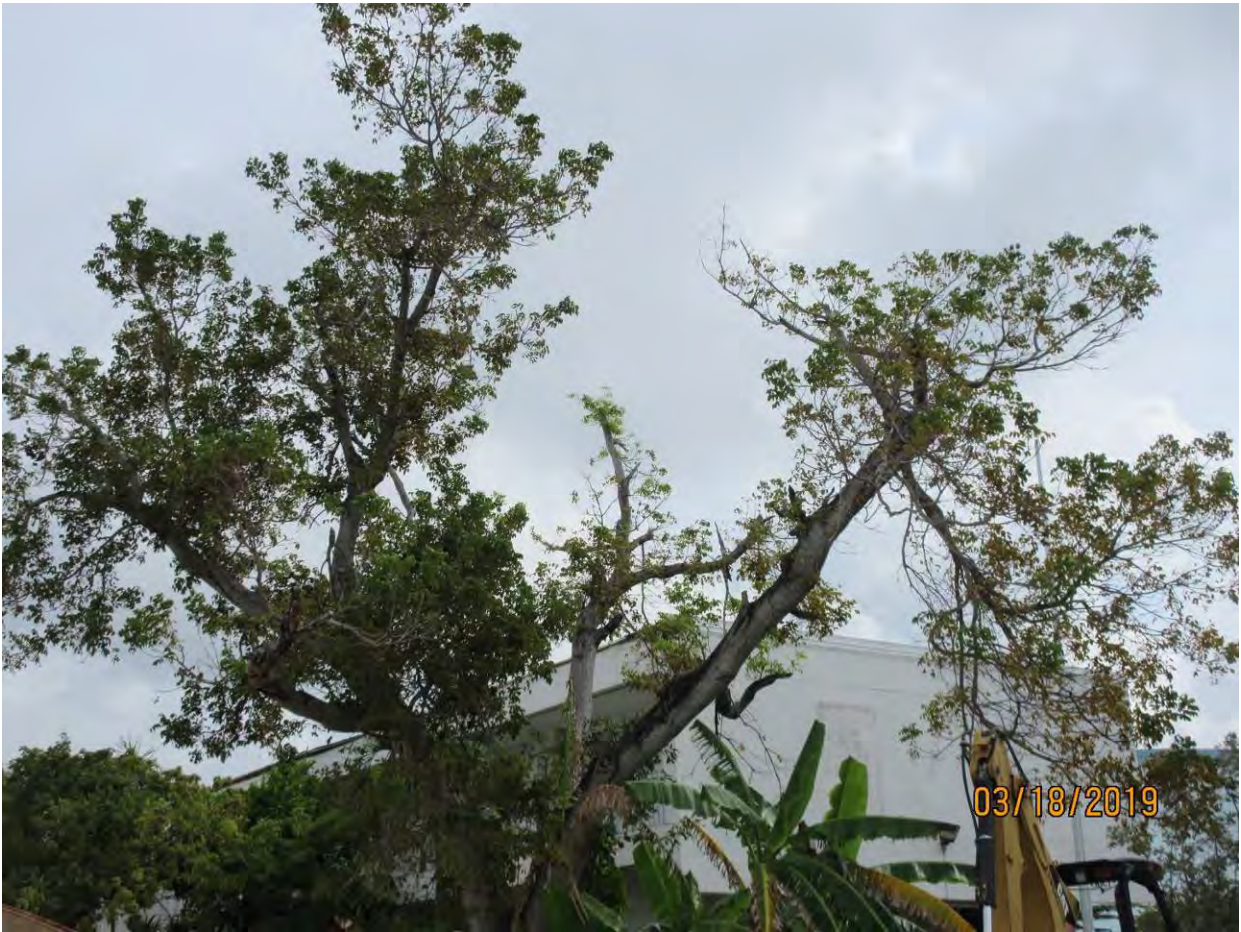
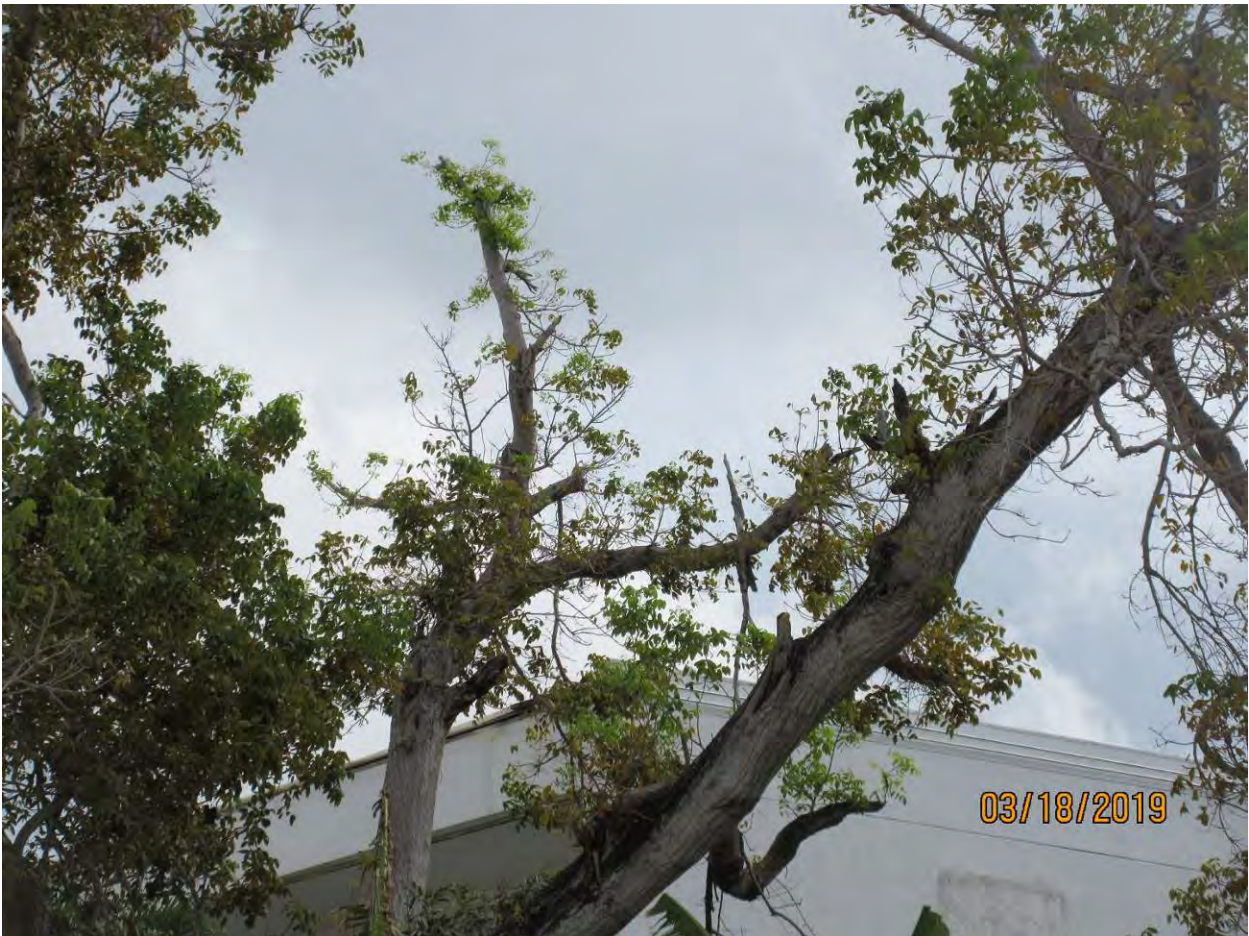
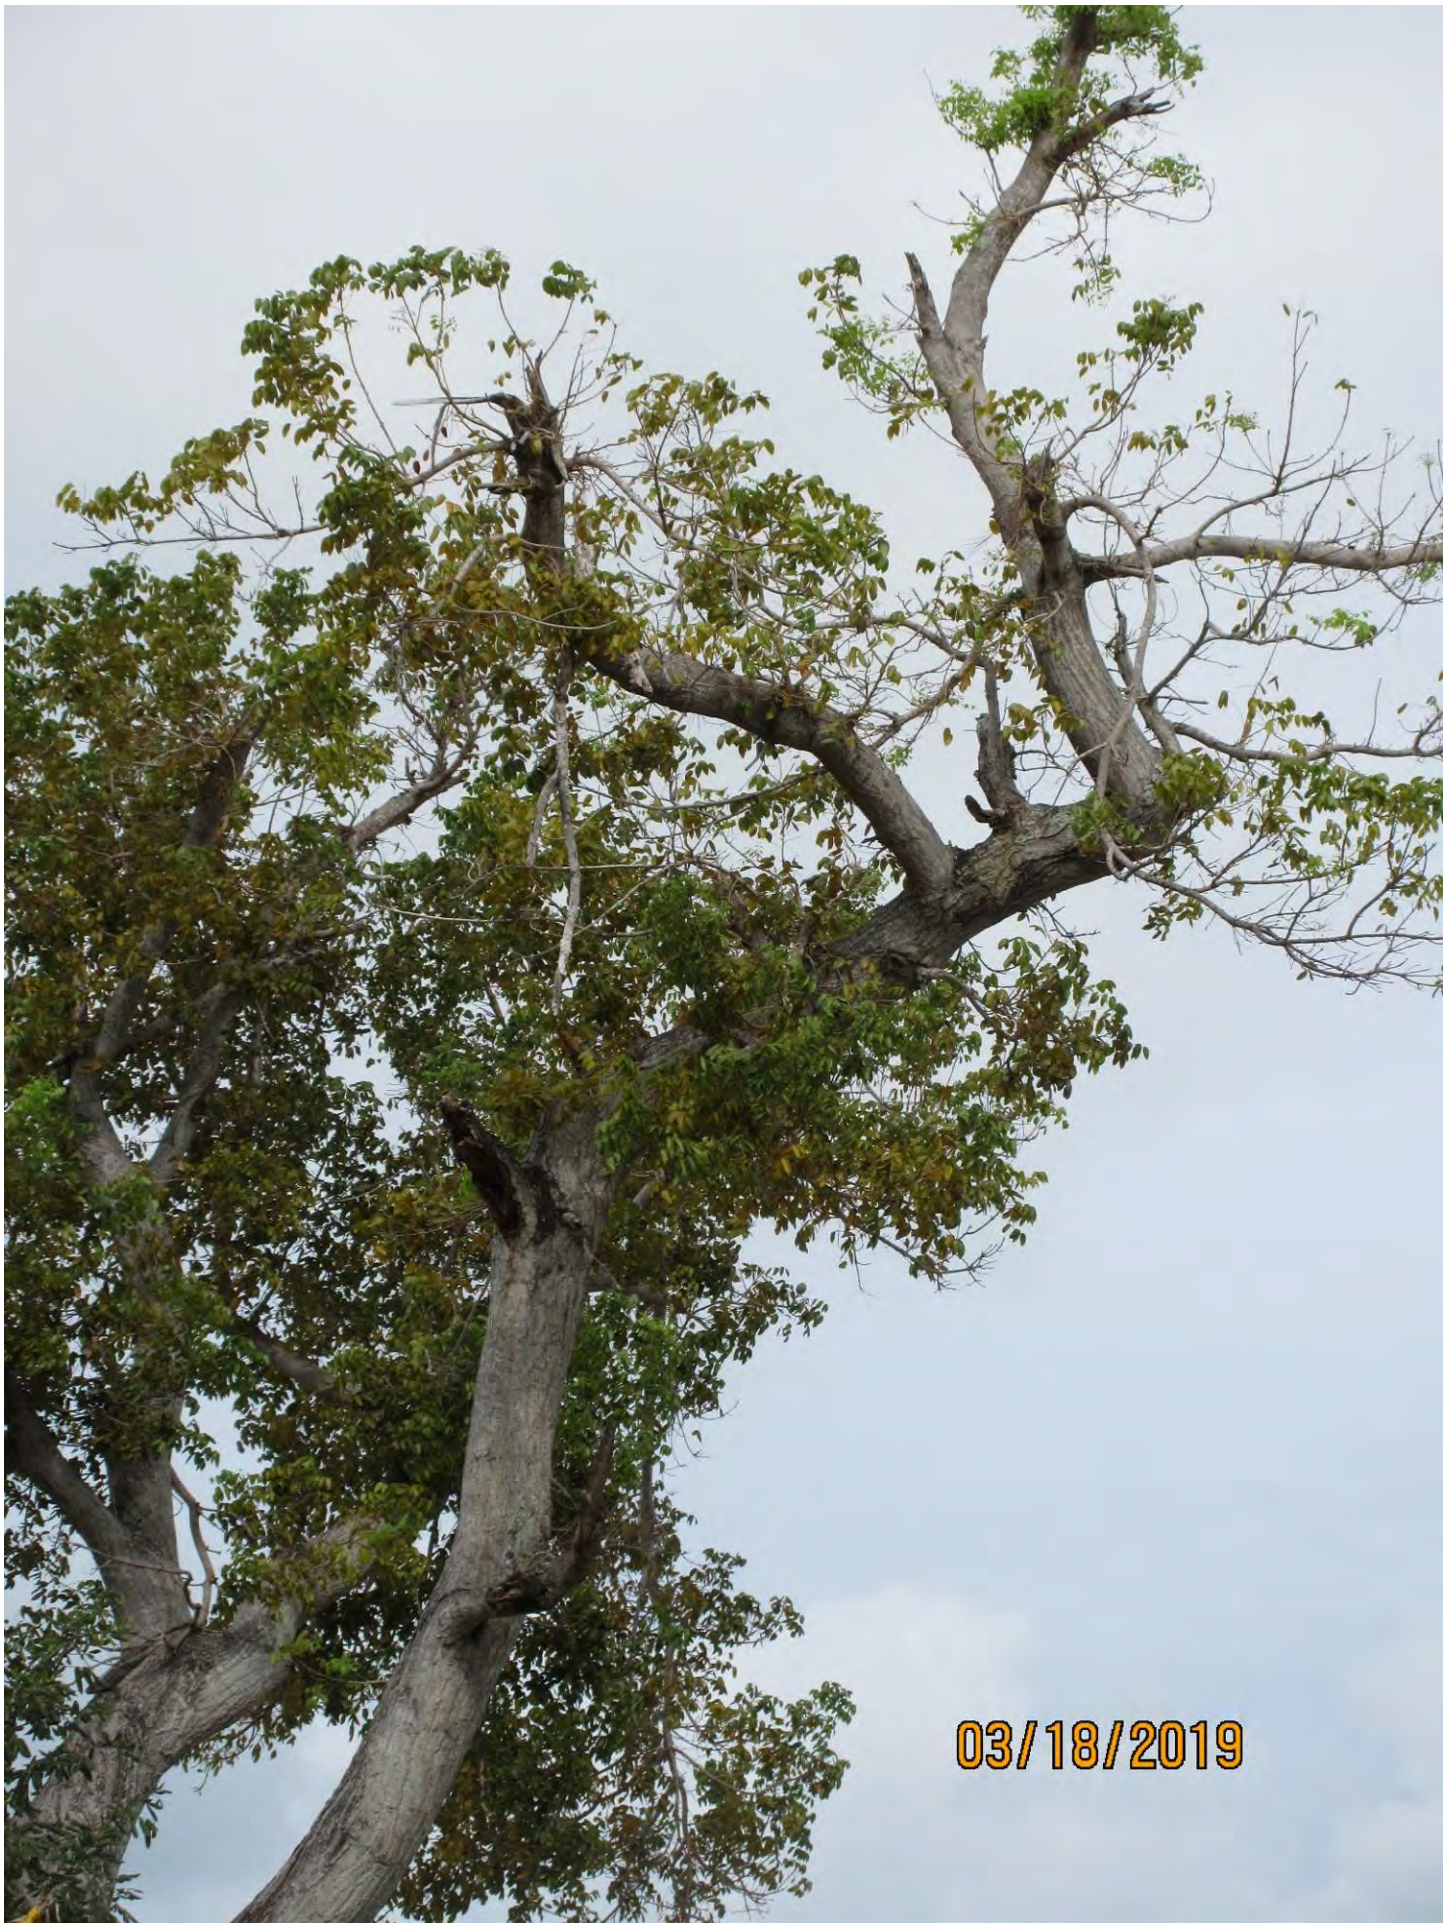
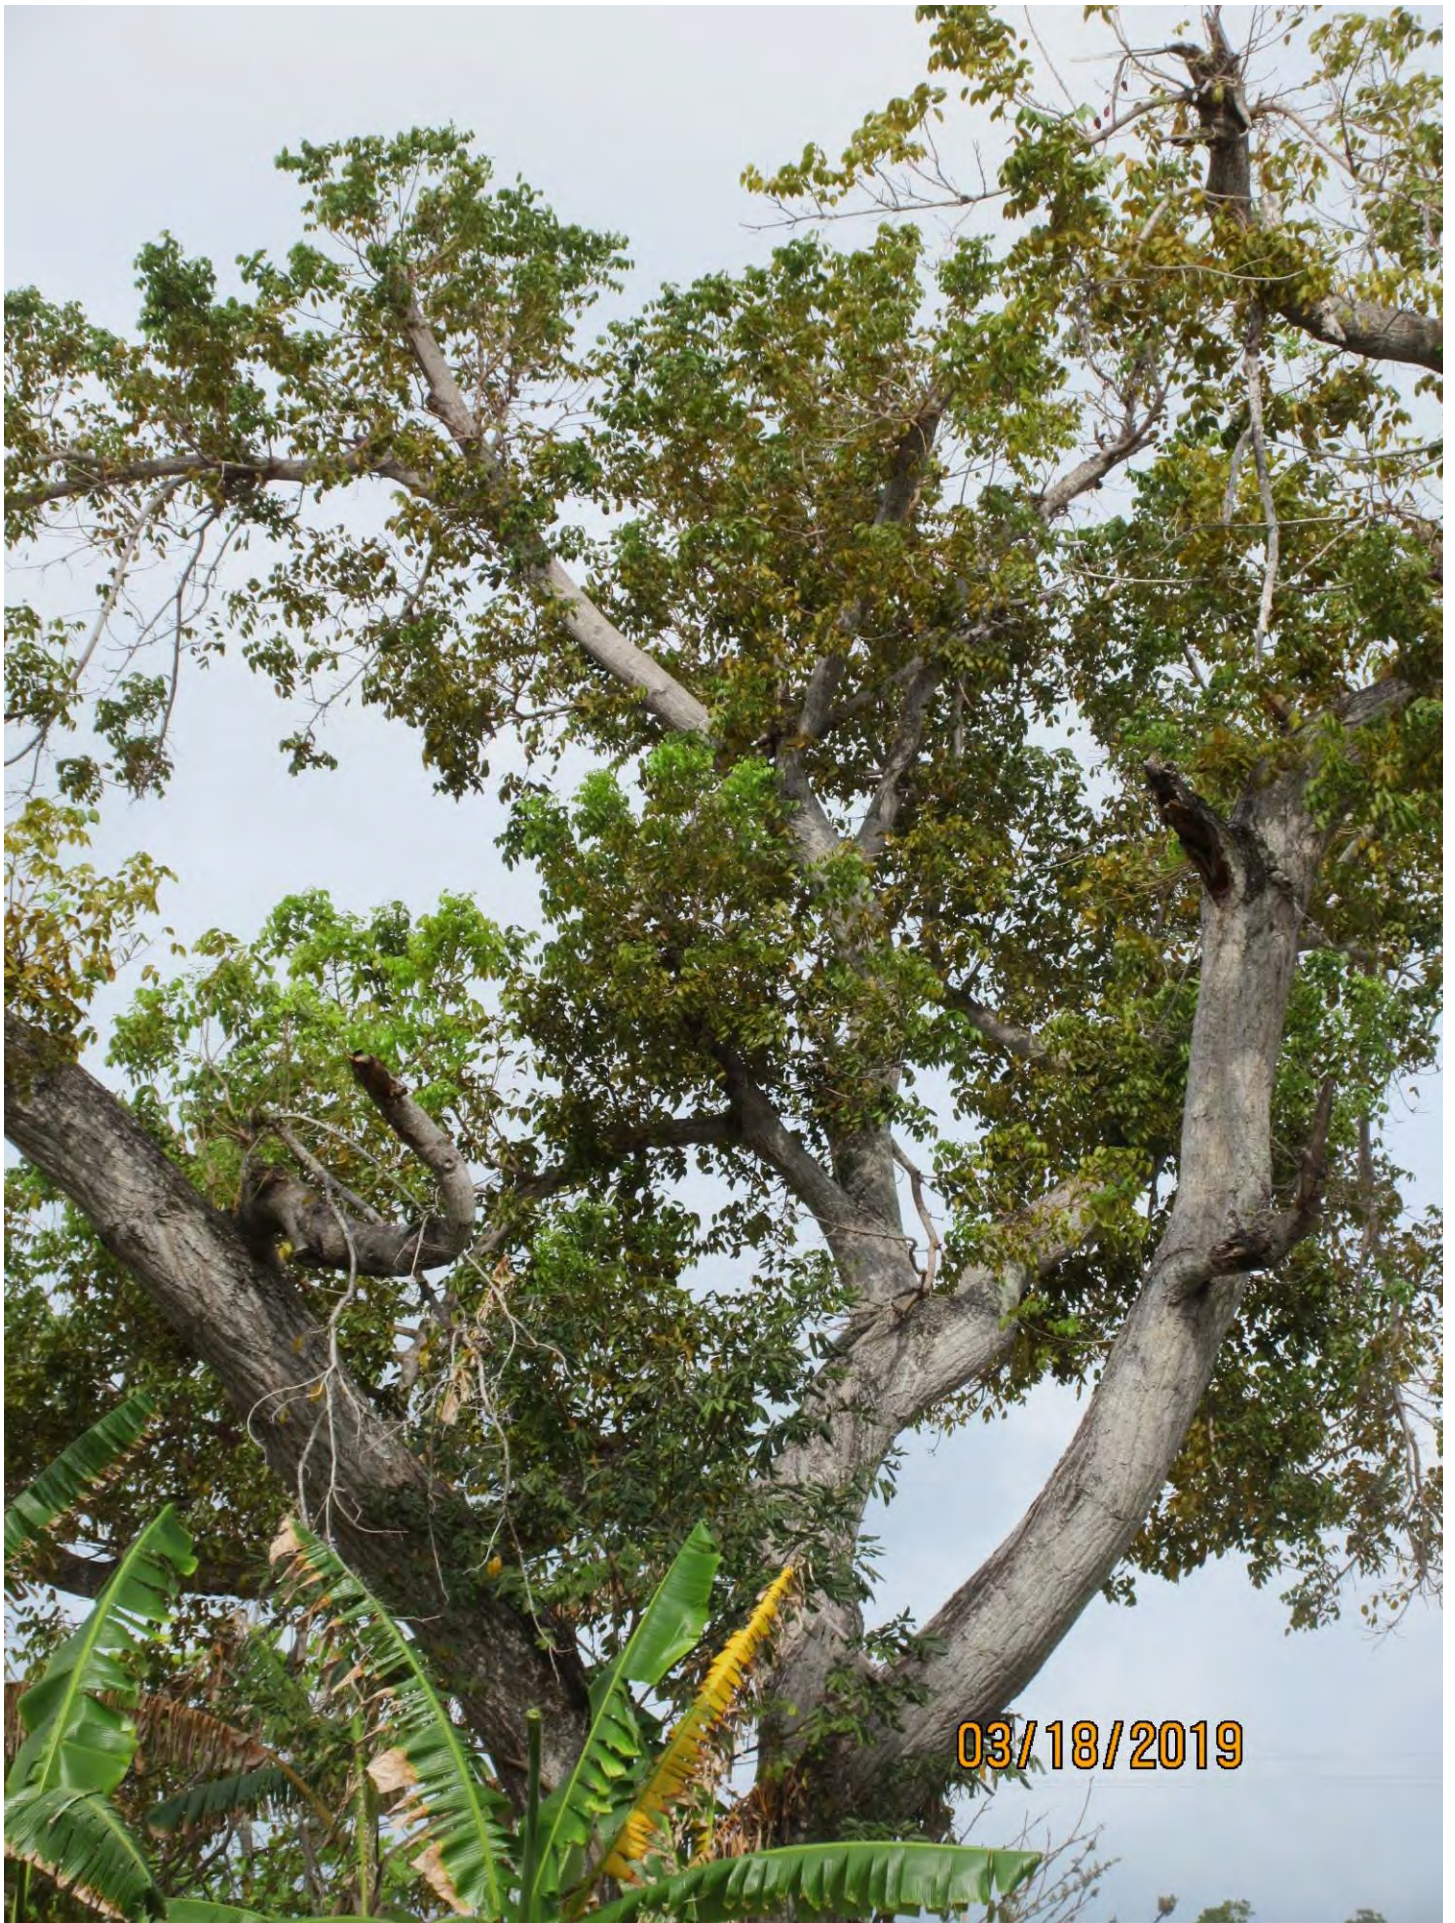
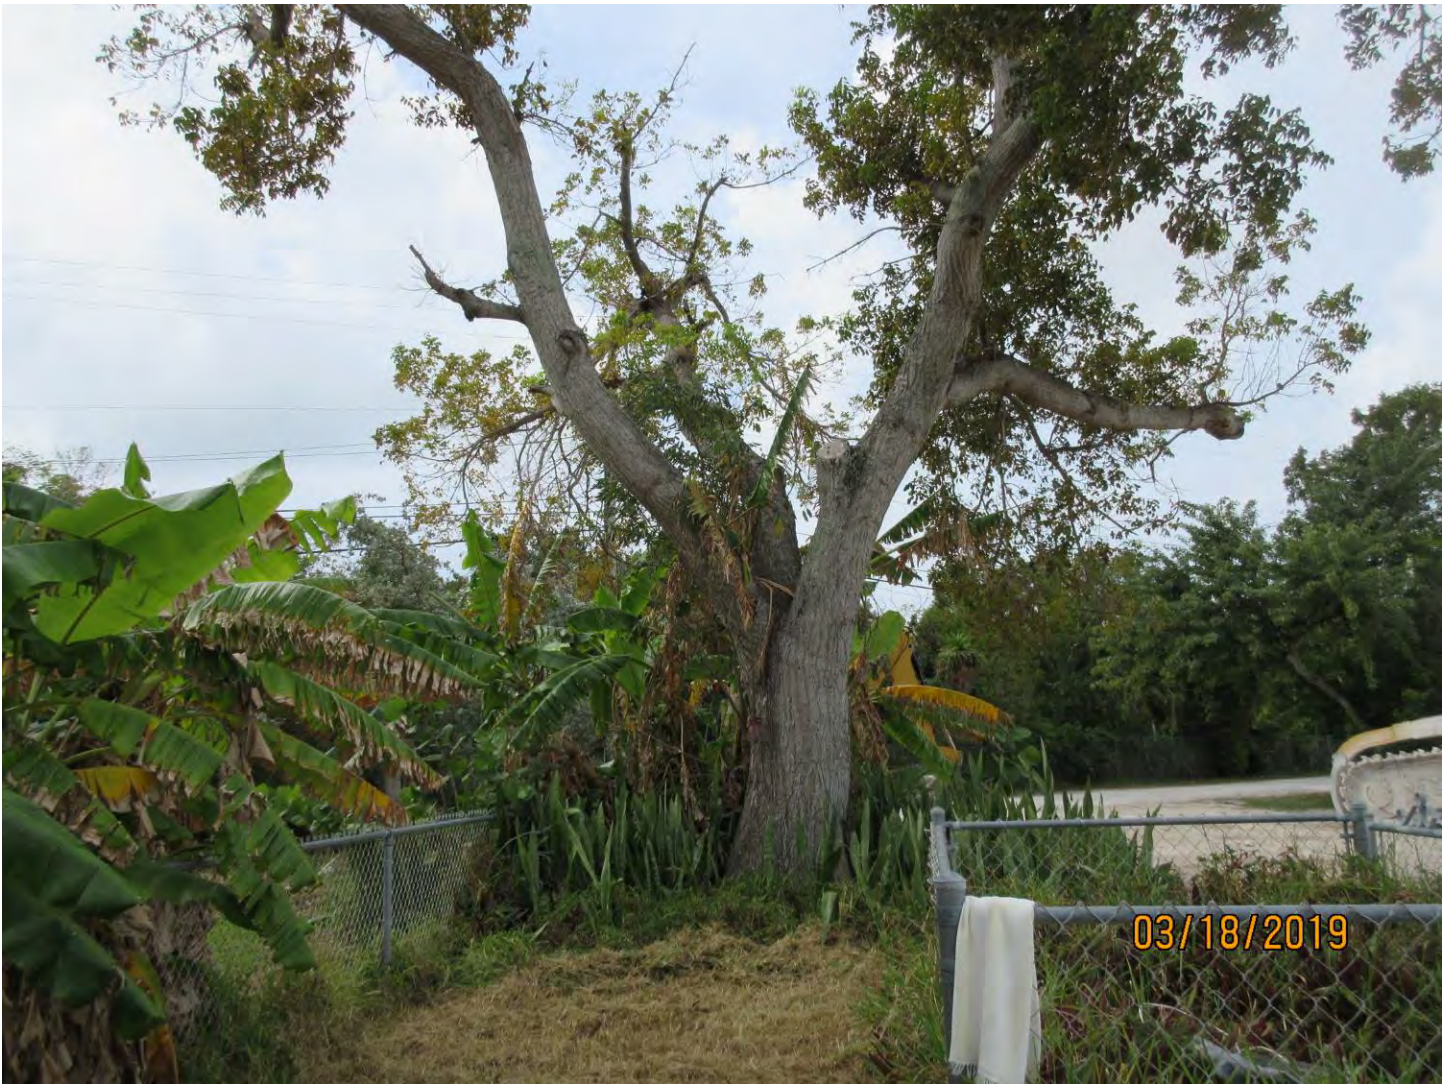
**Tree #15a:**

Condition: 50% (fair, a lot of storm damage in canopy, decay, poor structure)
