Structural Report

Single Family Residence
309 William Street
Key West, FL 33040

September 1, 2025

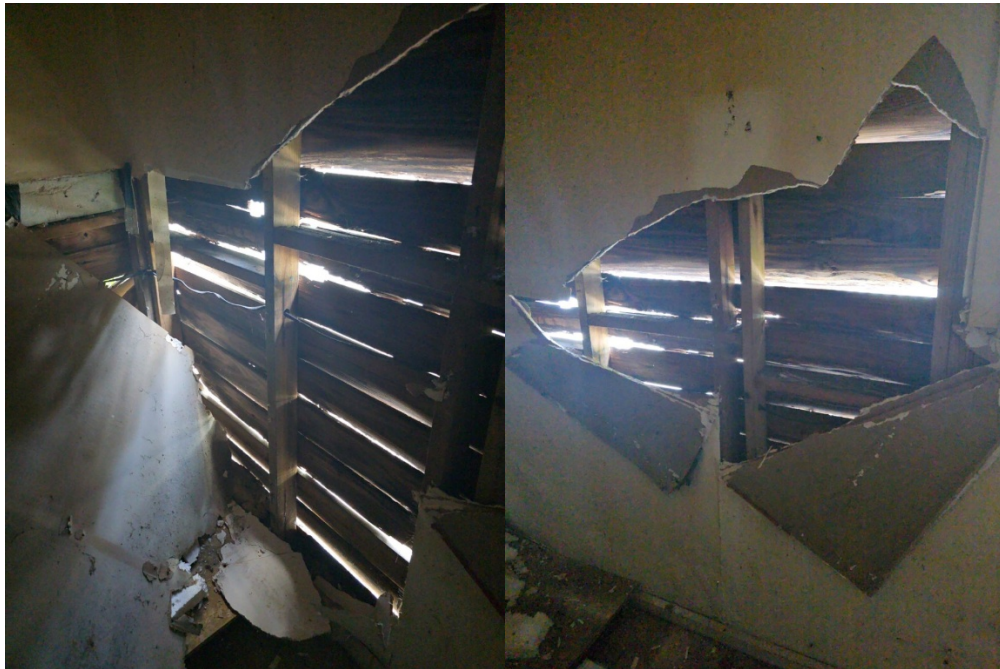
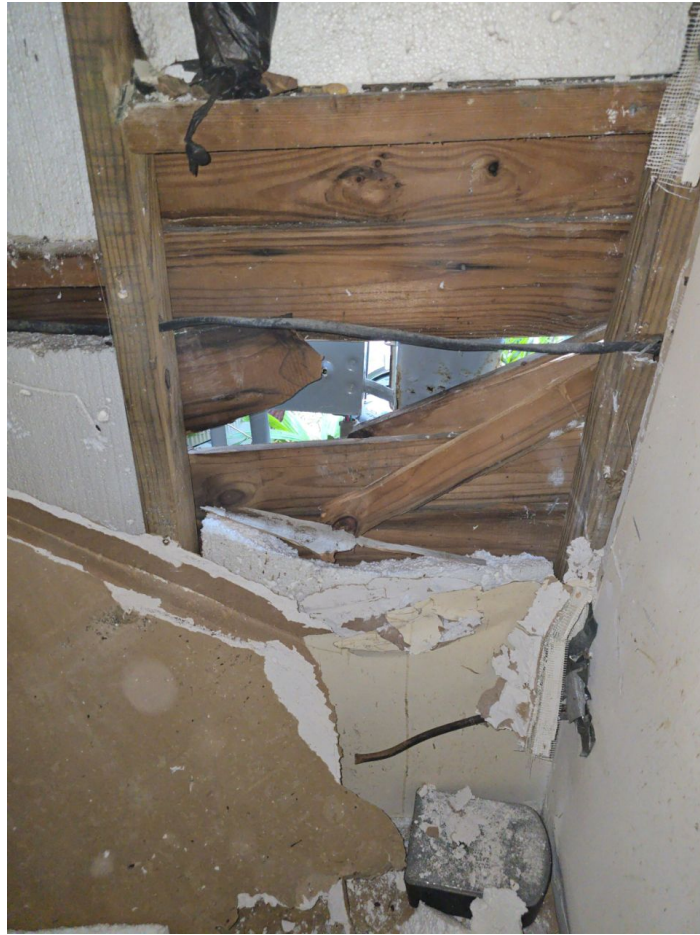
The siding is unsalvageable and in very poor condition due to a variety of factors including water damage, termite damage, and rot/decay. There is no sheathing present in the exposed areas.

DETERIORATED EXTERIOR SIDING W/ NO SHEATHING

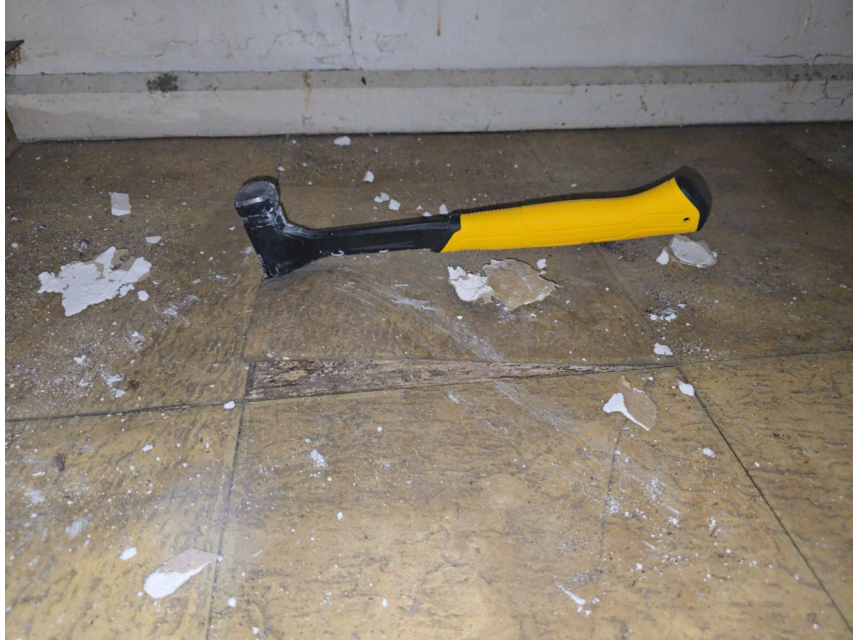
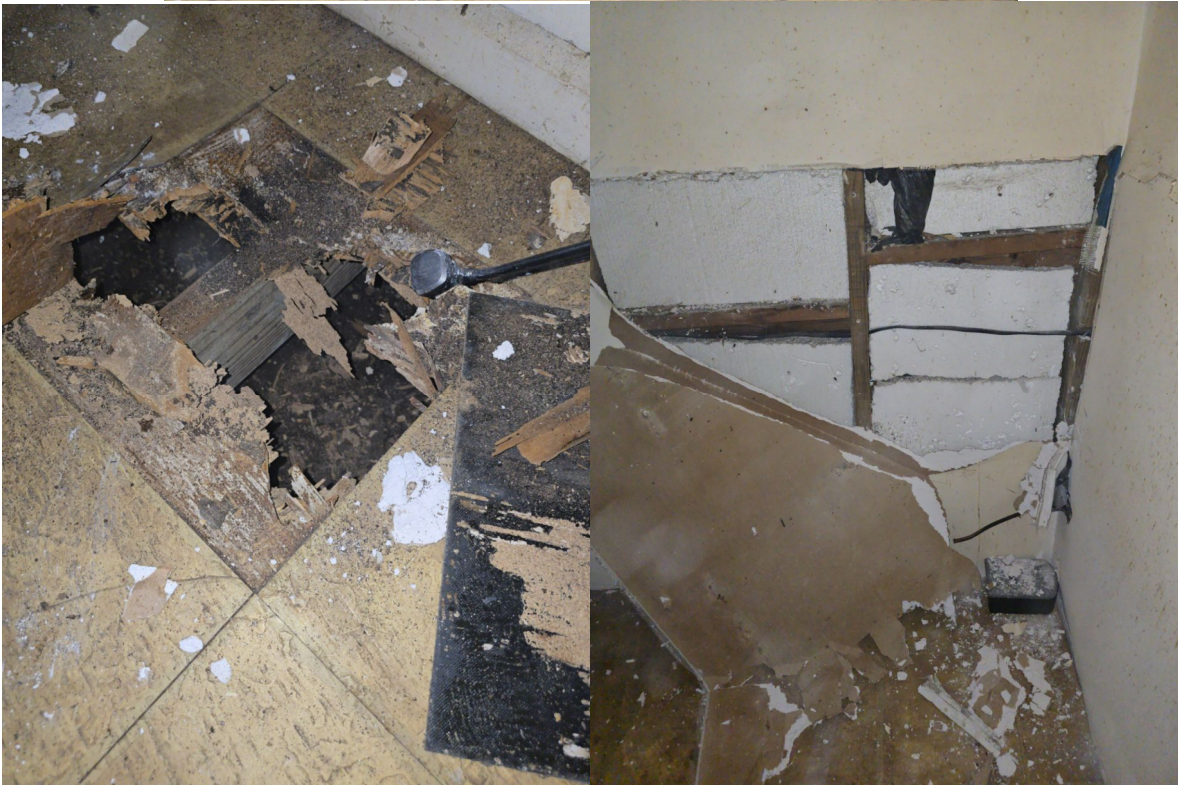
The floor framing is in a deteriorated state in all exposed locations. The floor sheathing/flooring material is soft and unstable for walking. Exposed locations indicate no structural attachment to the sill beams, and floor framing is resting on the ground below. A series of photos depict a significant slope in the floor, indicating failure of the floor framing and/or foundation settling. The lower diaphragm is completely compromised and in full need of replacement.

DETERIORATED FLOOR FRAMING & SHEATHING

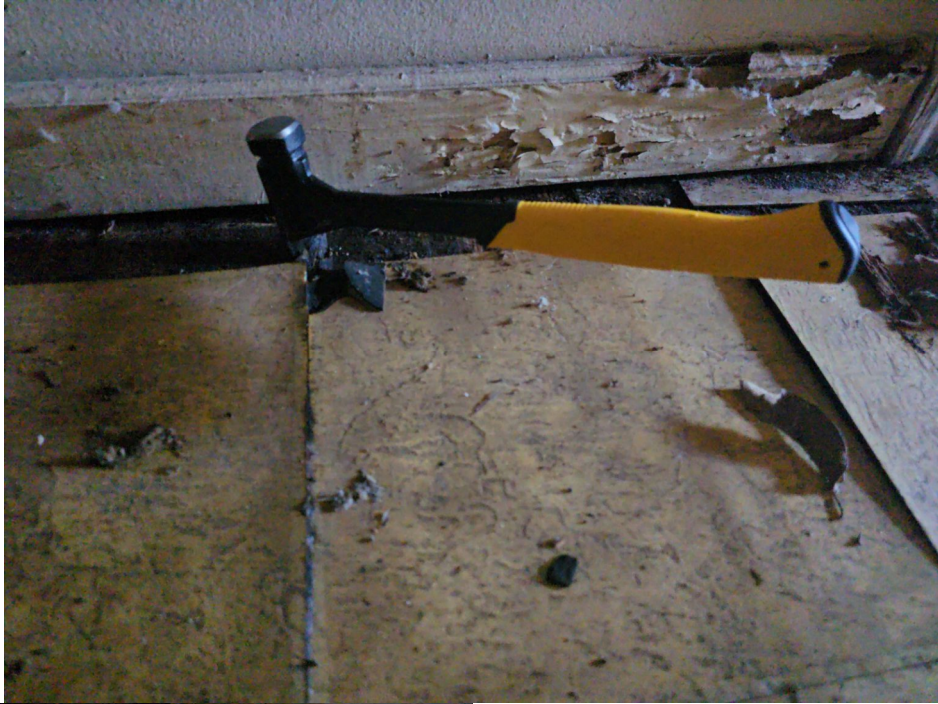
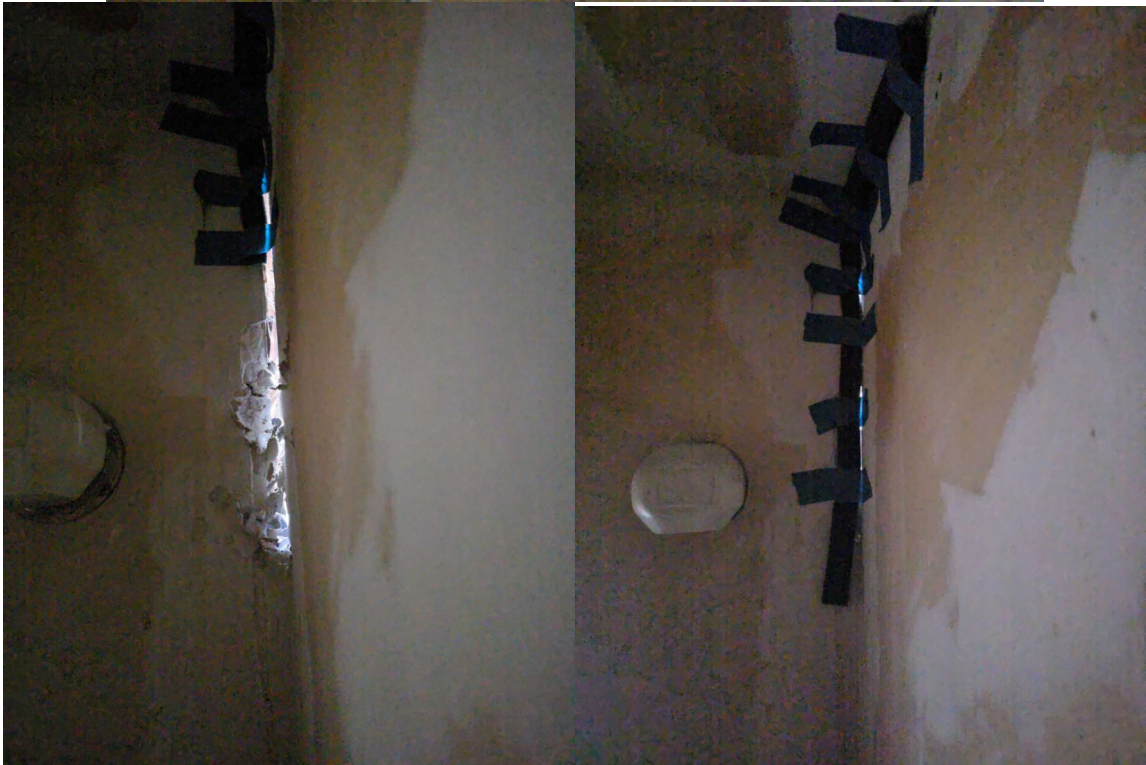
The wall framing is in a deteriorated state in all exposed locations. Duct tape was found to be holding one corner together. No strapping or sheathing was present in any exposed location. Daylight is visible through the siding. Wracking of the structure is visually evident. The ceiling and roof structure show visible signs of significant water damage, termite damage, and rot.

DETERIORATED WALL CONDITION (SEPARATION)

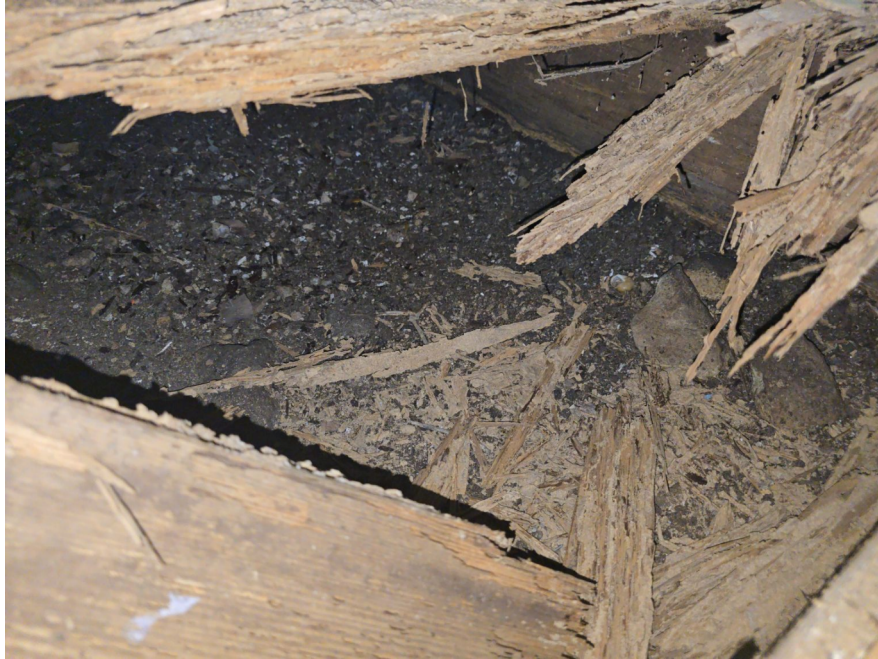
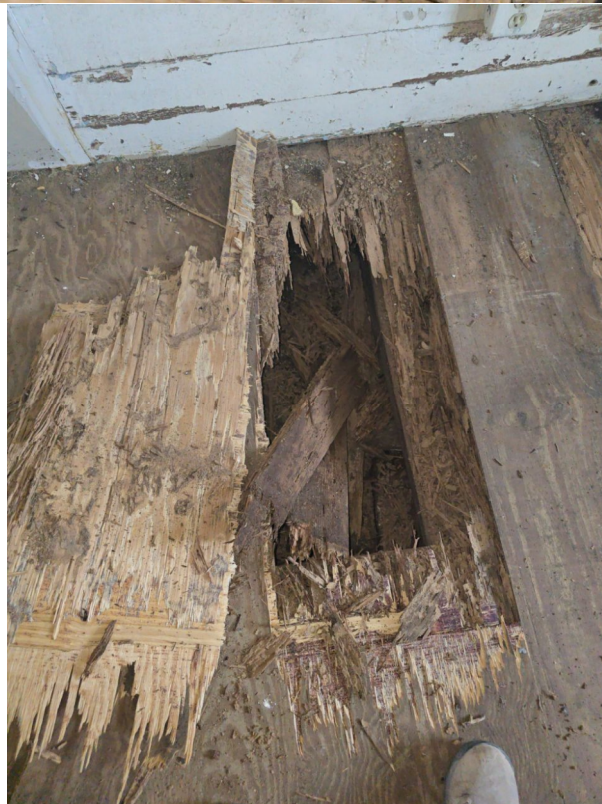
FLOOR FRAMING ON GRADE

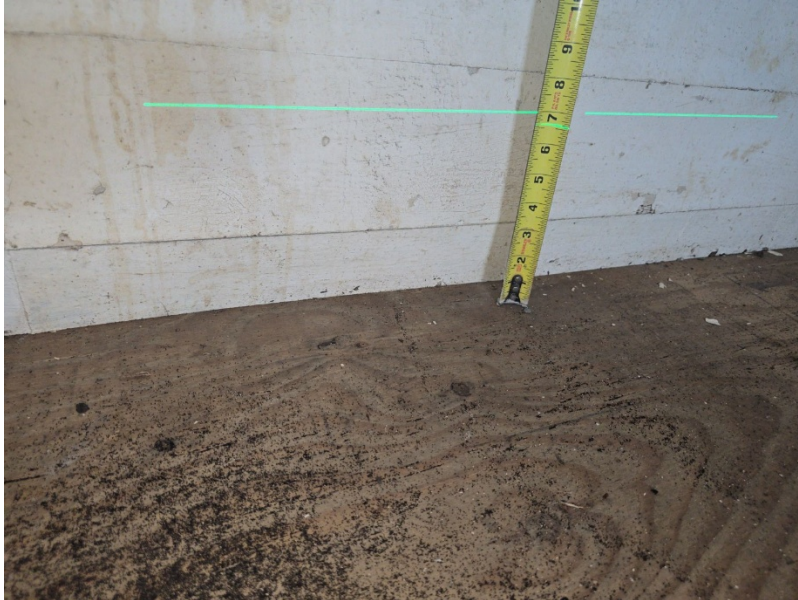
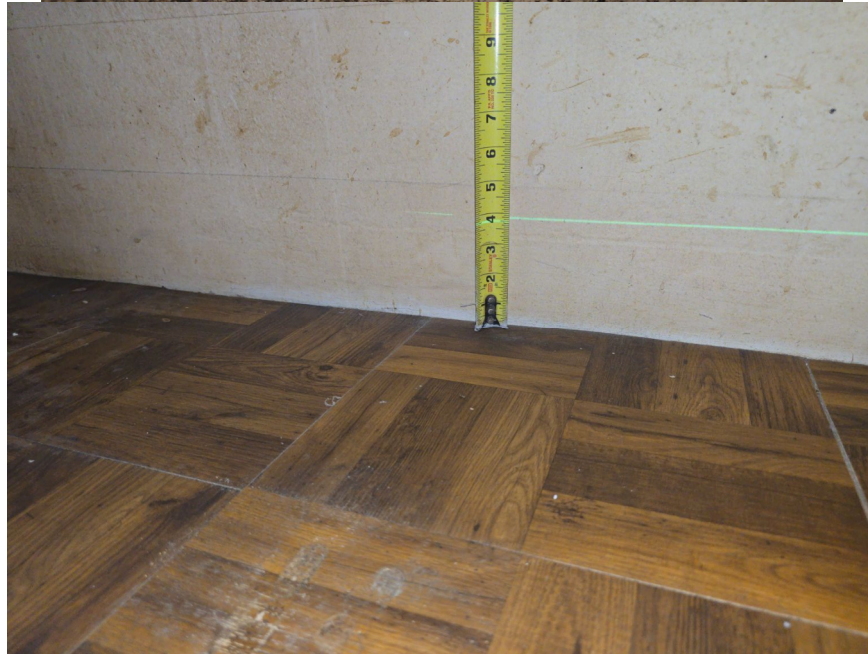
UNLEVEL FLOOR (SUNKEN FOUNDATION & FRAMING)

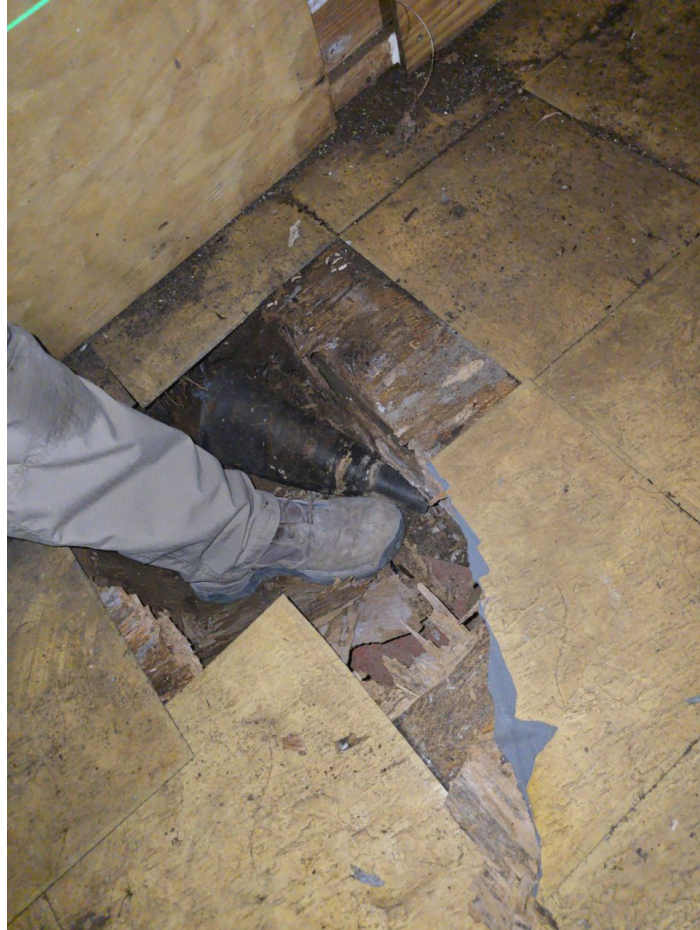
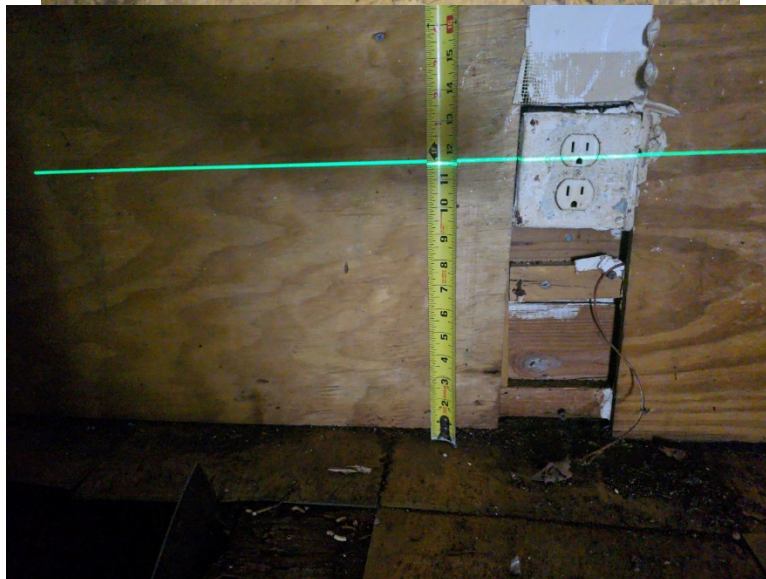
UNEVEL FLOOR (SUNKEN FOUNDATION & FRAMING)

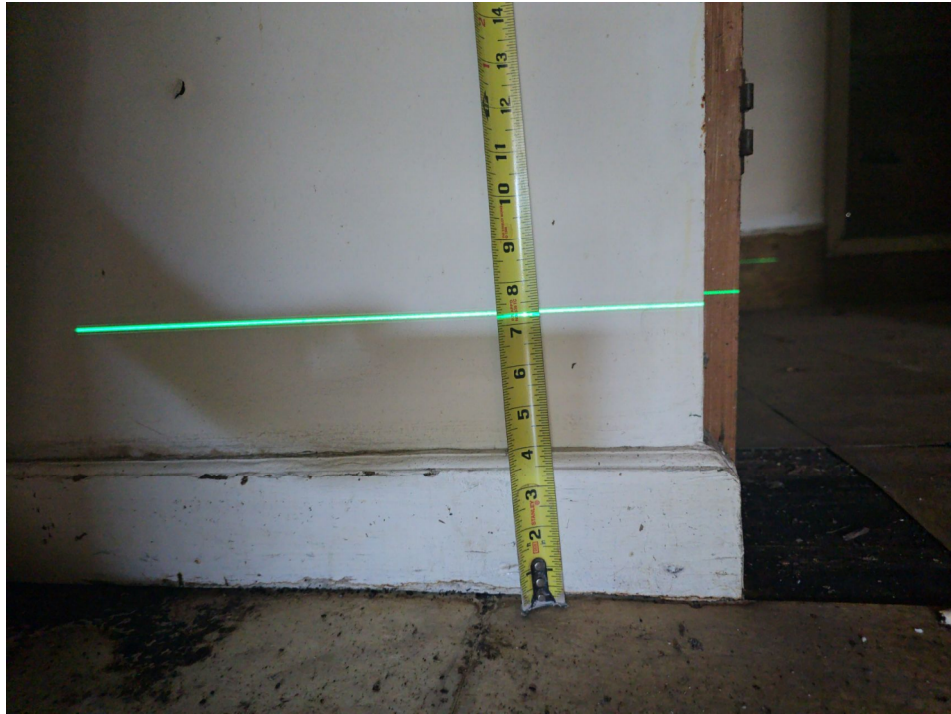
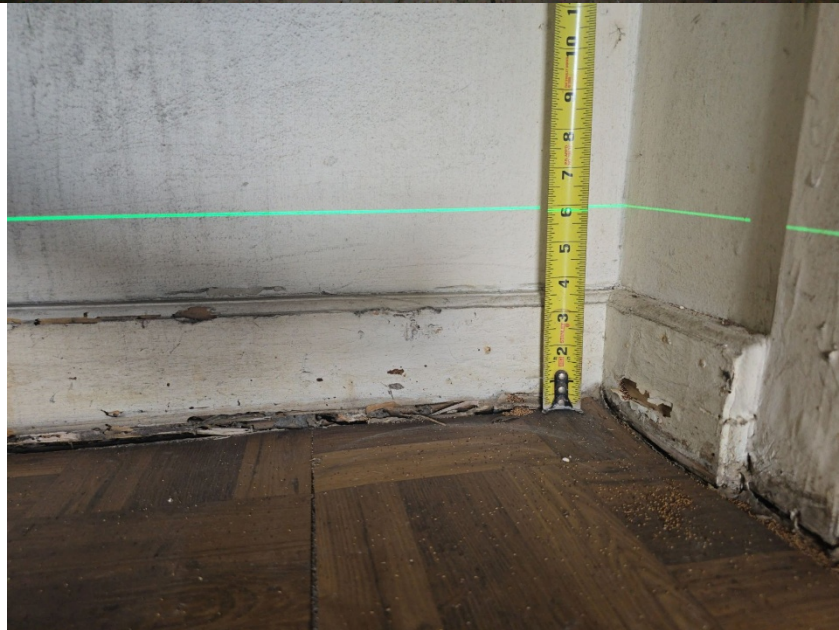
UNLEVEL FLOOR (SUNKEN FOUNDATION & FRAMING)

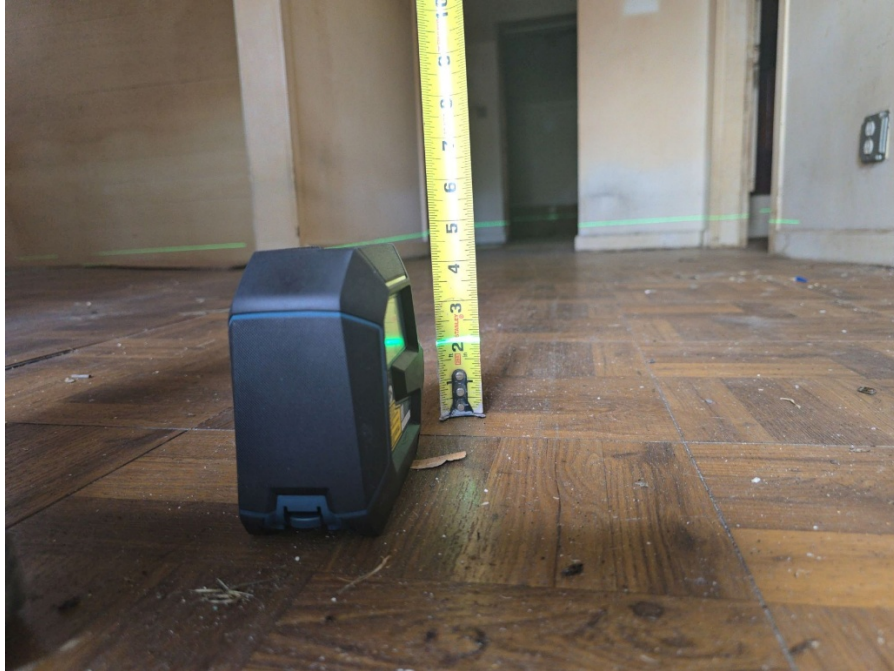
UNLEVEL FLOOR (SUNKEN FOUNDATION & FRAMING)

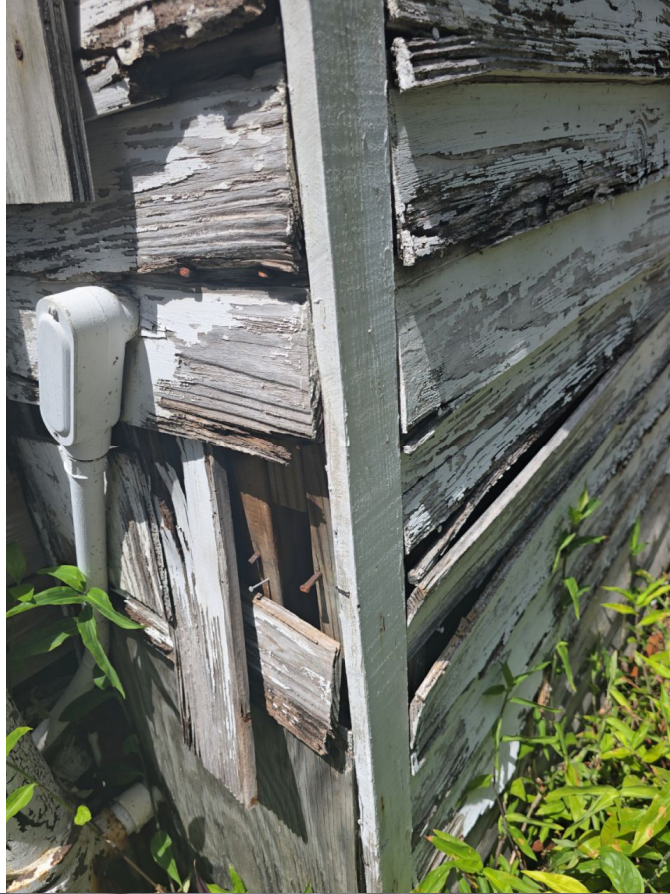
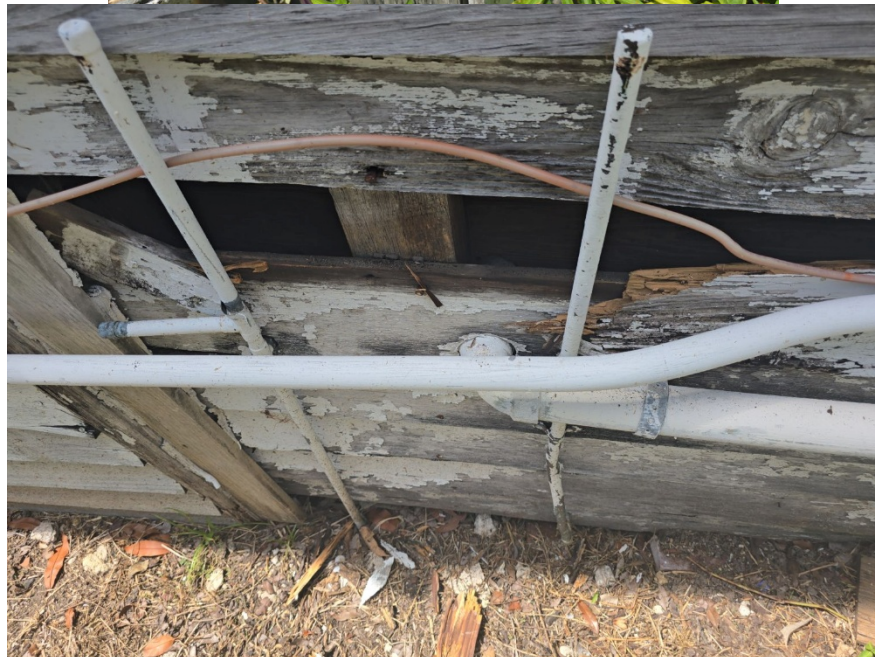
CONDITION OF EXTERIOR SIDING

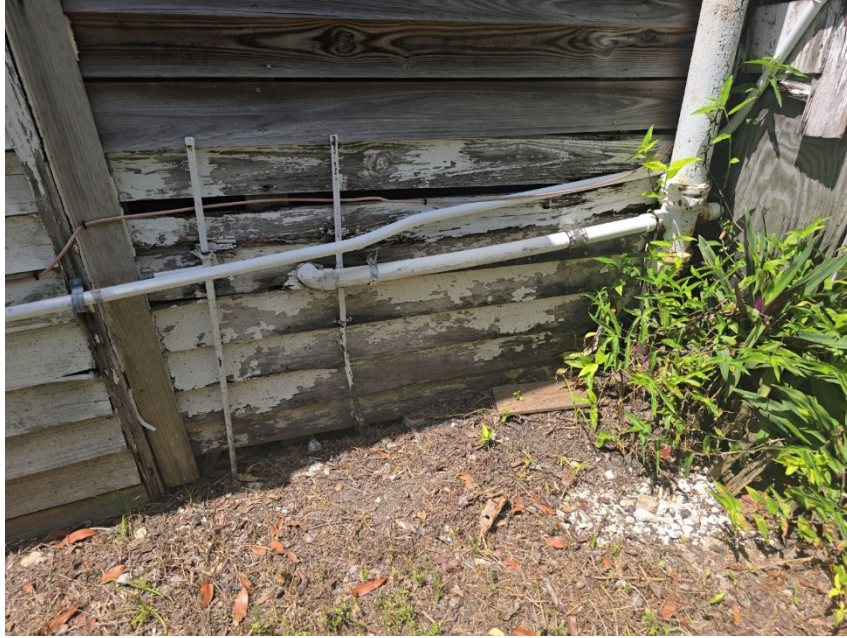
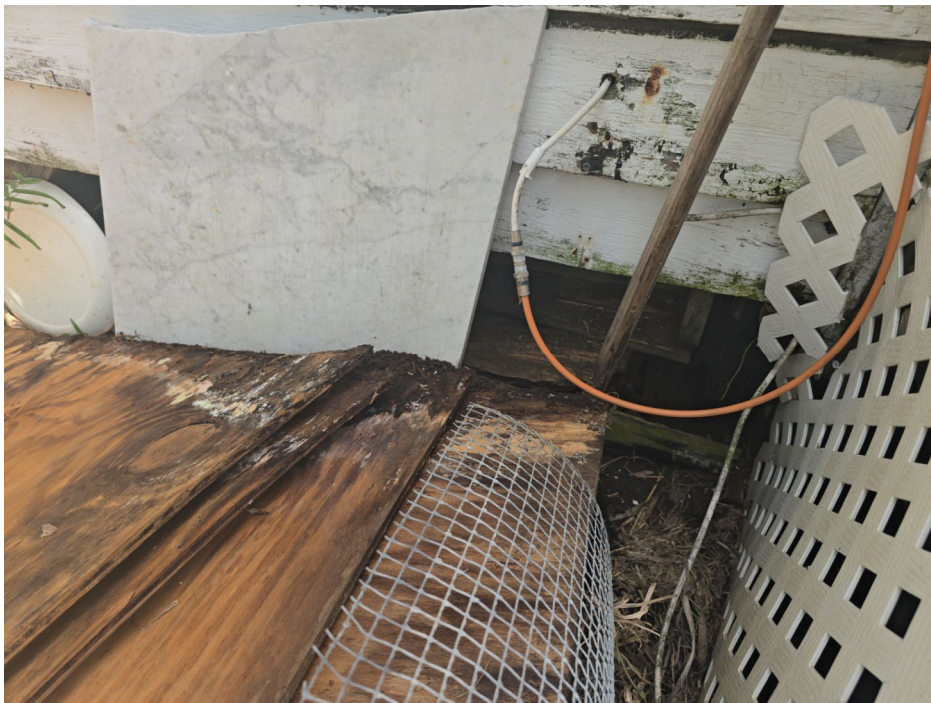
CONDITION OF EXTERIOR SIDING

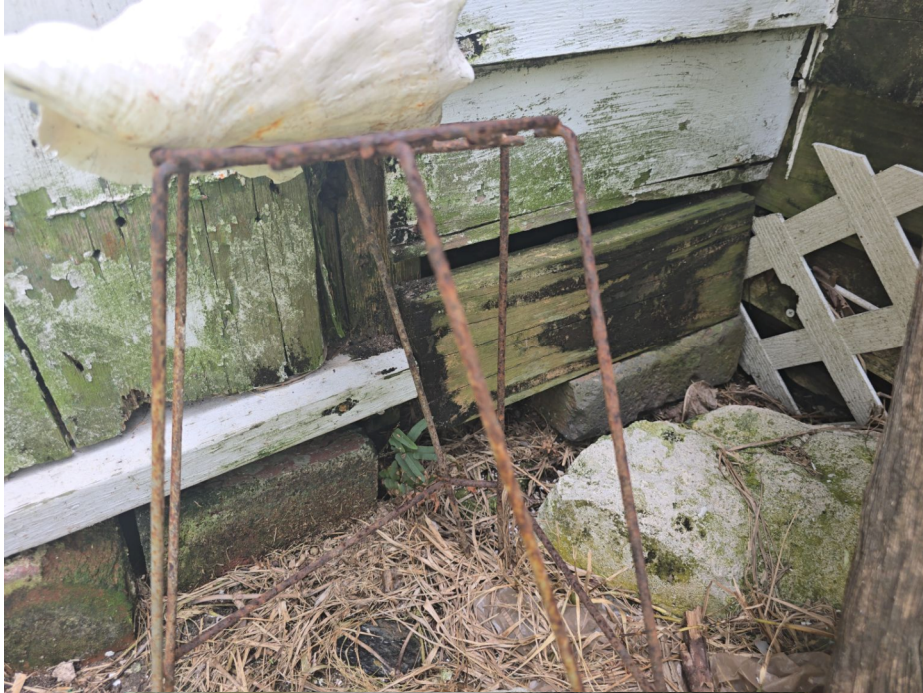
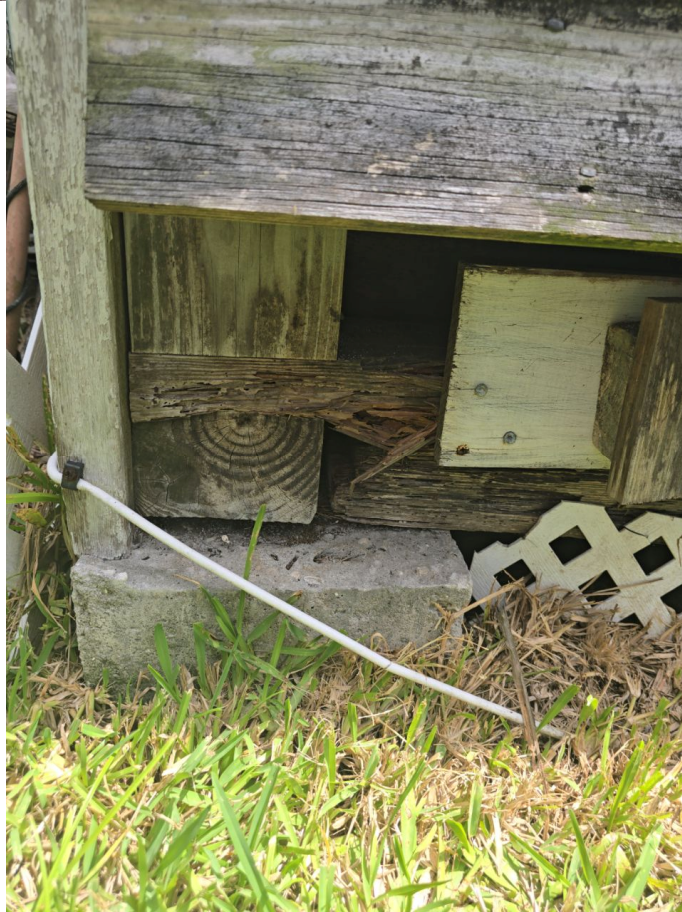
The foundation has been determined to be either non-existent, sunken into the ground, or deteriorated. It consists of limestone columns, bricks, and wood piles in varied locations with no indications of tie downs between the foundation and structure.

FOUNDATION ELEMENTS

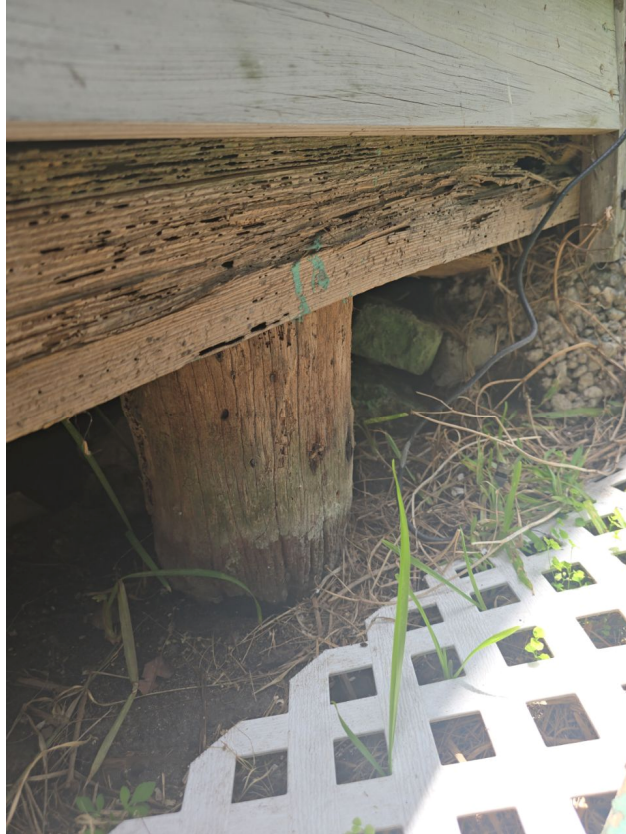
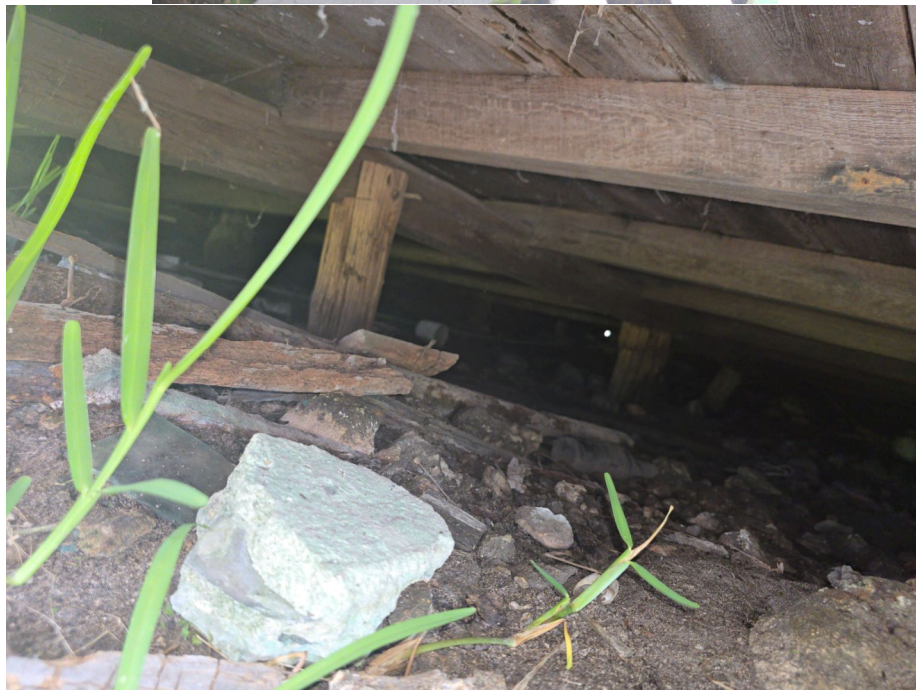
FOUNDATION ELEMENTS

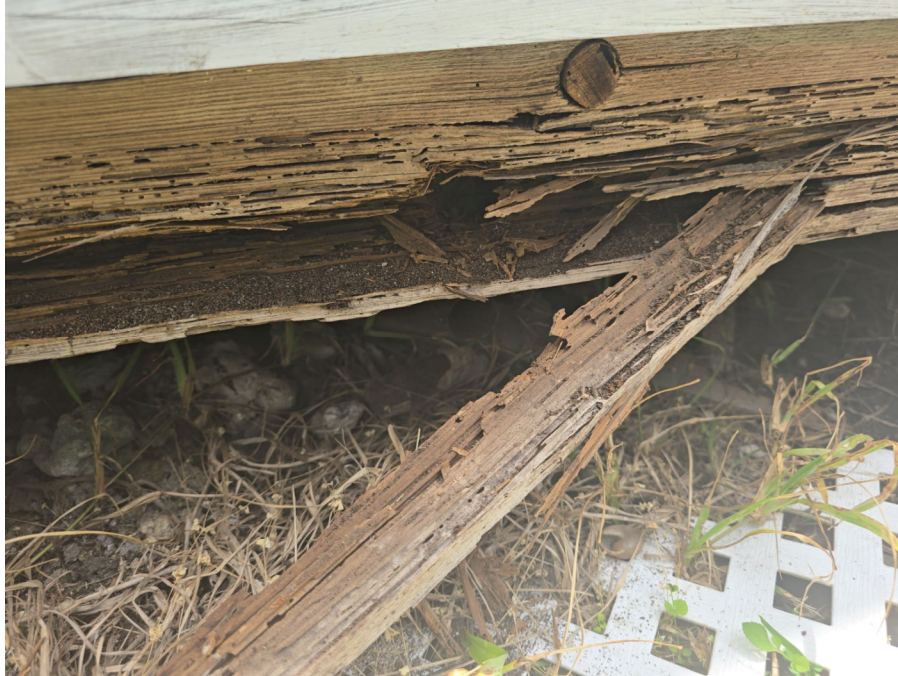
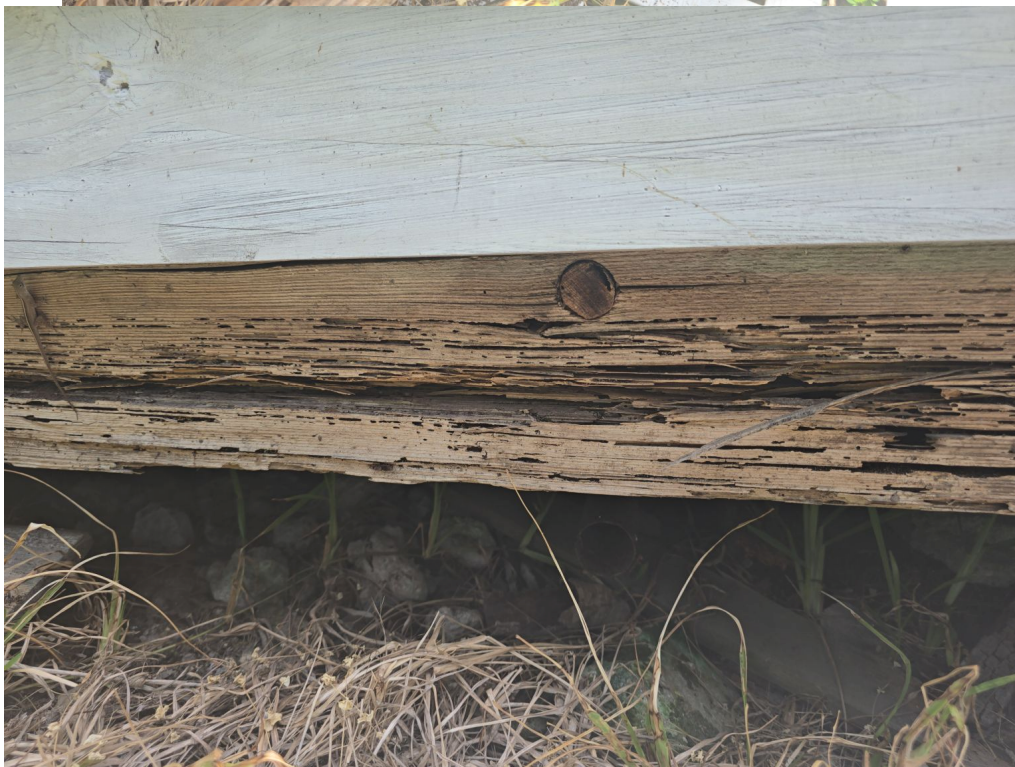
DETERIORATED RIM JOIST

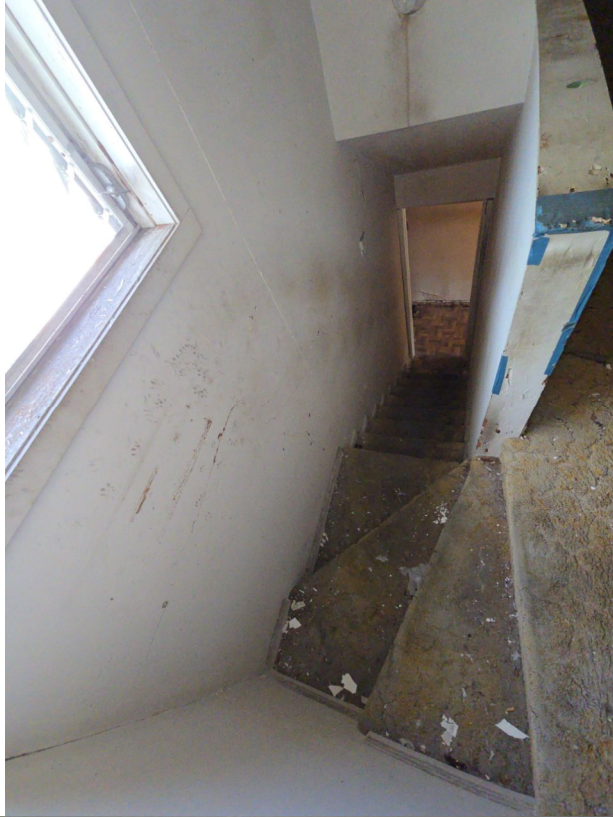
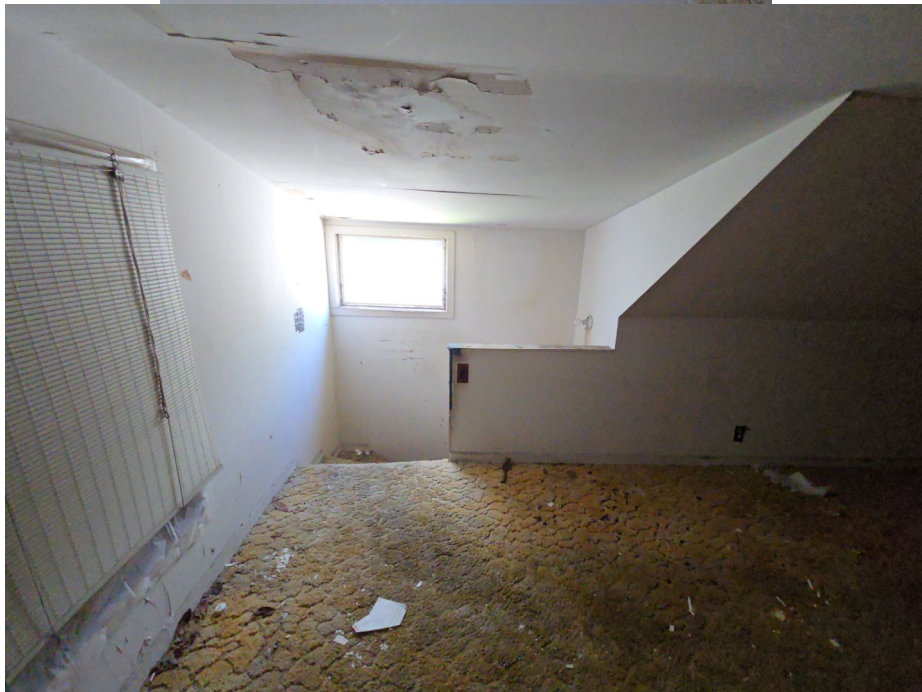
½ STORY WATER DAMAGE

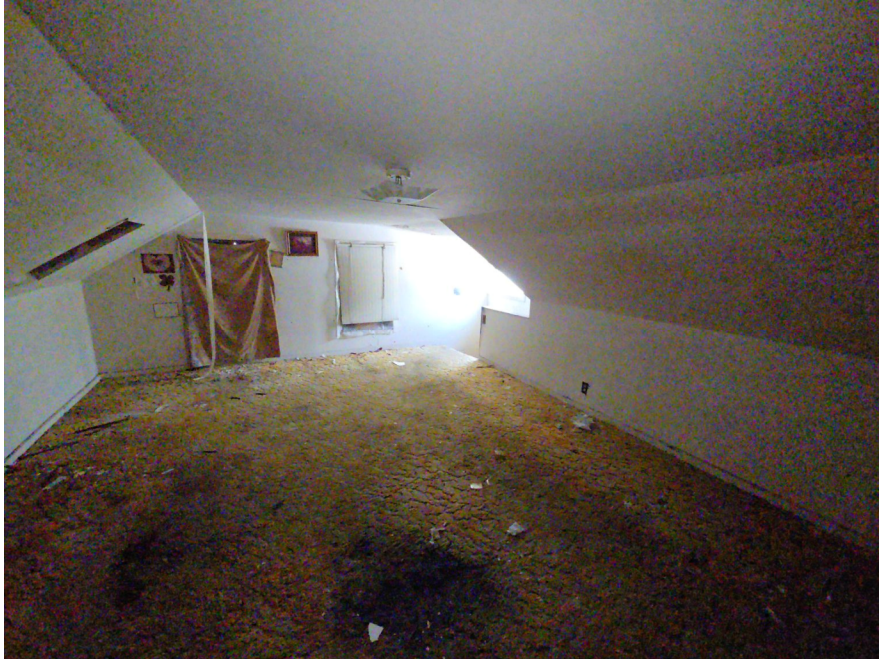
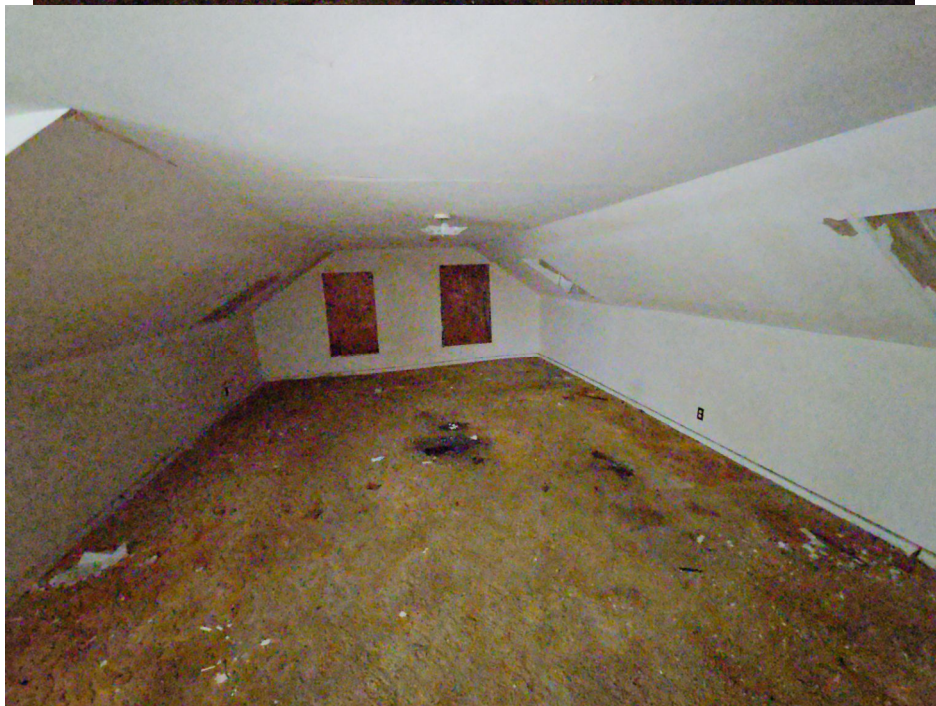
$\frac{1}{2}$ STORY WATER DAMAGE

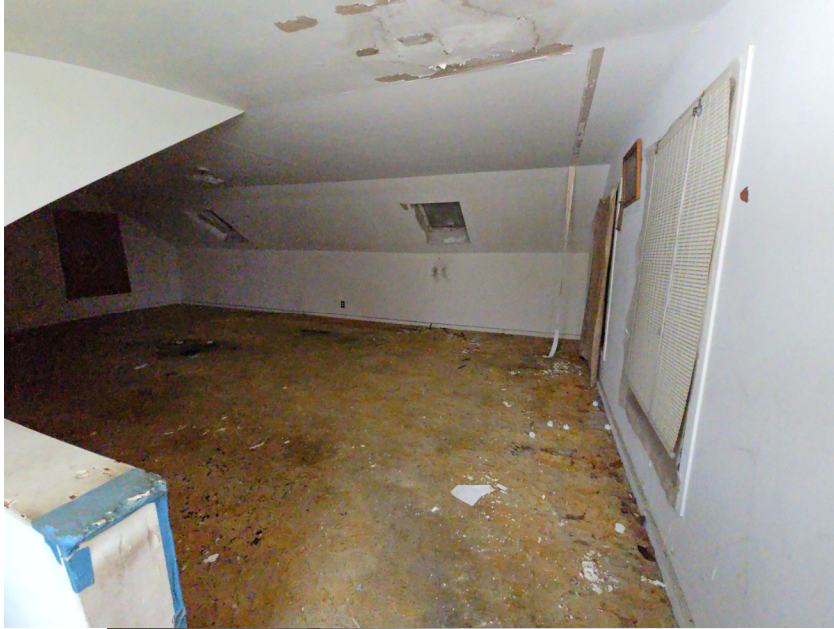
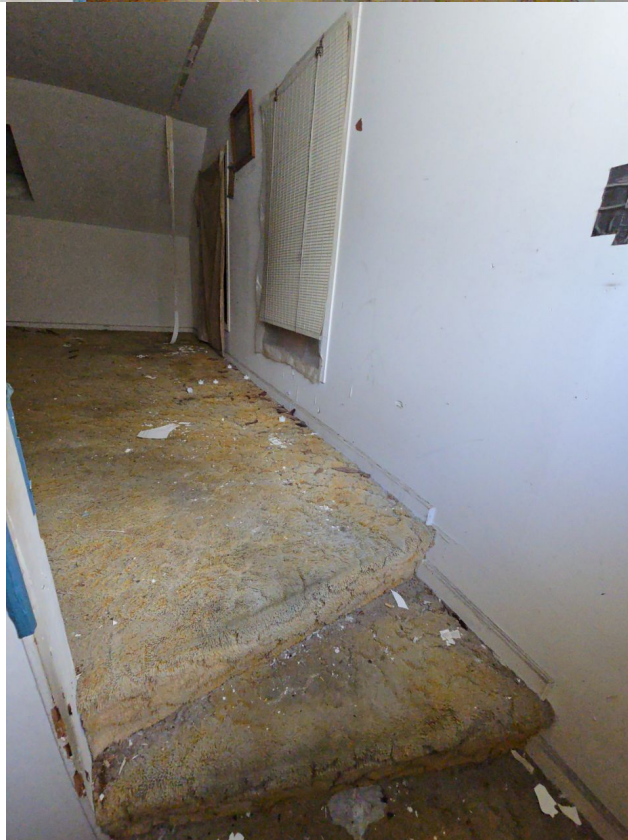
½ STORY WATER DAMAGE

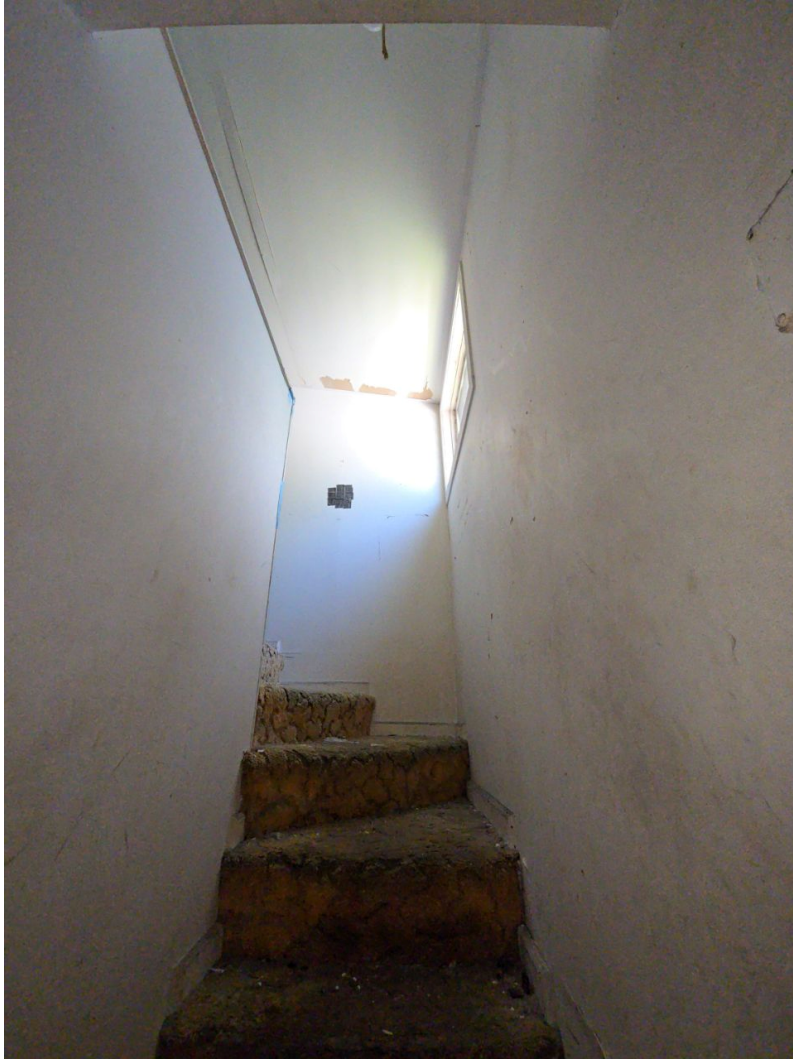
½ STORY WATER DAMAGE

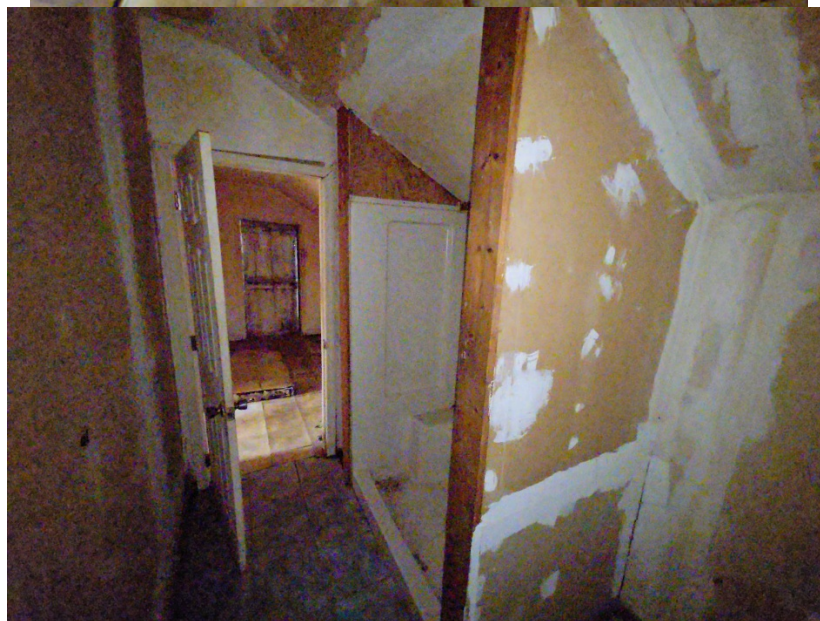
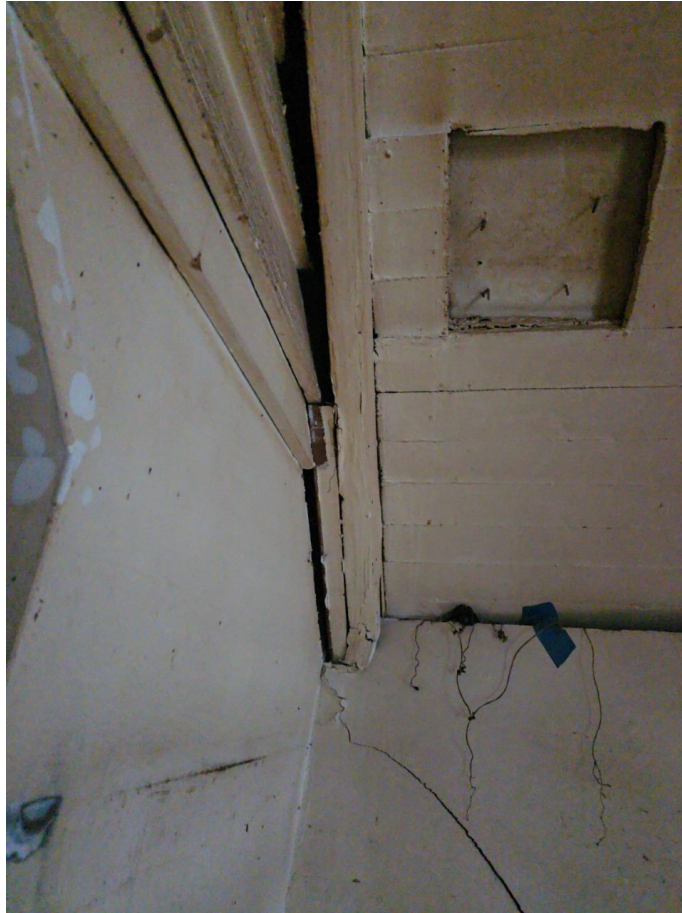
SEPARATED ROOF FRAMING
