# **CITY OF KEY WEST FIRE STATION #3 Structural Condition Assessment**

**1525 Kennedy Drive  
Key West, Florida**

**September 25, 2024**

Re: Fire Station #3 - 1525 Kennedy Drive, Key West  
Building Structural Assessment

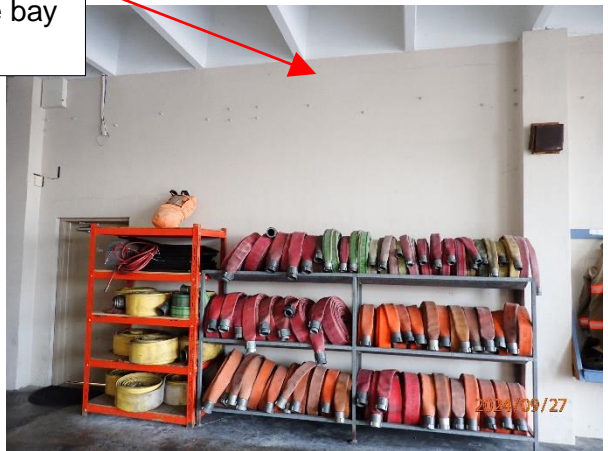
**Picture #10**

Spalling concrete tie beam in garage bay

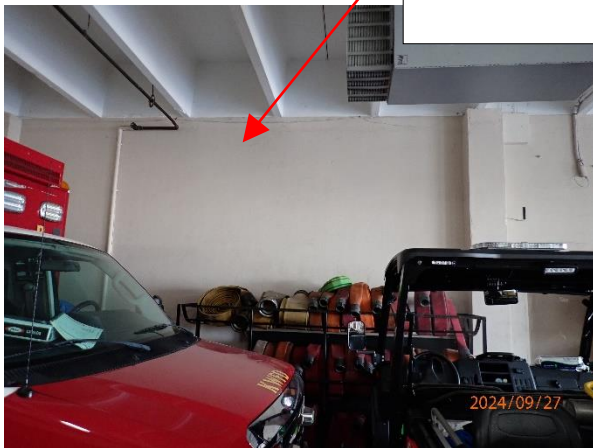
**Picture #11**

Loose, cracked mortar between roof tee-beams

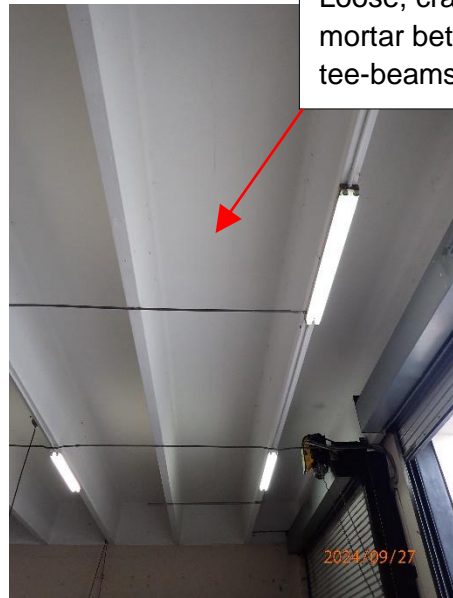
**Picture #12**

Spalling concrete tie beam outside garage bay

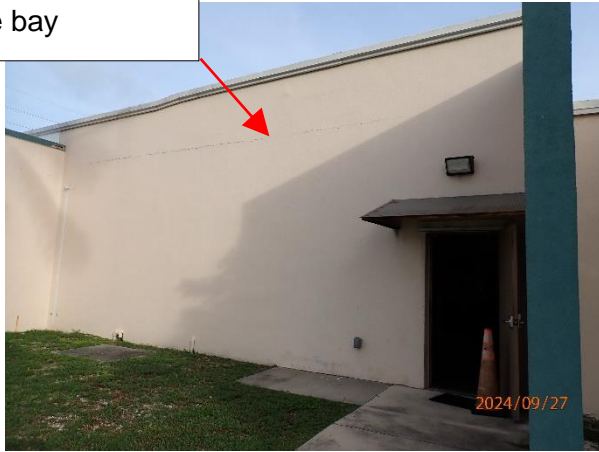
**Picture #13**

Deteriorated wood-framed patio roof

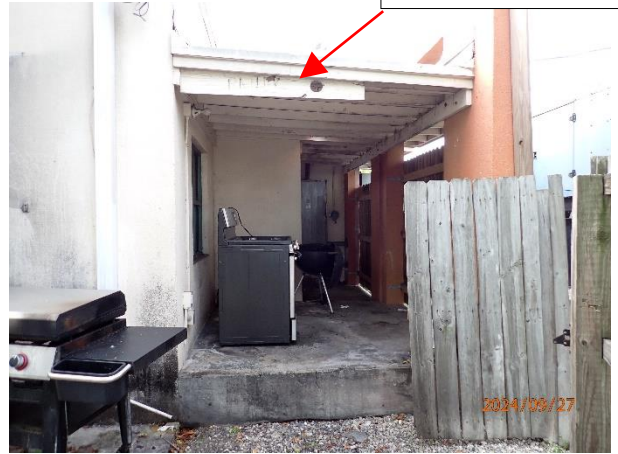
**Picture #14**

Deteriorated wood-framed patio roof cracked roof joists

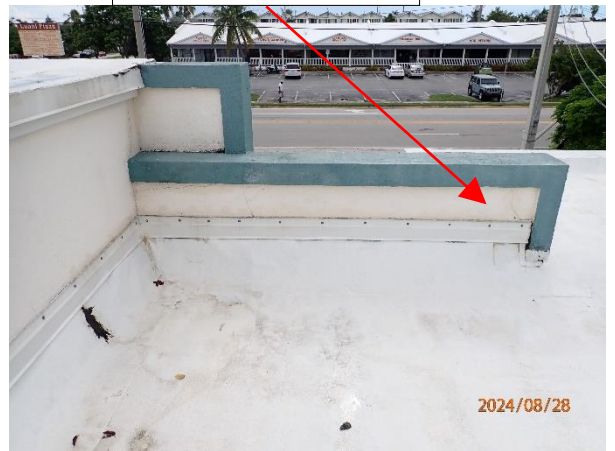
**Picture #16**

Cracked concrete  
roof parapet

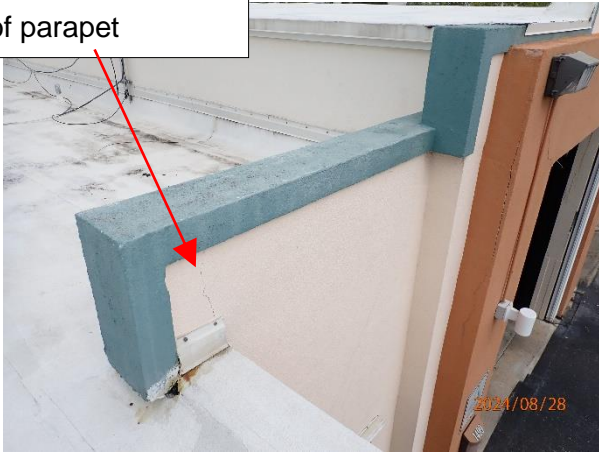
**Picture #17**

Cracked stucco on  
roof parapet

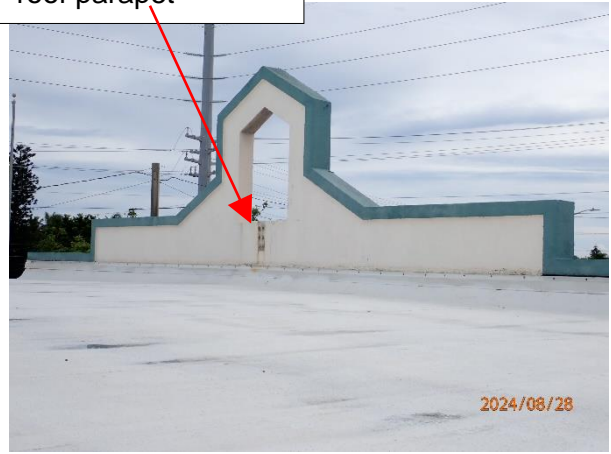
**Picture #18**

Cracked stucco on  
roof parapet

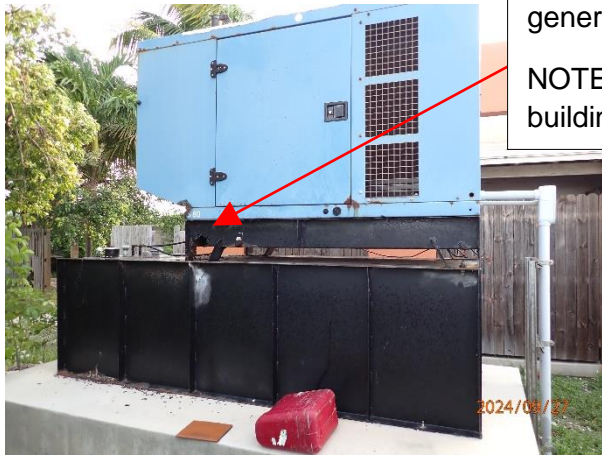
**Picture #21**

Severely corroded generator base.  
NOTE: Not part of building structure.
