Building Analysis Report

1012 Fleming St

Key West, Fl

Habitat for Humanity

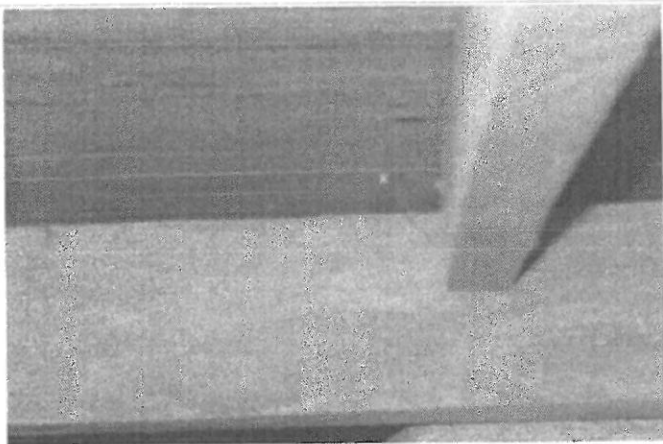
Center girder

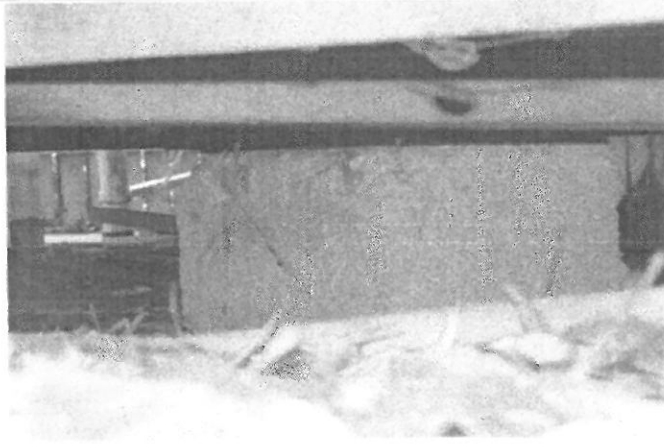
Addition masonry piers

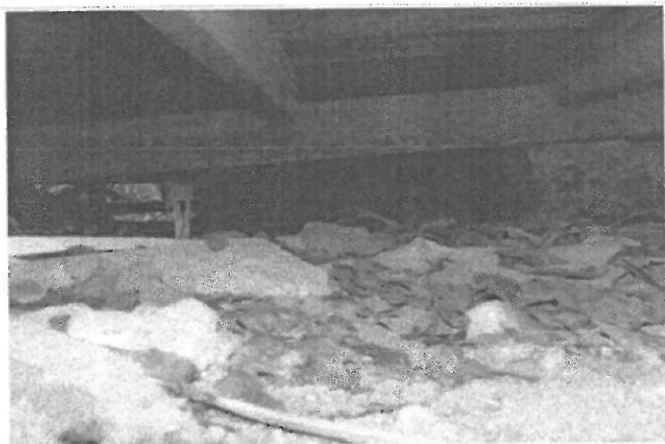
Deflection was also observed in the center girder at the front section of the house, which was the original front porch.

Deflection in center girder at unit 1

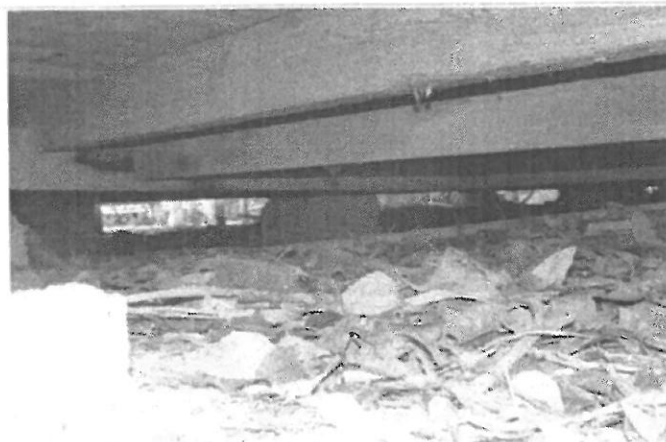
No anchors at piers to floor framing structure. Piers are resting on the top of the cap rock - No reinforcing steel.

Limestone piers and floor framing

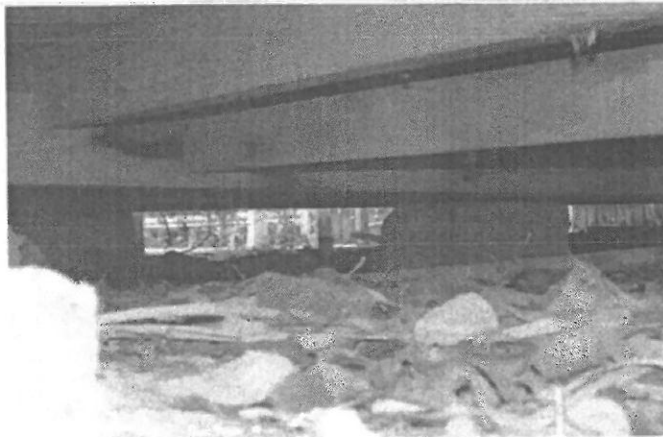
Only about 50% to 75%
Floor framing- was visible - rough sawn - nominal 2" x . Only minor deterioration observed from termites.

2 x 6 nominal floor joist

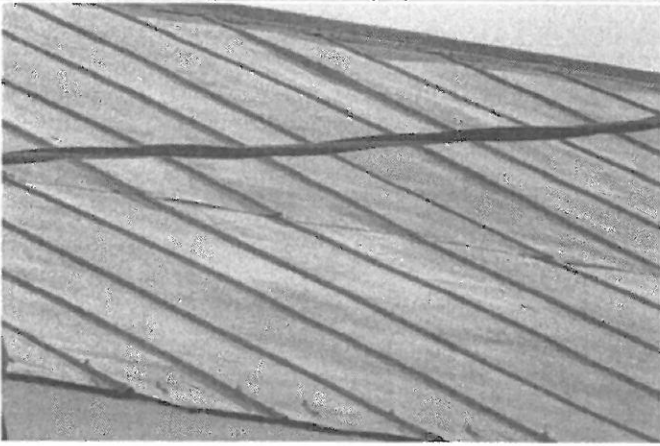
The roof covering on the main structure appears to be the second covering. There appears to be the original layer of wood shake shingles installed under the standing seam metal panels.

The roof covering material shows signs of a condition /or damage that needs attention to prevent any further problems that may lead to deterioration or leakage.

Main gable - right side- standing seam metal

Recommend contacting a Roofing Contractor for further evaluation due to the age of the roof. Roof appears to have reached and/or passed its typically life expectancy.

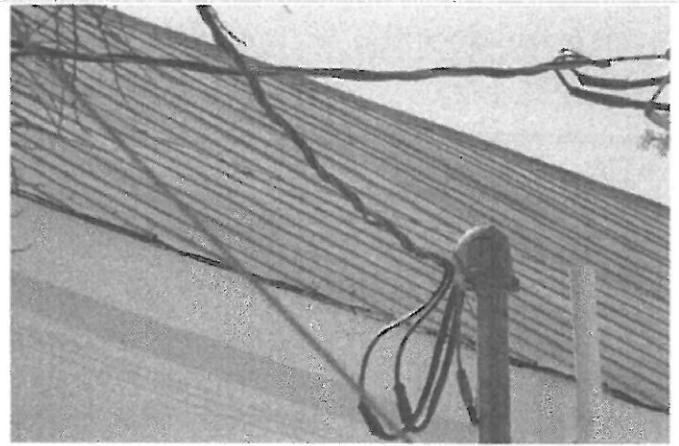
Main gable right side #2

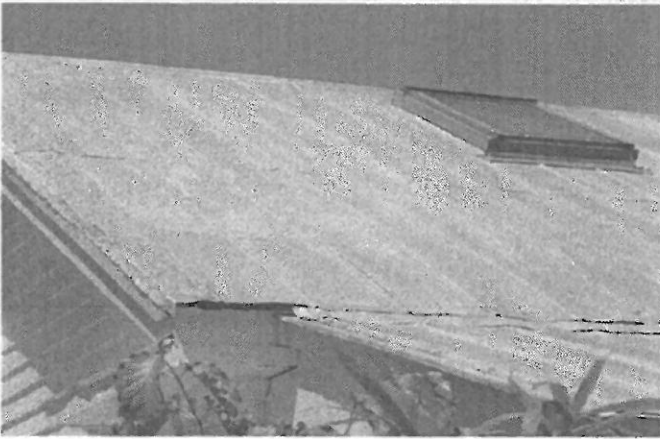
Main gable - left side w/ skylight

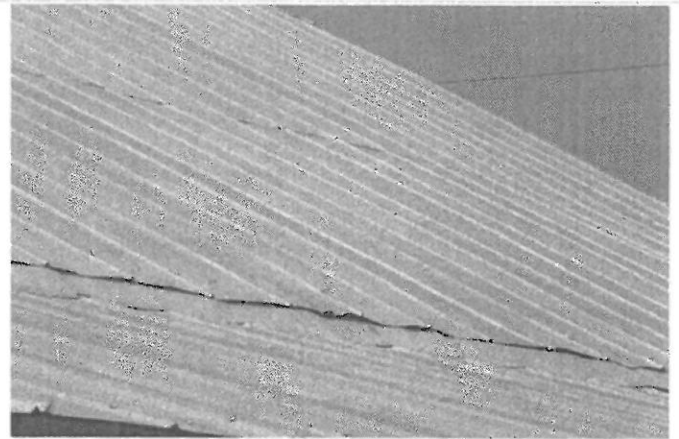
Main gable and roof - left side - #2

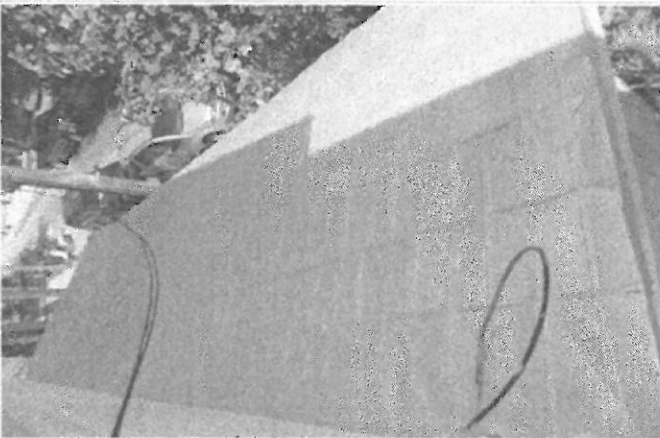
The roof covering material shows evidence of deterioration or leakage to the degree that action is required to determine the extent of repairs needed. Estimates from licensed professionals are needed.

Front roof - metal shingle

Contact a Roofing Contractor for a more precise estimate.

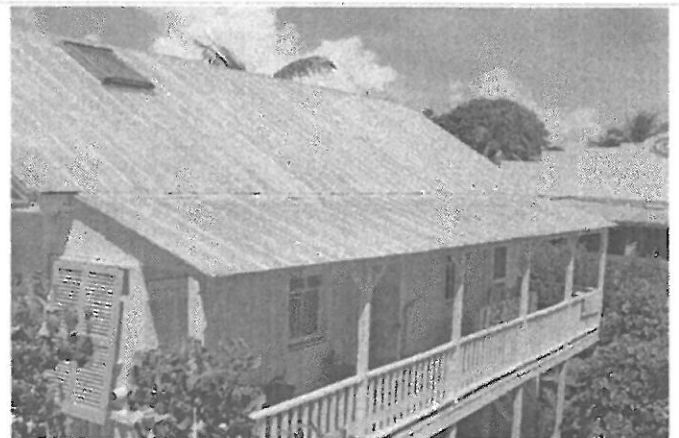
Overview roof - right side- Standing seam metal

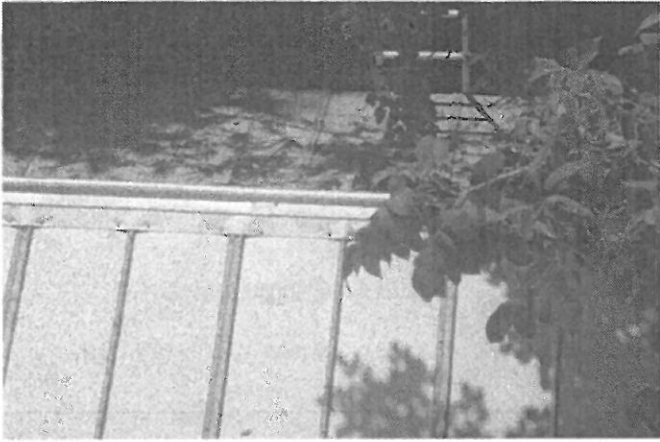
The roof covering material is either new or near new, and it appears to be installed correctly.

Unit #3 gable roofs

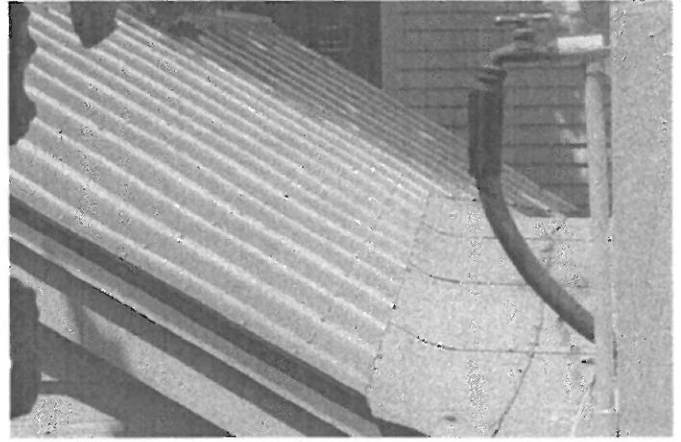
Unit #3 - valley flashing

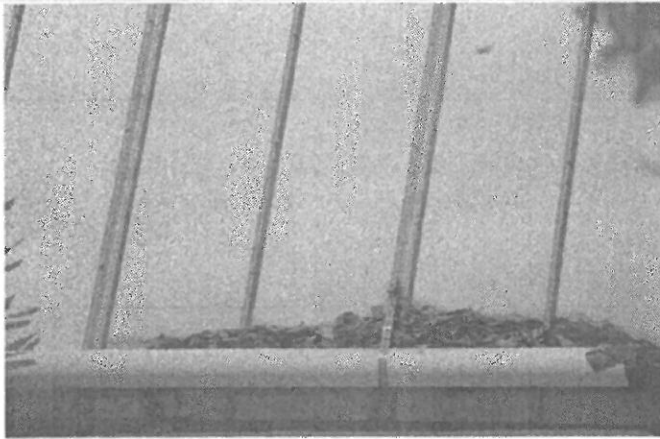
Unit #3 - Roof Covering - Metal

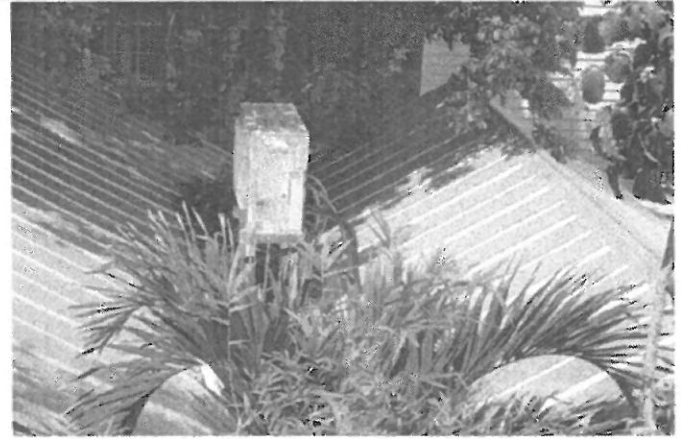
unit #3 - saw tooth gables w/ valley

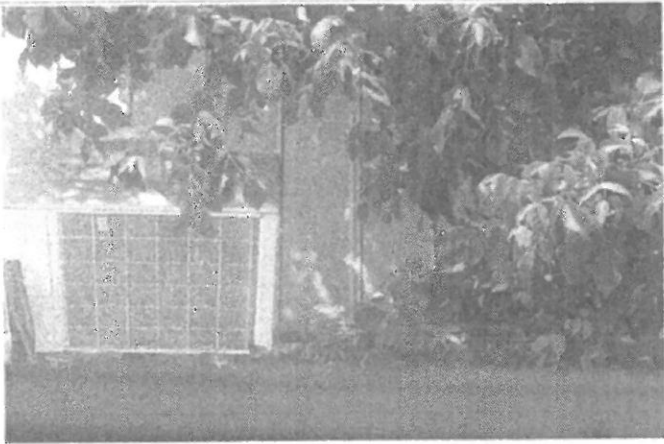
Ductless Mitsubishi system

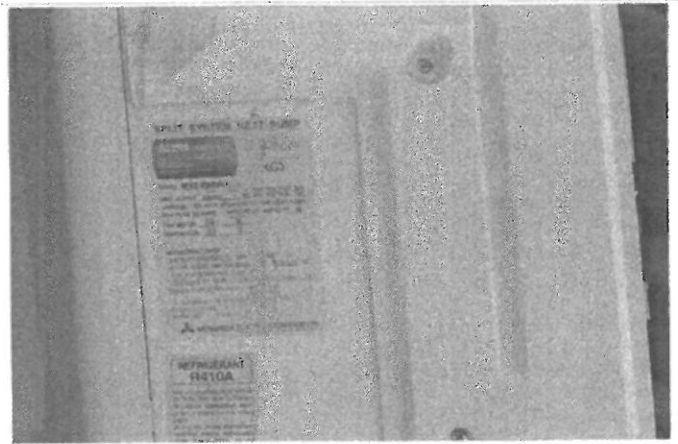
Data plate - 2010

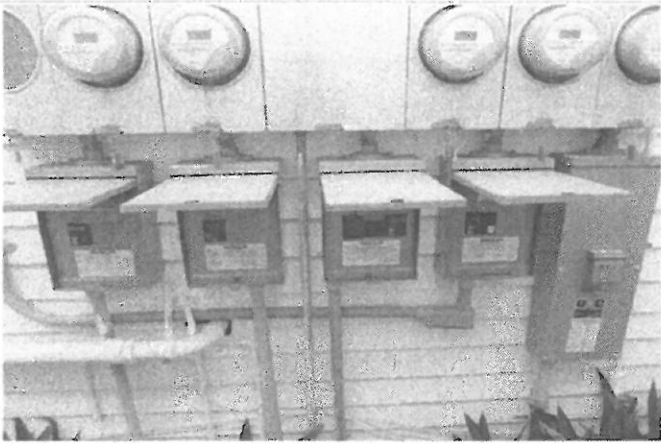
Meters & panels

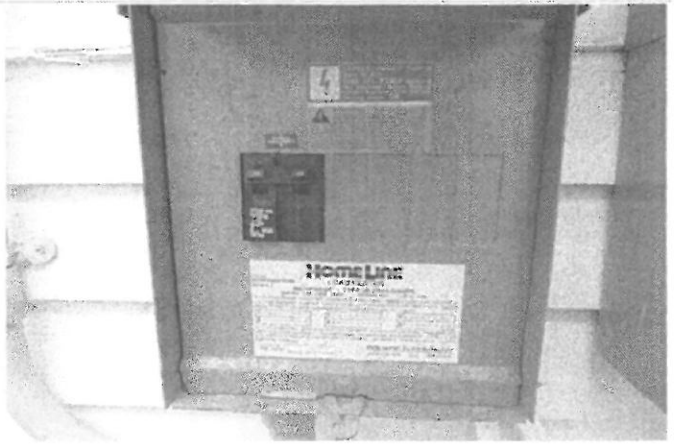
Disconnect -60 amp typical all units except #3

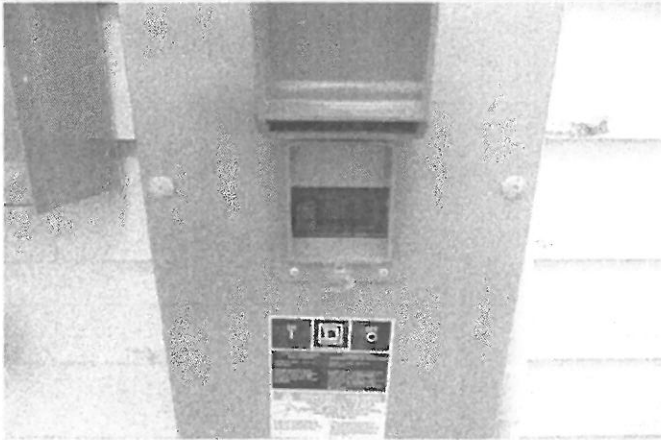
Disconnect 100 amp - Unit #3

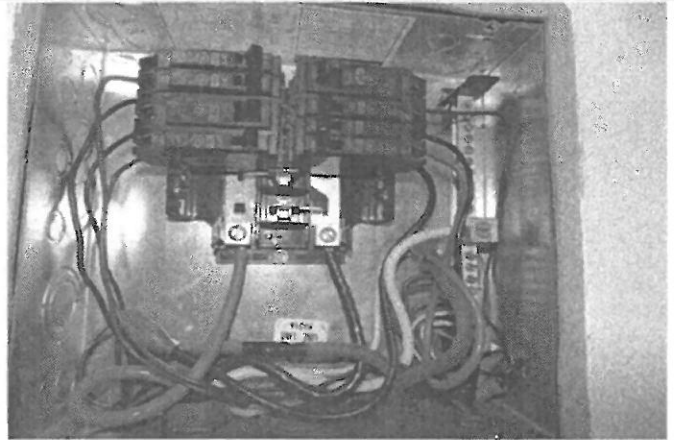
60 amp - Unit #1

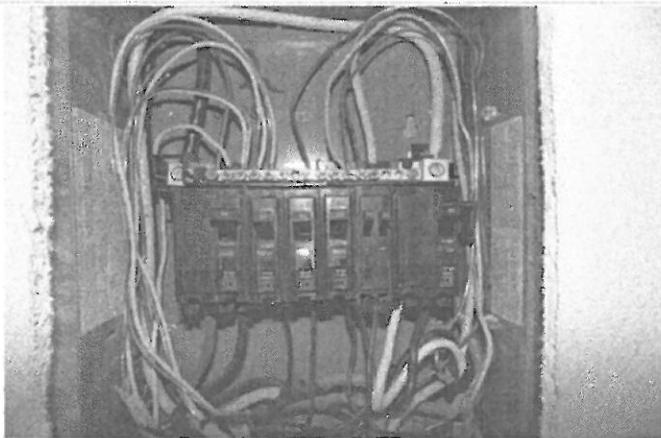
60 amp Unit #2

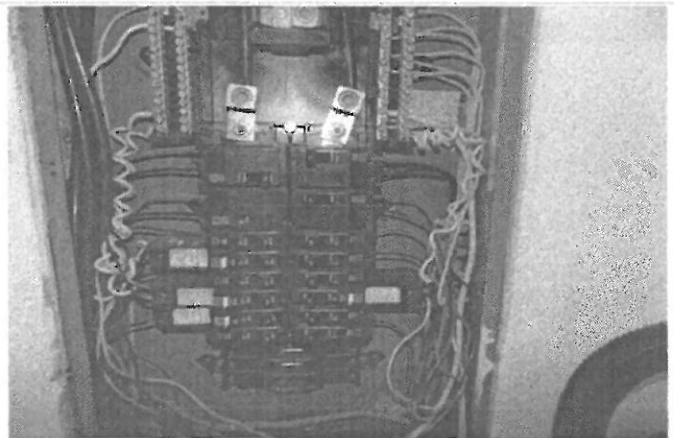
100 amp Unit #3

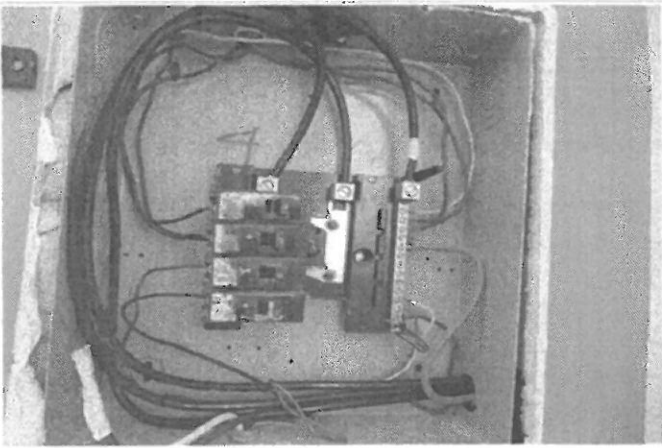
60 amp Unit #4

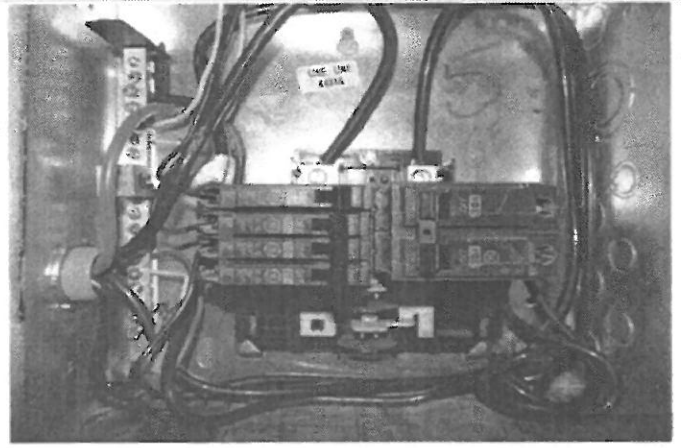
60 amp Unit #5

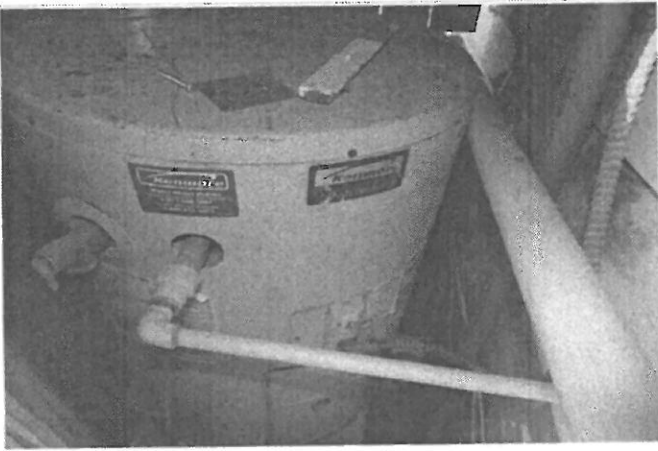
Unit 1- outside

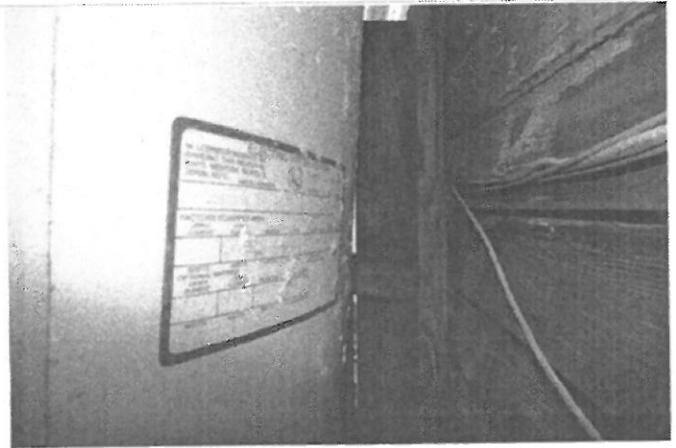
Unit 1 - Age - 2001- Capacity - 30 gal

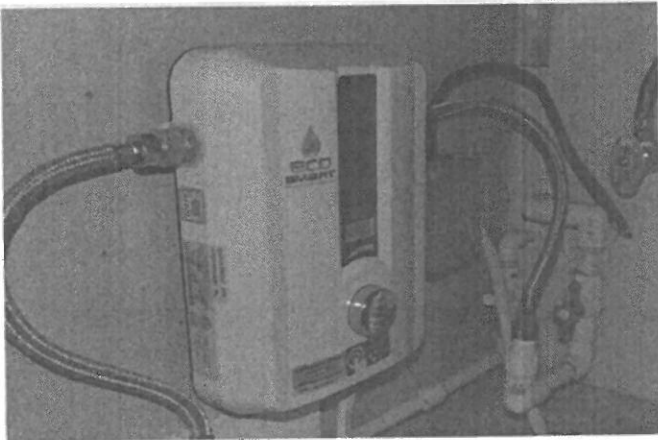
Unit 2 - 2010

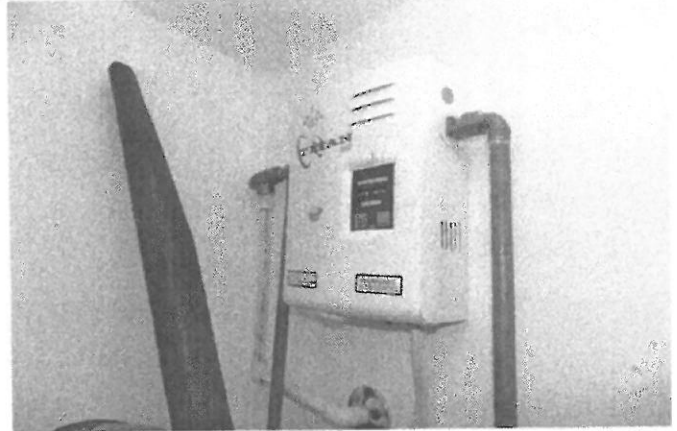
Unit 3- Age - 2010

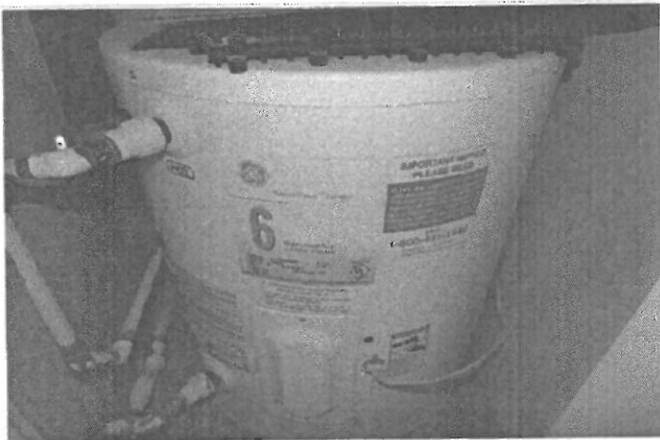
Unit 4- Age 1999 / Capacity - 19.9 gal

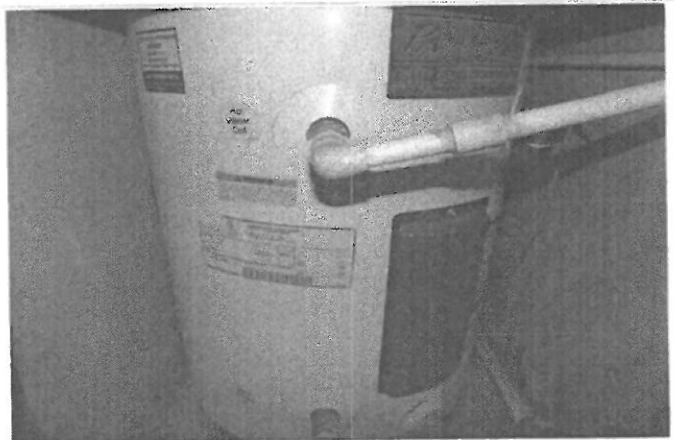
Unit 5 - Age - 2008 Capacity - 19.9 gal
