# Mallory Square Wharf Assessment

## Final Report

### Key West, Florida

June 17, 2025

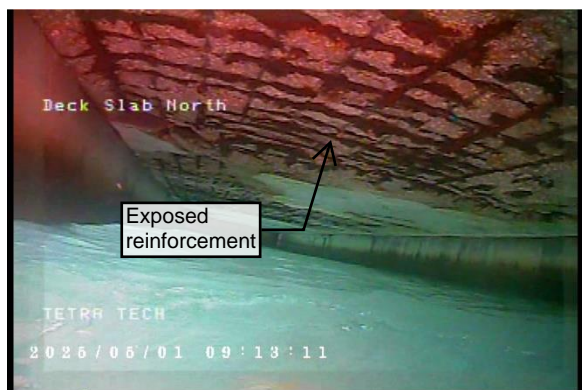
The deck slabs consist of a single layer of reinforcement. Spalled concrete was readily observed on the deck slabs, with most of the spalling occurring in Span 2. Spalling occurs when delaminated surface layers of concrete have broken off and exposed the underlying materials, resulting in section loss. The spalling of the deck slabs exposed the primary reinforcing and was observed to have rust staining. The traverse reinforcing (spanning north/south) was observed to have 100% section loss in some areas resulting in hanging reinforcing steel. The longitudinal reinforcing steel (spanning east/west) was observed to have about 35% section loss.

Figure 3 – Exposed reinforcing steel on underside of deck slab

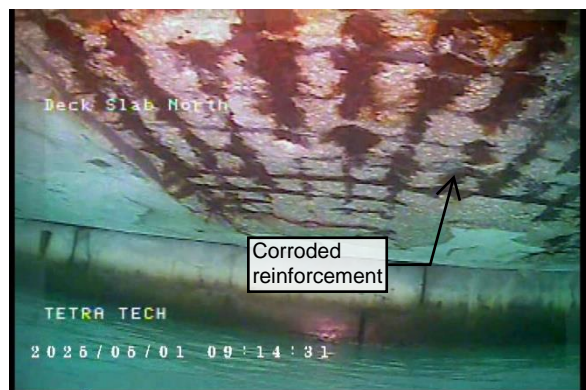
Figure 4 – Corrosion of exposed reinforcing steel

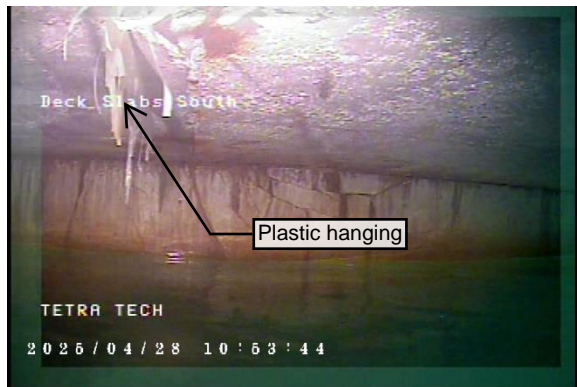
While observing the deck units a plastic material between the deck joints was noted, as seen in Figure 5. It was unclear what the plastic was, but it was present in several locations along both spans of the wharf.

*Figure 5 – Hanging plastic on underside decking*

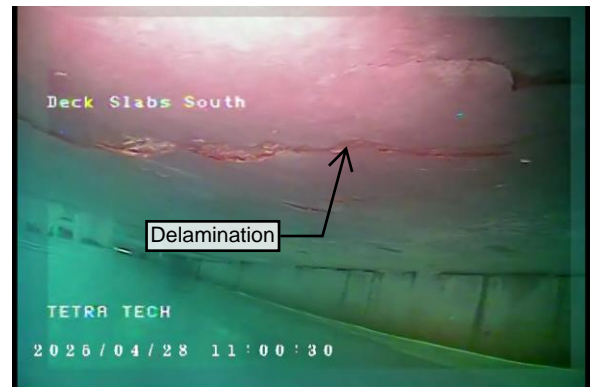
*Figure 6 – Delamination on underside decking*

Towards the middle of Span 1, delamination was observed across the entire span. Delamination was also observed near the south end of the wharf. Delamination is the mode of failure where the concrete fractures and creates an unbonded layer, which reduces the strength of the concrete member. This is often caused by the corrosion of the reinforcing steel. Longitudinal cracking was found in several concrete slabs in Span 2, which is located between Bent A and Bent B. About 95% of the concrete slabs in Span 2 and 70% in Span 1 were observed to have large spalling, delaminations, and are considered to be in poor condition. The remaining concrete slabs exhibited minor cracking and were observed to be in fair condition. Note, that though the remaining slabs were observed in fair condition, based on the performance of adjacent slab units it is likely that they have experienced similar levels of corrosion on the internal reinforcement but have not yet begun to visibly show signs of this deterioration.

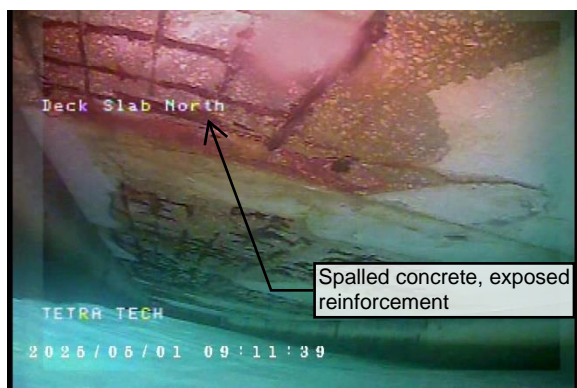
*Figure 7 – Exposed reinforcing steel*

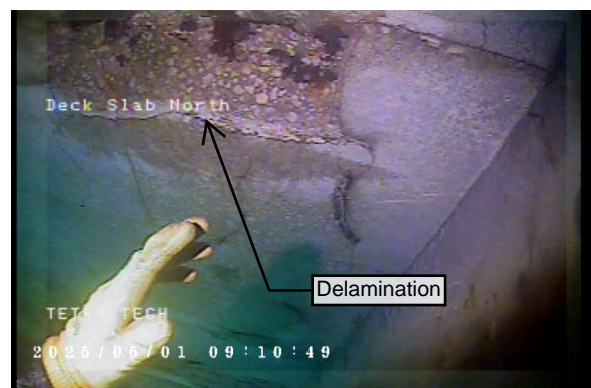
*Figure 8 – Delamination on underside*

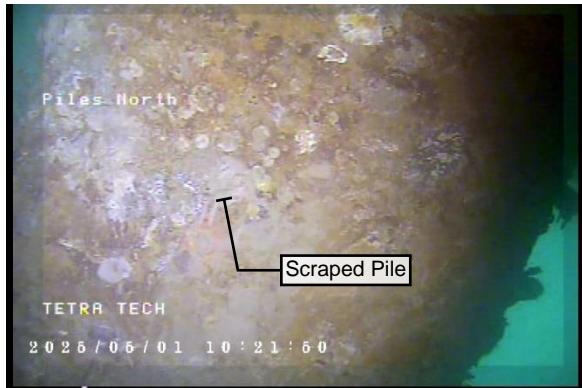
Figure 11 – Growth on pile cap

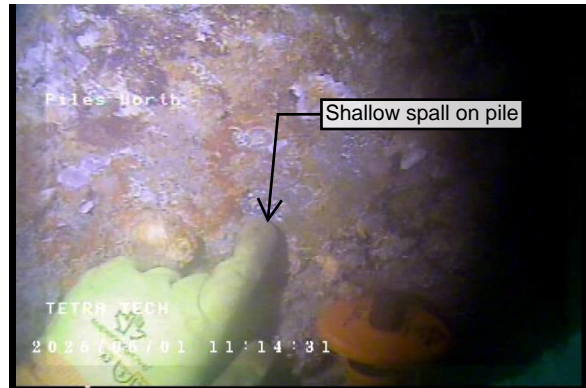
Figure 12 – Minor spall on pile cap

Minor shallow spalls were found on the surface of the concrete piles, and a couple of piles had minor spalling on the edges, but no major spalling was observed on the surface of the piles. Debris was found at the bottom of most piles, which mainly consisted of fallen concrete leaning against the pile surface.

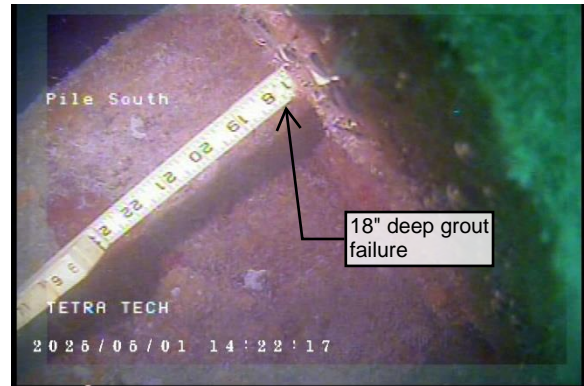
Figure 16 – Spall depth of grout

17% of the piles exhibited grout failures at the pile cap connection on the north end of the wharf. Grout failure was more prevalent on the South end of the wharf. About 50% of the piles inspected on the south end had signs of grout failure around the pile cap connection. The gaps found in the pile pockets due to deteriorated grout extended up to 18-inches deep, typically.

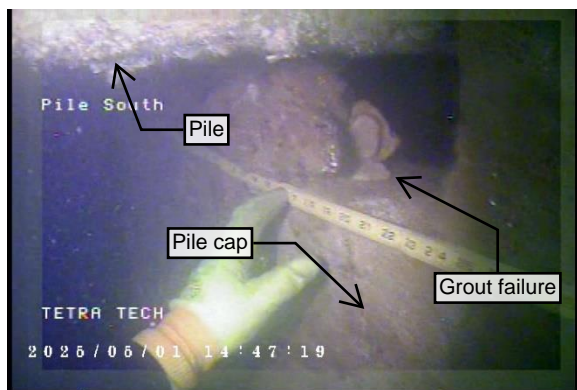
Figure 17 – Spall on underside of pile cap

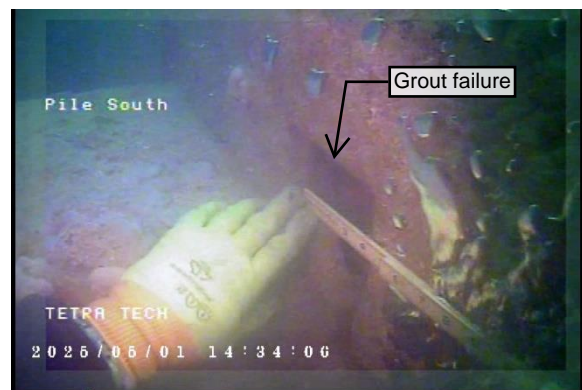
Figure 18 – Spall on underside of pile cap

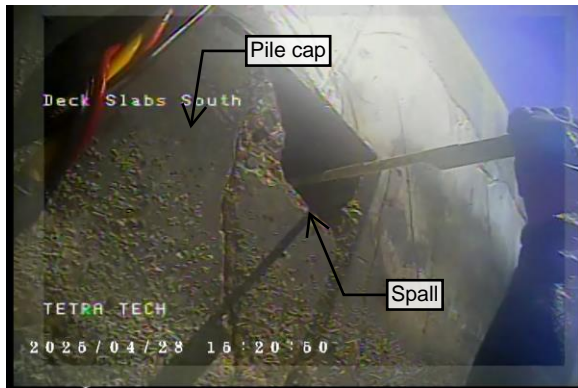
Rust stains were most present near the top of the joints between the pile caps. Rust staining is a discoloration on the concrete surface, caused by the corrosion of the reinforcing steel inside the concrete. There were instances of cracking with rust staining on the faces of the pile cap. Large spalling was also found along the pile caps most frequently at the joints between the pile caps. The cracking that occurred on the joints of the pile caps were often diagonal showing early signs of spalling with an instance of spalling occurring on the north joint between piles 5 and 6 on the west side face of Bent A as in Figure 17. The west face of Bent A pile cap exposed to the sun, was found to have larger spalls and cracking. The top face of the pile cap for Bent A was observed from the top side of the wharf and was found to have cracking along the span of the wharf indicating early signs of spalling similar to the joints.

Figure 19 – Large spall on pile cap to pile cap joint

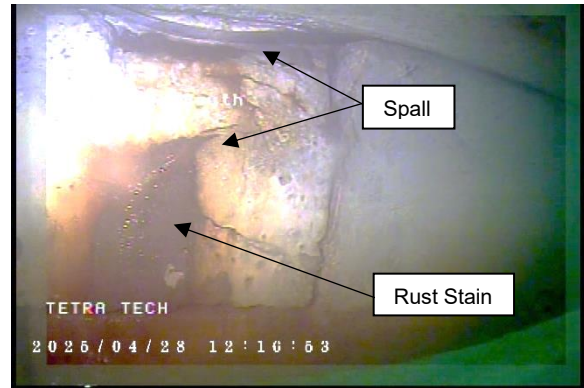
Figure 20 – Spall and rust staining of pile cap

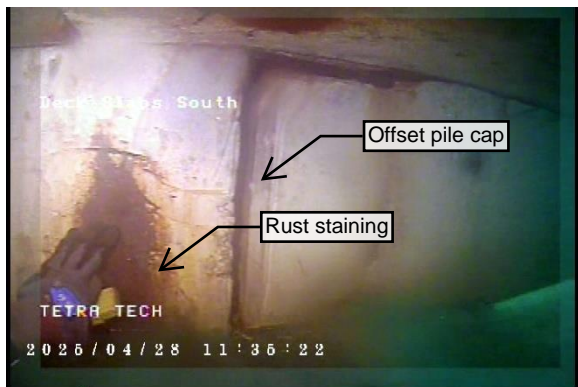
Grouted connections are present on all bents and there are signs of degradation of the grout pads throughout. In many of the joints, the grout pad had failed leading to separation in the north/south direction of the pile caps of up to four-inches in one instance as shown in Figure 21. In other instances, the grout was completely degraded making the other side of the cap visible.

Figure 21 – Rust and separation on joint

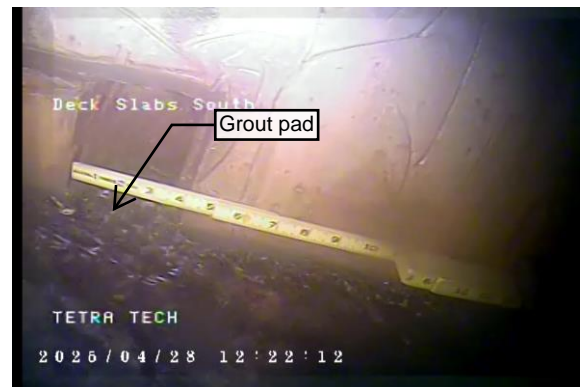
Figure 22 – Degradation of 1/2" grout pad on Bent B

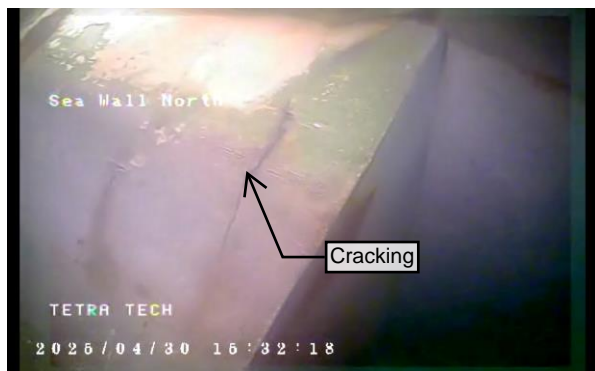
Figure 23 – Diagonal crack on Bent C

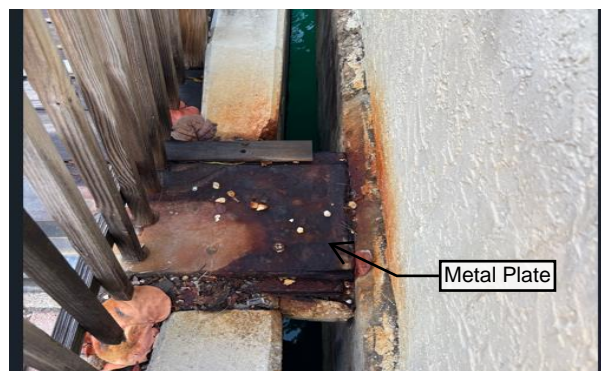
Figure 24 – Metal plate with rust stains.

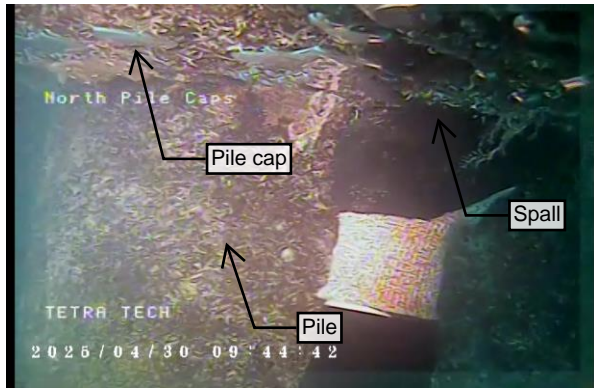
The pile cap around all the steel pipe piles was observed to have longitudinal cracking on the sides. Not all sides of the cap could be examined due to access limitations. Minor spalling at the corners was visible on the pile cap, with rust stains present on the sides. On the northwest dolphin there is a large spall with rust stains on the southwest corner above the water line. There is also cracking on this section which could lead to further deterioration.

Figure 27 – Pile to pile cap connection with hand in spall

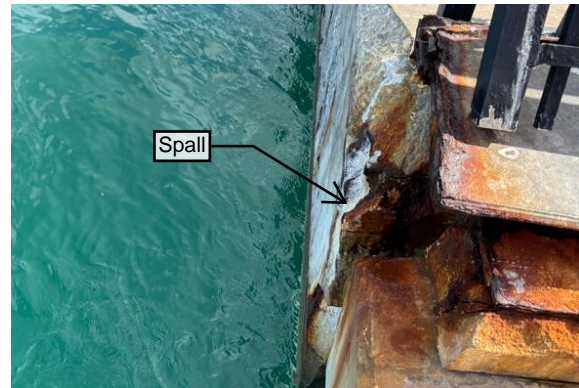
Figure 28 – Spall and rust stain on mooring dolphin

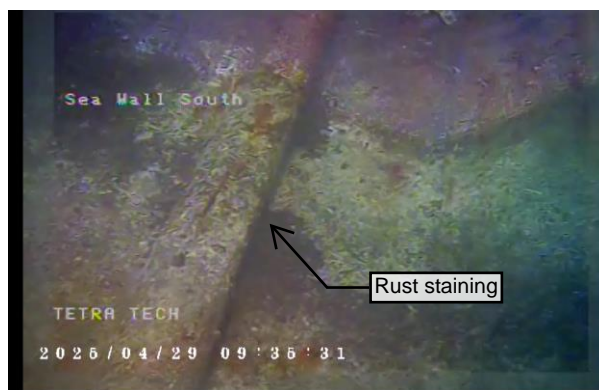
The sheet piles below the waterline showed little signs of degradation with marine growth covering most of the observable face. There were some instances where rust was present through the growth, but no cracking or section loss was observed. Within the splash zone the existing sheet piles exhibited significant corrosion with some instances of the sheet pile beginning to experience visible section loss of around 15%.

Figure 31 – Typical photo of sheet pile under water line

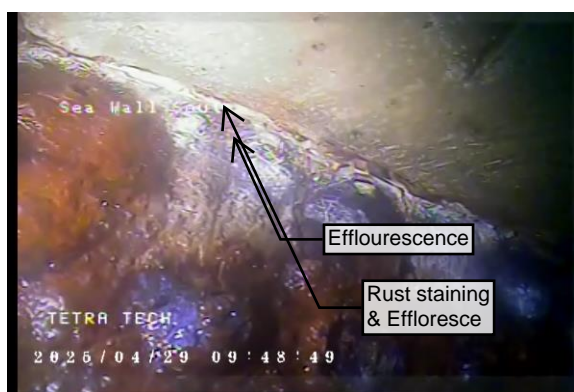
The corrosion of the sheet piles resulted in chloride buildup occurring at the connection between the sheet piles and the concrete cap, as shown in Figure 32 by the white discoloration. Efflorescence was also observed on the concrete cap along the 20-foot return on the south. Efflorescence is a deposit of chloride, usually white, formed on a concrete surface. The majority of the sheet piles were obstructed by riprap and other debris. Soil conditions behind the sheet piles and evidence of wall rotation or deformation could not be observed in areas of limited access and visibility. The areas with no obstructions showed no signs of wall rotation, deformation, or soil loss through the sheet wall.

Figure 32 – Sheet pile corrosion and efflorescence

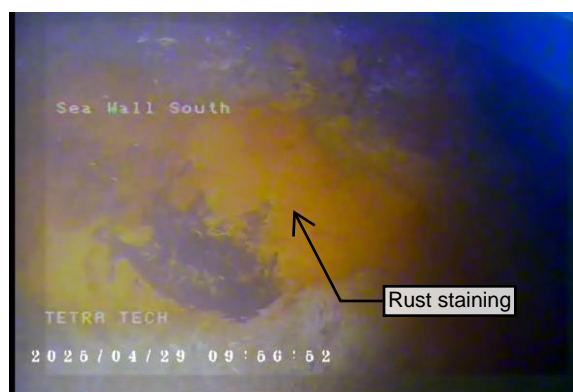
Figure 33 – Rust staining under water line

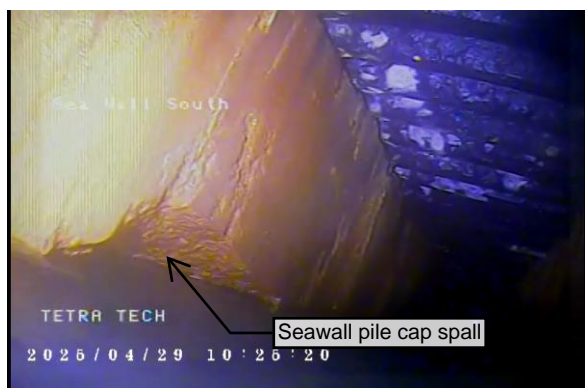
Only the west and bottom faces of the seawall pile cap were observable. The underside of the concrete cap outside the span of the wharf was in good condition, with only degradation due to corrosion from the sheet piles. Under the wharf, the bottom of the cap exhibited significant scaling and spalling. Scaling occurs when the surface of concrete begins to flake or peel away. As seen in Figures 34 and 35, large spalls occur on the underside face. Also, when looking at Figure 34, there is a metal sheet which was likely a stay in place form. This form on the top of the cap connects the sheet pile cap to Bent C. This galvanized corrugated metal sheet showed signs of corrosion leading to degradation of the cap. There was also spalling that occurred at the top edge of the concrete cap and the metal sheet.

Figure 34 – Spalling on bottom face of sheet pile cap

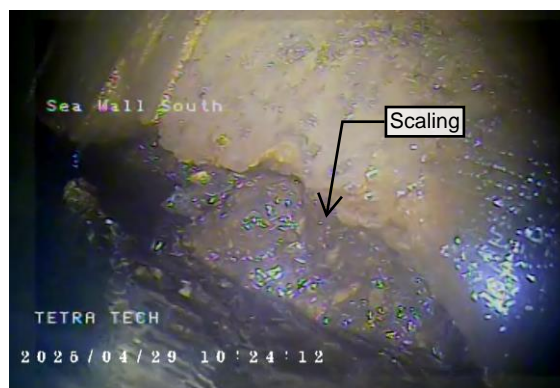
Figure 35 – Scaling on bottom face of sheet pile cap

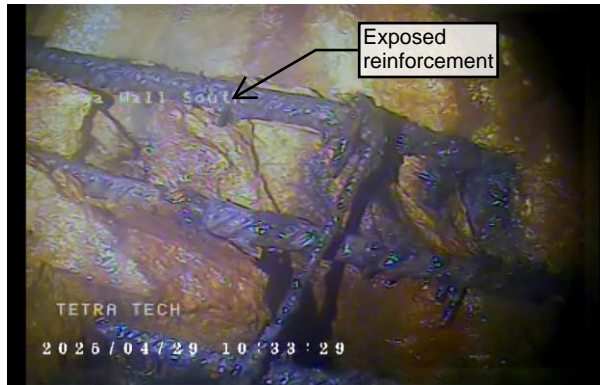
On the west side of the cap face there are instances of additional spalling. There was a section of major spalling located between Piles 8 and 9, measuring 56-inch long by 10-inch deep extending the full height of the cap. The reinforcing steel on the side of the pile cap was exposed and showed 100% surface corrosion on the horizontal and vertical reinforced steel. This resulted in a section loss of about 10% on both the vertical and horizontal reinforced steel. There were two more instances of exposed reinforcing steel on the pile cap, one instance on the bottom face and another along the west face. Both instances exhibited small spalling areas with corrosion on the exposed reinforcing steel.

Figure 37 –Exposed reinforcing steel on sheet pile cap.

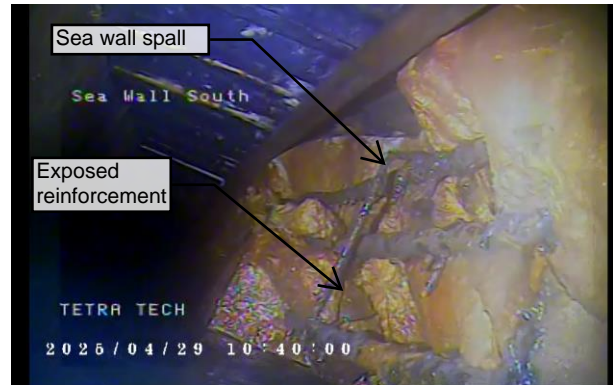
Figure 38 – Exposed reinforcing steel on sheet pile cap

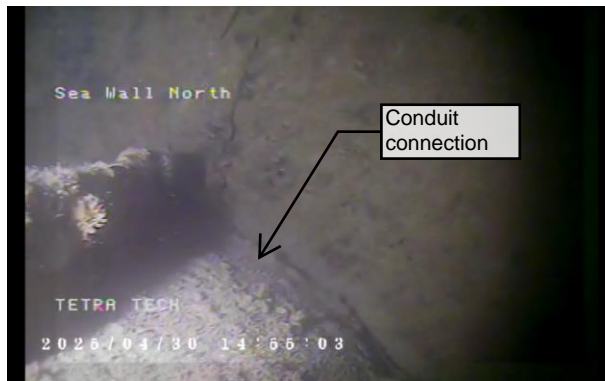
There is a pipe penetration through the northern end that runs about 70 feet to the middle of the Mallory Square parking lot. The penetration consisted of a metal casing housing a PVC pipe. The pipe looked to be in good condition. The connection between the conduit and the existing sheet piles was in good condition with no cracking or separation between the components present.

Figure 39 – Top of conduit connection

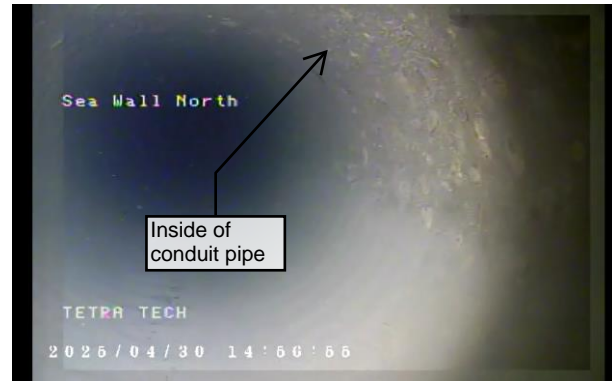
Figure 40 – Inside view of conduit pipe

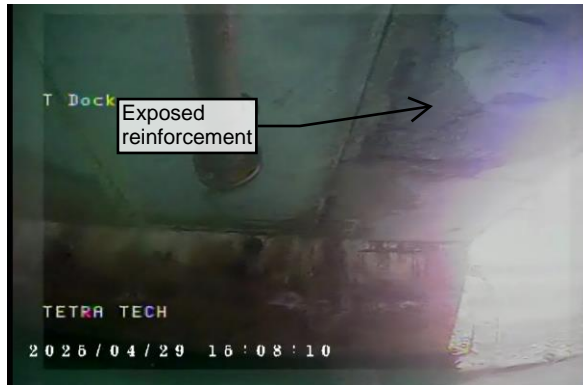
Overall, the components of the T-dock were in fair condition. The underside of the walkway had utilities running along the bottom of the concrete slabs. The bottom of the concrete slabs had large spalls and showed signs of delamination. On the existing walkway there was a spalled area which had exposed reinforcing steel along the north/south direction. The concrete piles appeared to have minor spalling along the corners. Rust staining were present along the concrete pile caps and longitudinal cracking. On the corners of the T-dock where the large cruise fenders are located, there were large cracks and spalling. Overall, the components of the T-dock were in fair condition.

Figure 42 – Exposed reinforced steel on decking

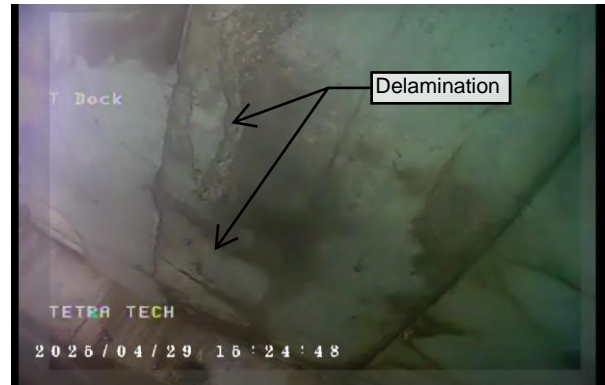
Figure 43 – Delamination on underside decking

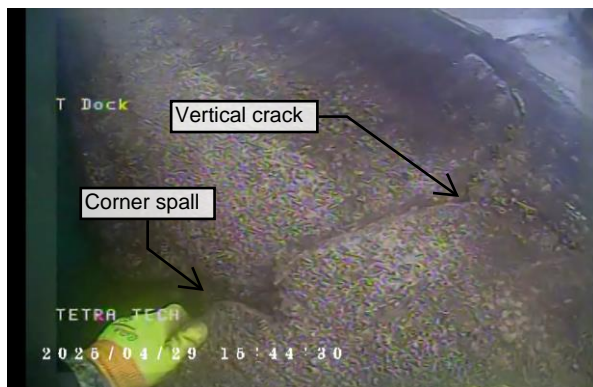
Figure 44 – Corner crack and spalling on T-Dock

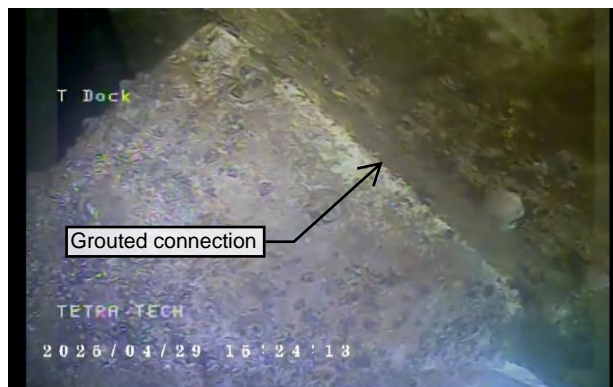
Figure 45 – Pile to pile cap connection

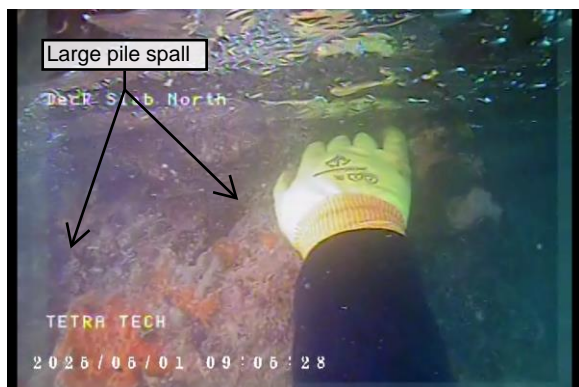
On the North dolphin, there was a large spall on the concrete pile located on the northwest corner. The spall on the pile spanned across the pile and had a depth of about eight-inches into the pile. There was no exposed rebar observed in the spall, but there was large marine growth impeding the view of the pile condition. The underside of the dolphin was found to have spalling and general erosion. The sides of the dolphin exhibited cracking above the water line, which could lead to spalling in the future.

Figure 49 – Large spall on pile of north dolphin

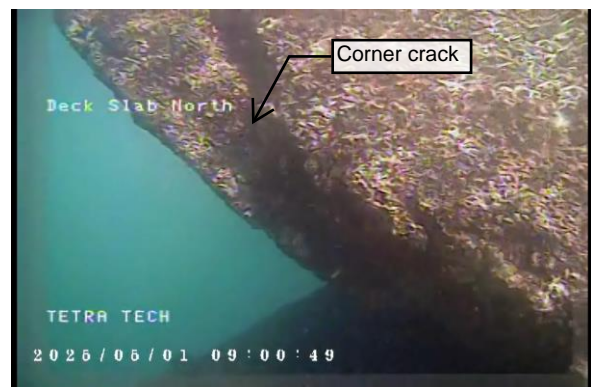
Figure 50 – Large crack on corner of dolphin pile cap

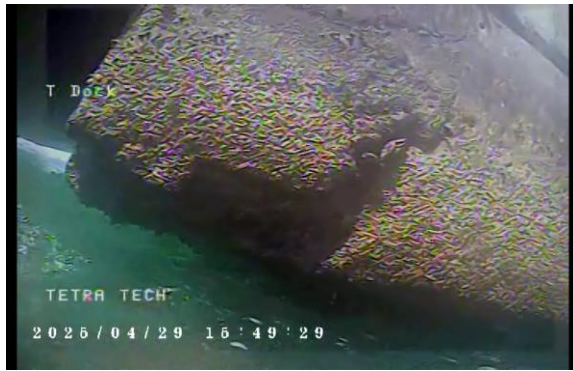
The dolphin adjacent to the T-dock on the south end has spalling and cracking on the corners of the pile cap. A protective fender is located on the west side of the dolphin and is attached to the pile cap with several anchor bolts. Cracking was observed at the location of these bolts. The concrete piles were observed to have minor rust staining, with most of the piles covered by marine growth.

Figure 51 – Spall on pile cap of south T-dock dolphin

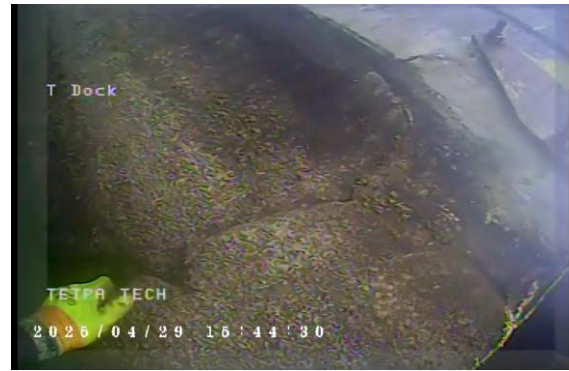
Figure 52 – Crack on corner of south T-dock dolphin

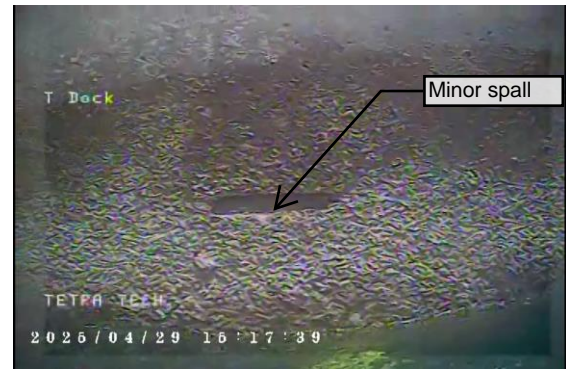
The north T-dock dolphin was found to be in good condition. There was minor spalling on the outside corner of the pile cap. The piles were observed to have minor rust staining through marine growth. No section loss of the steel pipe piles was observed. The pile caps were observed to have scaling in the splash zone.

Figure 54 – Minor spall and scaling on pile cap

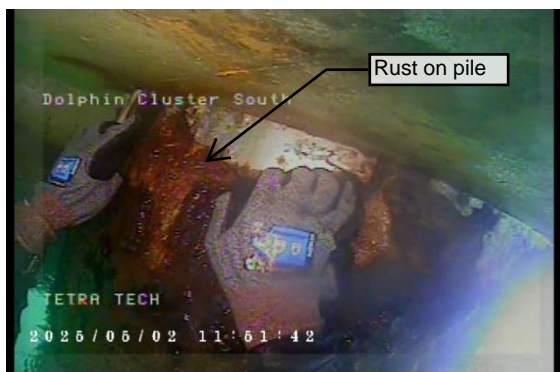
The south dolphin was observed to have delamination and spalling at the underside of the pile cap. There was no exposed reinforcement present. Large cracks and rust stains were visible on three sides of the pile cap. The steel piles were found to have rust staining along the outside surface through the marine growth. No section loss of the steel pipe piles was observed.

Figure 55 – Rust on pile of south dolphin

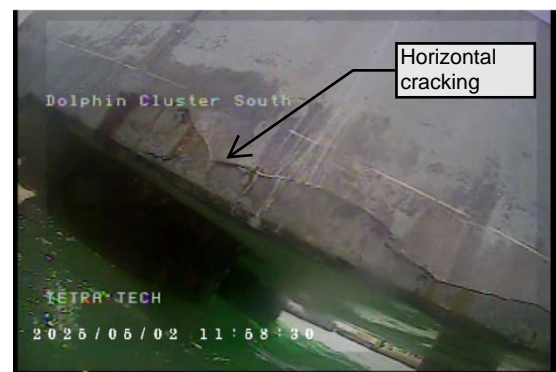
Figure 56 – Cracking on face of south dolphin
