# Structural Condition Assessment Key West Diesel Plant Key West, Florida

AES Project No. 316-048  
August 3, 2016

Re: Structural Condition Assessment  
Key West Diesel Plant  
Key West, Florida

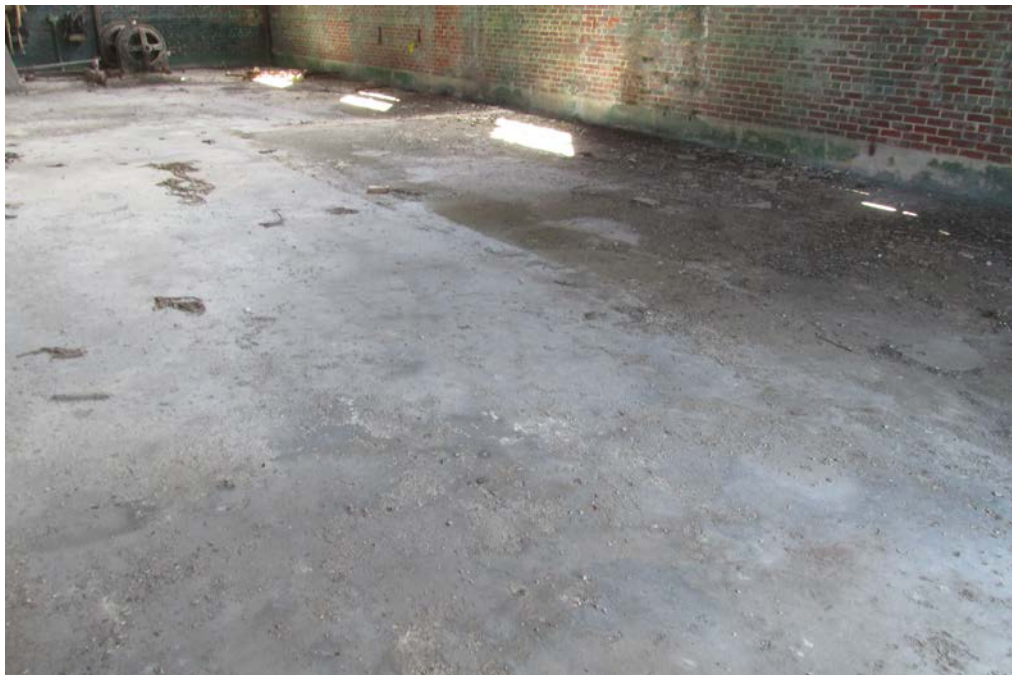
PHOTOGRAPH 14 (BUILDING I)

- I. The northernmost, eastern building (Building I) has been recently re-roofed and the original wood structure supported by the steel beams and trusses have been replaced with plywood sheathing and wood trusses. The new roofing and roof structure is in excellent condition except that the roofing screws are not stainless steel and are corroding (see Photograph 12). The original steel beams, trusses and columns are in good condition with surficial corrosion except for one (1) column, which has a badly corroded base with more than 20% material loss (see Photograph 13). The slab on grade is cracked and uneven and there is a large crack at the interior door to the adjacent building, and several of the western window sills are spalled with corroded reinforcing and the remainder are cracked (see Photographs 14, 15 and 16).

Building I is in good condition with the exterior masonry requiring repair and several window lintels requiring replacement. The steel structure is in good condition with surficial corrosion except for one (1) column that needs reinforcement due to excessive corrosion at its base. All of the steel needs to be cleaned of corrosion and coated with a corrosion inhibiting coating. The slab on grade is cracked and uneven and is due for replacement. The exterior masonry requires repointing and all of the corroded embedments and steel lintels need to be cleaned of corrosion and coated with a corrosion inhibiting coating. The deteriorated face brick needs to be removed and replaced and the vegetation in the wall cracks needs to be removed and the cracks repointed. At the western return metal panel wall, the badly corroded angle purlin needs replacement as well as the wall metal panels. The concrete spall in this wall also requires repair.

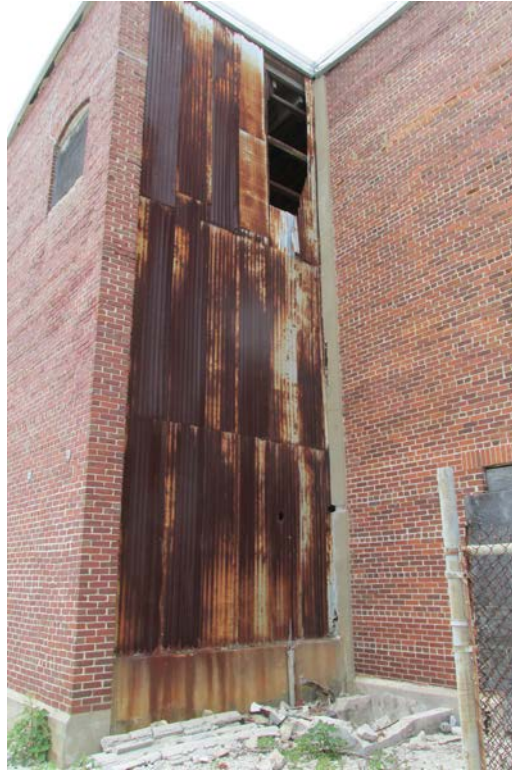
PHOTOGRAPH 27 (BUILDING I)

The exterior masonry walls are in good condition but there are numerous cracks, corroded embedments, deteriorated mortar, corroded lintels, deteriorated face brick, brick cracks with vegetation and random cracks in the concrete water table (see Photographs 17, 18, 19, 20, 21, 22 and 23). At the western return metal panel wall, there is a badly corroded angle purlin and a large column spall with corroded reinforcing and an area of missing metal wall panel (see Photographs 24, 25 and 26). The remaining metal panels are corroded and in poor condition (see Photograph 27).
