December 5, 2023

Re: Martin Luther King Pool-Structural Shoring Inspection 12/5/2023
304 Catherine Street

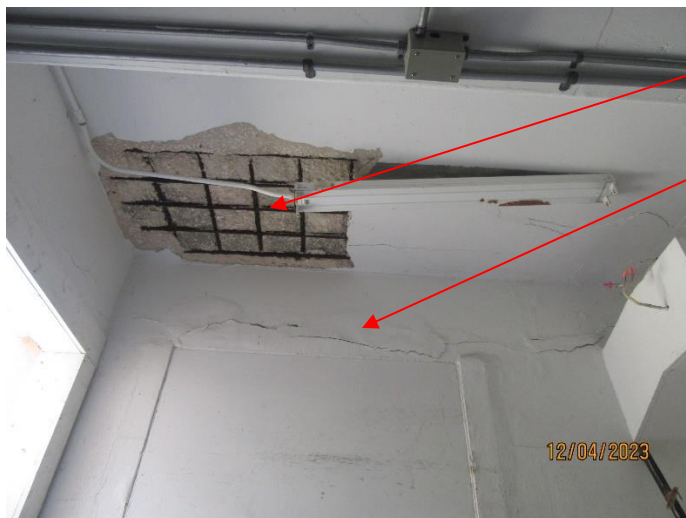
Underneath Lifeguard Station

As part of that review of the scope we discovered additional areas of spalling in addition to what was reported in the 11/16/2023 report. Most notably was the ceiling and floor of the life guard station near the elevator. A large section of the ceiling slab concrete had fallen away exposing the deteriorated reinforcing steel.

Exposed rebar under floor of
life guard station.
Cracking tie beam

The Lifeguards were advised to immediately restrict access to this area.

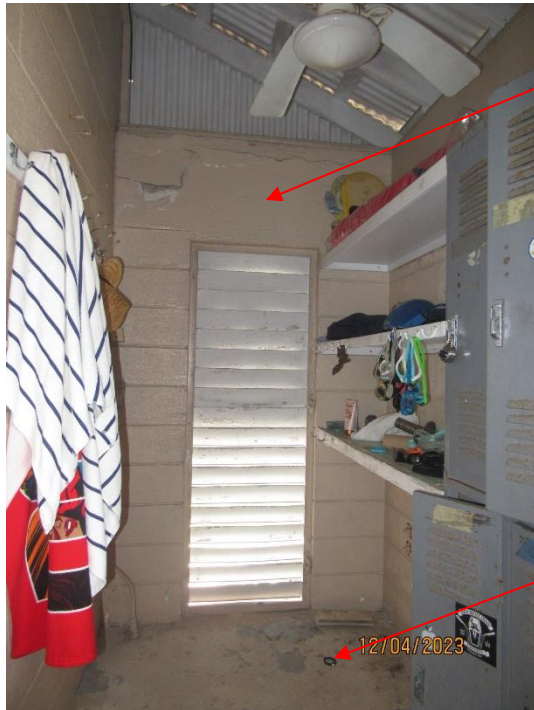
Lifeguard Station

Cracked and spalling concrete in lifeguard station.

Top of floor shown in previous picture.

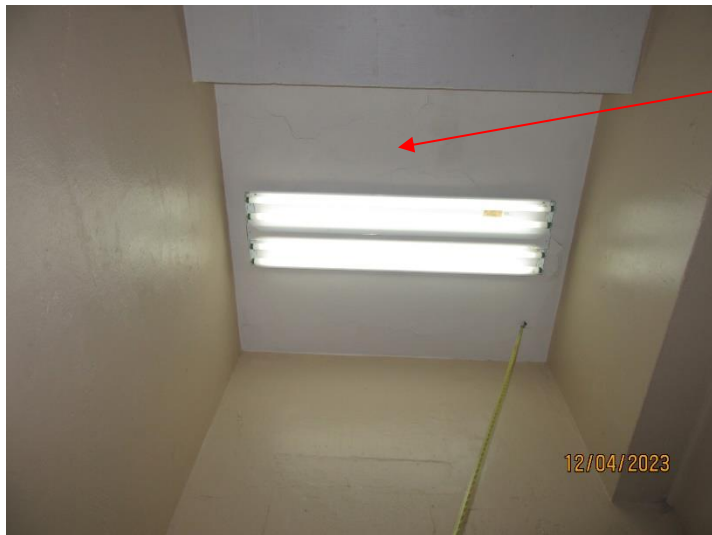
Top of stairwell

The ceiling at the top of the stairwell leading to the pool is cracked with delaminating concrete
