RESOLUTION NO. 18-088

A RESOLUTION OF THE CITY COMMISSION OF THE CITY OF KEY WEST, FLORIDA, REQUESTING THAT THE HISTORIC ARCHITECTURAL REVIEW COMMISSION (HARC) REVIEW THE DETERMINATION OF THE CHIEF BUILDING OFFICIAL REGARDING THE DEMOLITION OF CERTAIN STRUCTURES AT THE HISTORIC DIESEL ENERGY PLANT AT 100 ANGELA STREET/GERALDINE STREET, AND MAKE RECOMMENDATIONS TO THE CITY COMMISSION; PROVIDING FOR AN EFFECTIVE DATE

# Structural Condition Assessment Key West Diesel Plant Key West, Florida

Re: Structural Condition Assessment  
Key West Diesel Plant  
Key West, Florida

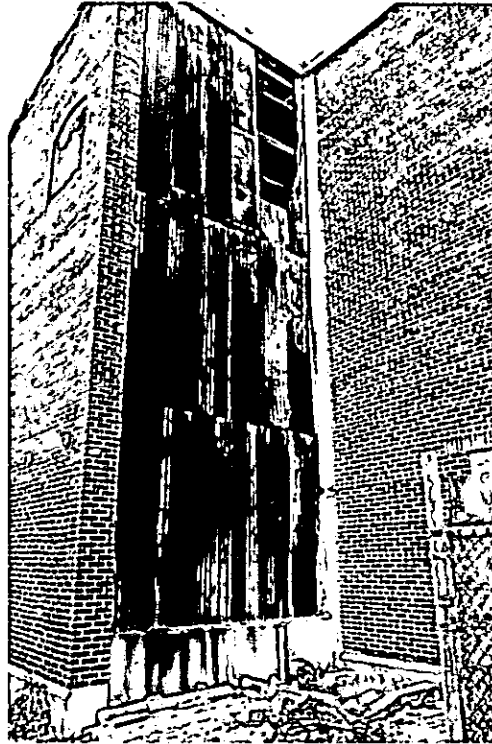
PHOTOGRAPH 27 (BUILDING I)

The exterior masonry walls are in good condition but there are numerous cracks, corroded embedments, deteriorated mortar, corroded lintels, deteriorated face brick, brick cracks with vegetation and random cracks in the concrete water table (see Photographs 17, 18, 19, 20, 21, 22 and 23). At the western return metal panel wall, there is a badly corroded angle purlin and a large column spall with corroded reinforcing and an area of missing metal wall panel (see Photographs 24, 25 and 26). The remaining metal panels are corroded and in poor condition (see Photograph 27).

Building I is in good condition with the exterior masonry requiring repair and several window lintels requiring replacement. The steel structure is in good condition with surficial corrosion except for one (1) column that needs reinforcement due to excessive corrosion at its base. All of the steel needs to be cleaned of corrosion and coated with a corrosion inhibiting coating. The slab on grade is cracked and uneven and is due for replacement. The exterior masonry requires repointing and all of the corroded embedments and steel lintels need to be cleaned of corrosion and coated with a corrosion inhibiting coating. The deteriorated face brick needs to be removed and replaced and the vegetation in the wall cracks needs to be removed and the cracks repointed. At the western return metal panel wall, the badly corroded angle purlin needs replacement as well as the wall metal panels. The concrete spall in this wall also requires repair.

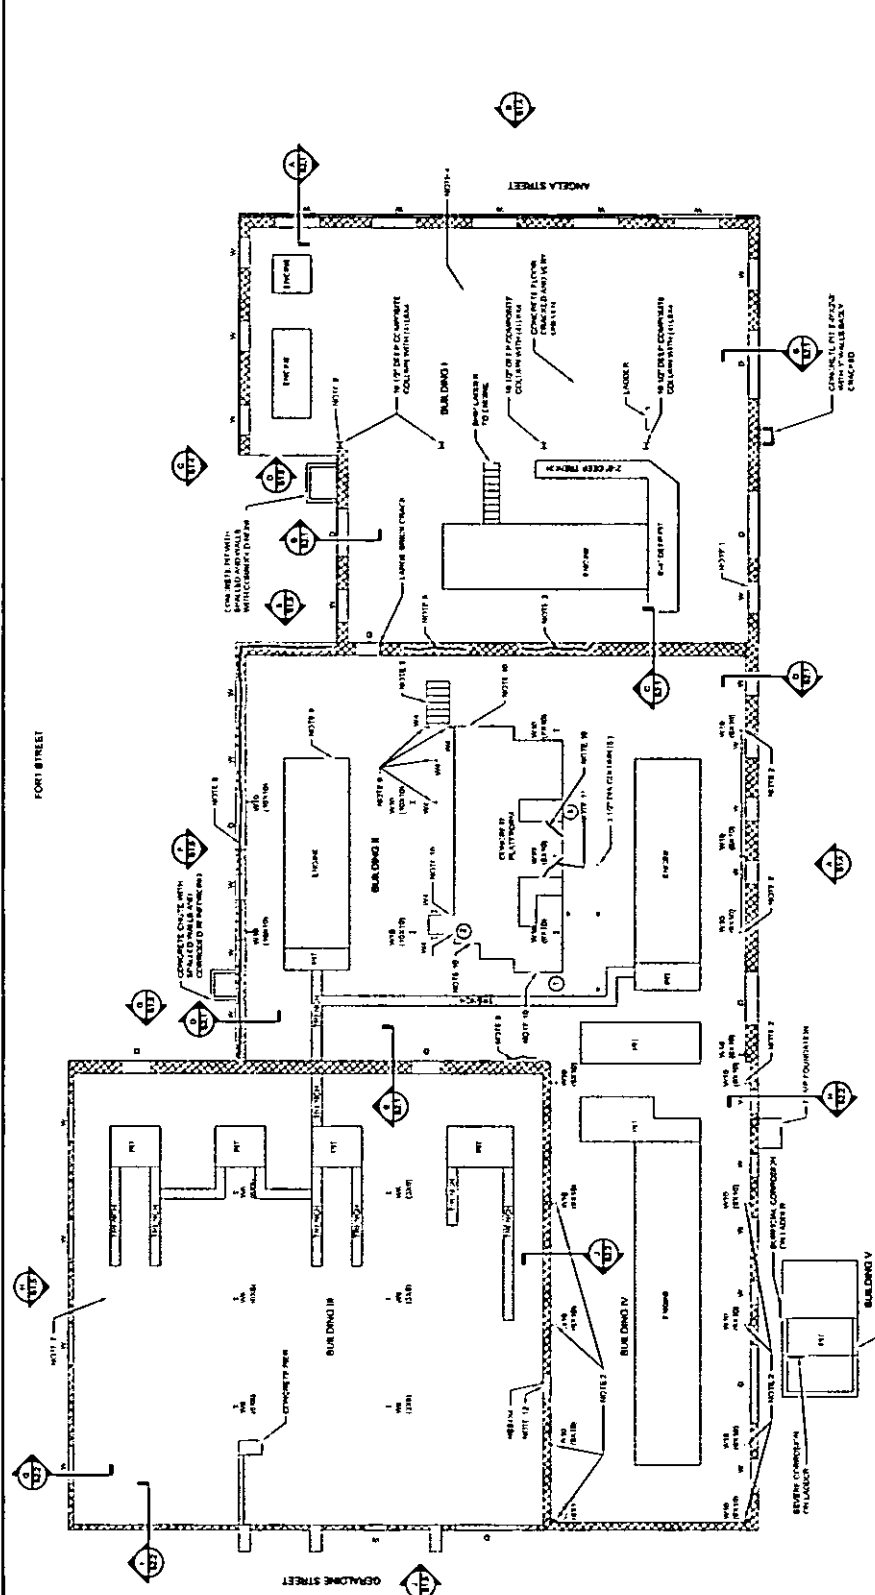
S1.1

- REMARKS:
1. DETERMINED FACE OF BRICK.
  2. EXISTING CONCRETE COLUMN BUILT AND ON COLUMN.
  3. CRACKS IN BRICK AT WALL FOR TRENCH AND CEMENT CONCRETE.
  4. CONCRETE FLOOR CRACKED AND UNIFORM.
  5. EXISTING CONCRETE TANK STRUCTURE AT BASE OF STAIR.
  6. TRENCH AND EXISTING WALLS CRACKED.
  7. CONCRETE FLOOR CRACKED AND UNIFORM - TRENCH AND EXISTING WALLS ARE CRACKED.
  8. DETERMINED EXISTING JOINTS.
  9. EXISTING CONCRETE POST BUILT.
  10. LARGE WALL WITH EXISTING CONCRETE REINFORCING.
  11. EXISTING CRACKS AT CONCRETE BUILT.
  12. EXISTING DETERMINED BRICK AT WALL CRACKS.
  13. SURVEY CRACKS ON ALL STRUCTURAL STEEL.
  14. CONCRETE AND CRACKS TEST.

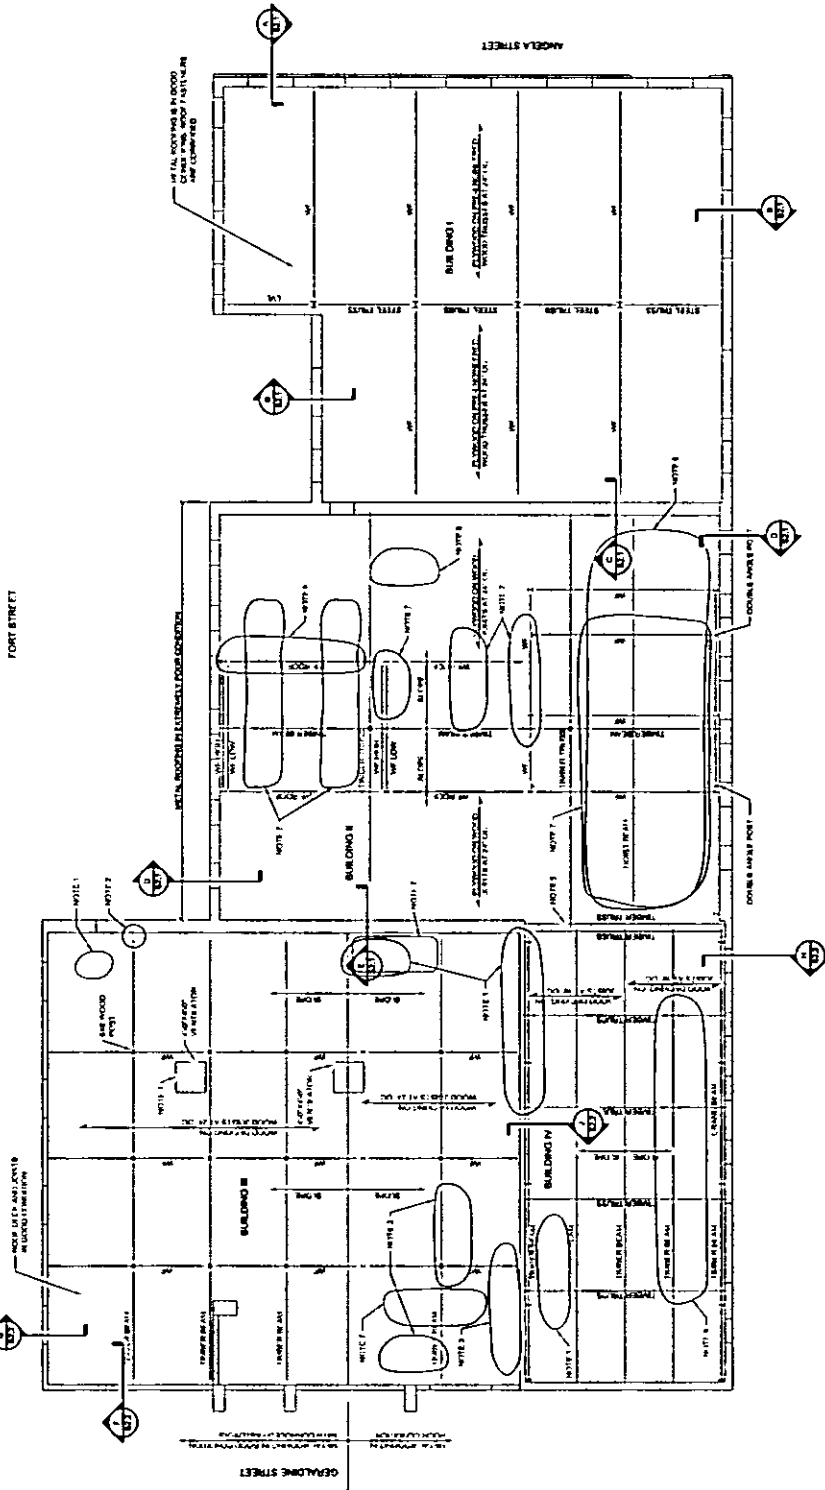
S1.3

1. CORROSION RESISTANT METAL ROOFING
2. DETERIORATED BRICK VENTILATORS
3. SALLY DRAIN REPAIRS ON EXISTING ROOF DECK
4. DETERIORATED ROOF BRACKETS
5. SALLY DRAIN REPAIRS ON EXISTING ROOF DECK
6. DETERIORATED ROOF BRACKETS
7. AREA OF EXISTING METAL ROOFING
8. SURFICAL CORROSION ON ALL STRUCTURAL STEEL
9. SALLY DRAIN REPAIRS AND REPAIRS TO ROOF DECK, JOISTS AND METAL DECK
