# Structural Condition Assessment Key West Diesel Plant Key West, Florida

AES Project No. 316-048  
August 3, 2016

Re: Structural Condition Assessment  
Key West Diesel Plant  
Key West, Florida

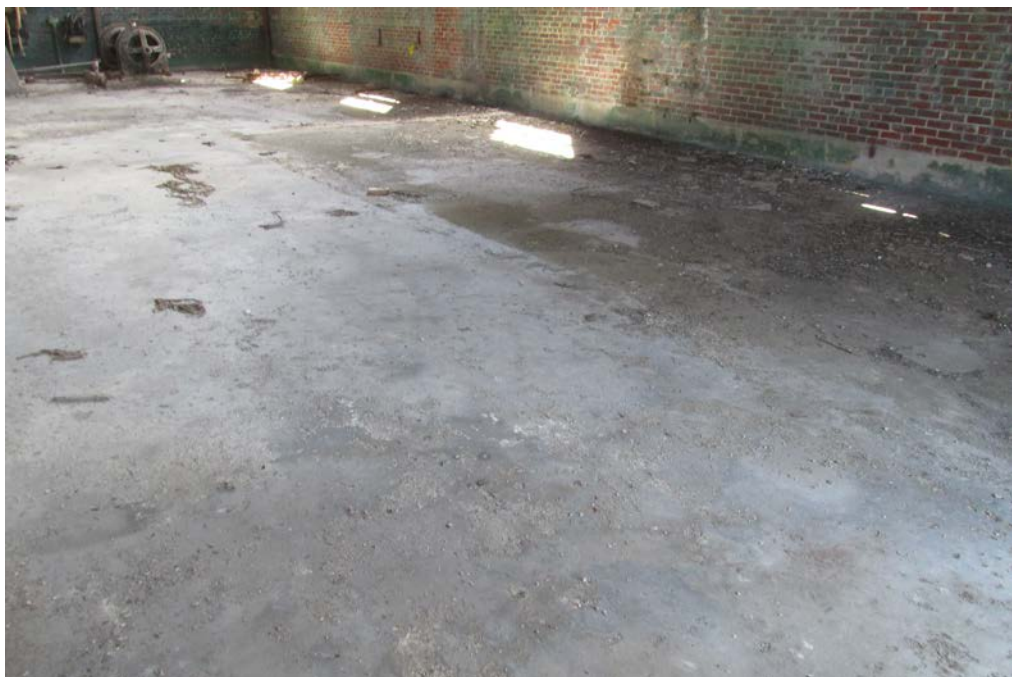
**PHOTOGRAPH 14 (BUILDING I)**

- I. The northernmost, eastern building (Building I) has been recently re-roofed and the original wood structure supported by the steel beams and trusses have been replaced with plywood sheathing and wood trusses. The new roofing and roof structure is in excellent condition except that the roofing screws are not stainless steel and are corroding (see Photograph 12). The original steel beams, trusses and columns are in good condition with surficial corrosion except for one (1) column, which has a badly corroded base with more than 20% material loss (see Photograph 13). The slab on grade is cracked and uneven and there is a large crack at the interior door to the adjacent building, and several of the western window sills are spalled with corroded reinforcing and the remainder are cracked (see Photographs 14, 15 and 16).

Building I is in good condition with the exterior masonry requiring repair and several window lintels requiring replacement. The steel structure is in good condition with surficial corrosion except for one (1) column that needs reinforcement due to excessive corrosion at its base. All of the steel needs to be cleaned of corrosion and coated with a corrosion inhibiting coating. The slab on grade is cracked and uneven and is due for replacement. The exterior masonry requires repointing and all of the corroded embedments and steel lintels need to be cleaned of corrosion and coated with a corrosion inhibiting coating. The deteriorated face brick needs to be removed and replaced and the vegetation in the wall cracks needs to be removed and the cracks repointed. At the western return metal panel wall, the badly corroded angle purlin needs replacement as well as the wall metal panels. The concrete spall in this wall also requires repair.

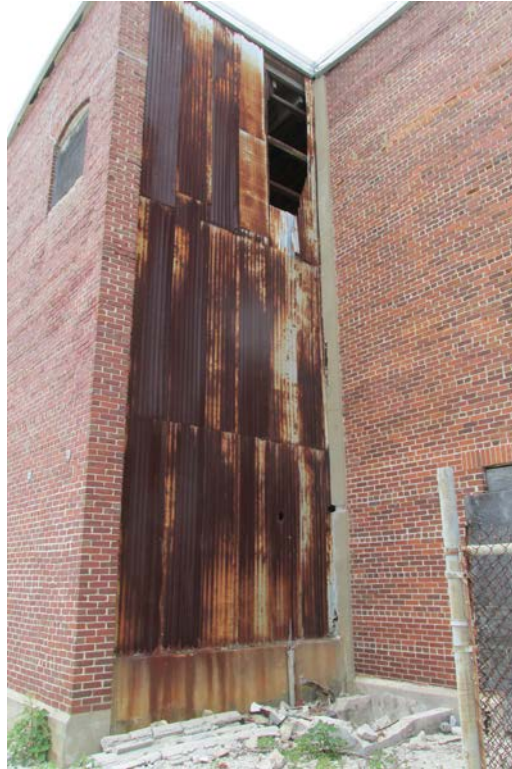
**PHOTOGRAPH 27 (BUILDING I)**

The exterior masonry walls are in good condition but there are numerous cracks, corroded embedments, deteriorated mortar, corroded lintels, deteriorated face brick, brick cracks with vegetation and random cracks in the concrete water table (see Photographs 17, 18, 19, 20, 21, 22 and 23). At the western return metal panel wall, there is a badly corroded angle purlin and a large column spall with corroded reinforcing and an area of missing metal wall panel (see Photographs 24, 25 and 26). The remaining metal panels are corroded and in poor condition (see Photograph 27).

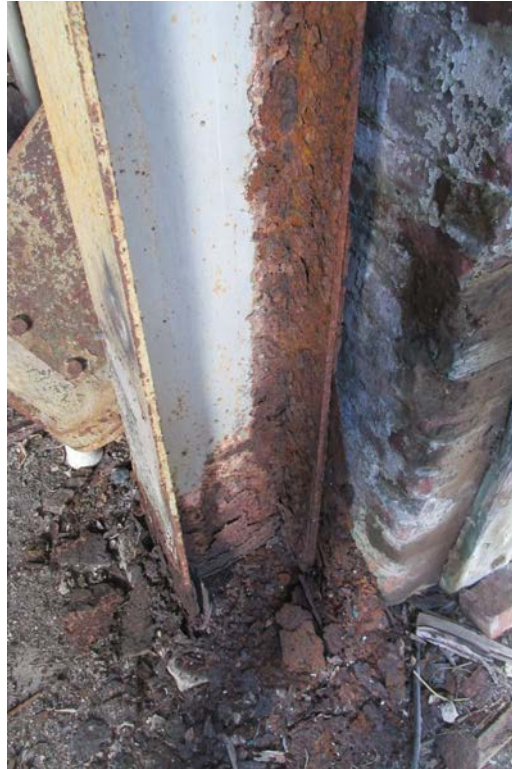
**PHOTOGRAPH 29 (BUILDING II)**

- II. The eastern center building (Building II) is in much worse condition than the Building I with metal roofing in extremely poor condition with large areas of missing metal roofing and large areas of deteriorated roof decking (see Photograph 28). The roof wood structure is in good condition as well as the steel structure with surficial corrosion except for several badly corroded columns and post bases with more than 20% material loss (see Photographs 29 and 30).

The remainder of the buildings are in worse condition than Building I with Building IV being in the worst condition with a portion of missing roof. These buildings are stable but require new roofs with extensive roof sheathing replacement and some wood structure reinforcement and replacement. At the areas of missing and badly deteriorated roofing, these roofs could sustain significant damage in a severe wind event losing the remainder of their roofing and sheathing. In general, the steel structure is in good condition with surficial corrosion but several columns will need reinforcement due to excessive corrosion at their bases. All of the steel needs to be cleaned of corrosion and coated with a corrosion inhibiting coating. At Building IV, the wall opening with numerous loose and missing bricks and falling bricks needs to be shored or repaired immediately to prevent further deterioration of the wall. The exterior masonry walls are in good condition except for the northwest corner of Building II where there is a large area of missing brick that needs to be rebuilt. The remaining walls need to be repointed, deteriorated face brick removed and replaced and the vegetation in the wall cracks removed and the cracks repointed. Like Building I, all of the corroded embedments and steel lintels need to be cleaned of corrosion and coated with a corrosion inhibiting coating. In many of the arched brick openings, brick has been infilled with no lintel installed. This infill brick is being held in place by the mortar alone and in areas is cracking. This infill brick needs to be removed or steel lintels installed to support it. At Building II, the concrete platform is in poor condition with large spalls and the concrete carbonated to the reinforcing with the concrete containing high levels of chlorides. If it is the owner's desire to rehabilitate this platform when the concrete is repaired, it should be treated with a penetrating corrosion inhibitor or an active cathodic protection system installed. Due to the thickness of the platform walls, both will be expensive, therefore strong consideration should be taken for demolishing this platform. The exterior concrete walls and pits, except for Building V, are in poor condition requiring extensive repair. Like the Building II concrete platform, the concrete contains high levels of chlorides and once repaired, the walls should be treated with a penetrating corrosion inhibitor or an active cathodic protection system installed, and the exterior concrete coated with a penetrating sealer. The exterior pits and chutes are abandoned and should be cleaned of debris, the top of the deteriorated walls demolished to 8" below grade and filled with clean fill or stone. All of the interior trench and pit edge angles are in poor condition and badly corroded. All of the dynamo pits are full of water and breeding mosquitos. When the deteriorated dynamos are removed, the pits need to be pumped empty of water. The pits and trenches need to be dewatered, cleared of debris with the edge angles removed, and the pits and trenches filled with clean fill or stone with a concrete slab on grade placed, drilled and adhesived into the pit and trench walls level with the surrounding concrete slabs on grade. If any of the dynamos are kept for display, their pits should be pumped empty of water and filled and capped as described above.

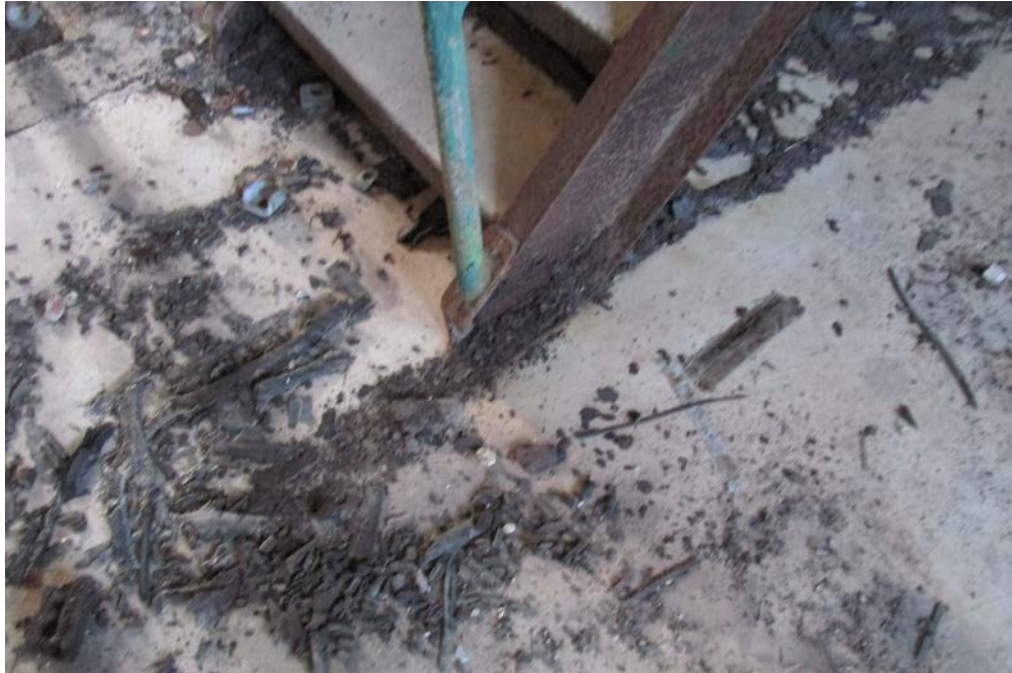
**PHOTOGRAPH 31 (BUILDING II)**

The stair to the concrete platform has badly corroded stair stringer bases with more than 20% material loss and the concrete platform has extensive large concrete spalls with exposed corroding reinforcing (see Photographs 31, 32 and 33). The exterior masonry walls are in good condition, but there are numerous cracks, corroded embedments, deteriorated mortar, deteriorated face brick, infilled arch brick with no lintel, large areas of missing brick, corroding lintels and brick cracks with vegetation (see Photographs 34, 35, 36, 37, 38 and 39).

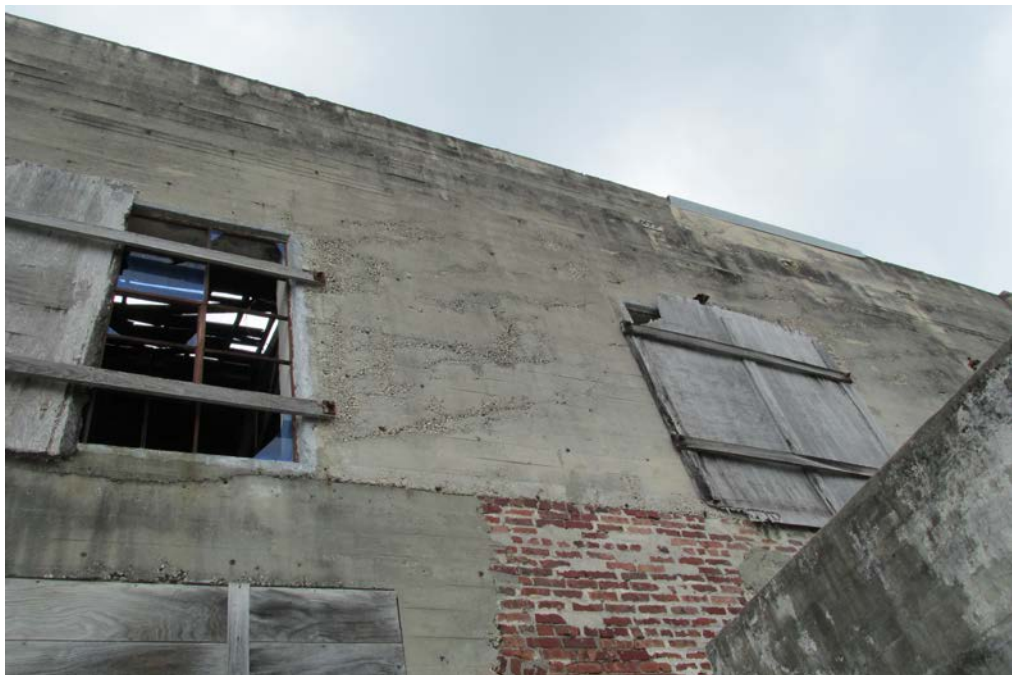
PHOTOGRAPH 44 (BUILDING IV)

- IV. The southernmost eastern building (Building IV) is in worse condition than Building II with a large area of missing metal roofing and wood sheathing, a deteriorated bottom roof truss chord and a wall opening with numerous loose and missing bricks with bricks falling (see Photographs 40, 41 and 42). The wood roof joists are in poor condition but the wood trusses appear in good condition. The steel structure is in good condition with surficial corrosion but many of the steel column bases are severely corroded with more than 20% material loss (see Photograph 43). The exterior masonry walls are in good condition but there are numerous cracks, corroded embedments, deteriorated mortar and loose and missing face brick. The upper concrete walls have large areas of honey combed concrete and an area of spalled concrete with corroded reinforcing (see Photographs 44 and 45).

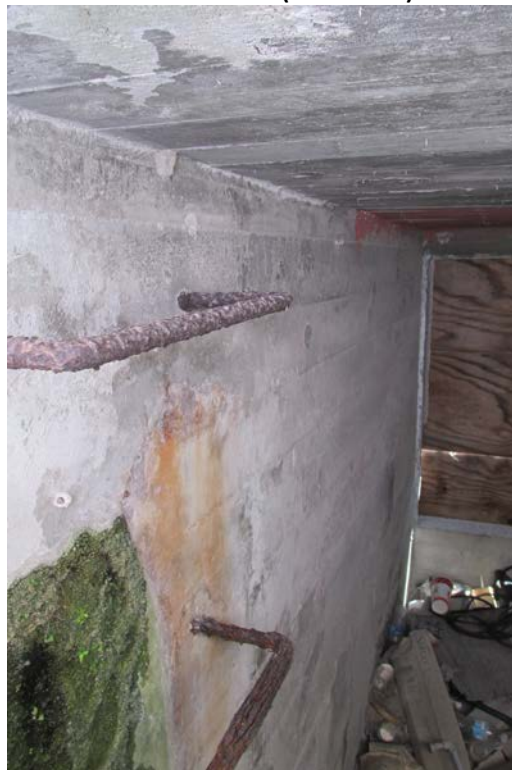
**PHOTOGRAPH 50 (BUILDING V)**

- V. The concrete exhaust building (Building V) is in good condition with corroded steel ladders; a badly corroded pipe support, a cracked housekeeping pad and a hairline crack in the roof parapet (see Photographs 50, 51, 52 and 53). The exterior pit and chute walls are in poor condition with cracked and spalling concrete with corroding reinforcing (see Photograph 54). All of the interior pits are full of water and breeding mosquitos. The interior trench and pit edge angles are in poor condition and badly corroded (see Photograph 55). All of the dynamos are in poor condition and badly corroded (see Photograph 56).

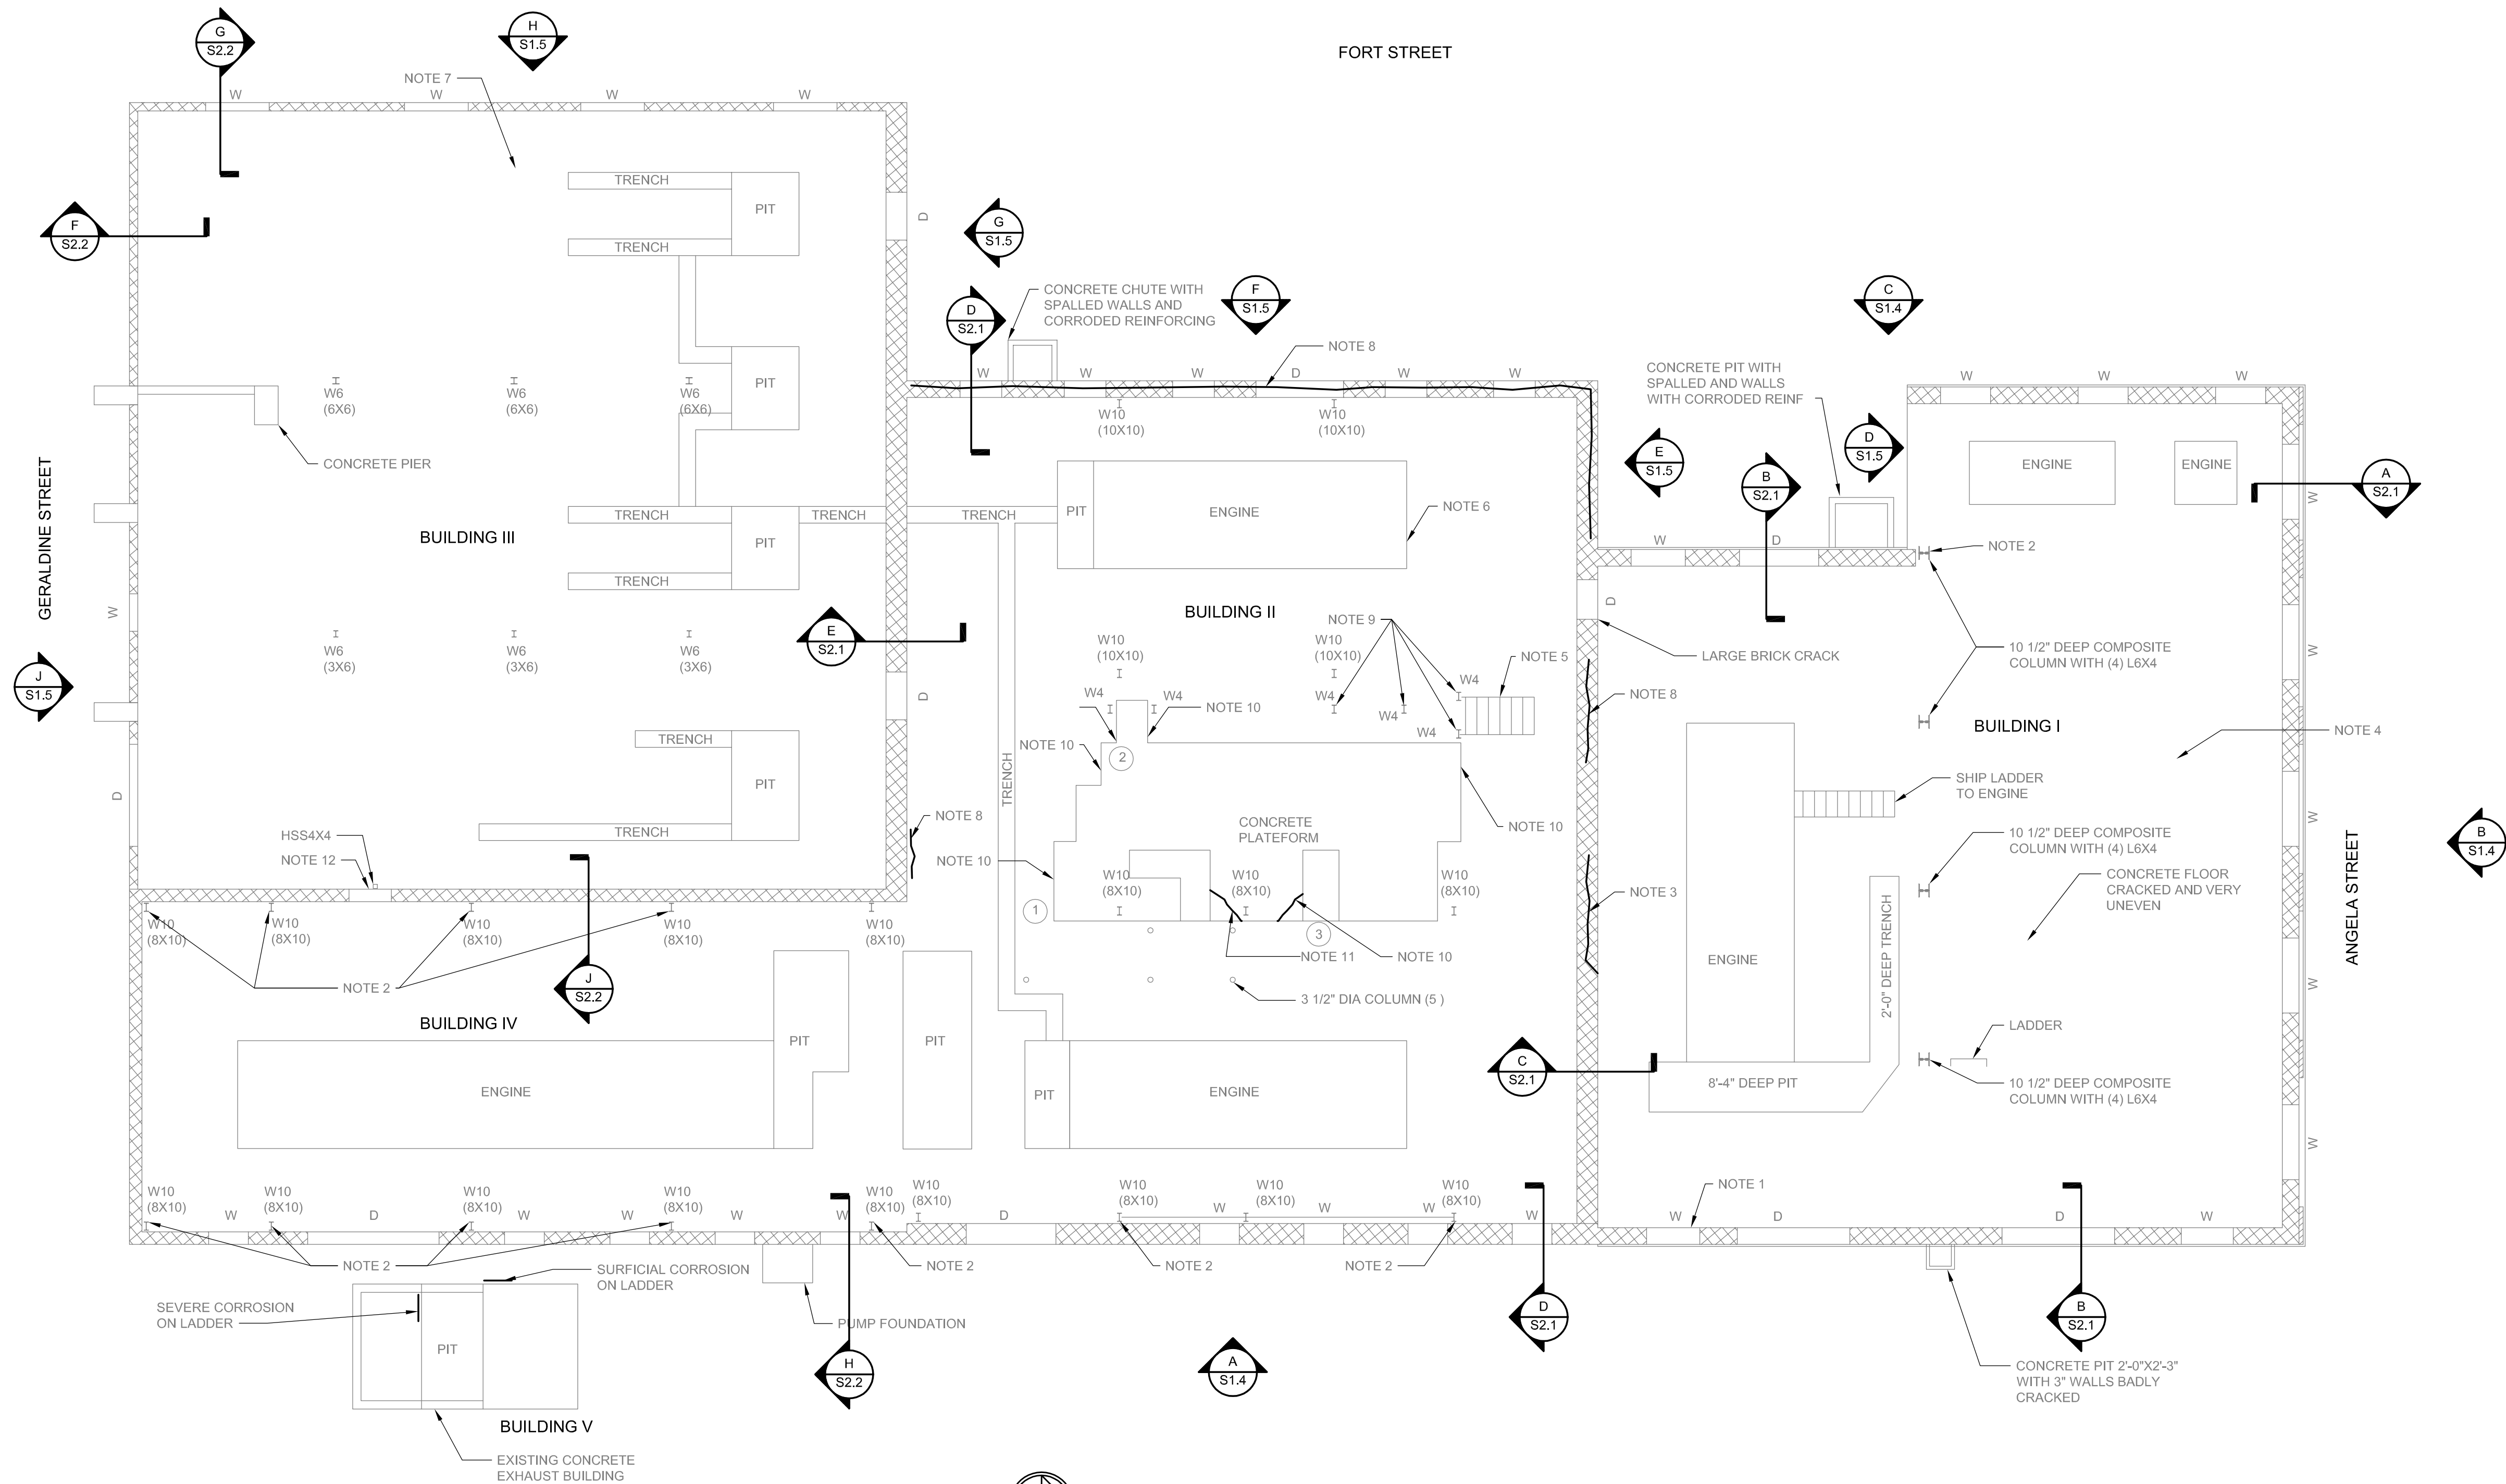
**EXISTING FLOOR PLAN**

1. DETERIORATED FACE OF BRICK
2. BADLY CORRODED COLUMN BASE AND OR COLUMN
3. CRACKS IN BRICK AT WALL PENETRATIONS AND ELEVATED OPENINGS
4. CONCRETE FLOOR CRACKED AND UNEVEN
5. BADLY CORRODED STAIR STRINGERS AT BASE OF STAIR
6. TRENCH AND PIT EDGE ANGLE BADLY CORRODED
7. CONCRETE FLOOR CRACKED AND UNEVEN - TRENCH AND PIT EDGE ANGLES ARE BADLY CORRODED
8. DETERIORATED MORTAR JOINTS
9. BADLY CORRODED POST BASE
10. LARGE SPALL WITH EXPOSED CORRODING REINFORCING
11. SEVERE CRACK AT CONCRETE BASE
12. BADLY DETERIORATED BRICK AT WALL OPENING
13. SURFICIAL CORROSION ON ALL STRUCTURAL STEEL.

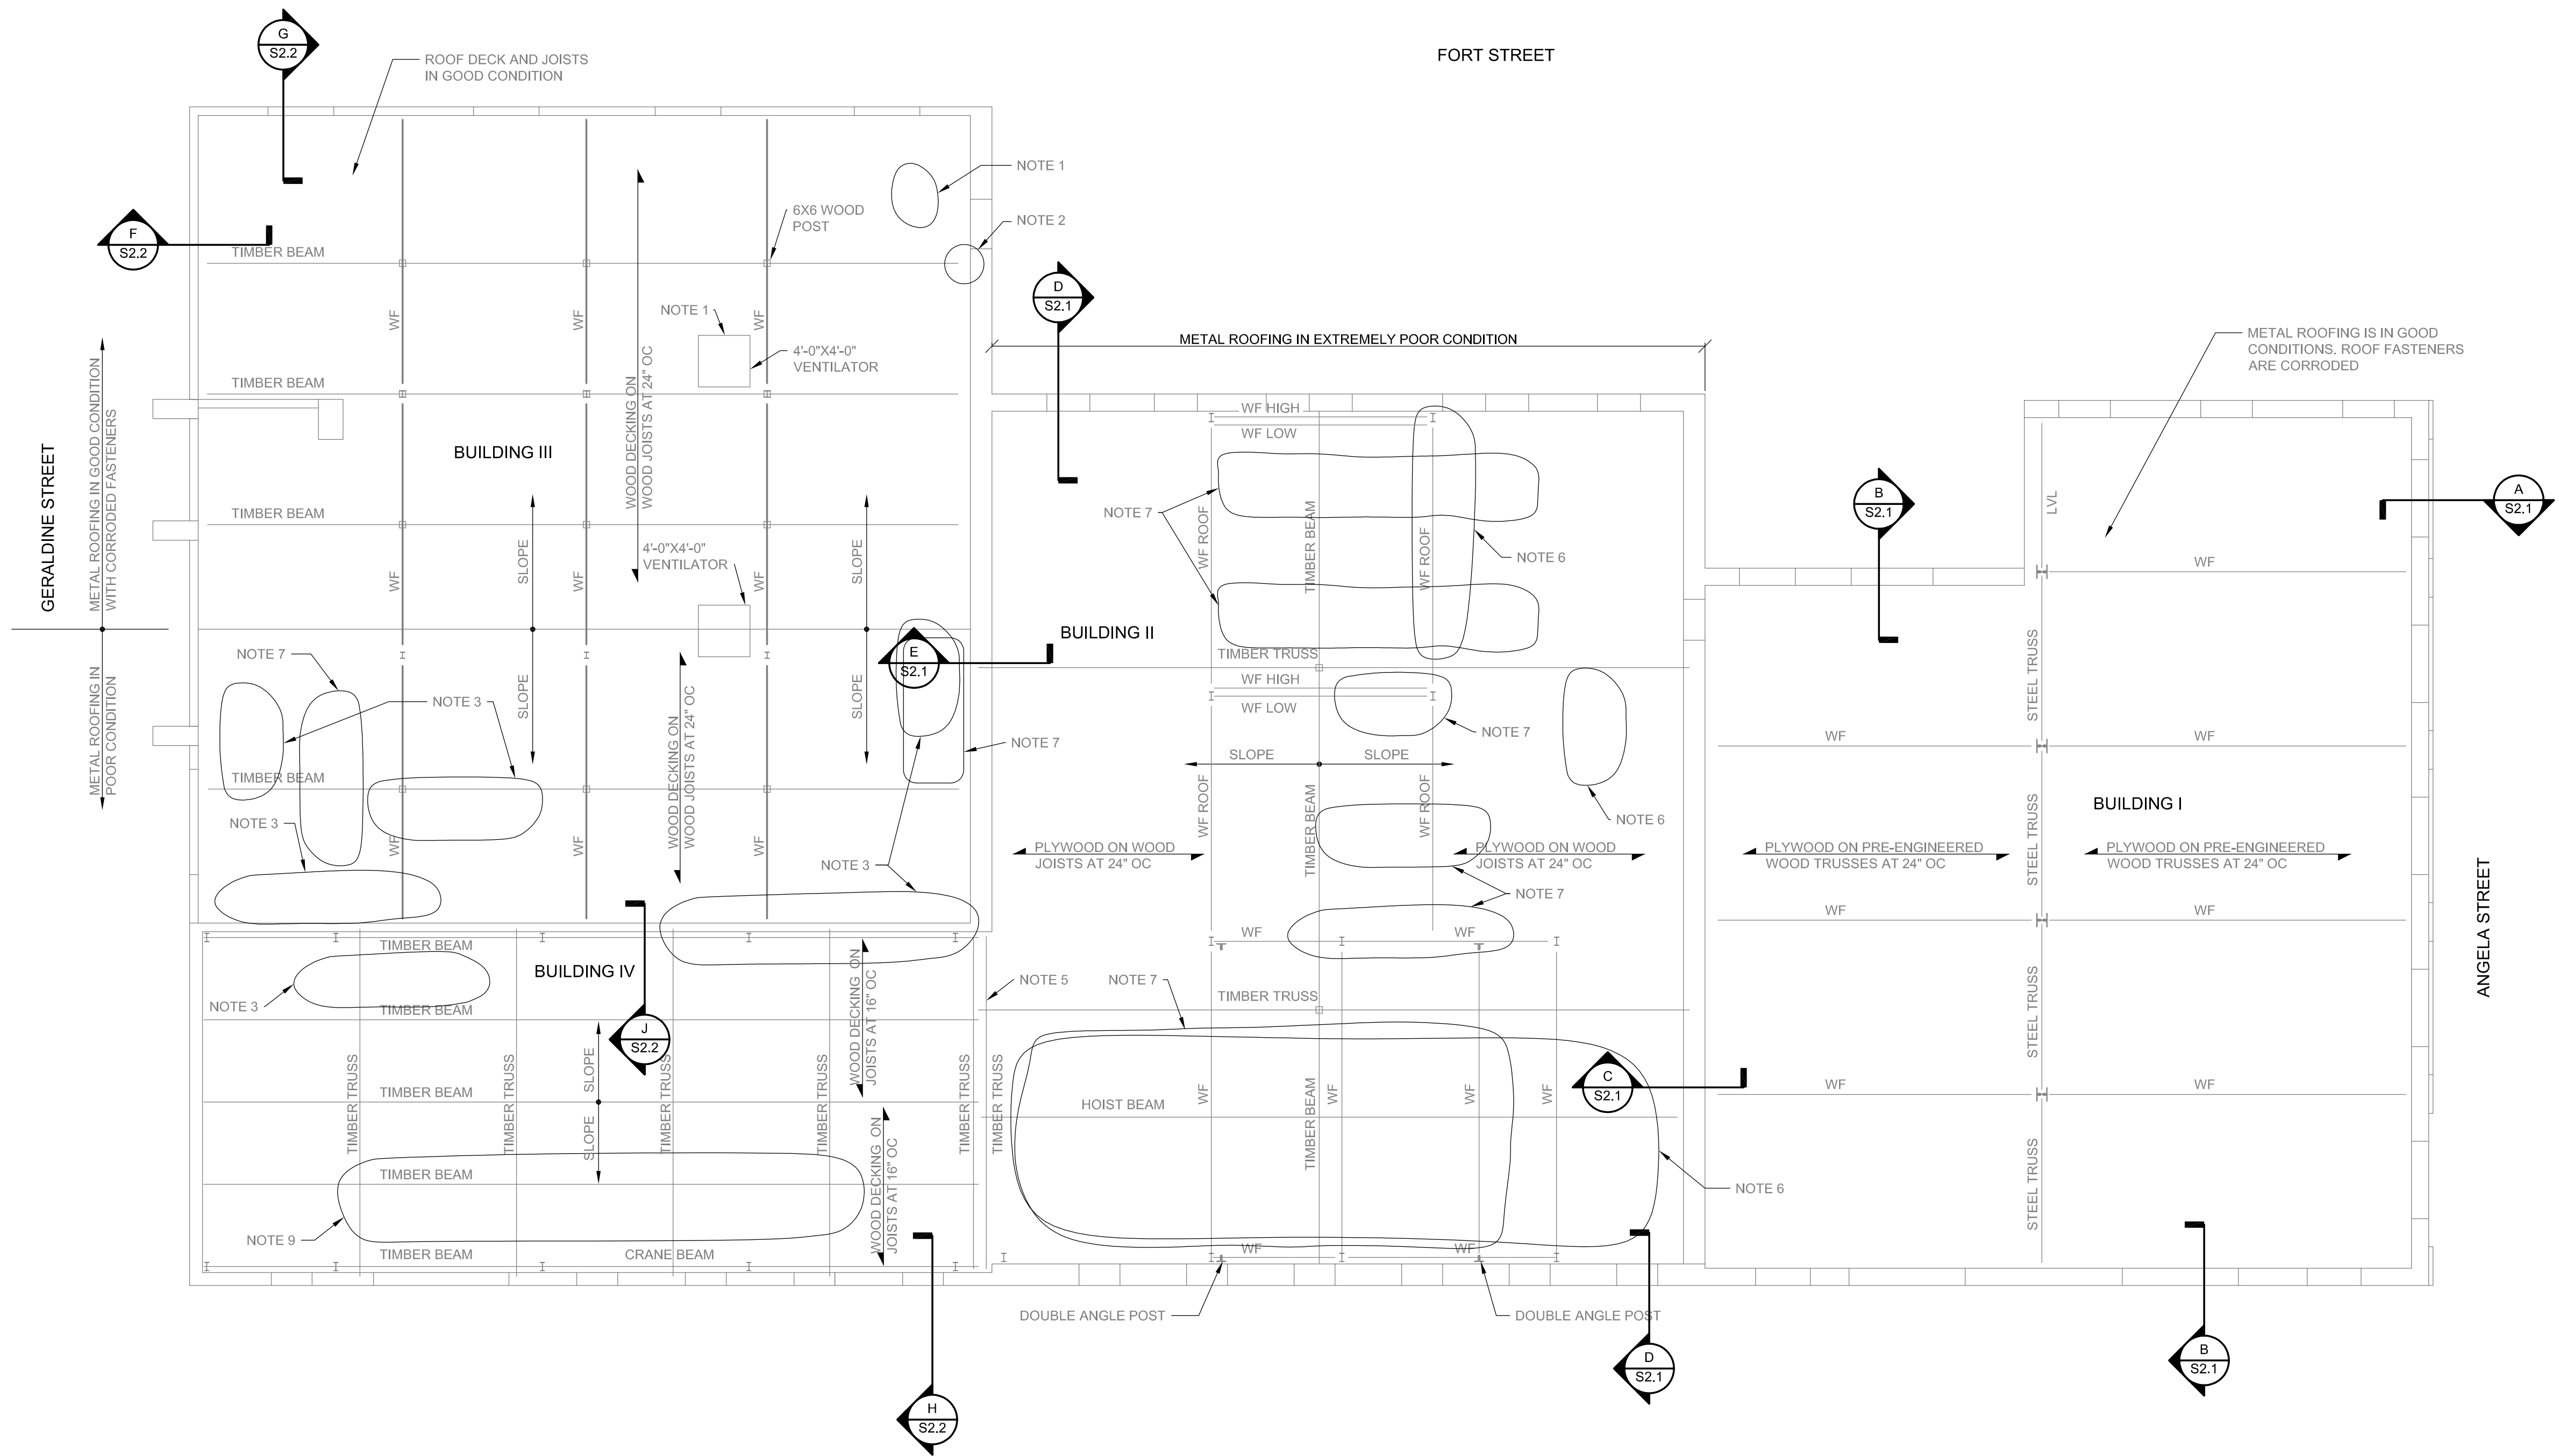
**EXISTING ROOF FRAMING PLAN**

1. CORRODED AREA ON METAL ROOFING
2. DETERIORATED BEAM KICKER
3. BADLY DETERIORATED OR MISSING ROOF DECK
4. DETERIORATED ROOF SHEATHING
5. BADLY DETERIORATED BOTTOM TRUSS CHORD
6. DETERIORATED ROOF SHEATHING
7. AREA OF MISSING METAL ROOFING
8. SURFICIAL CORROSION ON ALL STRUCTURAL STEEL
9. BADLY DETERIORATED AND MISSING ROOF DECK, JOINTS AND METAL DECK
