Engineer Report

**Waterfront Market
201 William Street
Key West, Florida 33040**

September 30, 2010

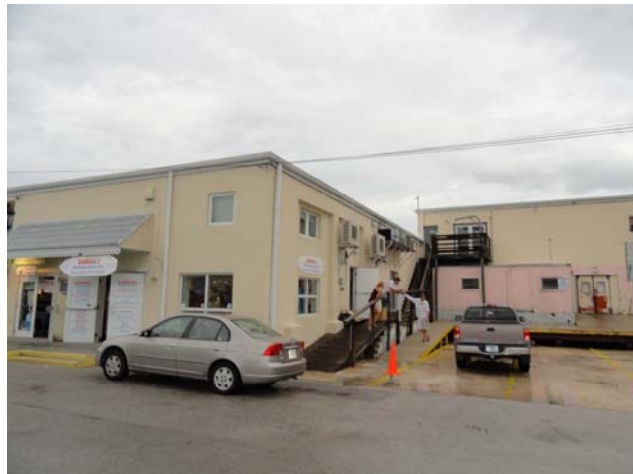
Photo 01- Building Structure A
Two Story (West End)

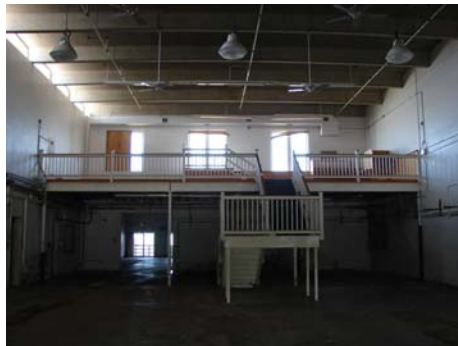
Photo 03
Building Structure B
Second Floor Terrace

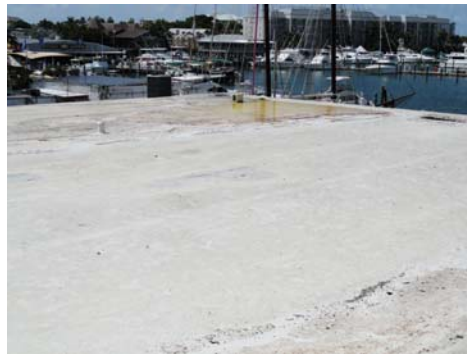
The precast concrete roof T-sections were observed from the finished floor level below and from the roof level adjacent to exposed surfaces. There were no signs of significant damage such as cracking, settlement, spalling, etc. There was evidence of ponding water at the west end of the building structure and along the building connection between Building Structure A and Building Structures B and C.

Photo 07 - Building Structure A
Roof Coverings (West End)

The roof over Building Structure A holds water. The water has likely caused damage to the structure at the building connection between Building Structure A and Building Structures B and C. The damage to the structure should be repaired and the roof should be repaired to provide proper drainage.

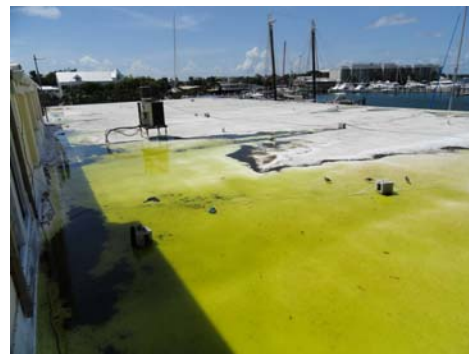
Photo 08 - Building Structure A
Roof Coverings (Building Connection)

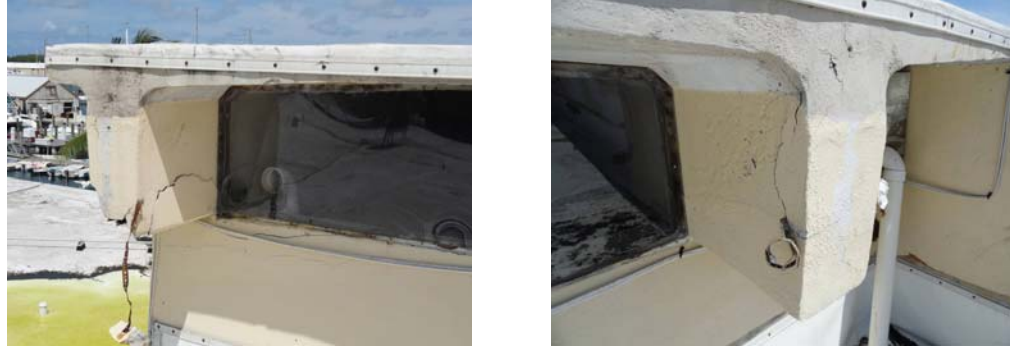
Photos 09 and 10 - Building Structure B
Damaged T-section

The precast concrete roof T-sections were observed from the finished floor level below and from the roof level adjacent to exposed surfaces. There was damage noted at the end of a precast concrete roof T-section where the T-sections overhang the structural walls. The damage was isolated to the end of the T-section. The damage did not appear to be significant to the structural integrity of the roof T-section.

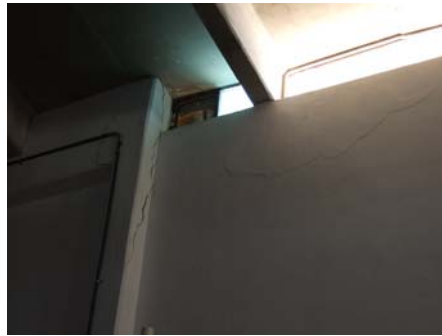
The reinforced concrete columns and beams were observed from the interior finished floor level and from the exterior grade level and roof areas adjacent to exposed exterior surfaces. There were signs of spalling damage in the structural columns and beams and in the concrete infill walls at the ends of the precast concrete T-sections. The spalling damage appeared to be worse at the building connection between Building Structure A and Building Structures C and D.

Photo 11- Building Structure B
Damaged Column

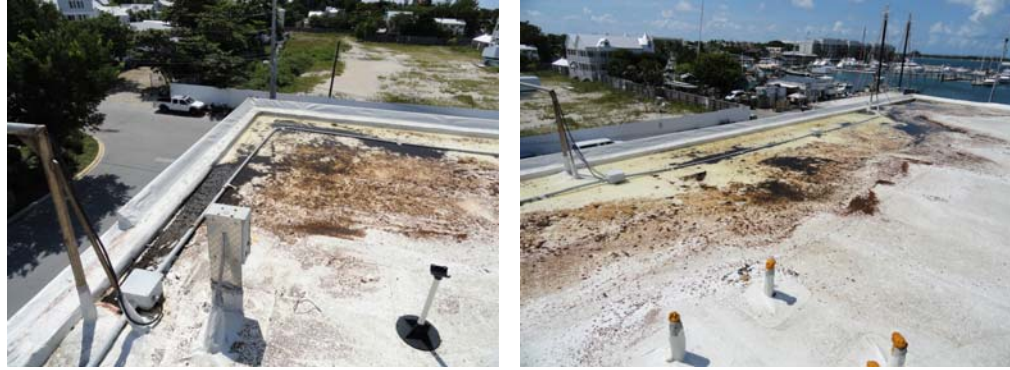
The precast concrete roof T-sections were observed from the interior finished floor level below and from the roof areas adjacent to exposed surfaces. There were no signs of significant damage such as cracking, settlement, spalling, etc. There was evidence of ponding water at the west end of the building structure.

Photos 12 and 13 - Building Structure D
Roof Ponding Water

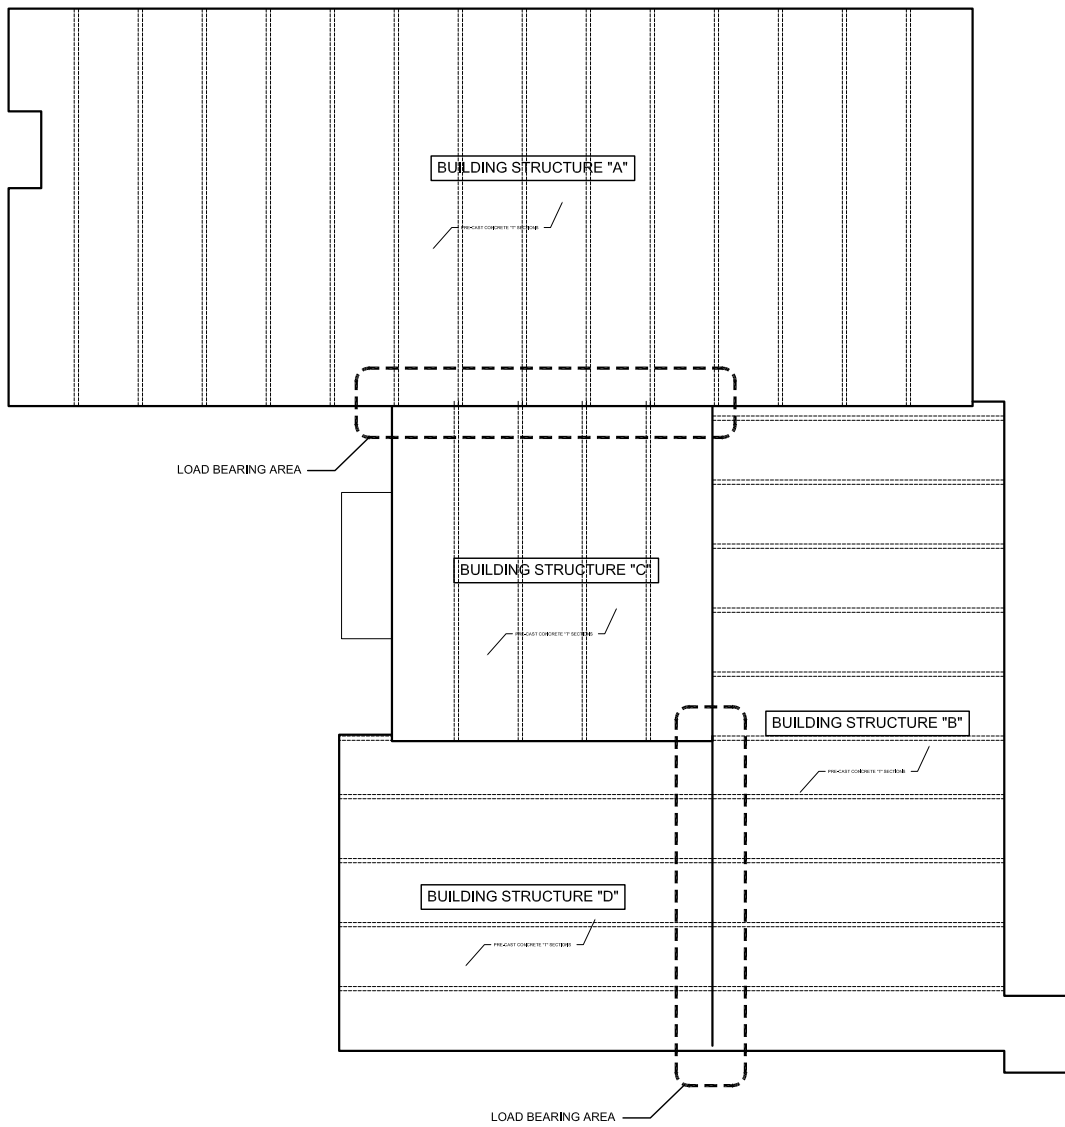
STRUCTURAL PLAN

The possibility of Structural Overload is present in the columns and beams that support the roof T-sections redundantly between adjacent building structures. (Attachment F) There is cracking that is indicative of shear stress that occurs when a structural member is overloaded. The might only be concrete spalling damage

but could not be determined by visual inspection only. The roof T-sections in the areas shown should be temporarily supported until the damaged structural members are repaired or replaced. The condition could possibly be dangerous to life and/or safety.
