THE CITY OF KEY WEST  
Urban Forestry  
1300 White Street  
Key West, FL 33040

## Tree Removal Report

**PROPERTY:** 615 Southard St.

**APPLICATION NUMBER:** T2026-0129

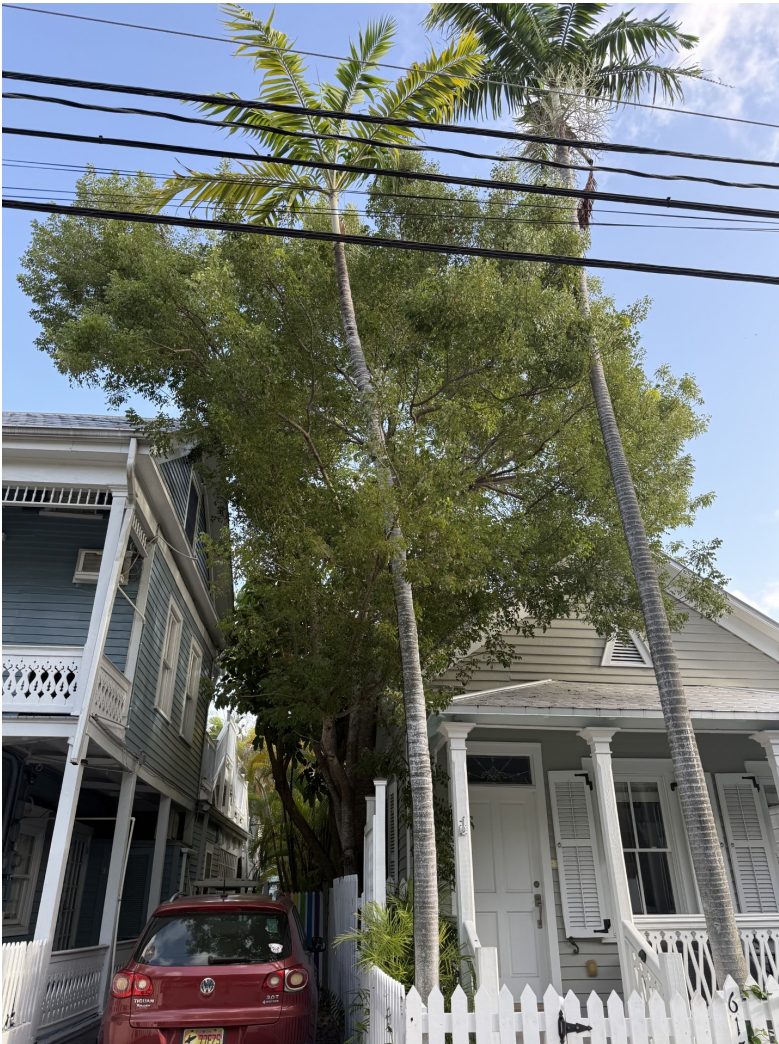
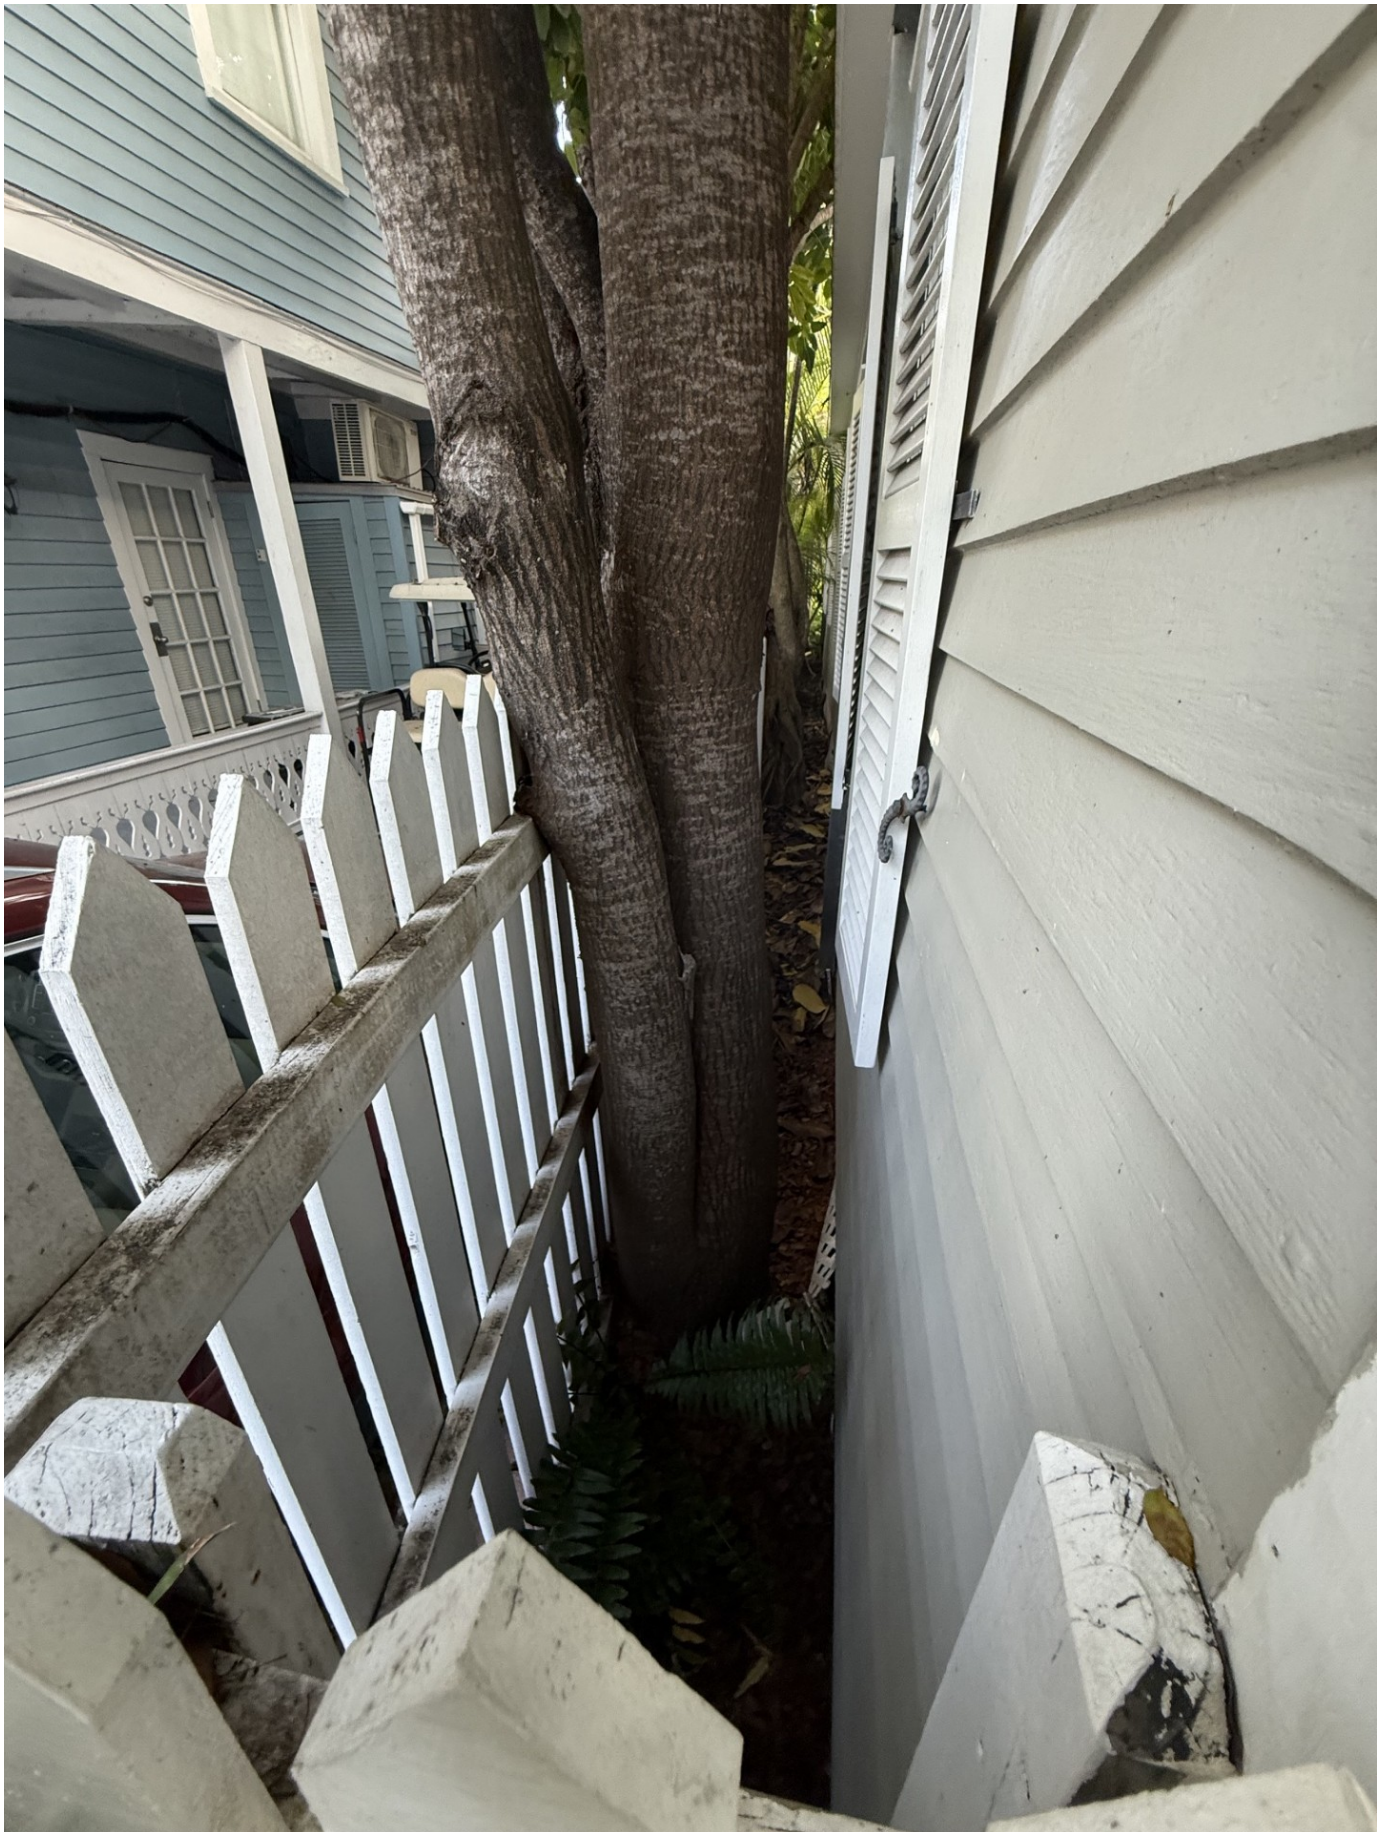
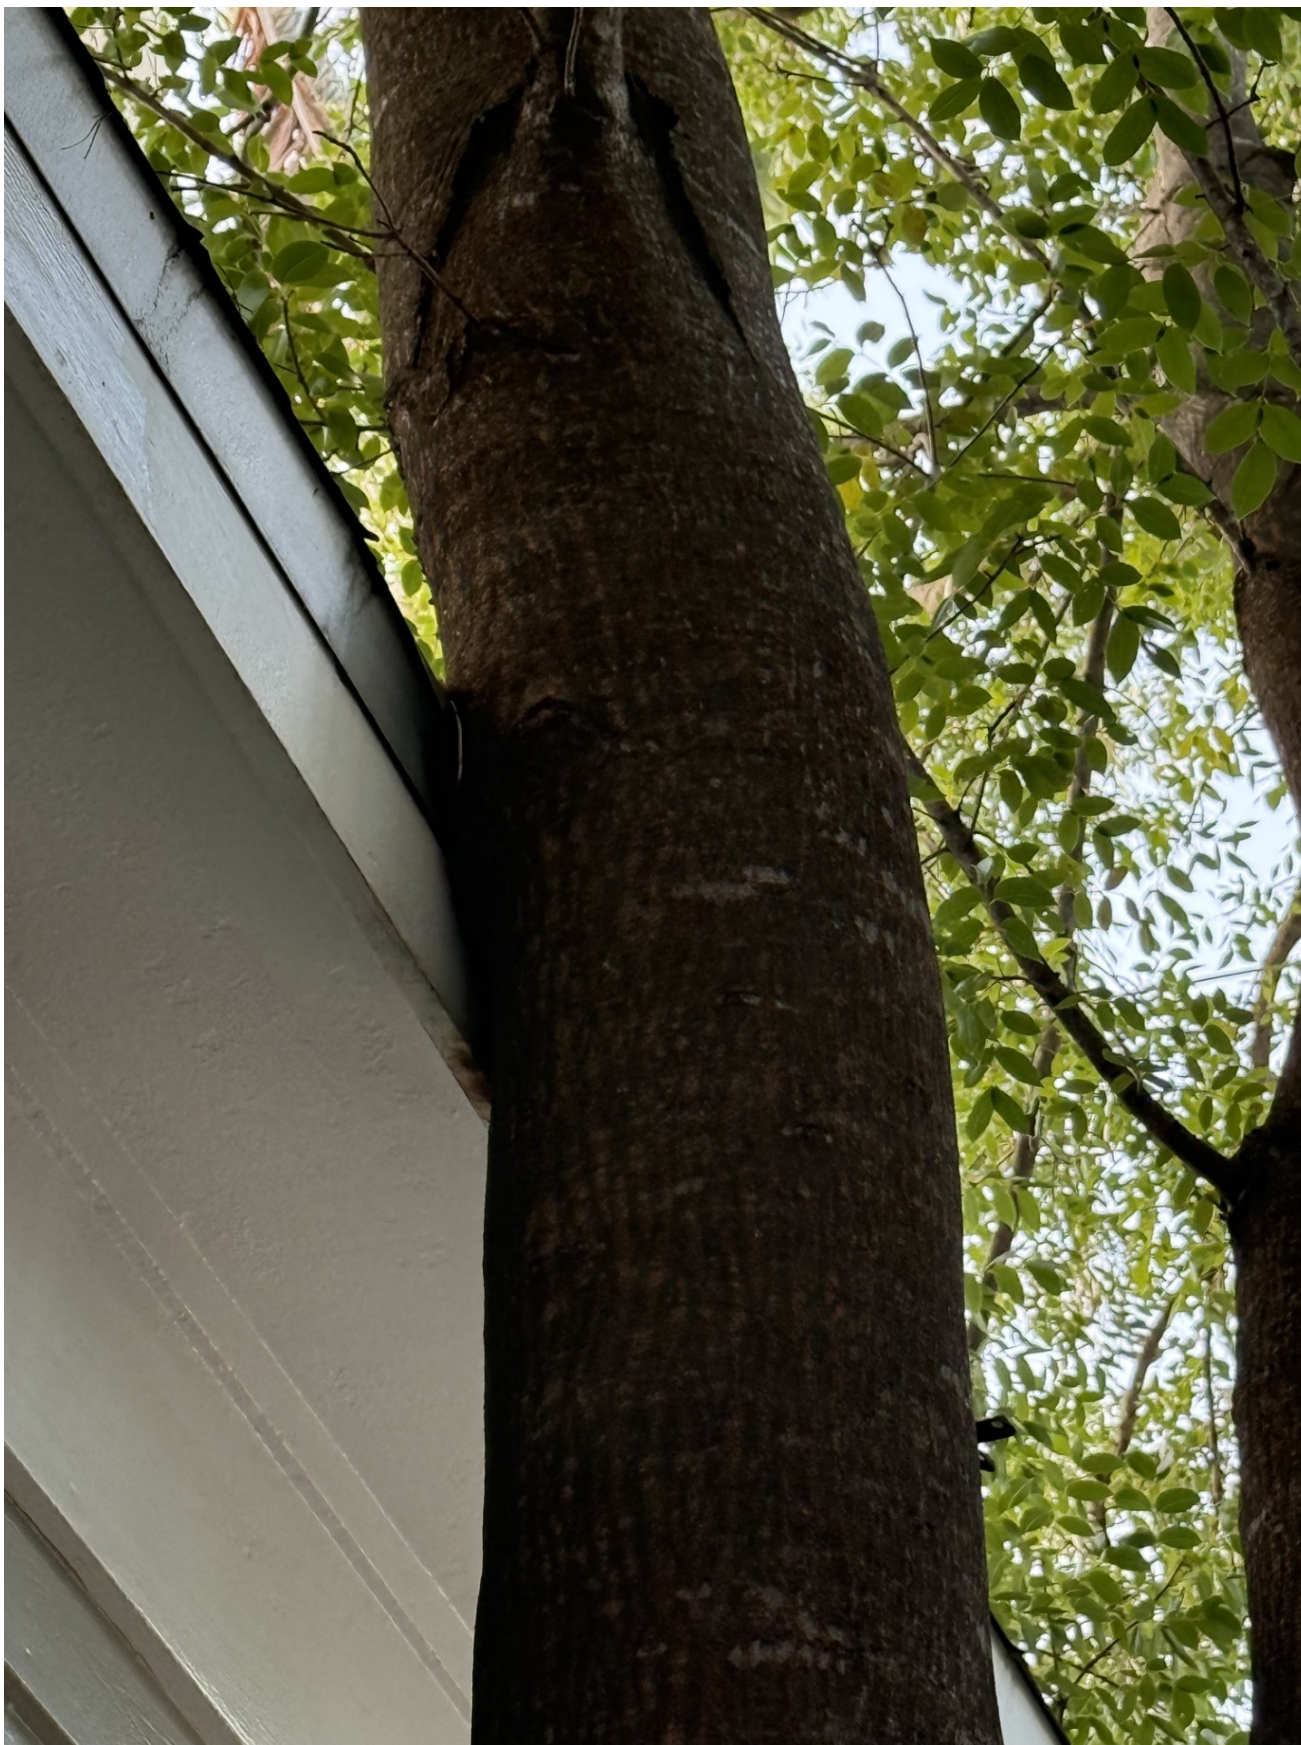
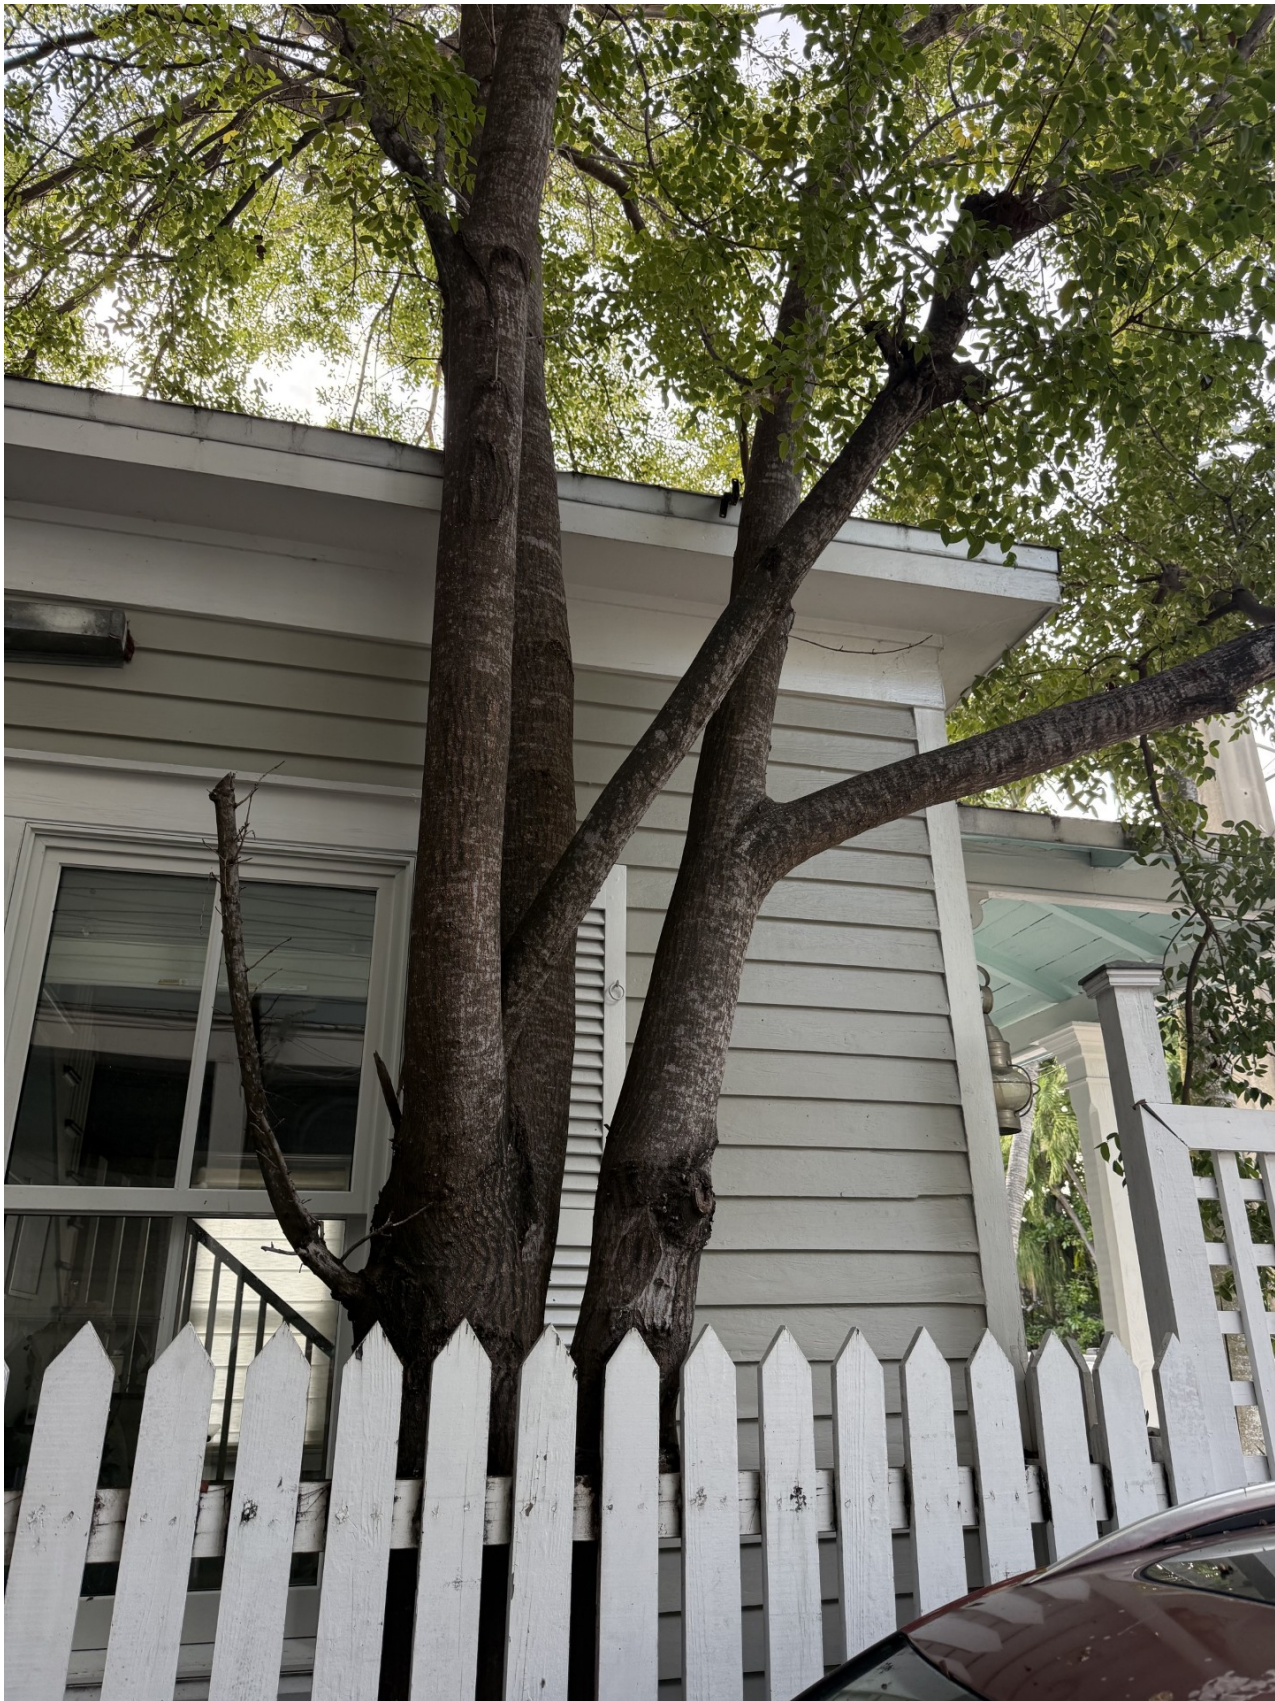
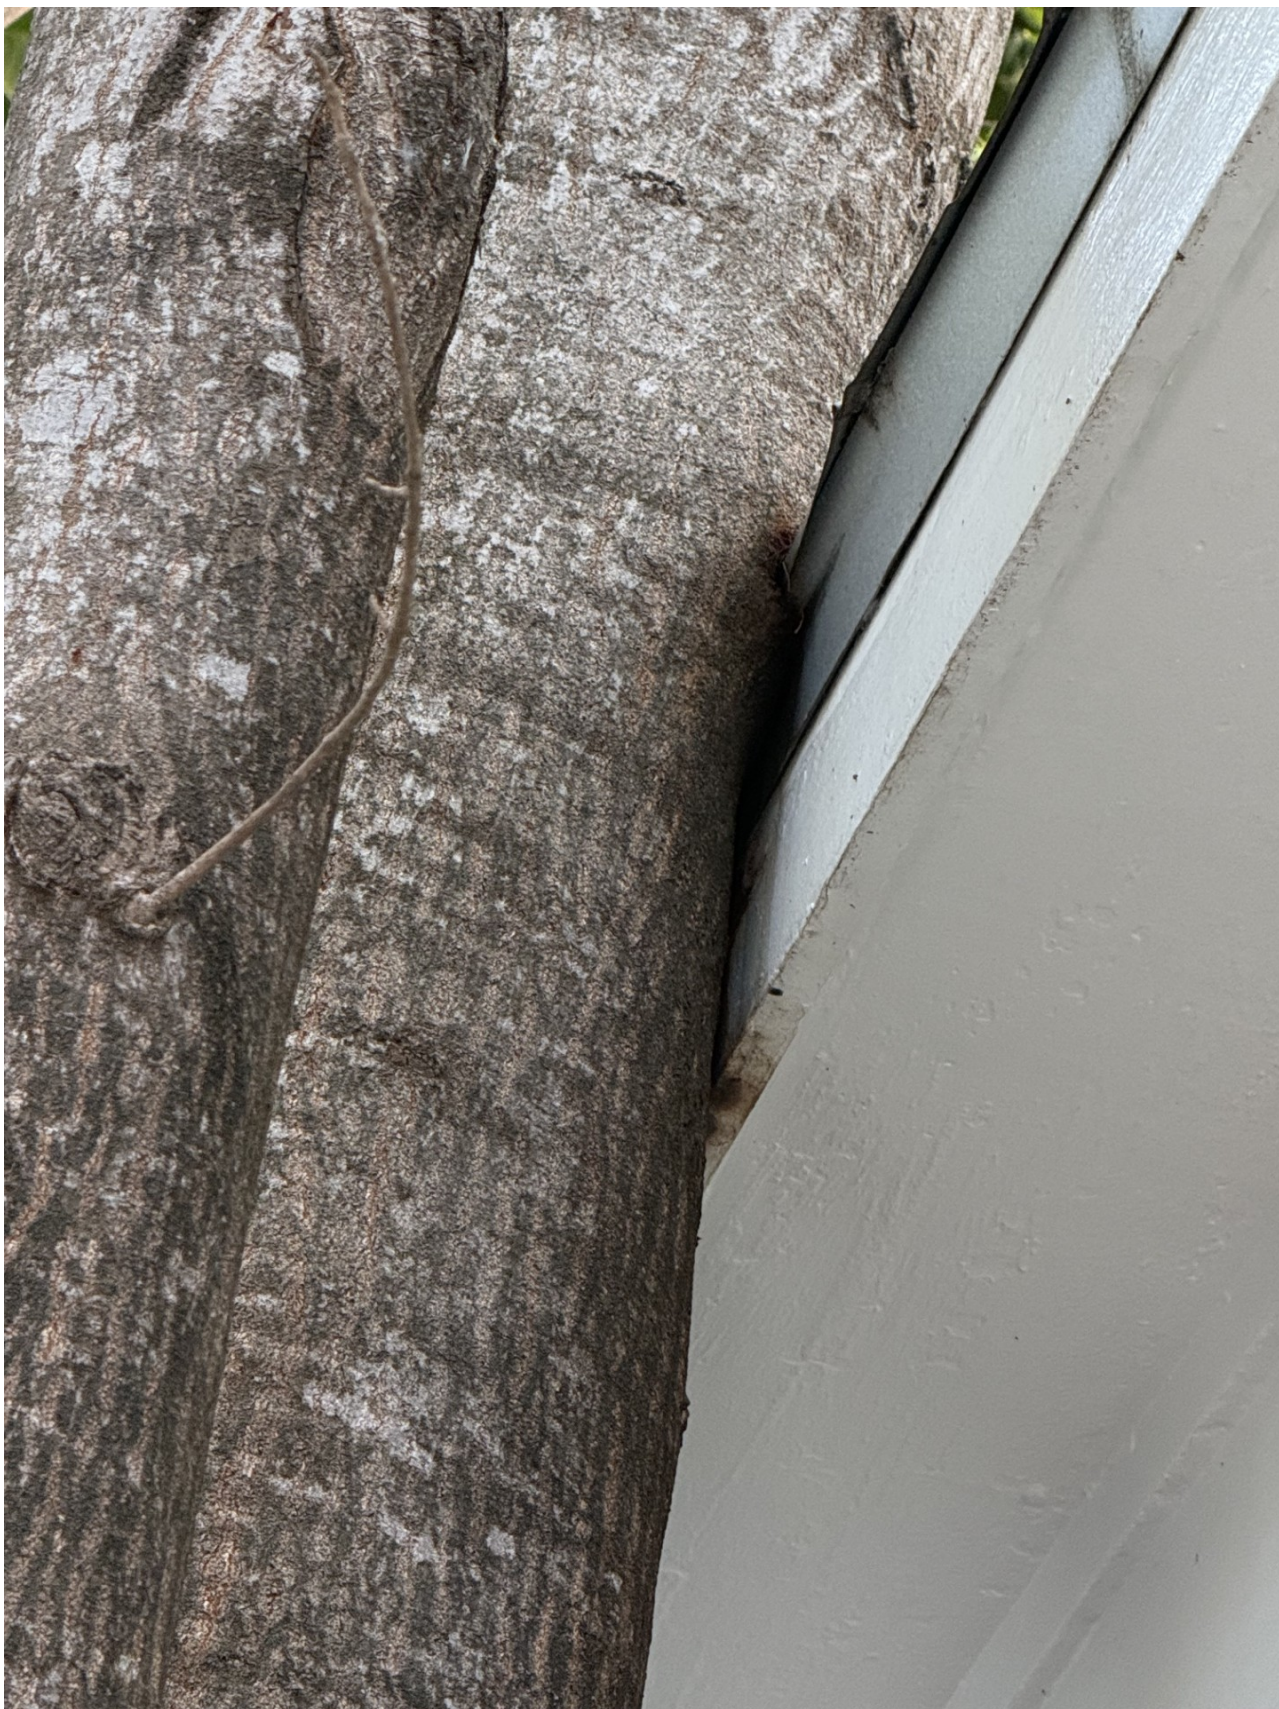
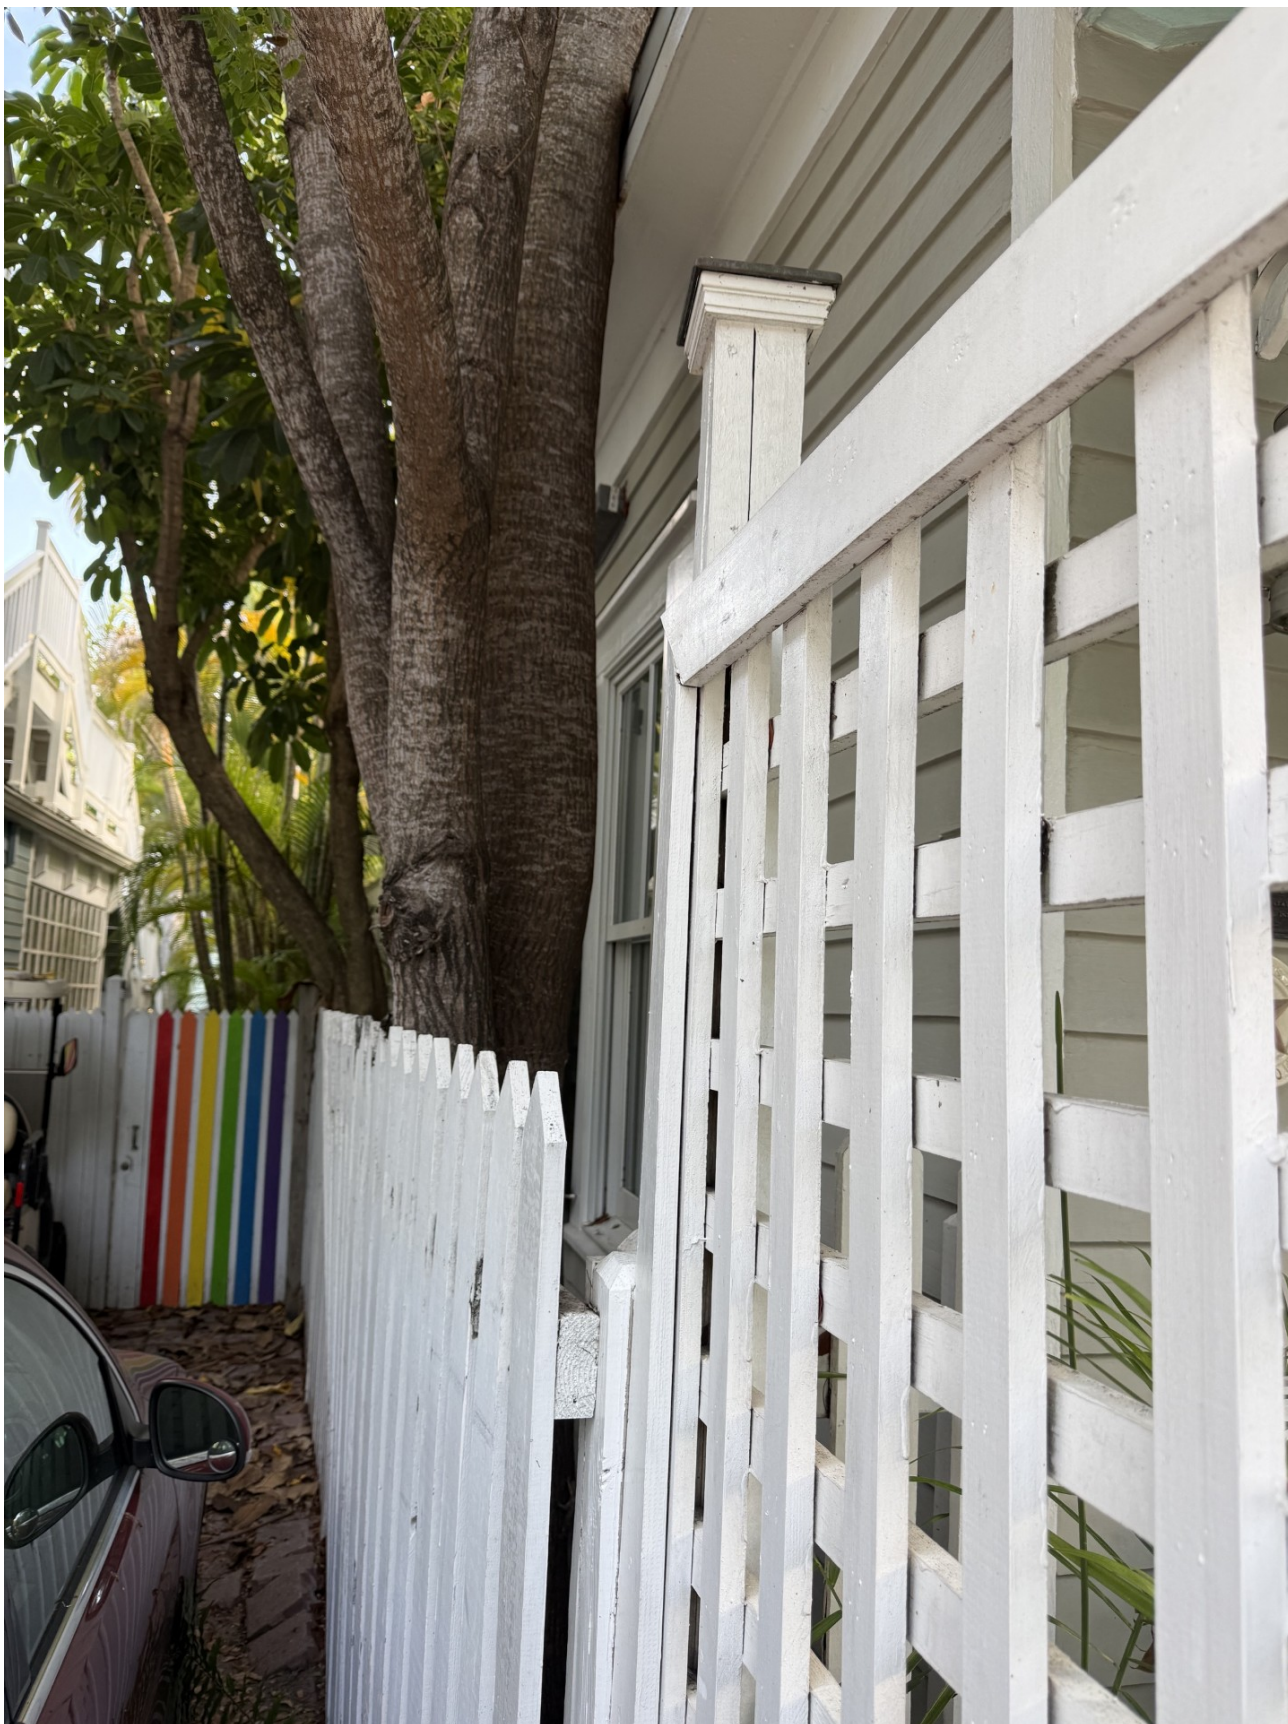
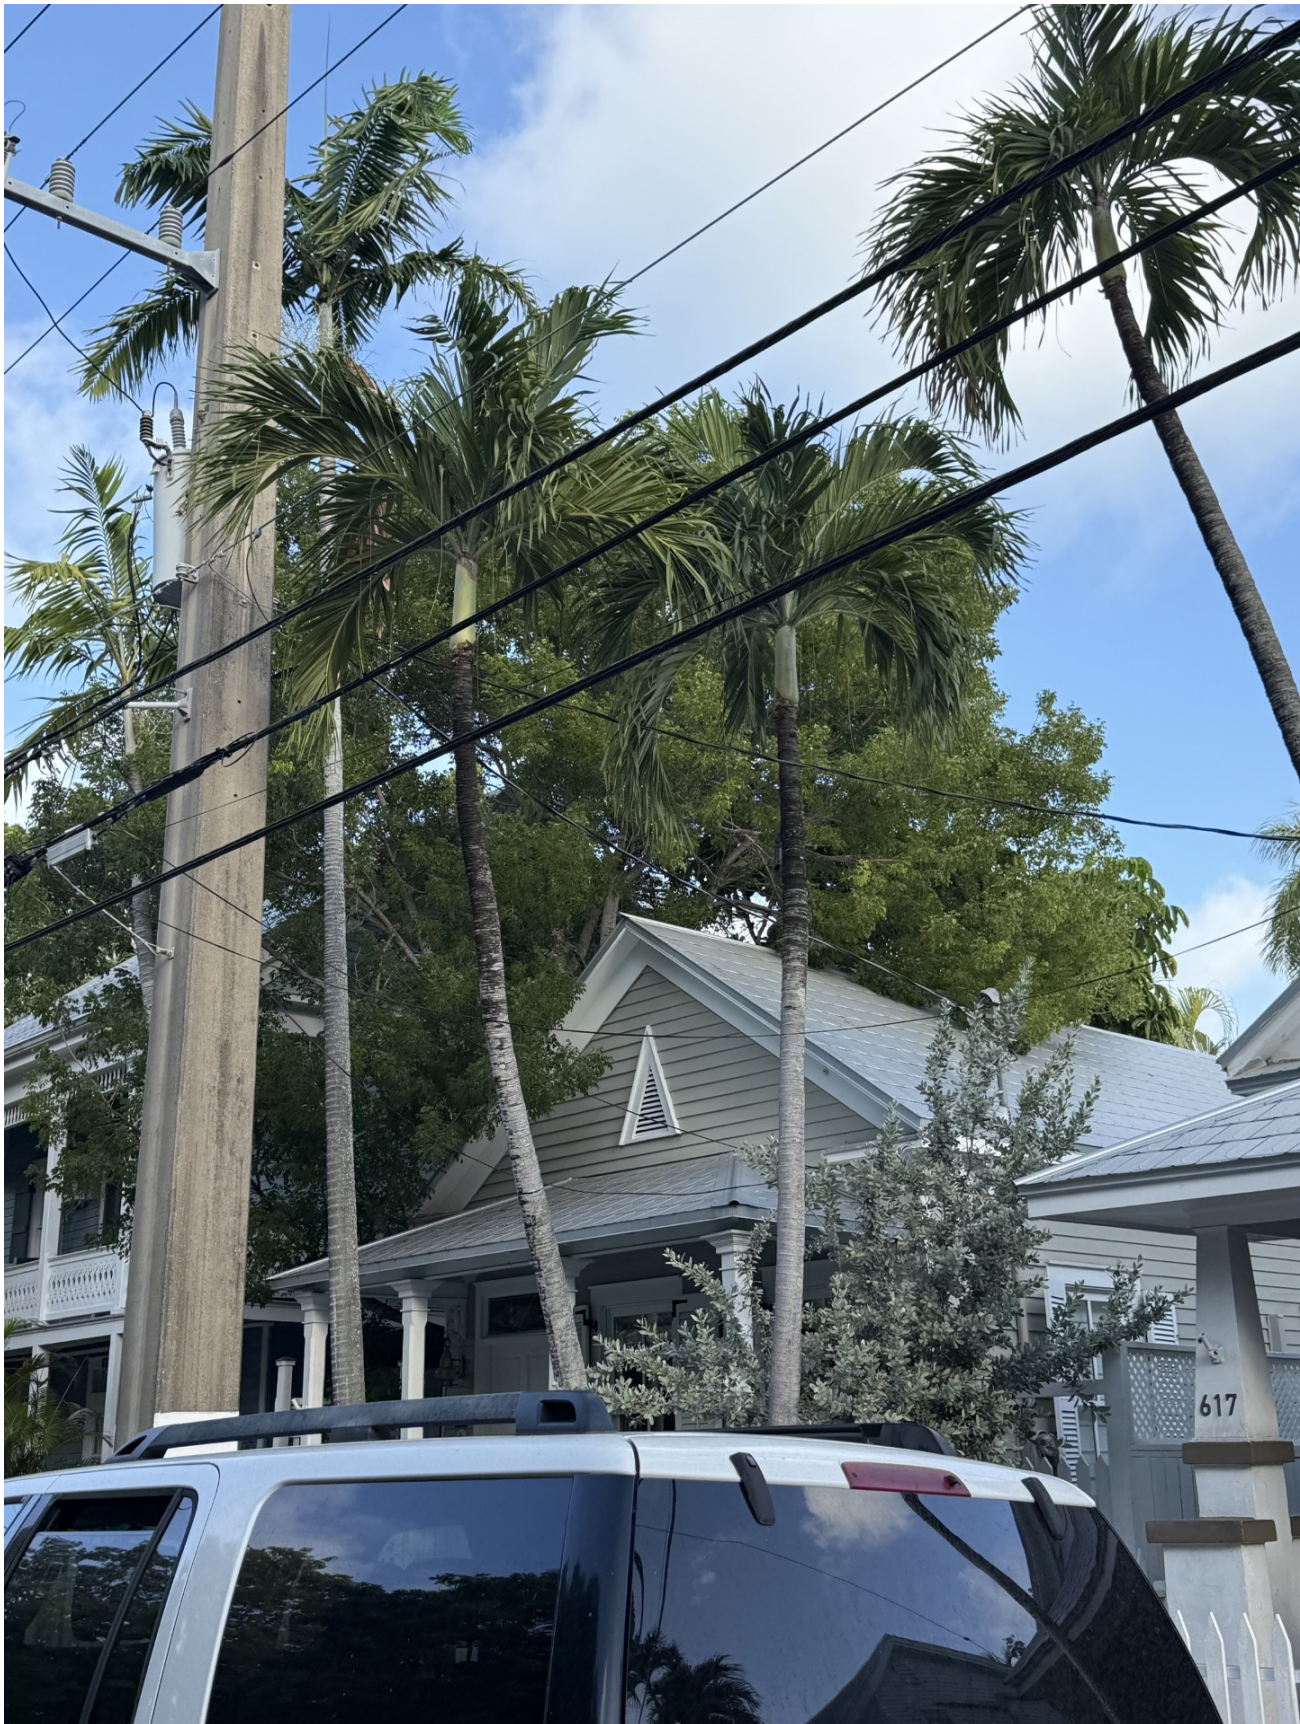
The subject tree is a 12-inch DBH Cuban mahogany growing in an extremely confined planting location between a single-family residence and a white picket property line fence. The available planting width between the structure and fence is approximately two feet. An adjacent single-family residence is located approximately eight feet from the tree. Based on its location, the tree appears to be a volunteer specimen rather than an intentionally planted landscape tree.

The tree exhibits codominant stems originating less than one foot above the root flare. The stem union contains included bark, creating a structurally weak attachment that is expected to become increasingly susceptible to failure as the tree matures.

The canopy is generally healthy with good foliage density; however, its architecture has become distorted due to the extremely restricted growing space between the two residences. The tree has developed an asymmetrical form as it competes for available light and growing space.

The primary stem is in direct contact with the residence, extending into the roof, soffit, and fascia. The metal roofing has already breached the bark and is creating continuous mechanical injury to the trunk. This damage is likely interfering with the tree's vascular system and will continue to compromise both the health of the tree and the integrity of the structure.

From one viewing angle, the trunk appears to be beginning to envelop portions of the roof assembly as secondary growth occurs. Continued radial expansion of the trunk will almost certainly increase structural conflict with the building over time.

Although no obvious foundation damage is currently evident, the tree has not yet reached maturity. Given the mature size, vigorous growth habit, and extensive root system characteristic of Cuban mahogany, continued development within such a confined space creates an increasing likelihood of future conflicts with adjacent structures and infrastructure.

This planting location is fundamentally incompatible with the mature size and growth characteristics of *Swietenia mahagoni*. The site provides insufficient space for normal trunk expansion, canopy development, and root growth. As a result, the tree is experiencing ongoing structural interference with the residence while simultaneously being subjected to chronic injury from the structure itself.

The combination of codominant stems with included bark, direct trunk contact with the roof assembly, ongoing bark and vascular injury, extremely restricted planting space, immediate proximity to multiple residences, and predictable future structural and root conflicts indicates that this tree is poorly suited for long-term retention at this location.

**Recommended Mitigation: 7.2 Caliper Inches**
