Re: Compliance Assistance Offer  
Stock Island Landfill-Closed  
WACS 97636  
Monroe County

**Florida Department of  
Environmental Protection  
Inspection Checklist**

**Facility Name:** STOCK ISLAND LF (SOUTHERNMOST WTE & KEY WEST LF)

## FLORIDA DEPARTMENT OF ENVIRONMENTAL PROTECTION TRIP REPORT

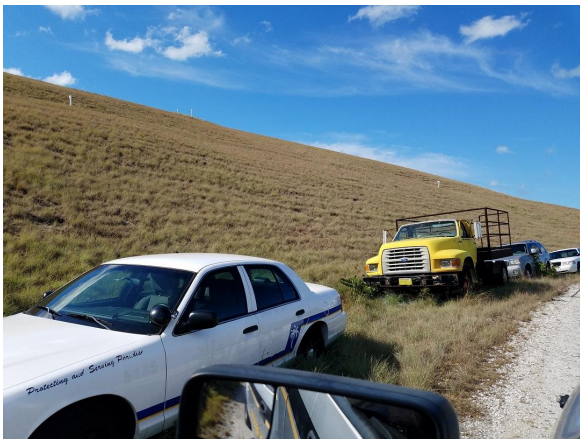
Explanation: Approximately 30 vehicles were being stored by the city on the north side of the landfill along the access road in the stormwater management area.

Vehicles along access road

Corrective Action: Remove vehicles so that stormwater management is fully operational.

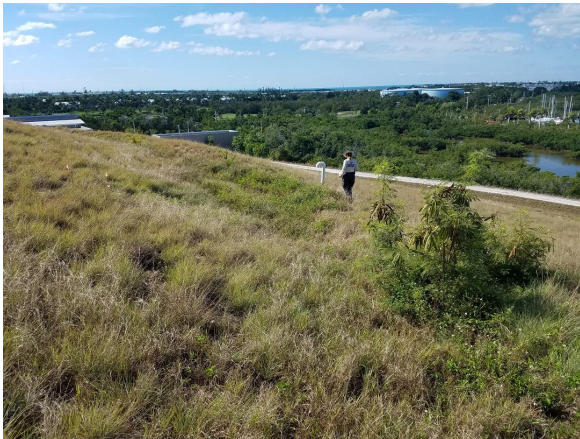
Explanation: Along the uppermost bench on the west side and the northwest corner of the landfill, there was some low points that could retain stormwater and accelerate erosion.

The cover in the low area on the west step is greener than the surrounding cover, which could indicate that stormwater is accumulating in that area.

Low point on west step

Corrective Action: Restore bench to original grade and stabilize with vegetation.

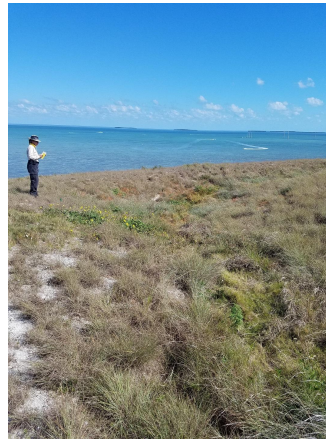
Low area on northwest corner step

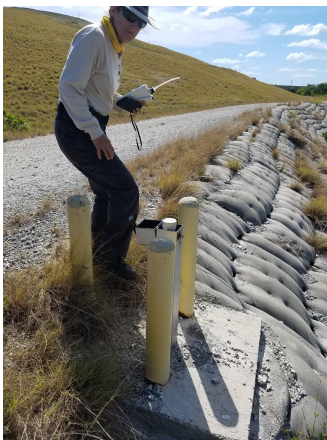
Explanation: No locks were observed on the monitoring wells. Department staff were able to open the well cover.

Unsecured monitoring well.

The LTC Report does not mention monitoring well security. However, if the wells are to remain in place they should be secured from tampering as required in 62-701.510(2)(d)5, F.A.C.

Monitoring well (MW) #2 was examined. Neither the well housing, nor the well cap were locked to prevent tampering.

Corrective Action: Appropriately lock and secure monitoring wells.

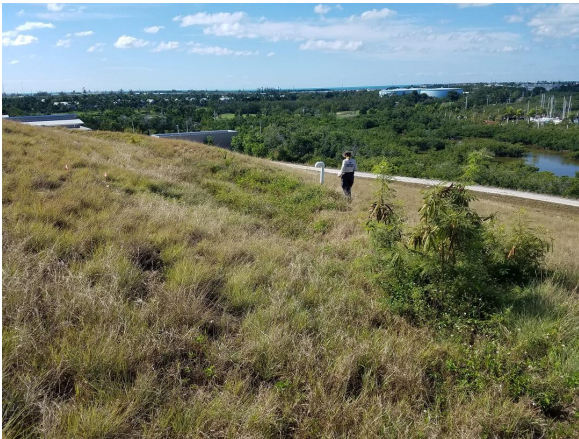
Explanation: The landfill cover does not show signs of recent mowing. Mr. Castro stated he does not remember when the last mowing event occurred. He further stated that the city's mower is not in operation at this time.

Overgrown plant on cover

Corrective Action: The city is supposed to mow the landfill cover six times a year. Mr. Castro stated that he is looking at getting a contractor to maintain the cover.

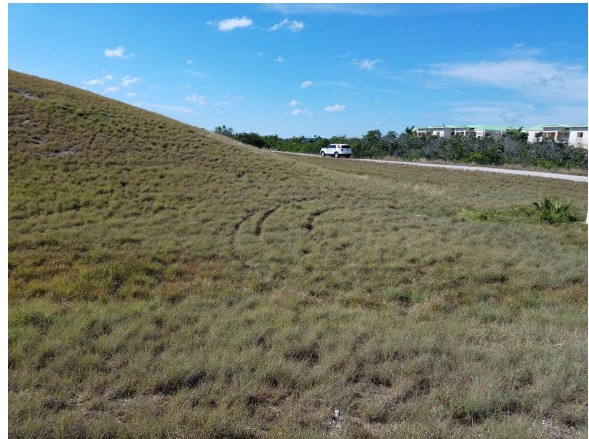
Tire tracks in NW swale

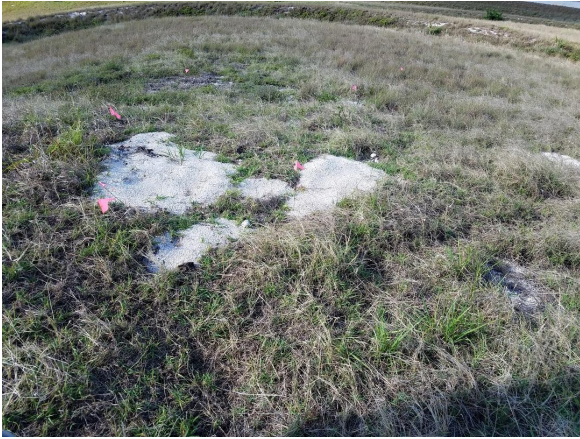
Flagged iguana burrows

Iguana burrows were present. Many of them had been flagged. Mr. Castro said they are working with a trapper to control the iguanas.
