1208 Virginia Project Report

1208 Virginia Street
Key West, Florida 33040

March 30, 2023

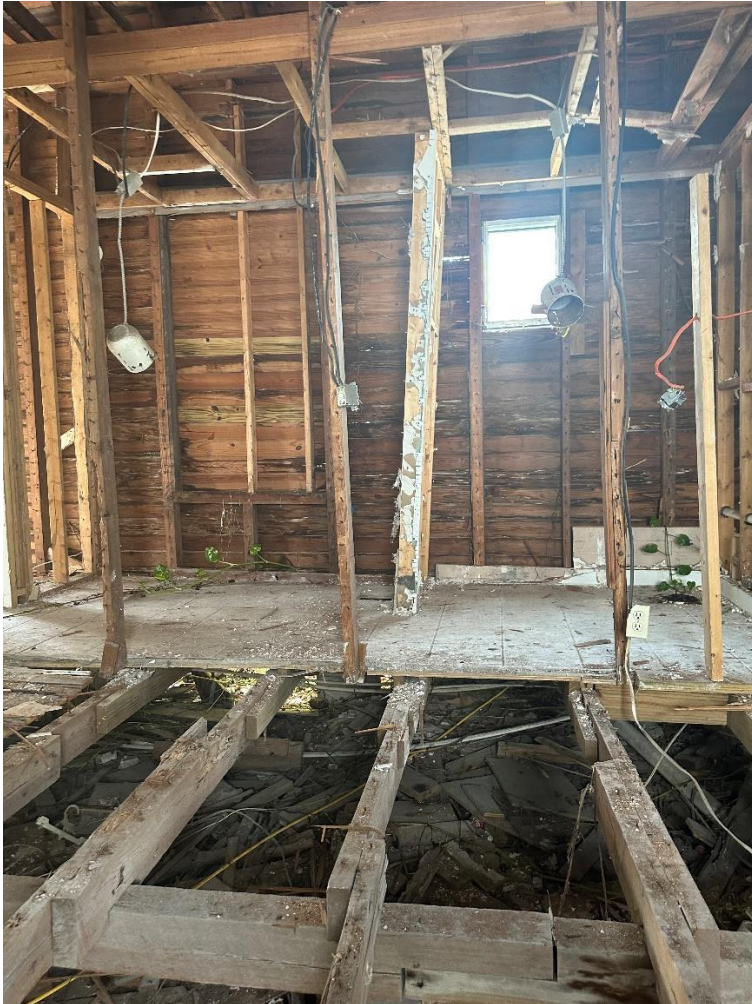
Photograph 1: View of the interior of the structure. The beam is not supported and the wall studs are damaged as well as the window.

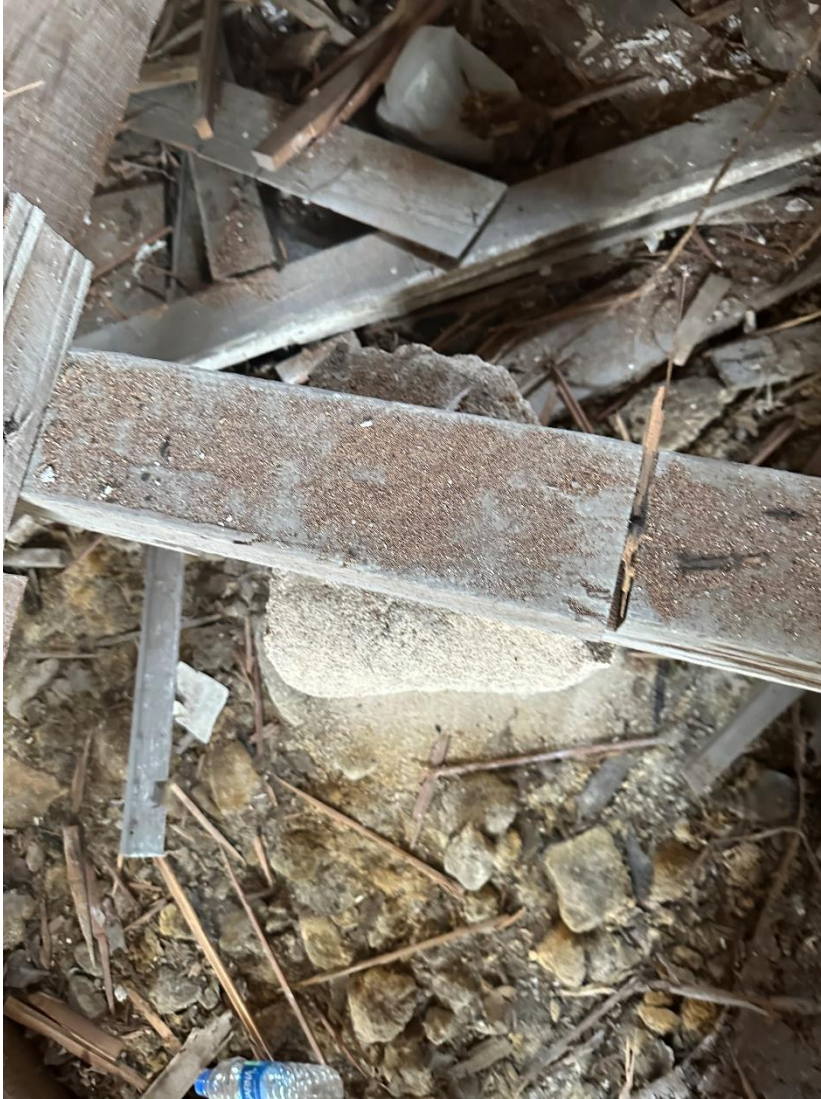
The foundation is in very poor condition. The structure is located on a crumbling limestone columns and concrete blocks. There are no indications of tie downs between the foundation and structure.

Photograph 2: View of eroded column with no tie downs and termite damaged beam.

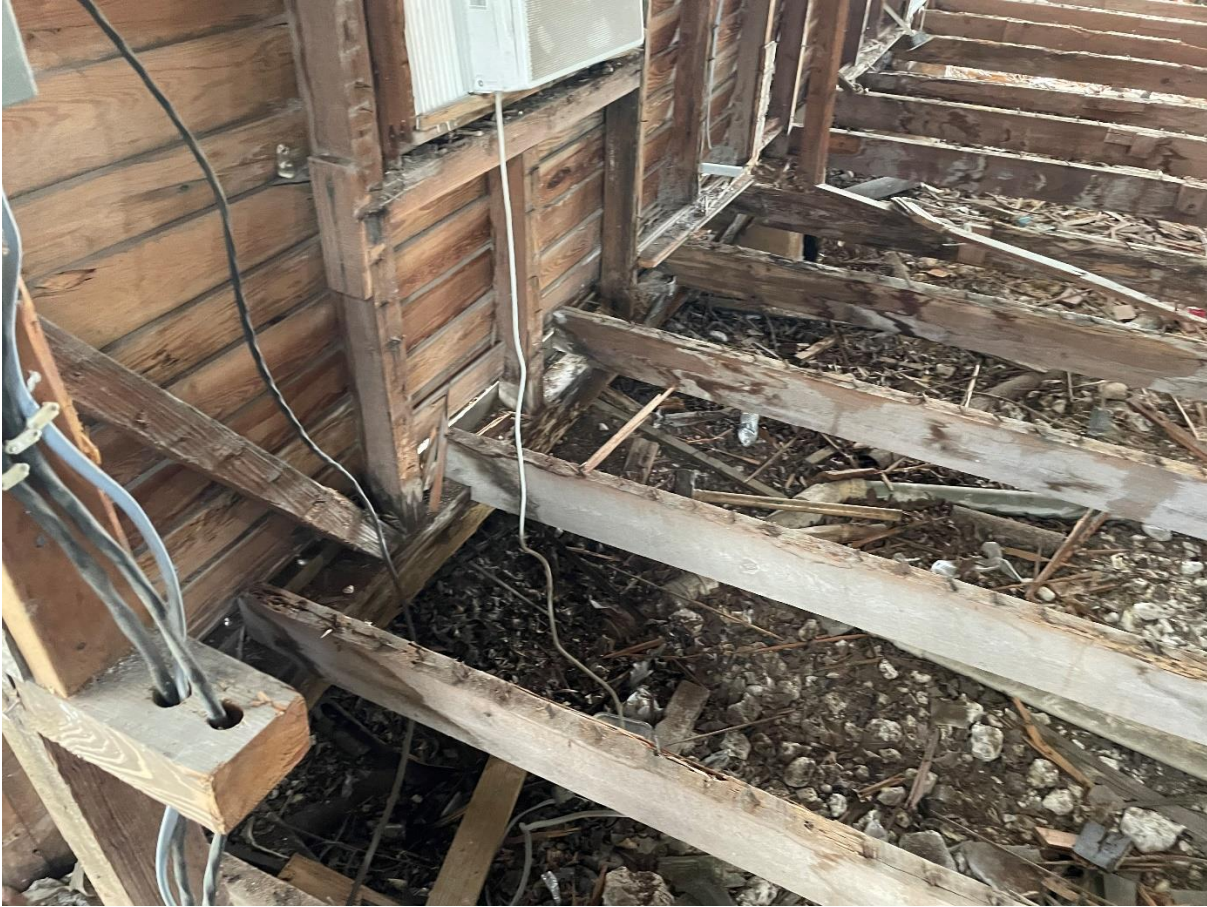
Overall, the structure is in poor condition. There is evidence of significant termite damage, water damage and rot in the framing. The wood rim beam is in poor condition with evidence of significant rot and termite damage and no longer adequately supporting the load-bearing wall studs and roof. The majority of window openings are damaged. The siding is in poor condition with numerous locations showing rot and decay. The structure has not been maintained and neglected for many years.

Photograph 3: View of the termite damaged rim beam, joists and studs.

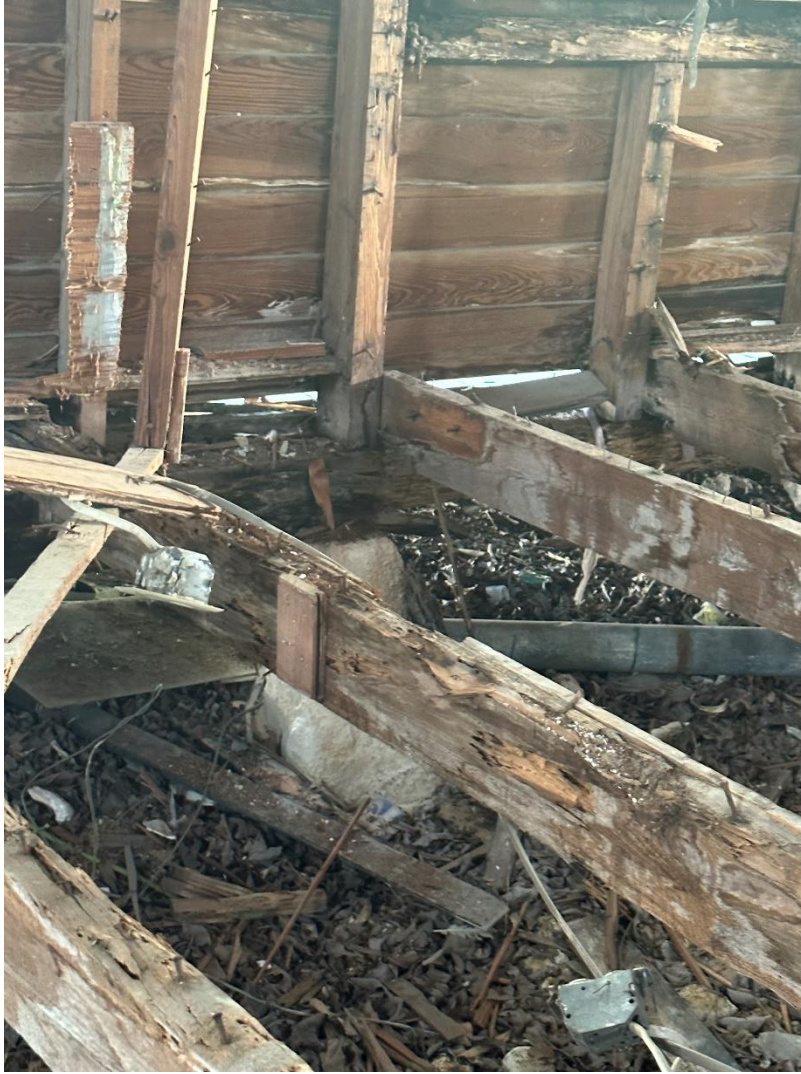
Photograph 4: Photograph of the interior joists, rim beam and window framing.

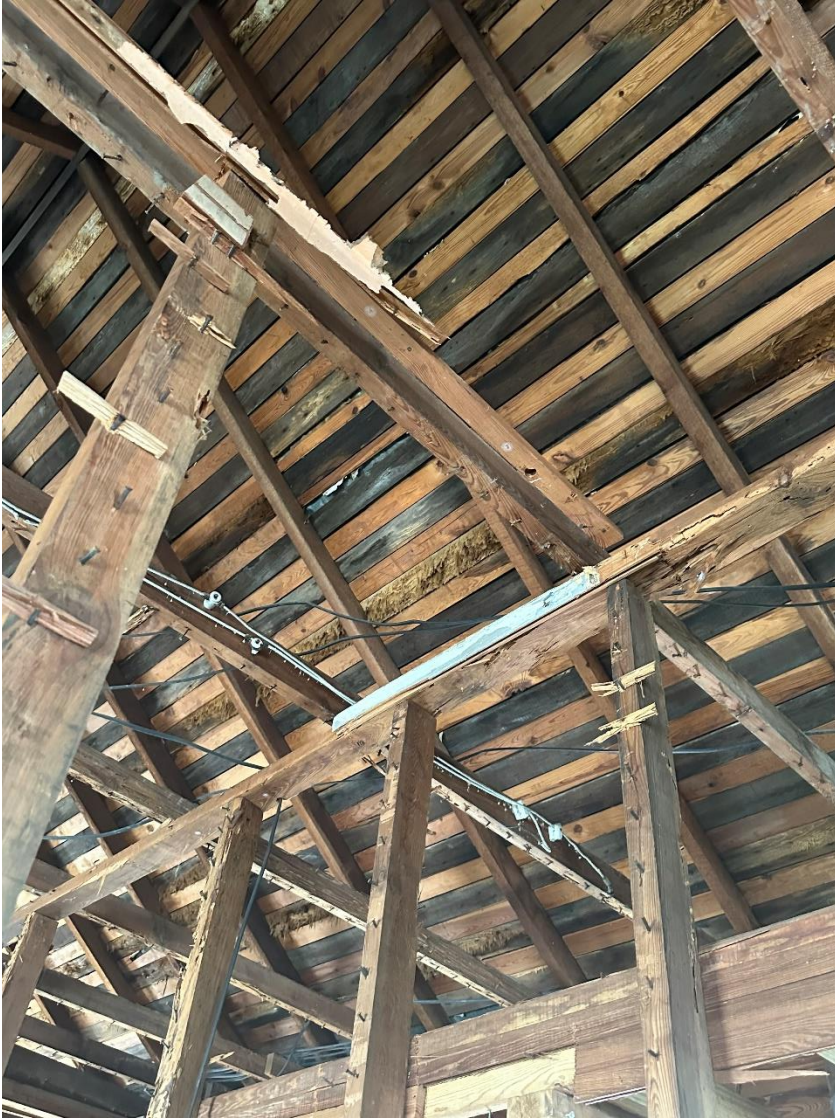
Photograph 5: Photograph of the undersized rafters and damaged wall framing.

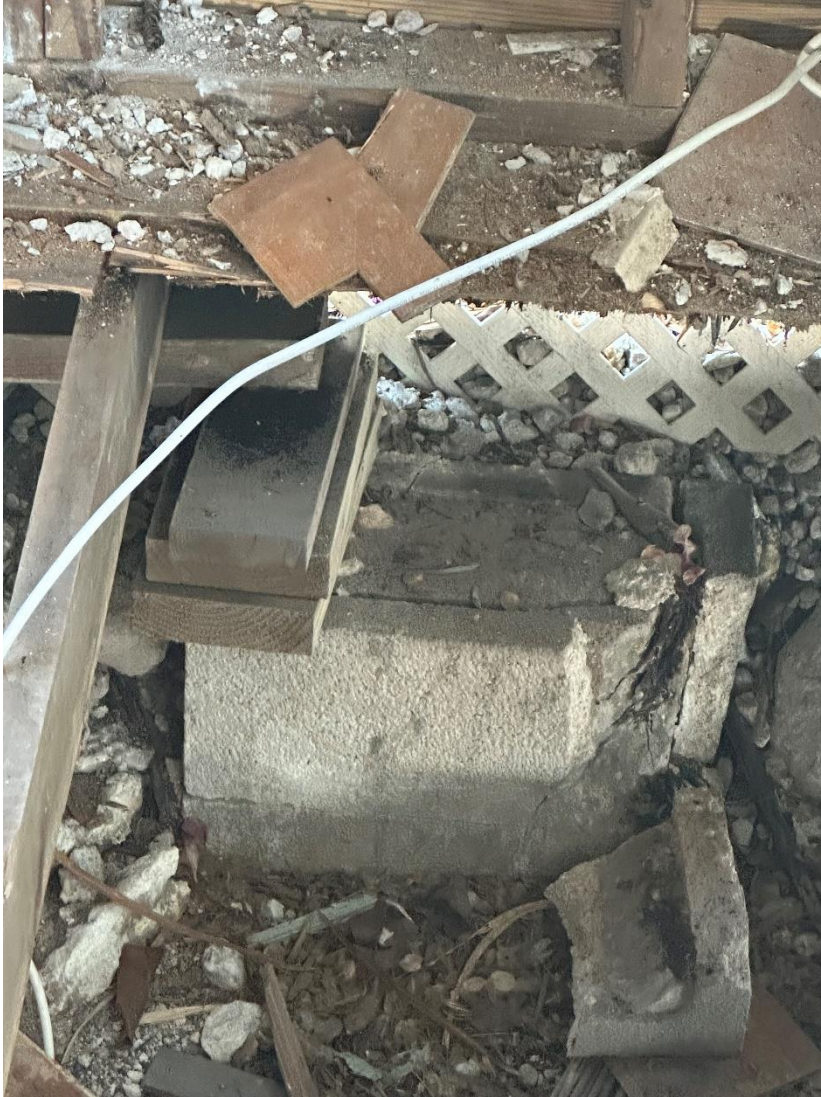
Photograph 6: Another photograph showing the foundation and damaged framing.

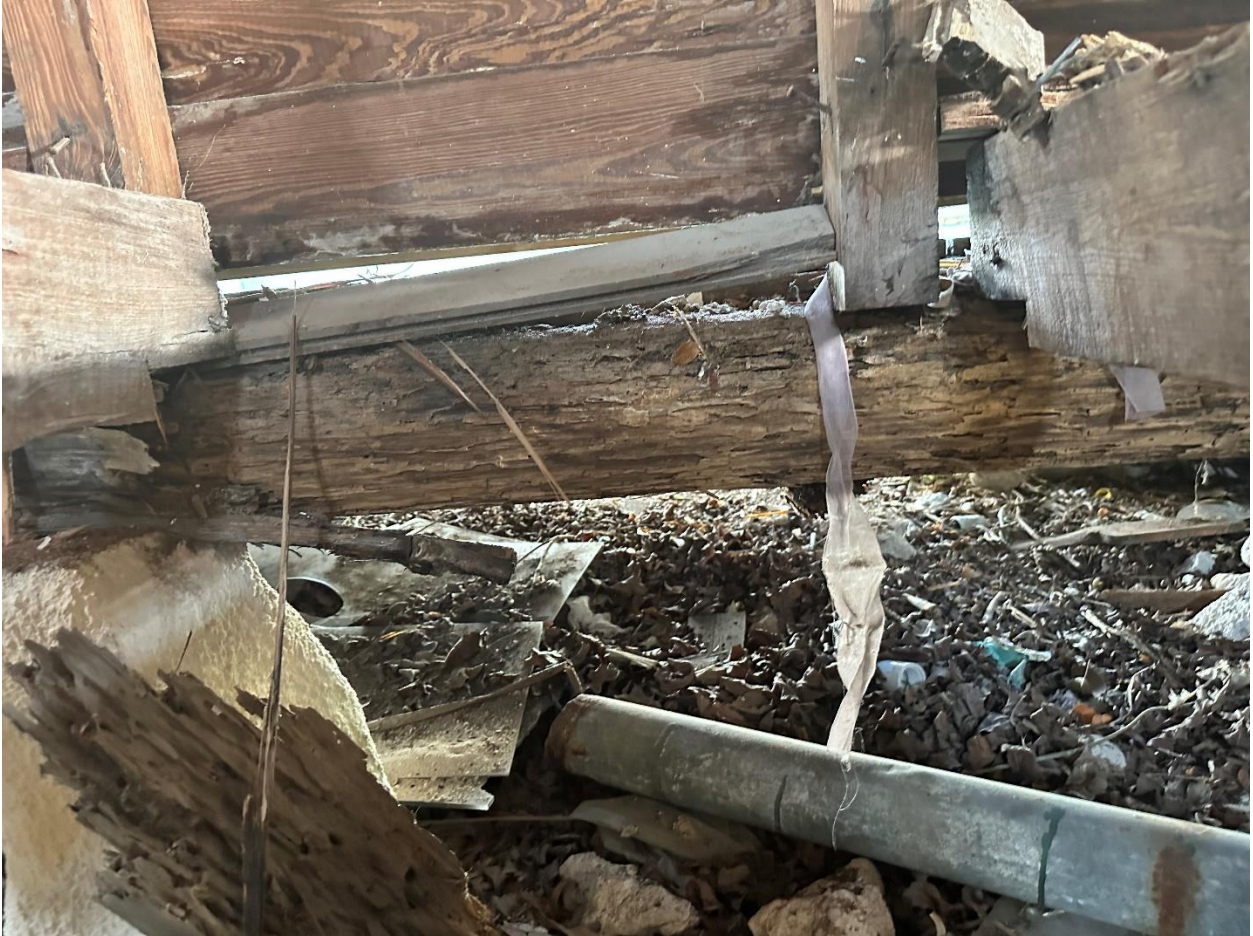
Photograph 7: Photograph of the damaged rim beam, eroded column and damaged studs and siding.
