Re: Compliance Assistance Offer
Stock Island Landfill-Closed
WACS 97636
Monroe County

**Florida Department of
Environmental Protection
Inspection Checklist**

Facility Name: STOCK ISLAND LF (SOUTHERNMOST WTE & KEY WEST LF)

FLORIDA DEPARTMENT OF ENVIRONMENTAL PROTECTION TRIP REPORT

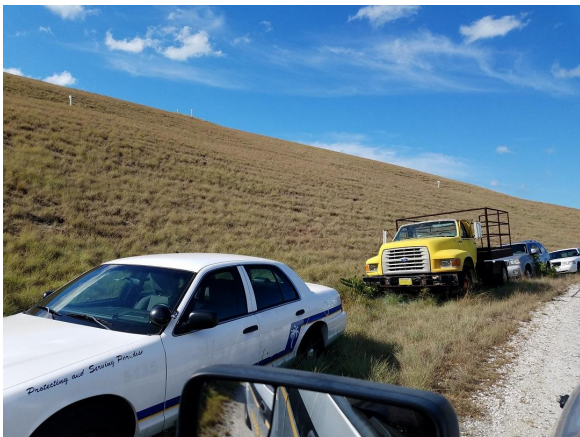
Explanation: Approximately 30 vehicles were being stored by the city on the north side of the landfill along the access road in the stormwater management area.

Vehicles along access road

Corrective Action: Remove vehicles so that stormwater management is fully operational.

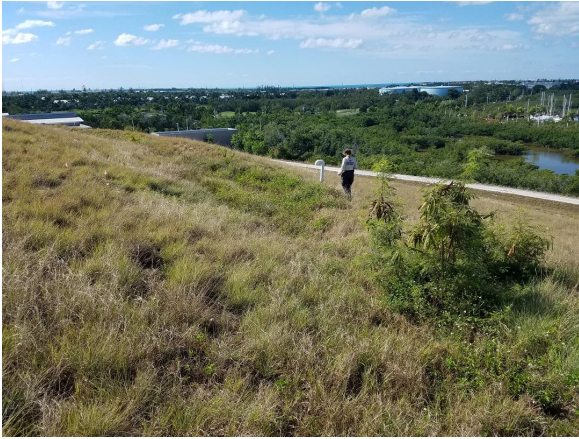
Explanation: The landfill cover does not show signs of recent mowing. Mr. Castro stated he does not remember when the last mowing event occurred. He further stated that the city's mower is not in operation at this time.

Overgrown plant on cover

Corrective Action: The city is supposed to mow the landfill cover six times a year. Mr. Castro stated that he is looking at getting a contractor to maintain the cover.

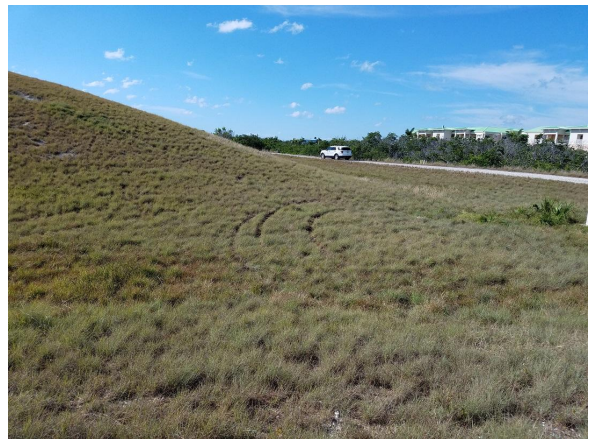
Tire tracks in NW swale
