Subject: Key West Garrison Bight Seawall Assessment

KEY WEST CITY MARINA AT GARRISON BIGHT
"CHARTER BOAT ROW" SEAWALL ASSESSMENT 2020

SUBMITTED: September 30, 2020

REVISED: October 9, 2020

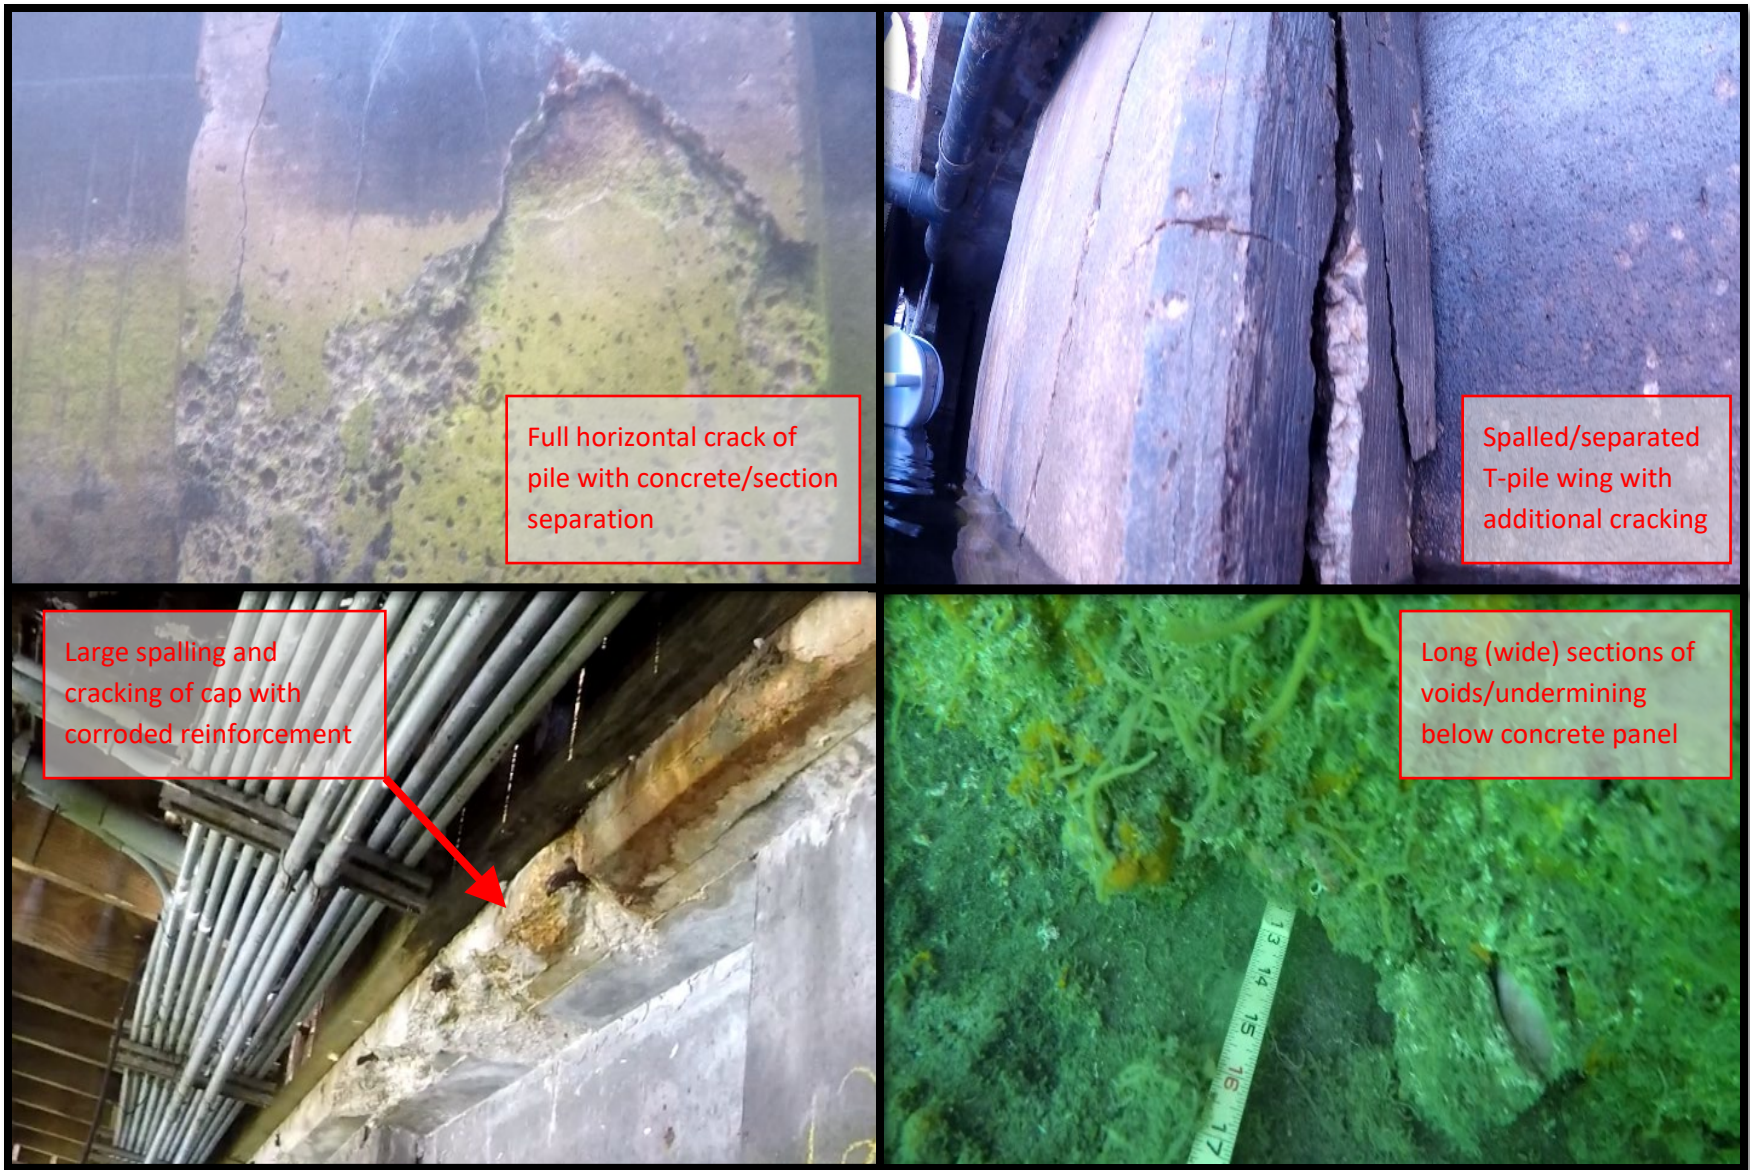
Figure 9: Typical Major Deficiencies – [Top Left] A-6 (Station 0+66), [Top Right] A-15 (Station 1+67), [Bottom Left] B-35 (Station 3+78), [Bottom Right] B-77 (Station 8+42 - 8+75)

For Major deficiencies as noted above, the deficiencies consisted of damage to the structural elements that can then significantly lead to damage of other adjacent structural elements. Mostly consisting of cracks/spalls on the piles, the weakened sections of the pile wings would lead to the concrete panel walls to begin tilting waterward. As most of the observed cracks/spalls were observed at the splash zone and above, it is clear that the loads behind the seawall will continue to add pressure to the seawall (greater along the top) escalating the damage already observed. With void/undermining areas beneath the concrete panel walls, the “rolling” effect of the seawall can become greater. The other possible effect of undermining is the loss of material behind the seawall which could lead to damage of upland structures (i.e. sidewalks, pavement, etc.). Areas most notably affected by these types of deficiencies, where compounding effects could lead to further damage and failure extend from approximately Station 7+38 to Station 7+96 and Station 8+42 to Station 9+86. Typical images of major deficiencies are shown on Figure 9.

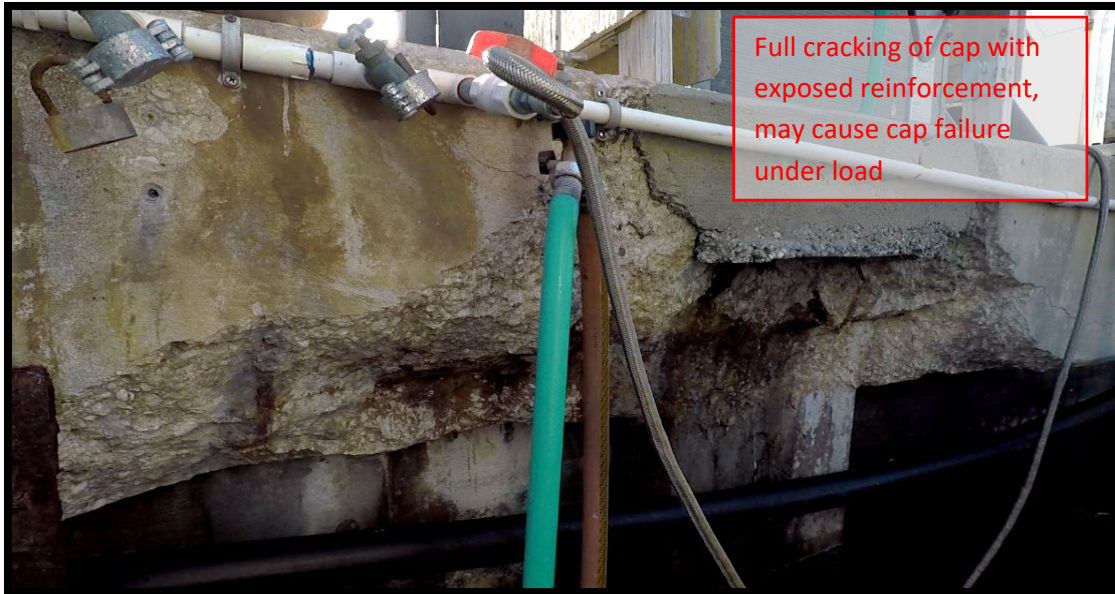
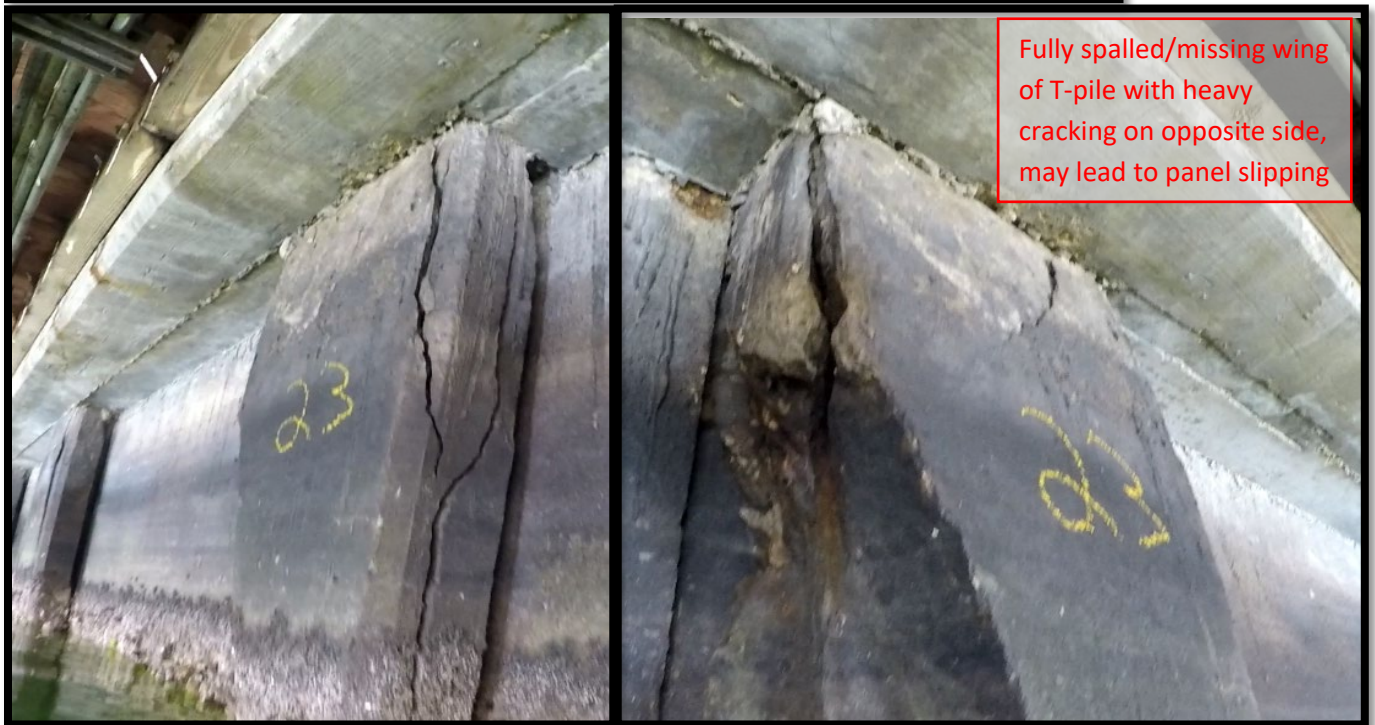
Figure 10: Critical Deficiencies – [Top] A-4 (Station 0+39), [Bottom] B-45 (Station 4+44)

For the Critical deficiencies noted above, of which there were only two (2), the deficiencies showed a failure of the structural element which can then have a cascading effect on the seawall system. At Station 0+39 the spalled concrete cap has exposed rebar that is regularly exposed to additional seawater, causing additional corrosion and leading to separation of the bond/delamination between the concrete cap and seawall. At Station 4+44 the spalled/missing concrete on the pile (Pile 65) appears to already be causing the shifting of the concrete panel wall, as evidenced by the visibility of the panel edge and the damage observed on Pile 66. Images of the critical deficiencies are shown on Figure 10.

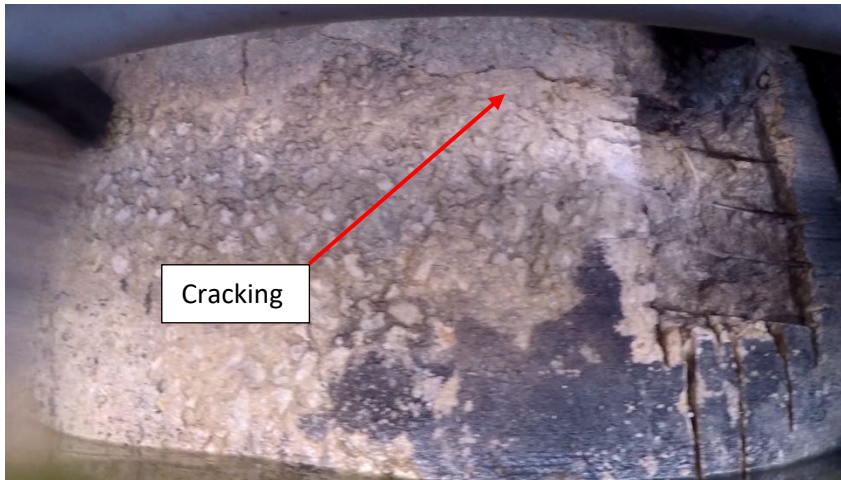
Deficiency A-1: Panel 3-4 (Station 0+14)

Baseline / Deficiency ID	Location / Pile #	Approx. Station Center	Deficiency Type	Description
A-1	Panel 3-4	0+14	Minor	14"x8" saw-cut hole in panel beside Pile 3 with some cracking extending from the cuts.
A-2	Pile 4	0+20	Moderate	22" long section of cracking along face/left wing with some spalling.
A-3	Pile 6	0+33	Moderate	Various cracks along face of pile up to 32" with impending spall.
A-4	Pile 7	0+39	Critical	60" long section of missing/spalled concrete in cap with corrosion/exposed rebar.
A-5	Pile 9	0+53	Minor	Hairline cracking observed at wings/face of pile.
A-6	Pile 11	0+66	Major	Full horizontal crack/separation near low-water line, and cracking along face/both wings with rust staining.
A-7	Panel 11-12	0+69	Moderate	Horizontal cracking along full length of panel, above water line.
A-8	Panel 12-13	0+75	Moderate	Void/undermining below panel with 10-23" of penetration.
A-9	Cap 13-16	0+84	Minor	Some horizontal hairline cracking observed along front face of cap.

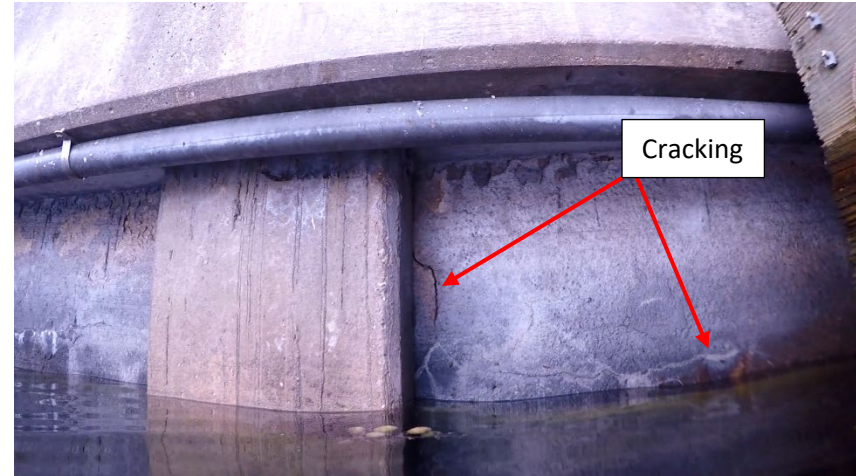
Deficiency A-19: Panel 27-28 (Station 2+12)

A-19	Panel 27-28	2+12	Moderate	Panel cracking next to Pile 28 (right side of pile), with cracks extending toward Pile 27.
A-20	Panel 28-29	2+17	Major	Horizontal cracking along full width of panel, above water line. Also, void/undermining below panel with 5" of penetration.
A-21	Pile 30	2+26	Major	Top right wing spalled/separated with multiple cracks on face of pile extending 38" from cap to below water.
A-22	Pile 31	2+33	Moderate	Cracks with some face spalling developing in front of both wings on face of pile extending 33" from cap to below water and rust staining.
B-23	Pile 35	2+51	Moderate	Cracks developing on face of pile, mostly right side, extending 28" from cap to below water.
B-24	Culvert Panel 36-37	2+60	Moderate	Multiple cracks developing above culvert opening with exposed aggregate around mouth of opening.
B-25	Pile 38	2+70	Minor	Crack beginning to develop on face of pile above water.

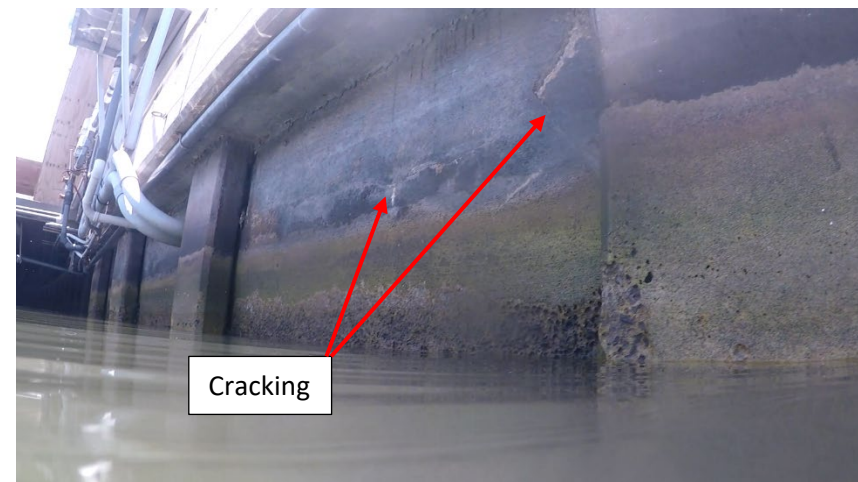
Deficiency B-26: Panel 40-41 (Station 2+86)

B-26	Panel 40-41	2+86	Moderate	Horizontal cracking along full width of panel, above water line, with additional cracks developing near Pile 40.
B-27	Panel 41-42	2+93	Moderate	Horizontal cracking beginning near pipe cutouts by Pile 41, extending along full width of panel, above water line.
B-28	Pile 42	2+96	Moderate	Cracks developing on face of pile extending 22" down from cap.
B-29	Panel 42-43	3+00	Moderate	Horizontal cracking along full width of panel, above water line.
B-30	Pile 43	3+04	Minor	Cracks beginning to form on face of pile with some rust staining.
B-31	Cap @ 47-48	3+33	Major	Spalled/broken-off chunk of concrete from cap with exposed rebar.
B-32	Pile/Cap 49	3+43	Moderate	Gap in concrete cap around top of pile with cracking developing along the cap.
B-33	Pile/Cap 50	3+50	Moderate	Cracking on front face of pile extending 23" down from cap. Also, 3 spalls/broken-off chunks, 6-12" wide, from cap at location of embedded reinforcement.

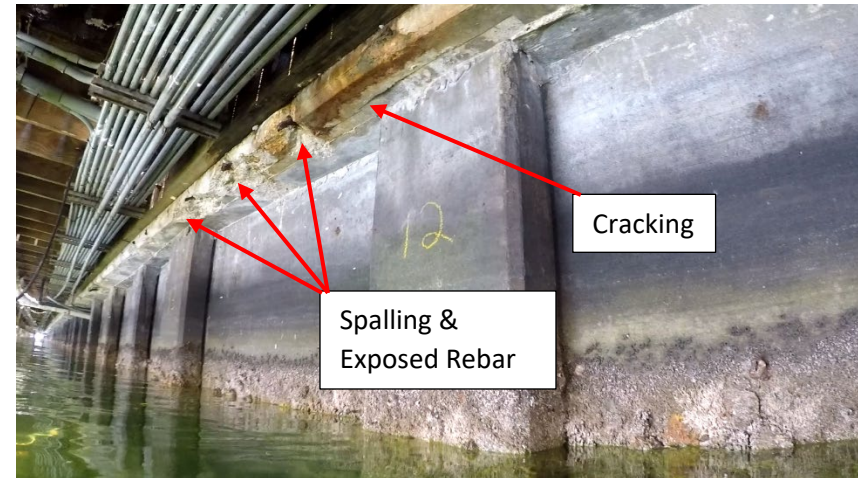
Deficiency B-35: Cap @54-55 (Station 3+78)

B-34	Cap @ 52	3+62	Minor	Small spall/broken edge of cap at location of embedded reinforcement.
B-35	Cap @ 54-55	3+78	Major	3 spalls/broken-off chunks, 10-12" wide, from cap at location of embedded reinforcement, with additional cracking occurring along the cap and at top of cap.
B-36	Pile/Cap 56	3+86	Moderate	Cracking on right wing of pile extending 21" down from cap. Also, 2 spalls/broken-off chunks, 6" wide, from cap at location of embedded reinforcement.
B-37	Pile 57	3+93	Moderate	Cracking with initial separation at right wing of pile extending 29" down from cap to below water.
B-38	Cap @ 57-58	3+95	Major	40" long section of spalled concrete from the cap with exposed rebar around locations of embedded reinforcement, with hairline cracking at top of cap.
B-39	Cap @ 58-59	4+01	Moderate	2 spalls/broken-off chunks, 8-16" wide, from cap at location of embedded reinforcement.
B-40	Pile 59	4+05	Moderate	Cracking with initial separation at right wing of pile extending 24" down from cap to below water.

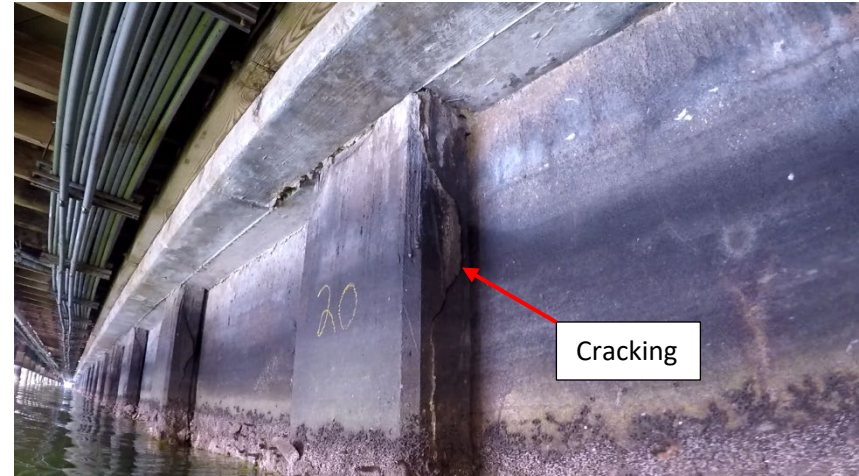
Deficiency B-42: Pile 62 (Station 4+25)

Baseline / Deficiency ID	Location / Pile #	Approx. Station Center	Deficiency Type	Description
B-41	Pile 60	4+12	Major	Cracking along both wings and face with impending spalls, extending 28" down from cap to water.
B-42	Pile 62	4+25	Moderate	Cracking at right wing extending 24" down from cap.
B-43	Pile 63	4+31	Moderate	Cracking at right wing extending 24" down from cap with additional cracks on the face of the pile.
B-44	Pile 64	4+37	Moderate	Cracking at both wings extending 18" down from cap with additional cracks/spalls on the face of the pile.
B-45	Pile 65	4+44	Critical	Heavy cracking/impending spall of right wing extending down the full pile, fully spalled sections of pile at left wing with exposed/corroded rebar, and spalled/missing concrete toward mudline at pile-panel interface with 6-10" of penetration behind pile.
B-46	Pile 66	4+50	Major	Heavy cracking/impending spalling of both wings at front face of pile, extending 36" down from cap to below water.

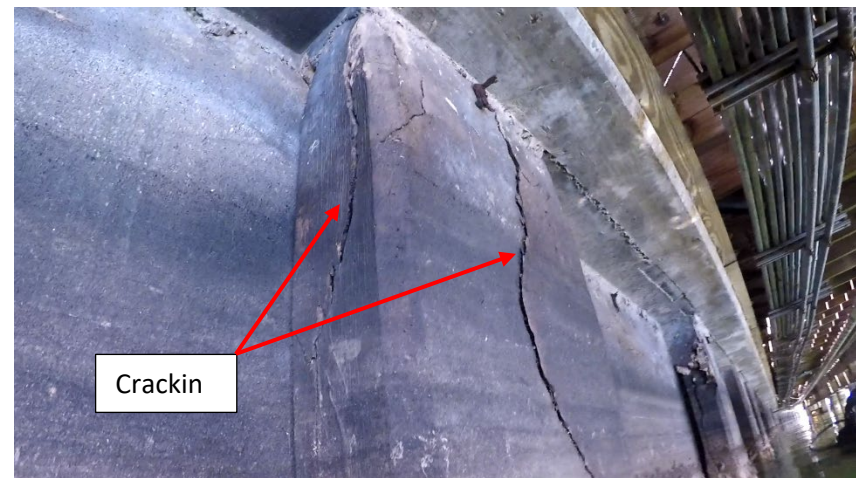
Deficiency B-48: Pile 69 (Station 4+70)

B-47	Pile 68	4+63	Major	Cracking at both wings and face of pile extending 24" down from cap and spalled/missing sections of concrete along left wing.
B-48	Pile 69	4+70	Moderate	Cracking at left wing and face of pile with impending concrete spalling, extending 27" down from cap.
B-49	Pile 70	4+76	Moderate	Cracking at left wing of pile extending 26" down from cap, and some cracking beginning to develop toward right face of pile.
B-50	Pile/Cap 71	4+83	Moderate	Various cracks along face and wings of pile extending 17-24" down from cap with signs of impending spalls. Also, approx. 24"x24" section of honeycombing at bottom of cap with apparent gaps between cap and pile.
B-51	Pile 72	4+90	Moderate	Various cracks at right wing and face of pile extending 25" down from cap to water.
B-52	Pile 73	4+99	Moderate	Spalled/missing concrete at top right wing of pile approx. 3"x7", with seeming separation between the pile and cap.

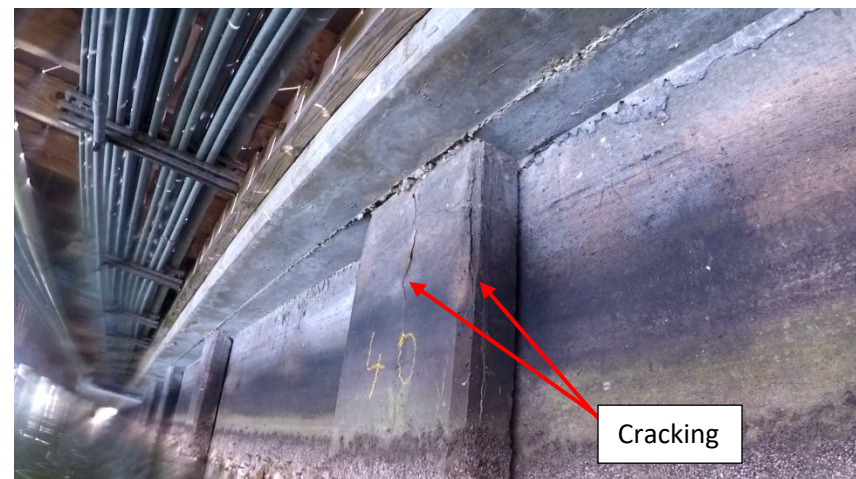
Deficiency B-54: Pile 82 (Station 5+70)

B-53	Pile/Cap 79	5+48	Moderate	Various cracks along face of pile extending 27" down from cap, and various locations of honeycombing underneath the cap. Also some cracking visible at top of cap.
B-54	Pile 82	5+70	Moderate	Cracking on right wing and face of pile extending 20" down from cap.
B-55	Pile 86	6+02	Minor	Cracks beginning to develop on right wing of pile.
B-56	Pile 89	6+27	Minor	Cracks beginning to develop on wings and face of pile.
B-57	Pile 92	6+51	Minor	Cracks developing on pile extending 26" down from cap.
B-58	Cap @ 95	6+76	Moderate	2"x6" cavity in cap next to Pile 95 with 2-4" penetration.
B-59	Pile 96	6+82	Minor	Cracks developing on pile extending 24" down from cap.
B-60	Pile 97	6+90	Moderate	Cracking on right wing and face of pile extending 27" down from cap.
B-61	Pile 98	6+99	Moderate	Cracking on face of pile extending 23" down from cap with concrete separation, and additional cracking on wings.

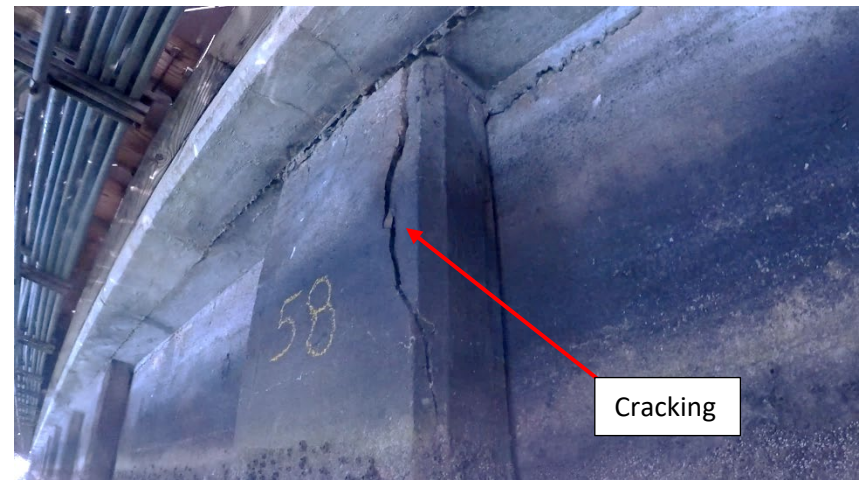
Deficiency B-62: Pile 100 (Station 7+15)

B-62	Pile 100	7+15	Major	Large crack with concrete separation of right wing of pile extending 23" down from cap.
B-63	Pile 101	7+22	Moderate	Cracking developing on face of pile extending 24" down from cap.
B-64	Panels 103-110	7+38 to 7+96	Major	Voids/undermining beneath panels along approximately 58-ft section with 4-10" of penetration.
B-65	Pile 103	7+38	Major	Large cracks with concrete separation on face and left wing of pile extending 22" down from cap.
B-66	Pile 104	7+47	Moderate	Cracking on face and right wing of pile extending 24" down from cap.
B-67	Pile 105	7+55	Major	Large cracks with concrete separation on left wing of pile extending 30" down from cap, and cracks beginning to form on face by right wing of pile.
B-68	Pile 106	7+63	Moderate	Cracking on face of pile extending 24" down from cap with impending spall of concrete cover.
B-69	Pile/Cap 107	7+71	Moderate	Cracking on face of pile extending 17" down from cap with impending spall of concrete cover. Some hairline cracking also visible at top of cap.

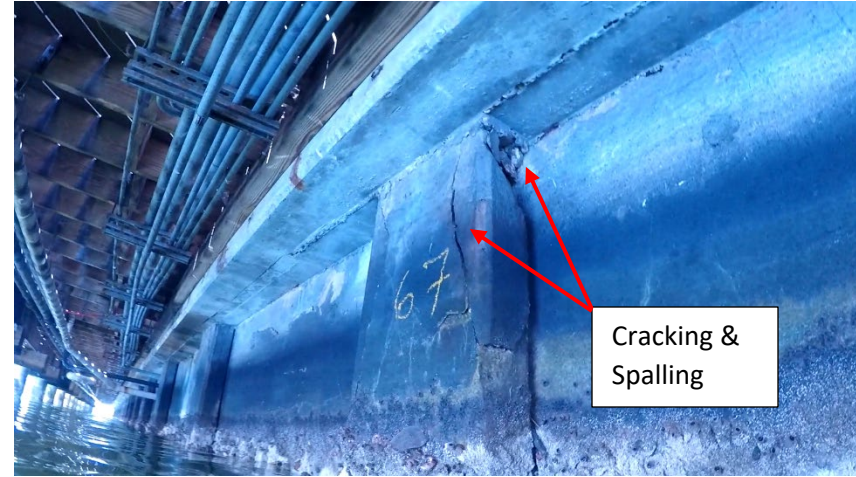
Deficiency B-71: Pile 109 (Station 7+88)

B-70	Pile 108	7+80	Moderate	Cracking on face at right wing of pile extending 17" down from cap, and spalled/missing concrete along base of pile at mudline at both wings.
B-71	Pile 109	7+88	Major	Large crack and missing/spalled concrete with concrete separation of right wing extending 24" down from cap, and cracking occurring at left wing.
B-72	Panels 111-116	8+03 to 8+38	Major	Voids/undermining beneath panels along approximately 35-ft section with 3-6" of penetration.
B-73	Pile 112	8+11	Minor	Cracks beginning to develop on face and wing of pile, with some rust staining.
B-74	Pile/Cap 113	8+19	Moderate	Cracking on left wing of pile extending 20" down from cap, and additional cracking forming on face of pile. Some hairline cracking also visible at top of cap.

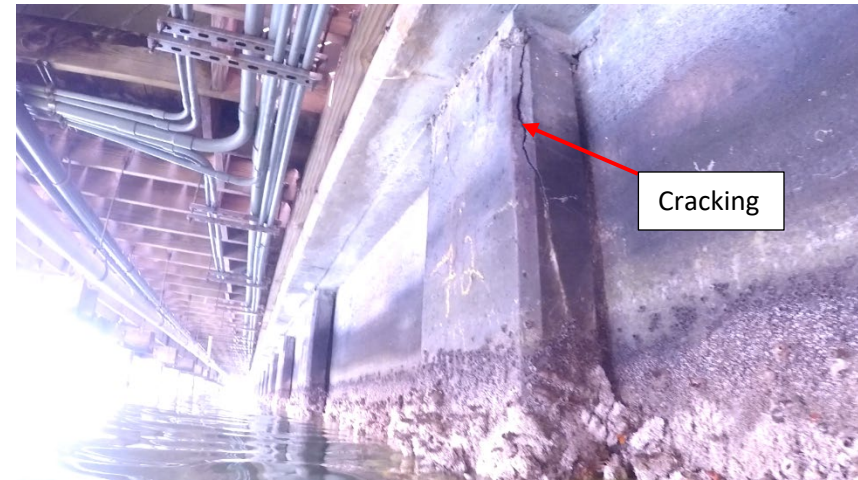
Deficiency B-75: Pile 114 (Station 8+27)

Baseline / Deficiency ID	Location / Pile #	Approx. Station Center	Deficiency Type	Description
B-75	Pile 114	8+27	Moderate	Cracking on right wing of pile extending 24" down from cap, and additional cracking forming on left wing of pile.
B-76	Pile 115	8+35	Moderate	Cracks developing on face of pile extending 20" down from cap, with rust staining.
B-77	Panels 116-120	8+42 to 8+75	Major	Voids/undermining beneath panels along approximately 35-ft section with 8-14" of penetration.
B-78	Pile/Cap 117	8+50	Major	Cracking on right wing of pile with some concrete separation extending 23" down from cap, and additional cracking forming on left wing of pile. Bottom of pile at the mudline has missing/spalled concrete. Cap has some scattered small areas of honeycombing.
B-79	Pile/Cap 118	8+58	Major	Various cracks on face of pile with some concrete spalling extending 25" down from cap, with cracking also occurring on panel. Also, various areas of honeycombing are seen on the cap near Pile 118.

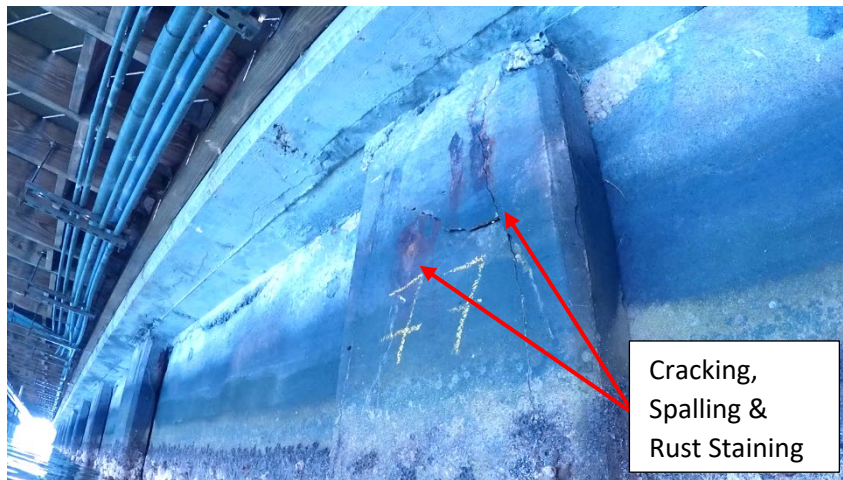
Deficiency B-80: Pile 119 (Station 8+67)

B-80	Pile 119	8+67	Major	Cracking with impending spalling on both wings of pile extending 24" down from cap with additional cracking across the face of the pile, with rust staining.
B-81	Pile 121	8+83	Moderate	Cracking on face and right wing of pile extending 21" down from cap, and with rust staining seeping from the cracks. Also, some cracking on the panel adjacent to the pile.
B-82	Panels 121-123	8+83 to 8+98	Major	Voids/undermining beneath panels along approximately 15-ft section with 3-8" of penetration, and spalled/missing portions of Pile 122 at bottom near mudline.
B-83	Cap @ 124-127	9+04 to 9+25	Moderate	Multiple locations on bottom of cap with areas of honeycombing, with some extending to the panel and causing cracks to form.
B-84	Panel 124-125	9+10	Moderate	Void/undermining below panel with 9-15" of penetration.
B-85	Pile 126	9+23	Major	Large section of right wing of pile cracking/spalling extending 27" down from cap with rust staining, and cracking forming along left wing of pile.

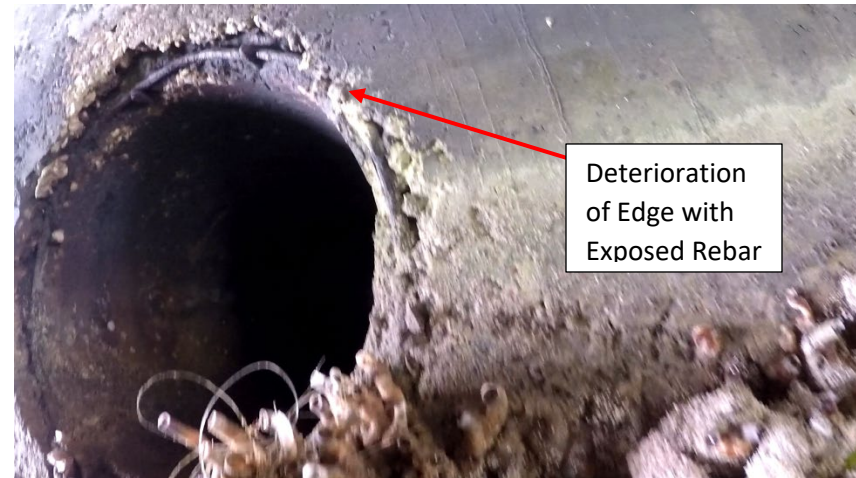
Deficiency B-88: Culvert Panel 128-129 (Station 9+43)

Deterioration of Edge with
Exposed Rebar

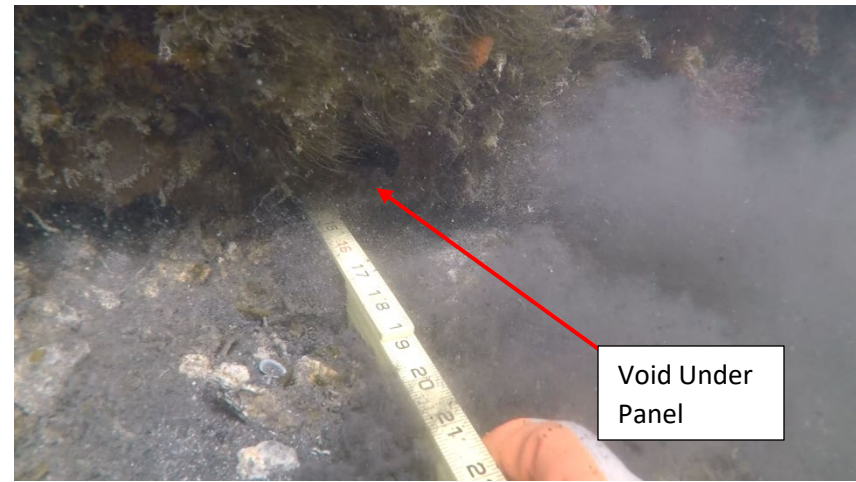
Deficiency B-102: Panel 139-140 (Station 10+06)

B-100	Pile 138	9+96	Moderate	Top of pile cracked just below the cap.
B-101	Pile 139	10+02	Moderate	Cracking along face and left wing of pile extending 29" down from cap.
B-102	Panel 139-140	10+06	Moderate	Void/undermining below panel with 5-13" of penetration.
B-103	Pile 140	10+09	Moderate	Cracking along face and left wing of pile extending 24" down from cap.
