CITY OF KEY WEST

PROJECT: GR1503 / SEAWALL REPAIR & REPLACEMENT OPTIONS

SEPTEMBER 2015

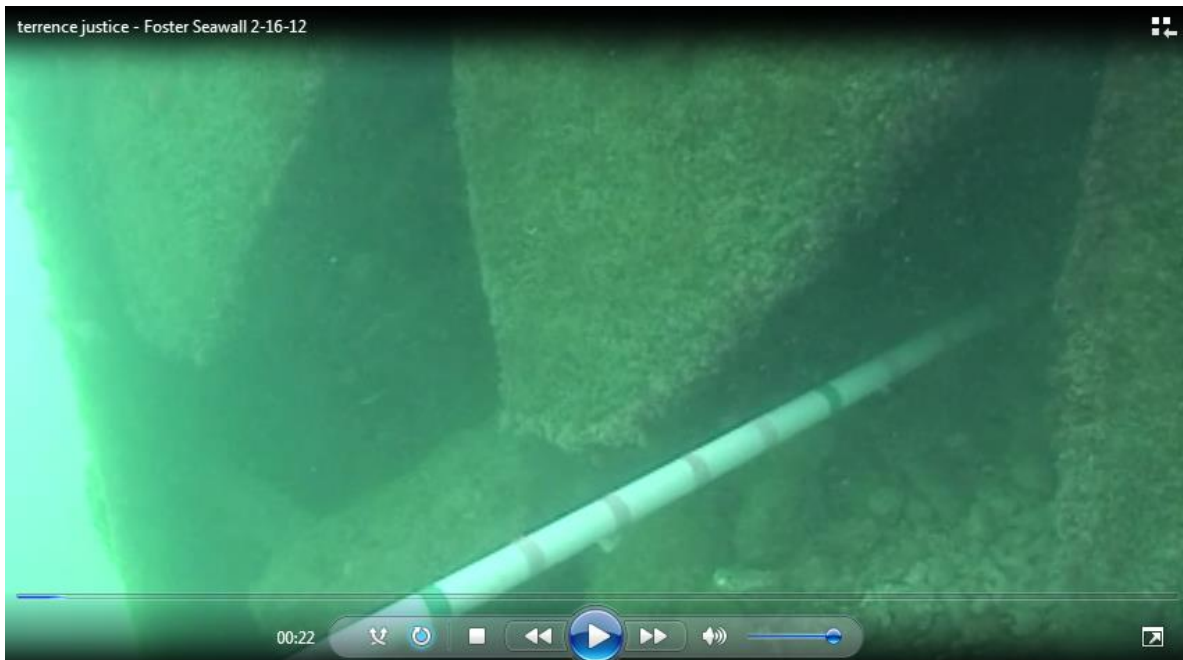
Insert 1: Video (0.22 Minutes) East End of Seawall near Boat Ramp

Based on a review of the video provided to Tetra Tech, the panels of the seawall appear to be in relatively good condition for their age. The issue is that at several points along the seawall, those panels are completely unsupported at the toe. That means the only thing keeping them in place is the wale beam and whatever connections are made in the concrete cap. If the support being provided in these locations along the wall fails those panels in jeopardy could drop several feet and roll into the basin.

At the point nearest the boat ramp, the video shows newer steel sheets (on the left hand side of Insert 1 above). This freeze frame shows the voids behind and under the wall. Because the slope is so steep in front of this wall, it will be very difficult to stabilize the erosion in this area without using a driven sheet in front of the old wall.

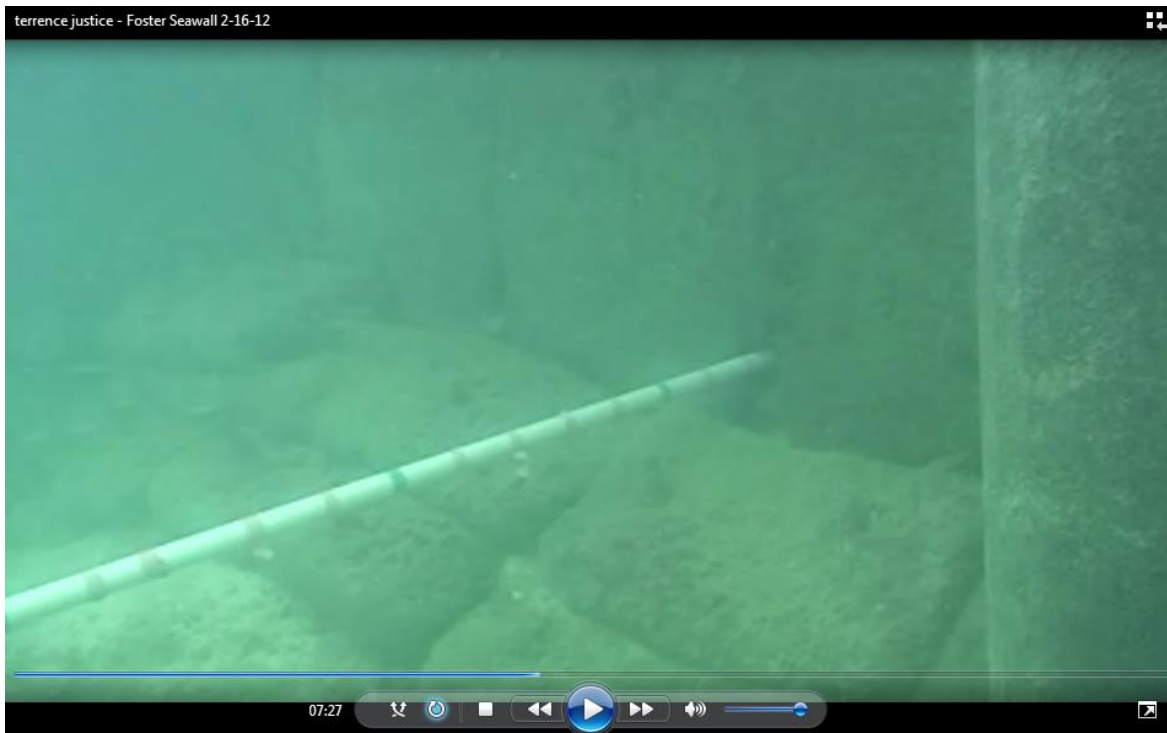
Insert 2: Video (7.27 Minutes), shows the point where the wall transitions from sack-crete toe protection to the cast in place toe protection. Notice in the photo above where the bottom of the panels are becoming visible. The pole looks like it is sticking in between the toes of two panels.

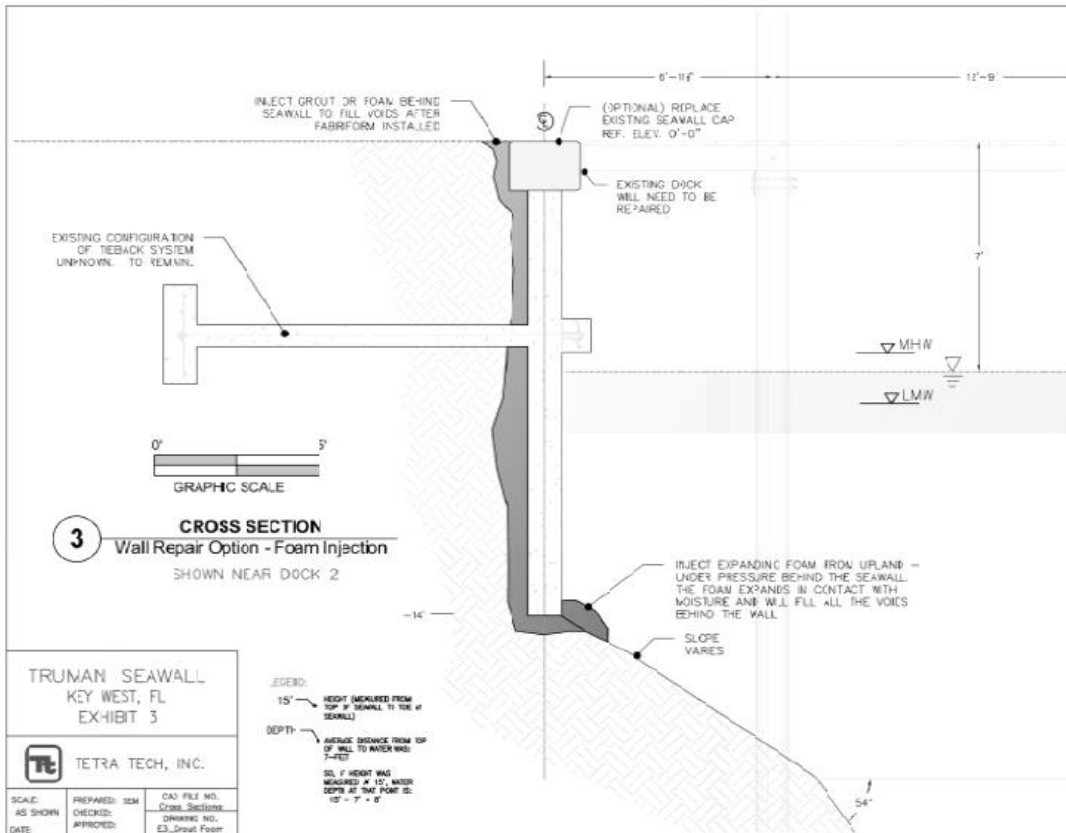
Insert 3: [Exhibit 3] "Stable Soils" Seawall Repair

Exhibit 3 shows a typical wall condition with an exaggerated void behind the wall. The repair method proposed in this exhibit is called Expanding Polyurethane Injection and can be performed by at least one relatively local (Florida) contractor. This contractor was contacted and provided with the characteristics of the existing wall and asked to submit a quote for this application. The quote from Stable Soils for \$150,720 and has been included with other estimates in **Exhibit 14**. The foam is injected in a tremie-type application by placing rods behind the wall at 3-5 feet on center, from the ground surface down to near the toe of the existing wall. As the foam is injected, the operator monitors the front of the wall looking for foam to float up indicating the foam has made it all the way through the opening. A floating turbidity curtain is used out in front of the wall to prevent foam from escaping into the basin. Total repair method cost is estimated to be **\$150,720**, with only a minimal amount of permitting or engineering cost which can be completed by the contractor.

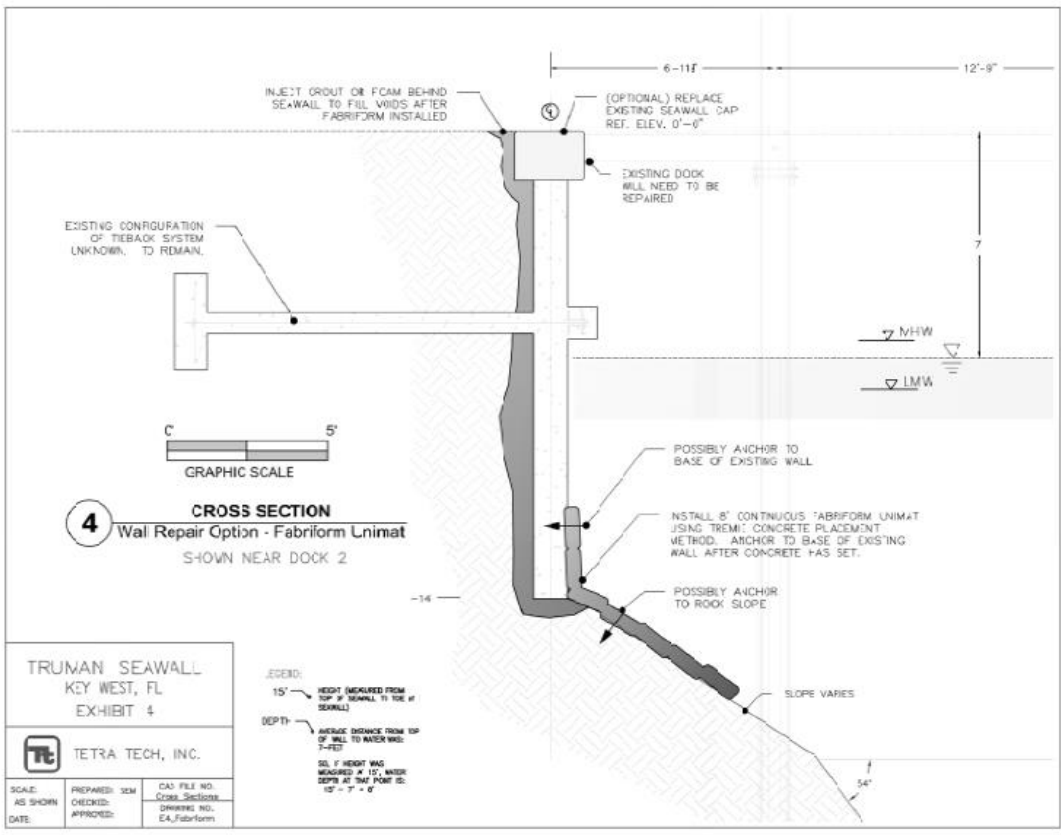
Insert 4: [Exhibit 4] “Stable Soils” Seawall Repair with Fabriform Toe Protection

Exhibit 4 has the same general cross section but adds the installation of toe protection to the wall in the form of a Fabriform Unimat. For this preliminary repair study Tetra Tech asked for a quote from Underwater Engineering Services, Inc. (UESI) for the installation of the Fabriform mat (using their commercial dive team) and was given a “verbal” estimate for approximately \$50,000 for the mat only. Any repair option should also include some method of pinning the mat in place. The estimate for the anchoring would add at least another \$25-50,000 and require the use of helical piles installed hydraulically along the toe of the wall or some other soil pinning method. The video shows the existing concrete bags pinned to the ground by what appears to be rebar hammered into the slope.

We do not recommend this option without attempting to fill the voids behind the wall as well. So, adding the previous repair option (expanding polyurethane injection, \$150,720K) to the Fabriform installation the estimated cost is: \$150,720 + \$50,000 + \$50,000 = **\$250,720.**

A repair near the east end (boat ramp) of this wall would be difficult using this technique because the fabriform would simply be too vertical. Although this would be suitable for repair along a majority of the wall, it does not appear to be suitable for the entire length.

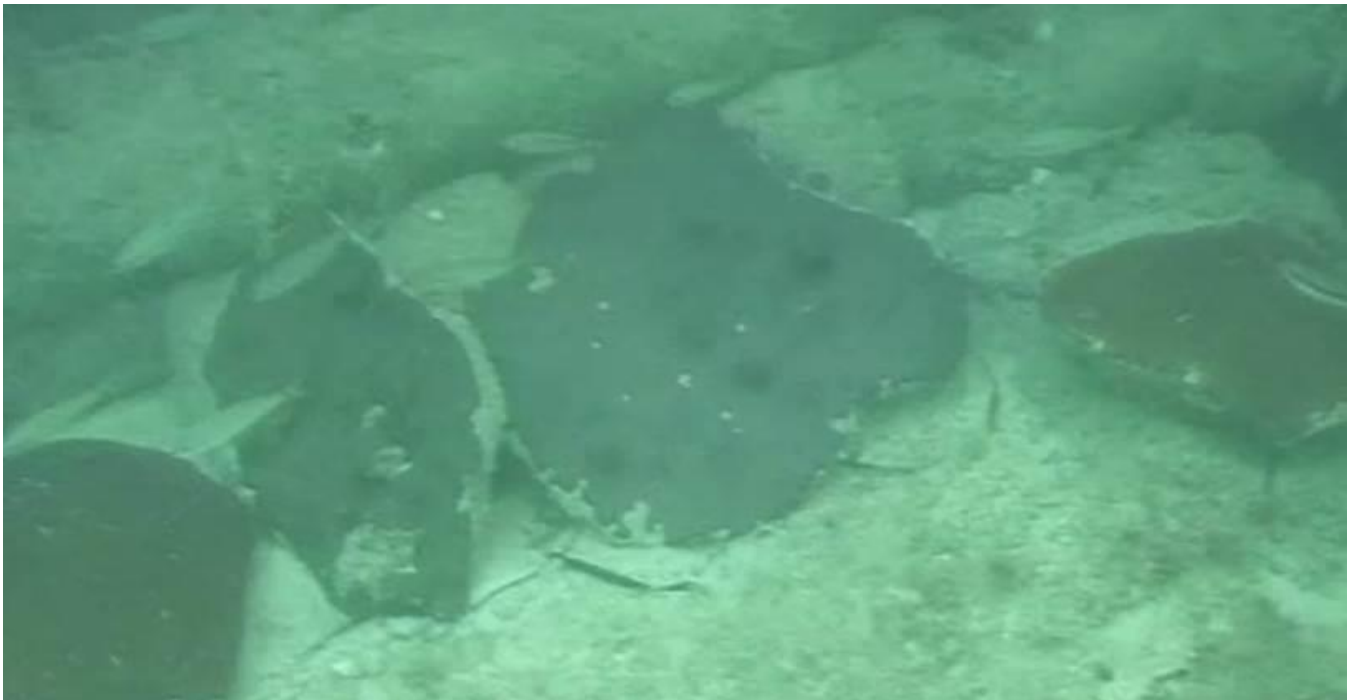
Insert 10: Toe of Existing Seawall – NOAA placed Corals

Tetra Tech has had preliminary discussions with NOAA regarding the small coral on the existing concrete panels and the corals that had been placed by NOAA near the toe of the wall. It is our understanding that NOAA will be performing a site survey (dive) in a few weeks to determine what type of rescue will be required prior to construction. The following picture shows some of the corals that have been placed on the toe of the wall by NOAA.

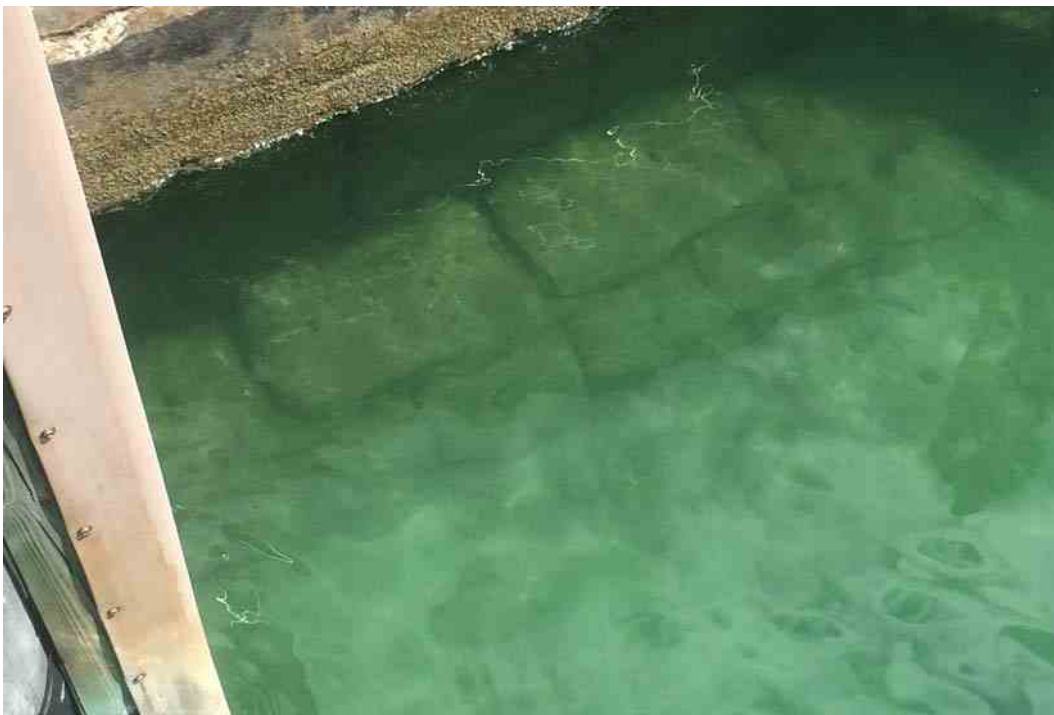
4) Sand-Cement Bags by Toe of Seawall

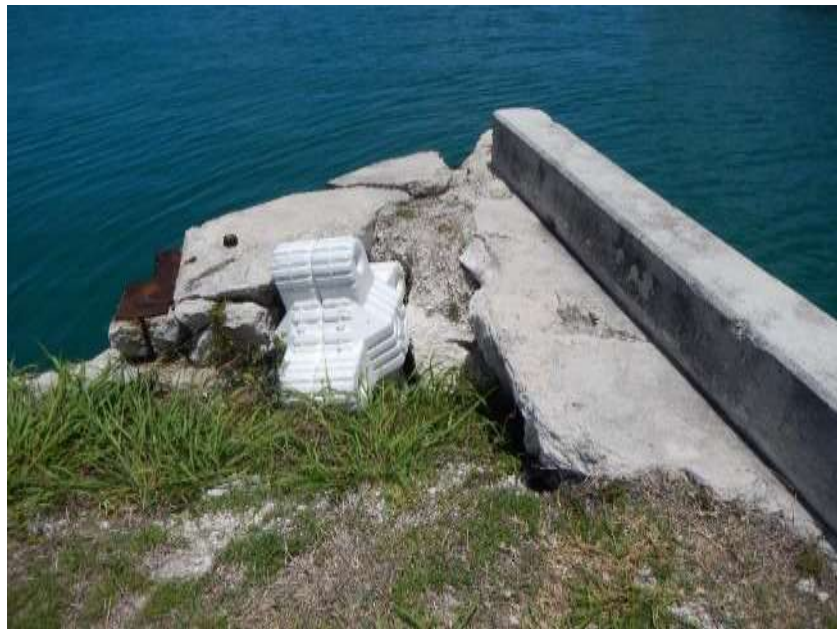
The seawall cap at the tip of the triangle on the Northeast end of the wall is broken and damaged. A buoy is covering a hole. Looking Northwest.

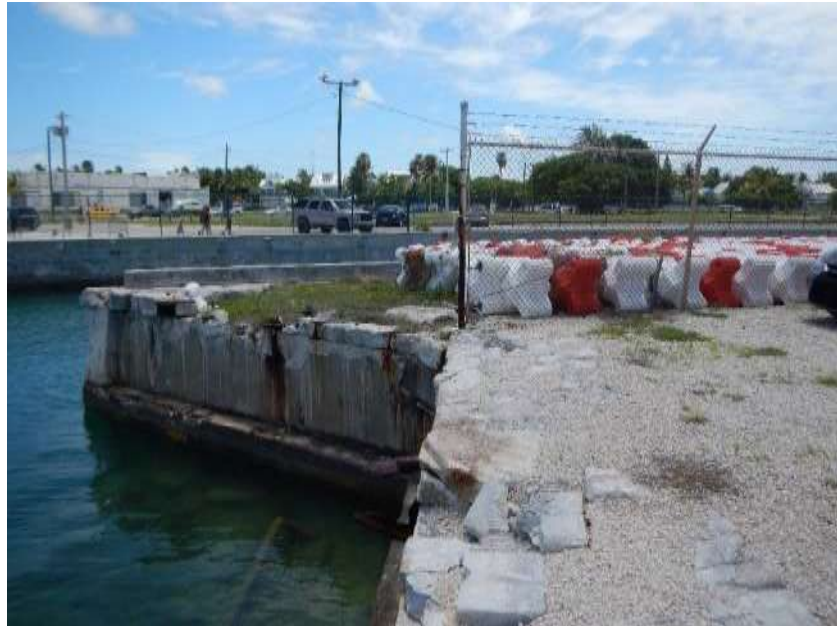
The Northeast end of the NOAA seawall. The concrete seawall cap does not extend all the way to the edge (damage is apparent). Quikrete bags appear to have been placed along the line where the cap should run. Looking Northeast.

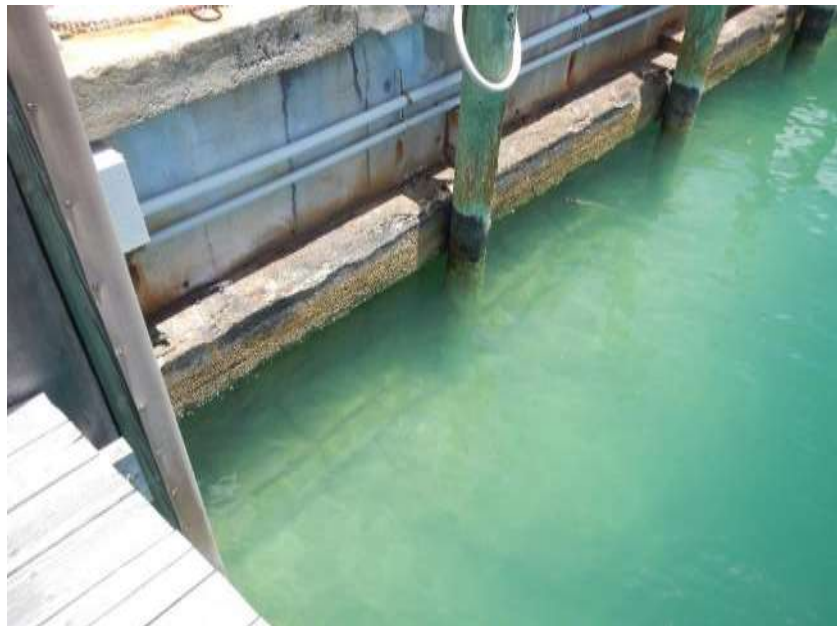
View of the seawall from Dock 2 – right. Quikrete bags are visible along the bottom edge of the seawall.

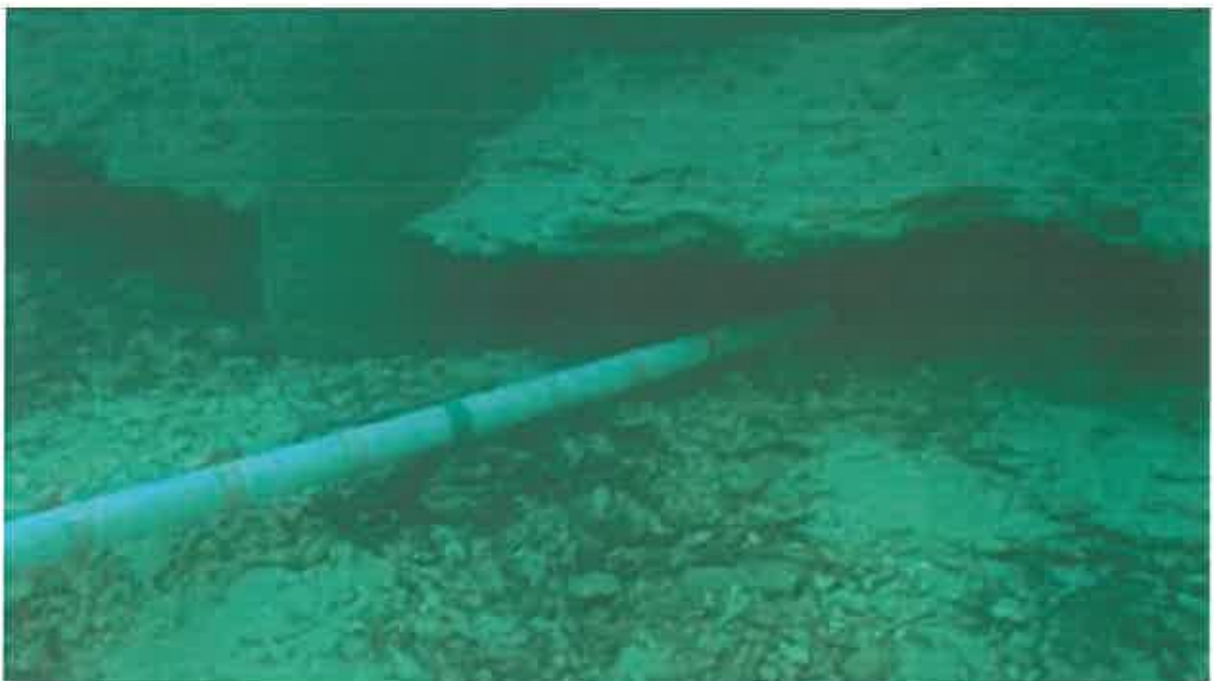
Undermining of the tremie concrete repairs at the base of the bulkhead.

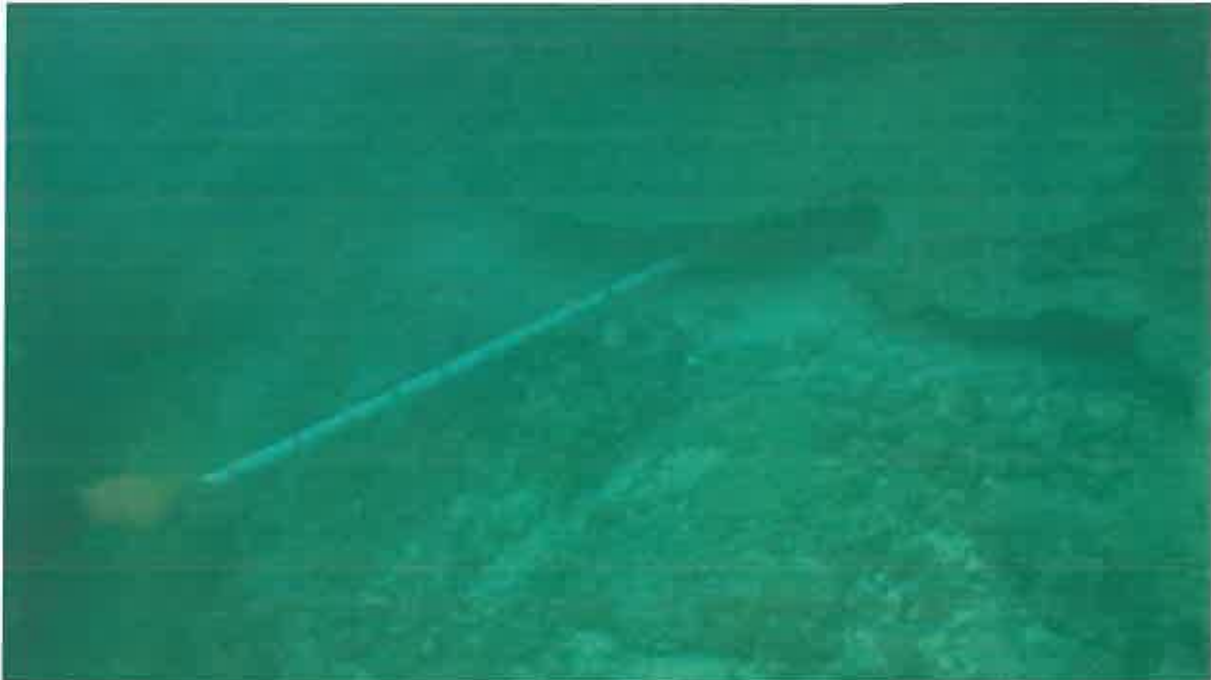
Undermining of the tremie concrete repairs at the base of the bulkhead. Note the steep slope of the dredge line.

If NOAA desires to pursue a near term solution that will plug the holes at the base of the bulkhead and reinforce to some degree the soft limestone bottom, I would recommend a tremie pour similar to what was done before. It is understood that this is not an engineered solution but rather a preventative maintenance measure against sinkholes. This approach was discussed openly amongst the group and the final concept is detailed in sketches SK-1, SK-2, and SK-3 attached. The tremie pour will be wide enough to encompass the Quikrete sacks on the eastern half of the site and high enough to cap the existing tremie pour on the west half.

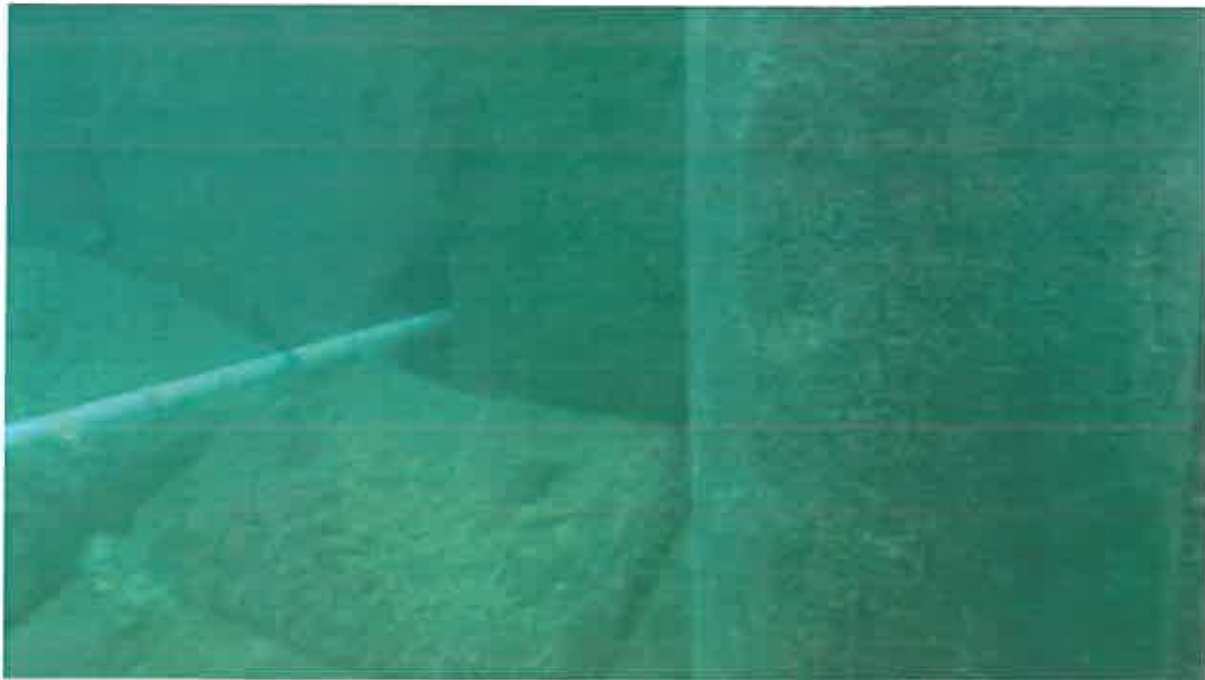
Quikrete concrete sacks placed in front of the sheet piling. Cavity evident above the sacks.
