STAFF REPORT

RE: 255 Trumbo Road (application # TP2022-0003)

FROM: Karen DeMaria, City of Key West Urban Forestry Manager

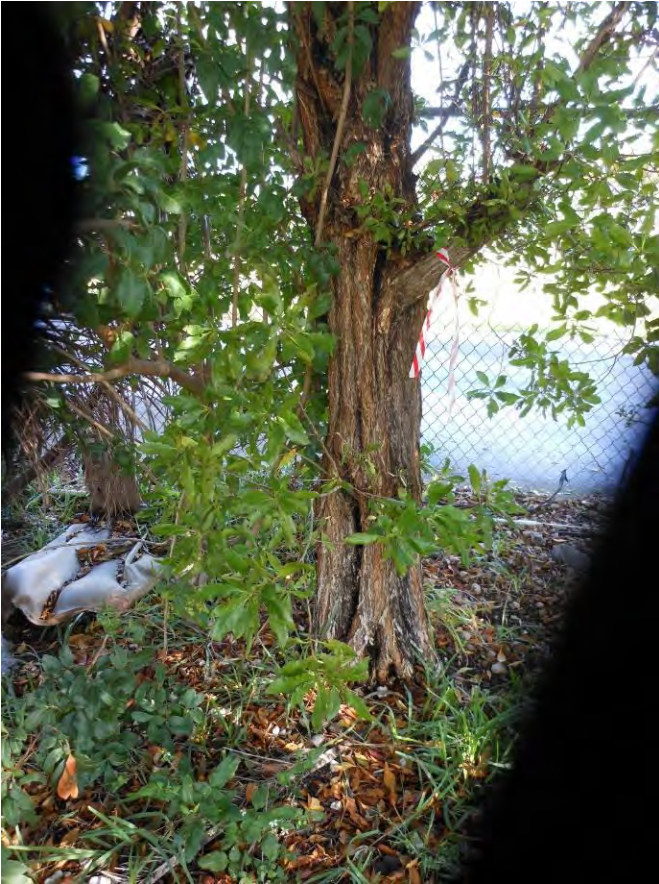
Tree #4-two photos of tree

Diameter: 11"

Location: 80% (growing close to property line along and existing access road, very visible)

Condition: 60% (fair)

Value x Diameter = 8.8
replacement caliper
inches

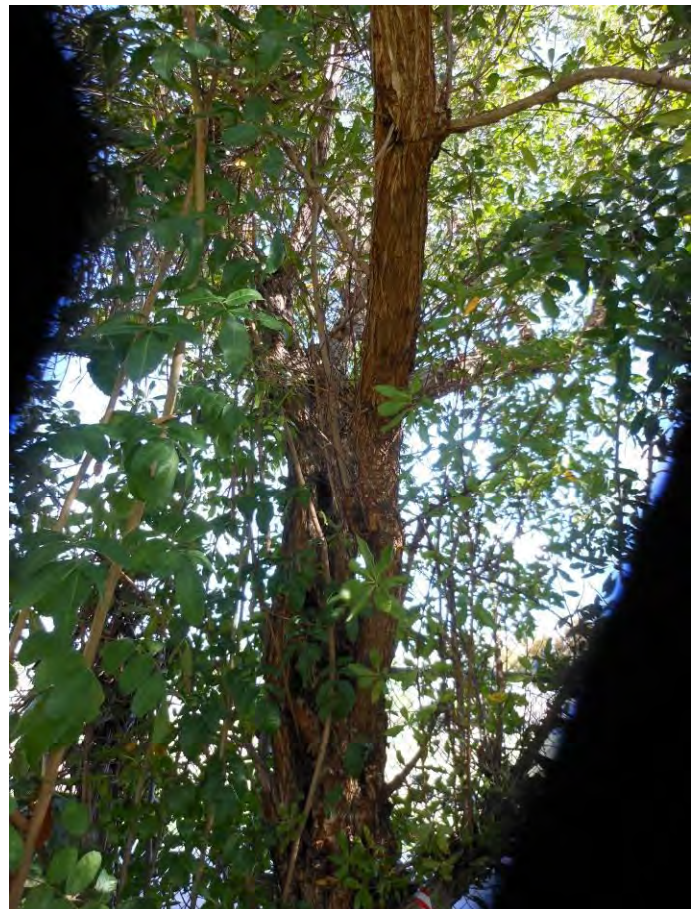
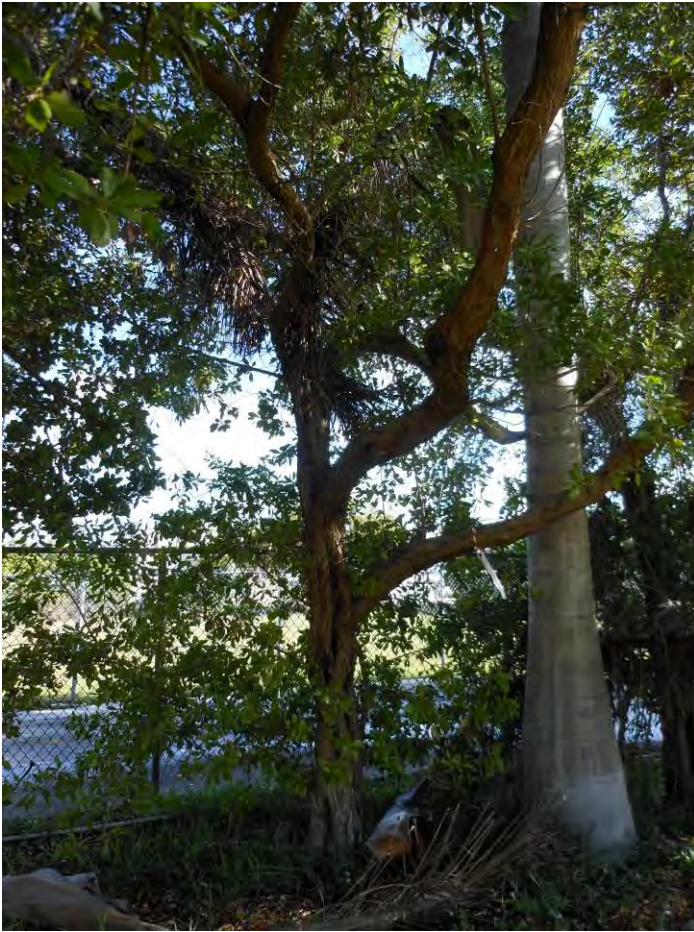
Tree #6-two photos of trees

Diameter: 12"

Condition: 40% (poor structure-top main leader missing)

Value x Diameter = 8.7
replacement caliper inches

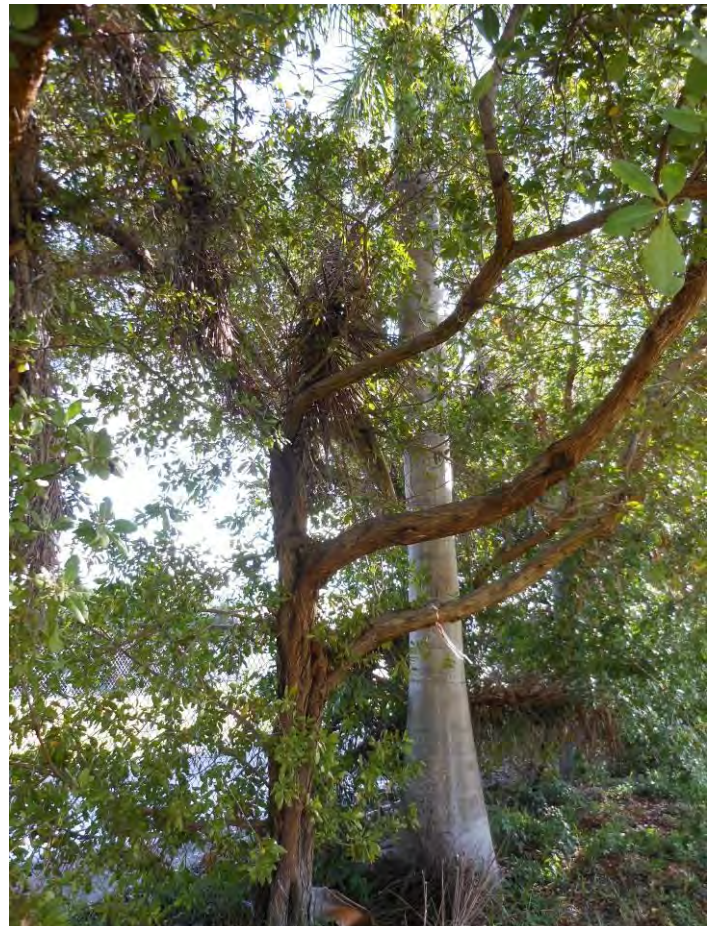
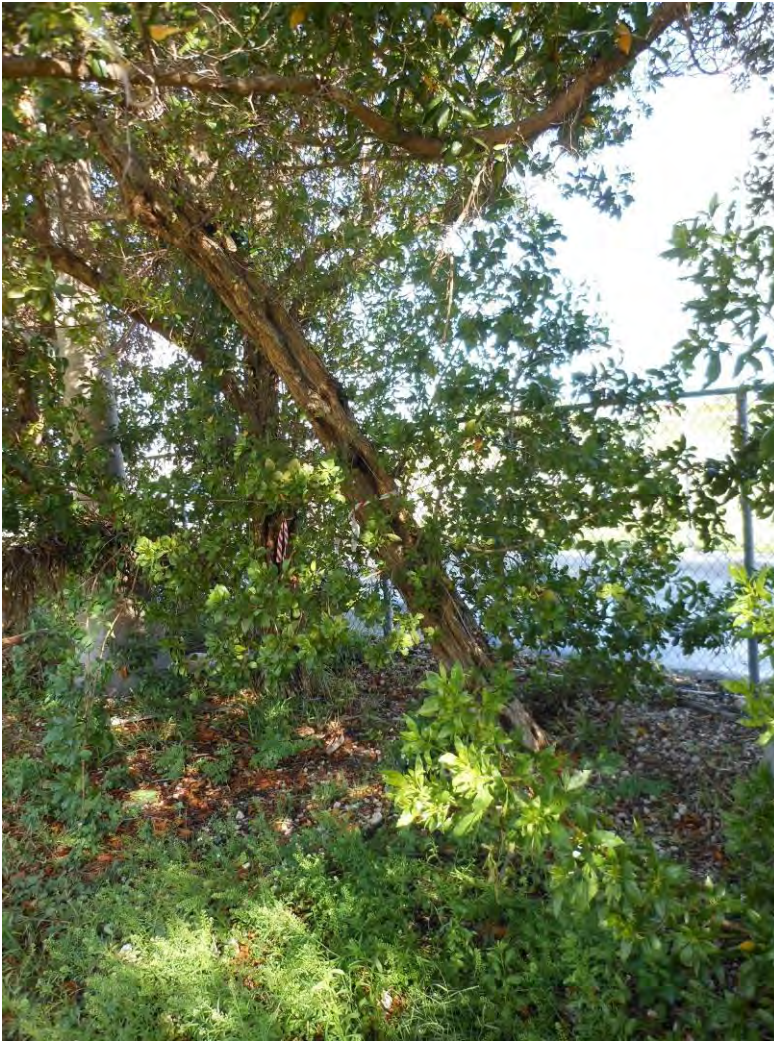
Tree #7-two photos of tree

Diameter: 11"

Condition: 40% (poor structure, heavy growth lean)

Value x Diameter = 8
replacement caliper
inches

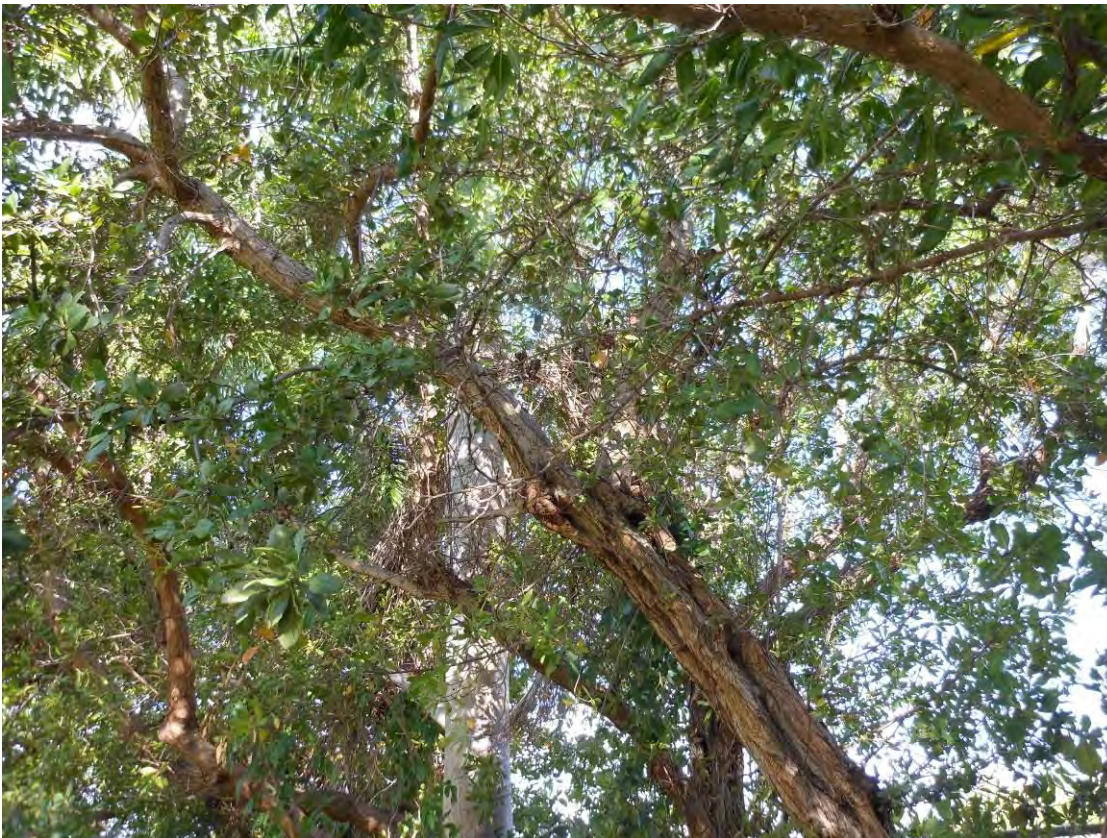
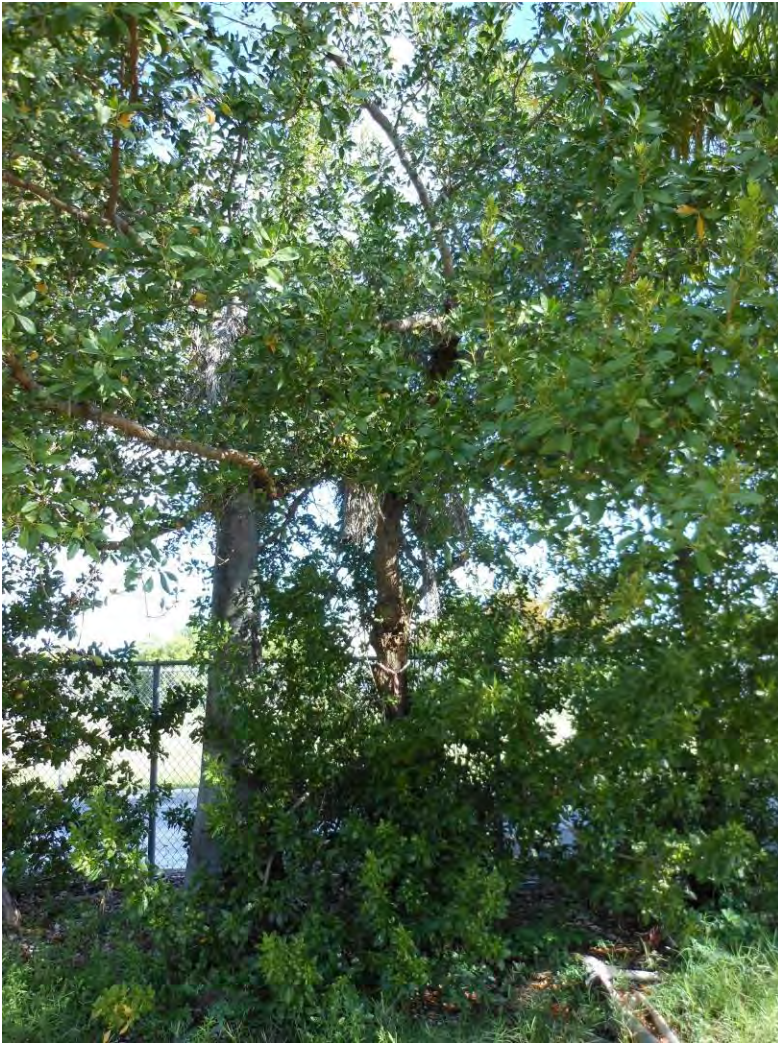
Tree #9-two photos of tree

Diameter: 9"

Condition: 40% (poor structure)

Value x Diameter = 6.5 replacement caliper inches

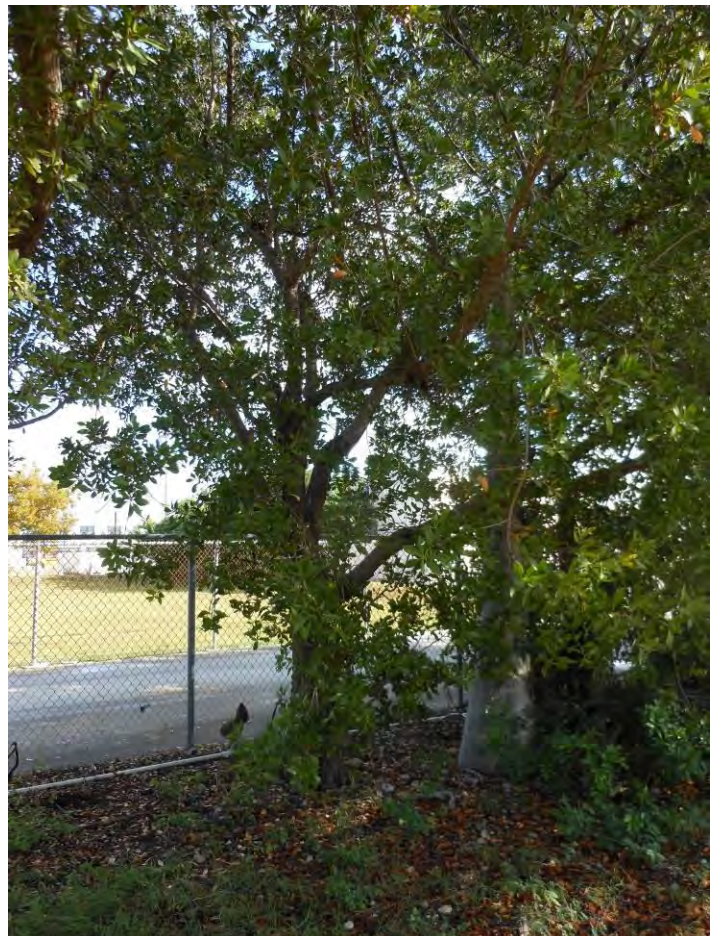
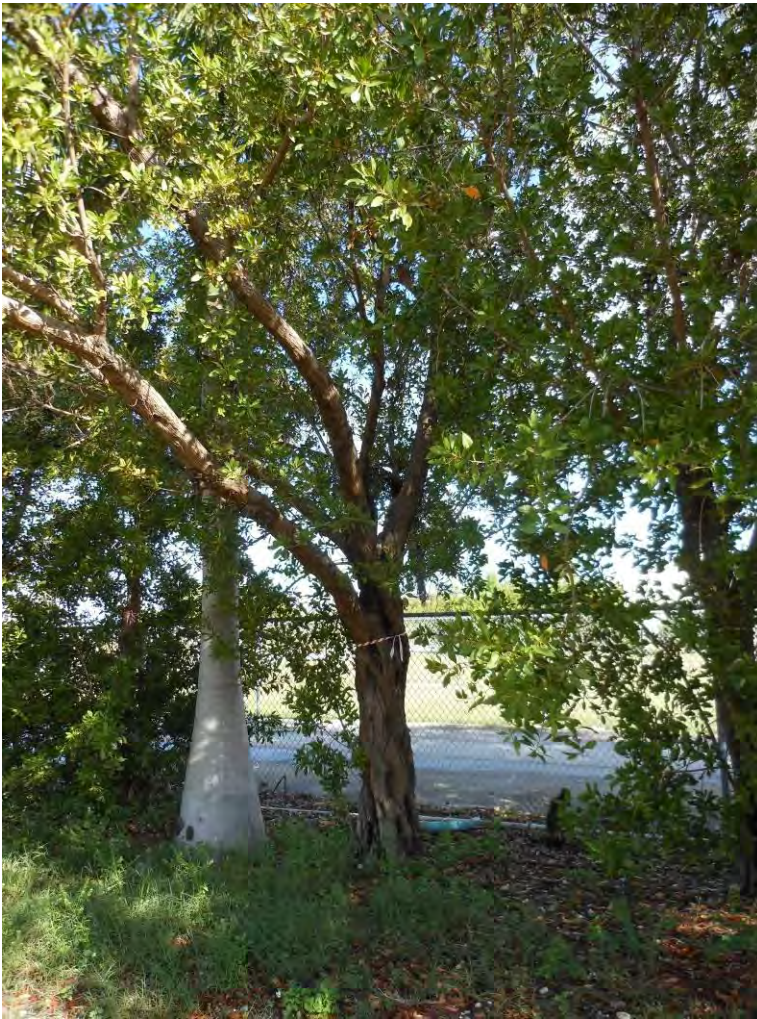
Tree #12-two photos of tree

Diameter: 15"

Condition: 60% (fair)

Value x Diameter = 12 replacement caliper inches

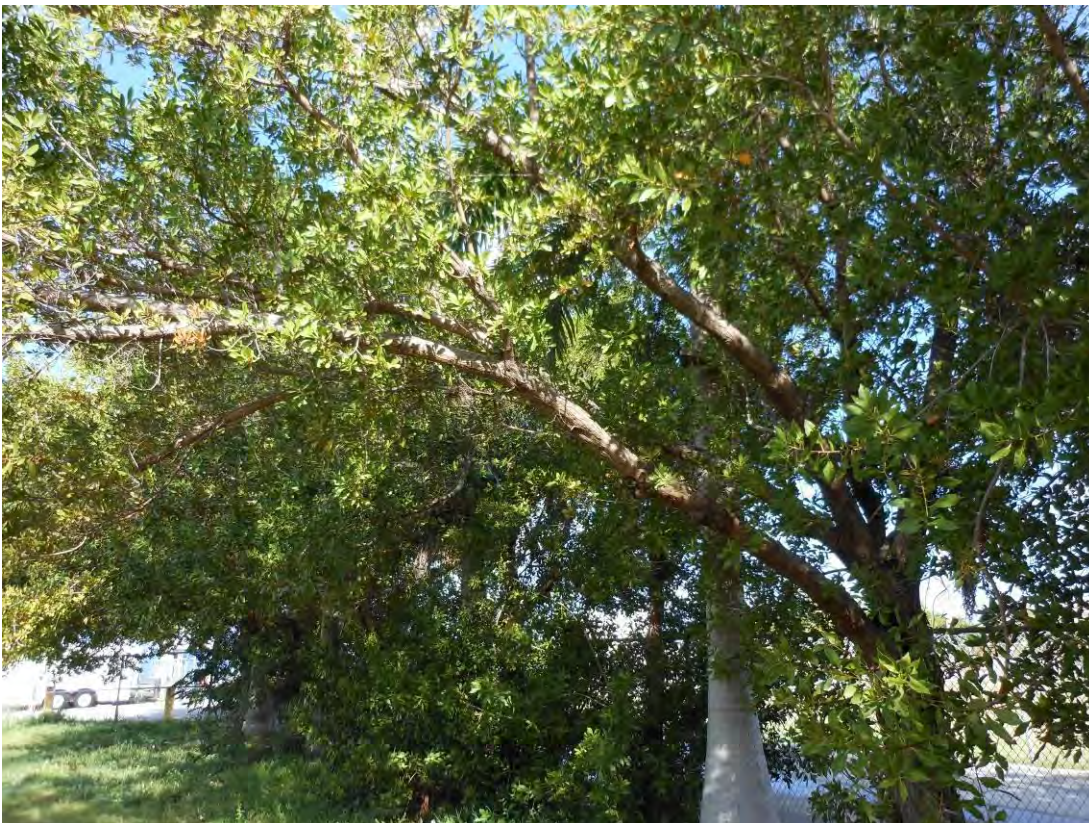
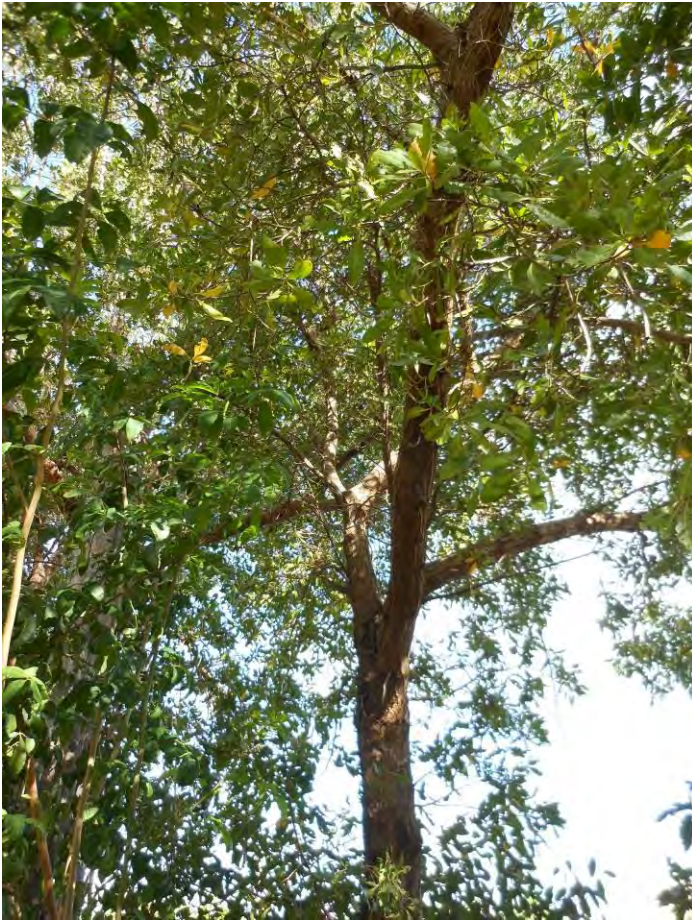
Tree #15-two photos of tree

Diameter: 10"

Condition: 60% (fair)

Value x Diameter = 8 replacement caliper inches

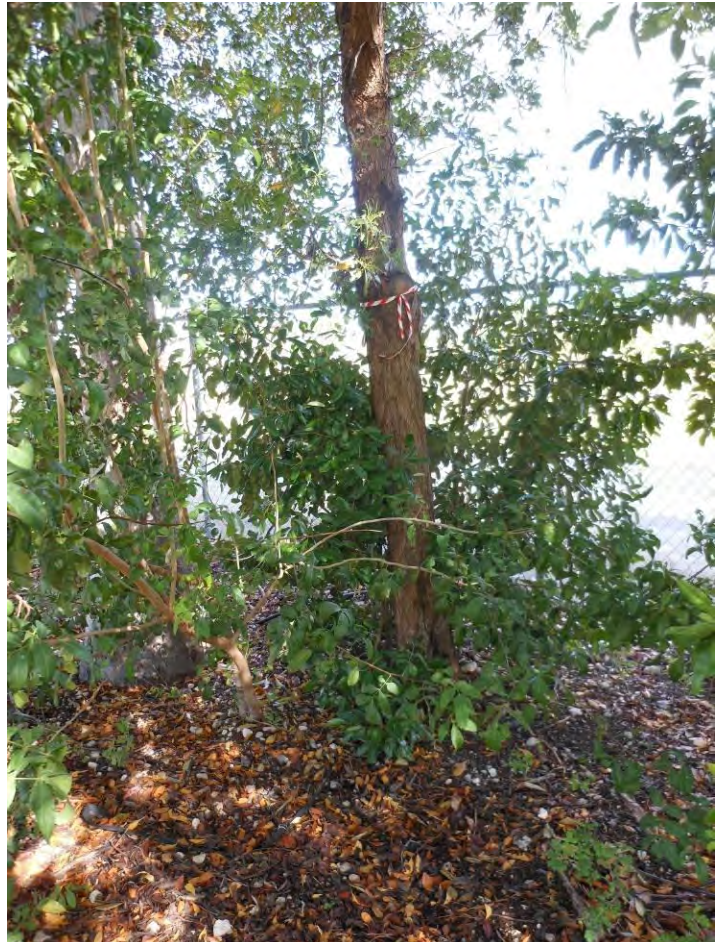
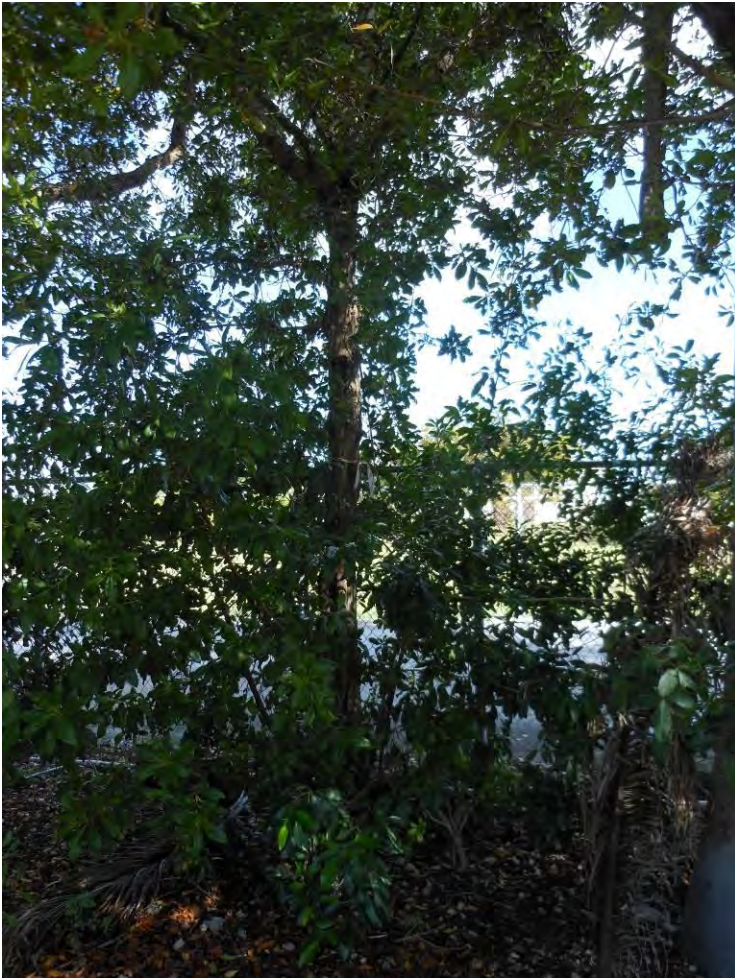
Tree #16-two photos of tree

Diameter: 8"

Condition: 60% (fair)

Value x Diameter = 6.4
replacement caliper
inches

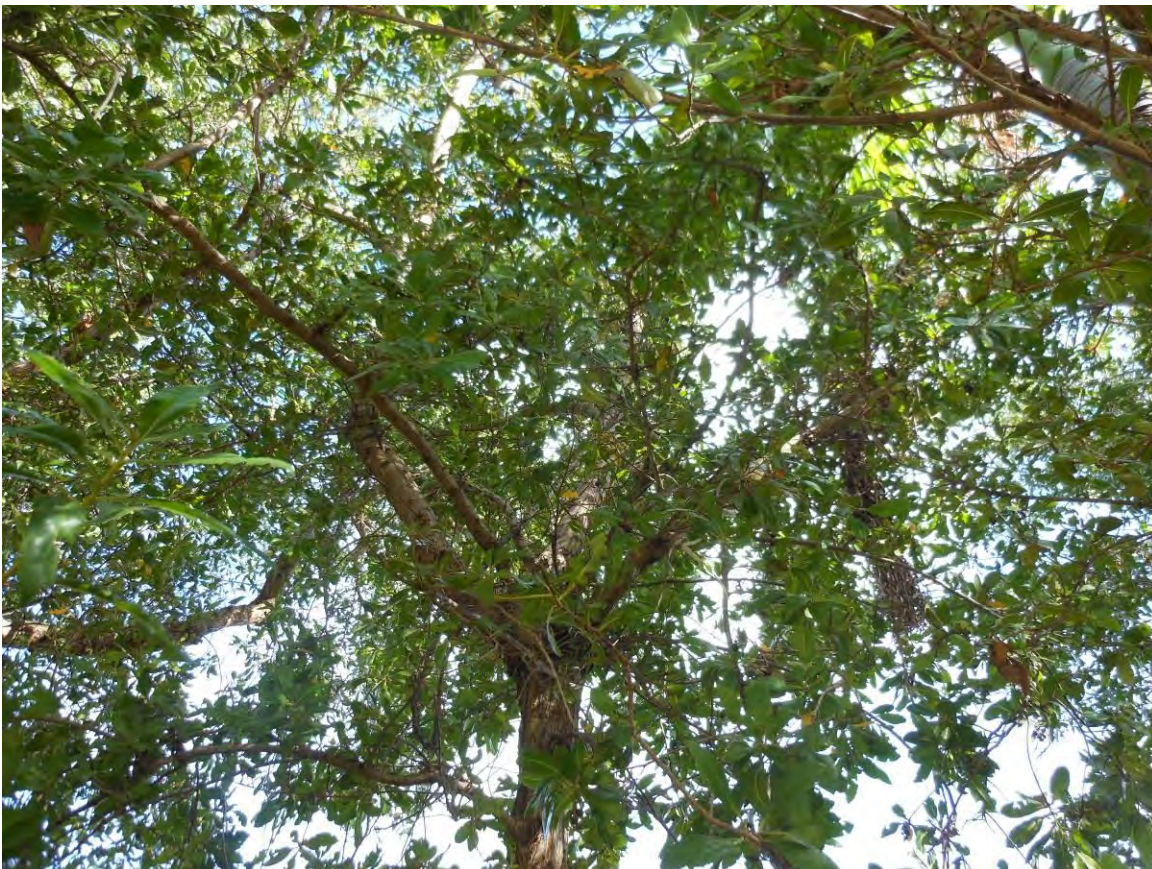
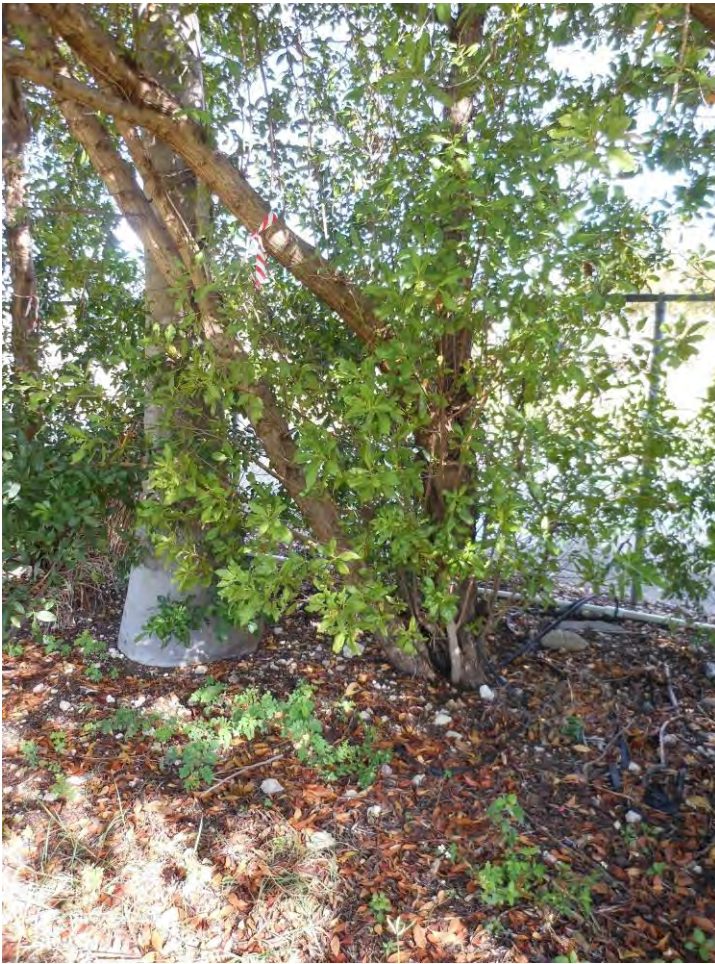
Tree #18-two photos of tree

Diameter: 15"

Condition: 40% (poor strcuture)

Value x Diameter = 10.9 replacement caliper inches

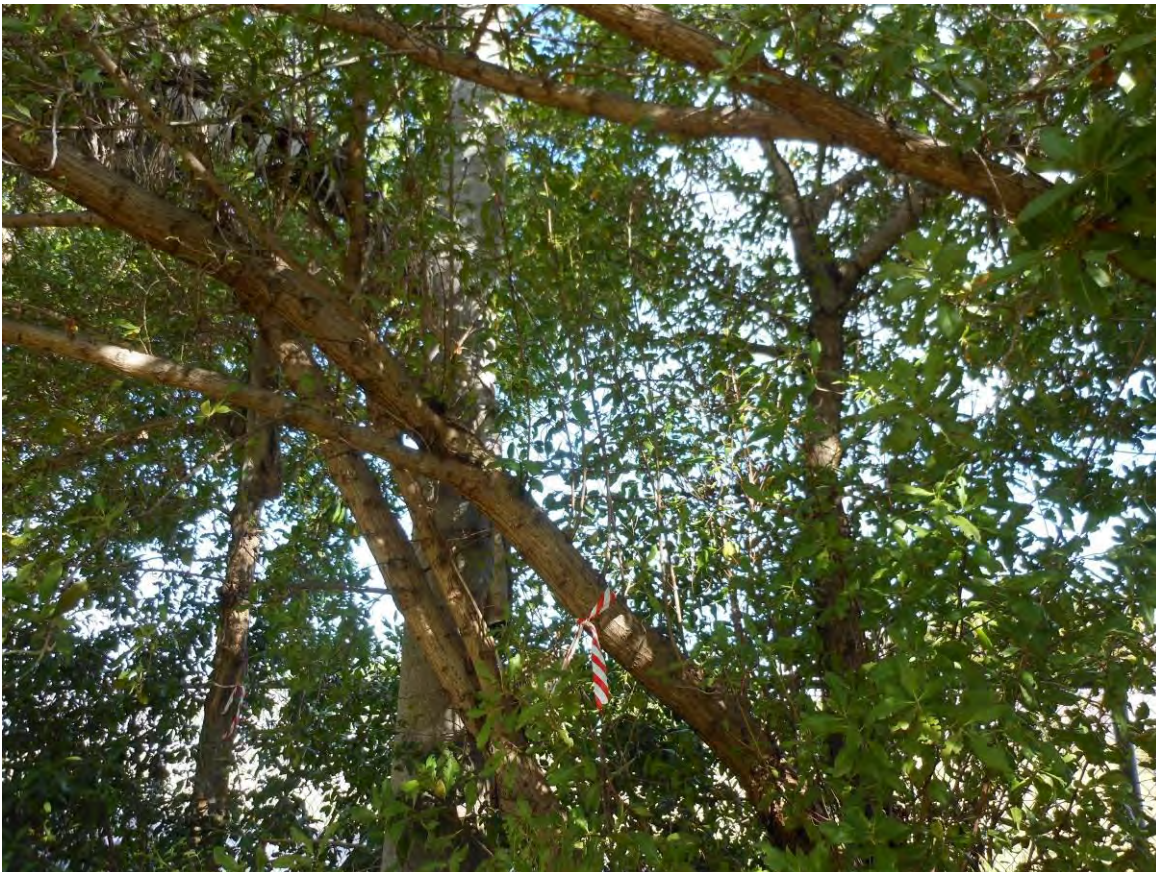
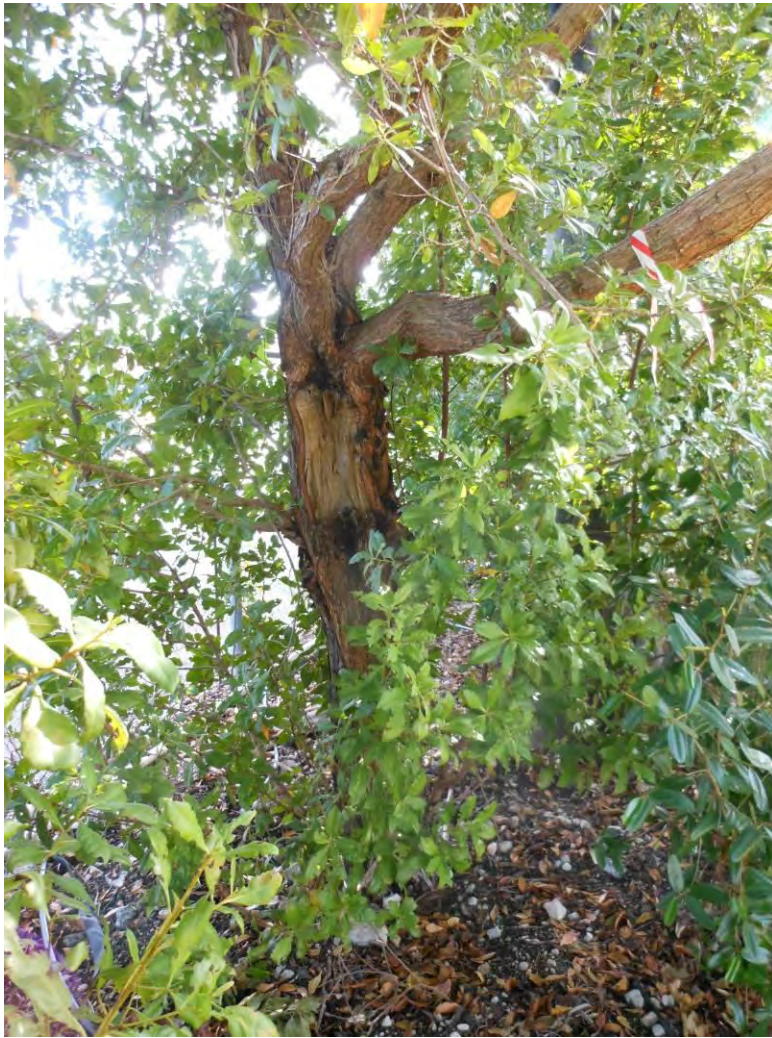
Tree #19-two photos of tree

Diameter: 11"

Condition: 60% (poor structure-trunk wound)

Value x Diameter = 8 replacement caliper inches

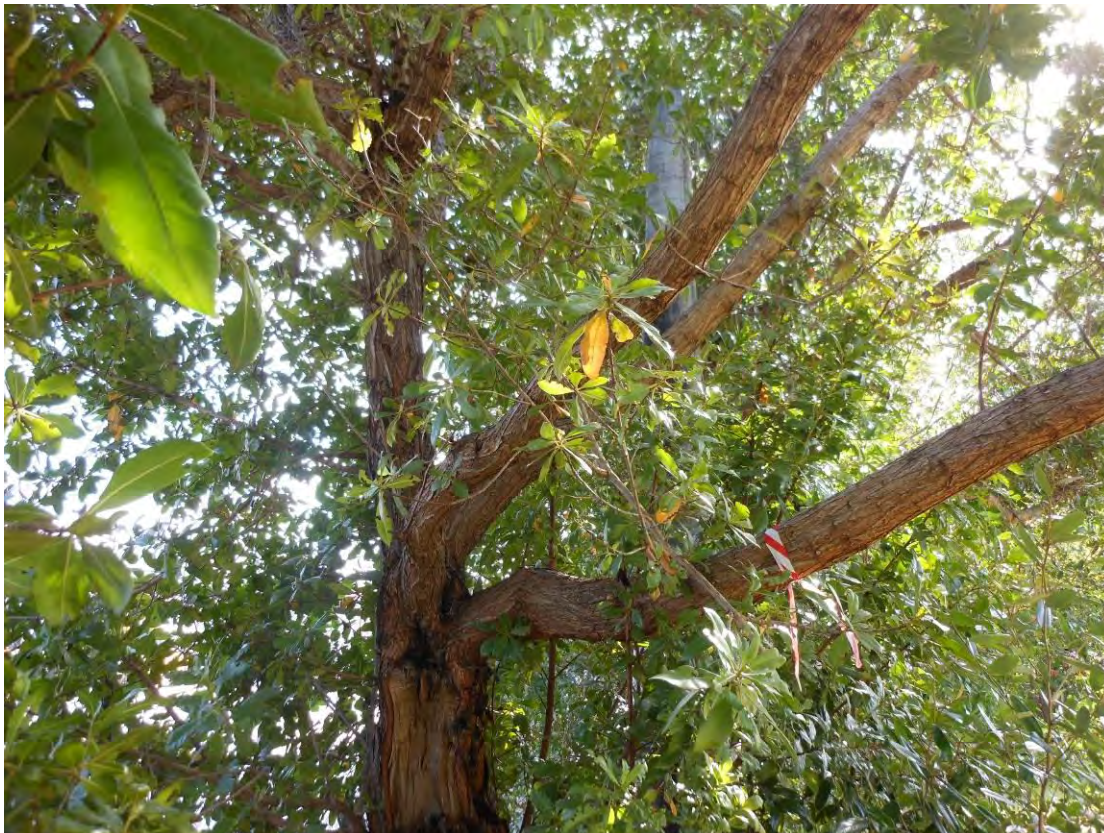
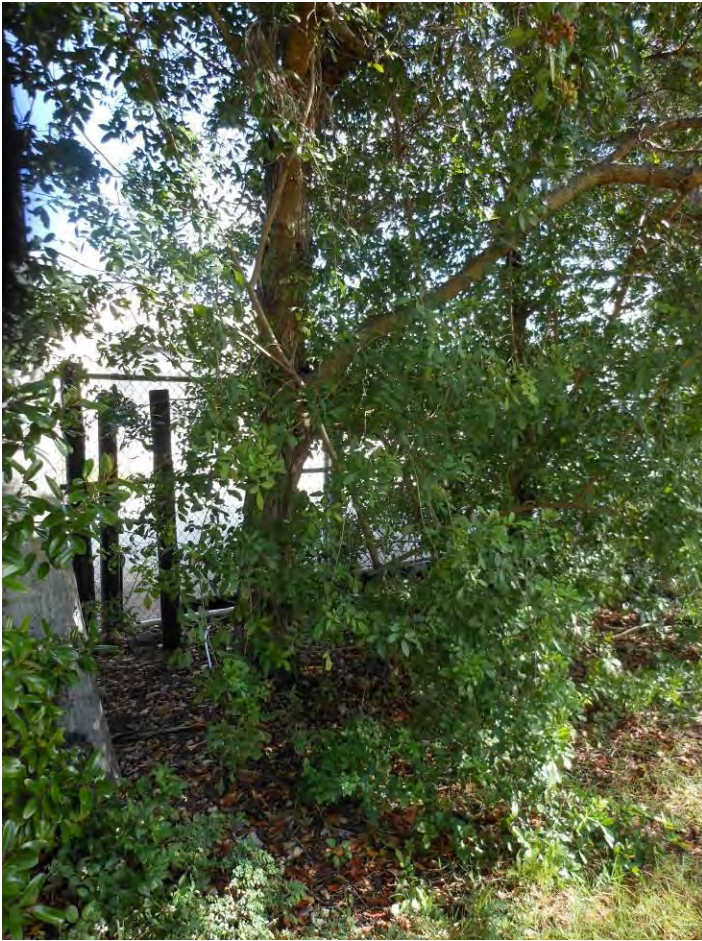
Tree #21-two photos of tree

Diameter: 12"

Condition: 60% (fair)

Value x Diameter = 9.6
replacement caliper
inches

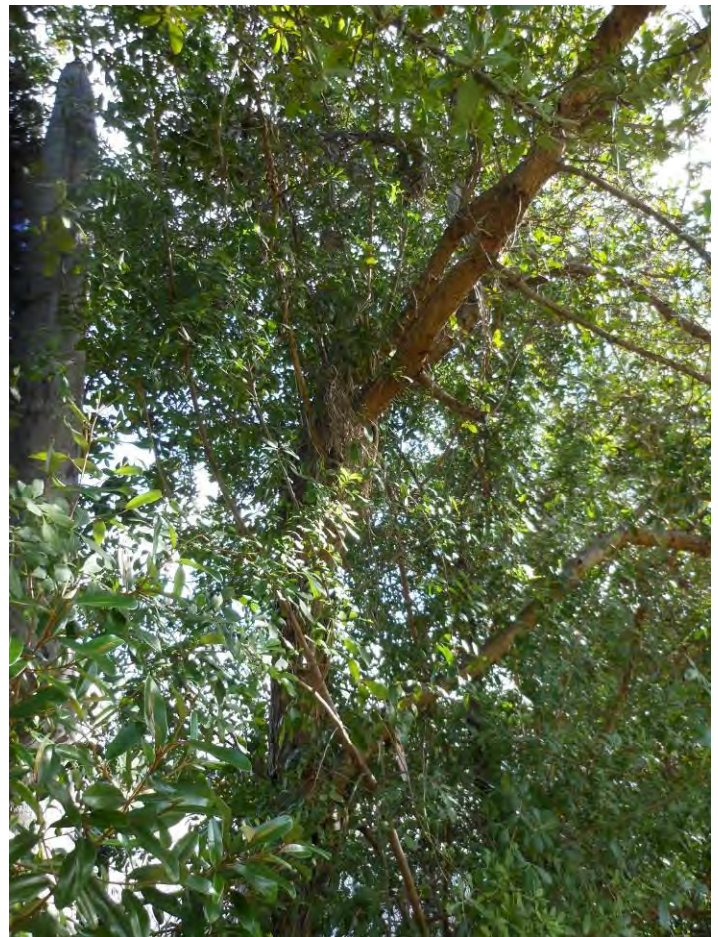
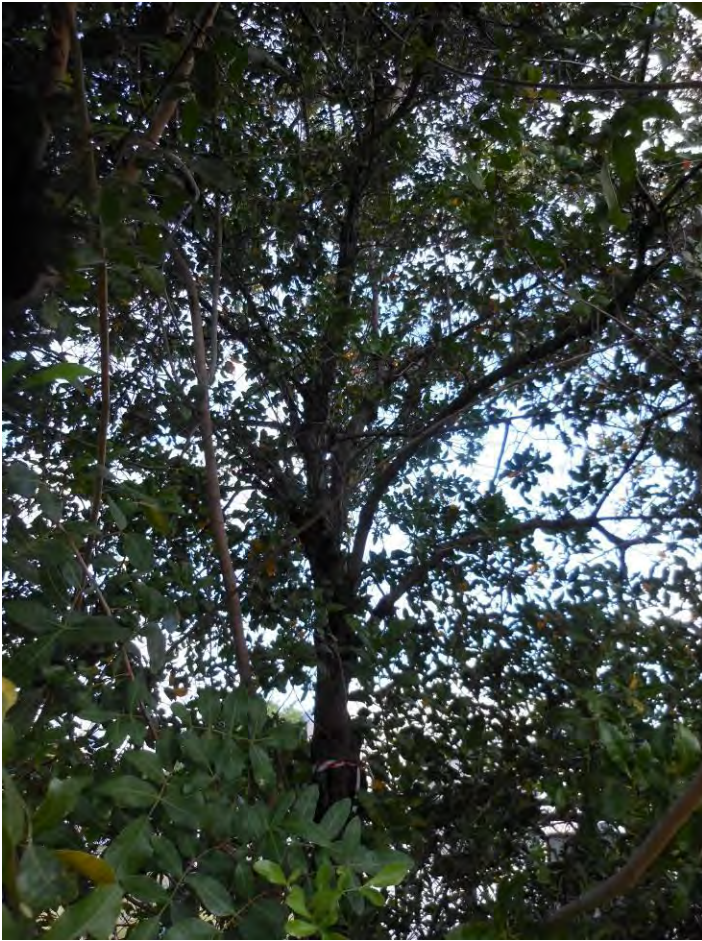
Tree #22-two photos of tree

Diameter: 8"

Condition: 60% (fair)

Value x Diameter = 6.4
replacement caliper inches

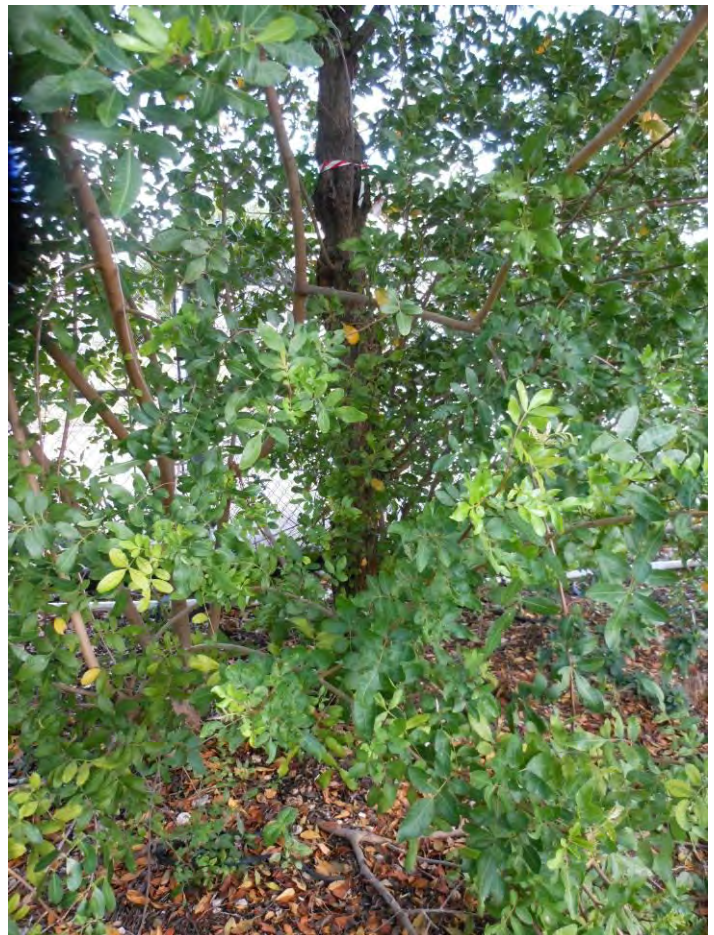
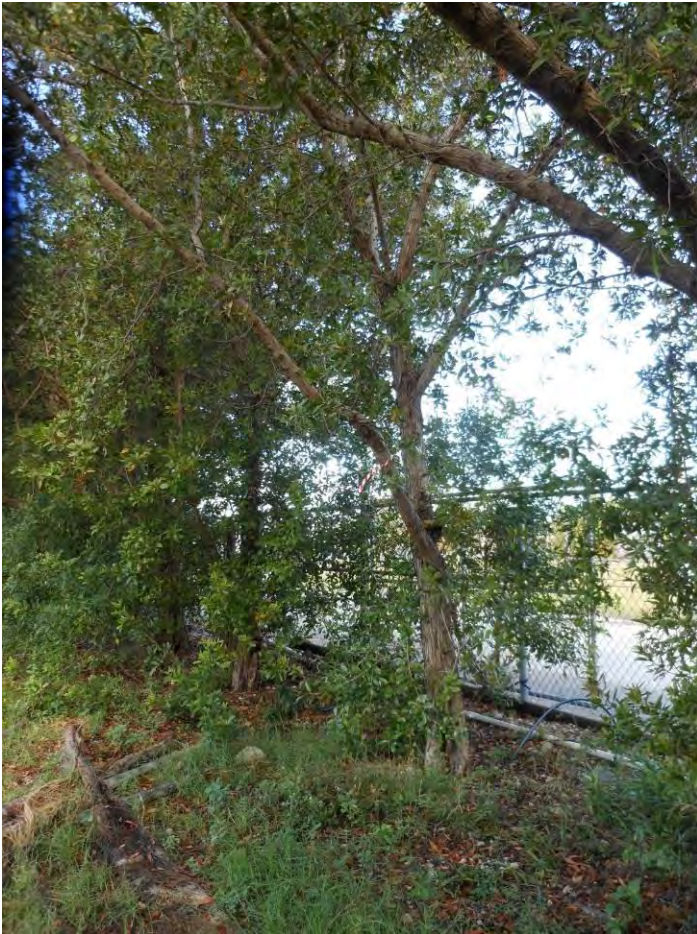
Tree #23-two photos of tree

Diameter: 9"

Condition: 60% (fair)

Value x Diameter = 7.2
replacement caliper inches

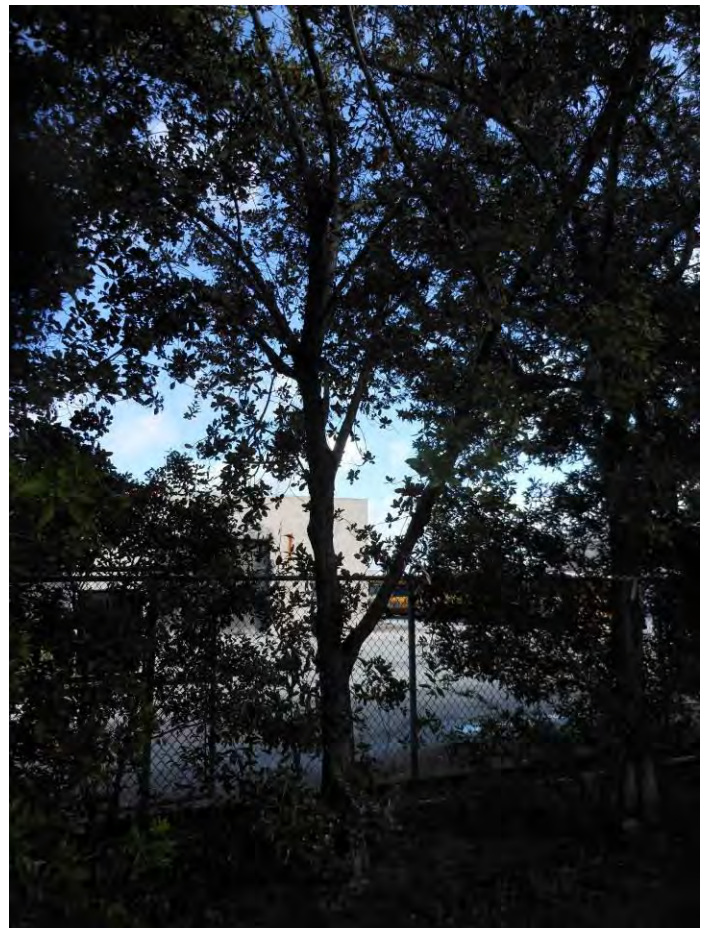
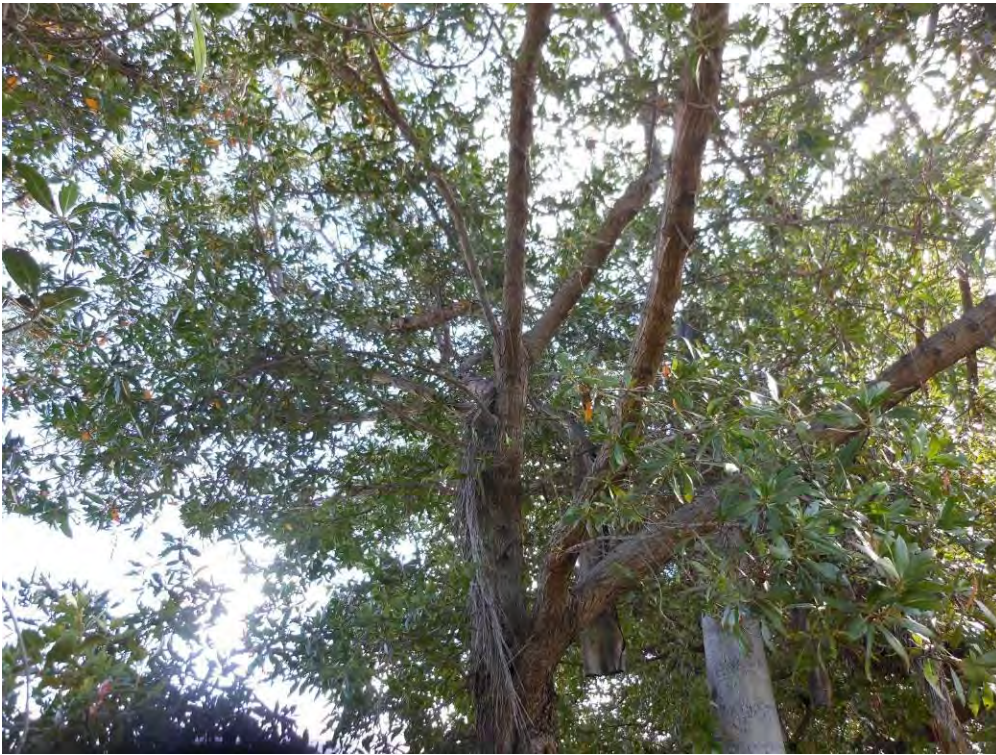
Tree #24-two photos of tree

Diameter: 10"

Condition: 60% (fair)

Value x Diameter = 8 replacement caliper inches

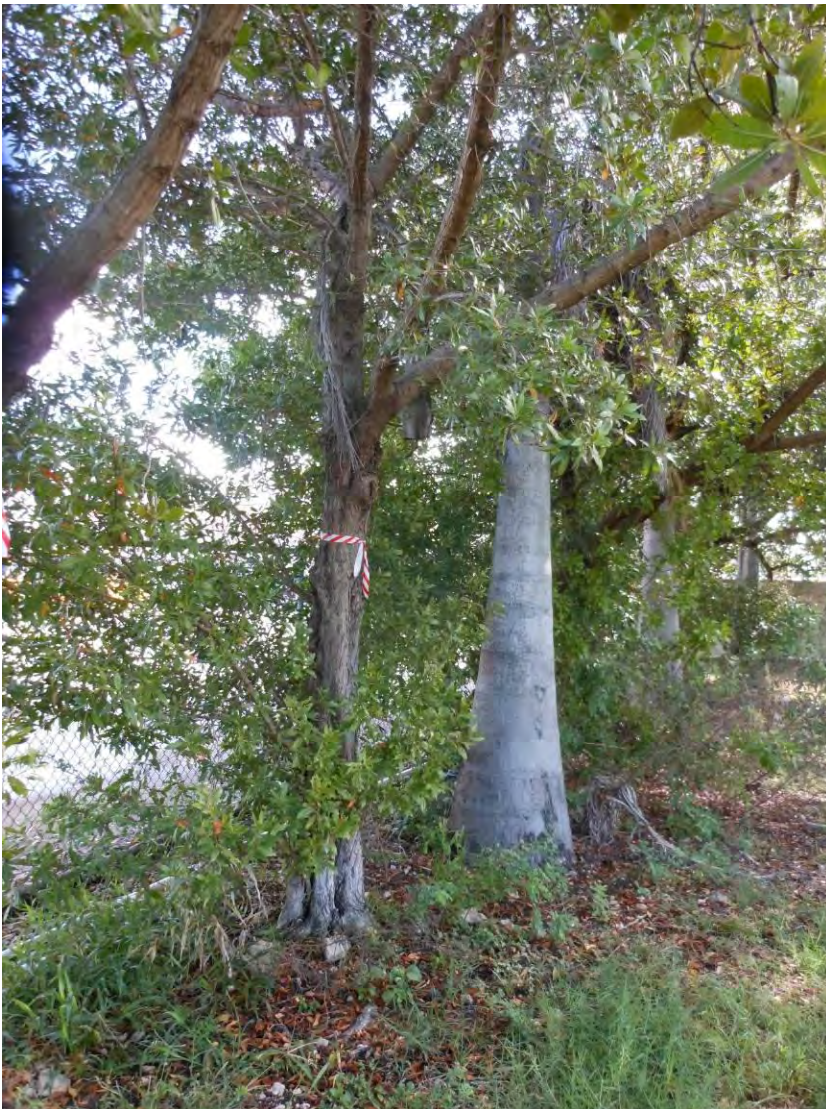
Photo of Tree #27

Diameter: 12"

Condition: 50% (fair to poor)

Value x Diameter = 9.1 replacement caliper inches

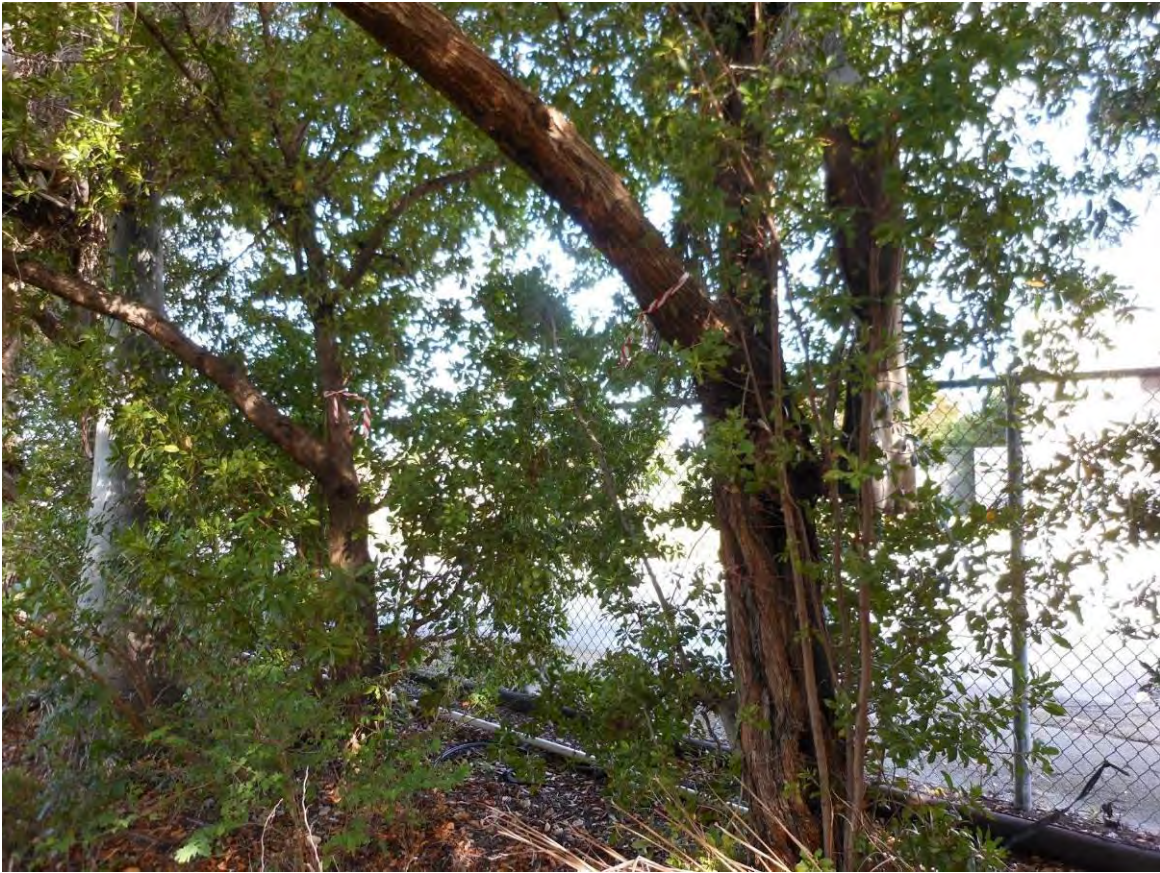
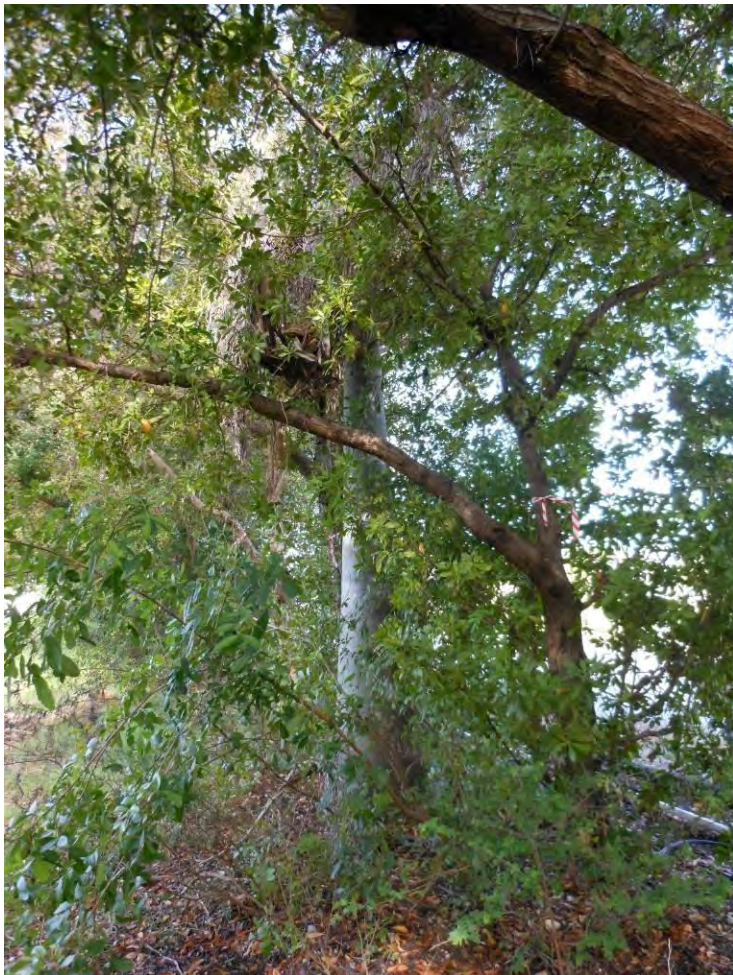
Photo of
Tree #26

Diameter: 10"

Condition: 50% (fair to poor)

Value x Diameter = 7.6
replacement caliper inches

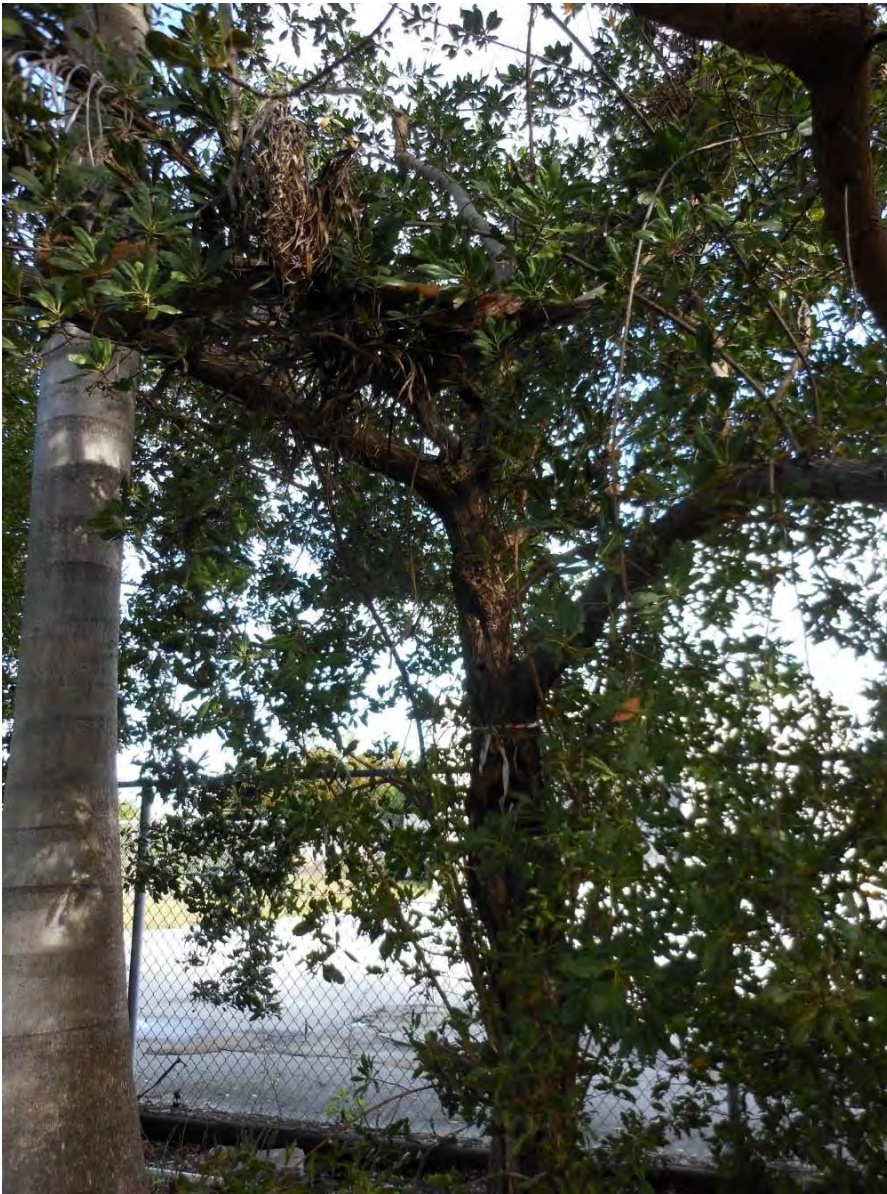
Tree #29-one photo of tree

Diameter: 9"

Condition: 60% (fair)

Value x Diameter = 7.2 replacement caliper inches
