STAFF REPORT

RE: 255 Trumbo Road (application # TP2022-0003)

FROM: Karen DeMaria, City of Key West Urban Forestry Manager

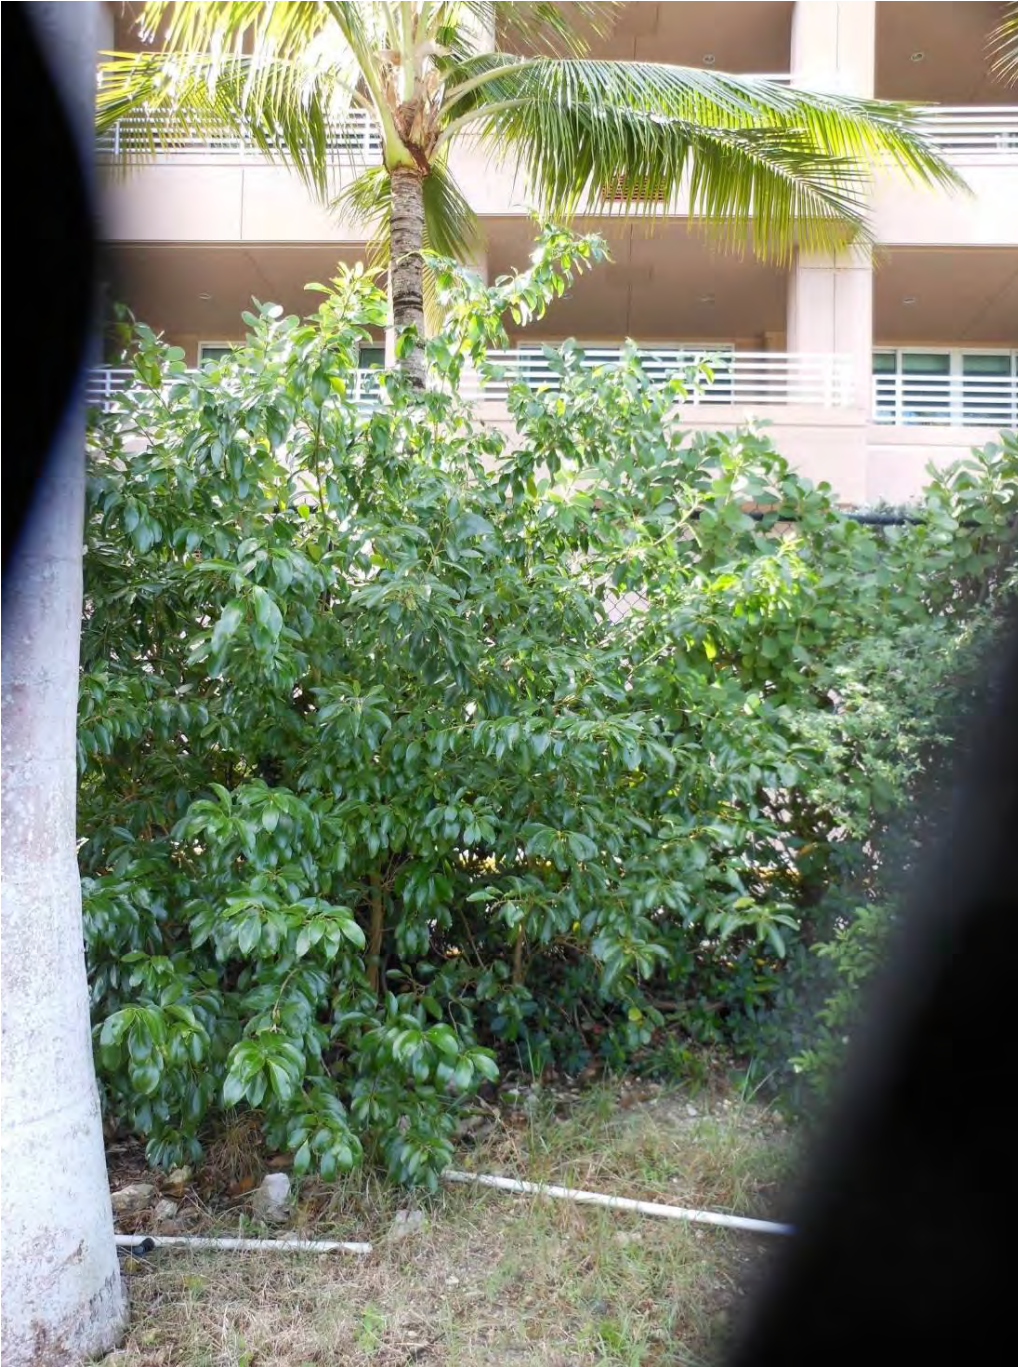
Tree #56-one photo of tree

Diameter: 2"

Condition: 80% (young tree)

Value x Diameter = 1.7 replacement caliper inches

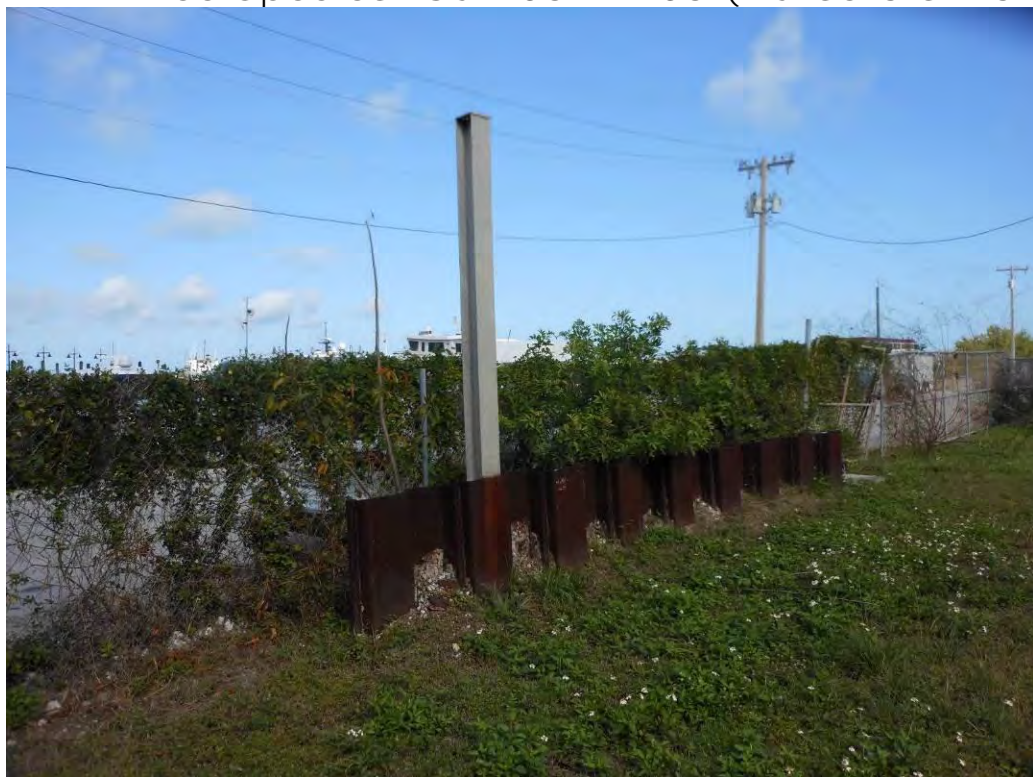
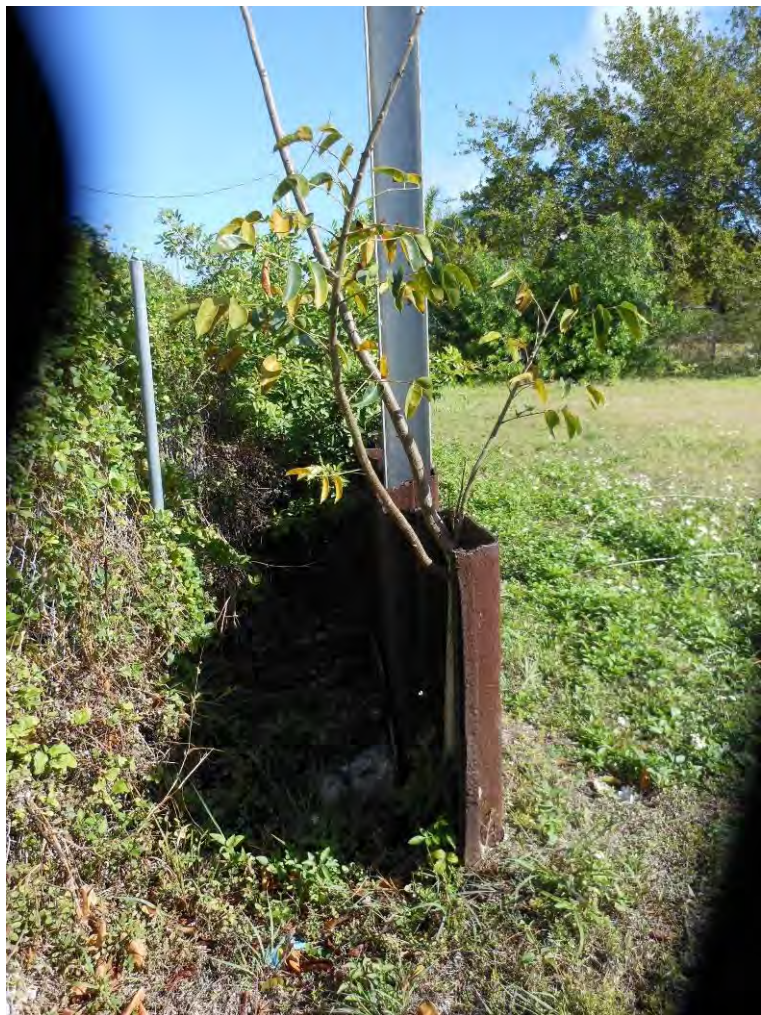
Two photos showing location
and whole tree (tree #57).

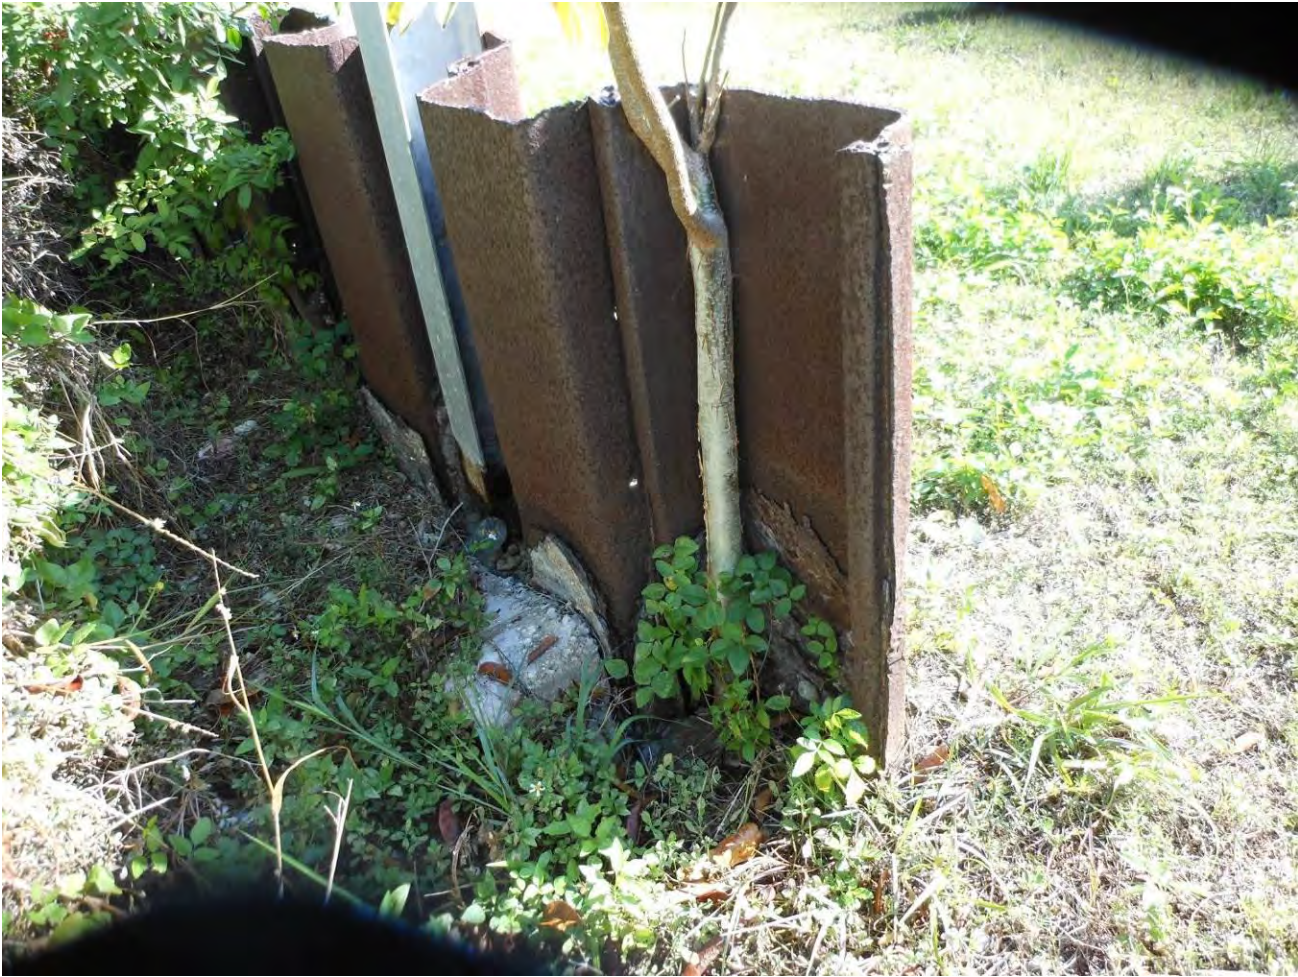
Tree #57-one photo of base of tree

Diameter: 2.5"

Location: 40% (growing at base of sheet piling)

Condition: 40% (poor)

Value x Diameter = 1.5 replacement caliper inches
