Archaeological Investigations of the Peary Court #3 Construction Area Within Buffer Zone as Delineated in 1991 by U.S. Army Corps of Engineers Archaeologists.

By Diane Silvia and Malachi Fenn July 20, 2022

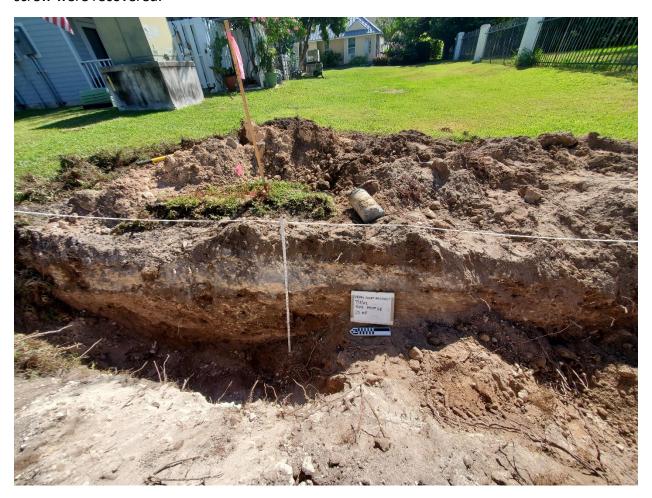
Trench 1

Glazed terracotta sewer pipe fragments and a sewer pipe with a concrete cap were located in Trench 1. One light blue-green bottle base fragment, one clear glass fragment, and one rusty screw were recovered.

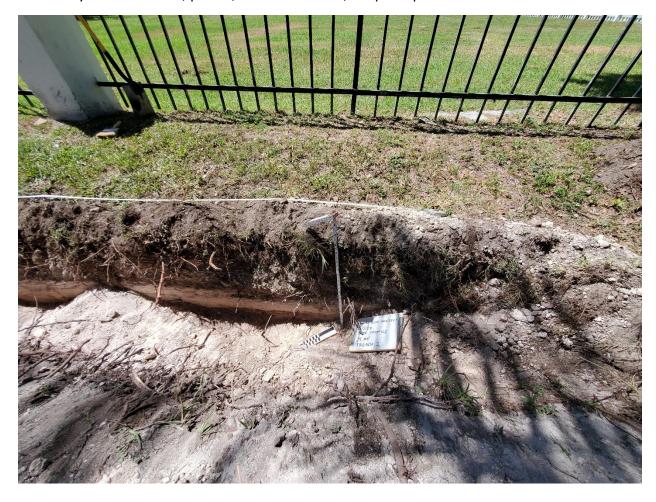
Trench 2
Trench 2 yielded a recent, plastic, Caldwell Banker, ballpoint pen.

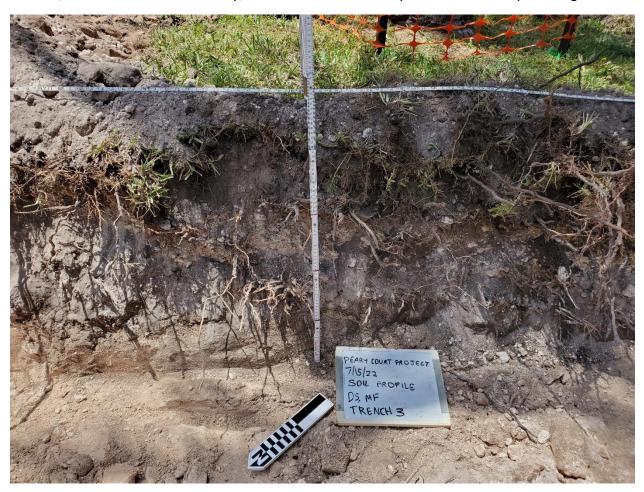
Trench 3

An unidentified bronze artifact was recovered in Trench 3. It is a cylindrical hollow piece $1 \frac{3}{4}$ " (4.45 cm) in diameter with a hole lengthwise through the center. One end of the hole is smooth and flat, the other has an internally, threaded neck. This may be some kind of plumbing valve.

Unidentified bronze fitting

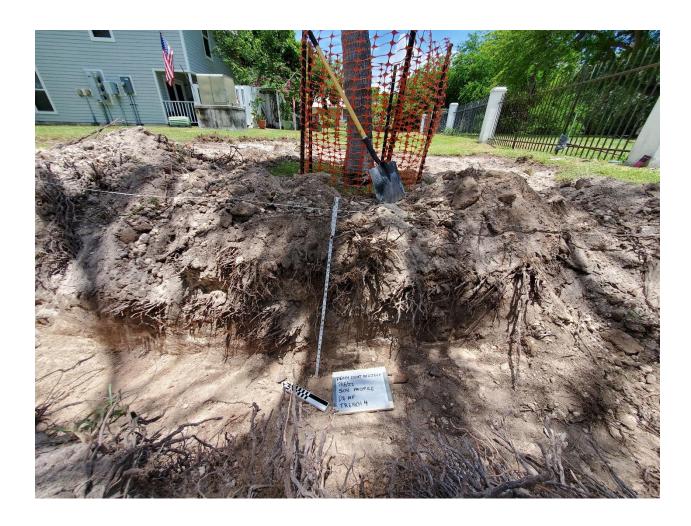
Trench 4Glazed terracotta sewer pipe fragments were encountered in Trench 4.

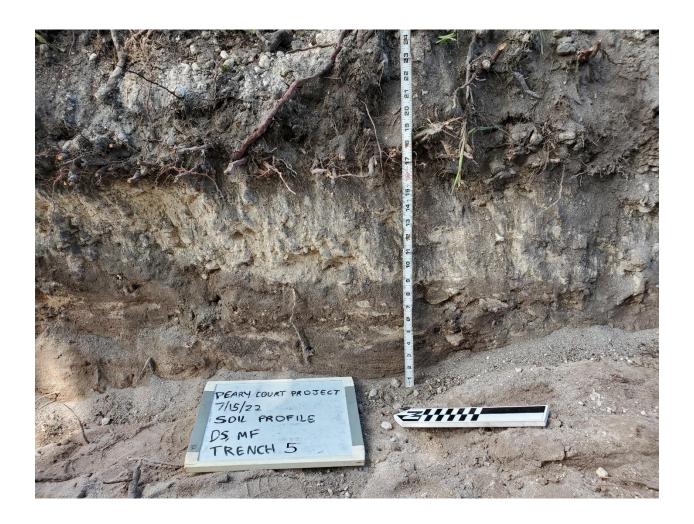
Trench 5One small brick fragment was found in Trench 5.

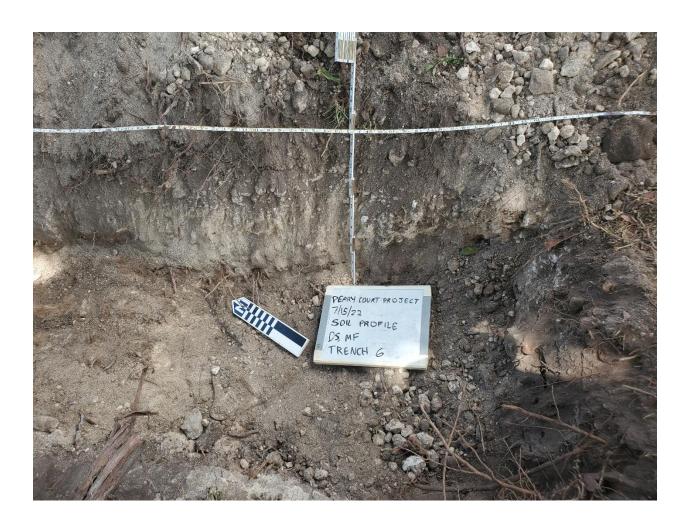
Trench 6

A 3 ½" square wood fence post piece with chamfered edges, in a broken concrete base that had provided about 8" of concrete coverage around the post, was located in Trench 6. A large brick 9 ½" long by 4" wide and 3 ½" high was also found, along with a golf ball.

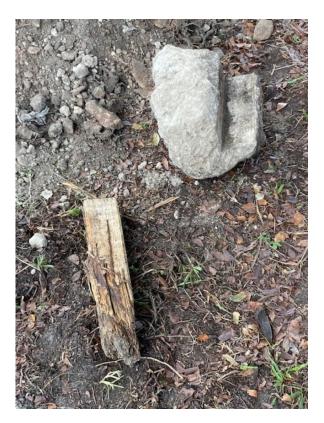
Post fragment in concrete
