STAFF REPORT

RE: Administrative Hearing for Southard & Whitehead Streets (TC2022-00007)

FROM: Karen DeMaria, City of Key West Urban Forestry Manager

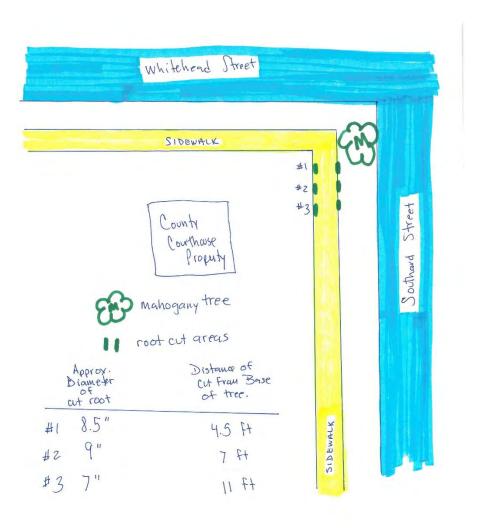
Drawing showing location of tree and root impact areas.

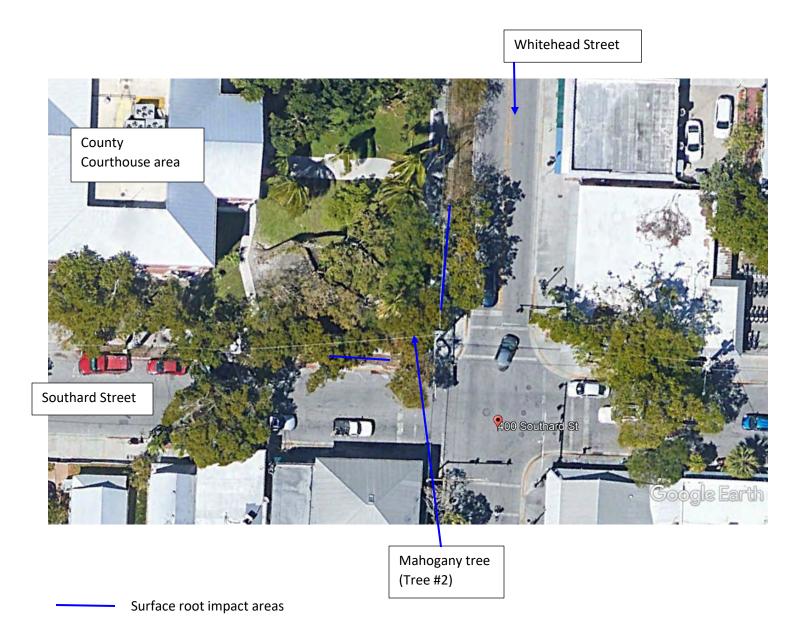
Site Map of Area showing location of issues.

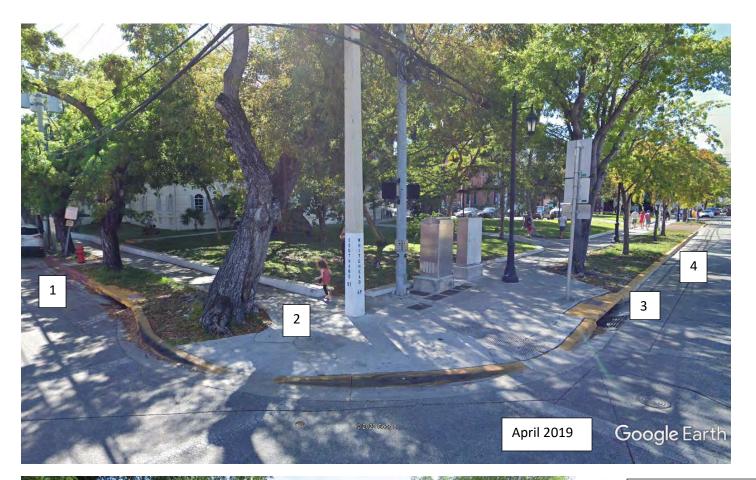
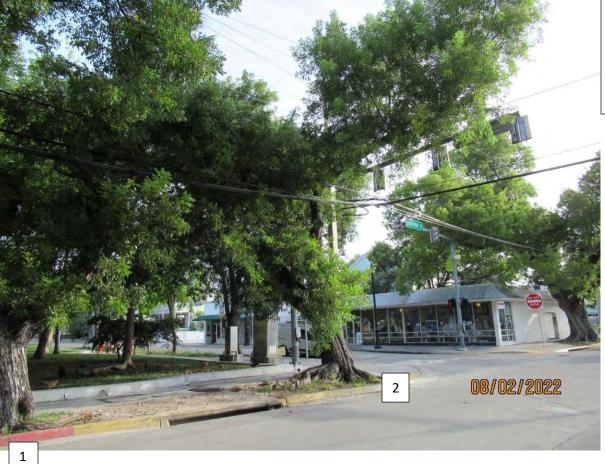
Photo above shows the tree impact areas. Area 1, 3, & 4 are surface root impacts.

> Location photo of Mahogany tree whose roots were cut (tree #2)

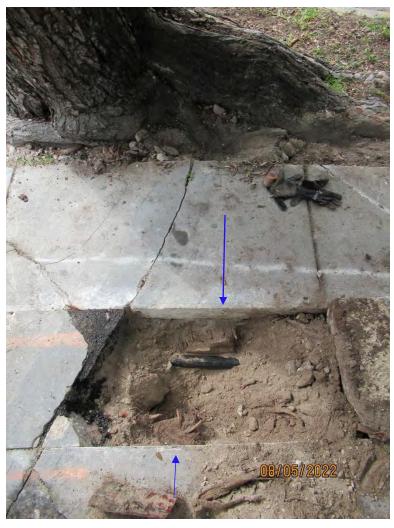
Photo showing location of root cut #1.

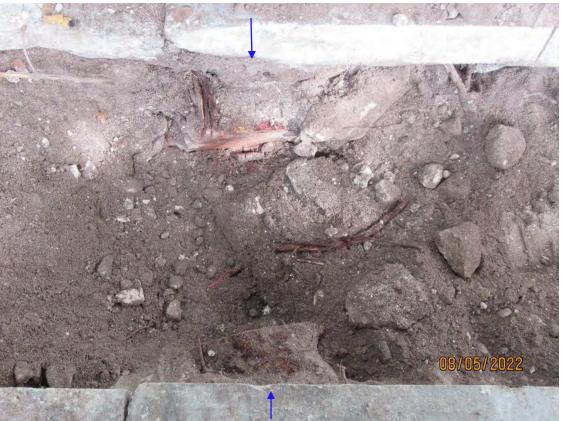
Close up photo of root cut area #1.

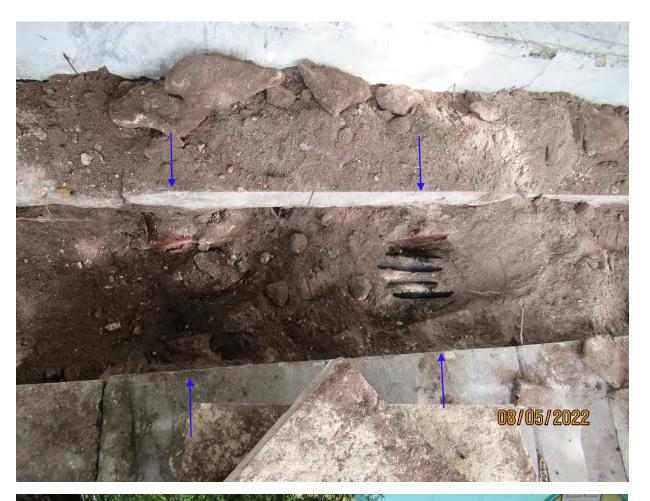
Close up photo of root cut area #2 and #3.

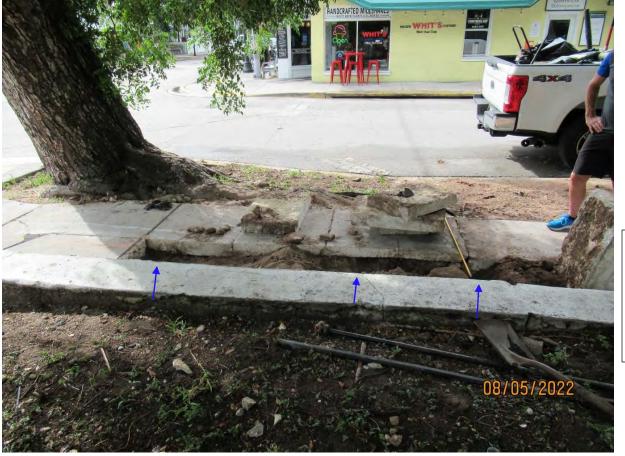
Looking at the whole tree area, photo showing the approximate location of the root cuts.

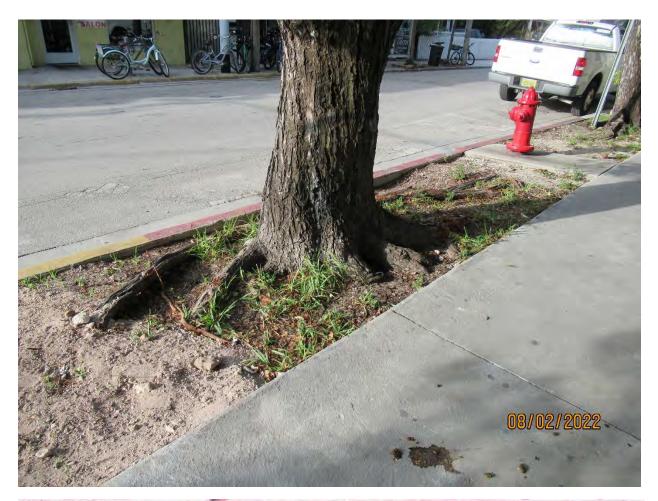
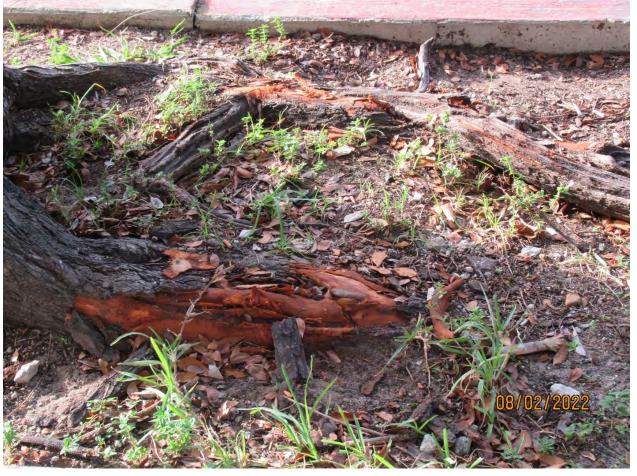
Two photos of tree area #1-surface root damage.

This mahogany tree has been in declining health for years and was not included in the heritage tree program list of WPA heritage mahogany trees due to its condition. Because of the tree health issue, representatives from Hotwire were asked to hire an arborist to submit a Tree Risk Assessment document as per ISA Standards, regarding the tree (report from New Leaf Environmental dated August 15, 2022 is attached). The representatives were also asked to place some soil and mulch over the damaged surface roots of the adjacent trees and to water them to help them heal.

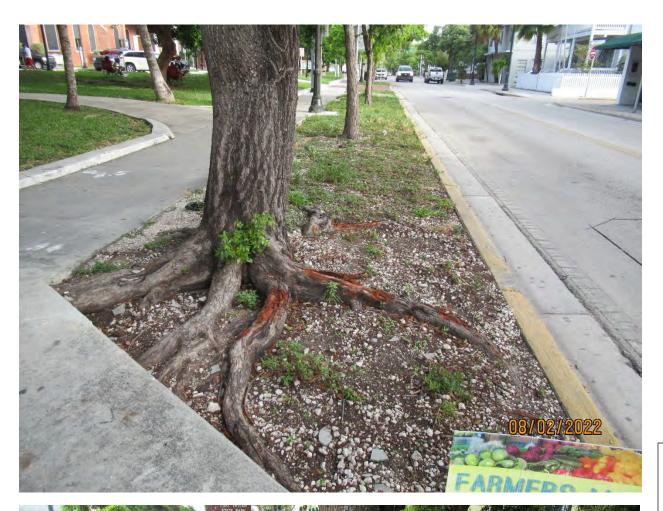
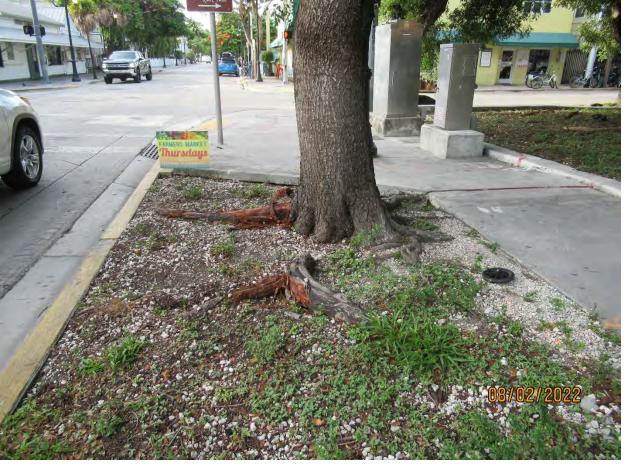
Two photos of tree area #3-surface root damage.

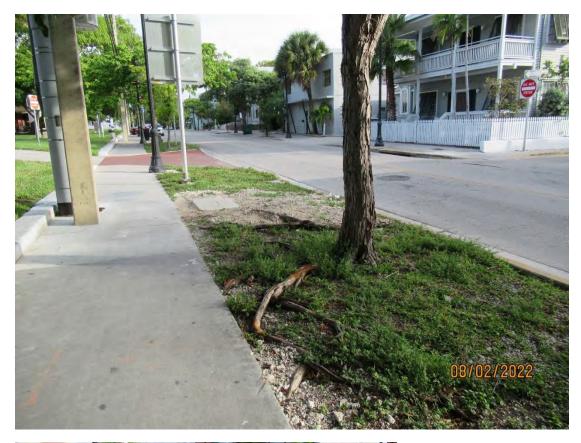
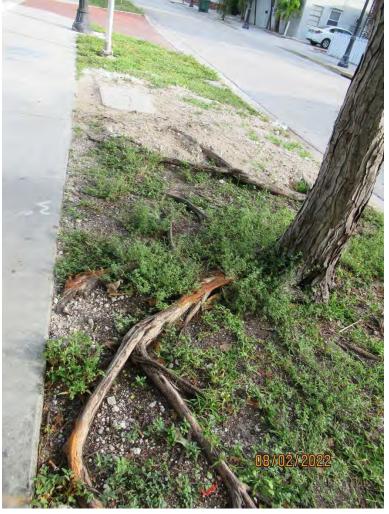
Two photos of tree area #4-surface root damage.

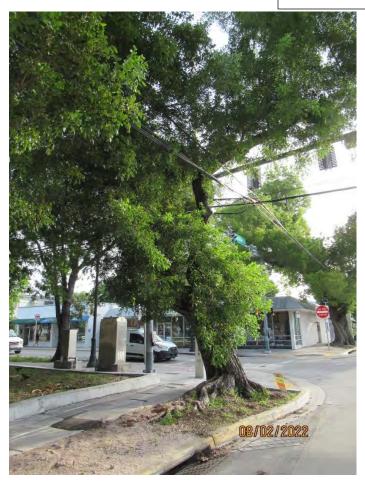
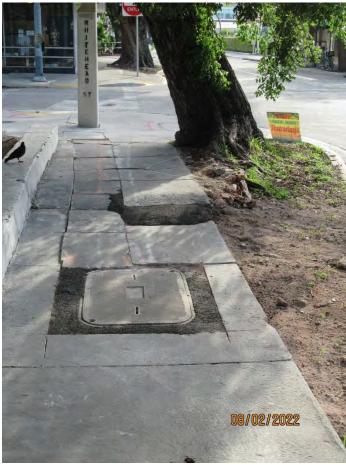
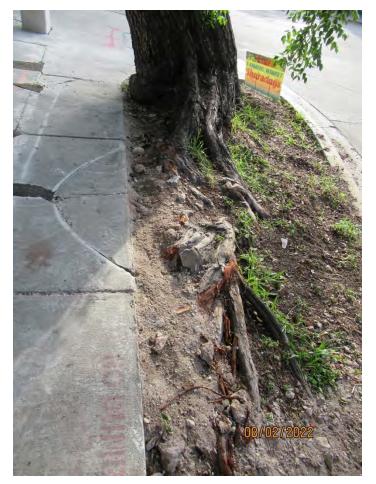
Tree Area #2

Photos showing whole tree and sidewalk work area near root system of the Mahogany tree (Tree Area #2 on map).

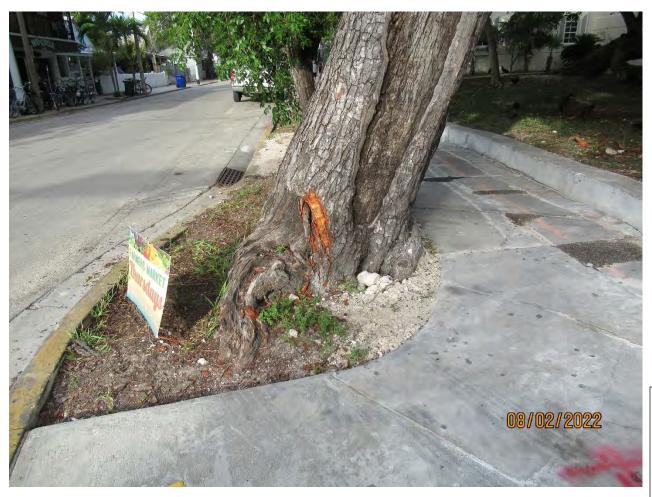
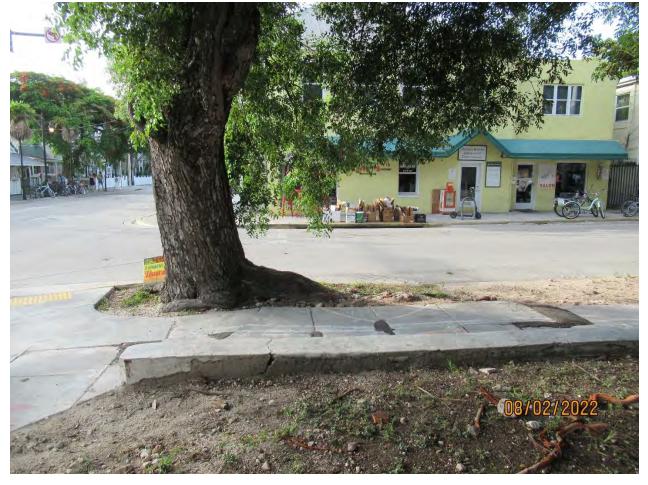
Two photos showing the constrictive root growth area of the mahogany tree and the existing, visual root structure.

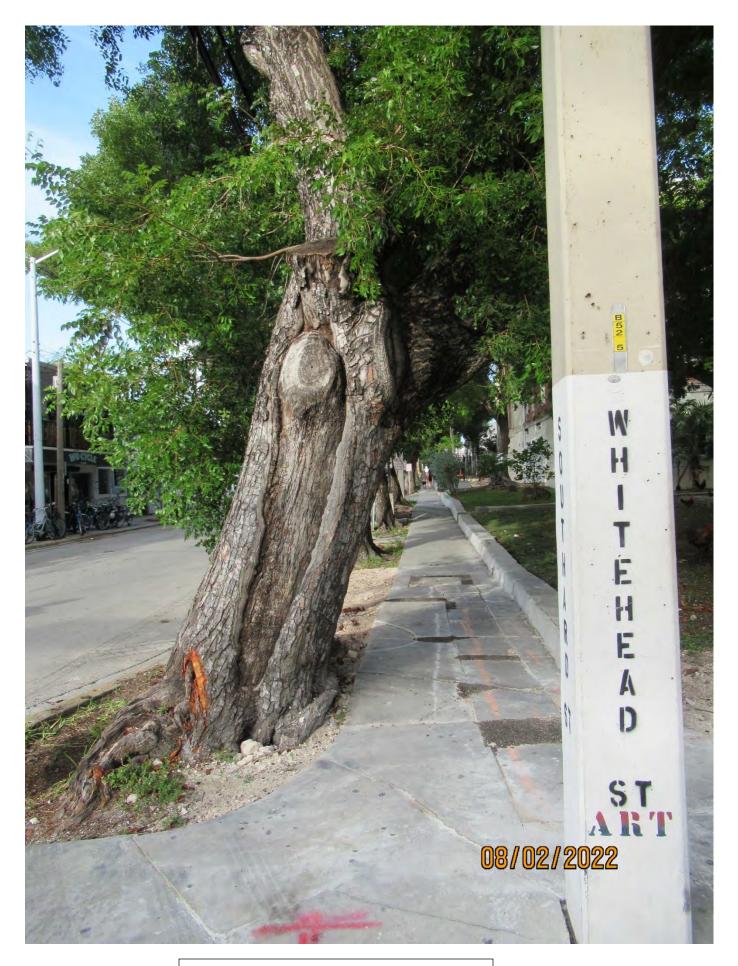
Photo showing tree trunk with old decay area.

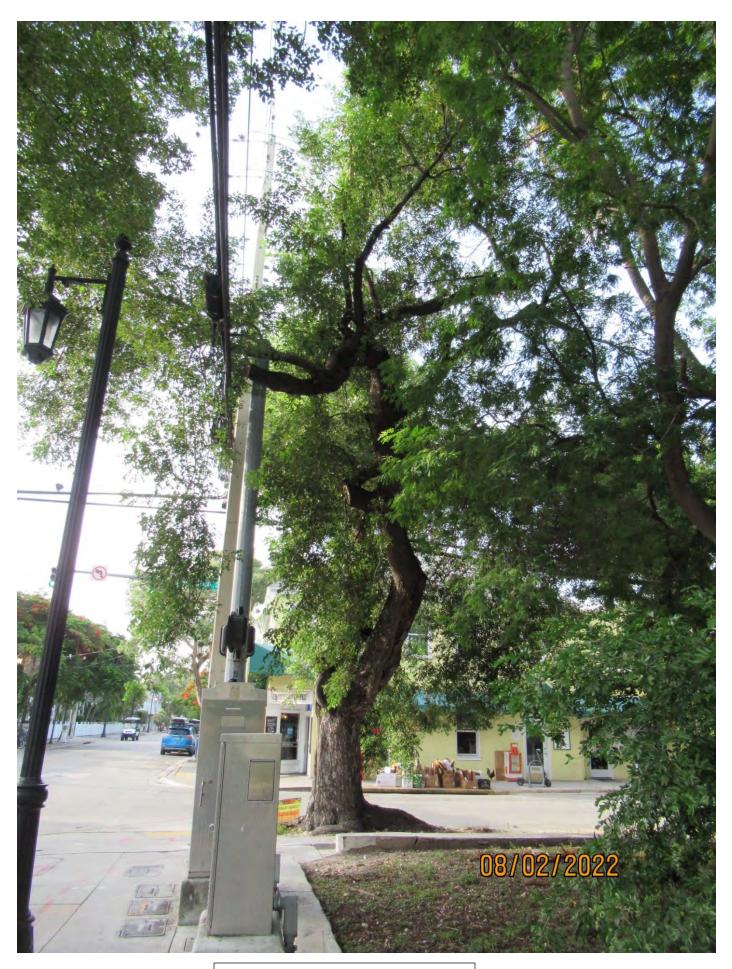
Photo showing tree structure, view 1.

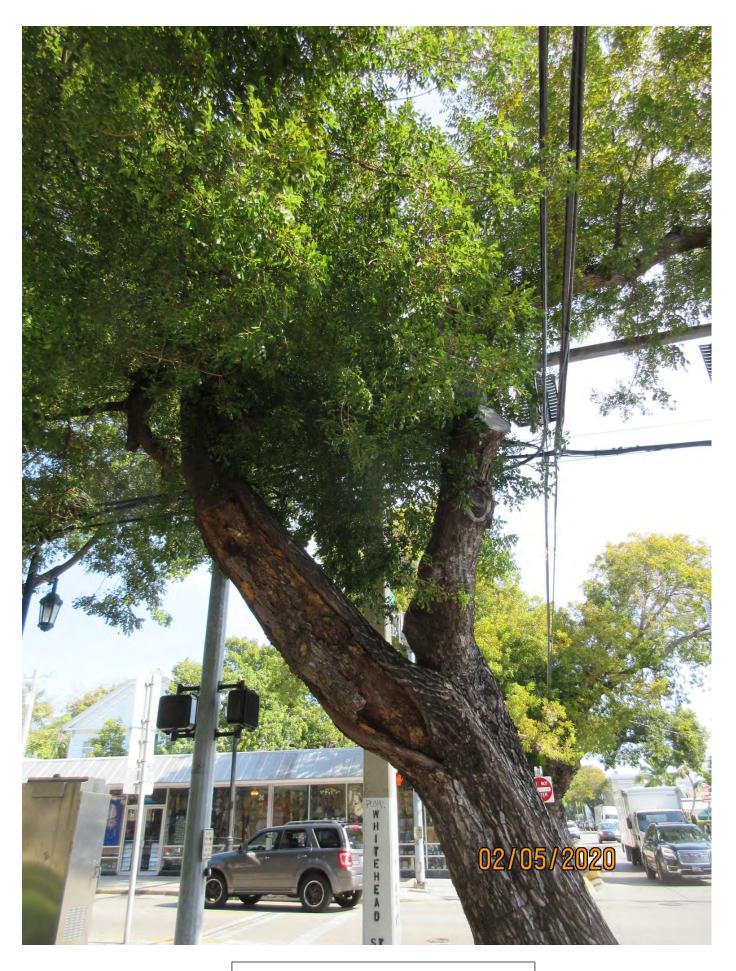
Photo showing old decay area in main trunk.

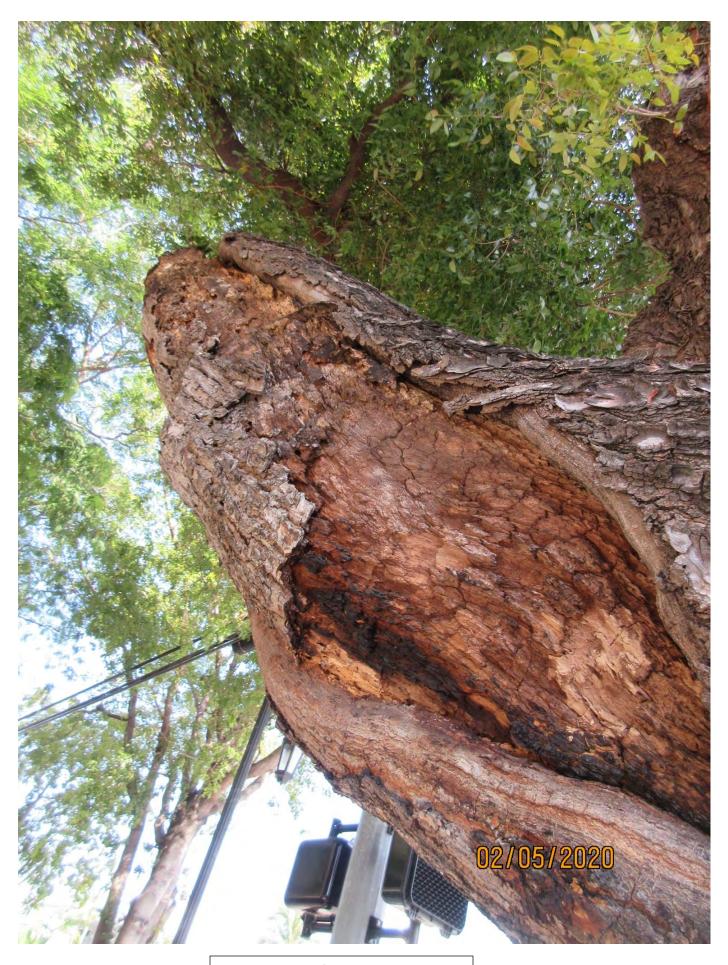
Close up photo of old trunk decay area.

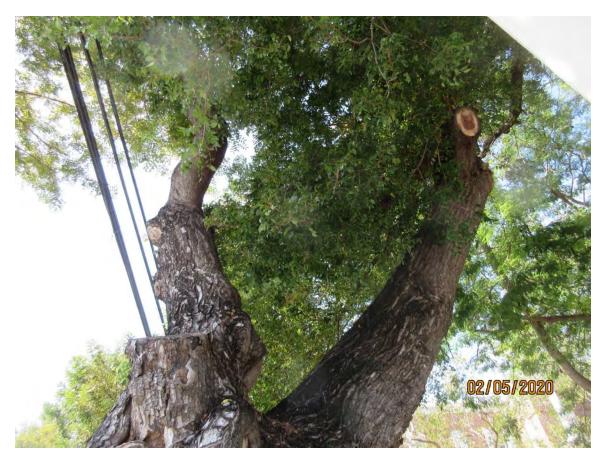
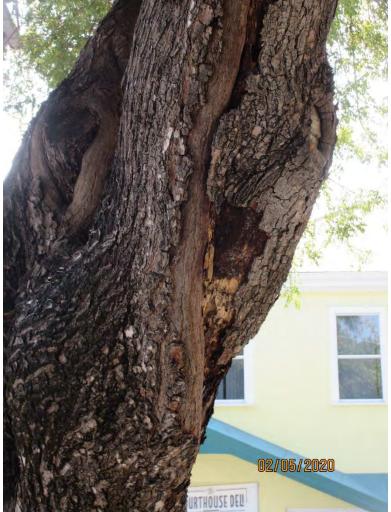
$\label{two-photos} \mbox{Two photos showing main trunks.}$

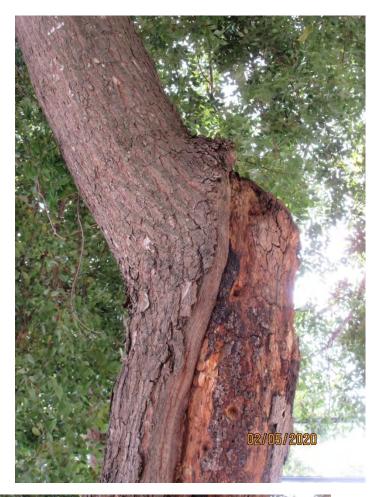
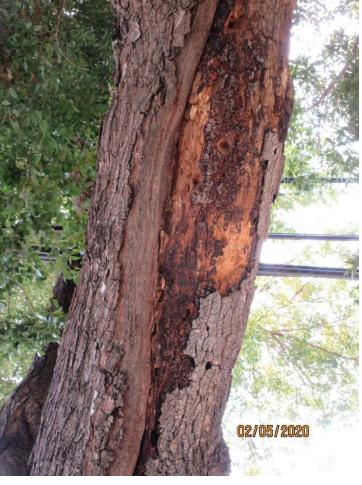
Two photos showing another main decay area in canopy trunks.

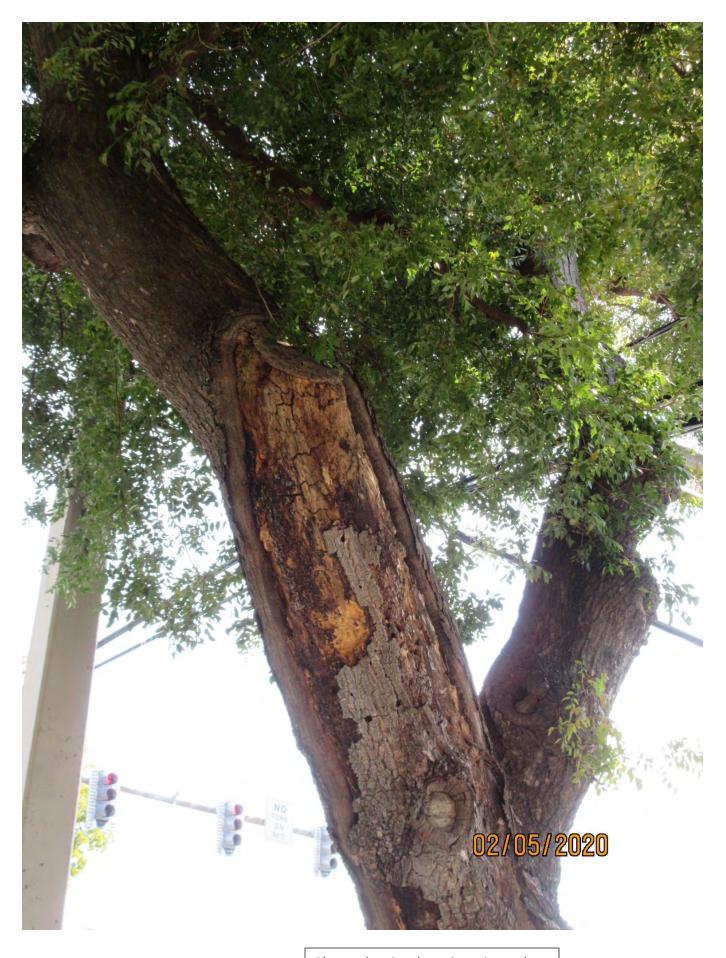
Photos showing decay in main trunk.
