# STAFF REPORT

DATE: February 28, 2023

RE: 541 White Street-Peary Court  
(permit application # T2023-0064)

FROM: Karen DeMaria, City of Key West Urban Forestry Manager

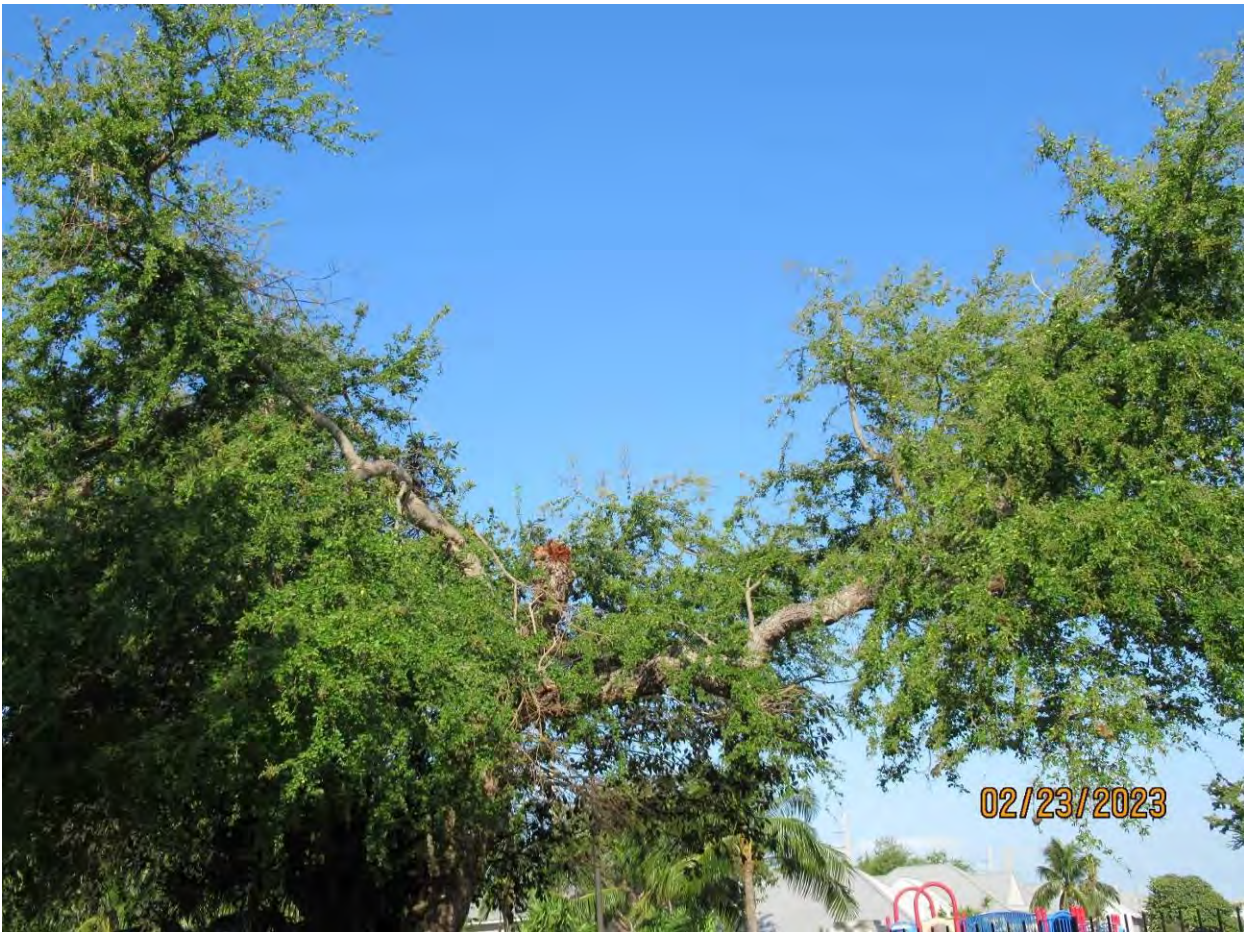
Photo of  
canopy  
showing old  
break.

Condition: 40% (overall condition is poor. Codominant trunks with poor structure. Ficus plant is growing on one of the main trunks. Large canopy branch break observed.)

Recommend removal of tree.

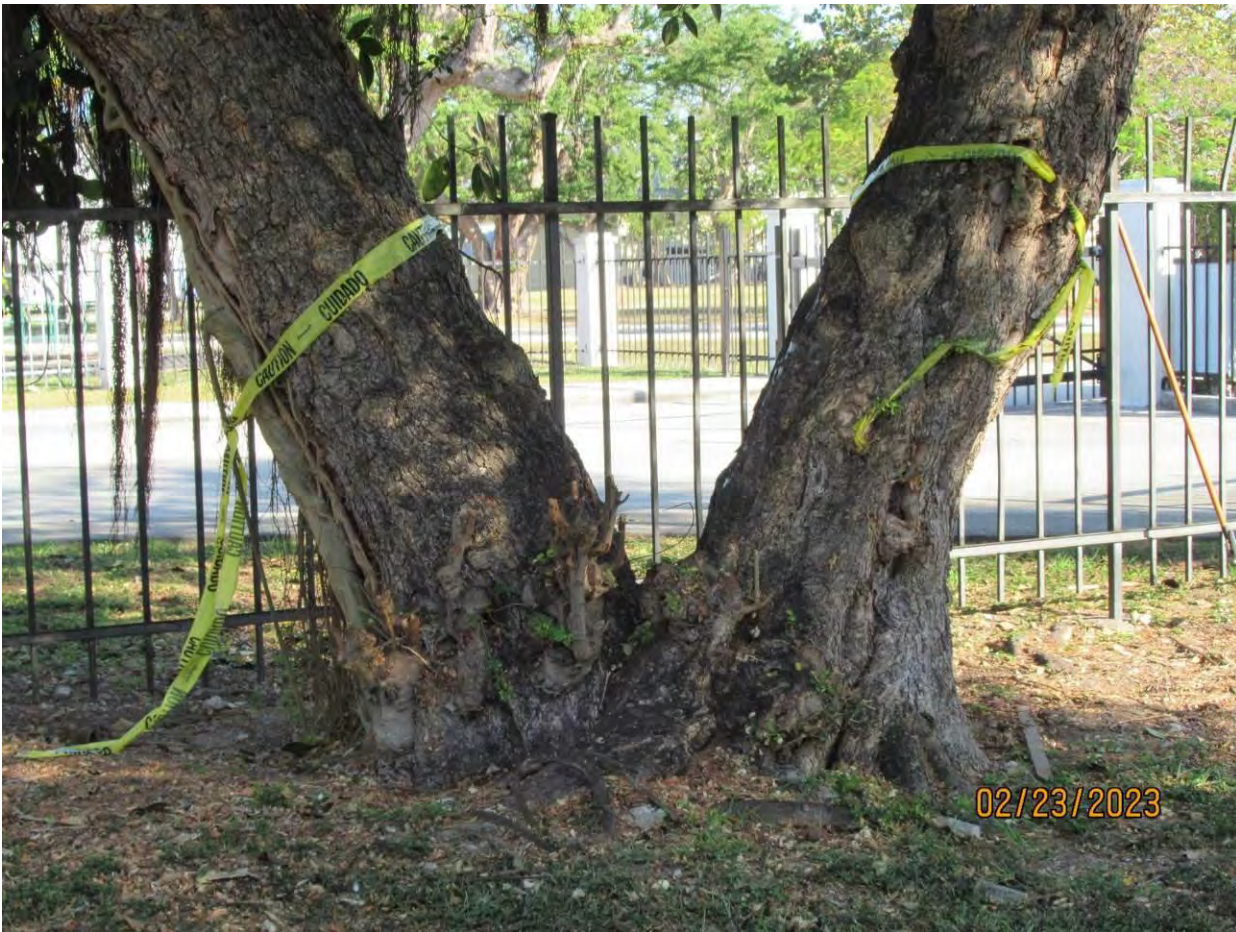
Photo showing co-dominant trunks.

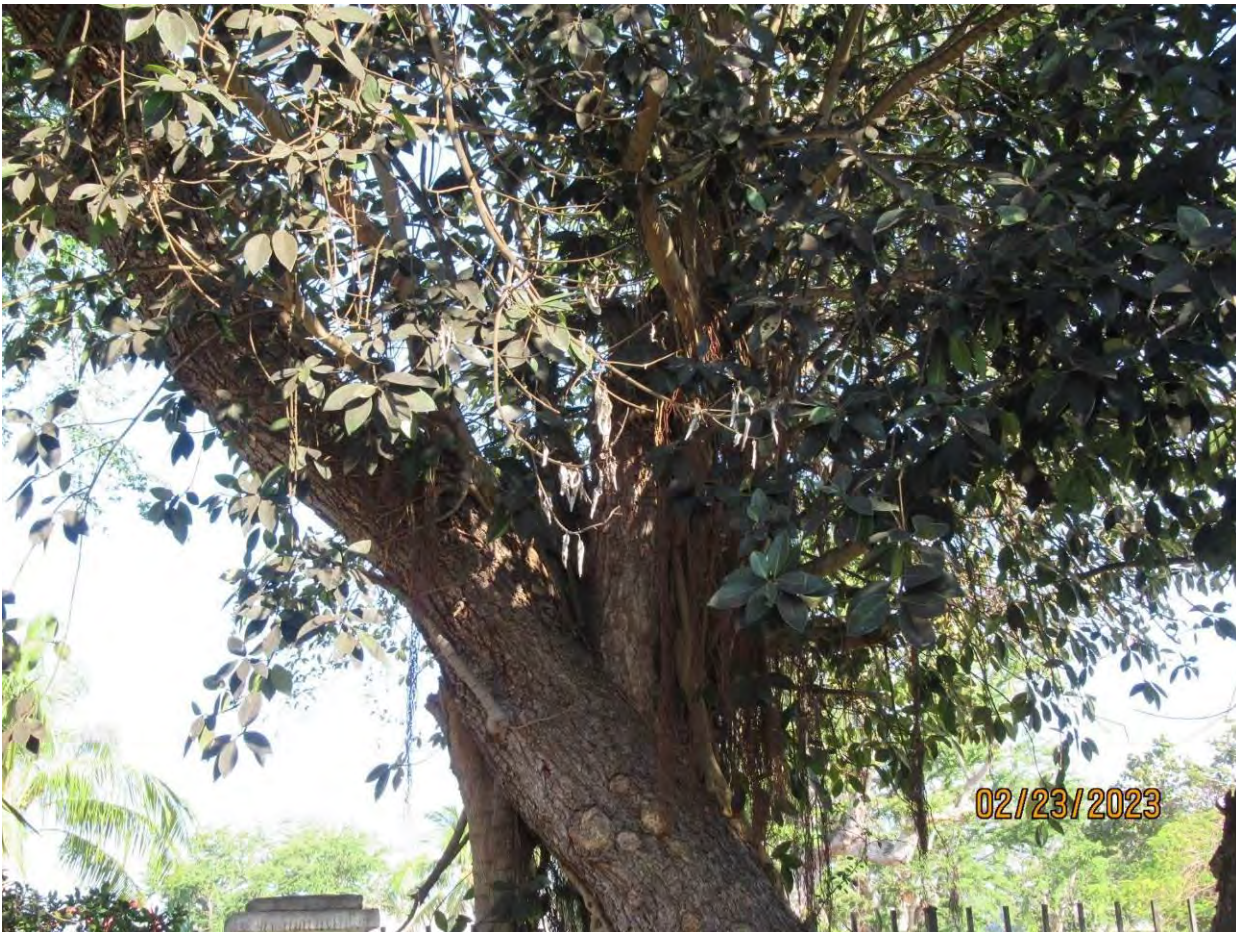
Photo of one trunk with ficus tree growing/attached, view 1.

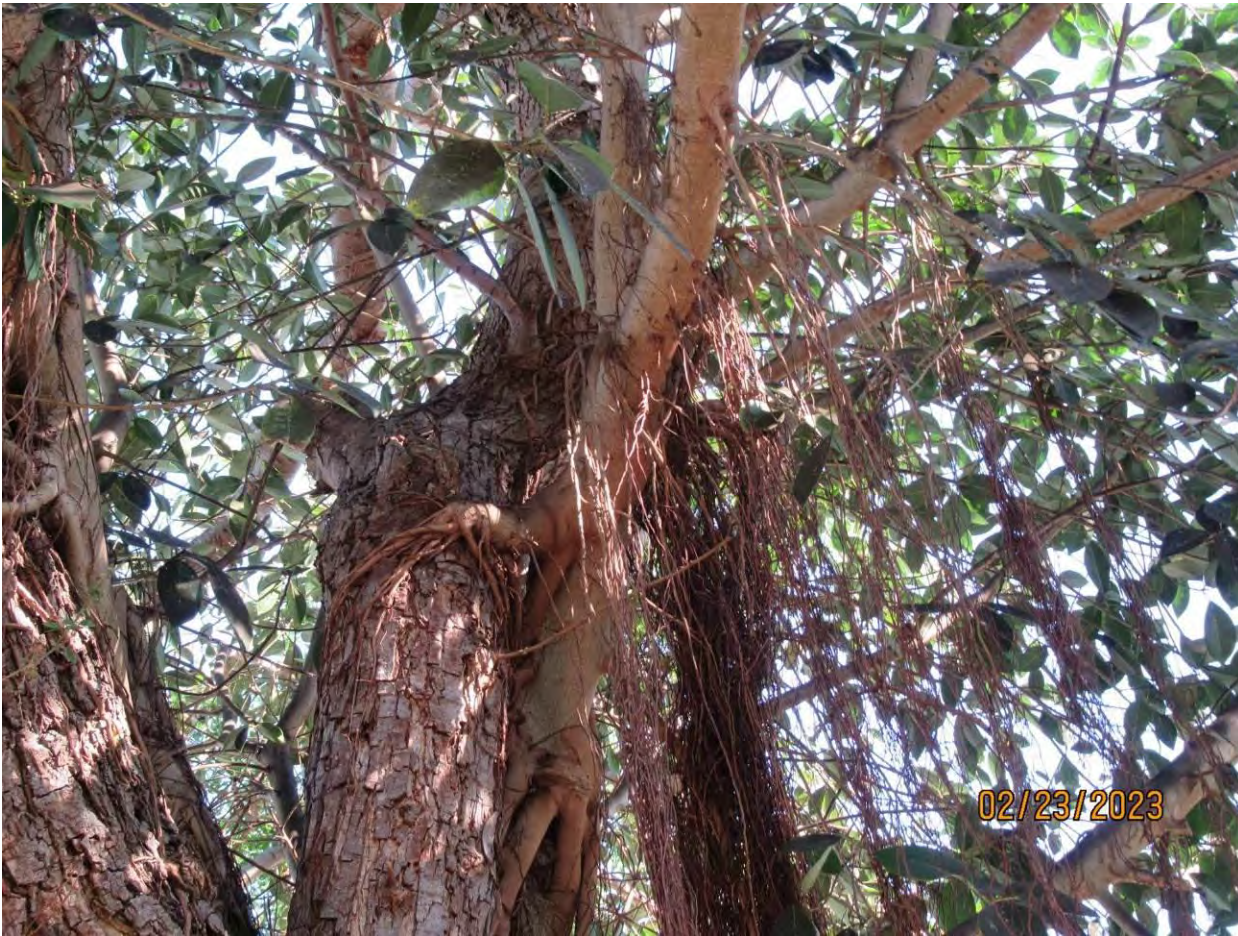
Photo of  
one trunk  
with ficus  
tree  
growing/  
attached,  
view 2.

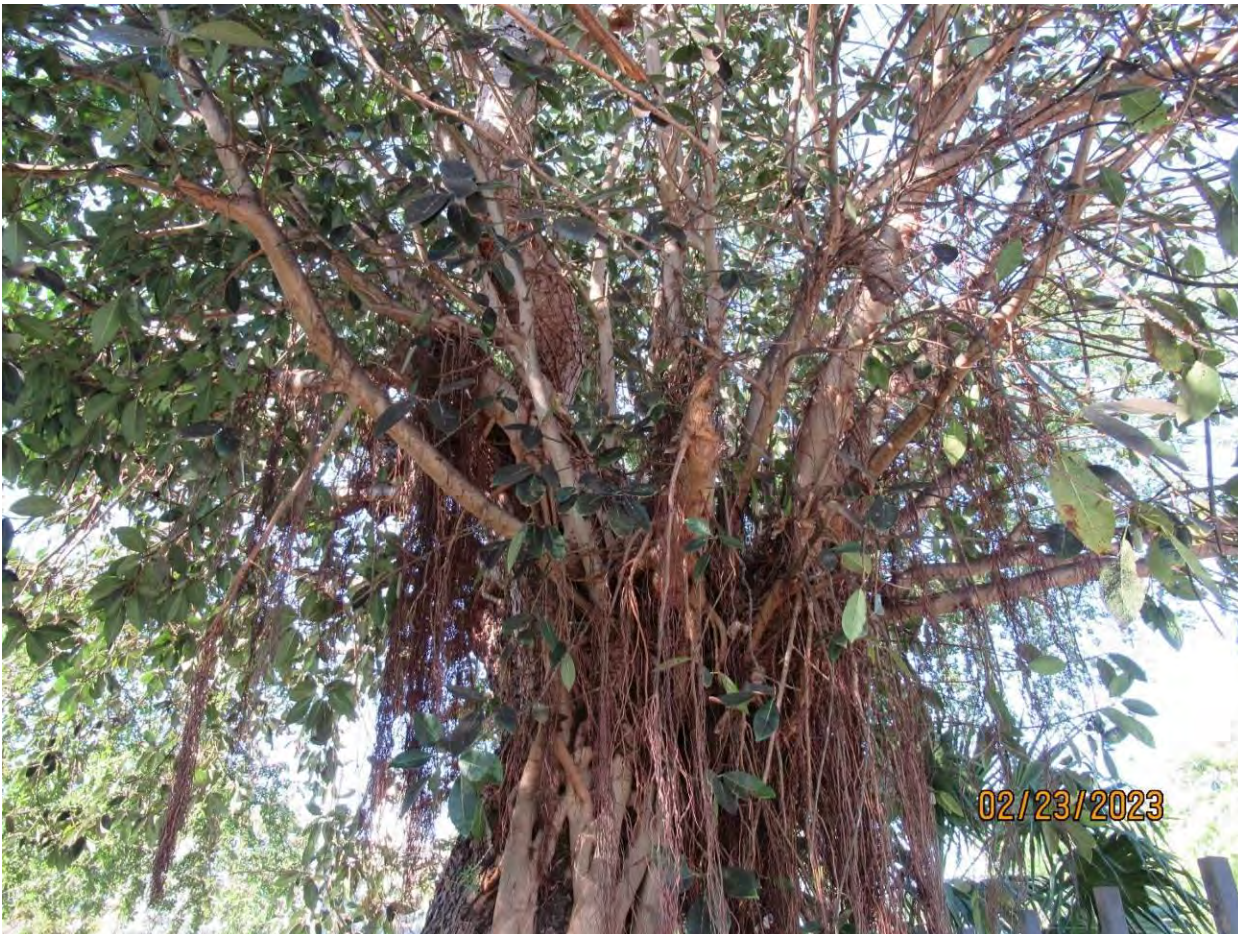
Photo of  
one trunk  
with ficus  
tree  
growing/  
attached,  
view 3.

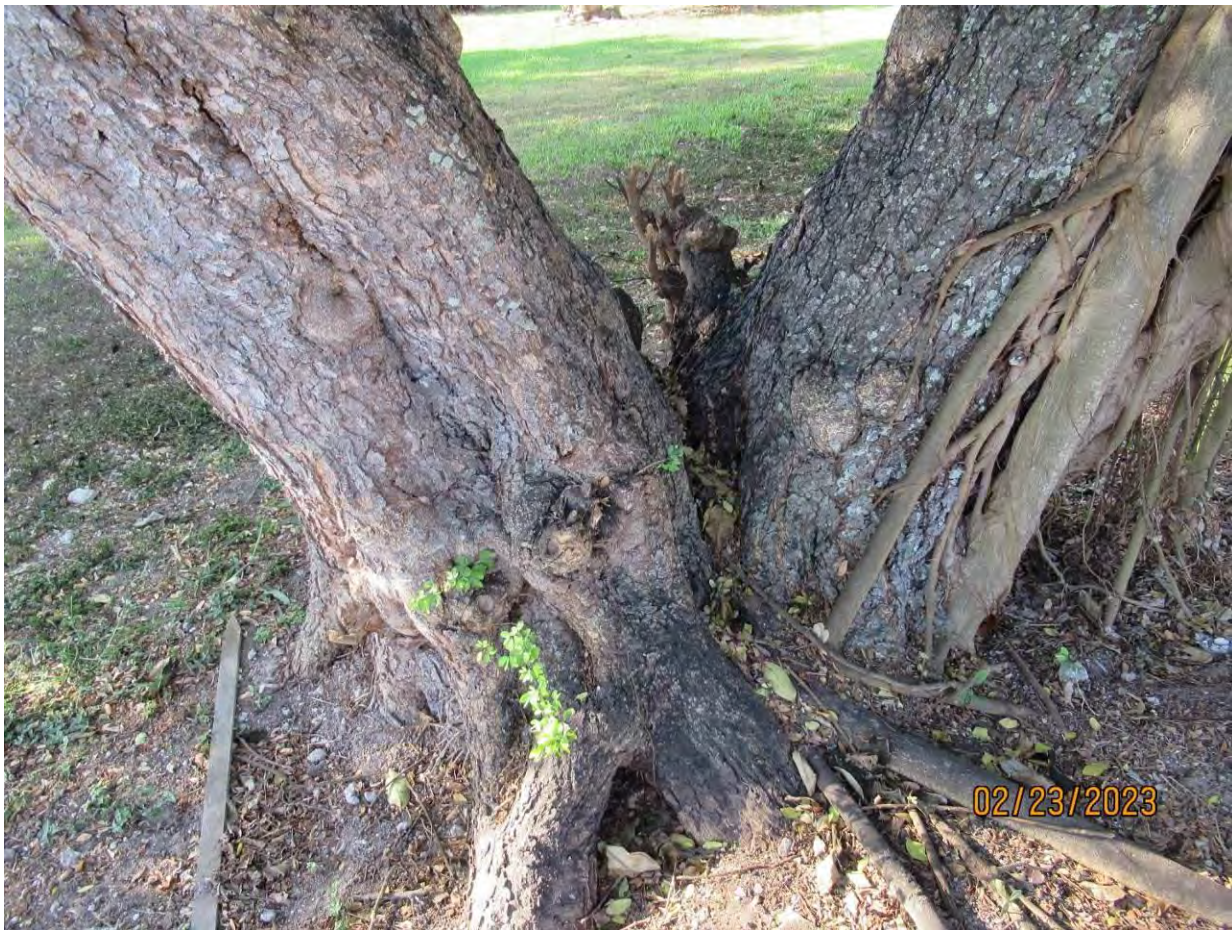
Photo showing base of trunks. Note ficus roots on one trunk.

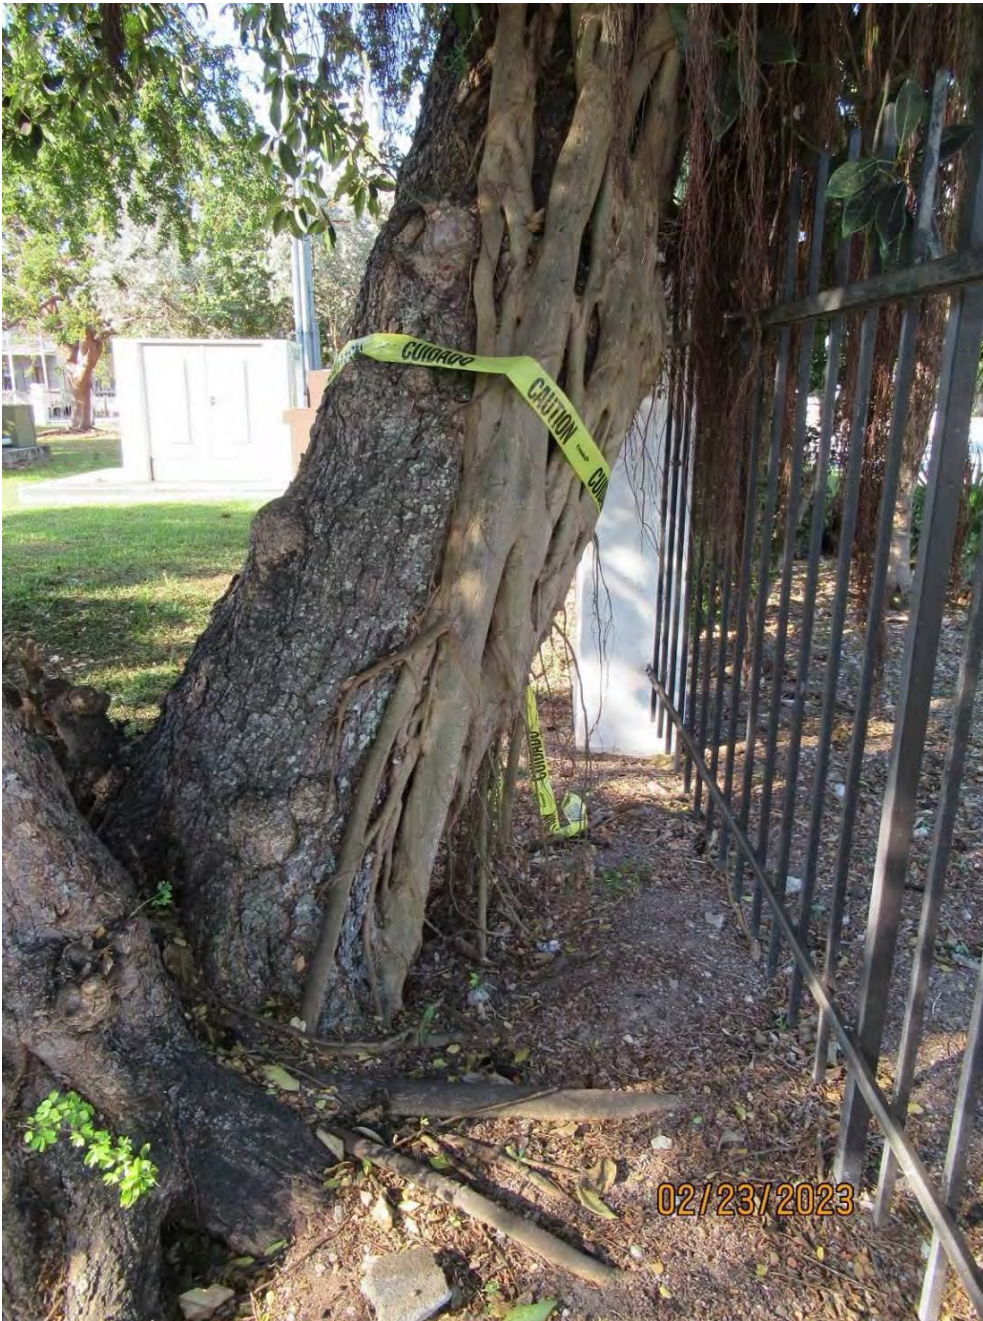
Photo showing trunk one with ficus tree growth and location of trunk to property line fence.

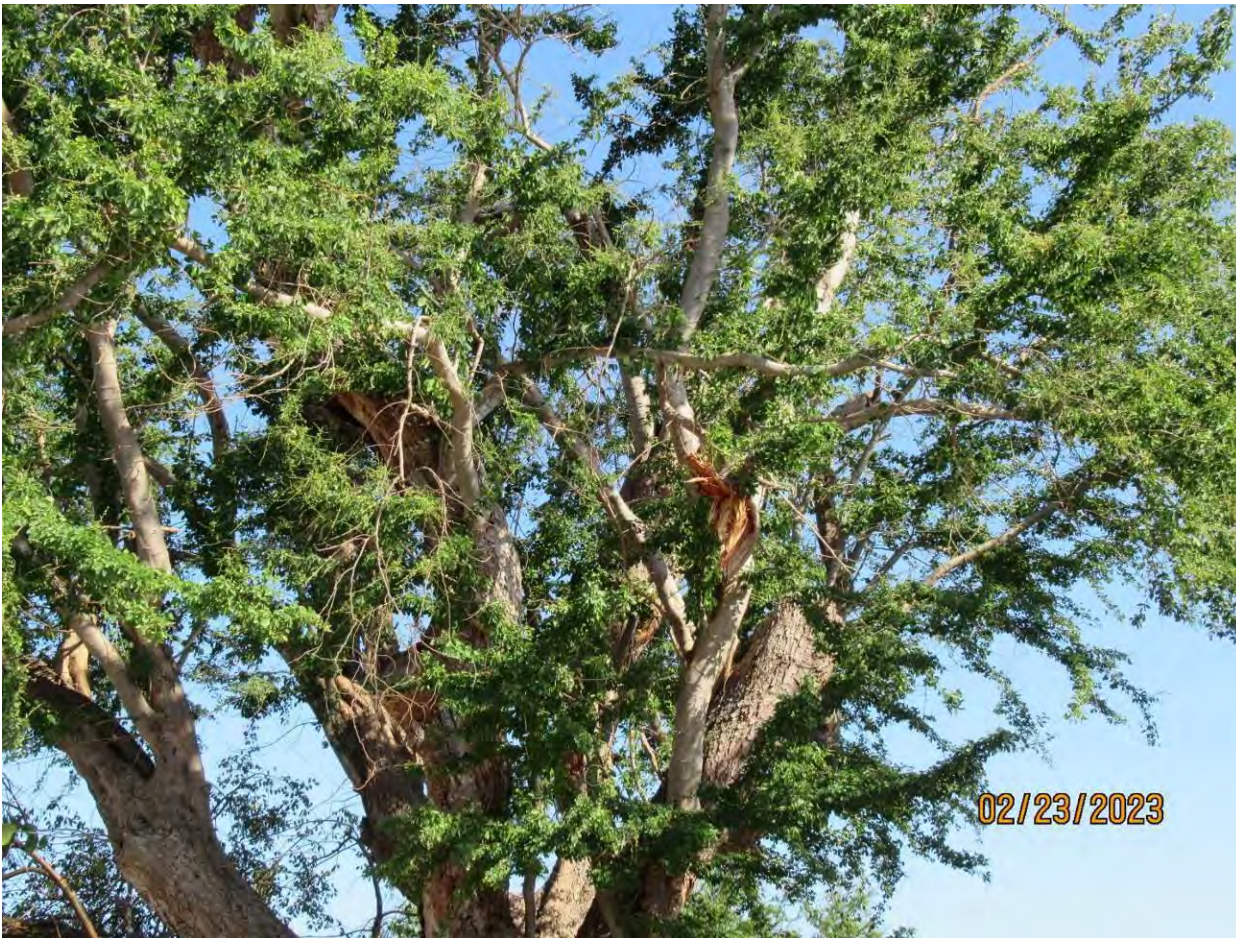
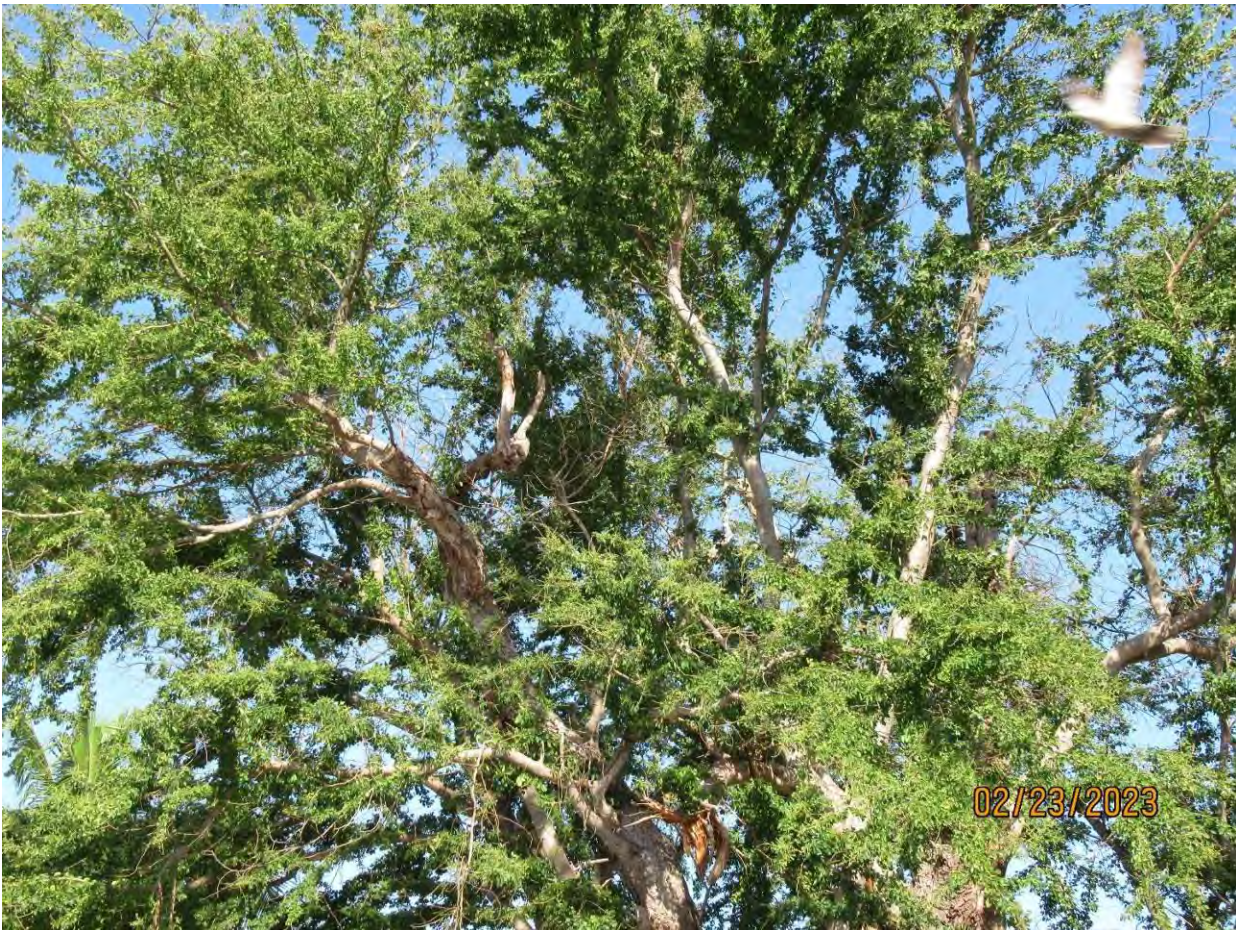
Two  
photos of  
tree  
canopy,  
view 1 &  
2. Note  
branch  
breakage.

Condition: 20% (overall condition is very poor, major decay throughout tree canopy and main trunk. Tree is a potential a safety risk.)

Recommend removal of tree.

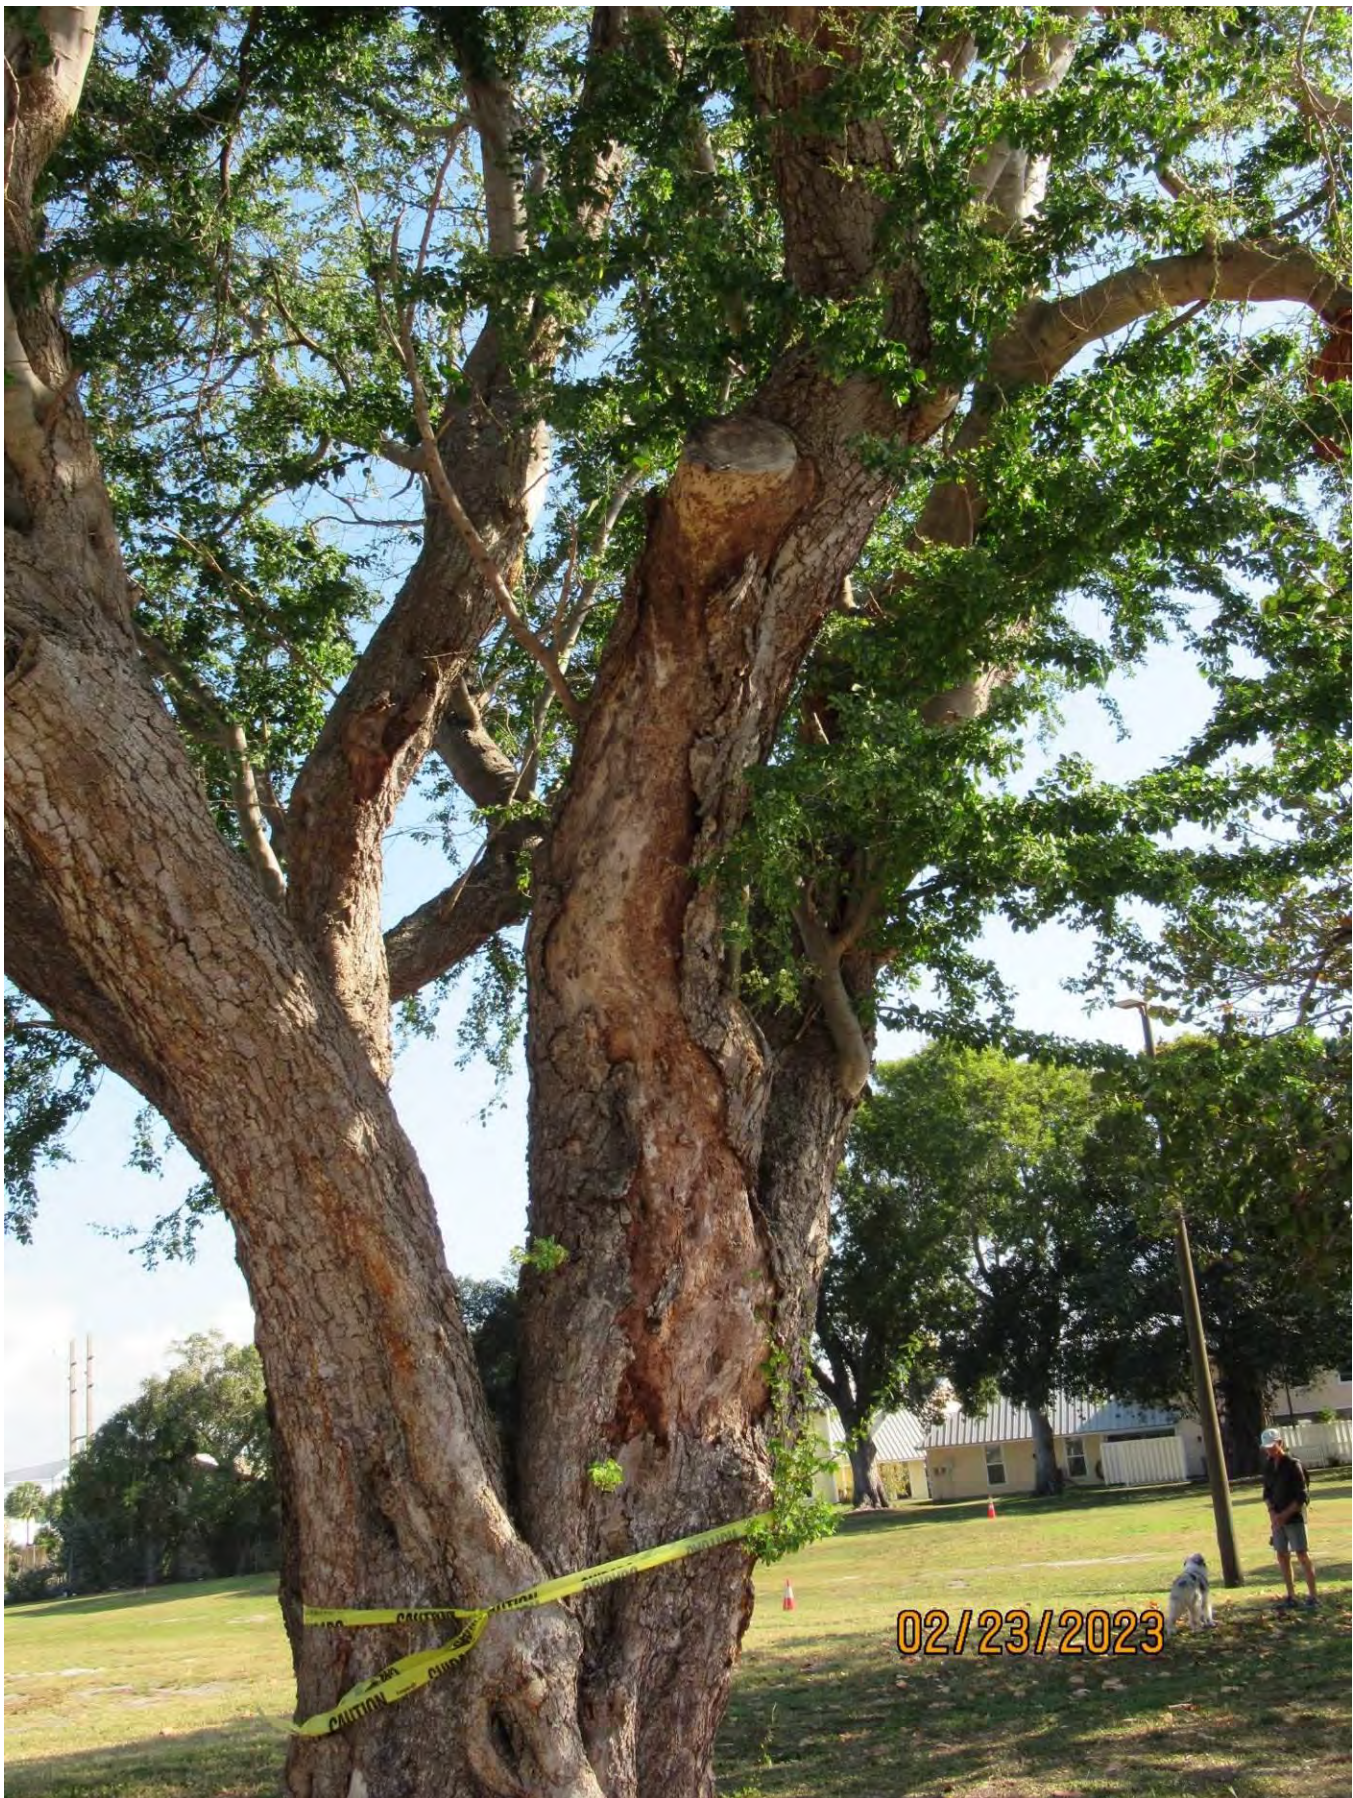
Photo of tree trunks. Note major decay in one trunk.

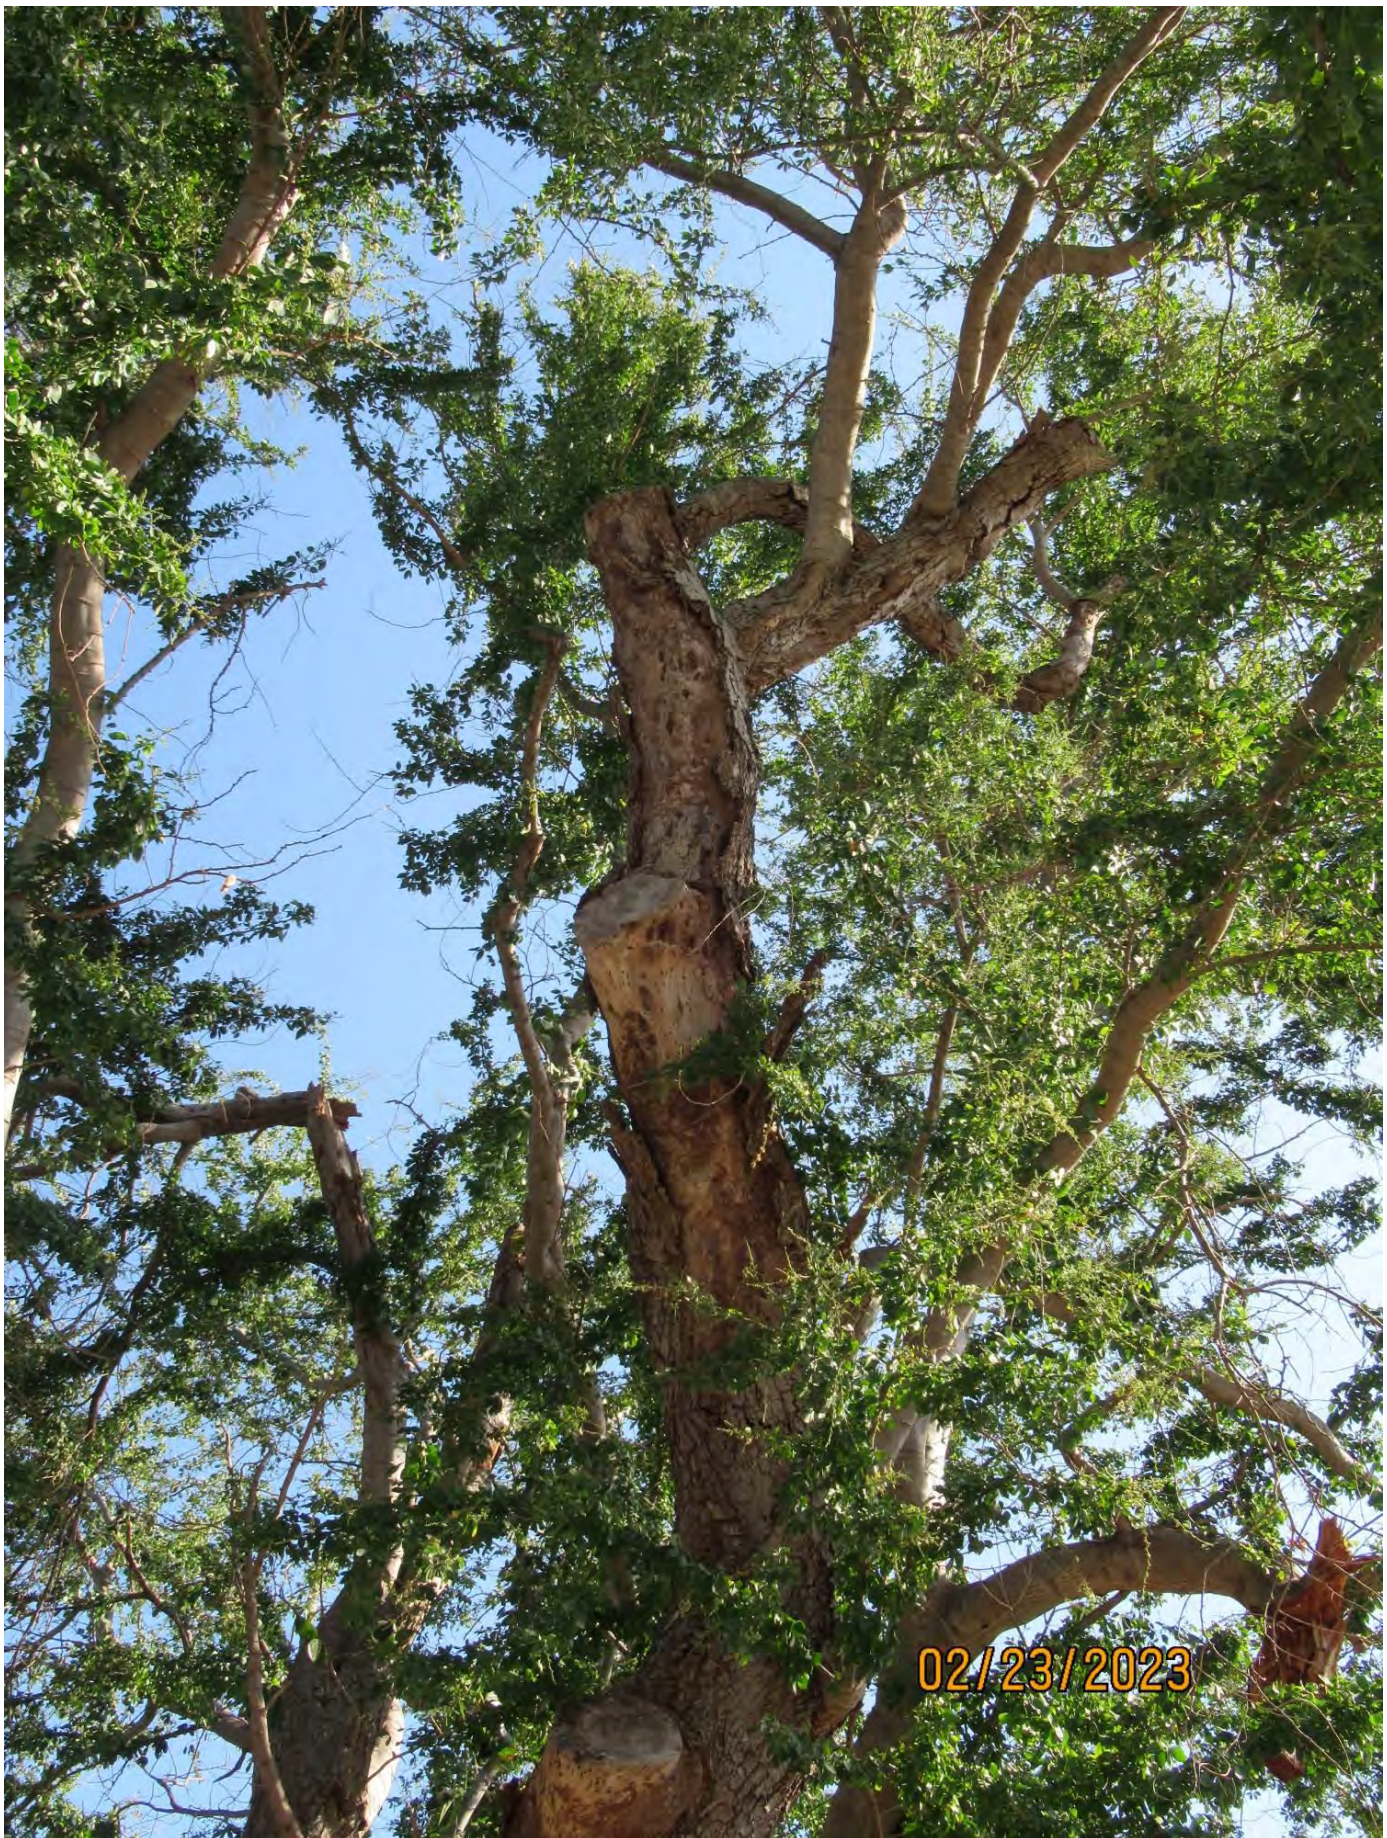
Photo of main canopy trunks and branches, view 1. Note decay in main trunk and breakage in canopy branches.

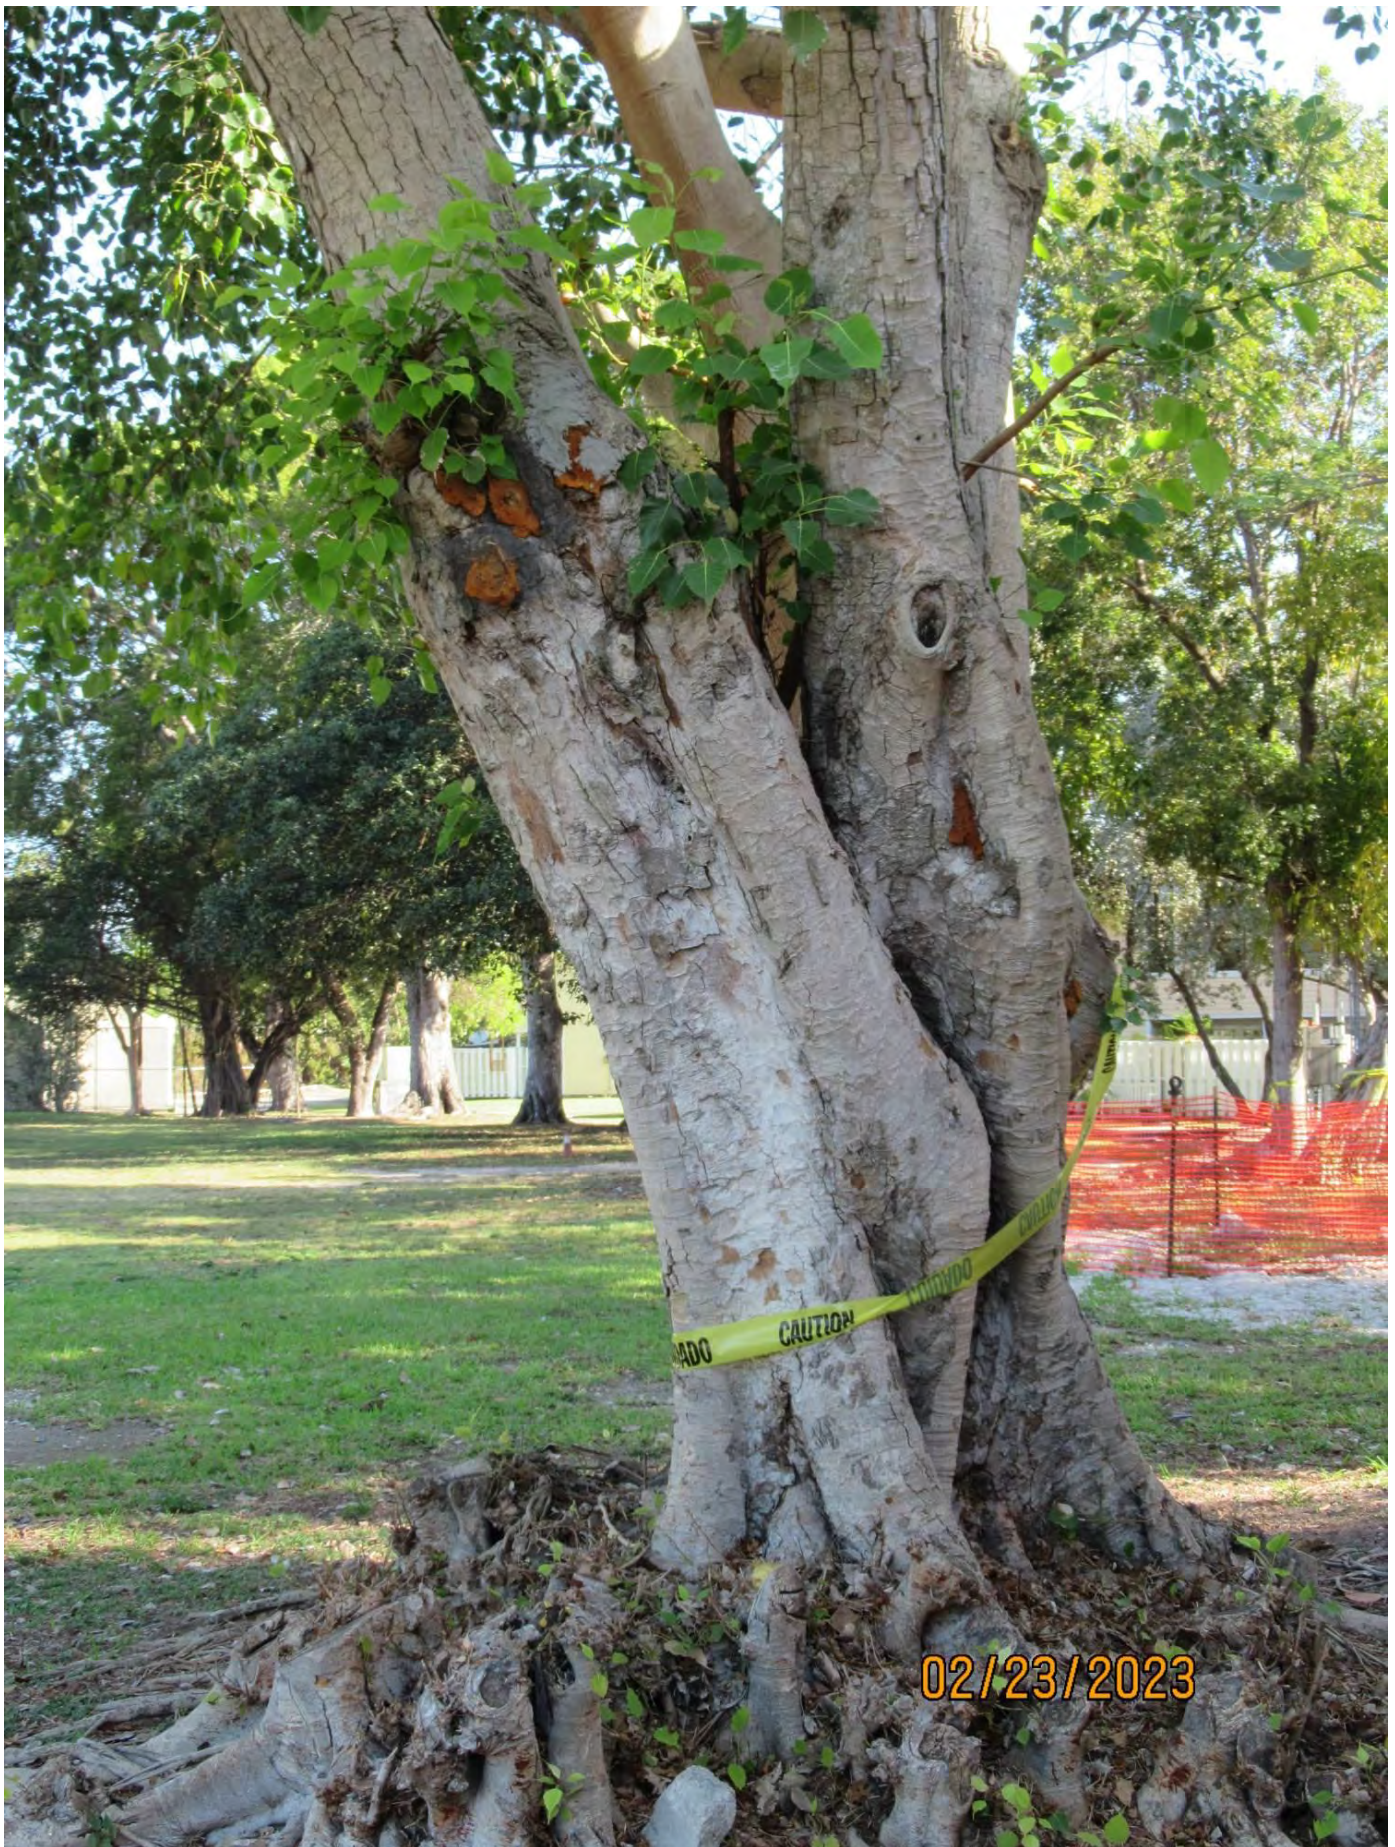
Photo of tree trunks. Tree has two main trunks and included bark, view 1.

Condition: 30% (overall condition is poor. Decay observed in canopy branches. Main trunk has insulation foam sprayed into hole areas. Exposed root flare area has been heavily trimmed/impacted.)

Recommend removal of tree.

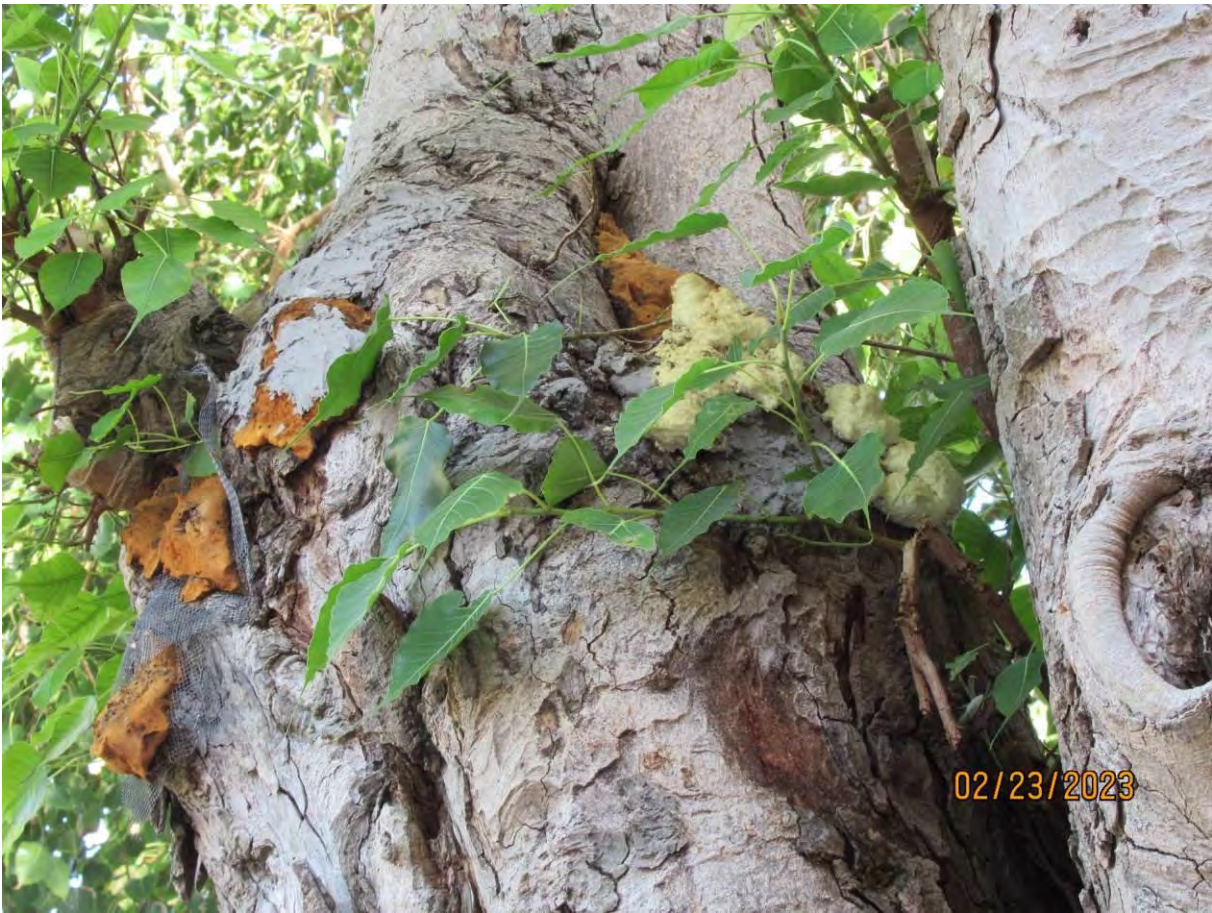
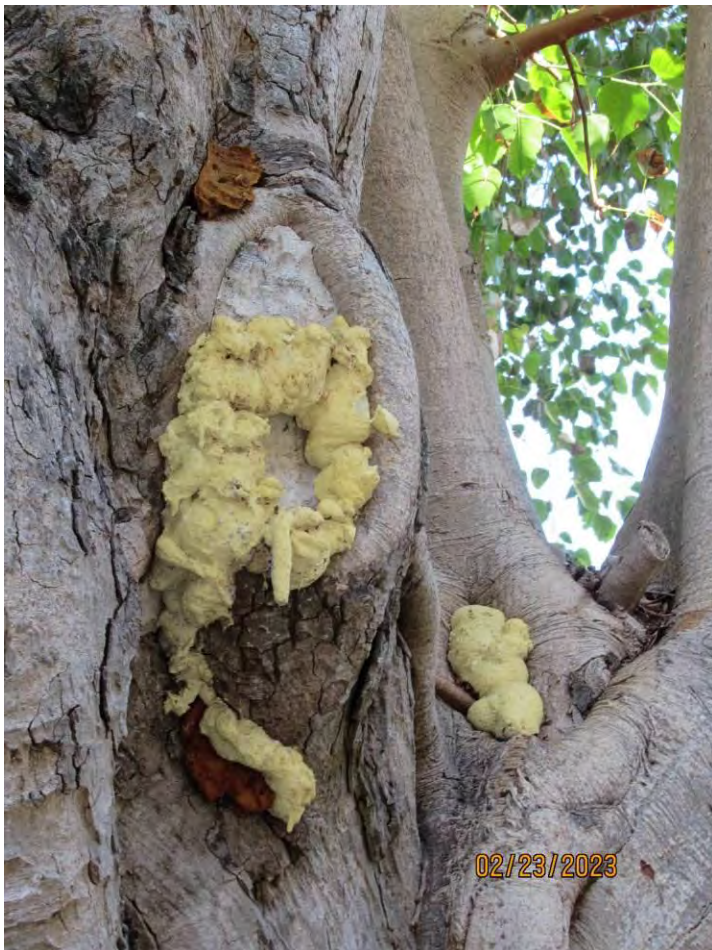
Two photos of areas of tree trunks  
with insulated foam.
