THE CITY OF KEY WEST  
Tree Commission  
Post Office Box 1409 Key West, FL 33041-1409

RE: 1701 Von Phister Street ROW/File # T2022-0462  
Represented by: Eric Denhart

# UPDATED STAFF REPORT

RE: 1701 Von Phister ROW (permit application # T2022-0462)

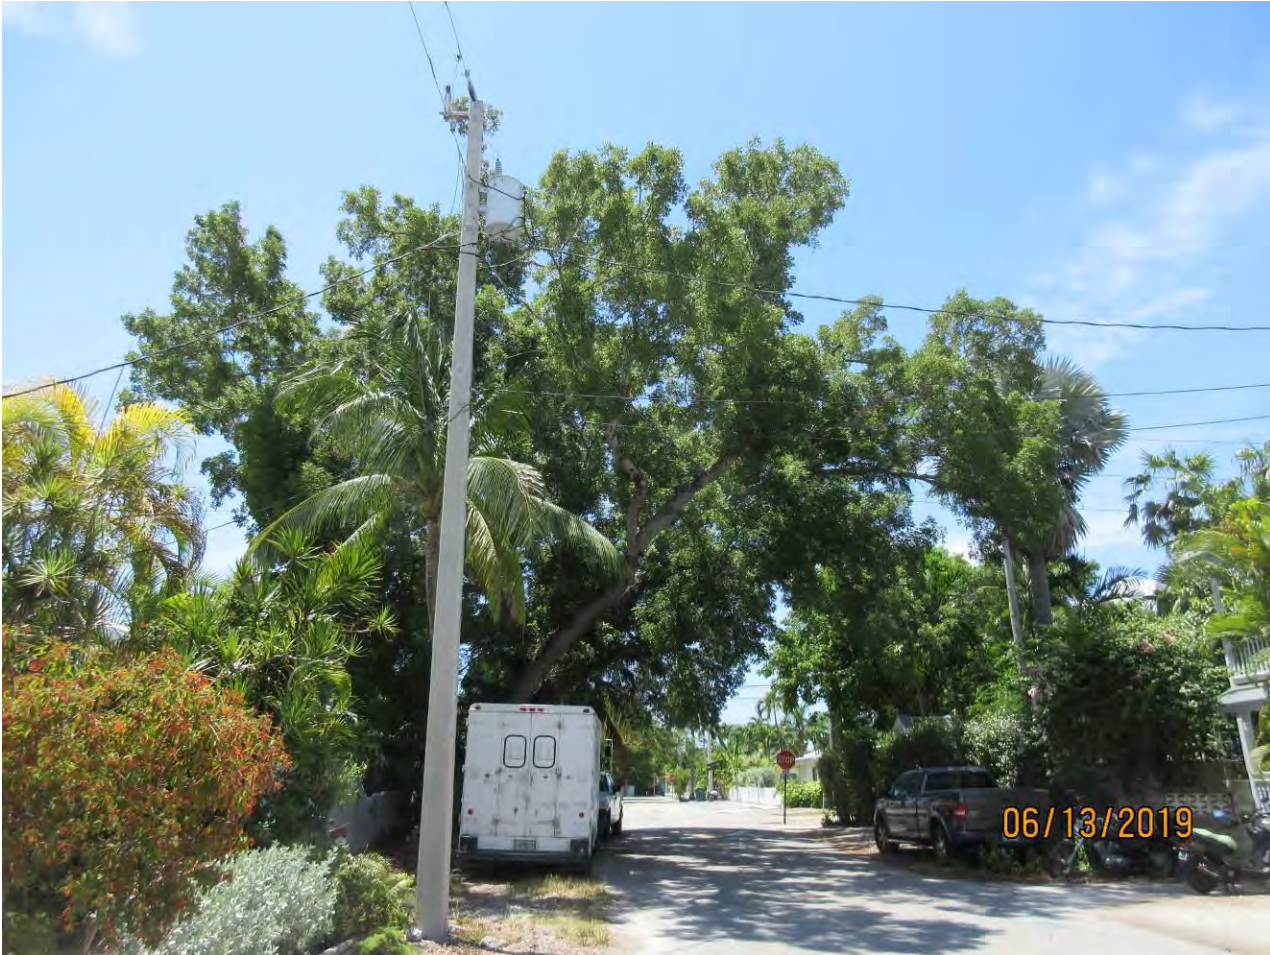
Standing on Ashby Street looking toward Von Phister Street, photo of tree prior to trimming.

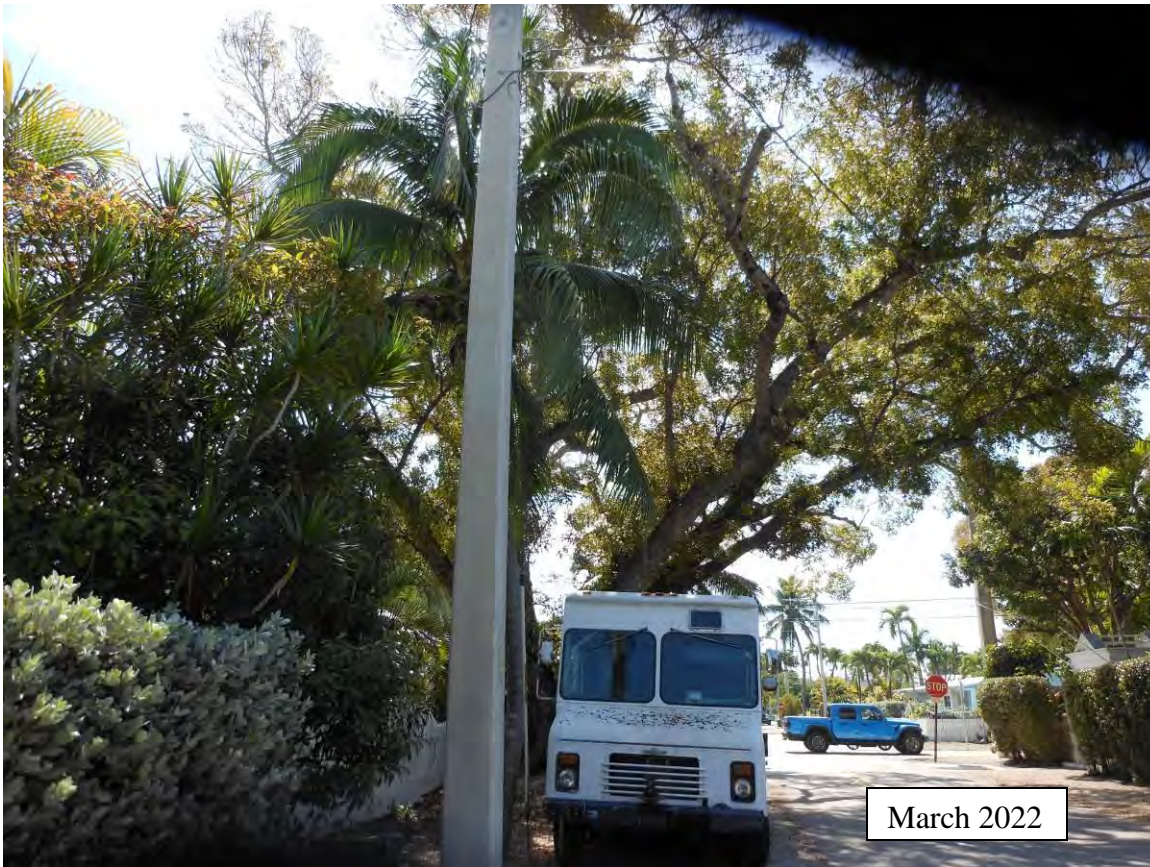
March 2022

Standing on  
Ashby Street  
looking toward  
Von Phister,  
photo of tree  
prior to  
trimming.

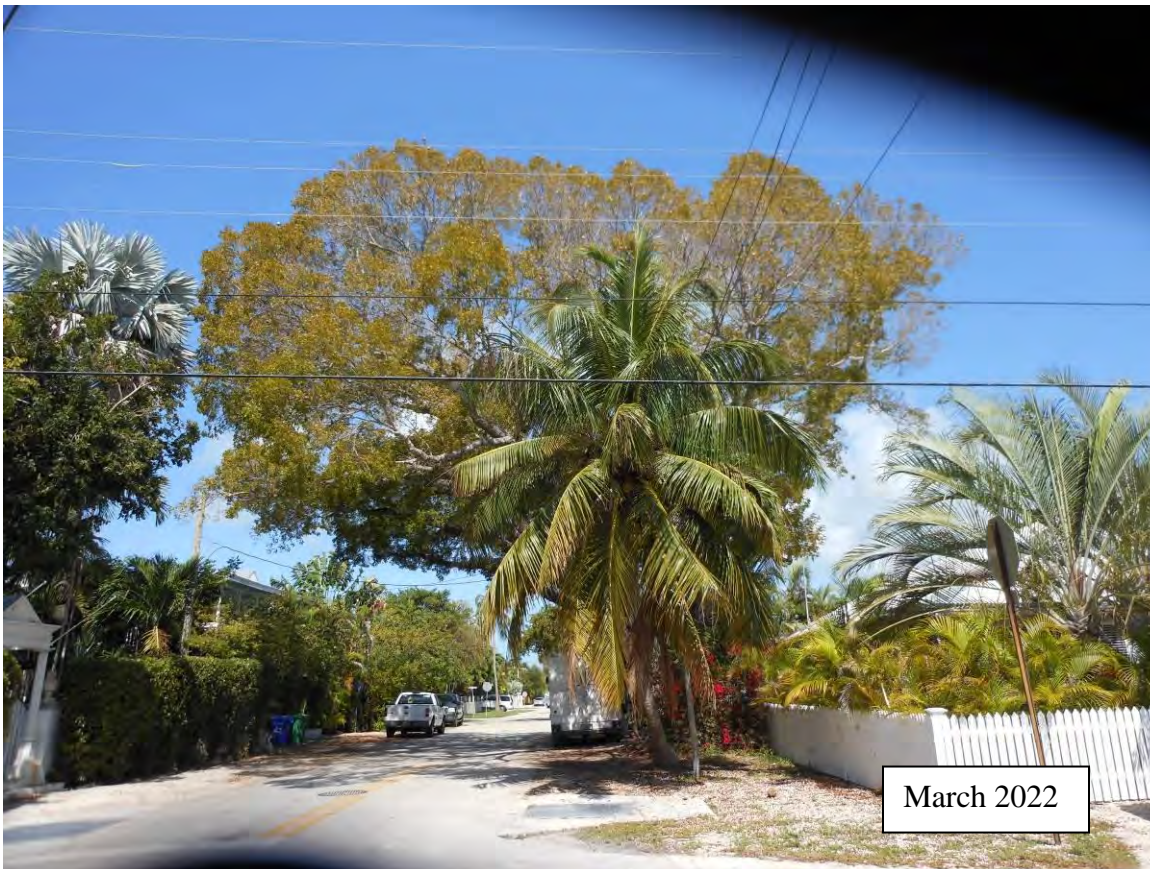
March 2022

Standing at  
corner of  
Ashby and Von  
Phister looking  
toward  
Washington  
Street, photo of  
tree prior to  
trimming.

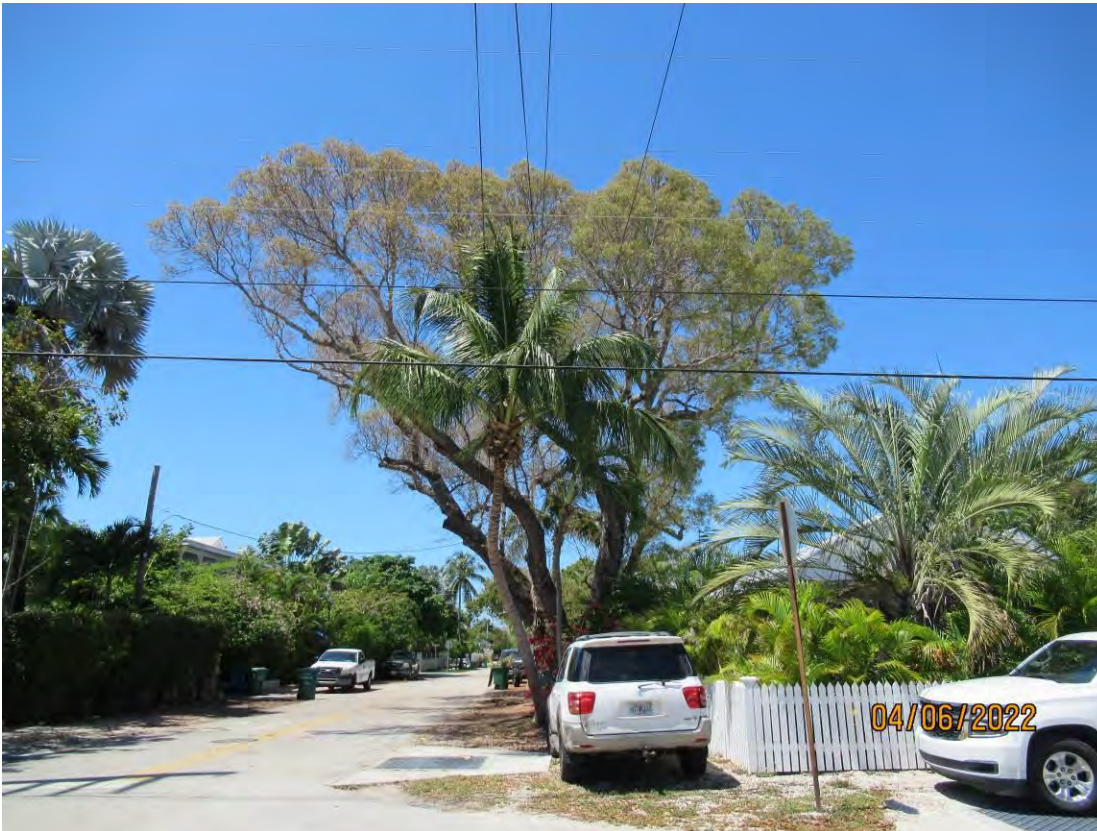
Standing at corner of Ashby and Von Phister looking toward Washington Street, photo of tree after street side trimming by City.

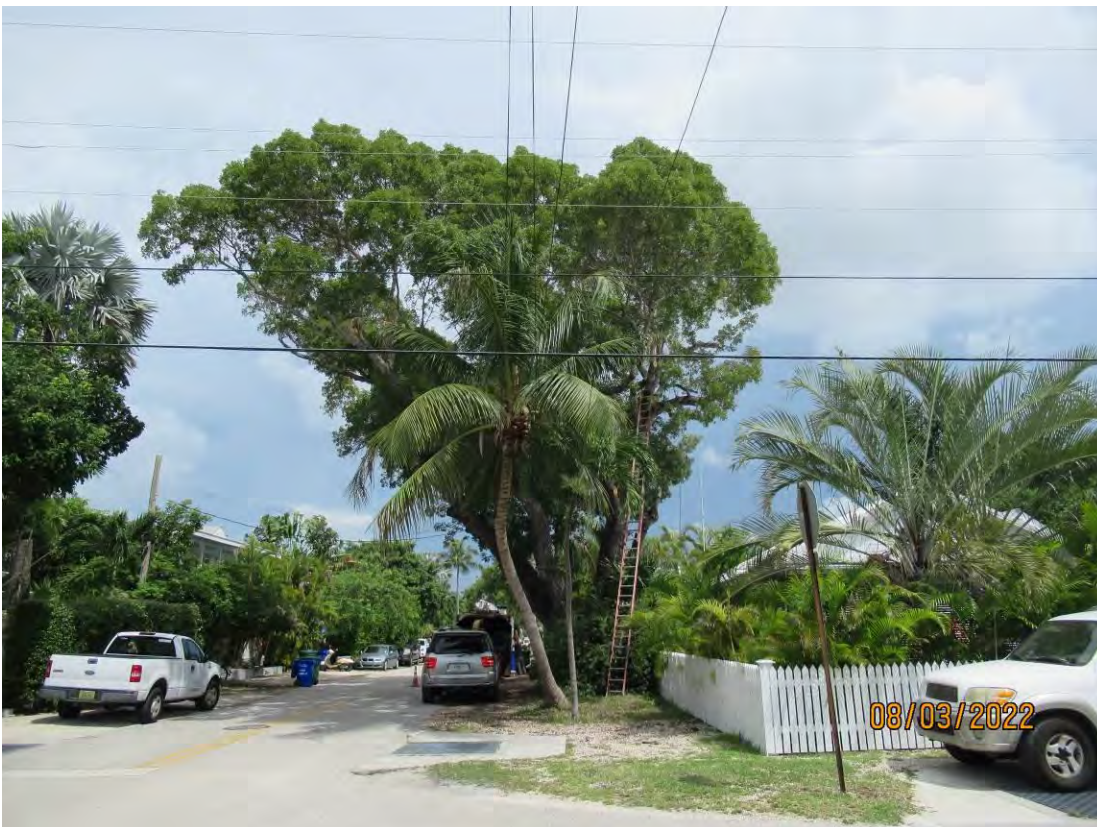
Standing at corner of Ashby and Von Phister looking toward Washington Street, photo of tree after trimming on house side of tree.

The tree canopy is currently in a lopsided shape due to the trimming that has been done in the past year. Standard trimming practices recommend not trimming more than 30% of a canopy in one calendar year. The continued plan is to trim the tree in 2023 to balance and reduce the canopy.

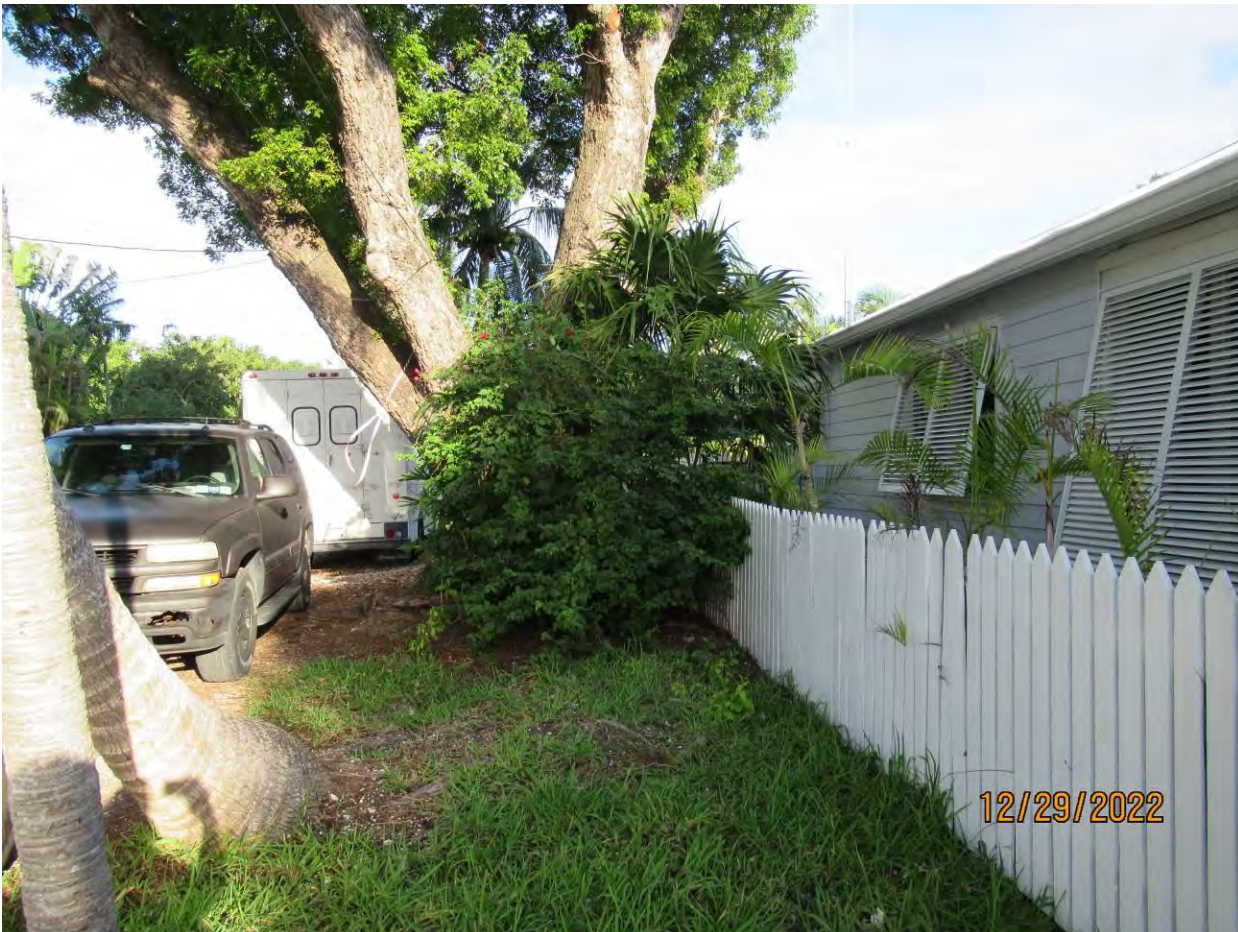
Photo of  
base of  
tree and  
main  
trunks in  
relation  
to house.

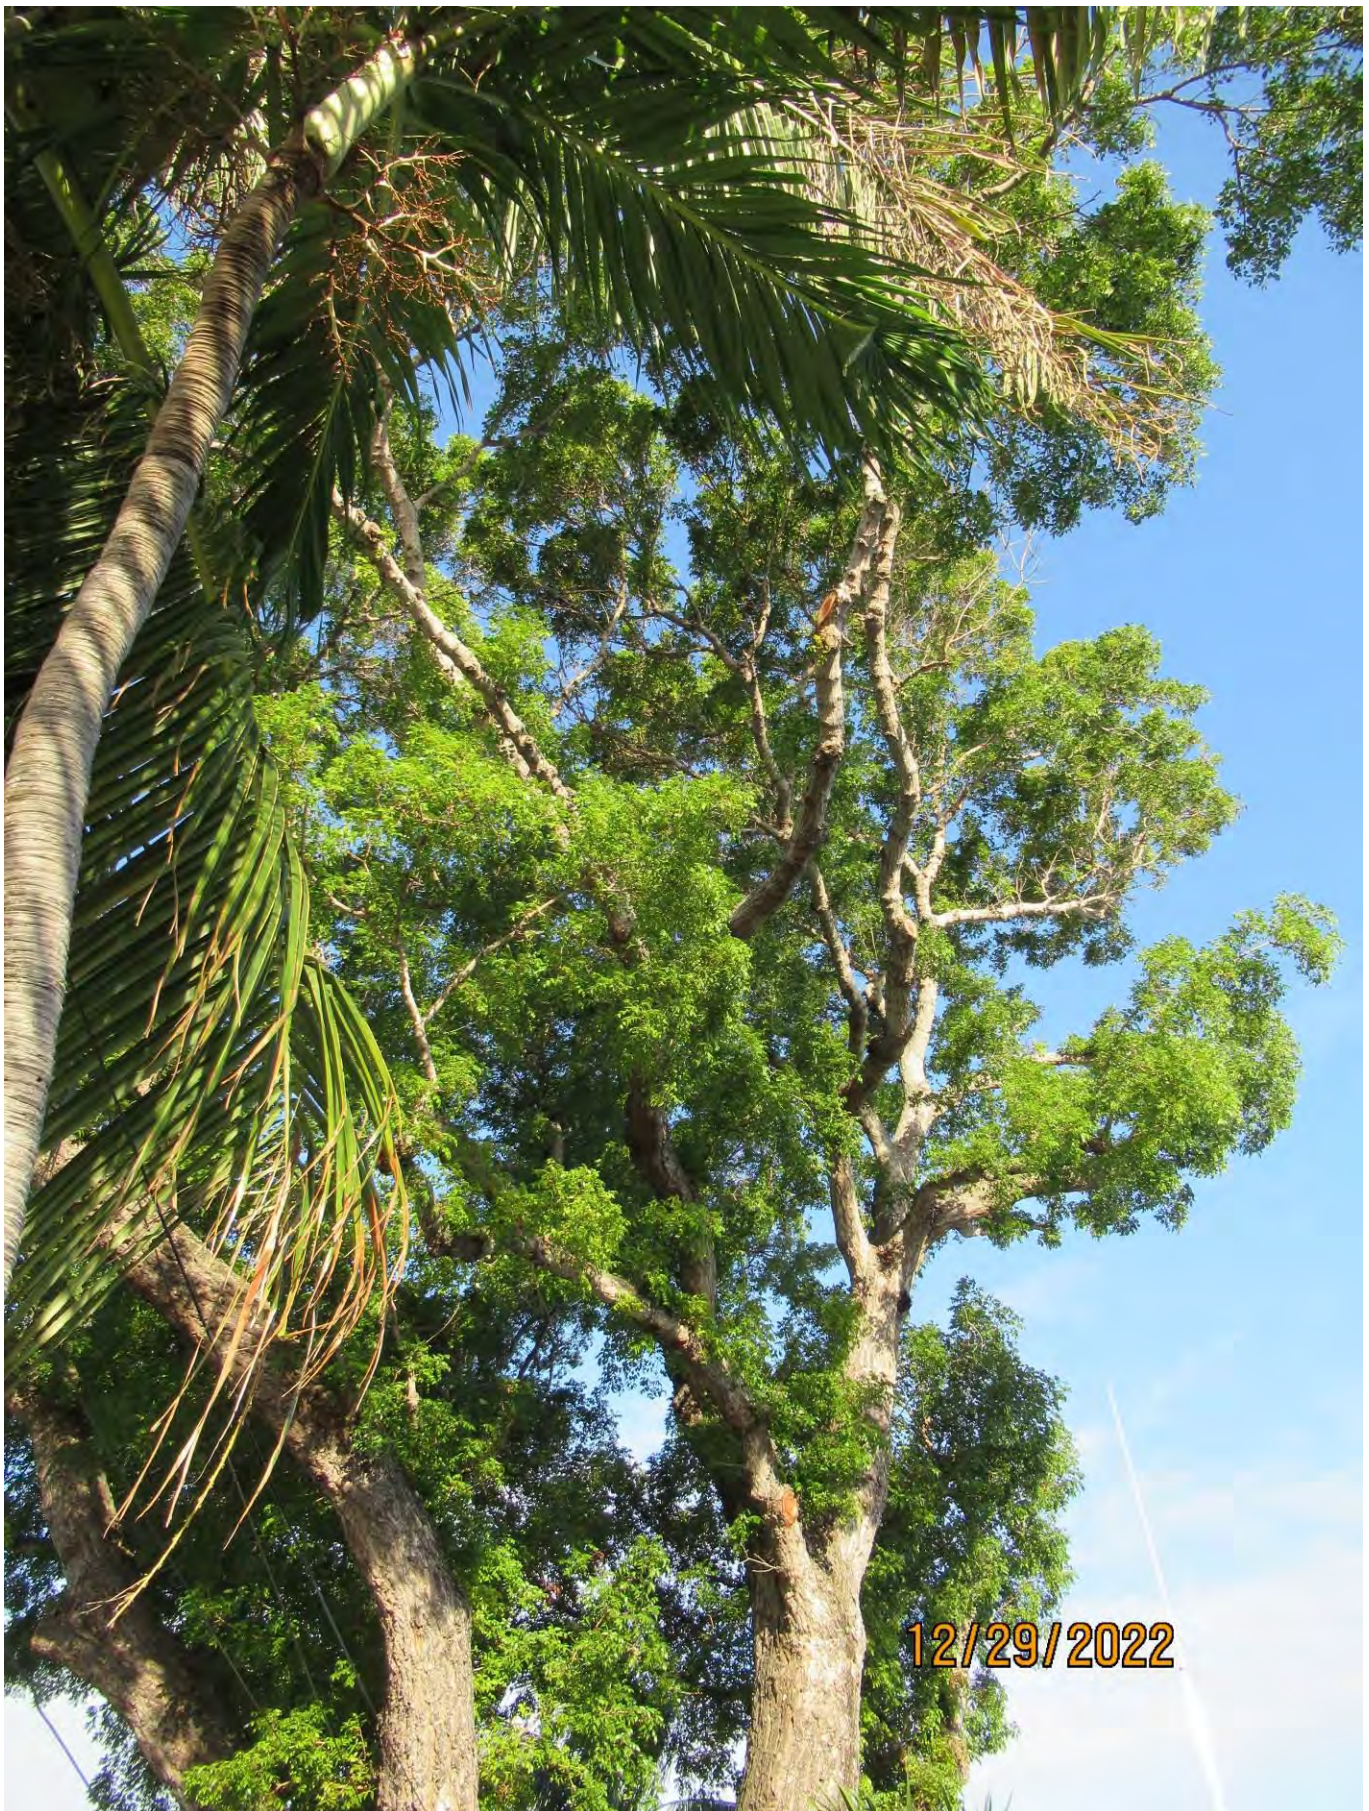
Photo of tree canopy over house.

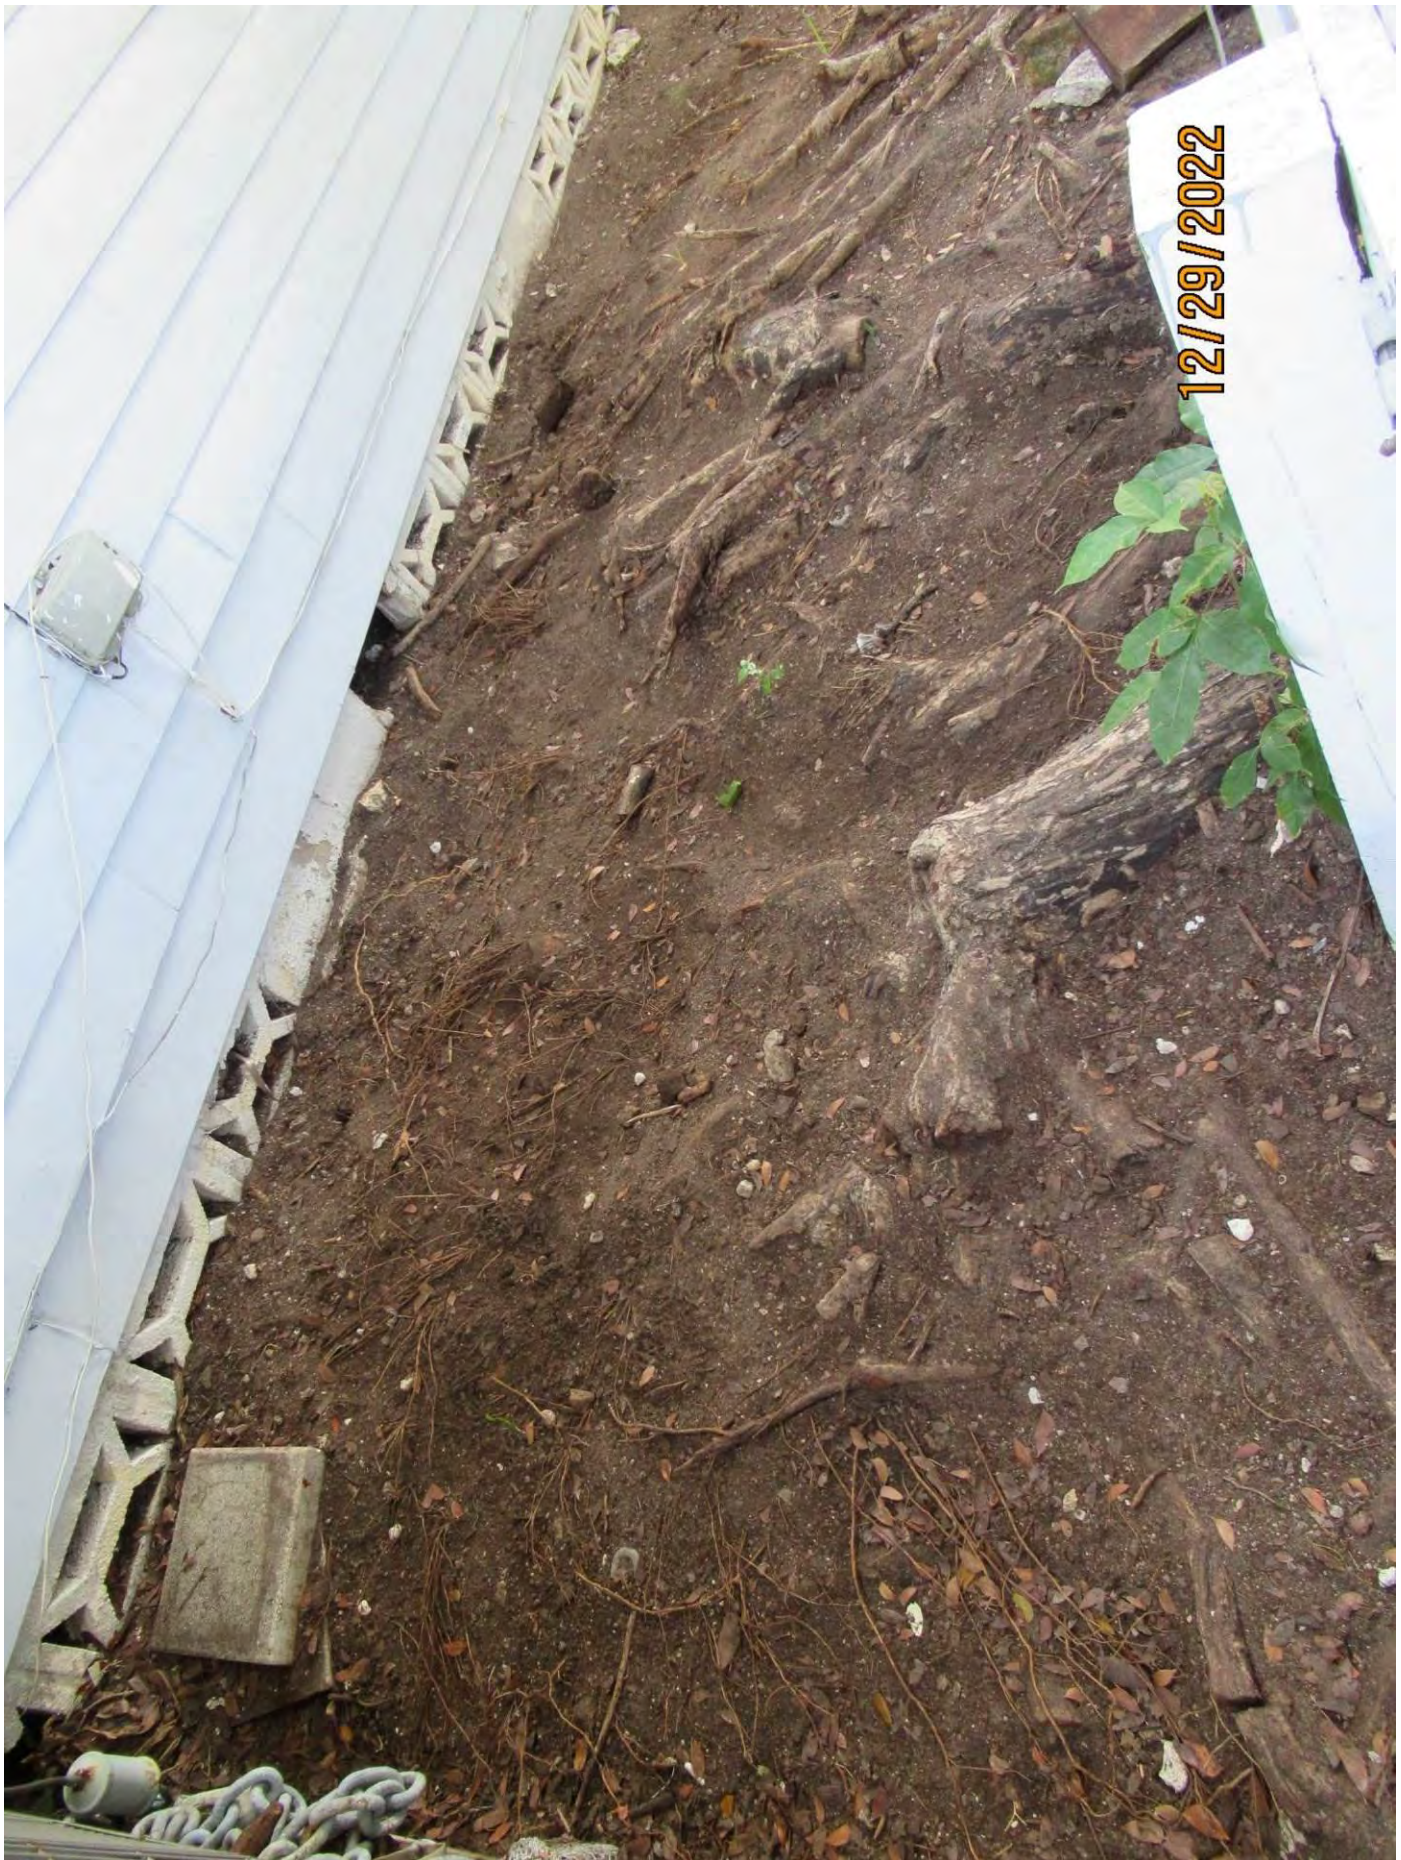
Photos of tree root are next to house. Property owner recently exposed the roots, view 1.

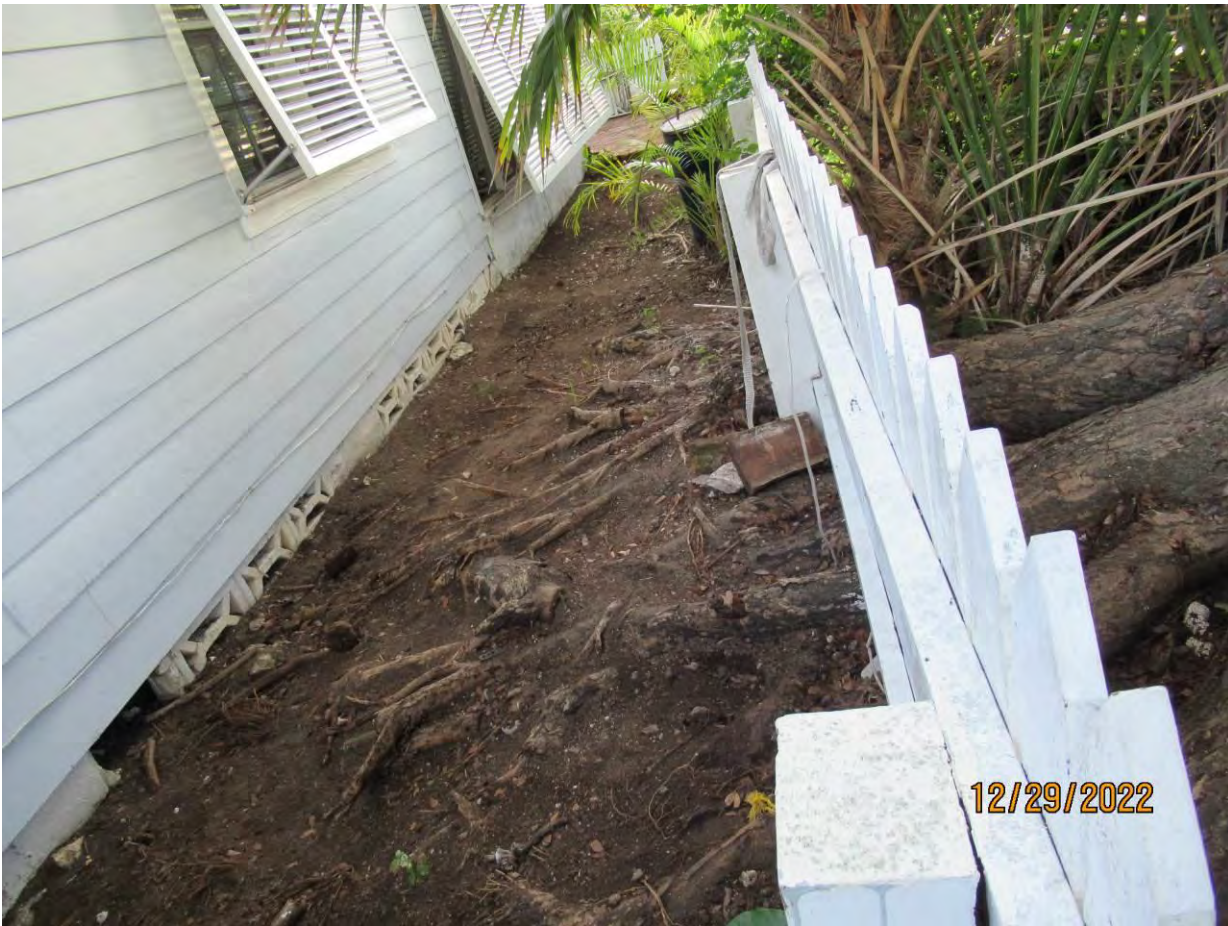
Photos of tree root are next to house. Property owner recently exposed the roots, view 2.

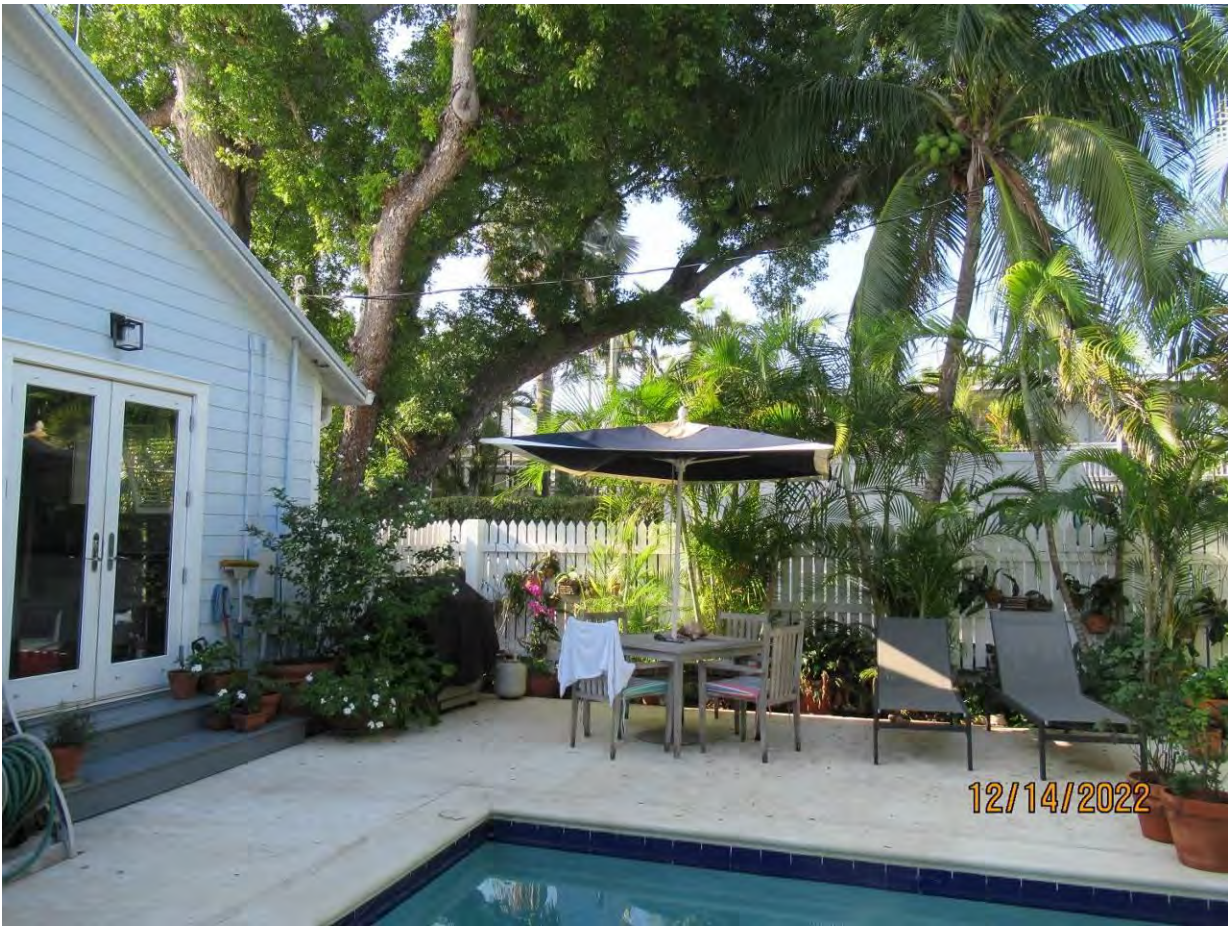
Photo of tree showing location in relation to pool and deck, view 1.

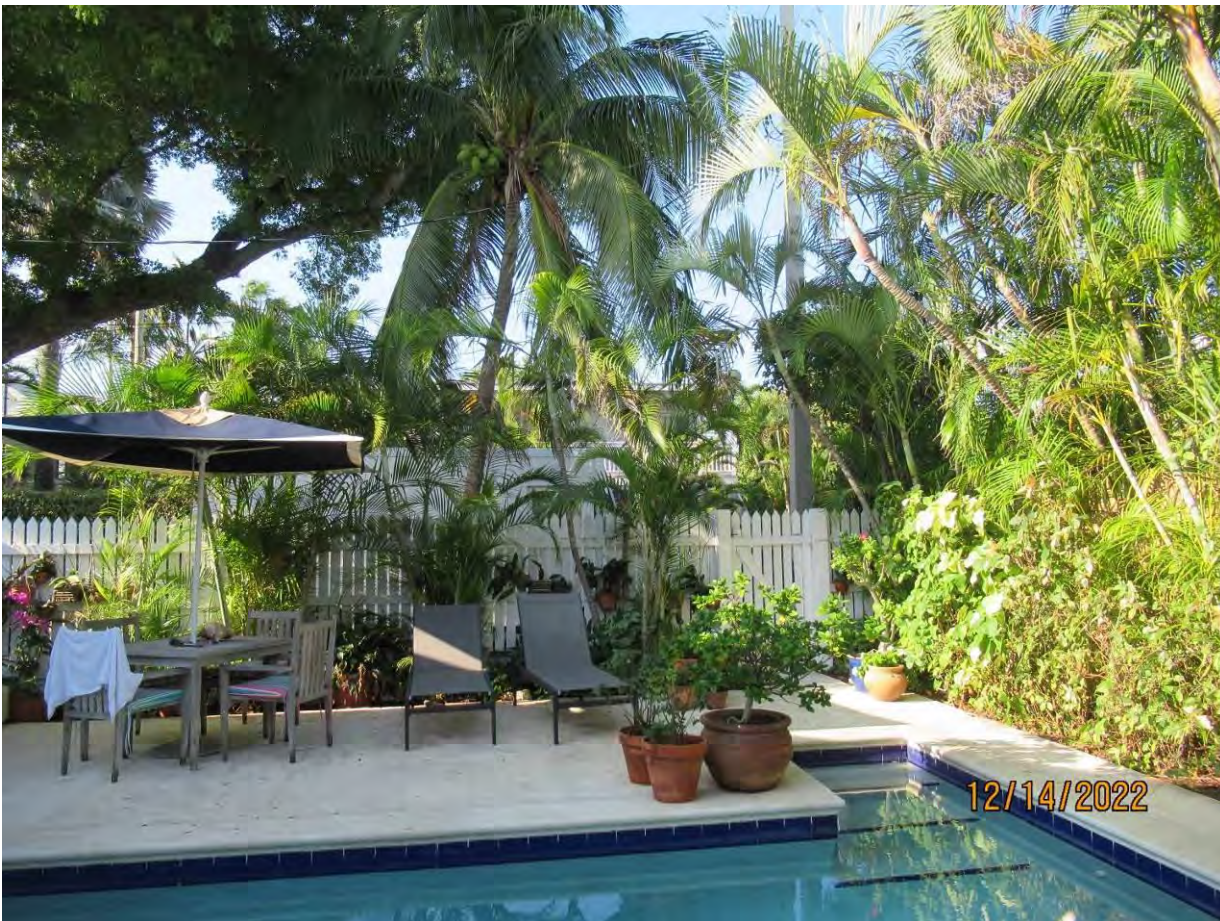
Photo of tree showing location in relation to pool and deck, view 2.

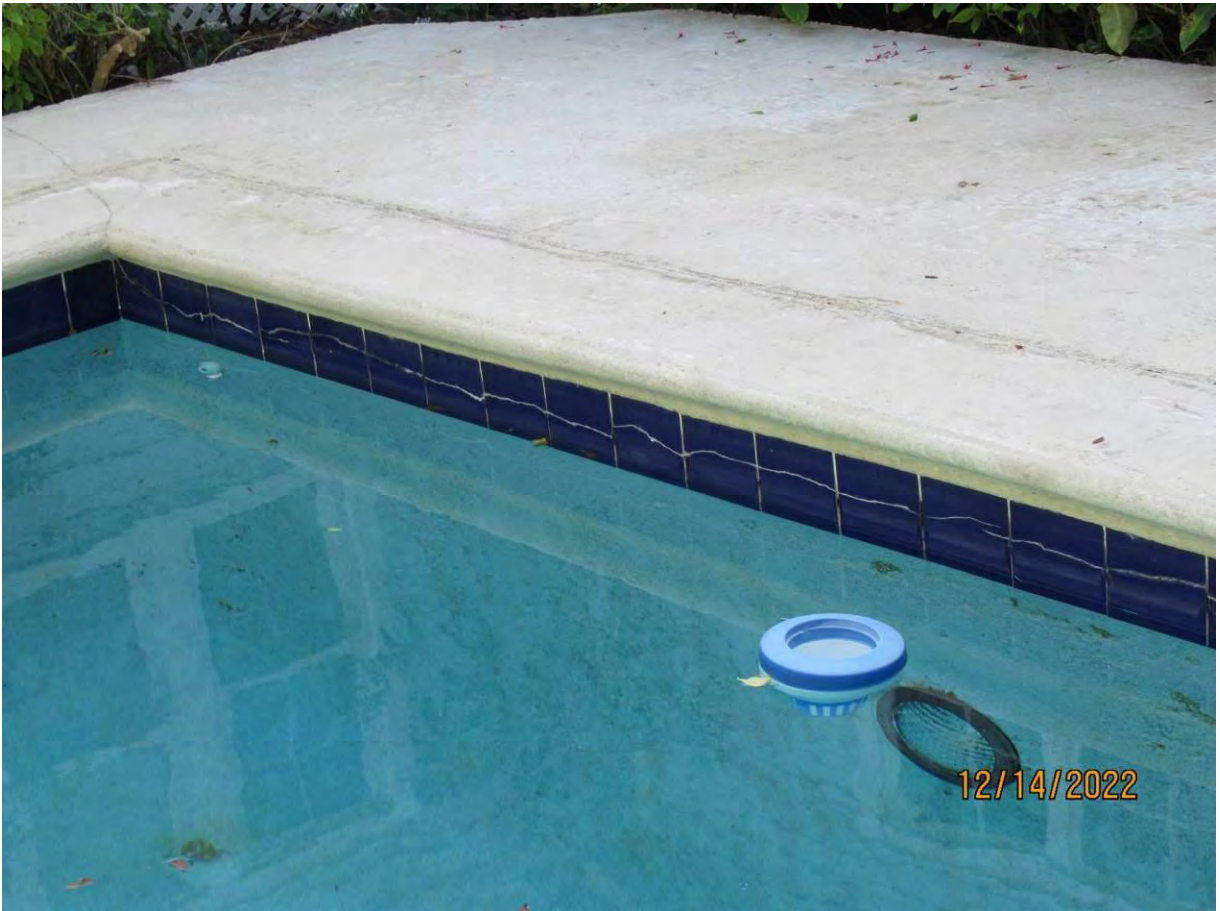
Photo of crack in pool tile closest to house.

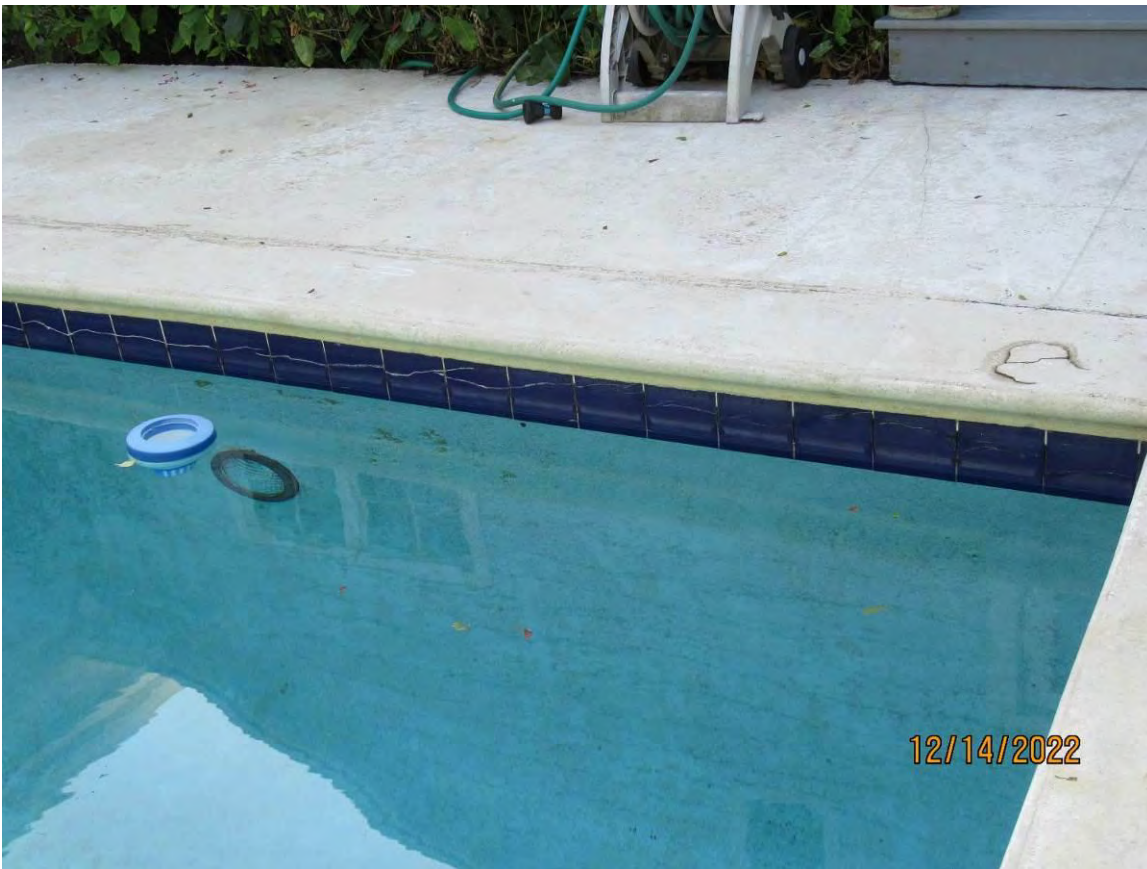
Photo of crack in pool tile closest to street.
