THE CITY OF KEY WEST  
Tree Commission  
Post Office Box 1409 Key West, FL 33041-1409

RE: 1701 Von Phister Street ROW/File # T2022-0462  
Represented by: Eric Denhart

# UPDATED STAFF REPORT

RE: 1701 Von Phister ROW (permit application # T2022-0462)

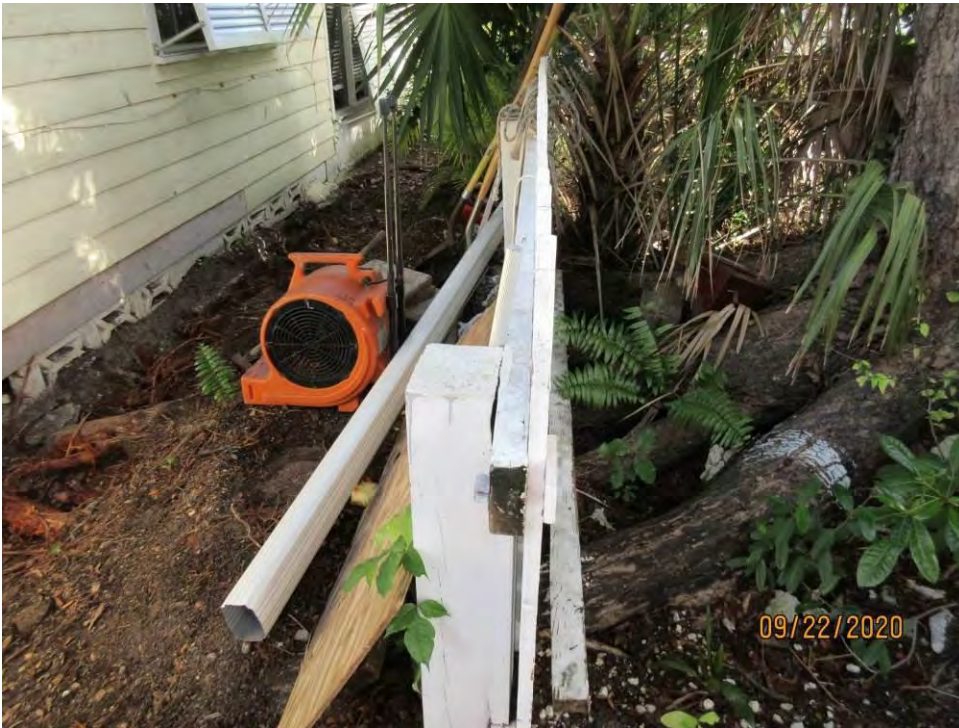
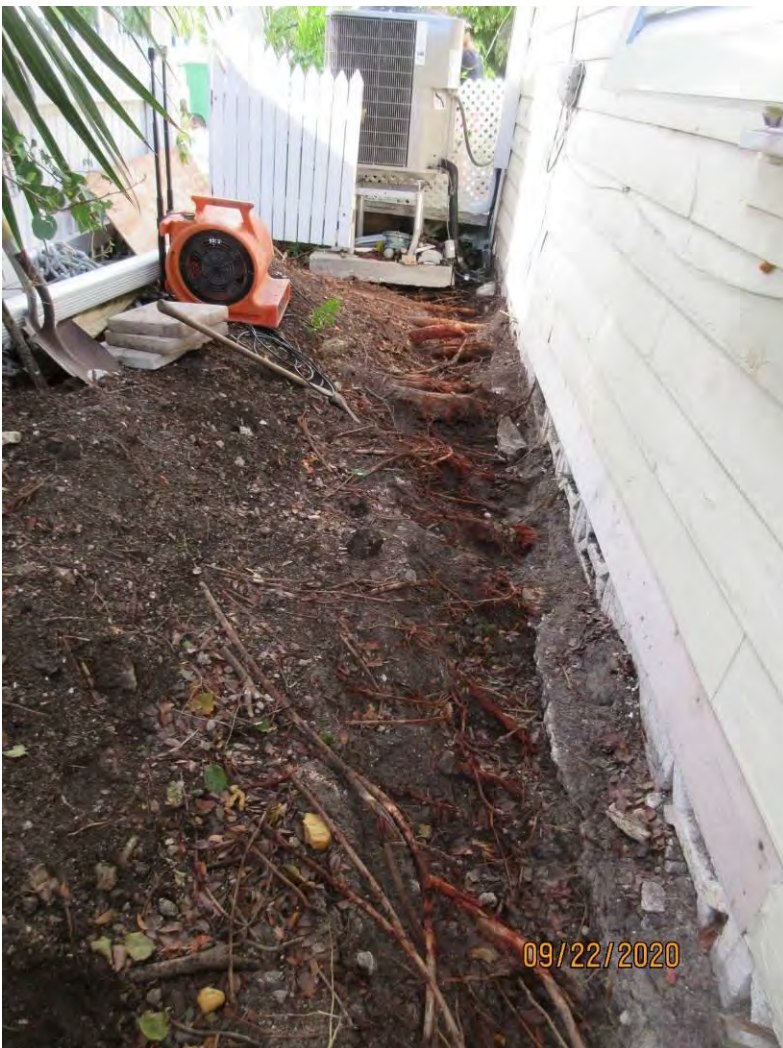
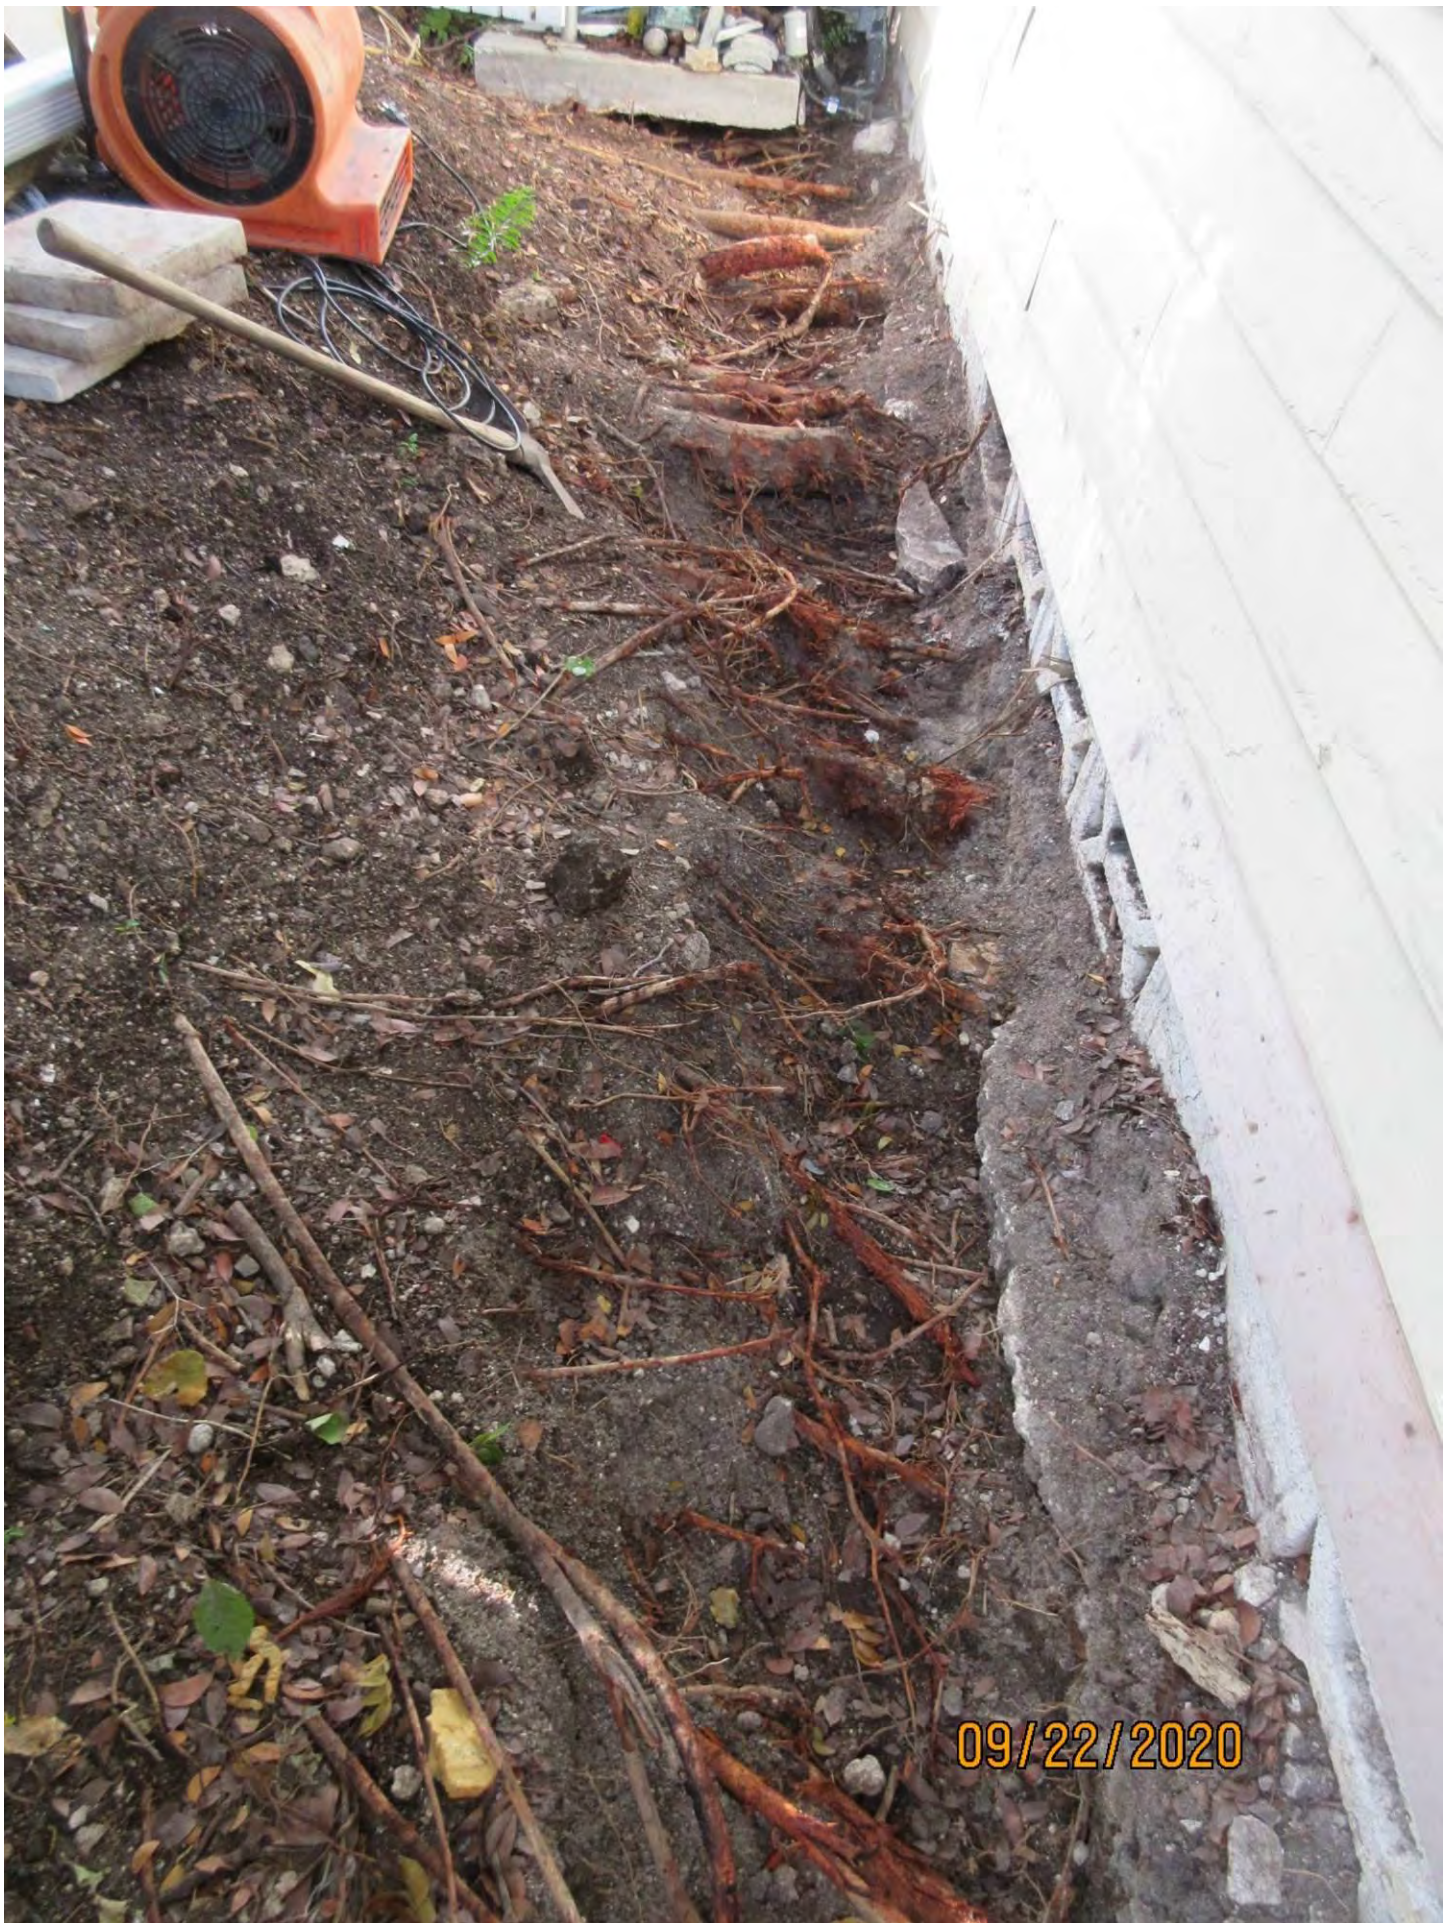
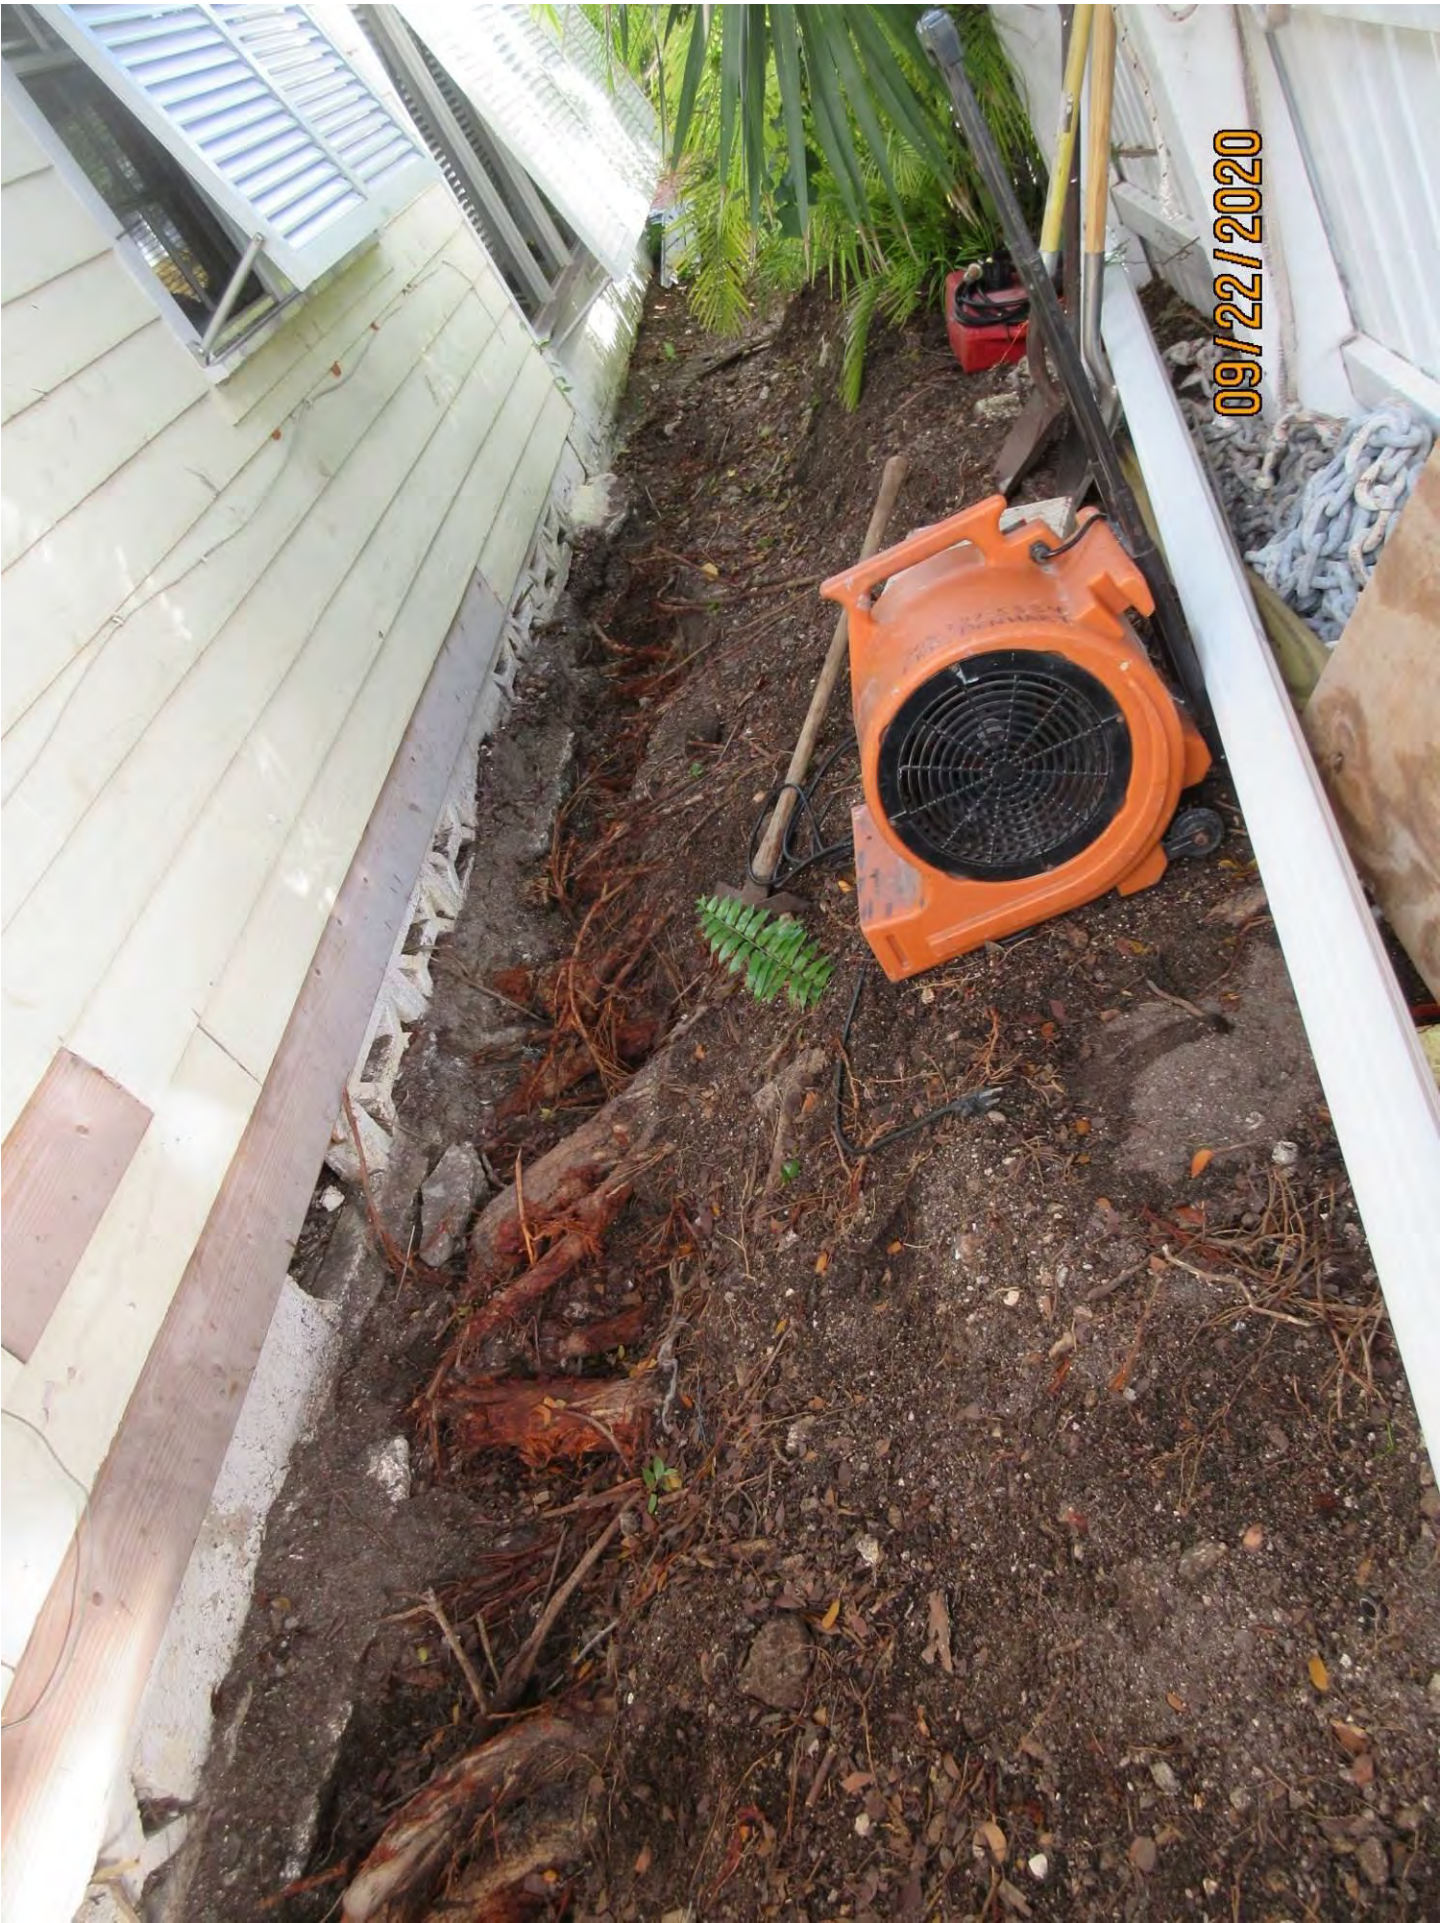
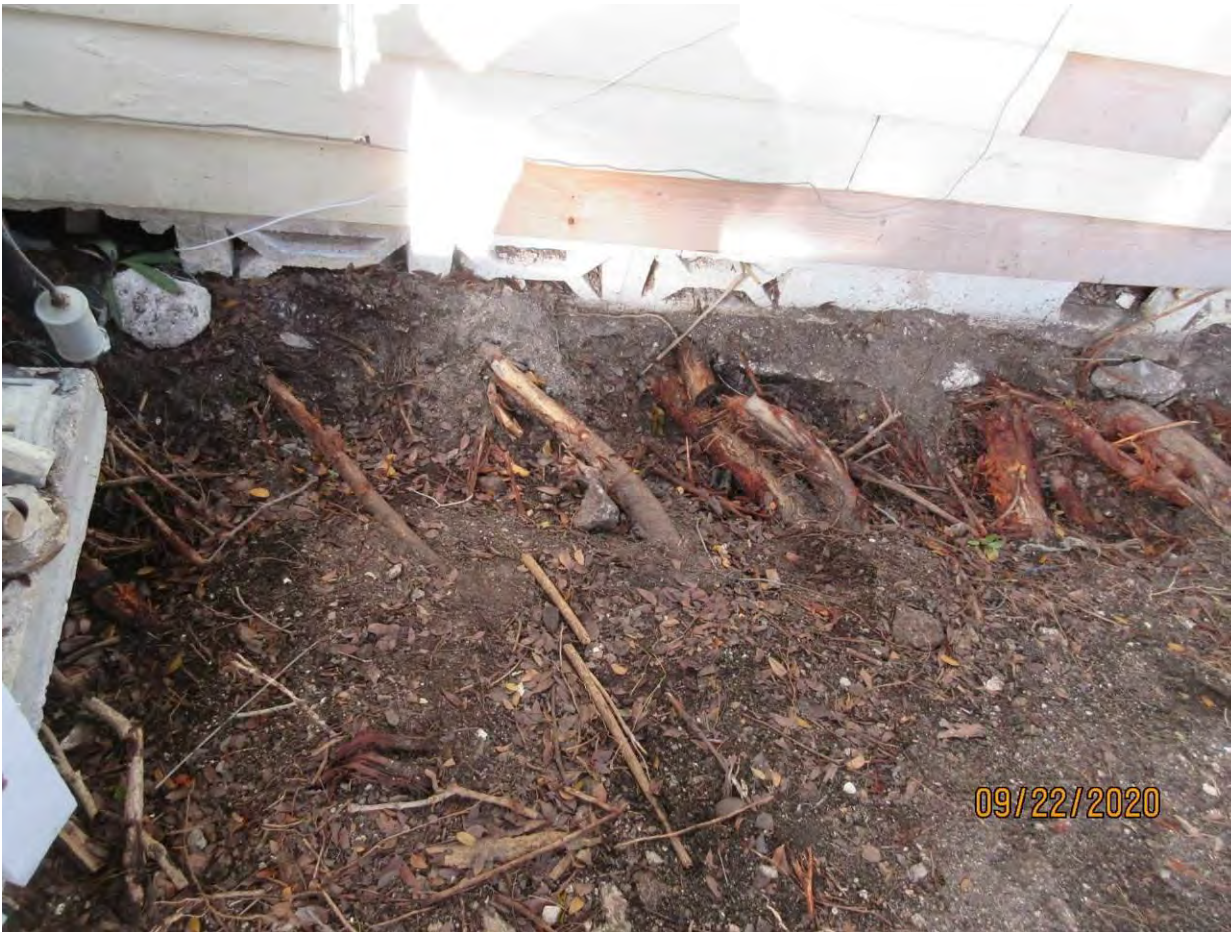
09/22/2020

Photo below are five photos from 2020 when property owner cut the roots.

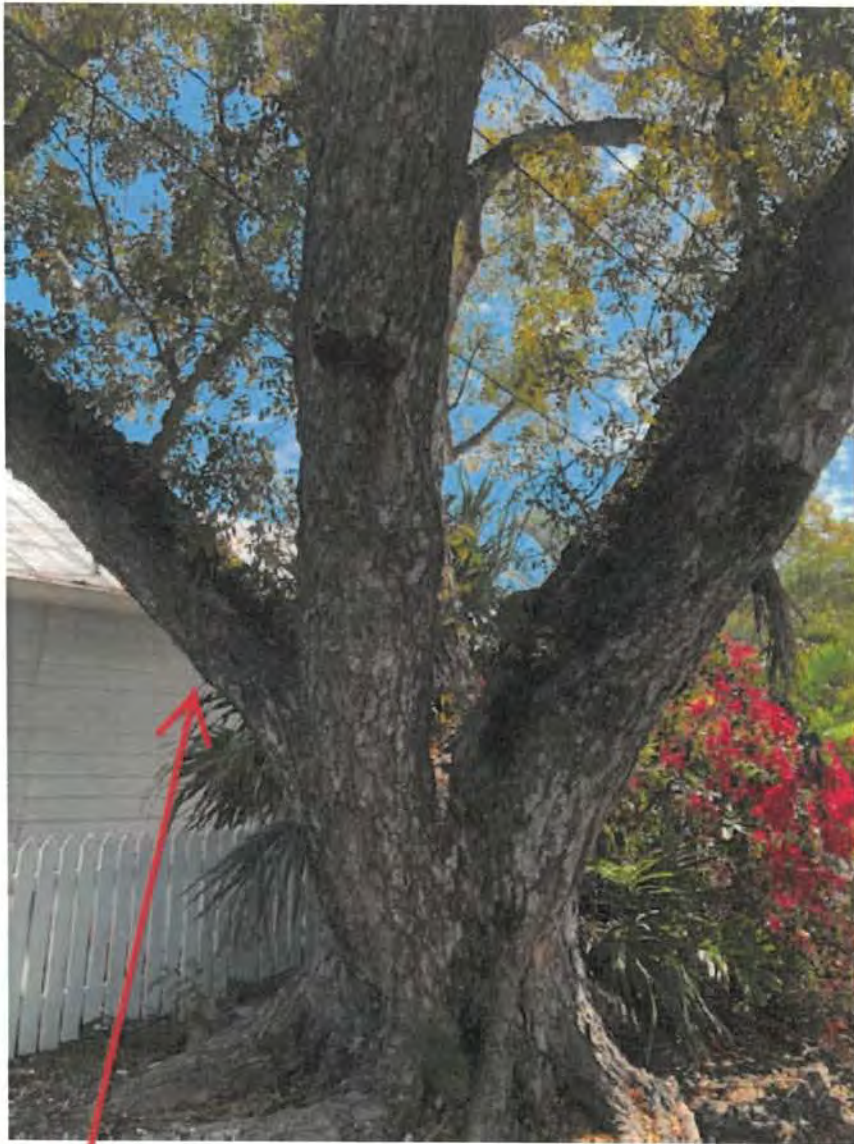
This limb should be removed as it poses a hazard to the home.

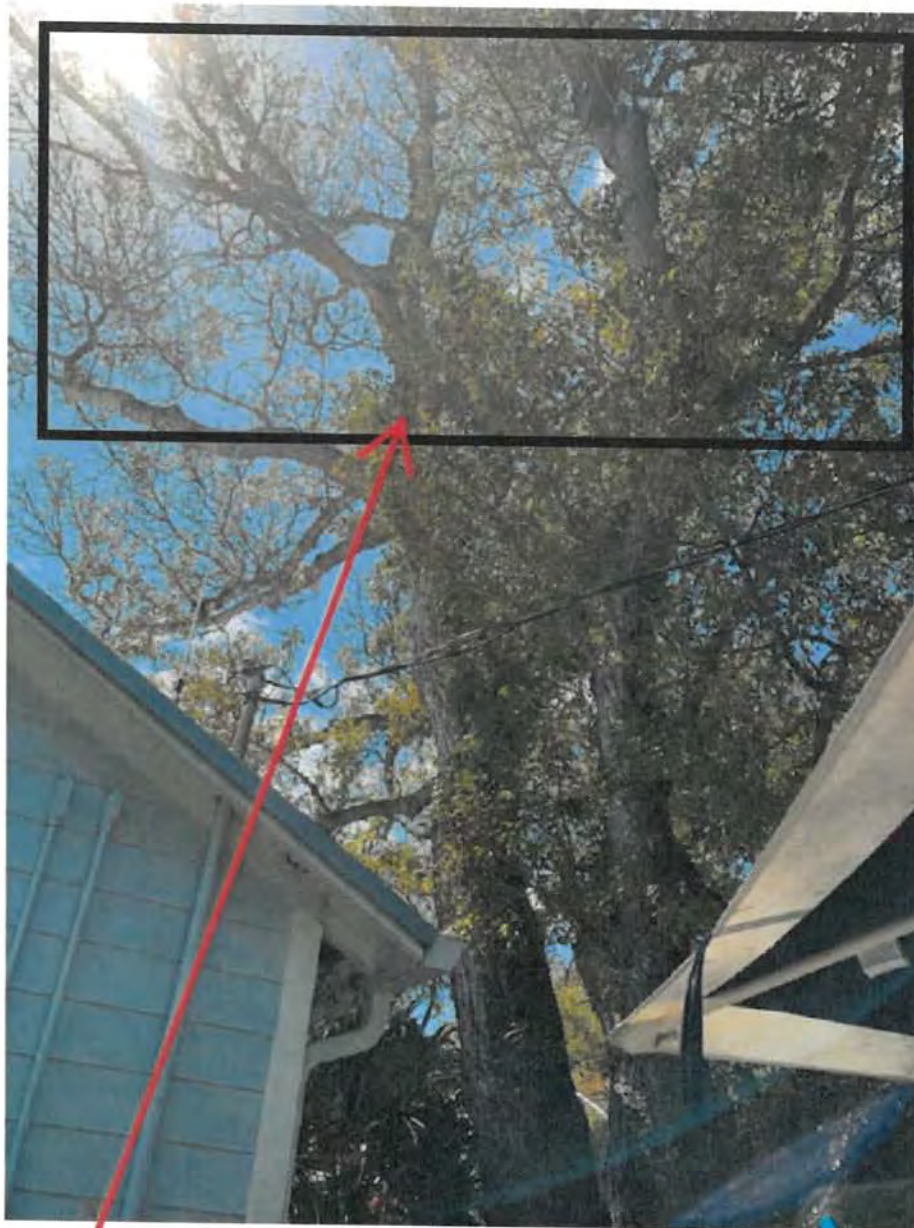
Major canopy trimming which would need to be contracted out.

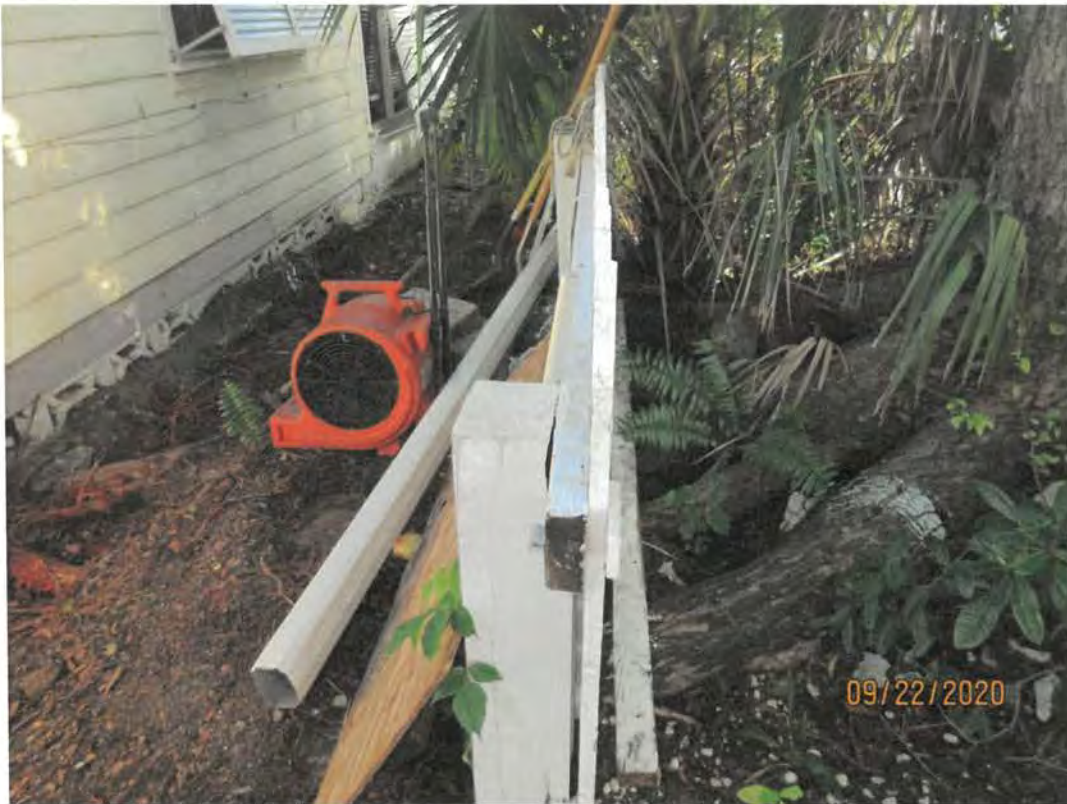
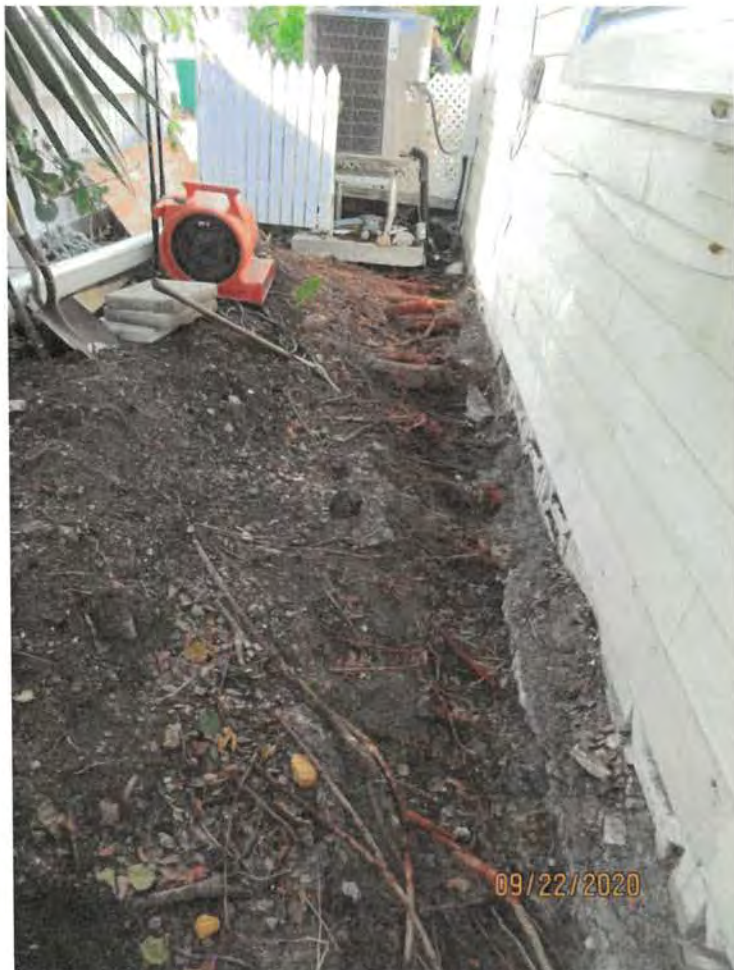
Photos showing the root system on the 1701 side of the house that the property owner cut.
