Engineering Report

Single Family Residence

1208 Virginia Street

April 6, 2023

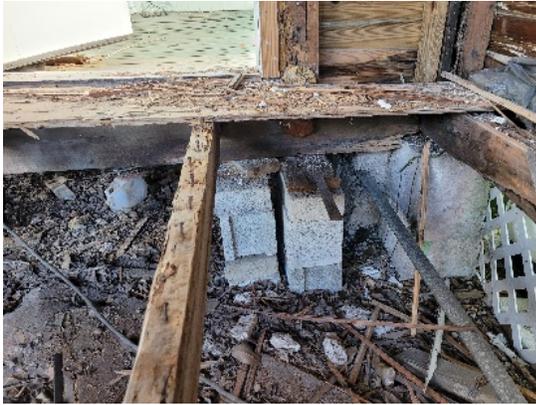
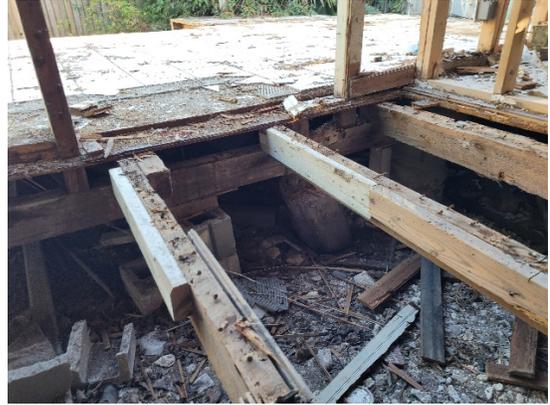
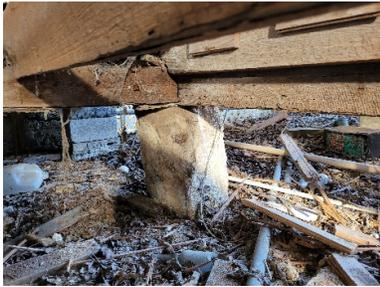
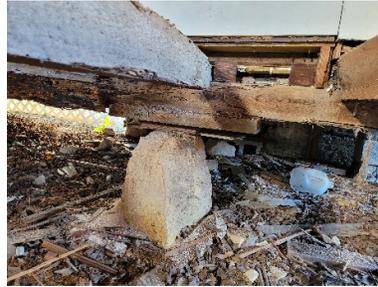
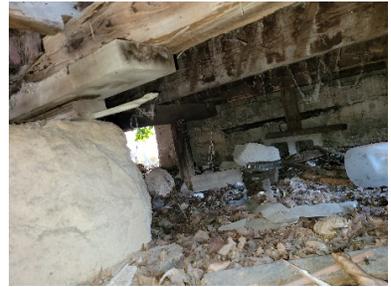
Foundations:

The original foundations appear to be limerock blocks typical of historic homes in Key West. Many of the blocks appear to be falling apart. Some of them have settled and shifted over time and blocking has been added above to compensate and prevent rim beams from sagging. Supplemental column blocks and wood posts have been added throughout the house to prevent the rotten rim beams from collapsing. These supplemental columns appear to have no footers or tie downs.

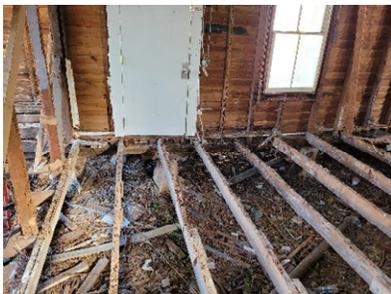
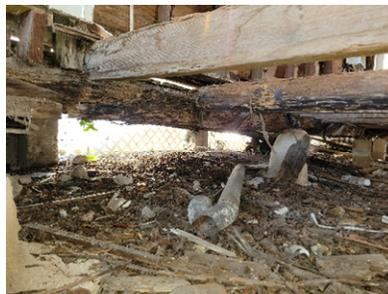
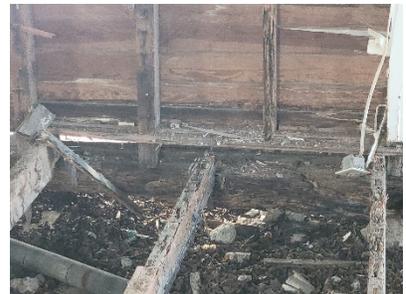
Floor Framing:

Rim beams around the perimeter are completely rotten from both water and termites and have minimal strength remaining and are clearly failing. This failure compromises the walls and roof framing above. It appears that the exterior siding is what is keeping the studs in place. Center beams are in good condition. Floor joists within the original structure have varying levels of termite damage. Regardless of the condition, due to the severe damage of the rim beam, joists have low strength.

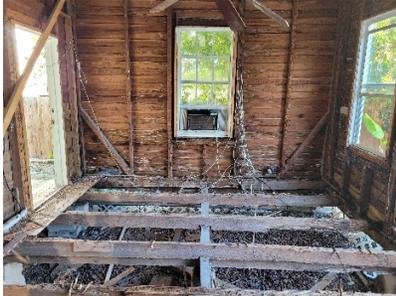
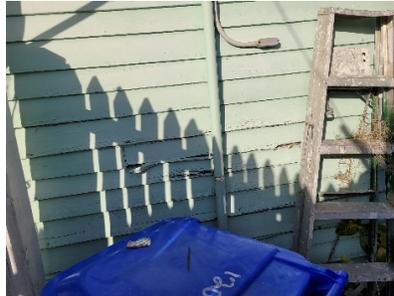
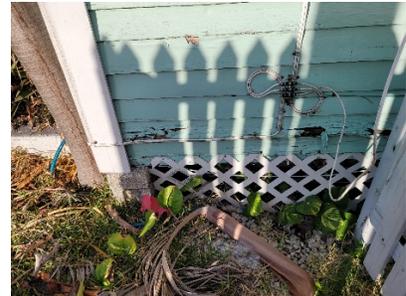
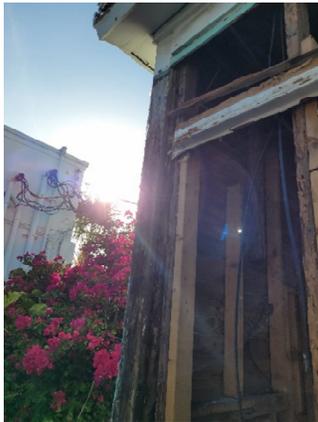
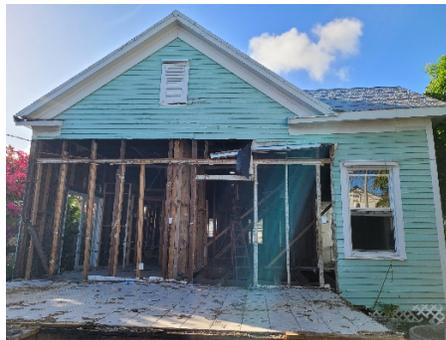
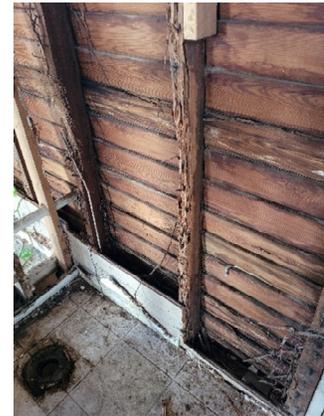
Walls:

Many of the interior walls were removed prior to my inspection. In addition to the failing rim beam below, exterior wall studs have varying degrees of termite and water damage. Door and window openings are in poor condition, and damaged siding has not been maintained.

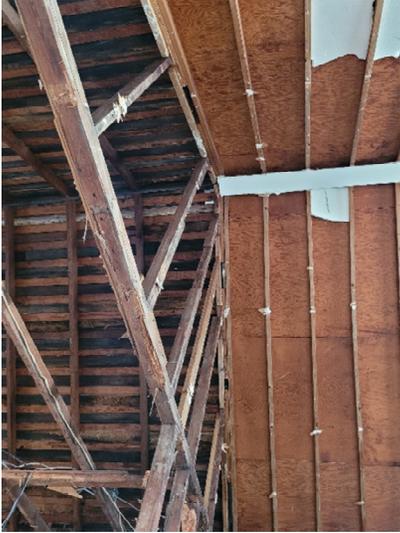
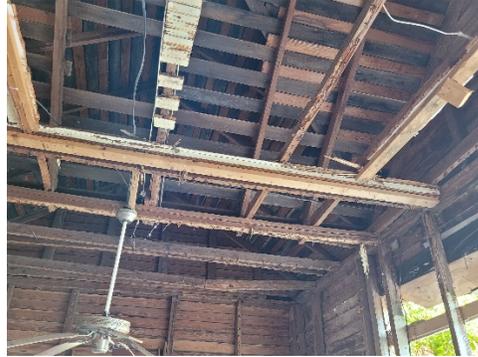
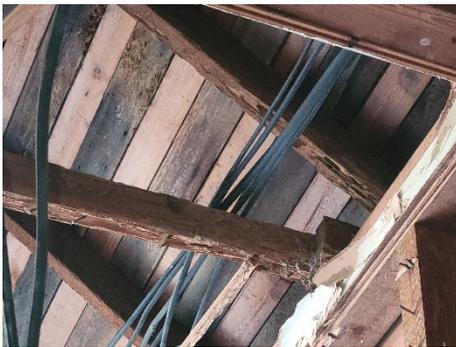
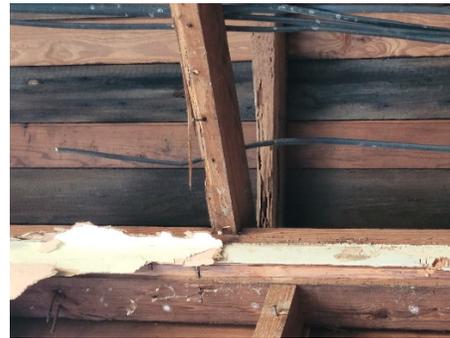
Roof:

Termite damage is apparent on wall bearing members. Limited access prevented thorough inspection of roof rafters. A portion of the roof rafters have no bearing point where there should be a bearing wall or a support beam and is currently being held together by the roof decking this area is extremely hazardous and failure may be imminent.

The foundations, rim beams, and floor joists are inadequate, many of the studs and siding boards are damaged, roof rafters appear to be undersized, and a portion of the roof rafters have no support below. This is a dangerous structure, and it is my opinion that this building should be demolished.
