STAFF REPORT

RE: 1315 Olivia Street (permit application # T17-8334)

FROM: Karen DeMaria, City of Key West Urban Forestry Manager

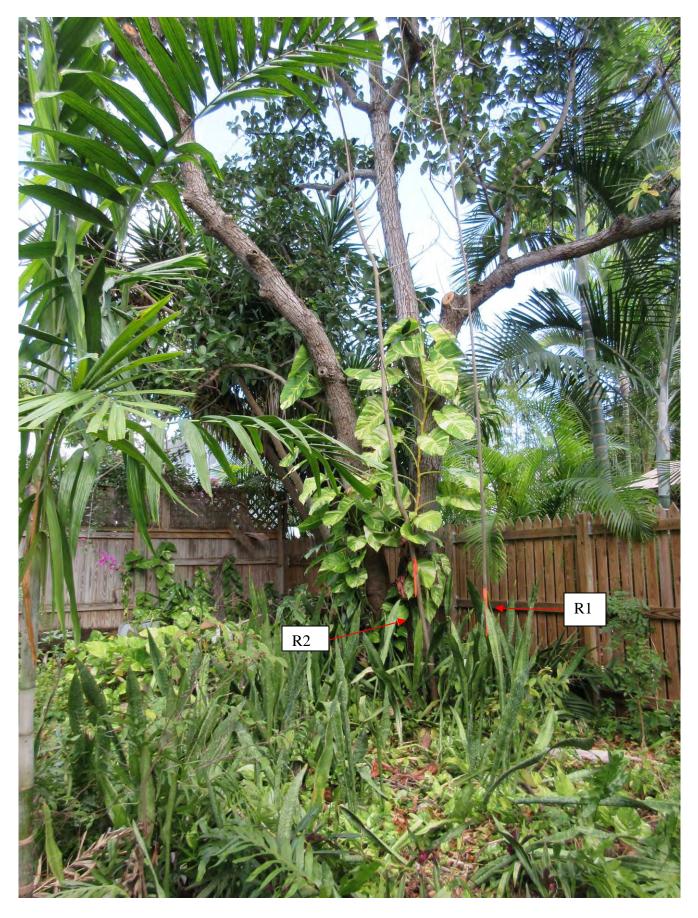
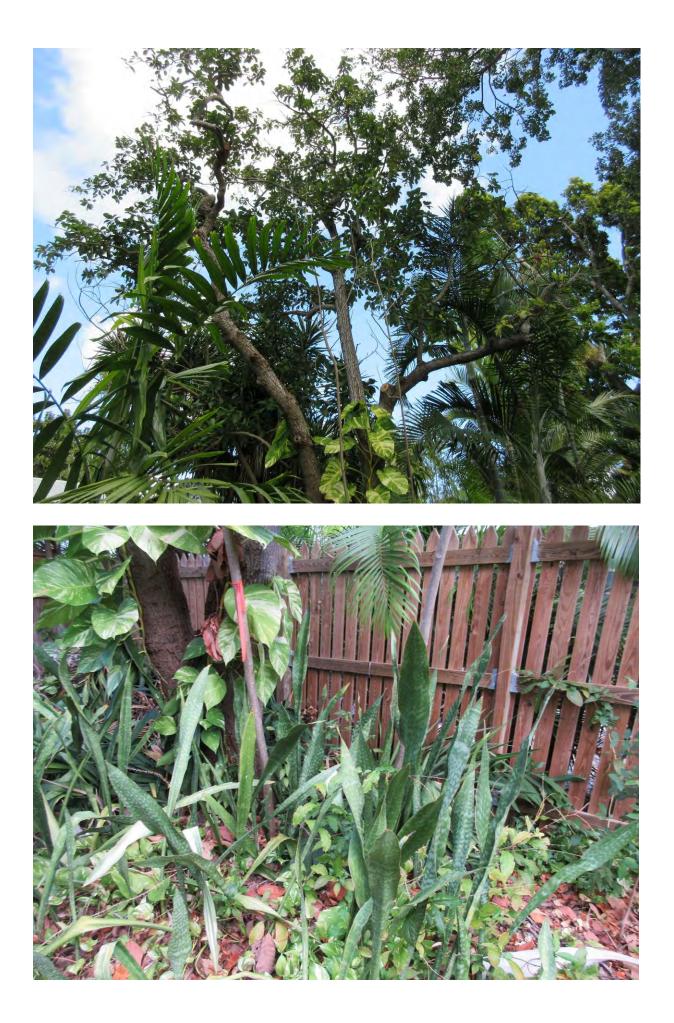
R1 Diameter: 1.4" Location: 50% (volunteer growing in the root zone of large avocado-future growth impacts due to Avocado tree) Species: 100% (on protected tree list) Condition: 50% (fair) Total Average Value = 66% Value x Diameter = 0.9 replacement caliper inches

R2 Diameter: 2.2" Location: 50% (volunteer growing in the root zone of large avocado-future growth impacts due to Avocado tree) Species: 100% (on protected tree list) Condition: 50% (fair) Total Average Value = 66% Value x Diameter = 1.4 replacement caliper inches

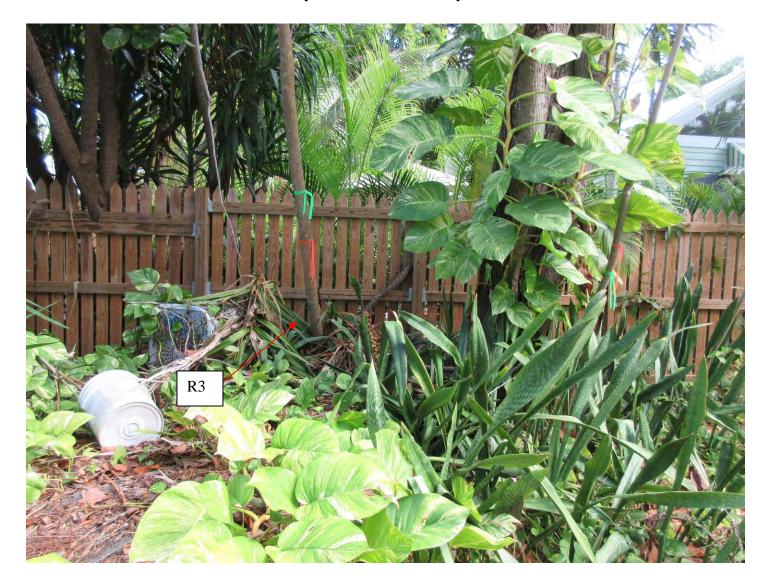
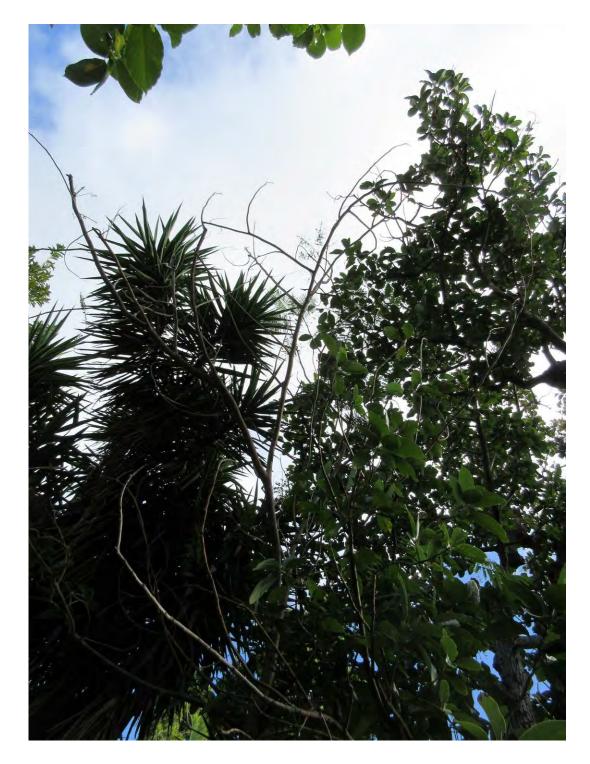
R3 Diameter: 3.5" Location: 50% (volunteer growing in the root zone of large avocado and edge of old cistern) Species: 100% (on protected tree list) Condition: 50% (fair) Total Average Value = 66% Value x Diameter = 2.3 replacement caliper inches

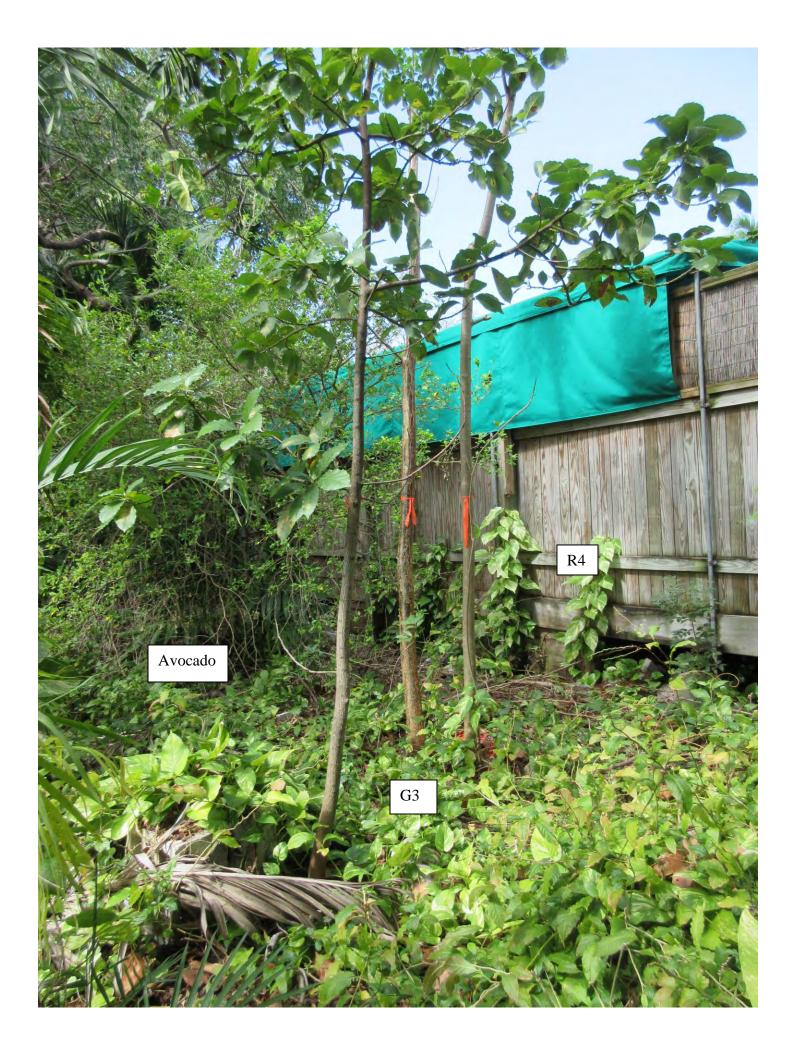
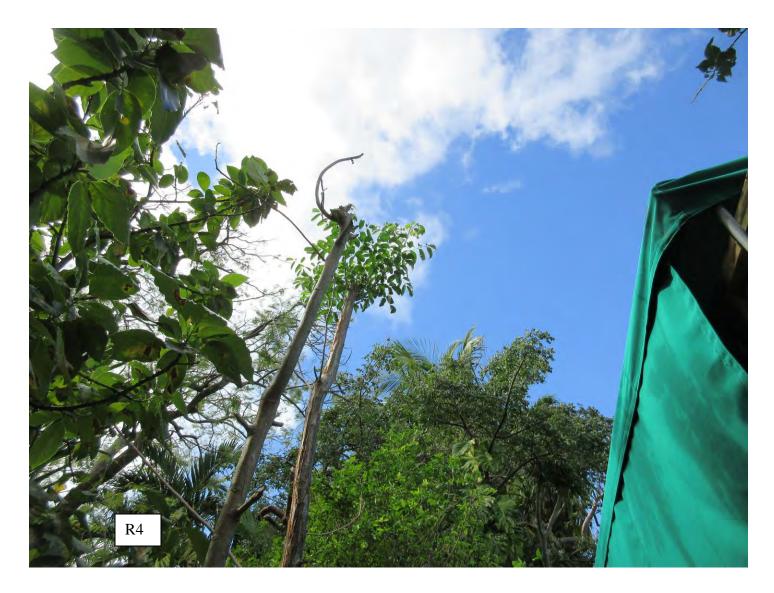
R4 Diameter: 2.8" Location: 60% (future competition with Gumbo Limbo) Species: 100% (on protected tree list) Condition: 50% (fair, canopy top chopped off) Total Average Value = 70% Value x Diameter = 1.9 replacement caliper inches

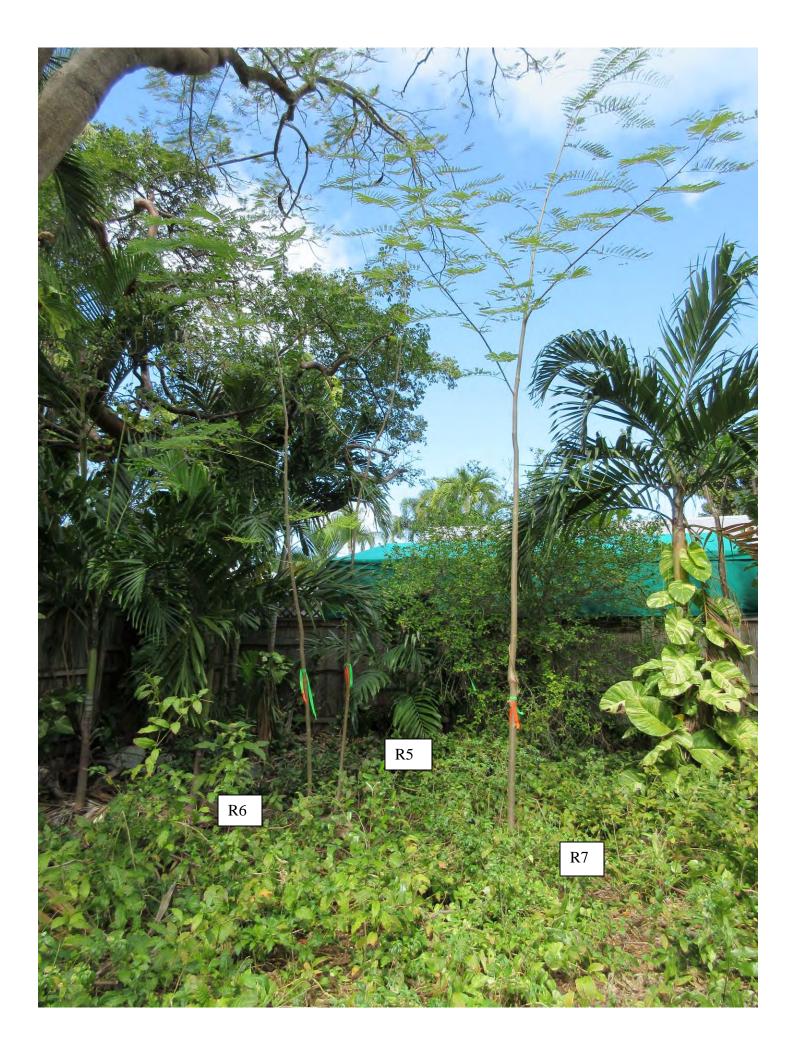
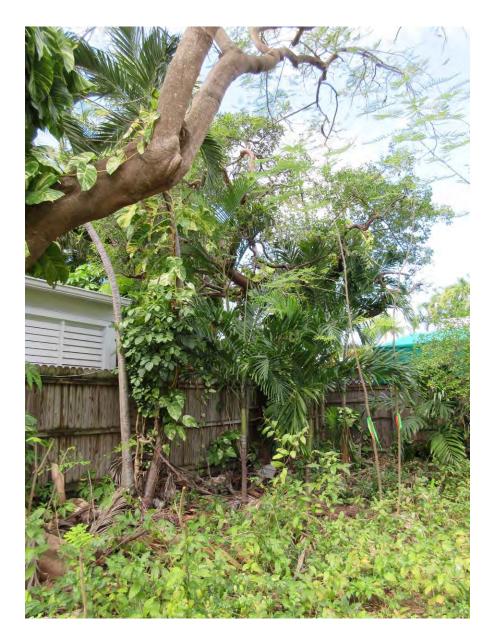
R5 Diameter: 1.5" Location: 70% Species: 100% (on protected tree list) Condition: 60% (fair) Total Average Value = 76% Value x Diameter = 1.1 replacement caliper inches

R6 Diameter: 1.5" Location: 60% Species: 100% (on protected tree list) Condition: 60% (fair) Total Average Value = 73% Value x Diameter = 1.0 replacement caliper inches

R7 Diameter: 2.5" Location: 60% Species: 100% (on protected tree list) Condition: 60% (fair) Total Average Value = 73% Value x Diameter = 1.8 replacement caliper inches

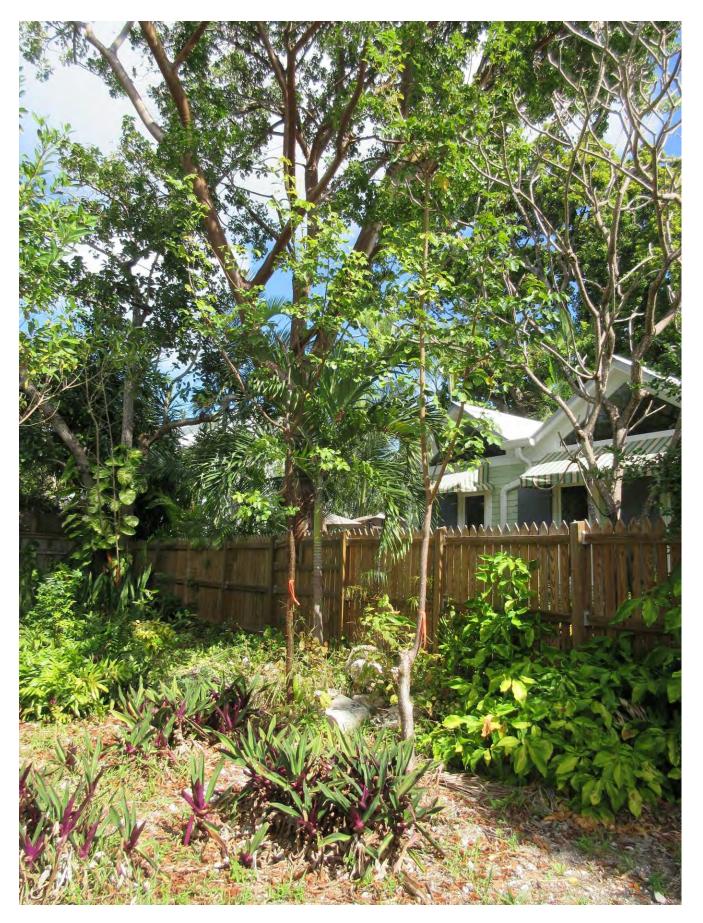
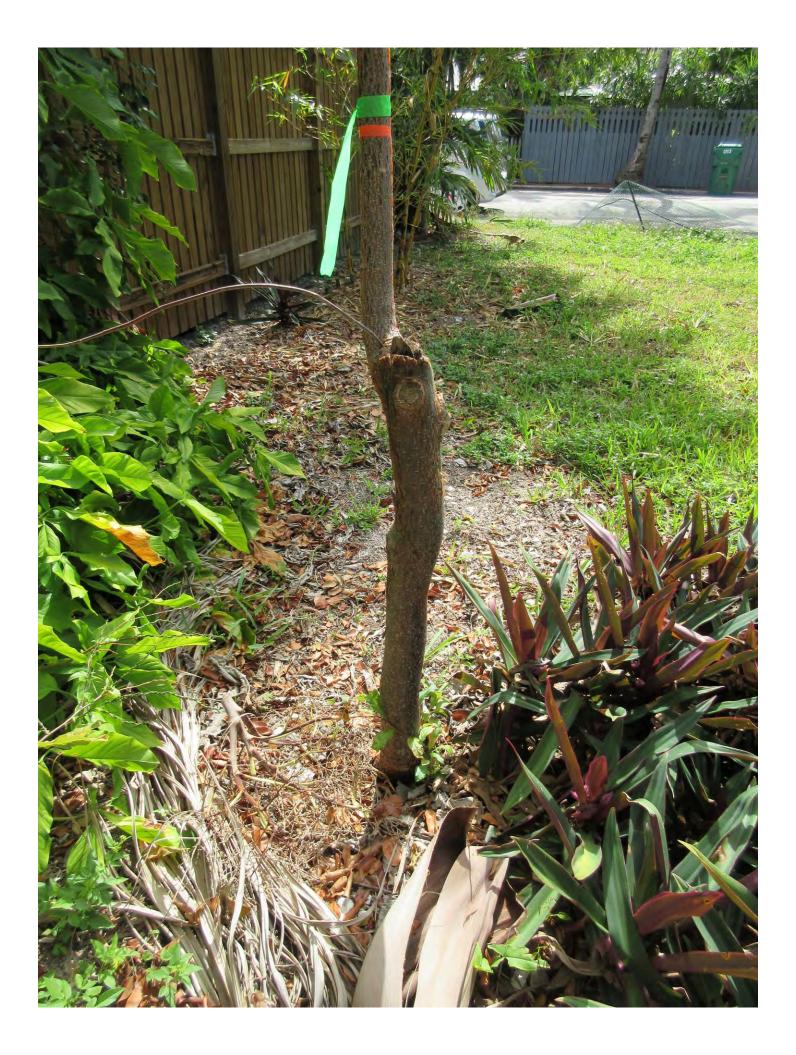
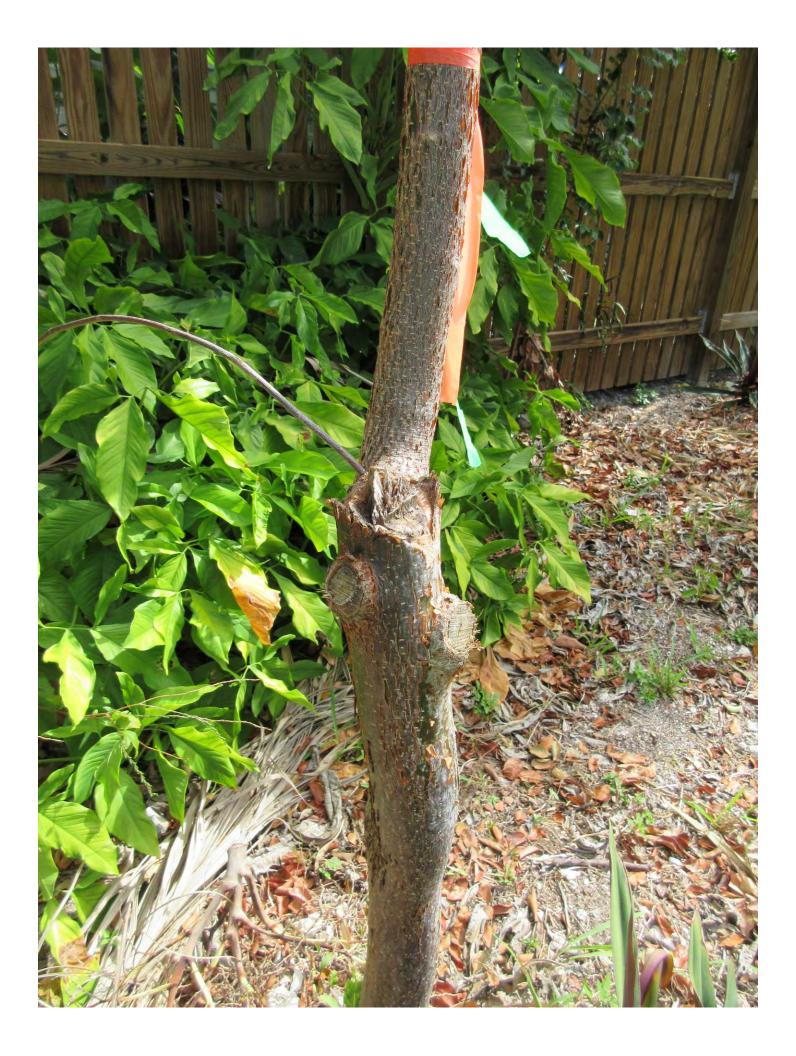
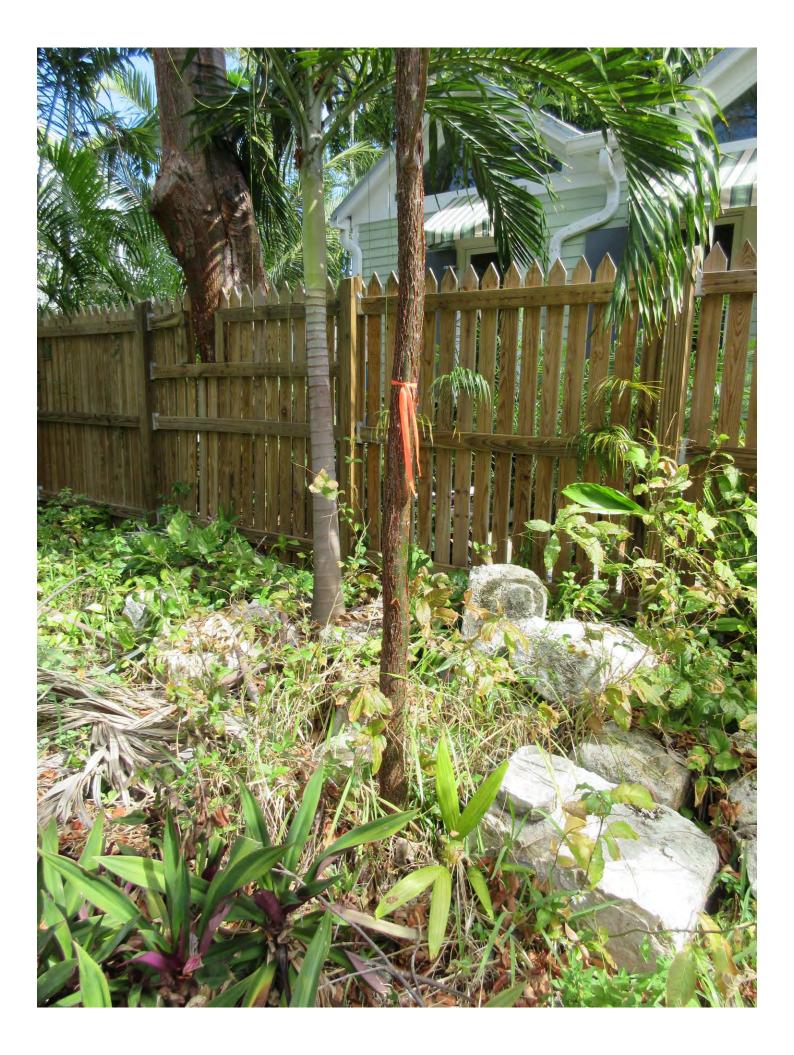
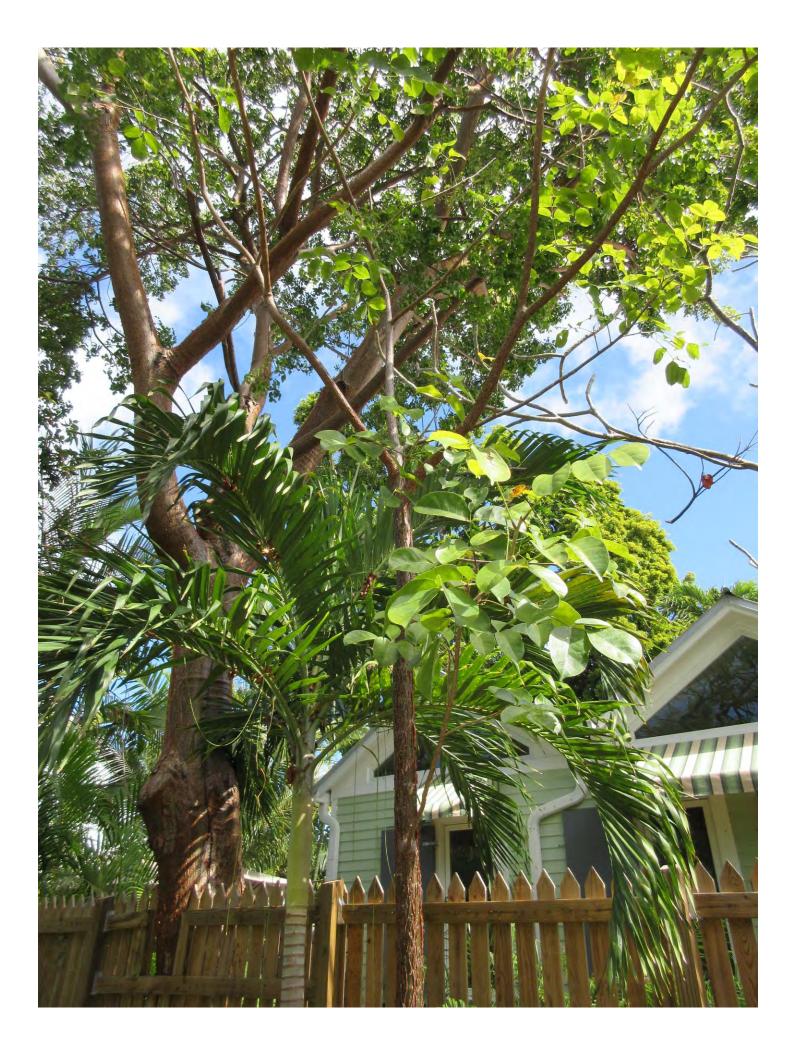
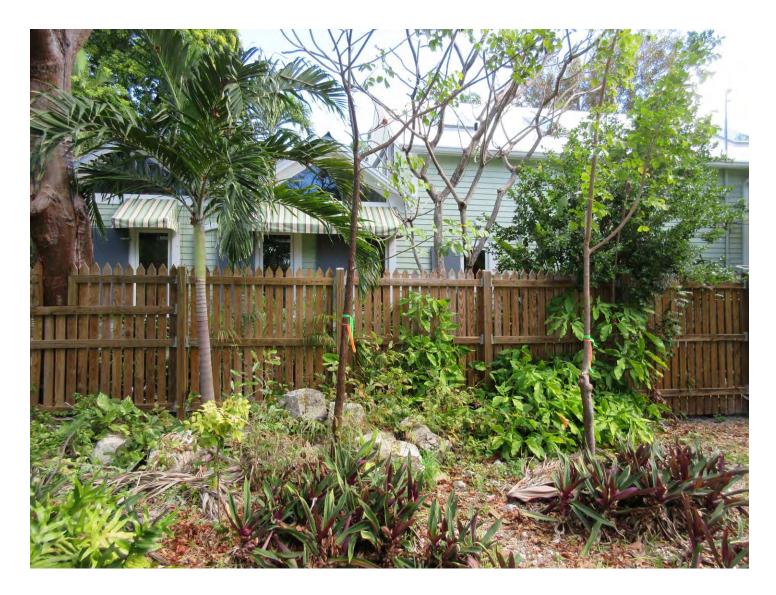
G1 Diameter: 2.2" Location: 70% Species: 100% (on protected tree list) Condition: 50% (poor, main trunk damaged) Total Average Value = 73% Value x Diameter = 1.6 replacement caliper inches

G2 Diameter: 2.5" Location: 50% (future canopy growth impacted by neighboring gumbo limbo) Species: 100% (on protected tree list) Condition: 80% (good) Total Average Value = 76% Value x Diameter = 1.9 replacement caliper inches

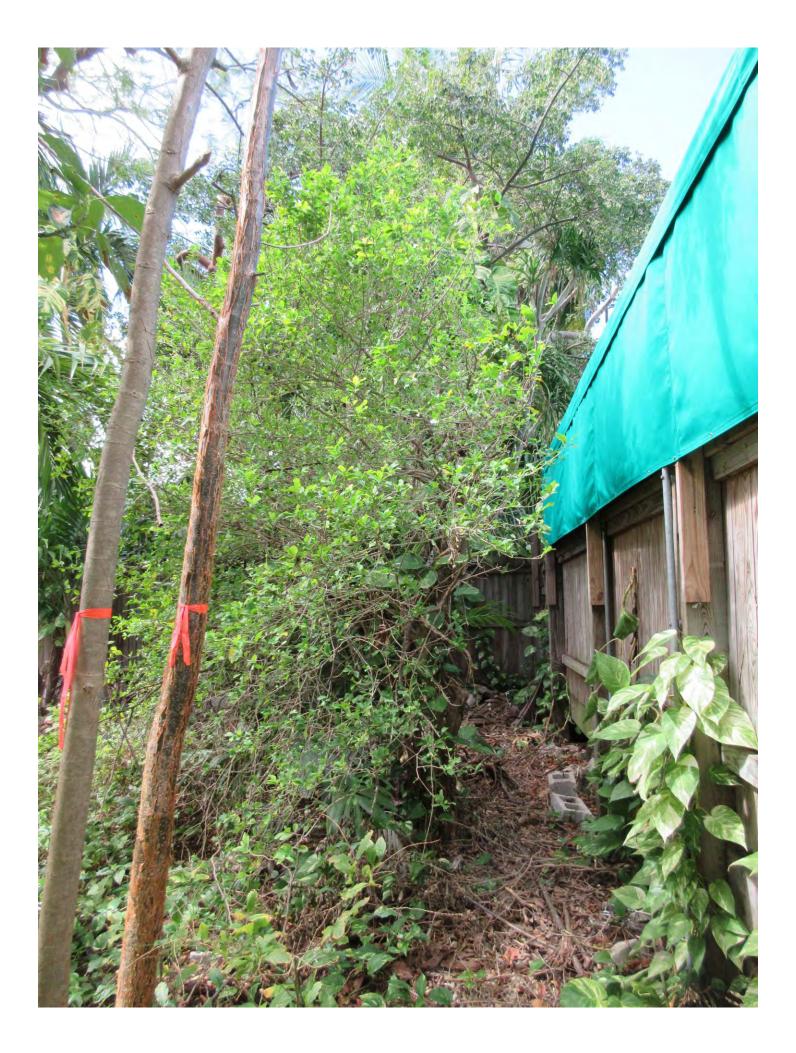
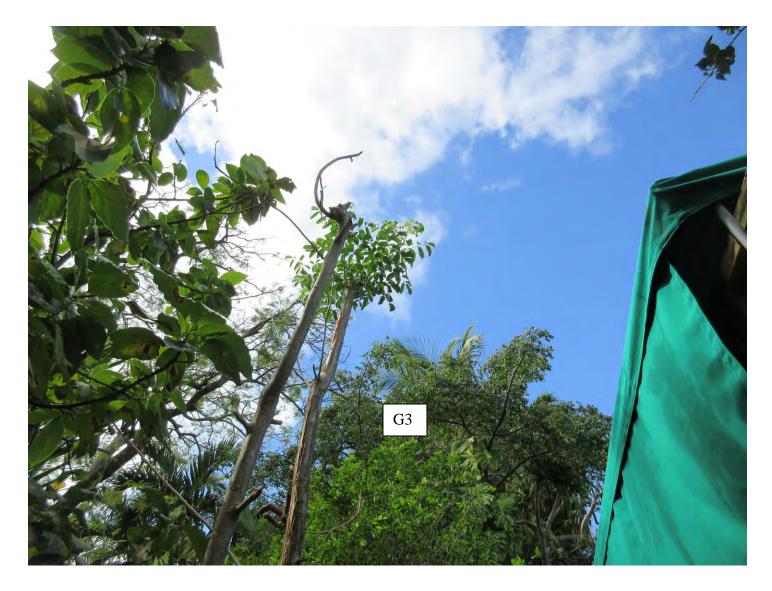
G3 Diameter: 3.8" Location: 60% (close to another canopy tree) Species: 100% (on protected tree list) Condition: 50% (fair to poor, canopy chopped off) Total Average Value = 70% Value x Diameter = 2.6 replacement caliper inches

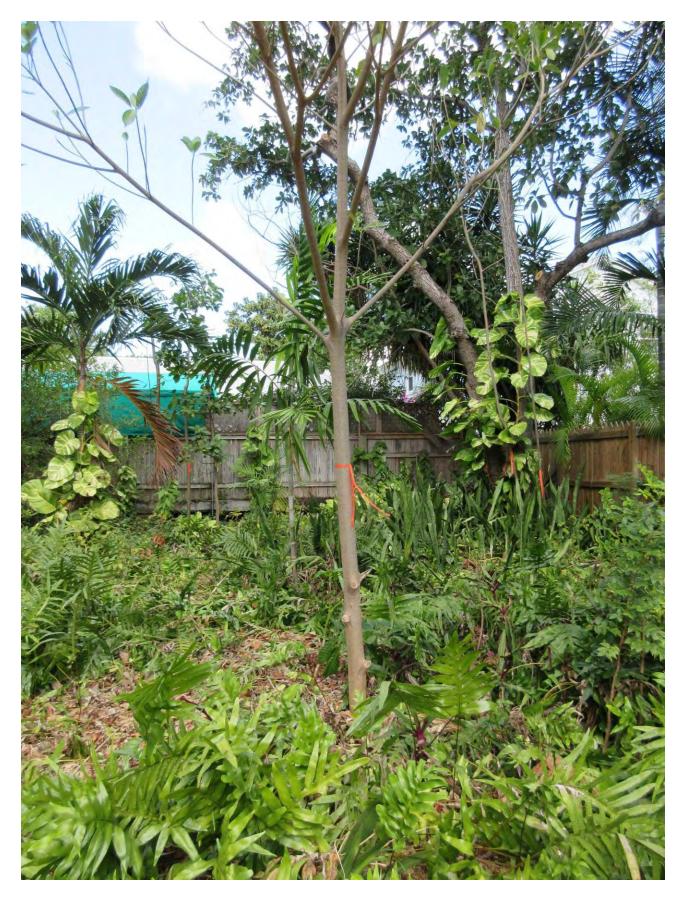
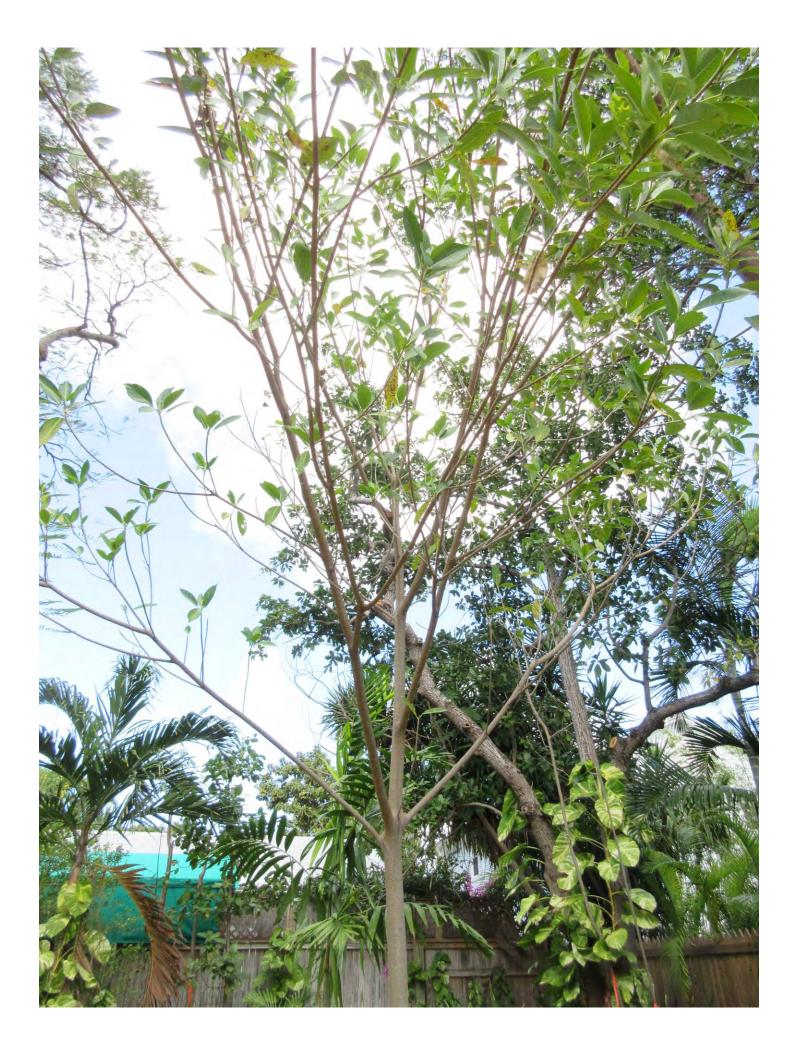
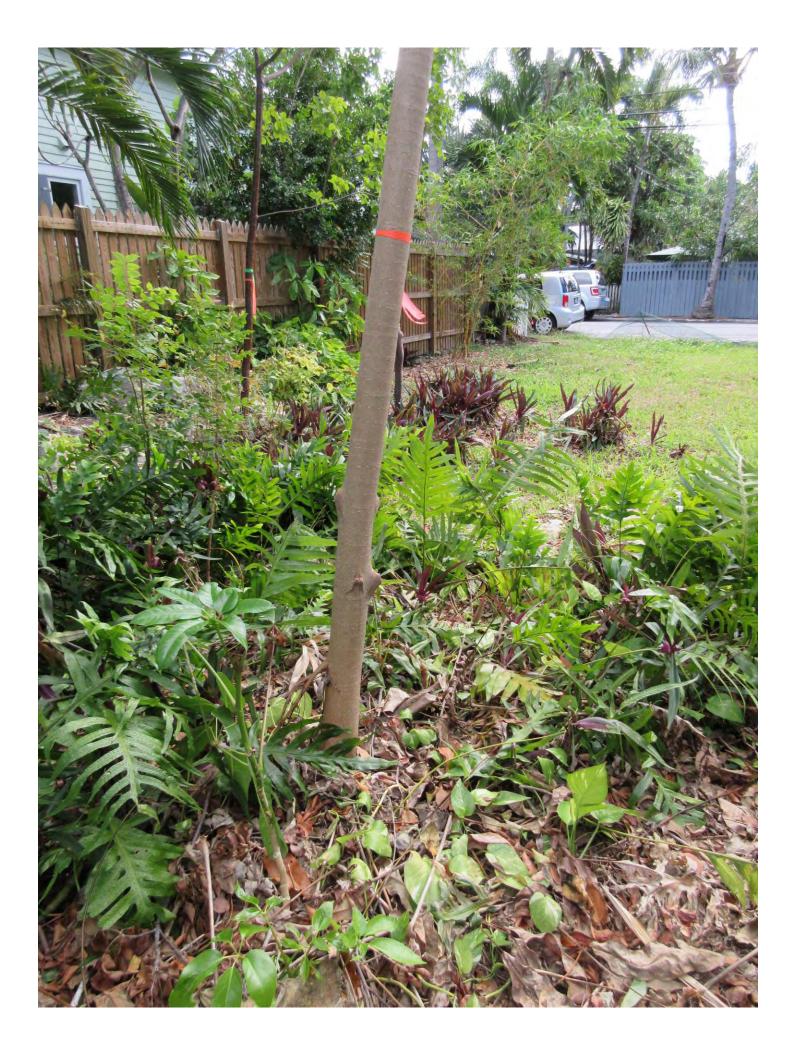
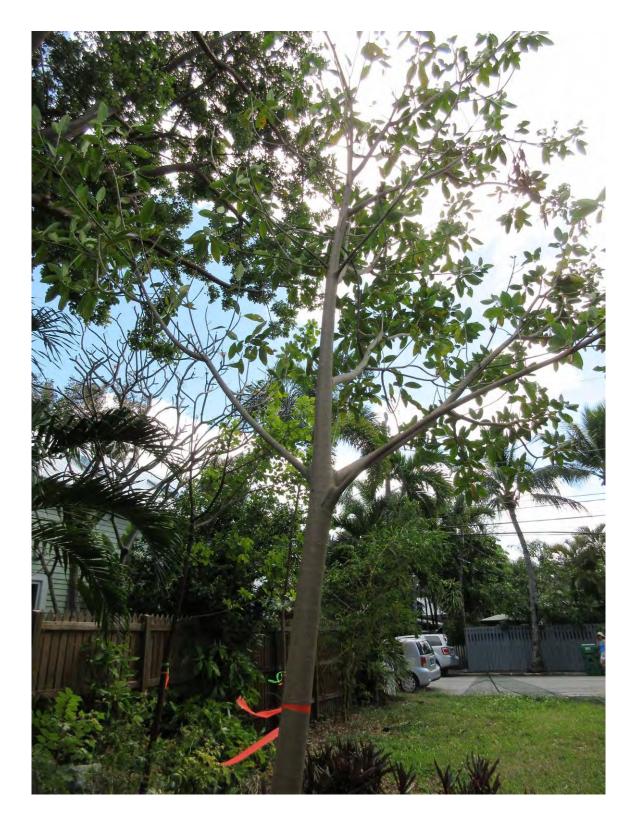
Diameter: 3.8" Location: 80% Species: 100% (on protected tree list) Condition: 80% (good) Total Average Value = 86% Value x Diameter = 3.2 replacement caliper inches

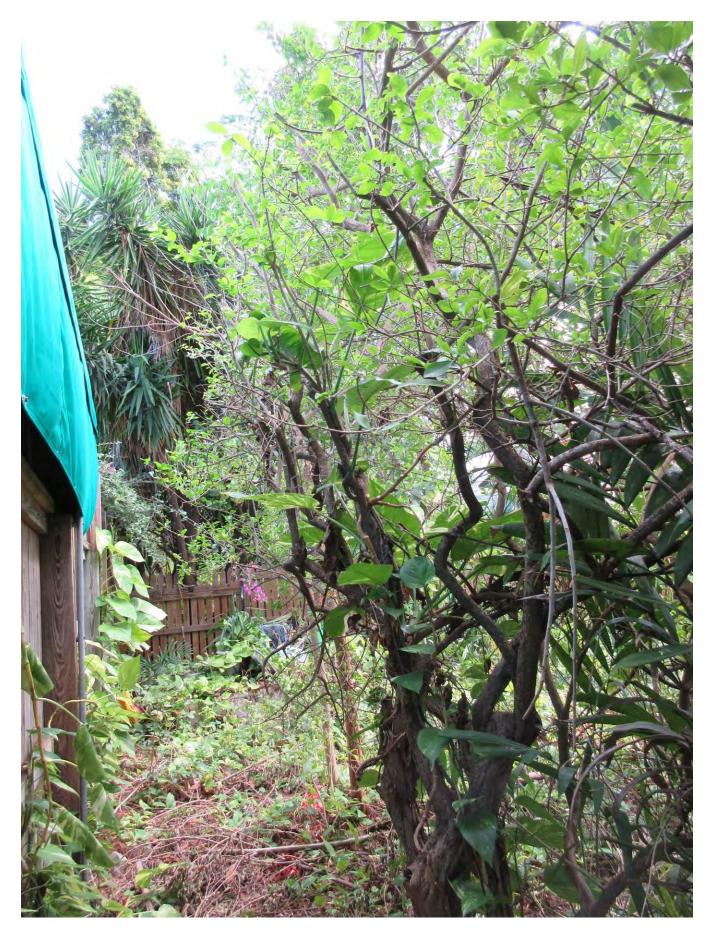
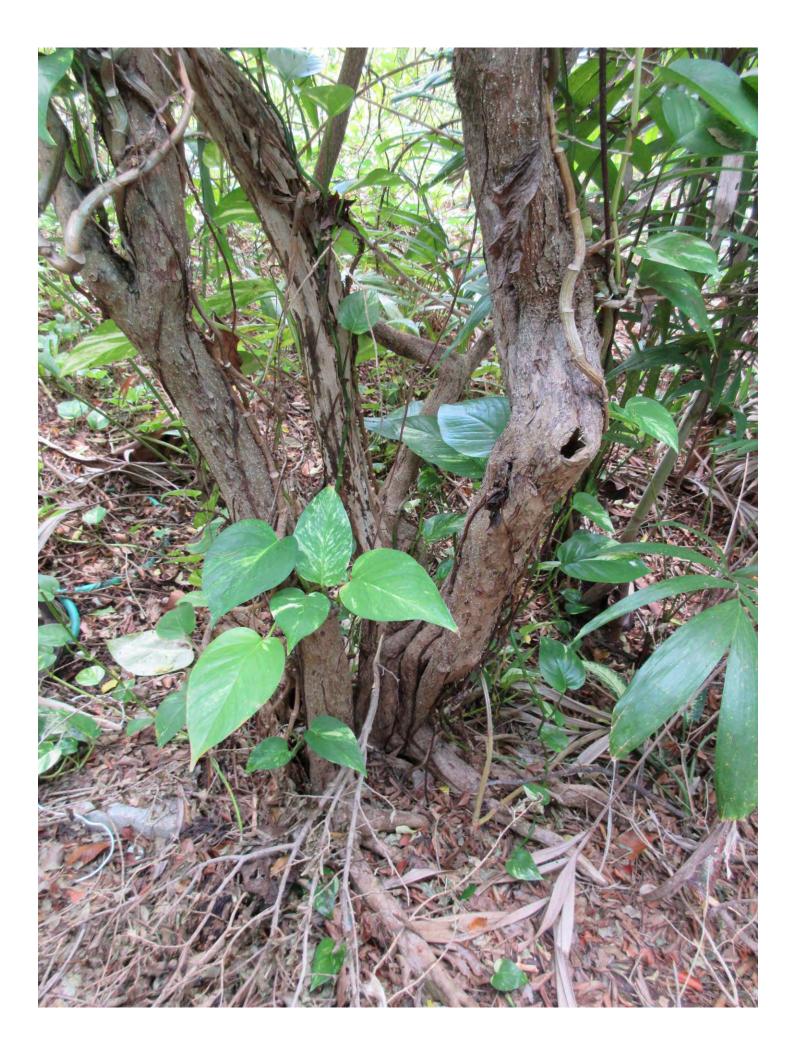
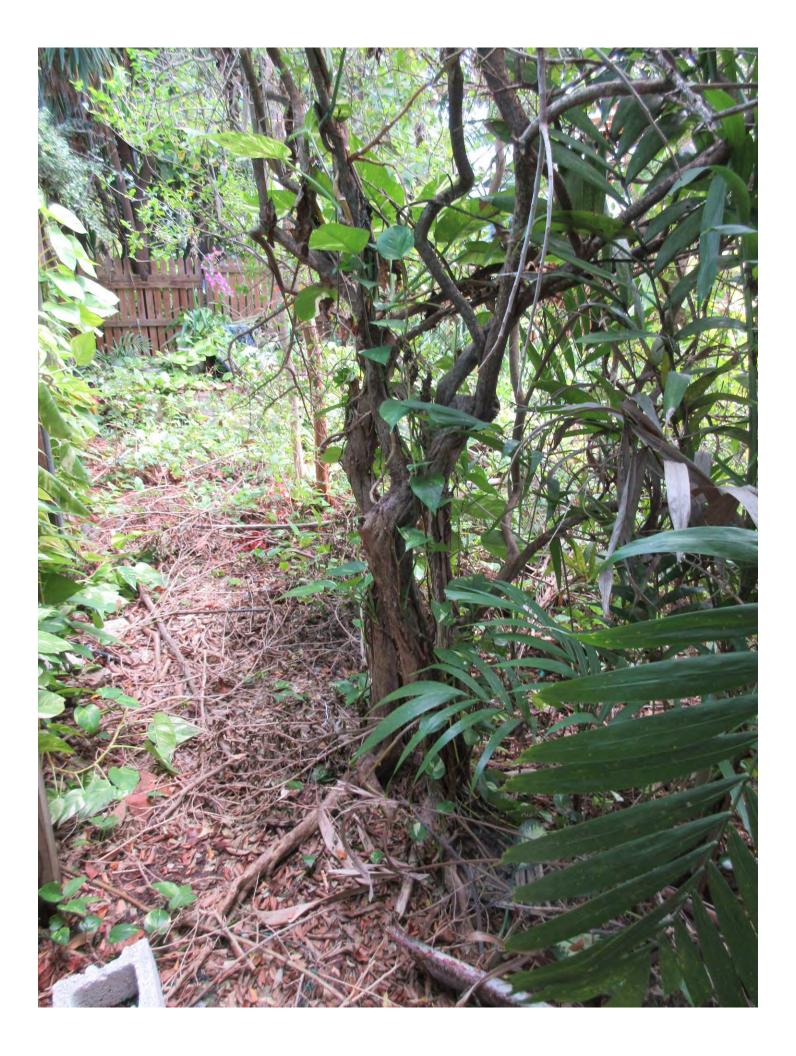
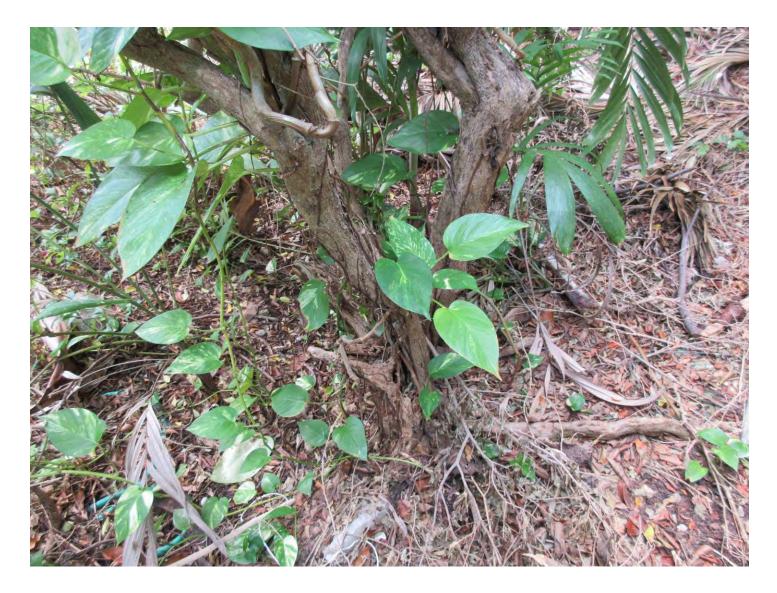
Diameter: 8.2" Location: 70% (close to property line) Species: 50% (not on protected or not protected tree list) Condition: 30% (poor, decay throughout base of tree) Total Average Value = 50% Value x Diameter = 4.1 replacement caliper inches

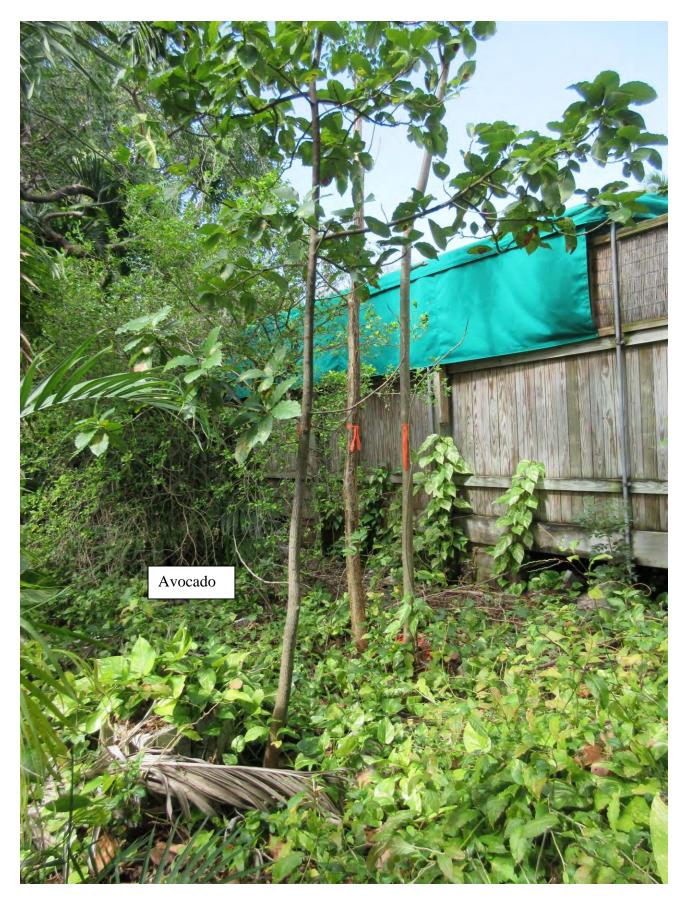
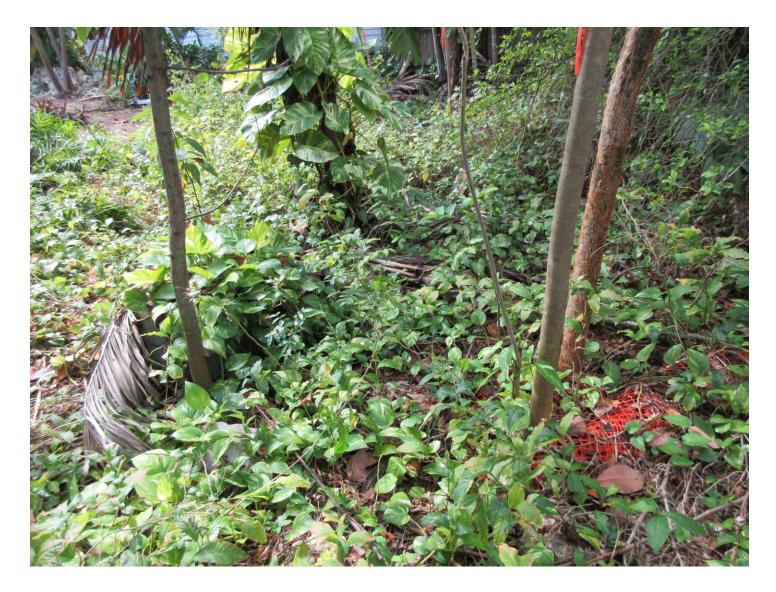
Diameter: 2.2" Location: 70% Species: 100% (on protected tree list) Condition: 80% (good) Total Average Value = 83% Value x Diameter = 1.8 replacement caliper inches
