Cynthia's Blue Palms

February 21, 2017

City of Key West Tree Commission

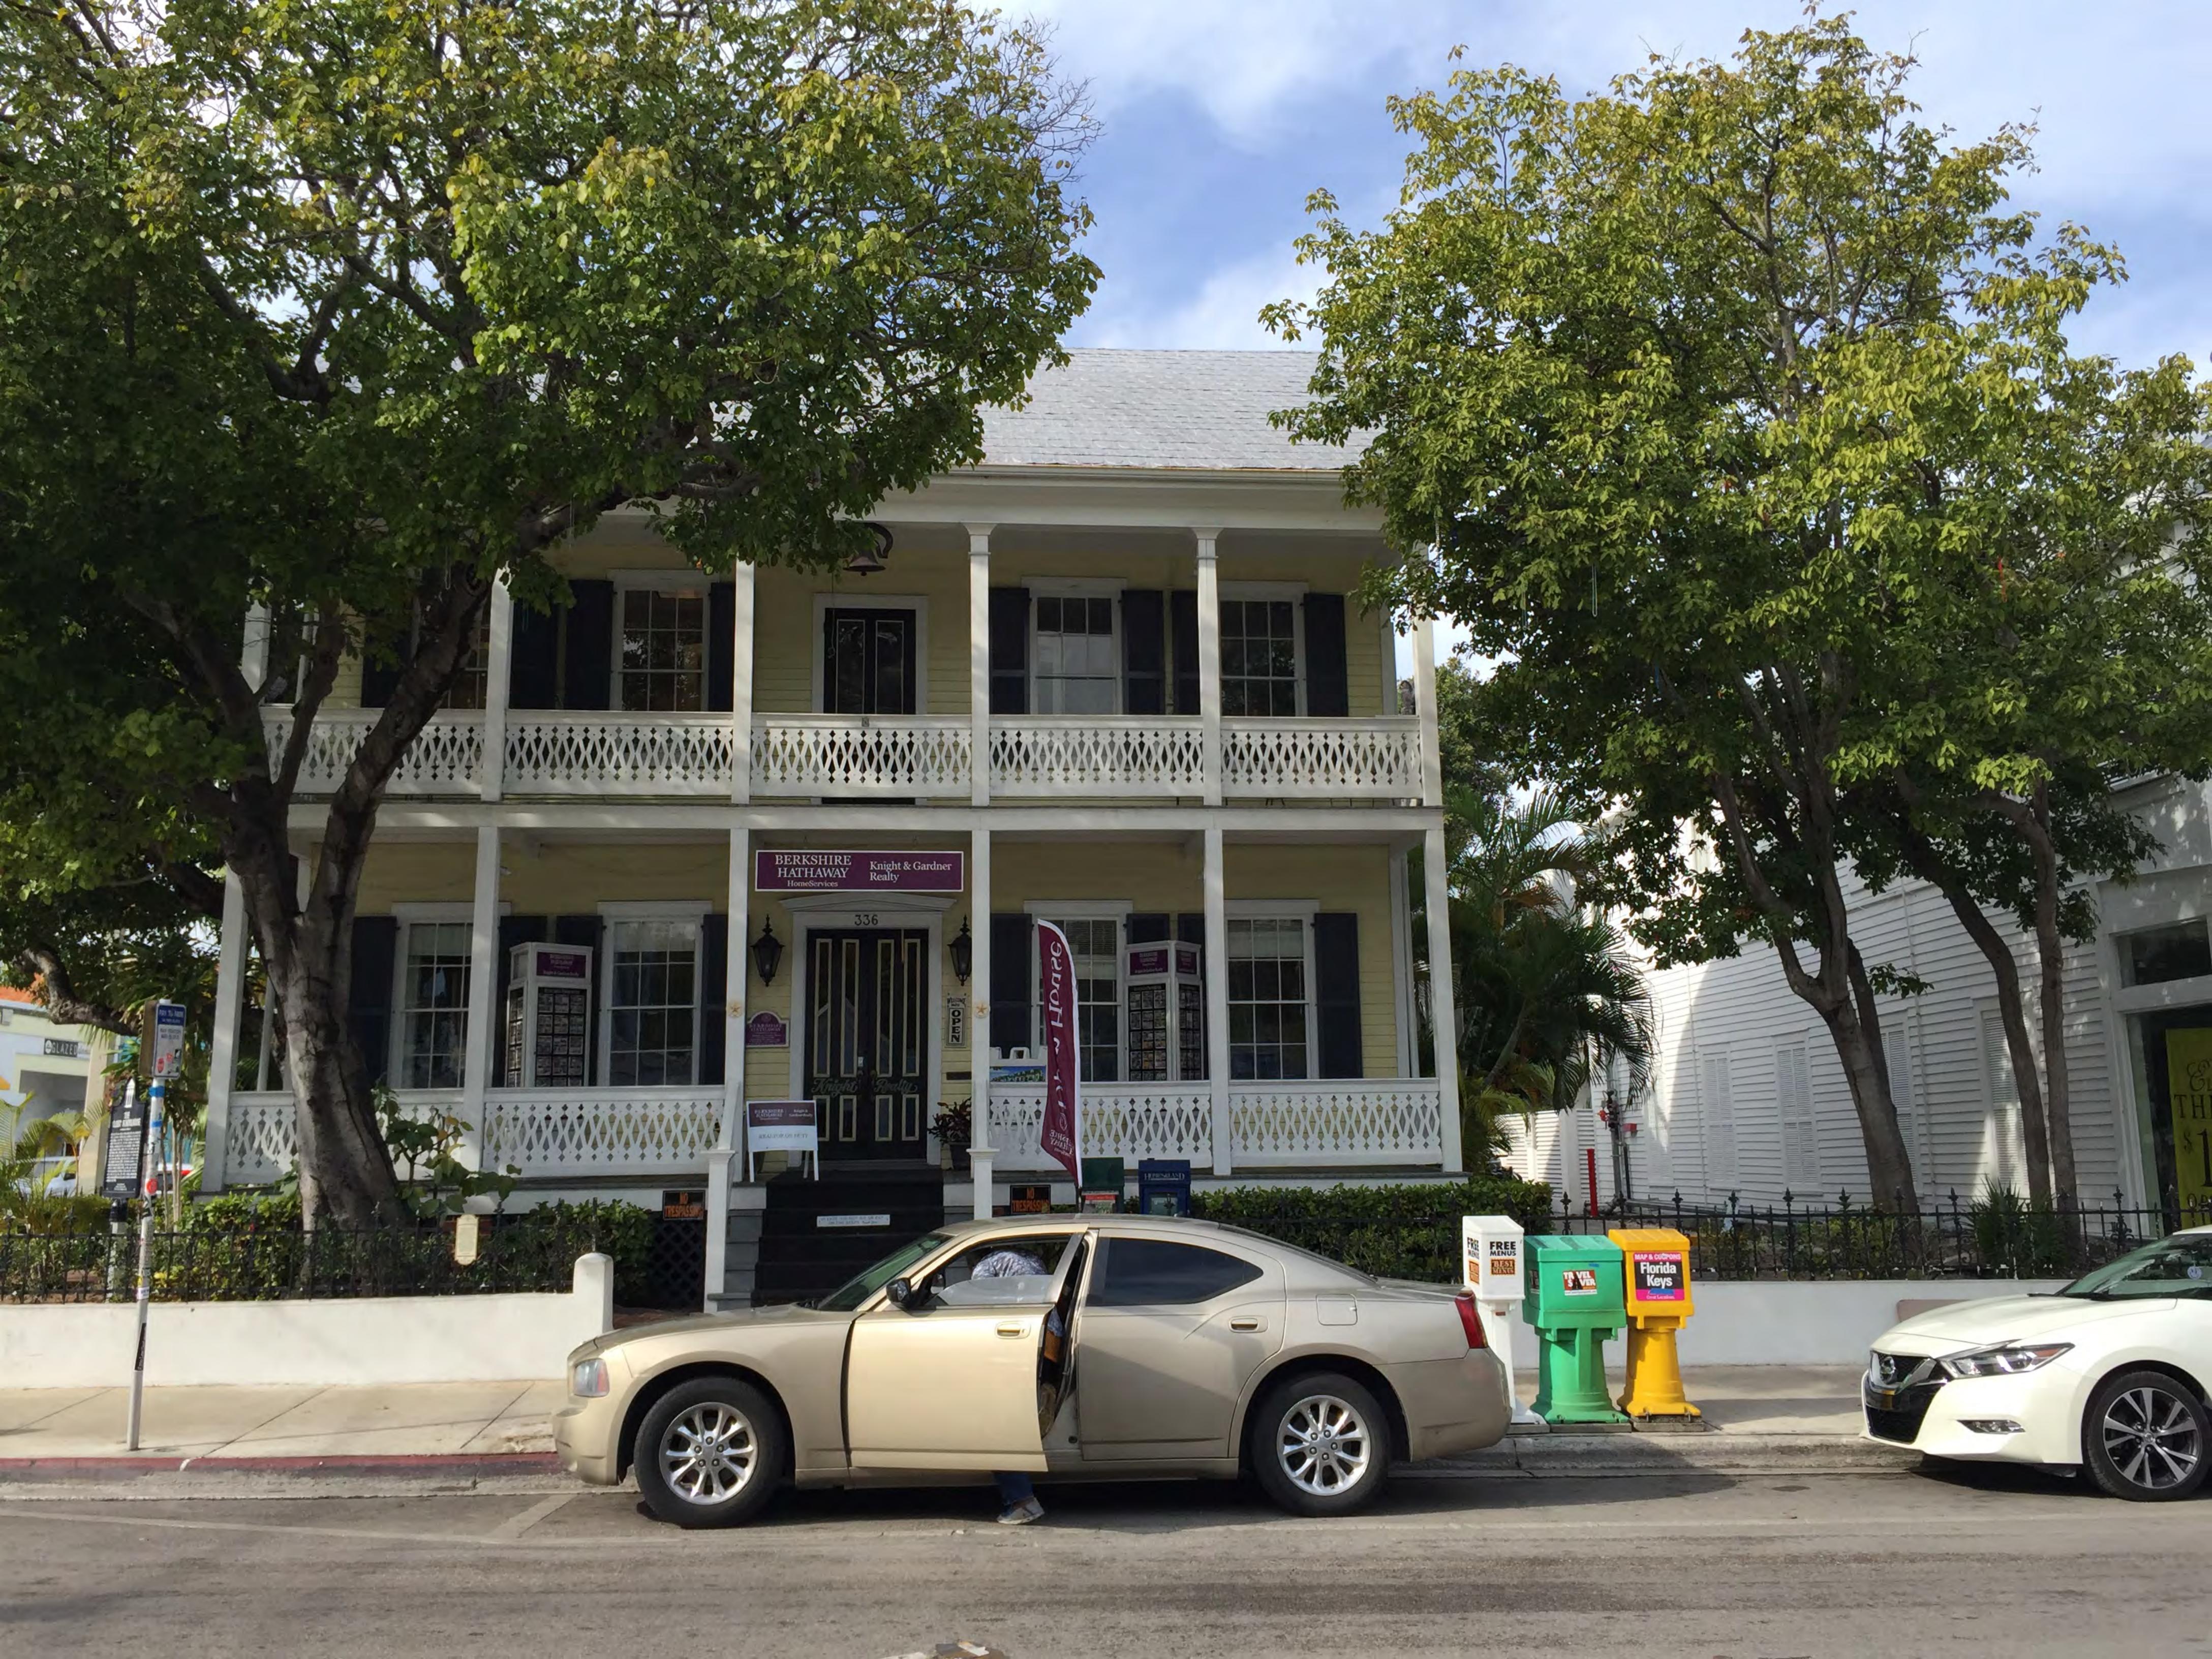
Purpose: Following are my findings of evaluation concerning 2 Spanish Lime trees (photo 1) and 2 Washingtonia palms (photo 2) located at 336 Duval Street, Key West, Florida. I have been retained by owner Claude Gardner, Jr., of Berkshire/Hathaway Knight & Gardner Realty. This application is submitted for purposes of constructing an additional building to the immediate north side of existing historic house. A new entrance from Duval Street will be constructed to access additional building (photo 3). Once built an art community will be developed surrounding property similar to the northern end of the 300 block. Replacement trees of endangered species will be planted on the Eaton Street side of historic building which includes a full property landscape enhancement.

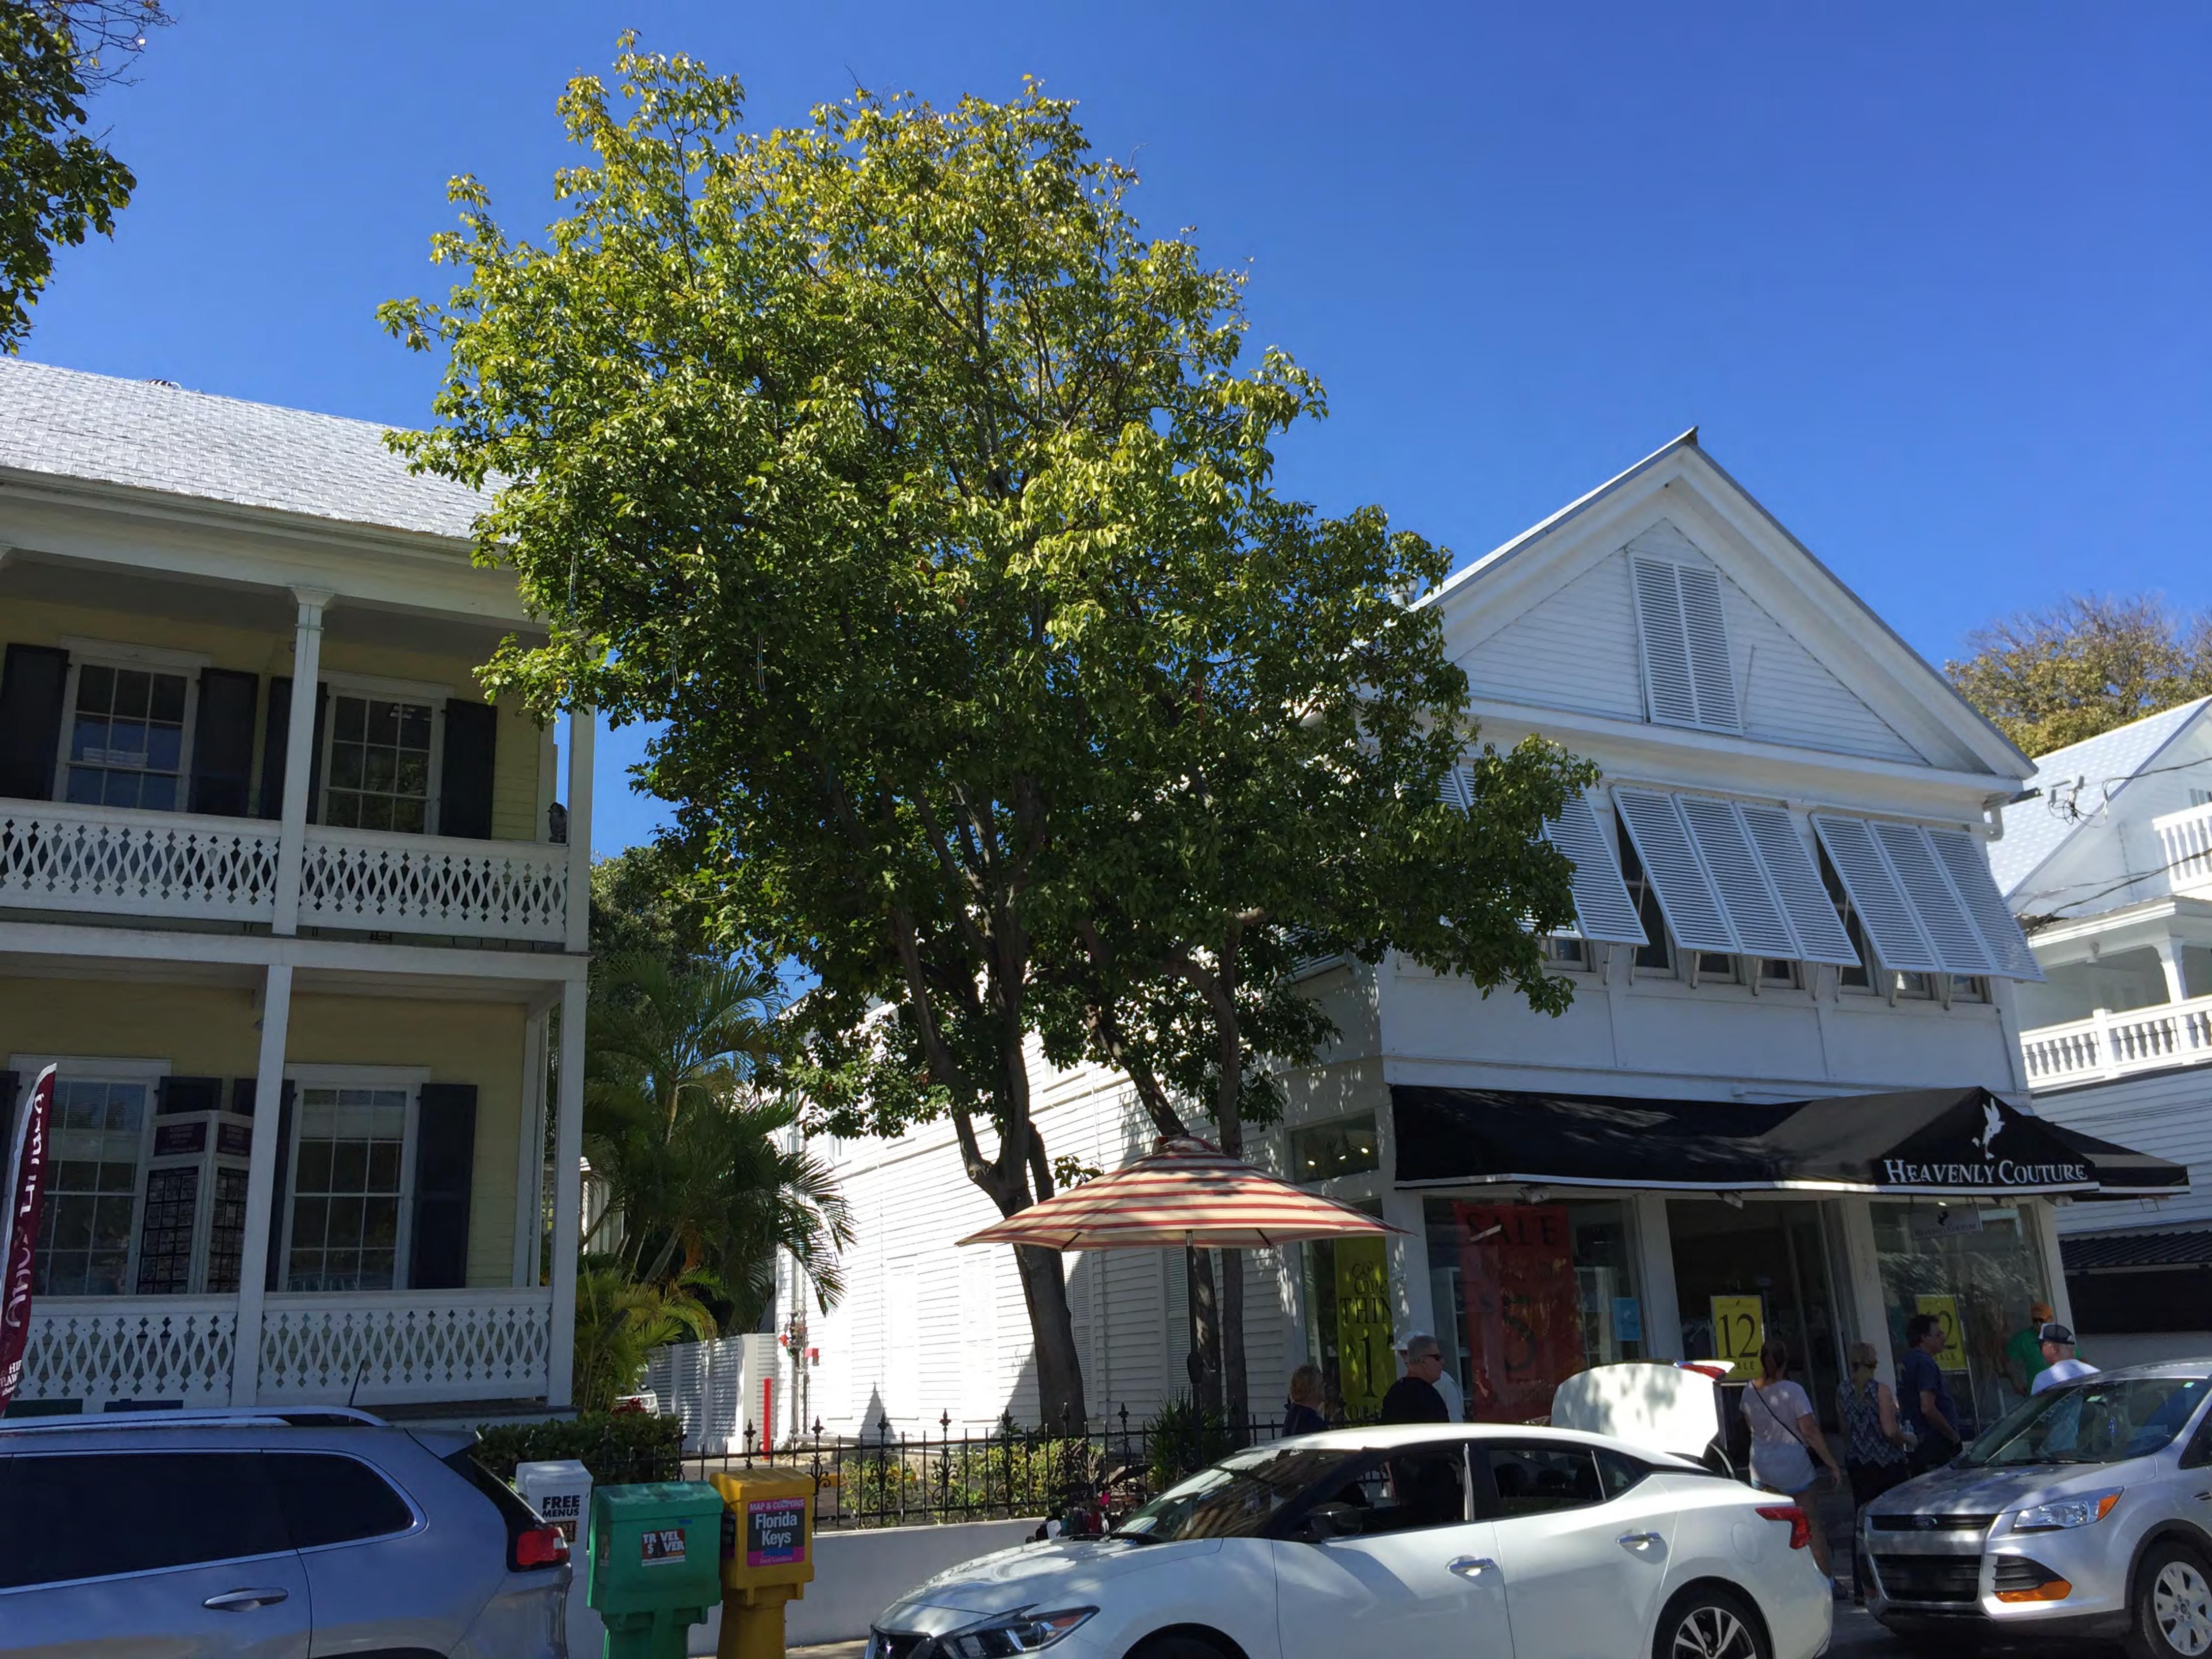
The Spanish Lime trees, *Meliococcus bijugatus*, are located at the north north east corner, front of property, abutting the historic wall (photo 4). The trees can be viewed from Duval and Eaton Streets (photo 5).

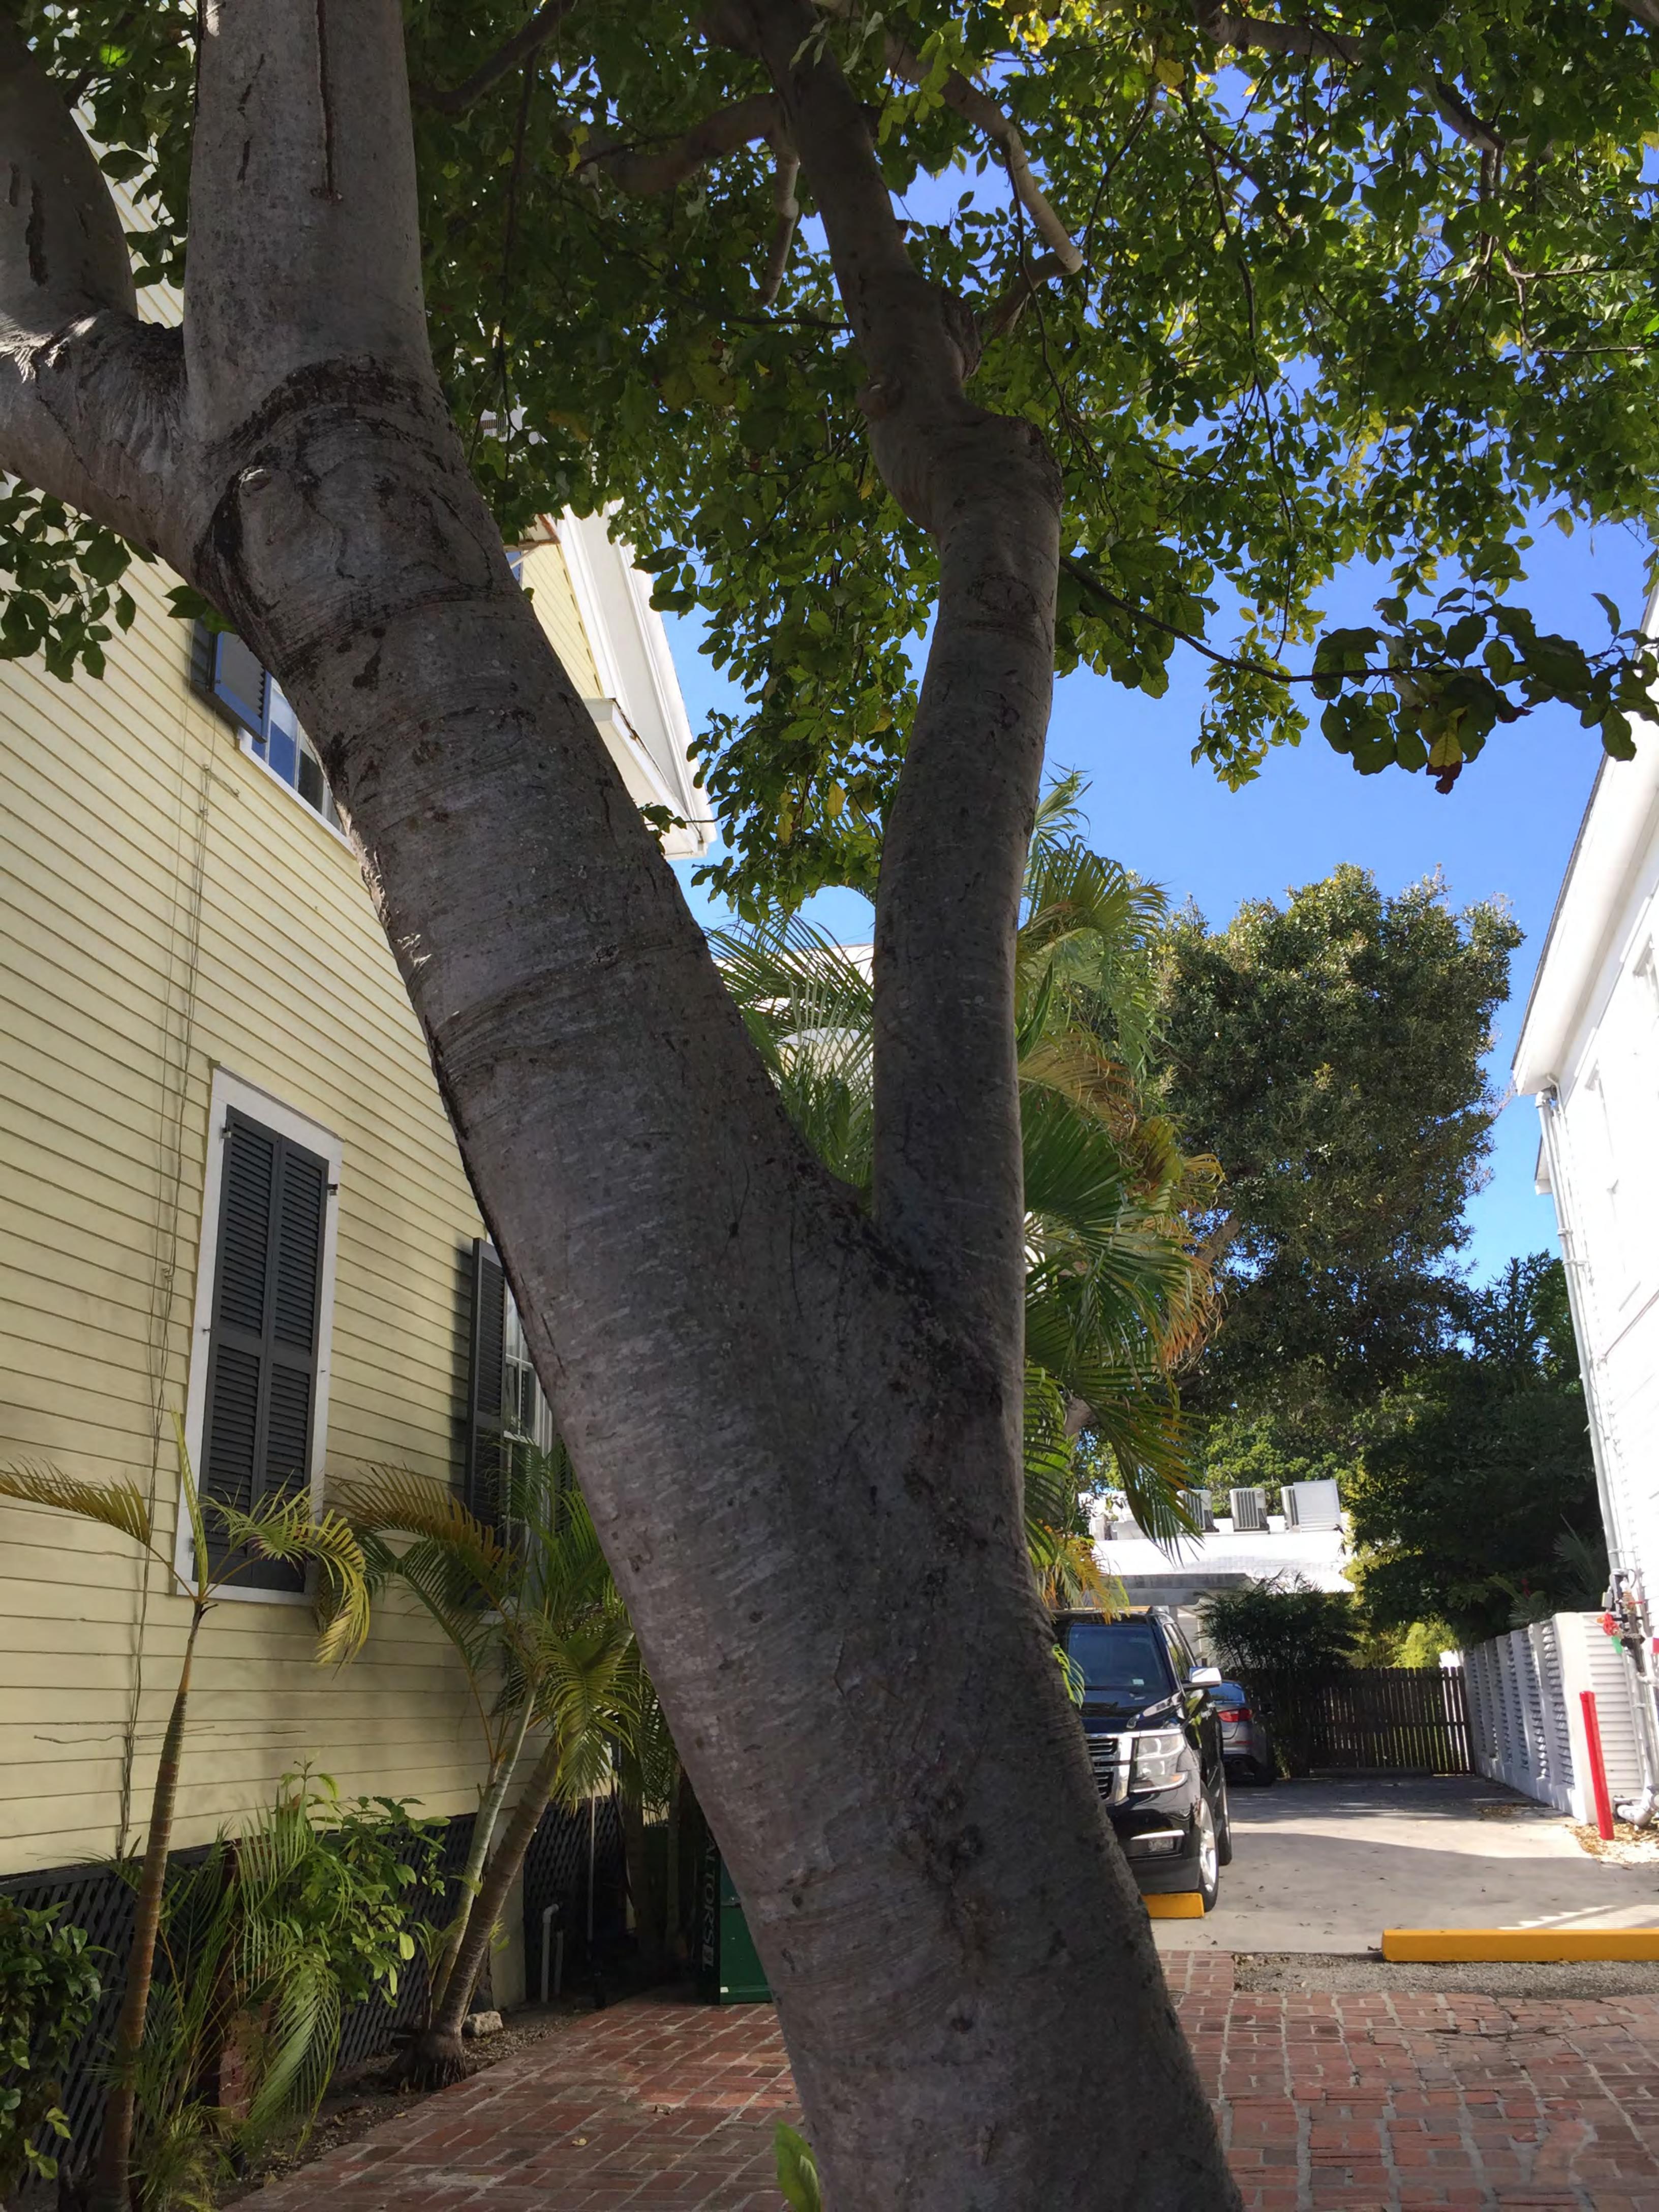
Tree number 1, the southernmost tree is approximately 11" diameter measured at approximately 5' above grade. Canopy approximately 30'x15' impacted by tree canopy number 2. Tree condition is fair. Included bark is evident on main stem; correction is possible of smaller limb however, main stem remaining has a significant lean toward historic building (photo 6).

Due to condition of trees transplanting is not recommended and should be removed.

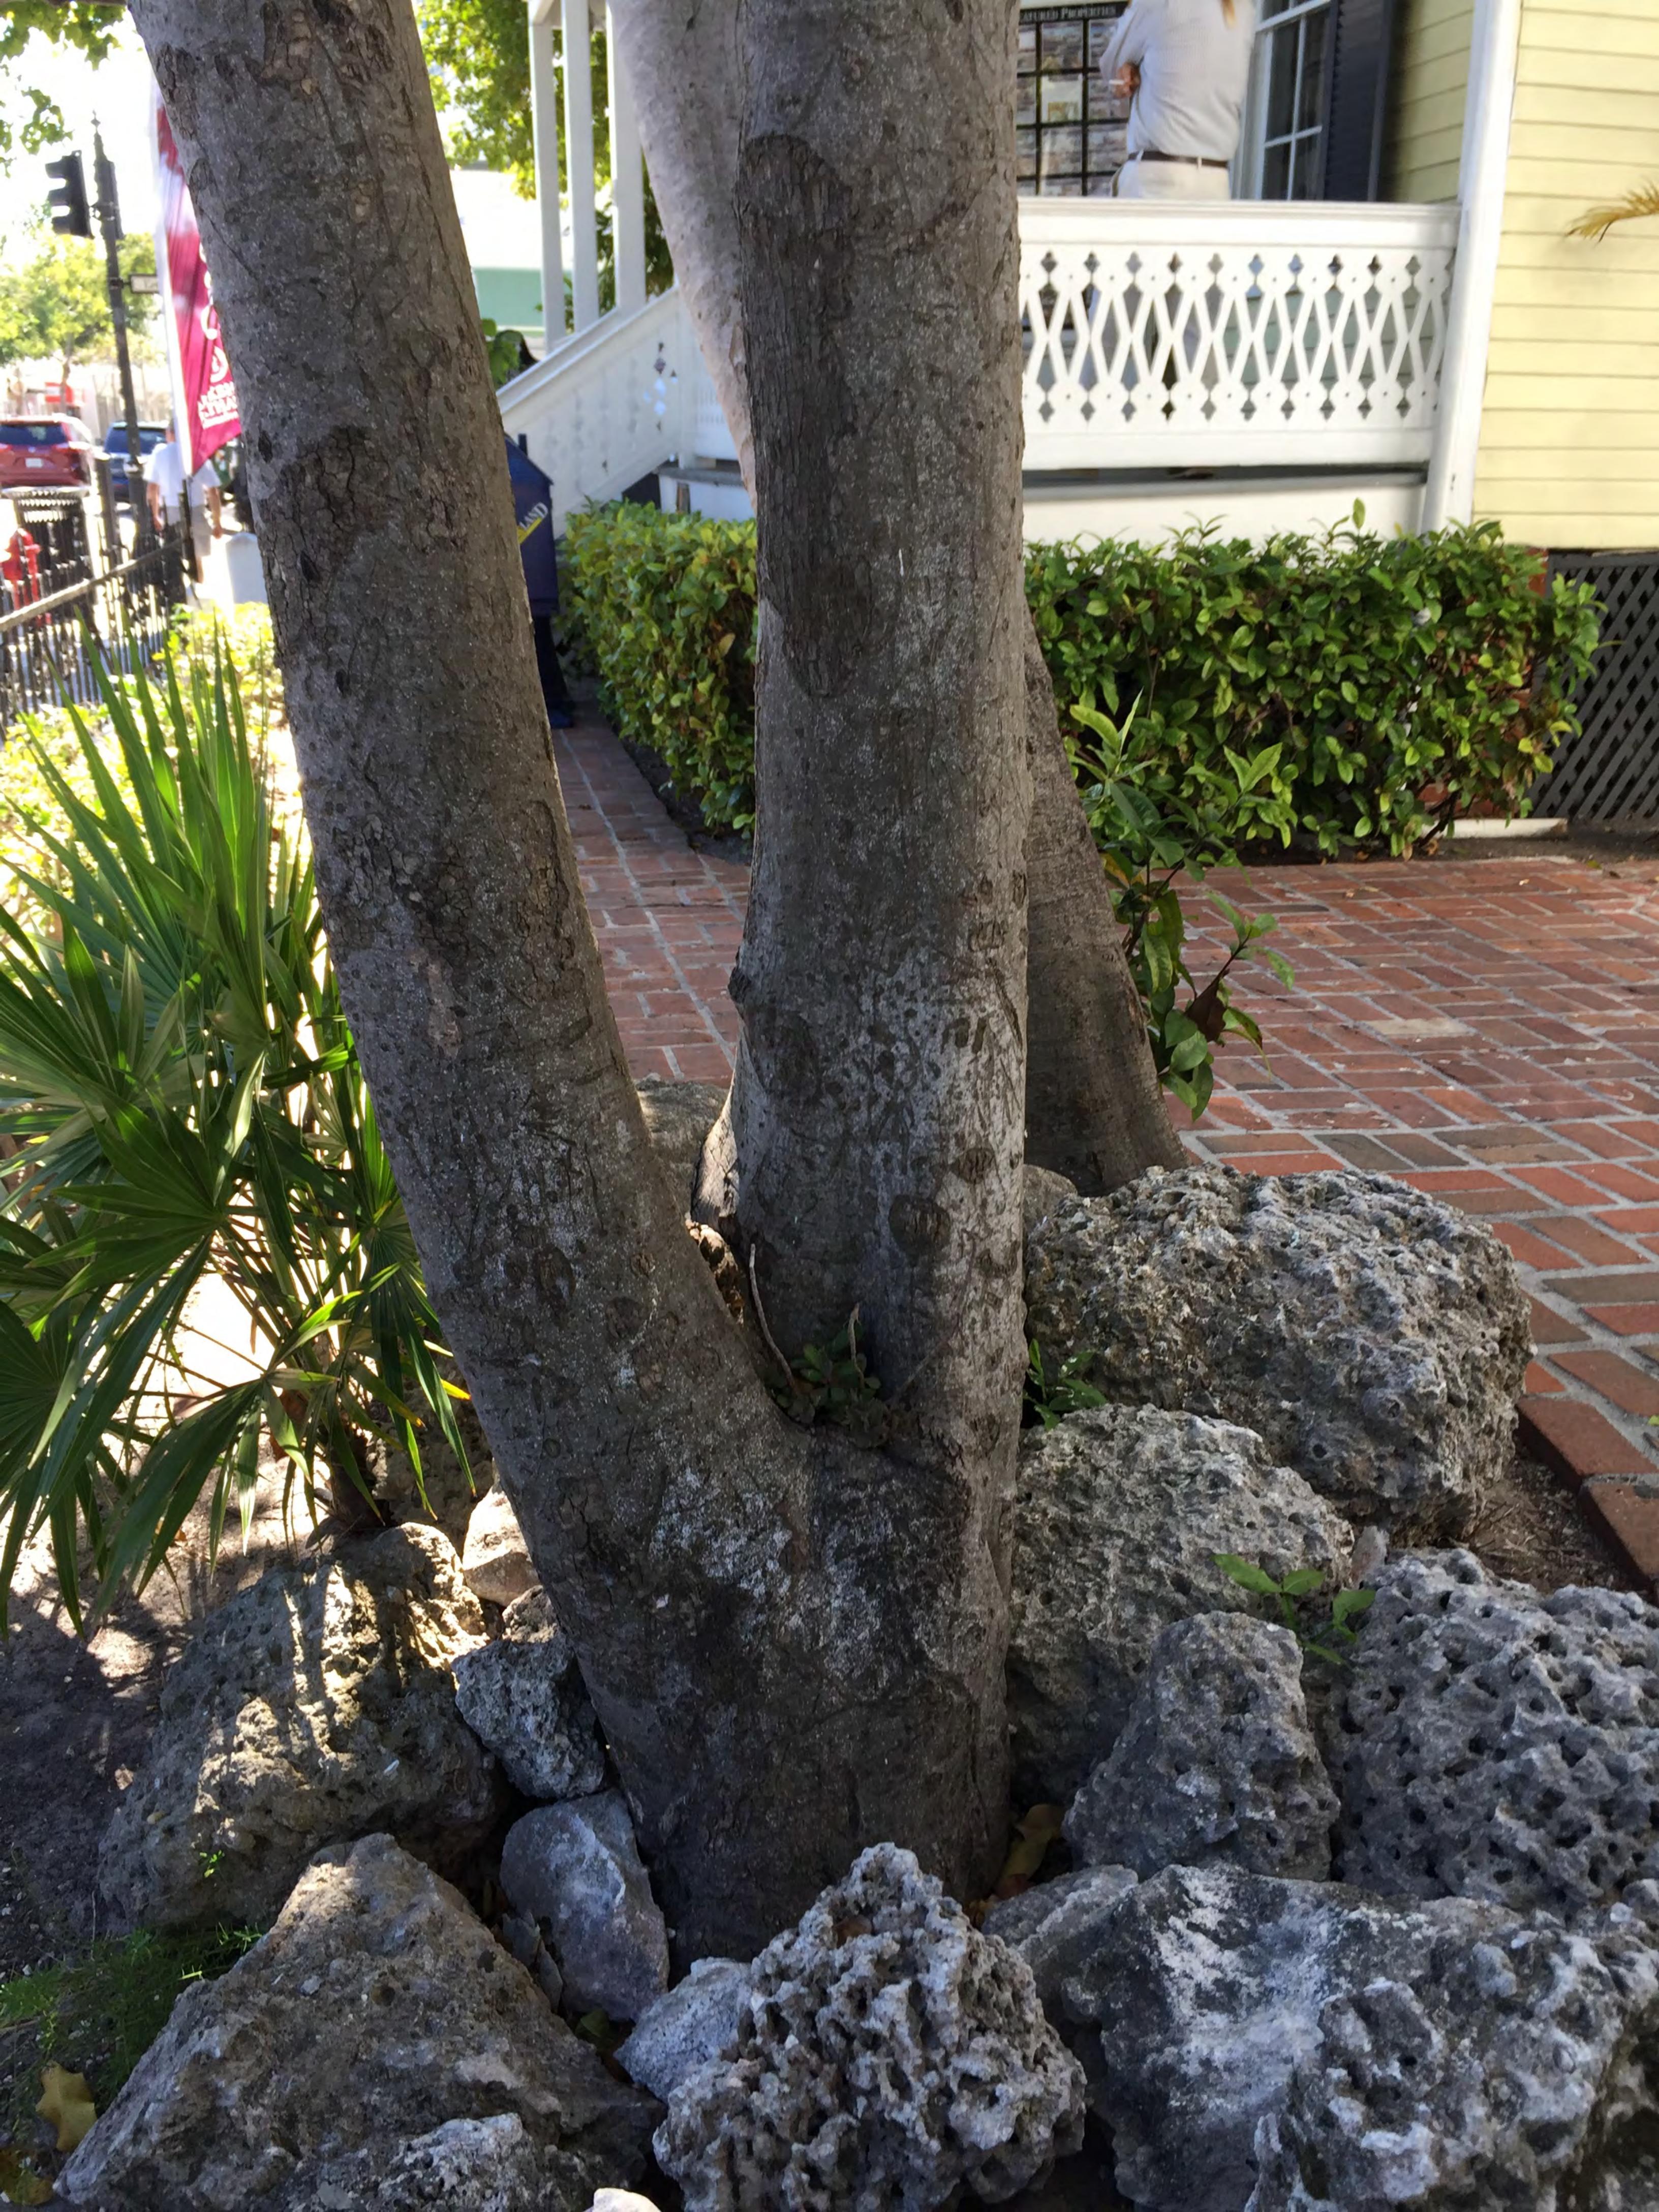
Tree number 2, the northernmost tree is approximately 11" diameter totaling both east and west codominate stems respectively measured at approximately 5' above grade. Canopy approximately 15'x10' impacted by tree canopy number 1. Condition is poor. Codominate stems originate at 1 ½' above grade (photo 7). Due to condition correction is not recommended.

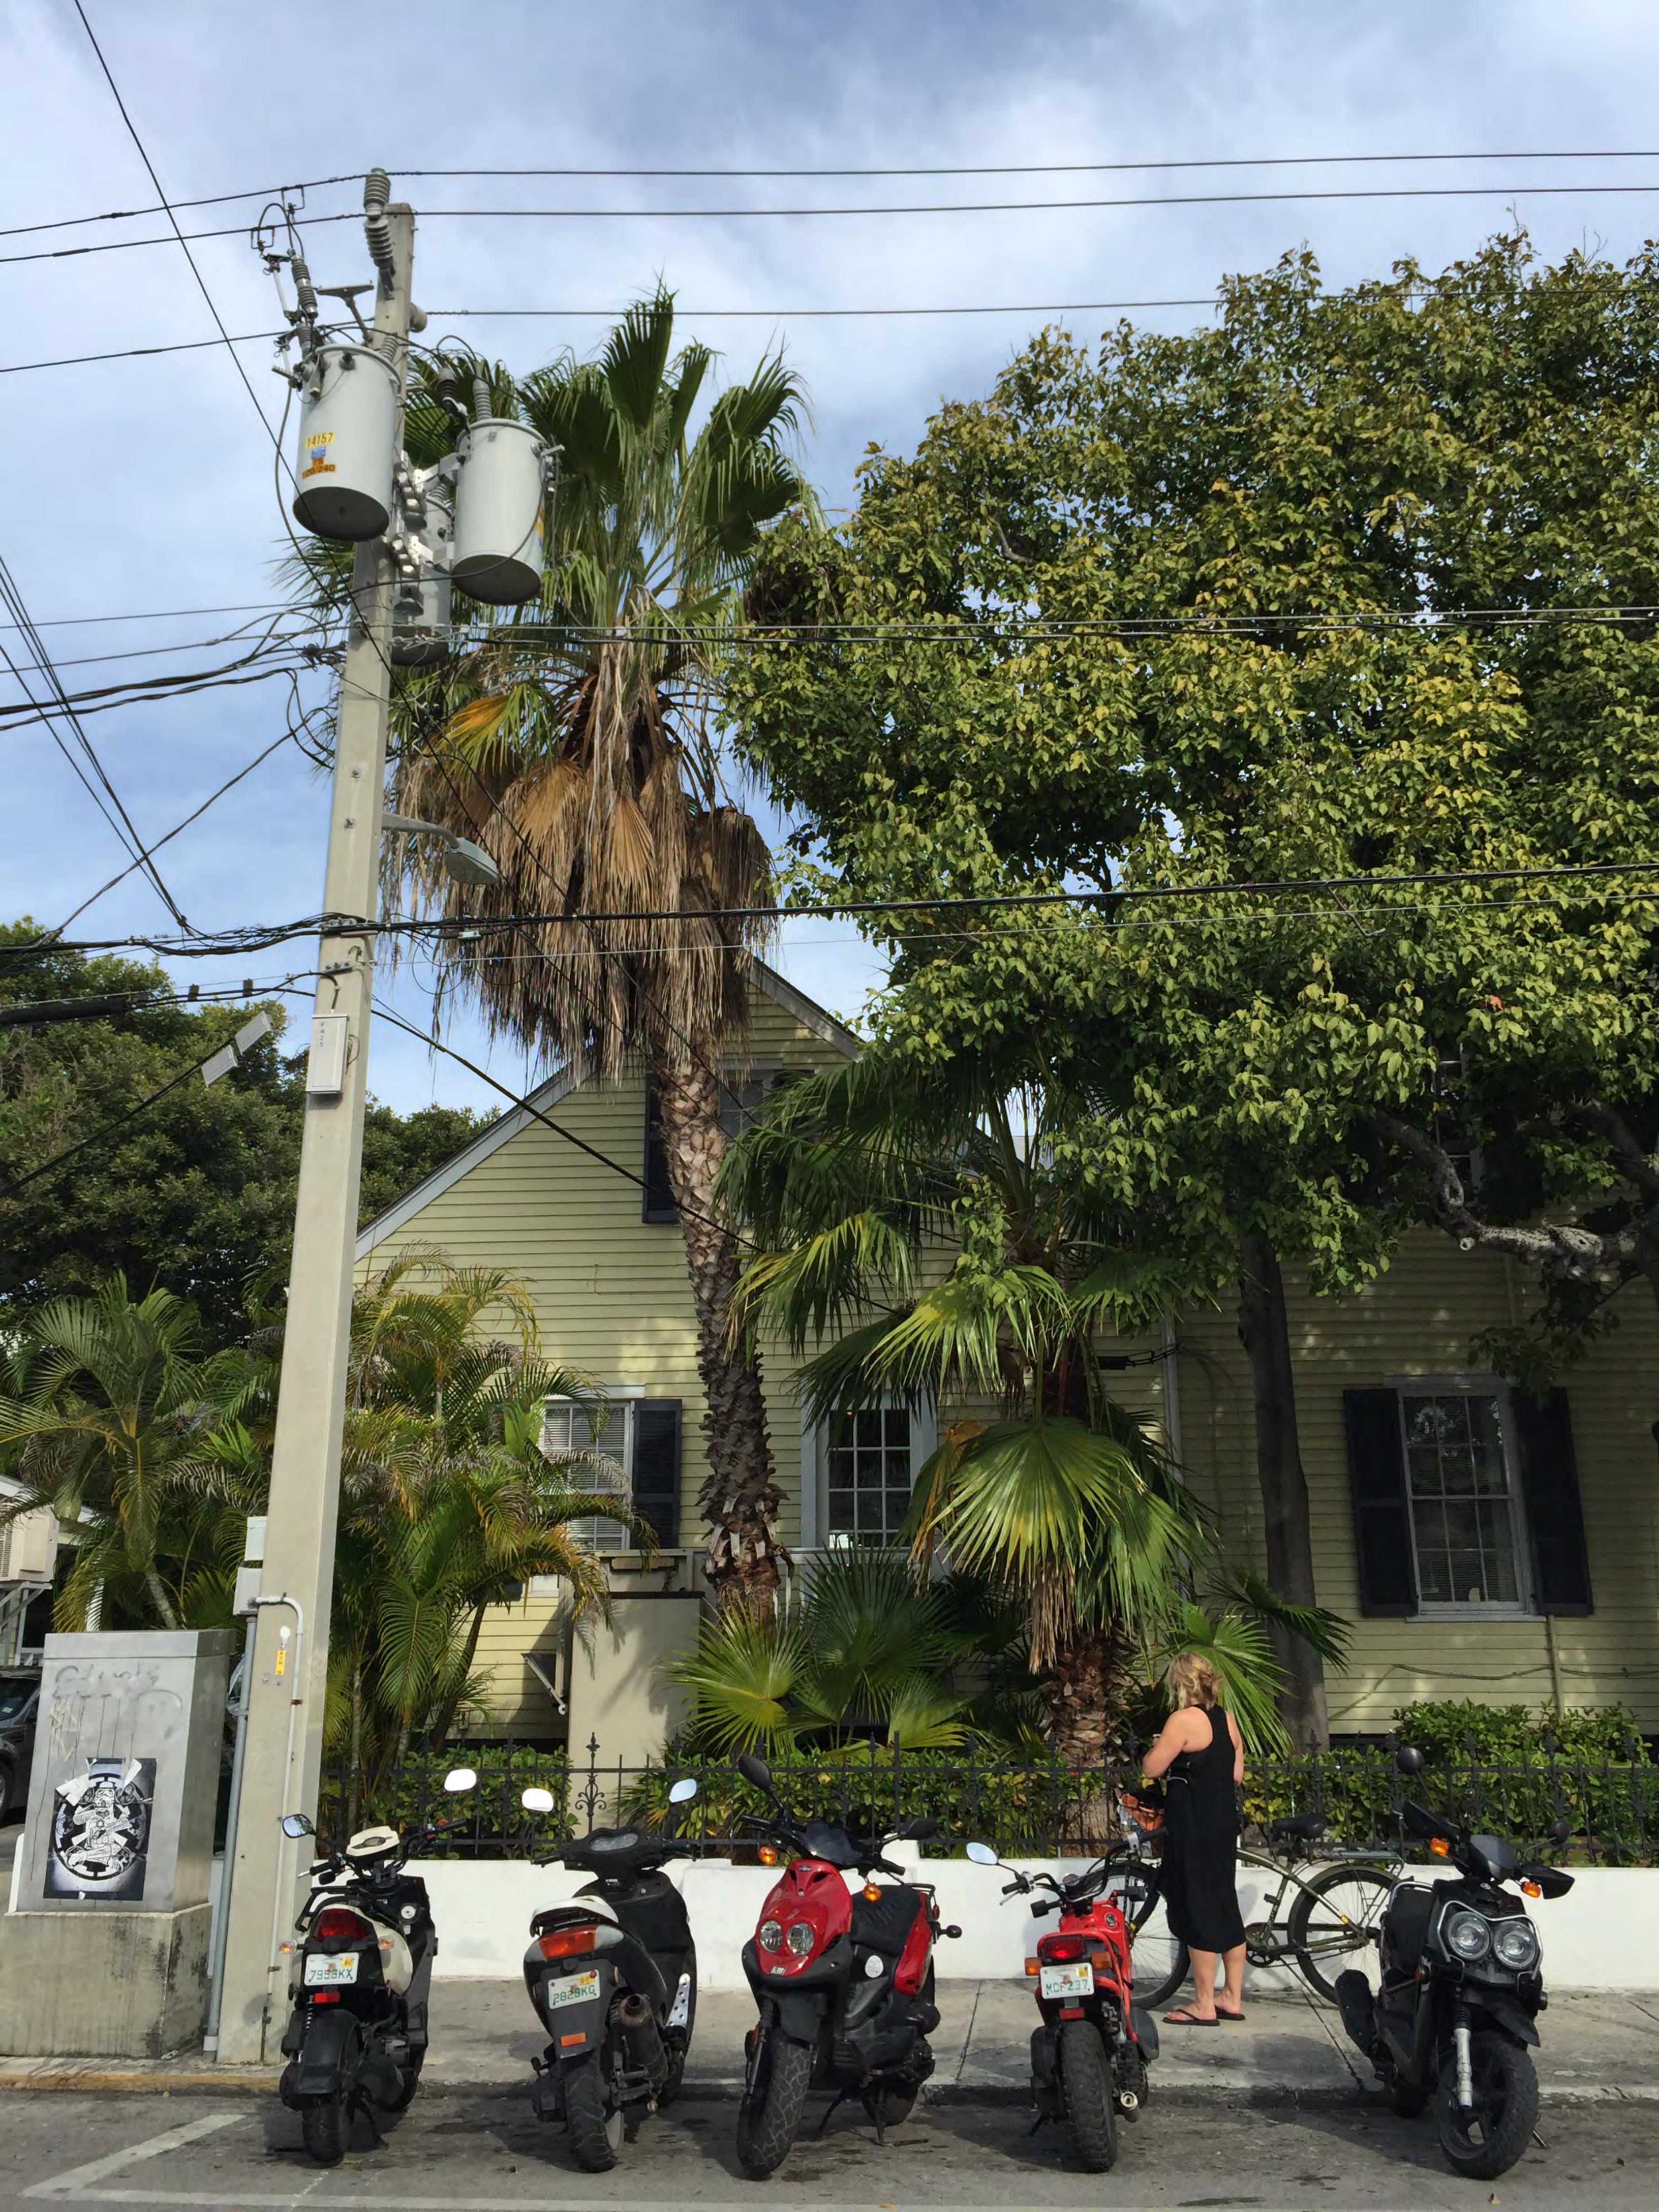
The 2 Washingtonia palms are located on the south side of historic building (photo 8). Heights are approximately 45' and 20' respectively. Not only are the palms listed by the State of Florida as an invasive exotic they are also in very close proximity to power and utilities supplying services to building (photo 9).

Due to species and close proximity to utilities these palms should not be transplanted but should be removed.
