## Cynthia's Blue Palms

City of Key West Tree Commission

February 22, 2017

Purpose: Following are my findings of evaluation concerning 1 Sapodilla trees, 2 Royal Poinciana trees, 2 Washingtonia palms and 2 Mahogany trees located at 3717 Eagle Avenue, Key West, Florida. I have been retained by owner Peter Batty, Jr. This application is being submitted as this is a new home purchase for Mr. Batty to include reconstruction and extensive landscaping. Trees can be seen from Eagle Avenue (photo 1).

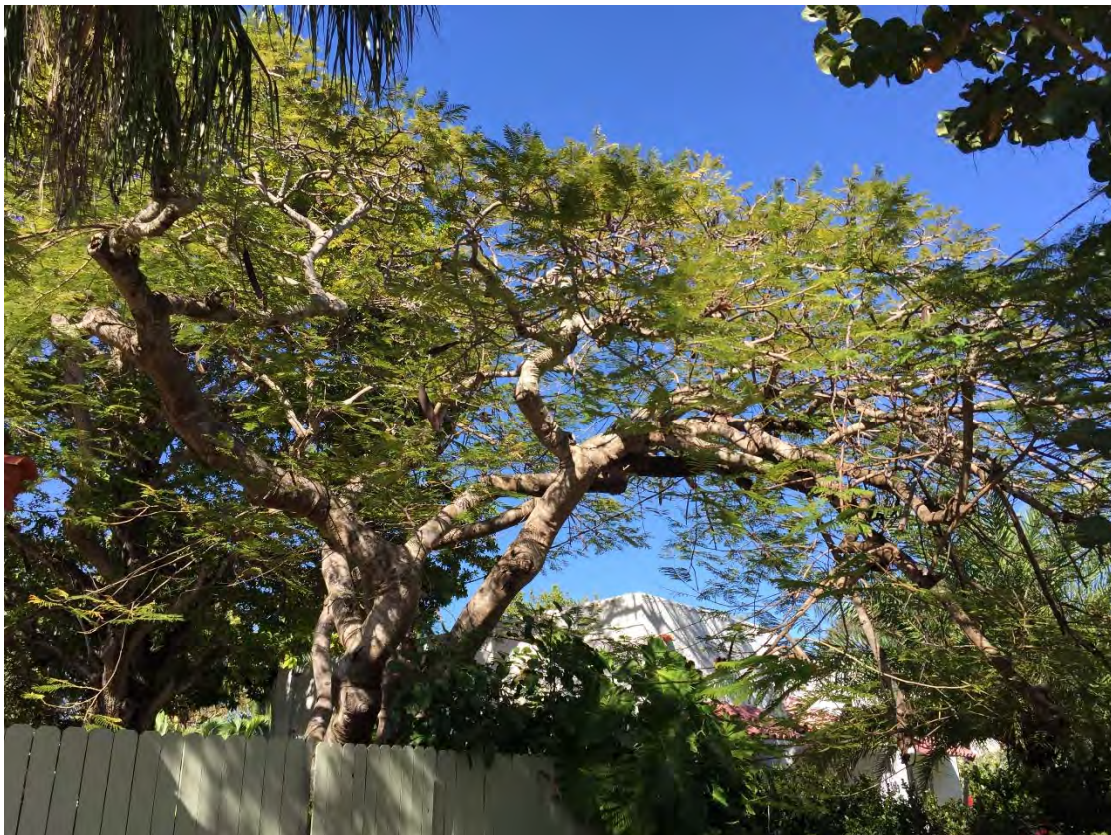
2b

**Royal Poinciana**, *Delonix regia*, tree number **1**, located directly behind and abutting concrete wall at the southeast side yard (photos 2,2b). The tree is approximately 25.5" diameter measured at approximately 5' above grade. Canopy spread is approximately 18'x20'. Condition is very poor and failure likely. Photographs depict main codominance at approximately 3.5' above grade with severely included bark (photos 2c,3,4,5). Southside base of tree has an area of decay with wound wood evident hence, suspect continual internal decay (photo 6). Branching from codominate stems further depicts included bark with decay (photos 7,8,9,). Scaffolding criss-crossing branches are also evident throughout the canopy (photos 9,10,11). The next three photos show a small tree codominance failure (photos 12,13,14). Since failure of this tree is likely, I recommend removal.

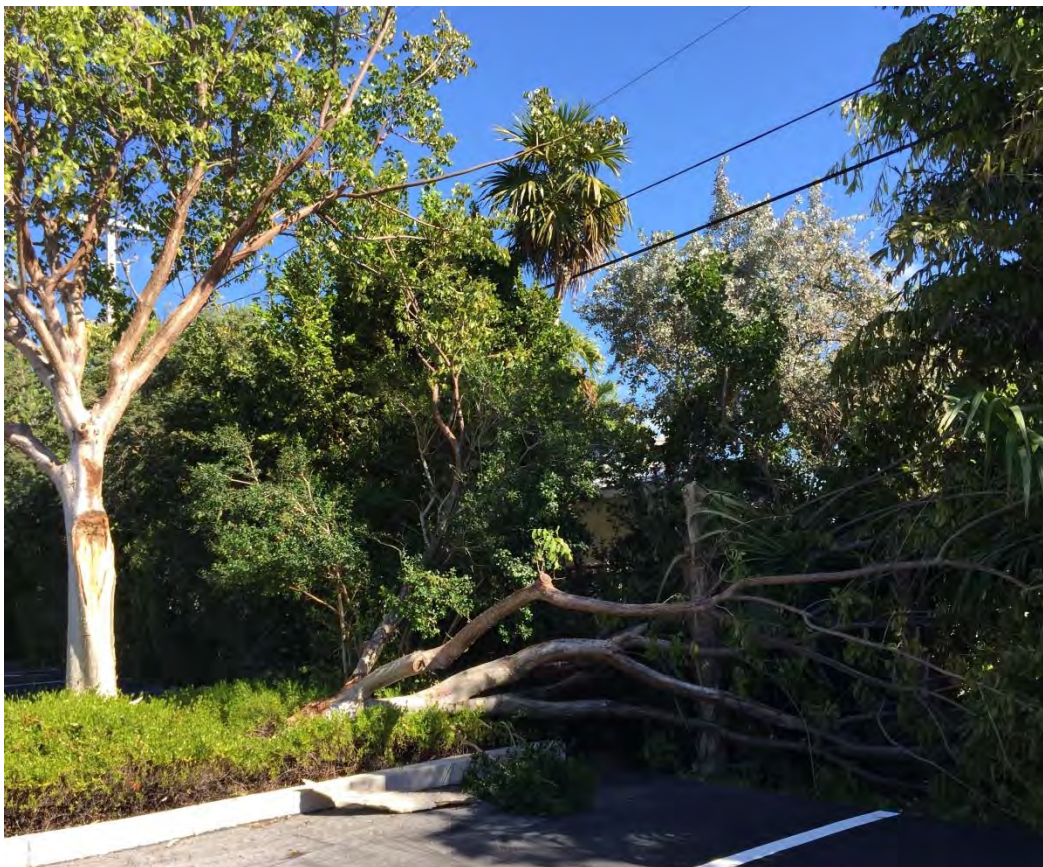
12—an example of  
codominance  
trunk failure

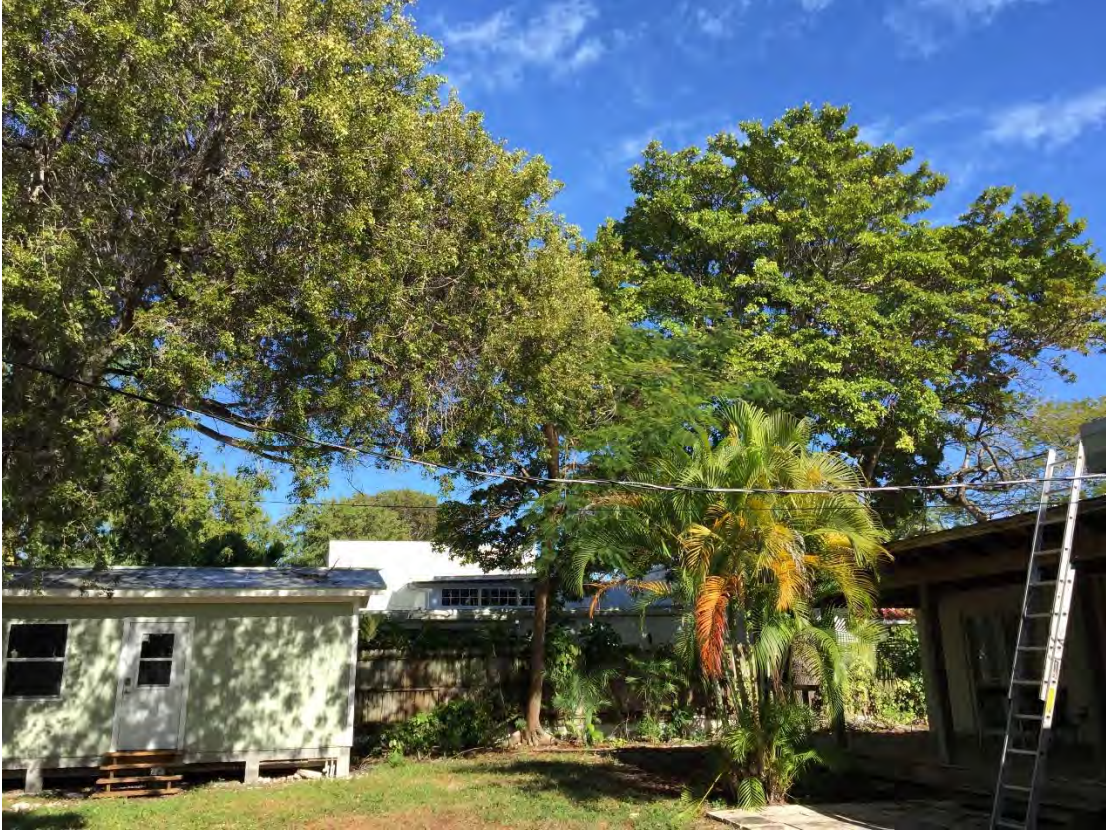
17

**Sapodilla** *Manilkara zapota*, tree number **2**, located adjacent to tree number 1 at the south side of rear yard. The tree is approximately 28" diameter measured at approximately 5' above grade. Canopy spread is approximately 45'x25' (photos 15,16,17). Condition is very poor. Photographs also depict large and small branch failures as well as numerous dead branches remaining throughout canopy. At the north side and base of tree conks are evident at various stages (photos 18,19,20). This tree is infected with Ganoderma or Butt Rot, a wood decaying disease. The canopy is continuing to thin with branch failures as decay at root system and base of tree progresses. Repair is not possible by restoration pruning or by chemical

infusion. Due to the trees massive size and location failure in any direction will destroy its 'target', and since this disease is incurable with failure certain I recommend the Sapodilla tree removed. Next photos depict a small tree failure from Butt Rot (photos 21,22).

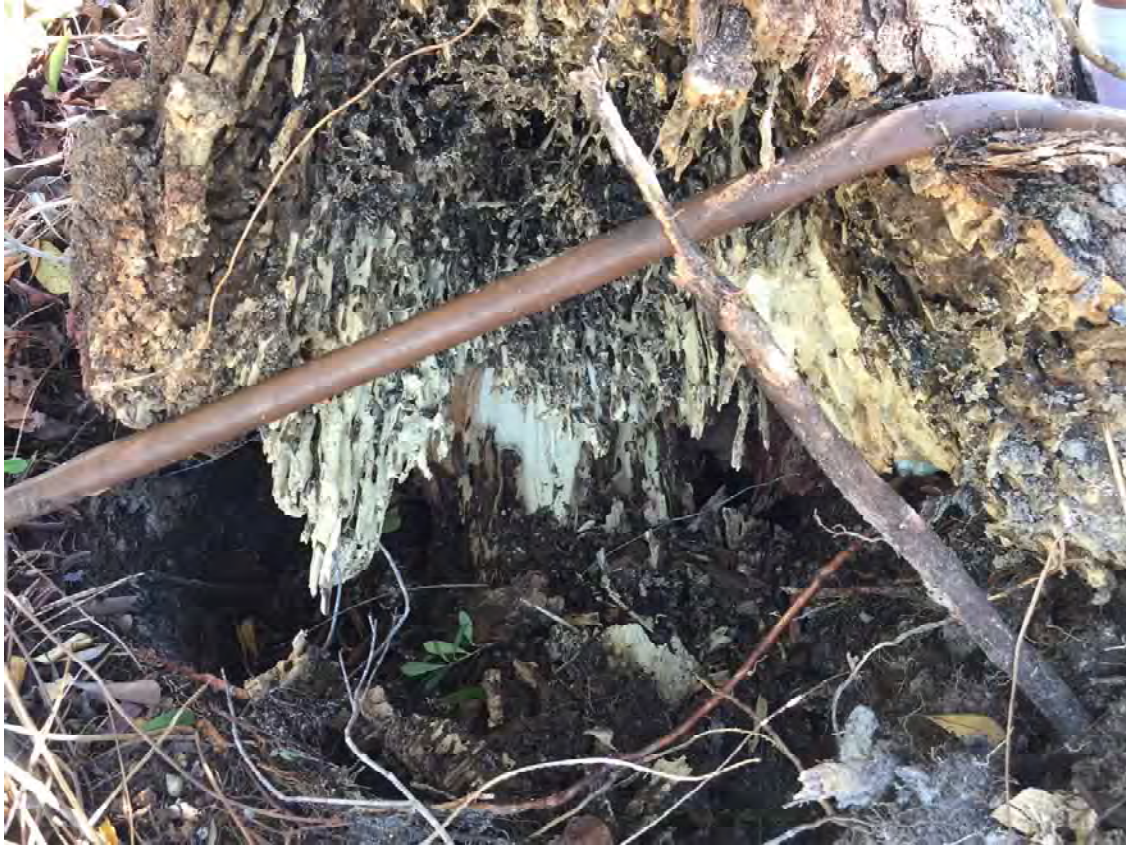
Photos 21 and 22 show examples of butt rot tree failure
