Re: Royal Poinciana Tree Evaluation

Property Location: 913 White Street, Key West, Florida 33040

ROYAL POINCIANA:

Recommendations as to Health, Structural Stability and Impact on Immediate Surroundings

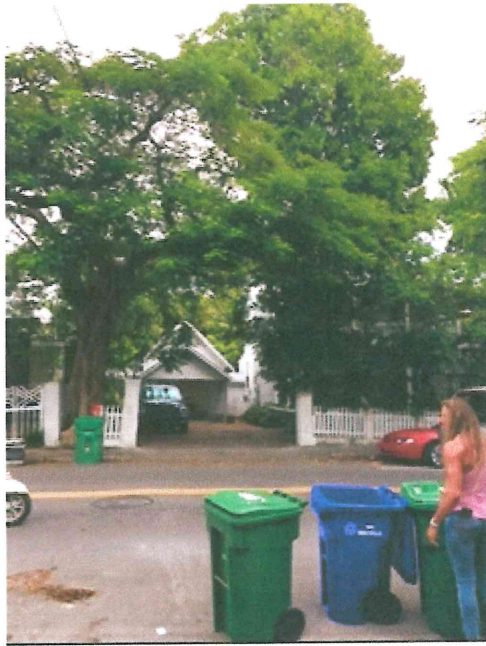
The Royal Poinciana tree (*Delonix regia*) is a mature tree in the subject area and contributes significantly to the street tree canopy. Its age is unknown. (See Photo #1).

Photo #1 - Canopy spread

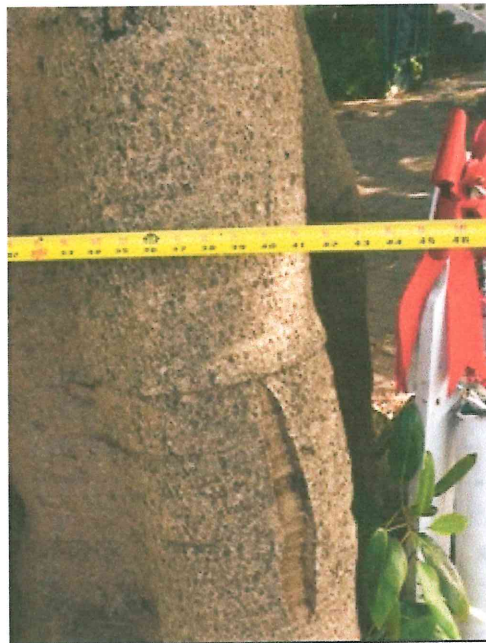
Additional information obtained using a standard measuring tape showed the approximate height of the tree to be 30' with a **crown radius** of 60'. The canopy is about 50% over the sidewalk and street, 25% over our client's home and 25% over the next door property who owns the tree. (See Site Sketch). The diameter or circumference of the trunk is 41'. (See Photo #2).

Photo #2 - Trunk diameter

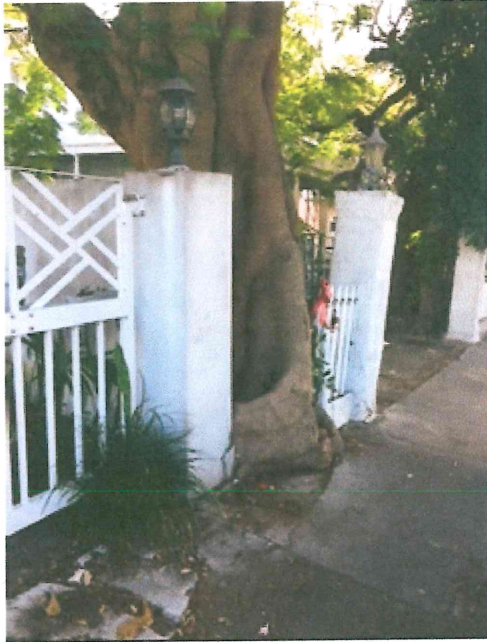
The subject tree is positioned in the front of the neighbor's property which is within city limits of a neighborhood of historic homes some of which have been renovated into small offices and businesses. The tree is actually squeezed between the driveway to the south and our client's wall to the north. (See Photo #3). It is 28" from the wall to the driveway. The wall itself is 8" thick and 5 ½' tall and is made of concrete. There are obvious cracks in the wall and some lifting of the driveway. (See Photo #4). The gated entrance has also been compromised and is inoperable due to the roots. The sidewalk and street area have been affected as well and are lifted and buckled.

Photo #3 – Tree squeezed between driveway and wall

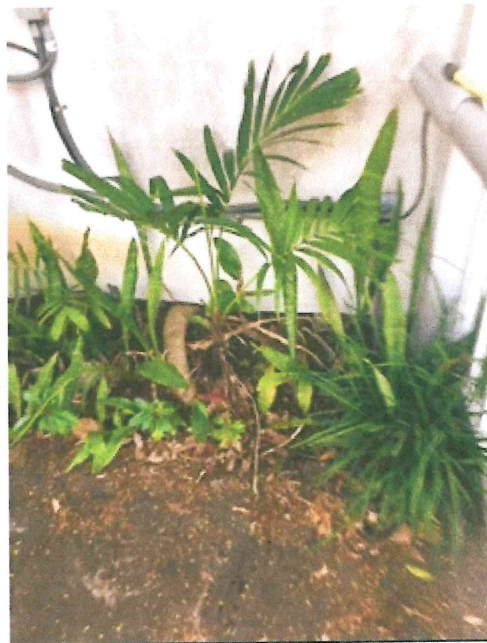
James LeGette of Lauderdale Tree Service, Inc., was contacted by Mark Grushiken, Esquire, in late December 2016. Mr. Grushikin's clients have a large Royal Poinciana tree located in the neighbor's yard in front of their residence. The concrete wall in between the properties has multiple cracks in it, the driveway has been damaged by the subject tree, and its roots have also impacted the sidewalk and roadway.

Photo #4 – Cracks in wall

Historically, the suggested resolution of the tree/wall conflict is to demolish the section of the wall that is being displaced by the tree and then use either pin or auger piles to create footer attachment points to float a beam over the affected root zone. The wall may then be recreated using the newly-formed floating footer. This is the least invasive option to preserve the tree's root system and integrity and is quite effective, has reasonable longevity and would be a cost effective solution.
