# Structural Condition Assessment Key West Diesel Plant Key West, Florida

AES Project No. 316-048  
August 3, 2016

Re: Structural Condition Assessment  
Key West Diesel Plant  
Key West, Florida

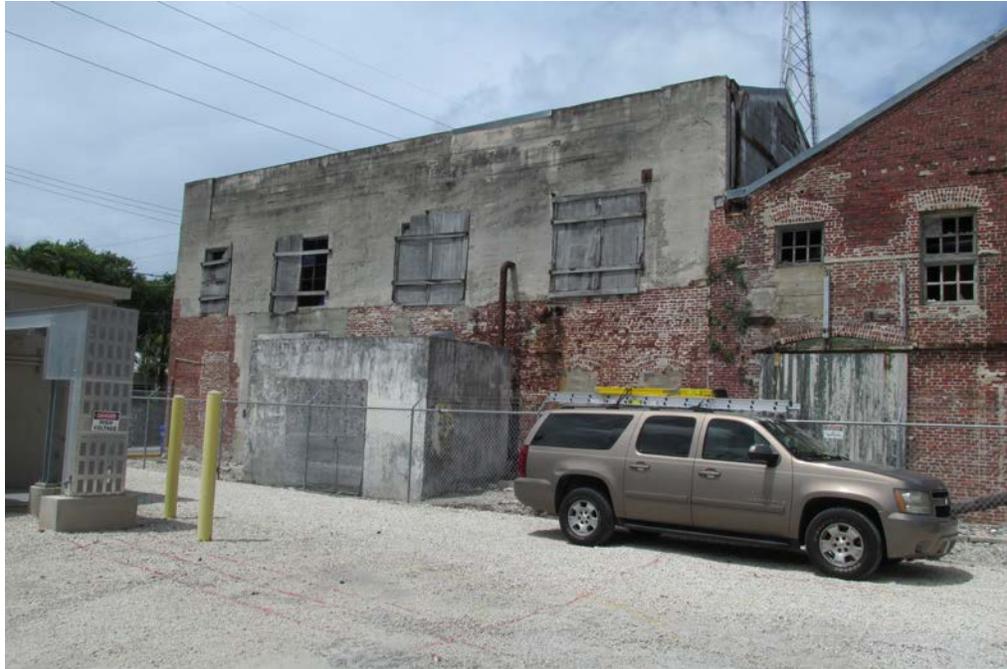
**PHOTOGRAPH 5 (BUILDING IV AND V)**

The abandoned Diesel Plant consists of four (4) connected one-story, buildings with the three (3) eastern buildings housing four (4) electric dynamos and the southwestern building having a lower roof that probably housed a shop and support spaces. The northernmost eastern building (Building I) houses one (1) dynamo and consists of a high new pre-engineered wood truss framed roof with plywood sheathing and metal roofing supported by perimeter multi-wythe brick walls and interior steel beams and columns (see Photographs 1 and 2). The easternmost center building (Building II) houses two (2) dynamos and consists of metal roofing on plywood sheathing, on wood joists and beams supported by heavy timber trusses and steel beams and columns that support crane beams (see Photographs 3 and 4). The heavy timber roof trusses are supported by perimeter multi-wythe brick walls. The southernmost eastern building (Building IV) houses one (1) dynamo and consists of metal roofing on wood sheathing on wood joists and beams supported by heavy timber trusses, and perimeter low multi-wythe brick walls and upper concrete walls (see Photographs 5 and 6).

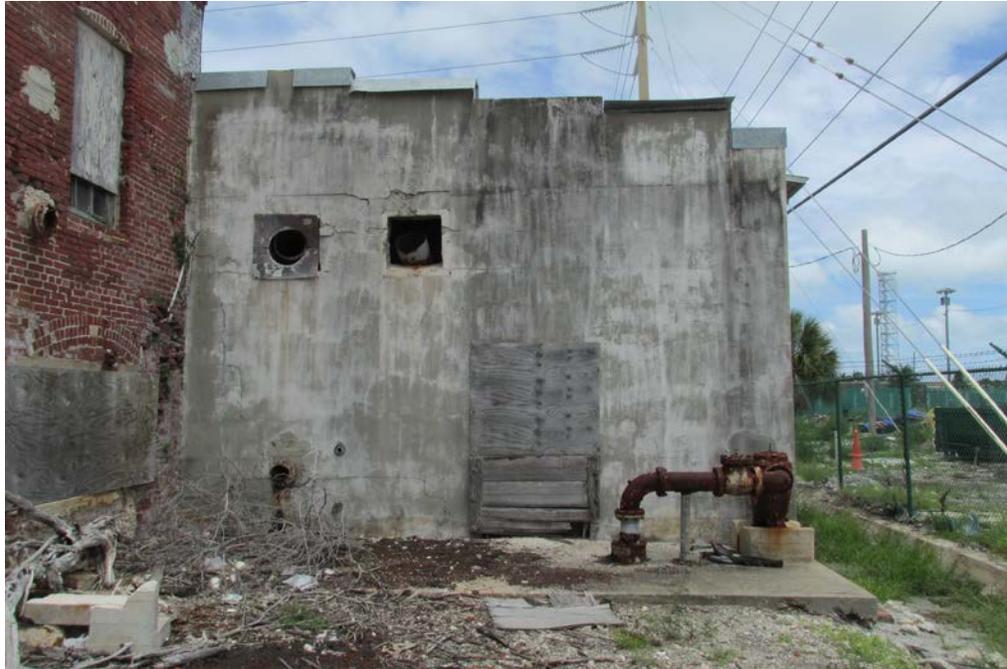
PHOTOGRAPH 9 (BUILDING III)

Below the roof structure is a gantry crane supported by a steel crane beam and steel columns independent of the perimeter brick walls. To the east of this building is an exterior concrete exhaust structure (Building V), which consists of a concrete roof slab with concrete parapets supported by concrete walls (see Photographs 7 and 8). The southwestern building (Building III) consists of metal roofing on wood sheathing on wood joists, and beams supported by interior steel beams and columns and perimeter multi-wythe brick walls, CMU walls and concrete walls (see Photographs 9 and 10).

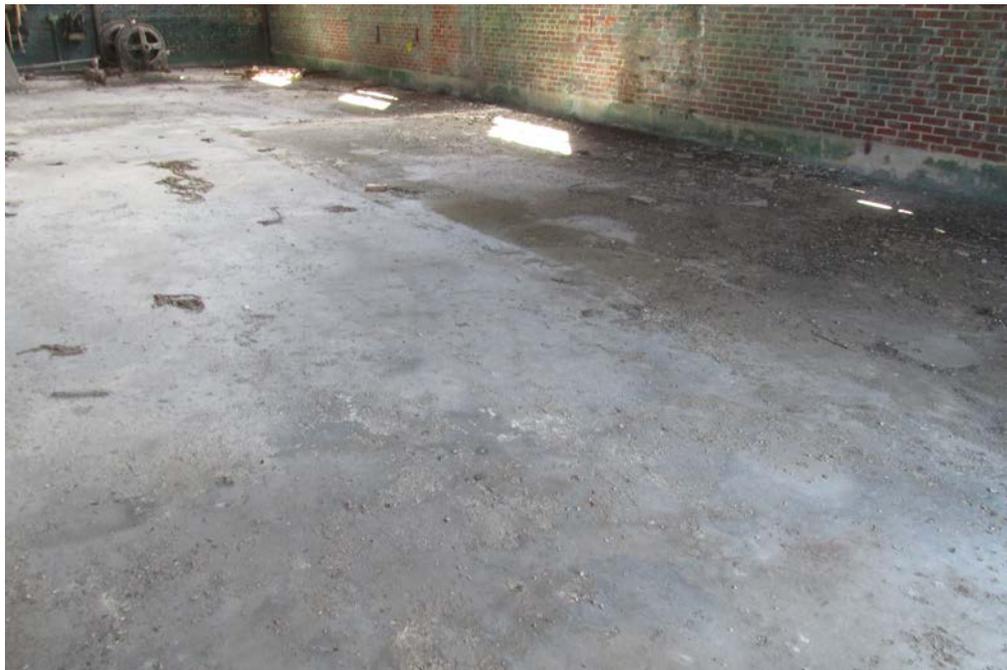
PHOTOGRAPH 14 (BUILDING I)

- I. The northernmost, eastern building (Building I) has been recently re-roofed and the original wood structure supported by the steel beams and trusses have been replaced with plywood sheathing and wood trusses. The new roofing and roof structure is in excellent condition except that the roofing screws are not stainless steel and are corroding (see Photograph 12). The original steel beams, trusses and columns are in good condition with surficial corrosion except for one (1) column, which has a badly corroded base with more than 20% material loss (see Photograph 13). The slab on grade is cracked and uneven and there is a large crack at the interior door to the adjacent building, and several of the western window sills are spalled with corroded reinforcing and the remainder are cracked (see Photographs 14, 15 and 16).

Building I is in good condition with the exterior masonry requiring repair and several window lintels requiring replacement. The steel structure is in good condition with surficial corrosion except for one (1) column that needs reinforcement due to excessive corrosion at its base. All of the steel needs to be cleaned of corrosion and coated with a corrosion inhibiting coating. The slab on grade is cracked and uneven and is due for replacement. The exterior masonry requires repointing and all of the corroded embedments and steel lintels need to be cleaned of corrosion and coated with a corrosion inhibiting coating. The deteriorated face brick needs to be removed and replaced and the vegetation in the wall cracks needs to be removed and the cracks repointed. At the western return metal panel wall, the badly corroded angle purlin needs replacement as well as the wall metal panels. The concrete spall in this wall also requires repair.

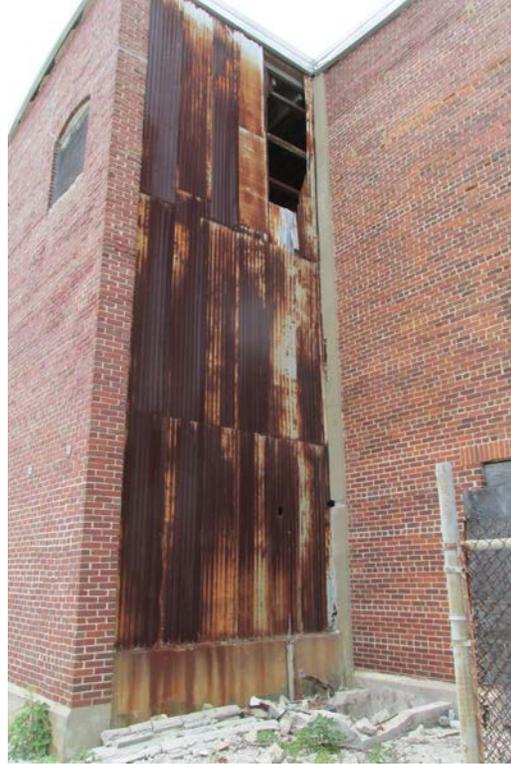
PHOTOGRAPH 27 (BUILDING I)

The exterior masonry walls are in good condition but there are numerous cracks, corroded embedments, deteriorated mortar, corroded lintels, deteriorated face brick, brick cracks with vegetation and random cracks in the concrete water table (see Photographs 17, 18, 19, 20, 21, 22 and 23). At the western return metal panel wall, there is a badly corroded angle purlin and a large column spall with corroded reinforcing and an area of missing metal wall panel (see Photographs 24, 25 and 26). The remaining metal panels are corroded and in poor condition (see Photograph 27).

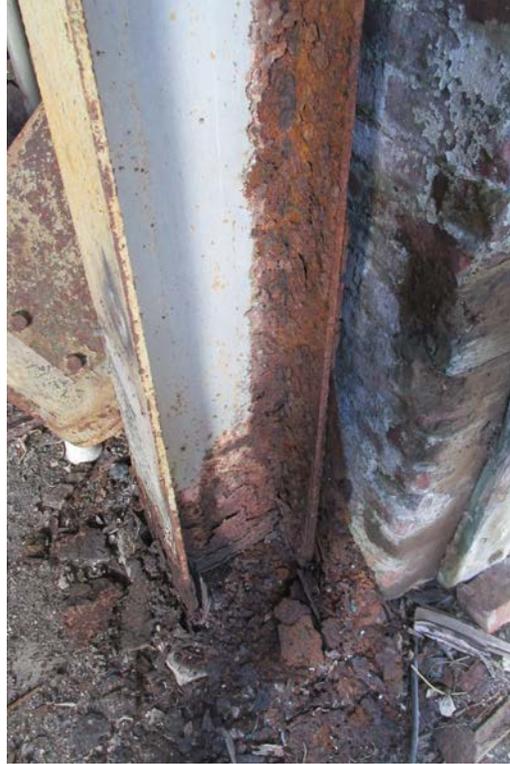
PHOTOGRAPH 29 (BUILDING II)

- II. The eastern center building (Building II) is in much worse condition than the Building I with metal roofing in extremely poor condition with large areas of missing metal roofing and large areas of deteriorated roof decking (see Photograph 28). The roof wood structure is in good condition as well as the steel structure with surficial corrosion except for several badly corroded columns and post bases with more than 20% material loss (see Photographs 29 and 30).

The remainder of the buildings are in worse condition than Building I with Building IV being in the worst condition with a portion of missing roof. These buildings are stable but require new roofs with extensive roof sheathing replacement and some wood structure reinforcement and replacement. At the areas of missing and badly deteriorated roofing, these roofs could sustain significant damage in a severe wind event losing the remainder of their roofing and sheathing. In general, the steel structure is in good condition with surficial corrosion but several columns will need reinforcement due to excessive corrosion at their bases. All of the steel needs to be cleaned of corrosion and coated with a corrosion inhibiting coating. At Building IV, the wall opening with numerous loose and missing bricks and falling bricks needs to be shored or repaired immediately to prevent further deterioration of the wall. The exterior masonry walls are in good condition except for the northwest corner of Building II where there is a large area of missing brick that needs to be rebuilt. The remaining walls need to be repointed, deteriorated face brick removed and replaced and the vegetation in the wall cracks removed and the cracks repointed. Like Building I, all of the corroded embedments and steel lintels need to be cleaned of corrosion and coated with a corrosion inhibiting coating. In many of the arched brick openings, brick has been infilled with no lintel installed. This infill brick is being held in place by the mortar alone and in areas is cracking. This infill brick needs to be removed or steel lintels installed to support it. At Building II, the concrete platform is in poor condition with large spalls and the concrete carbonated to the reinforcing with the concrete containing high levels of chlorides. If it is the owner's desire to rehabilitate this platform when the concrete is repaired, it should be treated with a penetrating corrosion inhibitor or an active cathodic protection system installed. Due to the thickness of the platform walls, both will be expensive, therefore strong consideration should be taken for demolishing this platform. The exterior concrete walls and pits, except for Building V, are in poor condition requiring extensive repair. Like the Building II concrete platform, the concrete contains high levels of chlorides and once repaired, the walls should be treated with a penetrating corrosion inhibitor or an active cathodic protection system installed, and the exterior concrete coated with a penetrating sealer. The exterior pits and chutes are abandoned and should be cleaned of debris, the top of the deteriorated walls demolished to 8" below grade and filled with clean fill or stone. All of the interior trench and pit edge angles are in poor condition and badly corroded. All of the dynamo pits are full of water and breeding mosquitos. When the deteriorated dynamos are removed, the pits need to be pumped empty of water. The pits and trenches need to be dewatered, cleared of debris with the edge angles removed, and the pits and trenches filled with clean fill or stone with a concrete slab on grade placed, drilled and adhesived into the pit and trench walls level with the surrounding concrete slabs on grade. If any of the dynamos are kept for display, their pits should be pumped empty of water and filled and capped as described above.

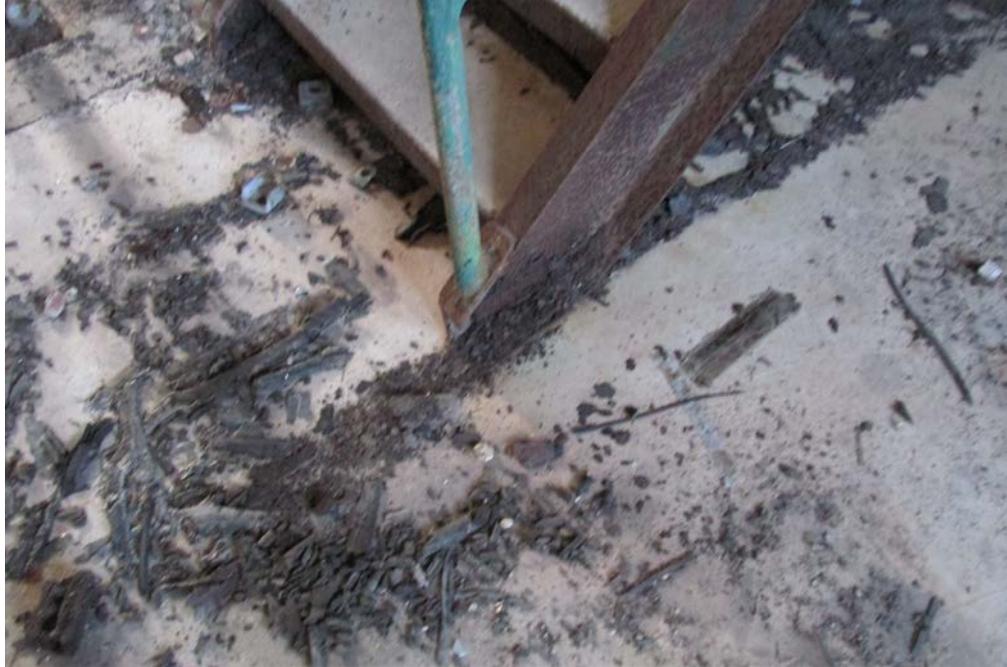
PHOTOGRAPH 31 (BUILDING II)

The stair to the concrete platform has badly corroded stair stringer bases with more than 20% material loss and the concrete platform has extensive large concrete spalls with exposed corroding reinforcing (see Photographs 31, 32 and 33). The exterior masonry walls are in good condition, but there are numerous cracks, corroded embedments, deteriorated mortar, deteriorated face brick, infilled arch brick with no lintel, large areas of missing brick, corroding lintels and brick cracks with vegetation (see Photographs 34, 35, 36, 37, 38 and 39).

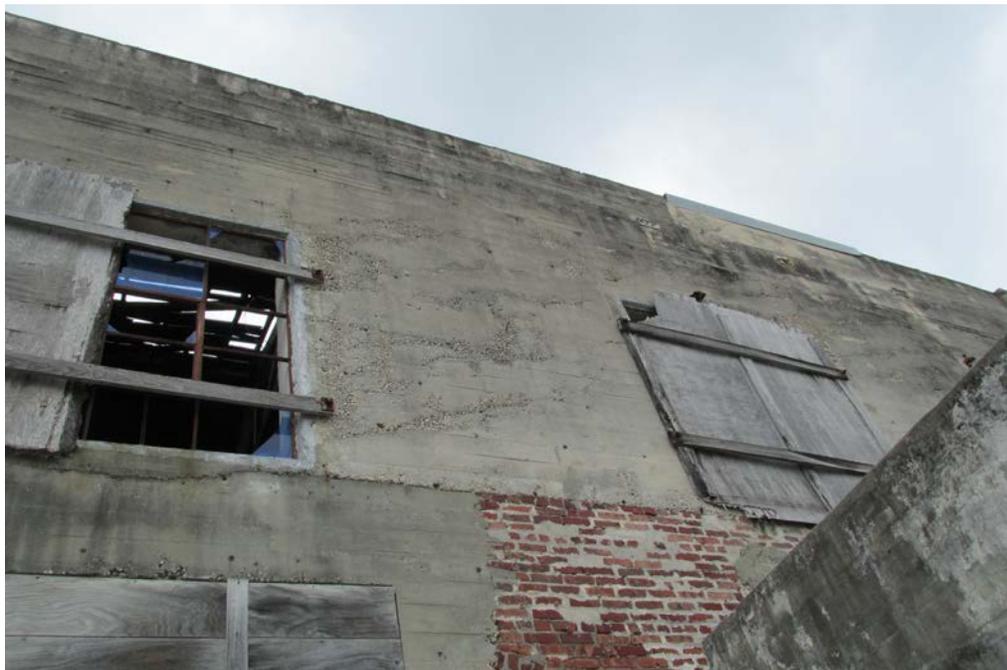
**PHOTOGRAPH 44 (BUILDING IV)**

- IV. The southernmost eastern building (Building IV) is in worse condition than Building II with a large area of missing metal roofing and wood sheathing, a deteriorated bottom roof truss chord and a wall opening with numerous loose and missing bricks with bricks falling (see Photographs 40, 41 and 42). The wood roof joists are in poor condition but the wood trusses appear in good condition. The steel structure is in good condition with surficial corrosion but many of the steel column bases are severely corroded with more than 20% material loss (see Photograph 43). The exterior masonry walls are in good condition but there are numerous cracks, corroded embedments, deteriorated mortar and loose and missing face brick. The upper concrete walls have large areas of honey combed concrete and an area of spalled concrete with corroded reinforcing (see Photographs 44 and 45).

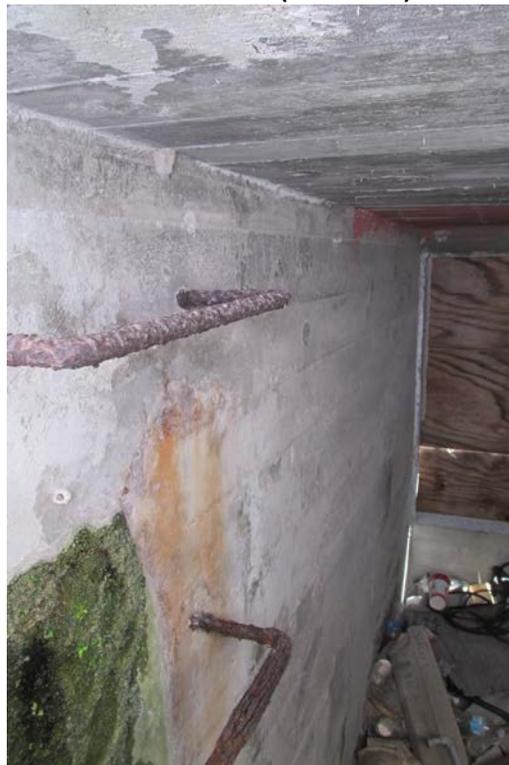
**PHOTOGRAPH 50 (BUILDING V)**

- V. The concrete exhaust building (Building V) is in good condition with corroded steel ladders; a badly corroded pipe support, a cracked housekeeping pad and a hairline crack in the roof parapet (see Photographs 50, 51, 52 and 53). The exterior pit and chute walls are in poor condition with cracked and spalling concrete with corroding reinforcing (see Photograph 54). All of the interior pits are full of water and breeding mosquitos. The interior trench and pit edge angles are in poor condition and badly corroded (see Photograph 55). All of the dynamos are in poor condition and badly corroded (see Photograph 56).

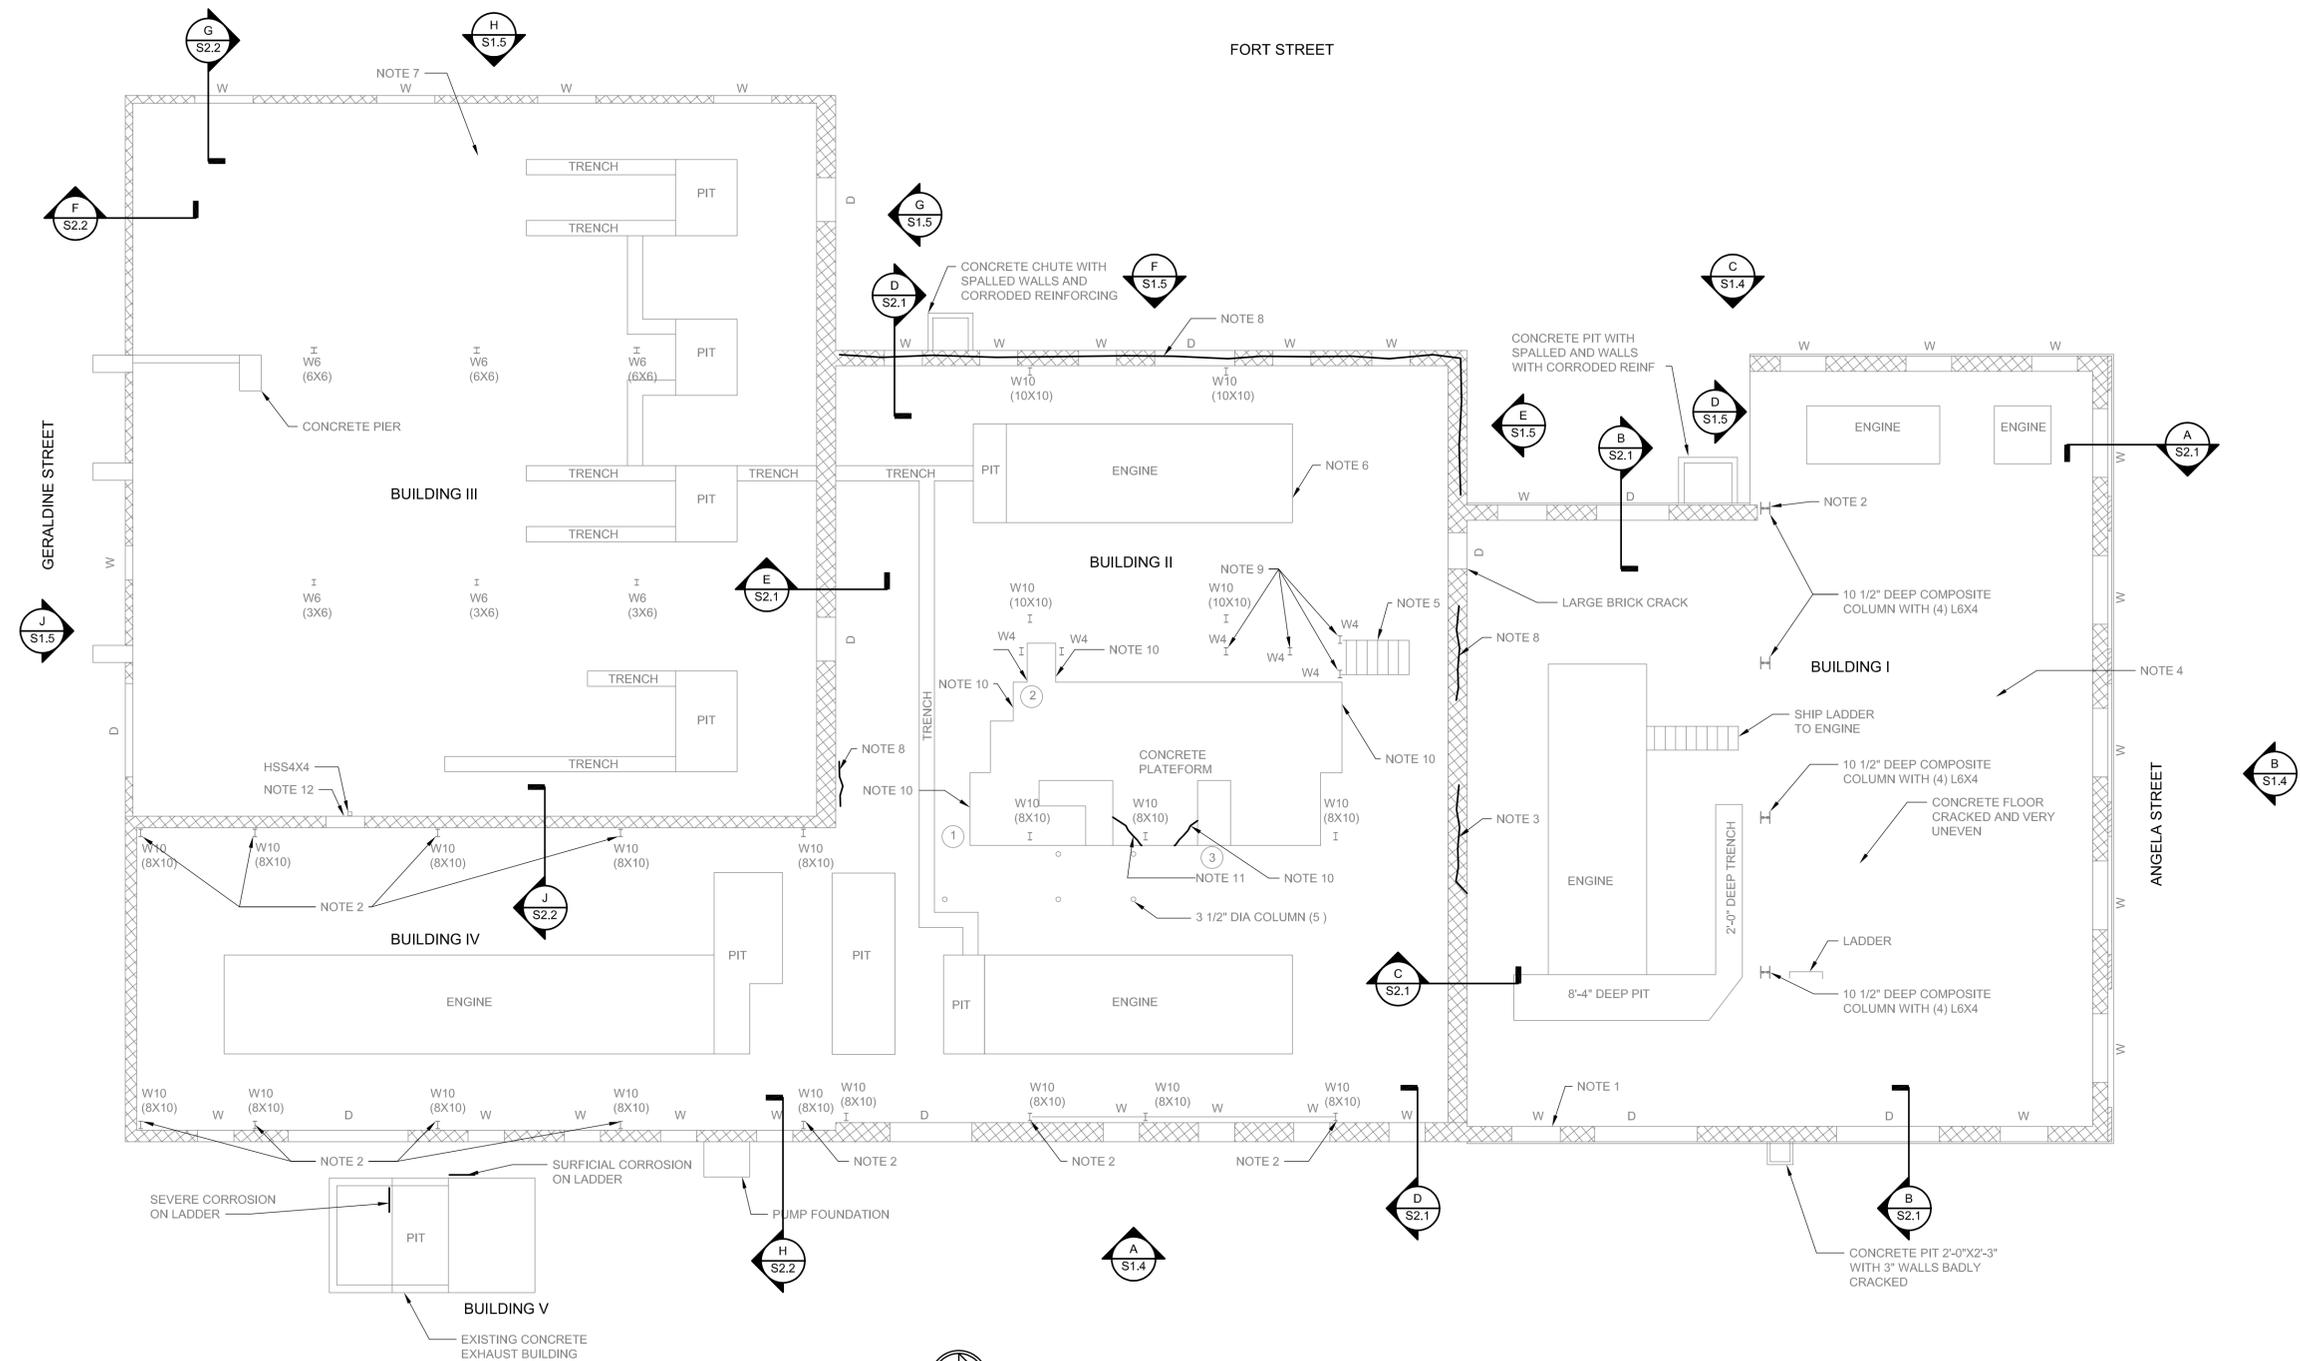
**EXISTING FLOOR PLAN**  
SCALE: 1/8"=1'-0"

- SURVEY NOTES:**
1. DETERIORATED FACE OF BRICK
  2. BADLY CORRODED COLUMN BASE AND OR COLUMN
  3. CRACKS IN BRICK AT WALL PENETRATIONS AND ELEVATED OPENINGS
  4. CONCRETE FLOOR CRACKED AND UNEVEN
  5. BADLY CORRODED STAIR STRINGERS AT BASE OF STAIR
  6. TRENCH AND PIT EDGE ANGLE BADLY CORRODED
  7. CONCRETE FLOOR CRACKED AND UNEVEN - TRENCH AND PIT EDGE ANGLES ARE BADLY CORRODED
  8. DETERIORATED MORTAR JOINTS
  9. BADLY CORRODED POST BASE
  10. LARGE SPALL WITH EXPOSED CORRODING REINFORCING
  11. SEVERE CRACK AT CONCRETE BASE
  12. BADLY DETERIORATED BRICK AT WALL OPENING
  13. SURFICIAL CORROSION ON ALL STRUCTURAL STEEL.
- # CARBONATION AND CHLORIDE TEST

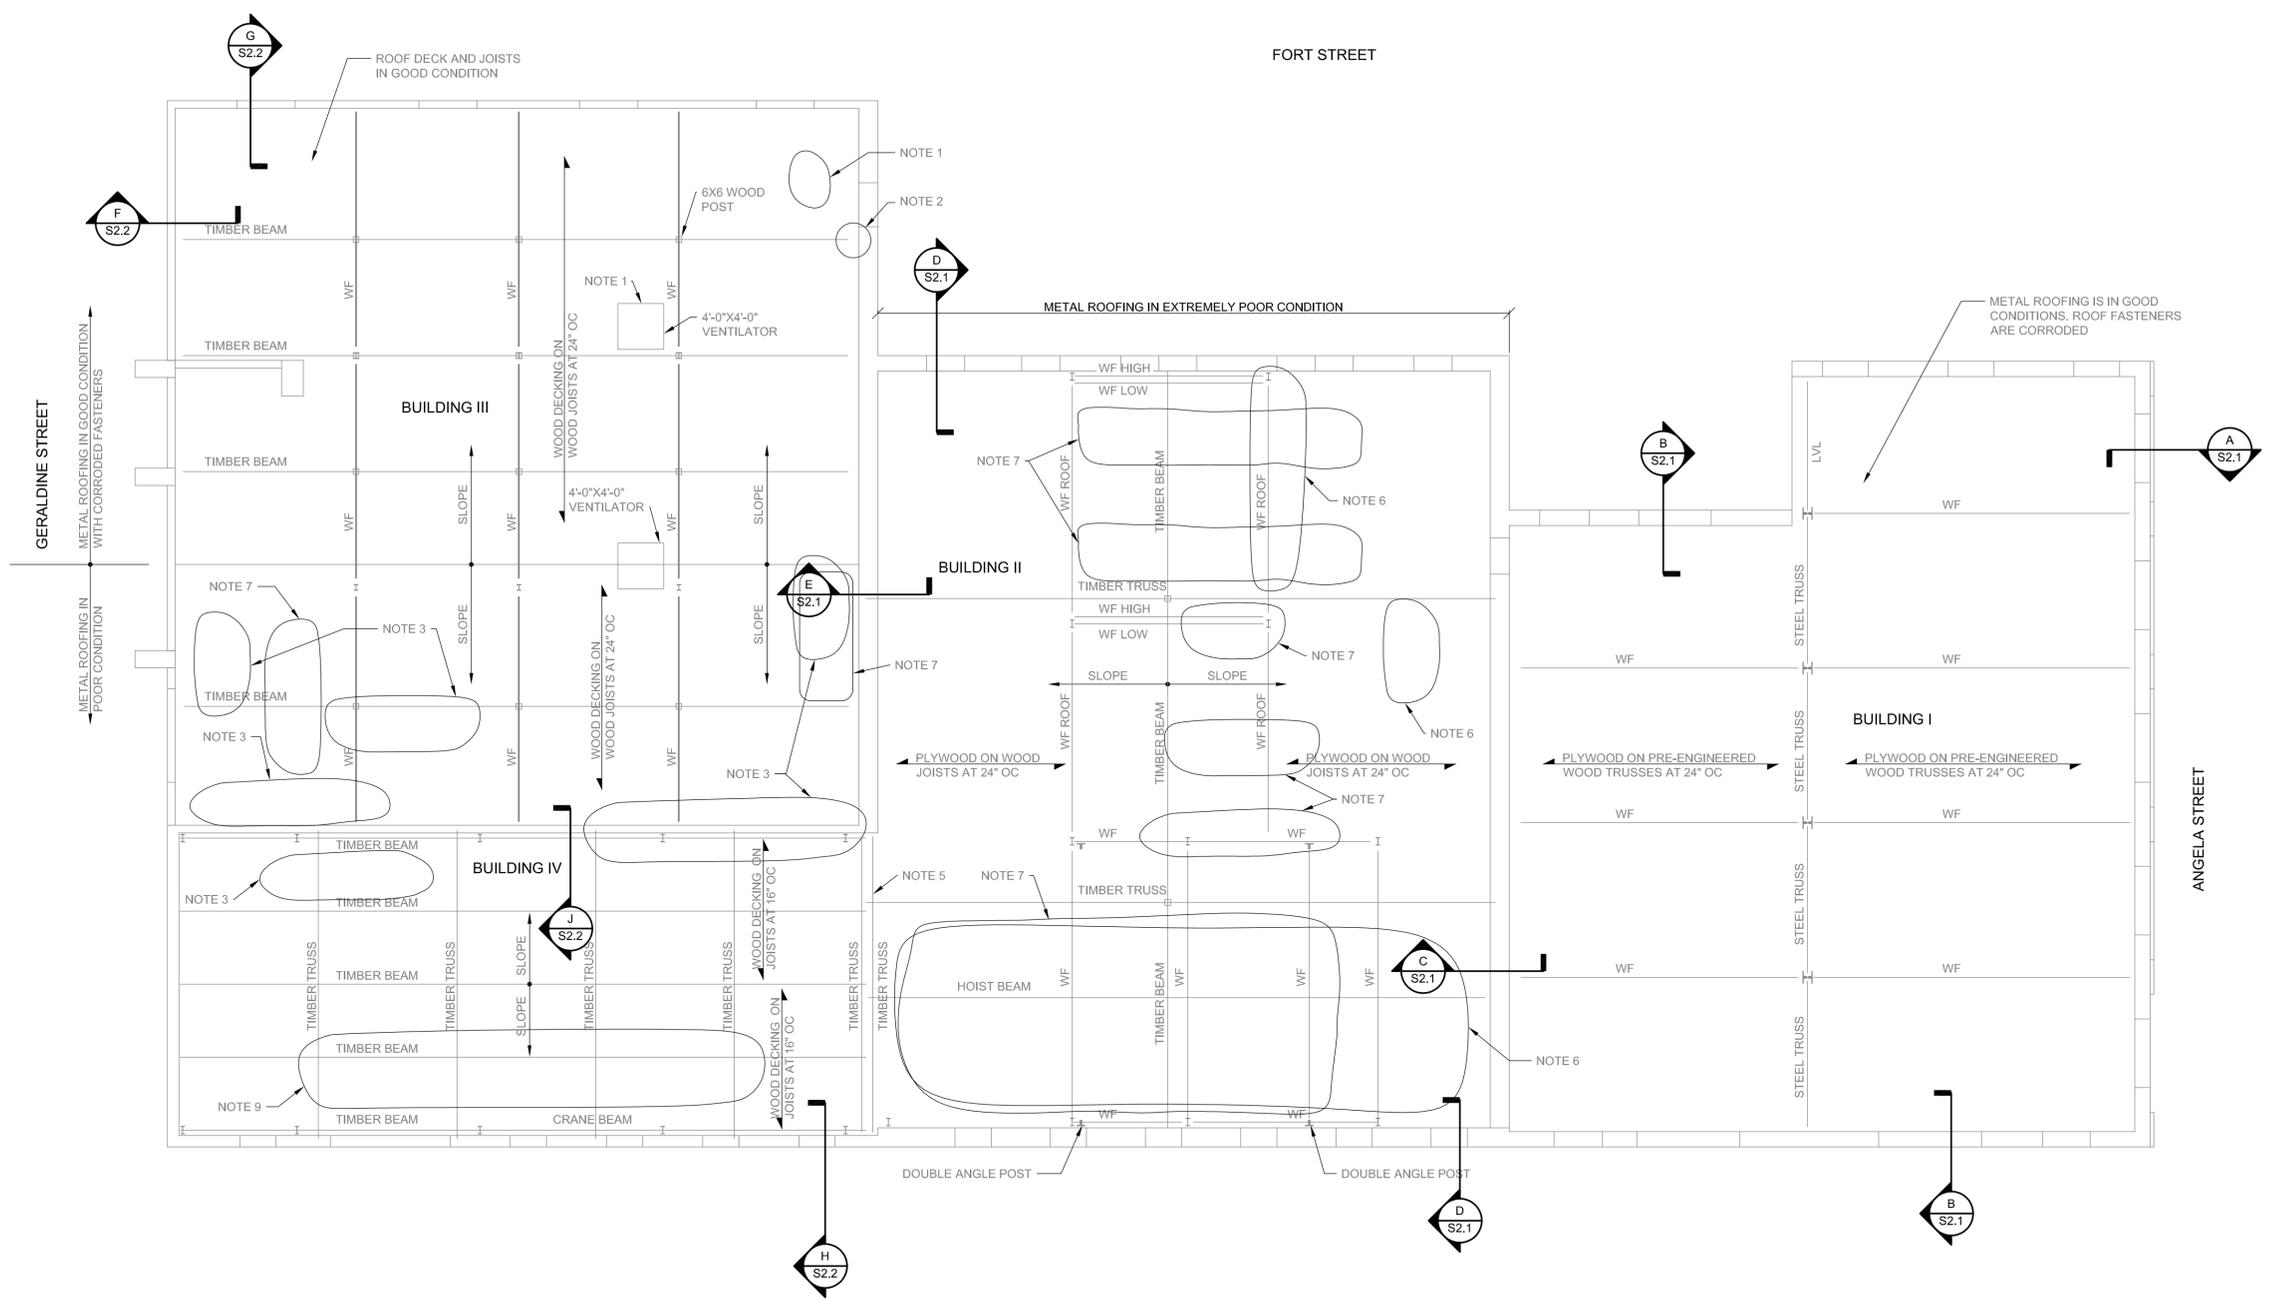
**EXISTING ROOF FRAMING PLAN**

1. CORRODED AREA ON METAL ROOFING
2. DETERIORATED BEAM KICKER
3. BADLY DETERIORATED OR MISSING ROOF DECK
4. DETERIORATED ROOF SHEATHING
5. BADLY DETERIORATED BOTTOM TRUSS CHORD
6. DETERIORATED ROOF SHEATHING
7. AREA OF MISSING METAL ROOFING
8. SURFICIAL CORROSION ON ALL STRUCTURAL STEEL
9. BADLY DETERIORATED AND MISSING ROOF DECK, JOINTS AND METAL DECK
