Structural Condition Assessment Truman Water Front Park, Building 103 Key West, Florida

AES Project No. 314-192
December 4, 2014

Re: Structural Condition Assessment
Truman Water Front Park, Building 103
Key West, Florida

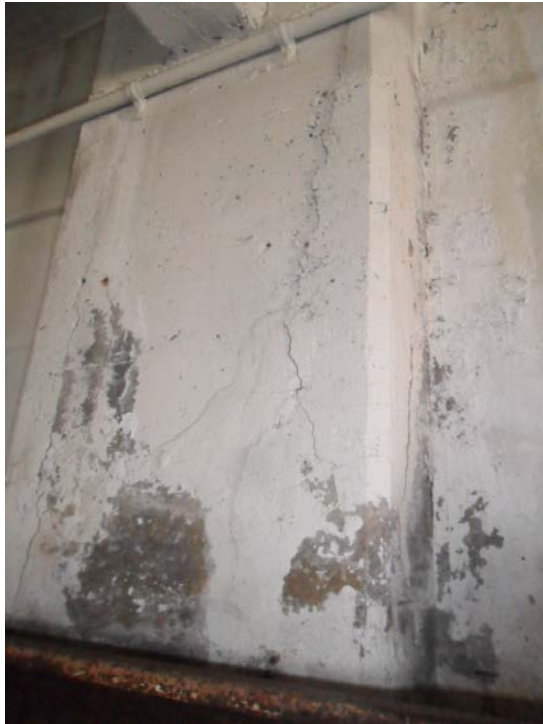
PHOTOGRAPH 1

Approximately half of the columns from the low roof to the high roof are cracked and spalling with corroding reinforcing (see Photograph 1). Approximately half of the lower columns are cracked and spalling with corroding reinforcing (see Photographs 2 and 3). Of these lower columns, the majority are on the north side and several are spalled full height (see Photograph 2). Almost all of the concrete beams above the roof are cracked and spalling and several are severely spalled and deteriorated (see Photograph 4). At the high gable concrete beams, there are isolated areas of cracked and spalling concrete with corroding reinforcing (see Photograph 5). These areas are concentrated on the east and west ends of the building. The crane beam has extensive areas of cracked and spalling concrete with corroding reinforcing (see Photographs 6 and 7). Several of the areas are extensive. At the roof slabs, there are isolated areas of cracked and spalling concrete with corroding reinforcing (see Photographs 8 and 9). These areas are concentrated on the east and west ends of the building. The ribbed low roof slab at the northwest corner of the building has an old roof opening that was cut through two roof joists and was not properly framed (see Photograph 10). This condition will need to be properly framed. There is extensive cracked and spalling concrete with corroding reinforcing at the western high concrete walls (see Photograph 11). The exterior stucco is in poor condition with numerous cracks and areas of delamination (see Photograph 12). Many of these cracks are cracks in the CMU telegraphing through the stucco (see Photograph 13). The majority of the window sills have cracked grout and are in poor condition (see Photograph 14). The roof of the small, lower roof addition is in poor condition with a noticeable hole in it and the CMU walls are noticeably cracked with stair stepped, cracking (see Photographs 15 and 16). The ground floor has numerous pits, trenches, equipment pads and tunnels (see Photograph 17). Some of these may lead to the seawall. In general, the concrete slab on grade, ground floor and tunnel slabs are in good condition with no signs of distress.

In general the structure is in fair condition with areas that are in poor condition. There is a great deal of concrete repair required for the columns and beams, and isolated areas of repair for the concrete slabs. The cut roof joists at the ribbed low roof slab, at the northwest corner of the building will require restructuring. The badly deteriorated concrete beams above the low roof should be removed since they are not needed to support rooftop equipment anymore.

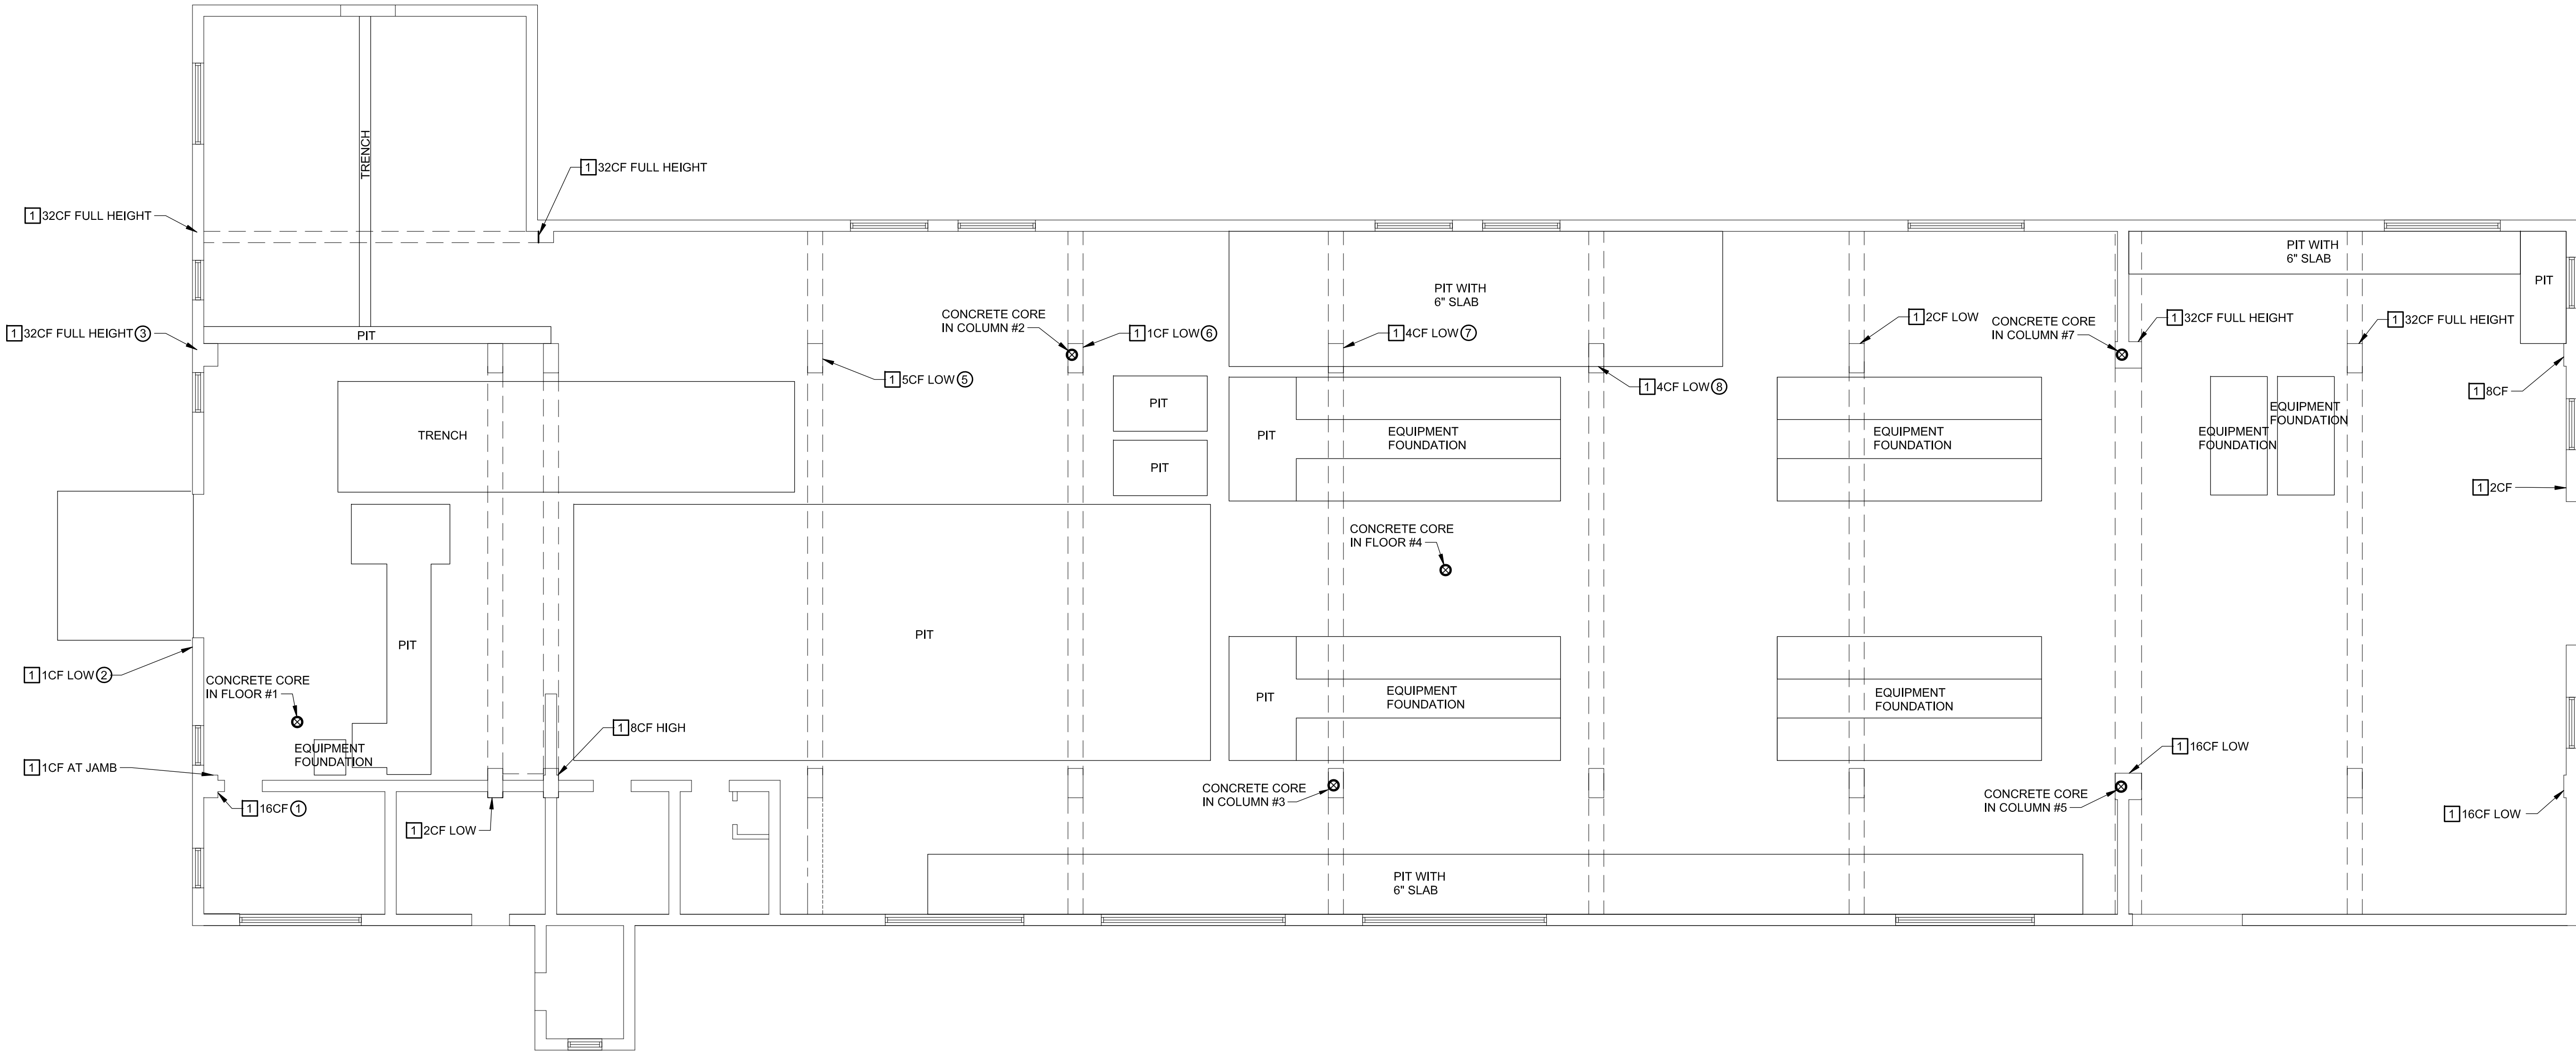
FOUNDATION AND FLOOR PLAN
SCALE: 1/8" = 1'-0"

- 1 SPALLED COLUMN WITH EXPOSED CORRODING REINFORCING.
- 2 SPALLED BEAM WITH EXPOSED CORRODING REINFORCING.
- 3 SPALLED SLAB WITH EXPOSED CORRODING REINFORCING.
- 4 WALL SPALL WITH EXPOSED CORRODING REINFORCING.
- 5 CARBONATION TEST LOCATION.

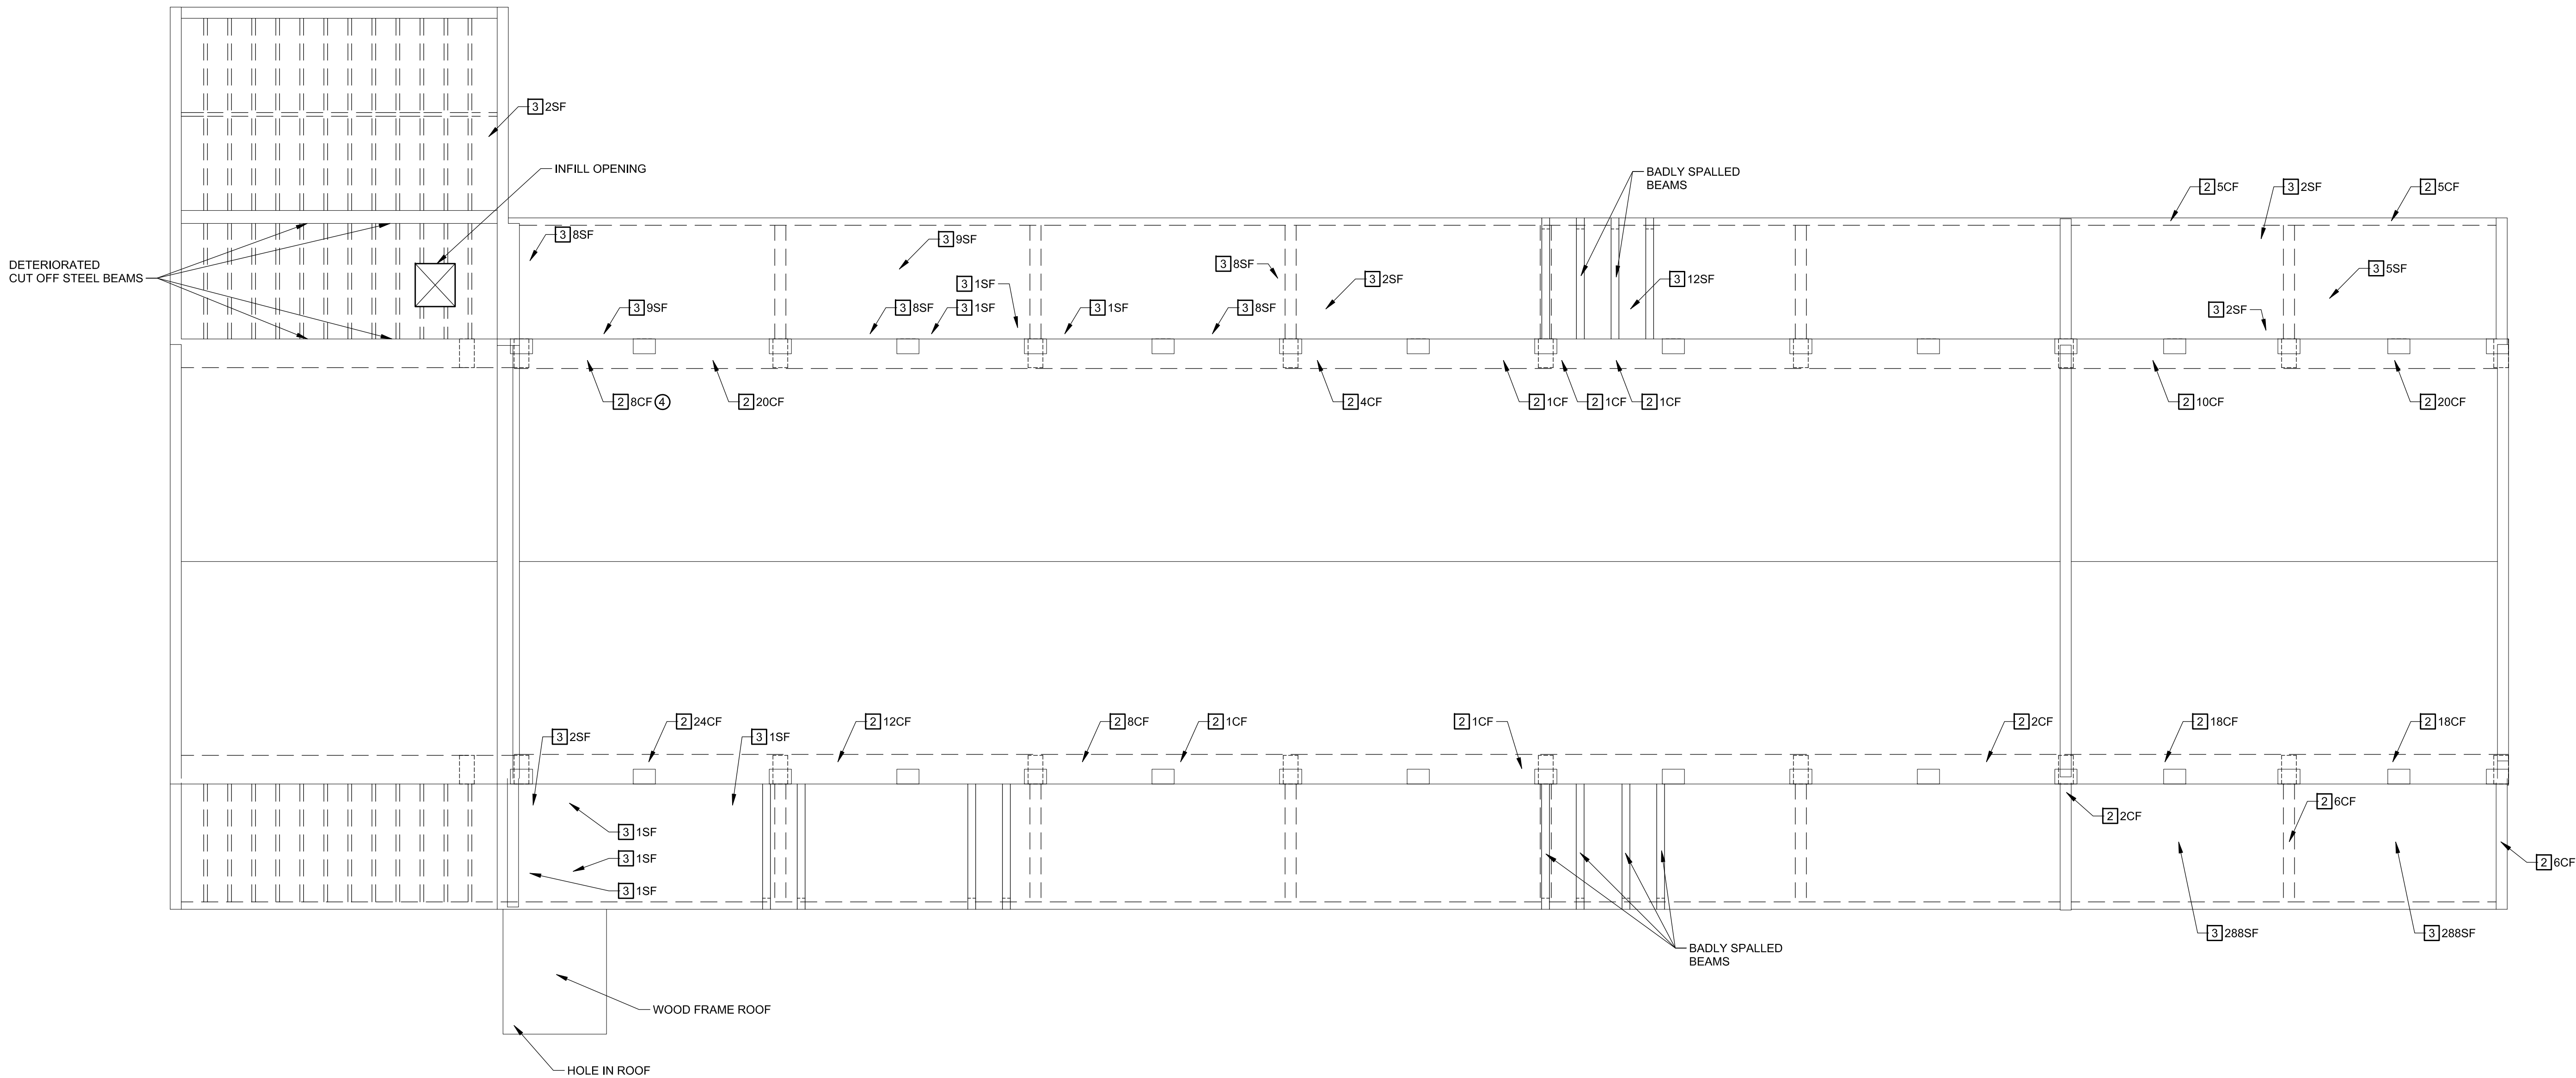
**LOW ROOF PLAN**
SCALE: 1/8" = 1'-0"

- 1 SPALLED COLUMN WITH EXPOSED CORRODING REINFORCING.
- 2 SPALLED BEAM WITH EXPOSED CORRODING REINFORCING.
- 3 SPALLED SLAB WITH EXPOSED CORRODING REINFORCING.
- 4 WALL SPALL WITH EXPOSED CORRODING REINFORCING.
- C CARBONATION TEST LOCATION.

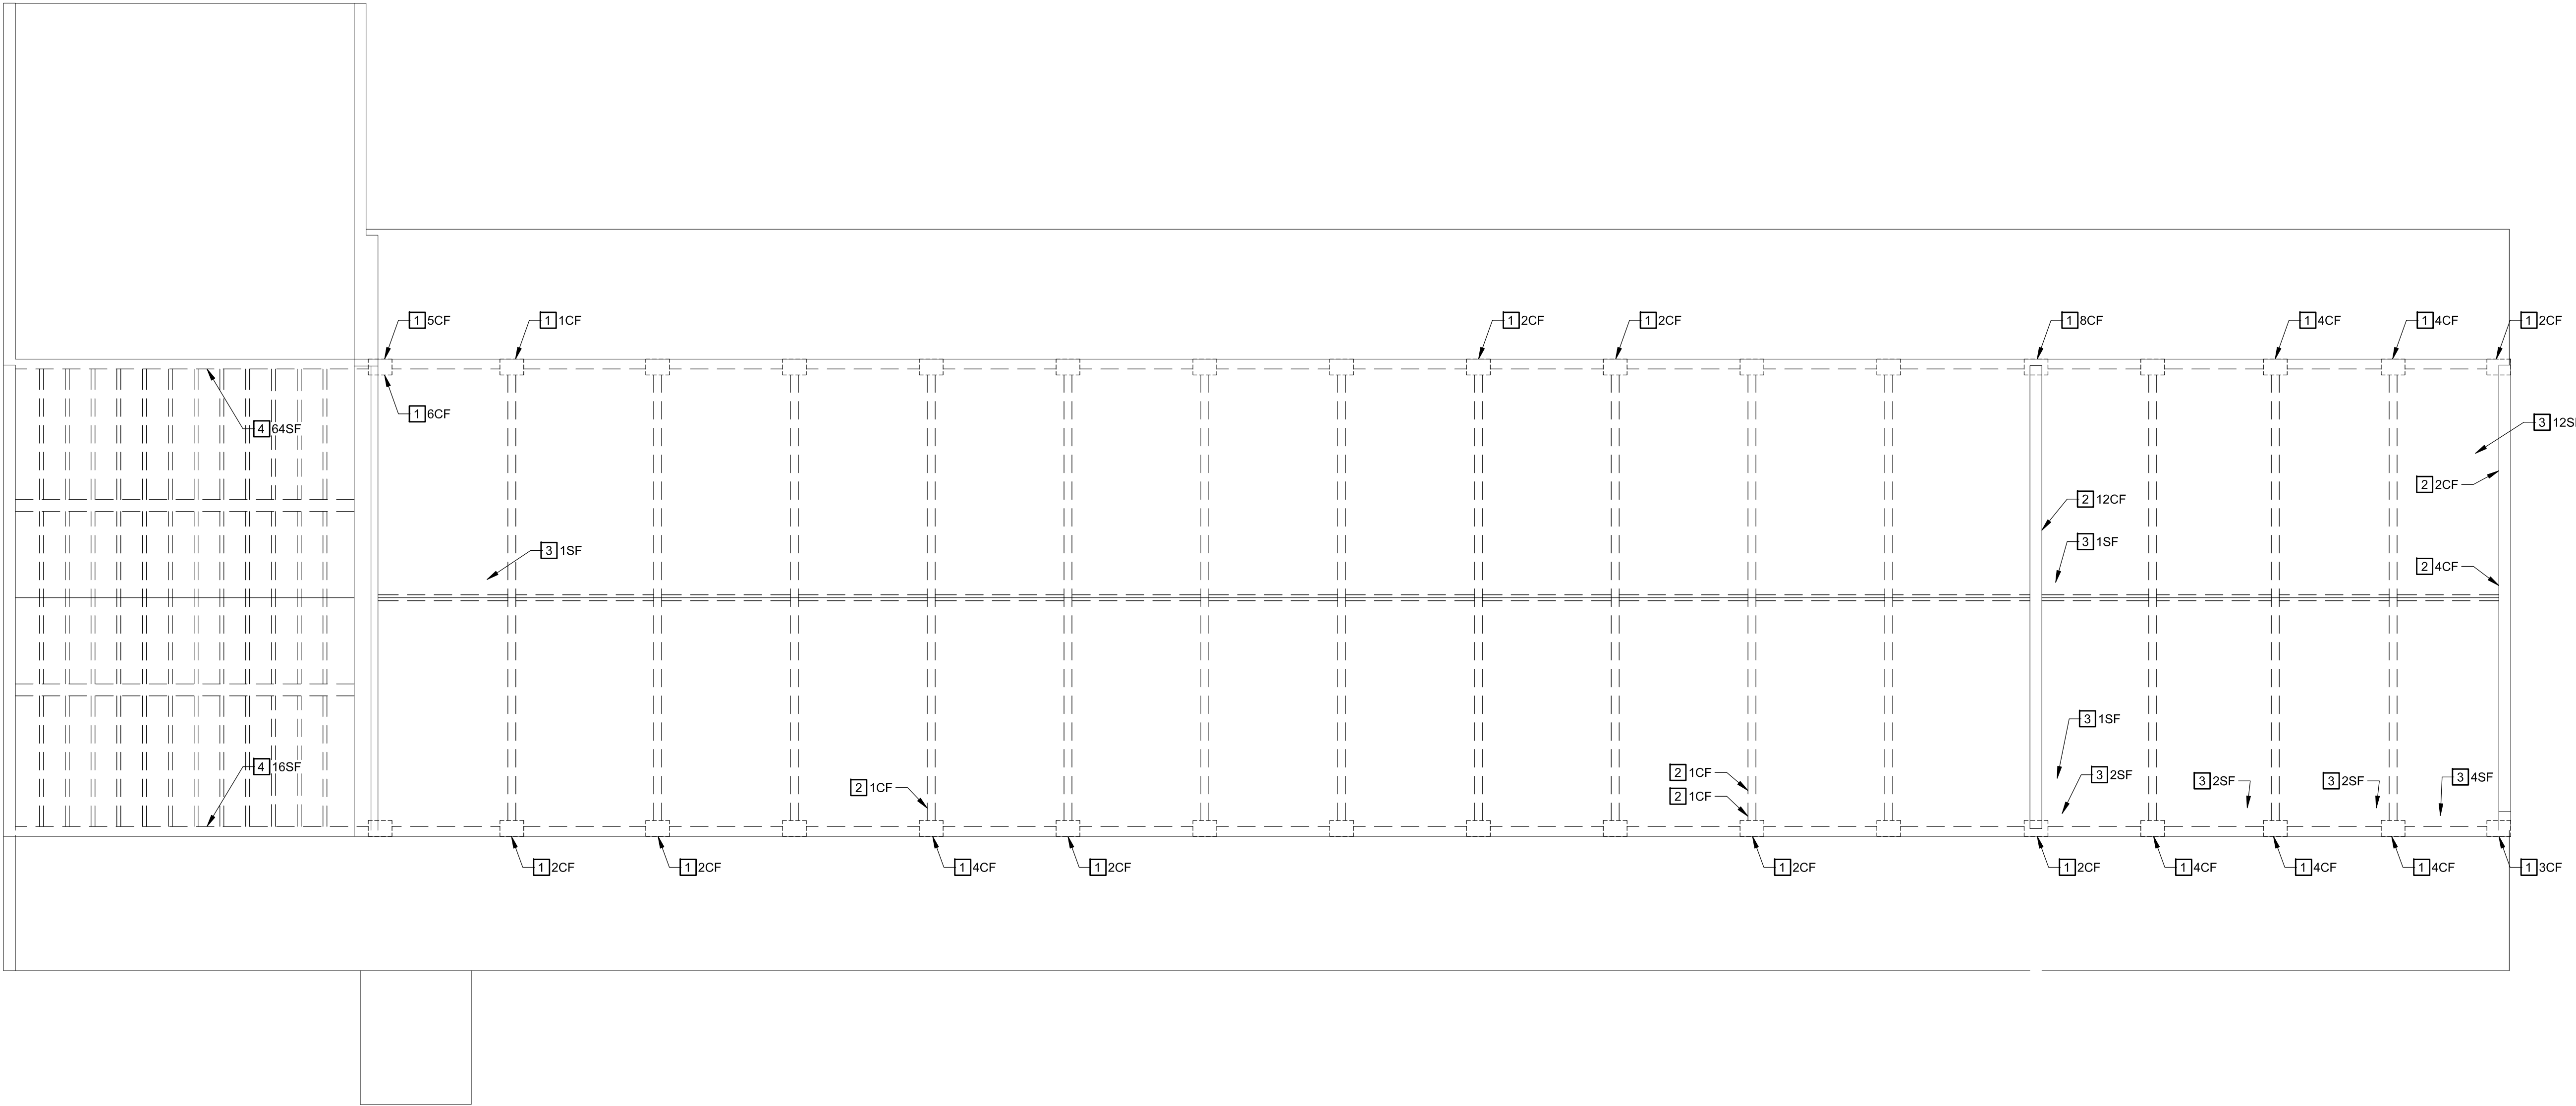
**HIGH ROOF PLAN**
SCALE: 1/8" = 1'-0"

- 1] SPALLED COLUMN WITH EXPOSED CORRODING REINFORCING.
- 2] SPALLED BEAM WITH EXPOSED CORRODING REINFORCING.
- 3] SPALLED SLAB WITH EXPOSED CORRODING REINFORCING.
- 4] WALL SPALL WITH EXPOSED CORRODING REINFORCING.
- Ⓢ CARBONATION TEST LOCATION.

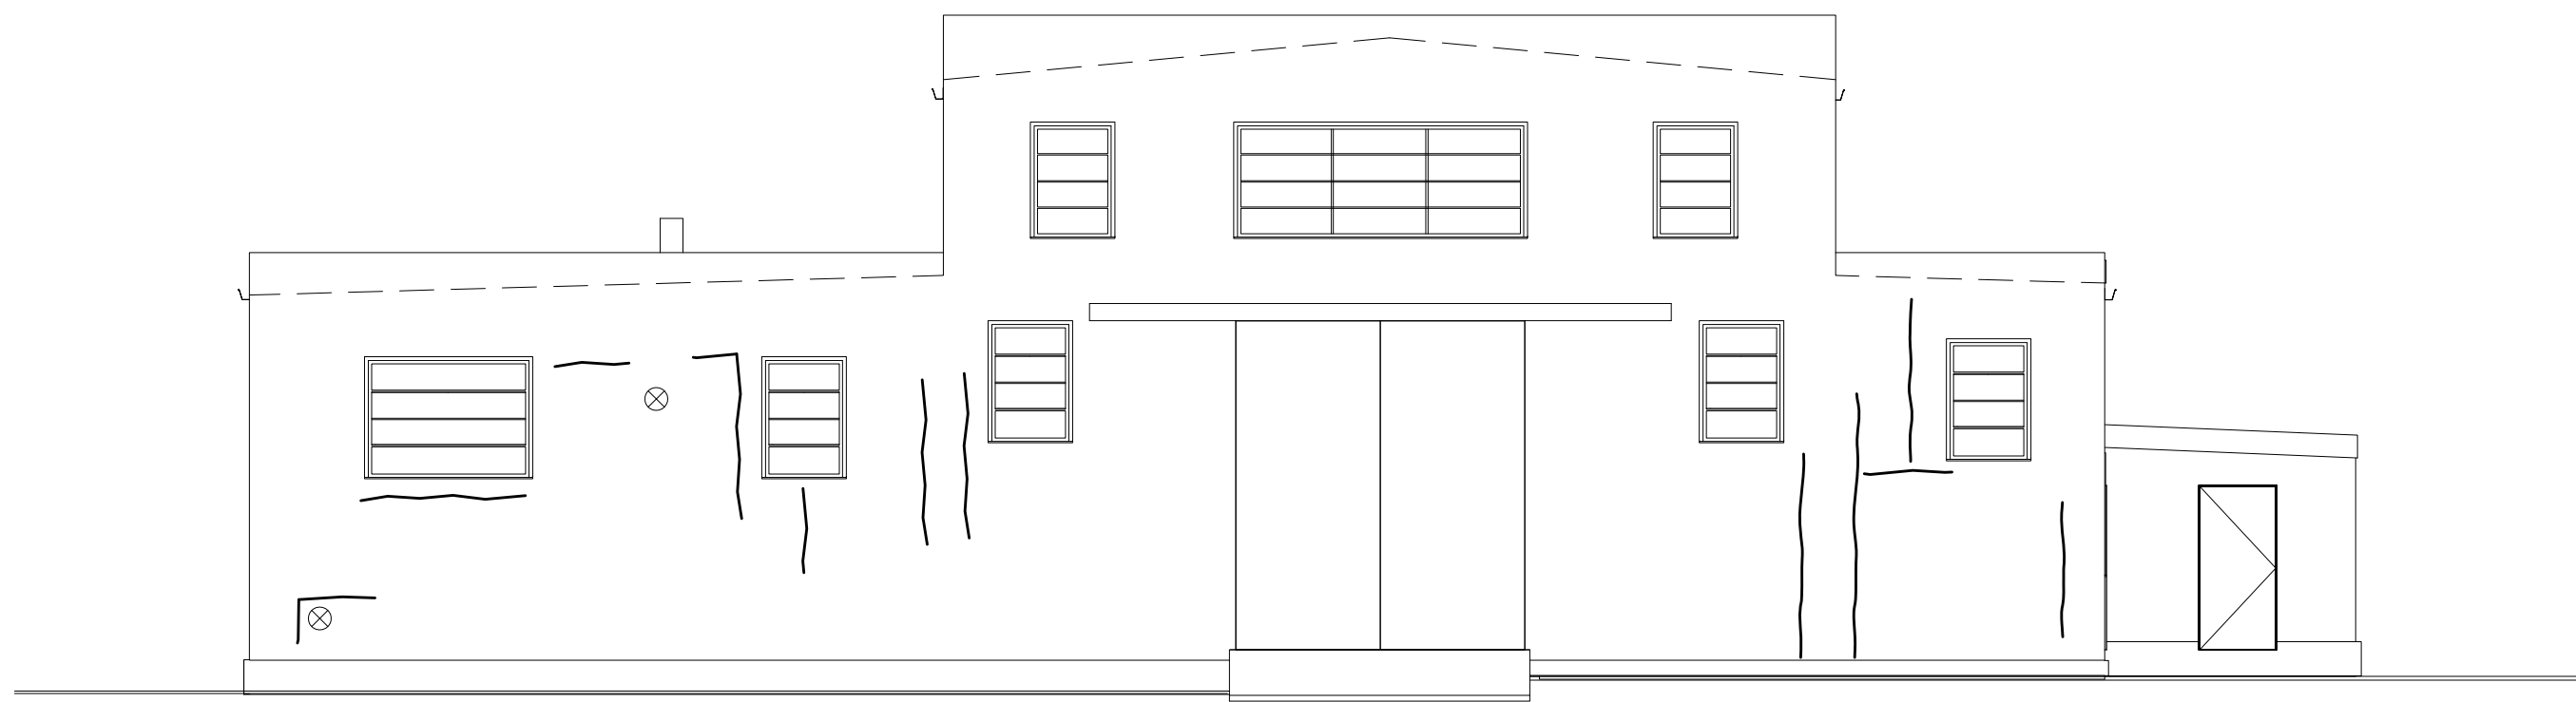
WEST ELEVATION
SCALE: 1/8" = 1'-0"
STUCCO CRACKS

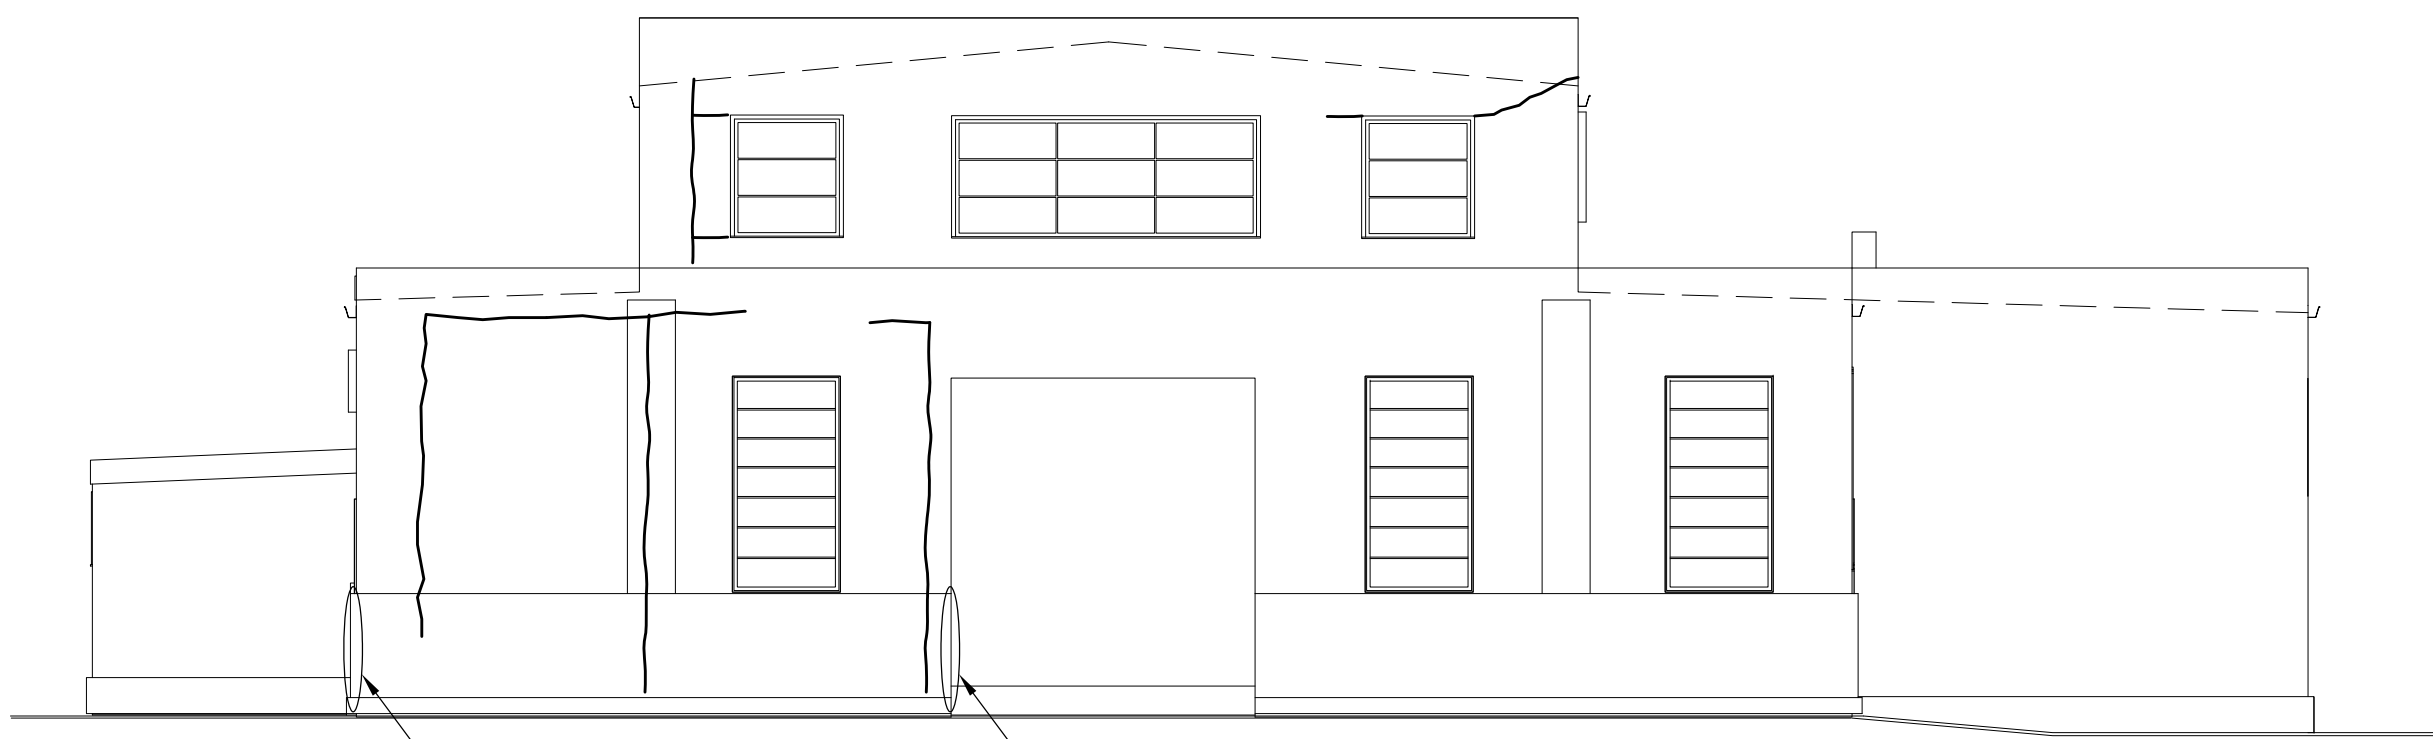
EAST ELEVATION
SCALE: 1/8" = 1'-0"
STUCCO CRACKS

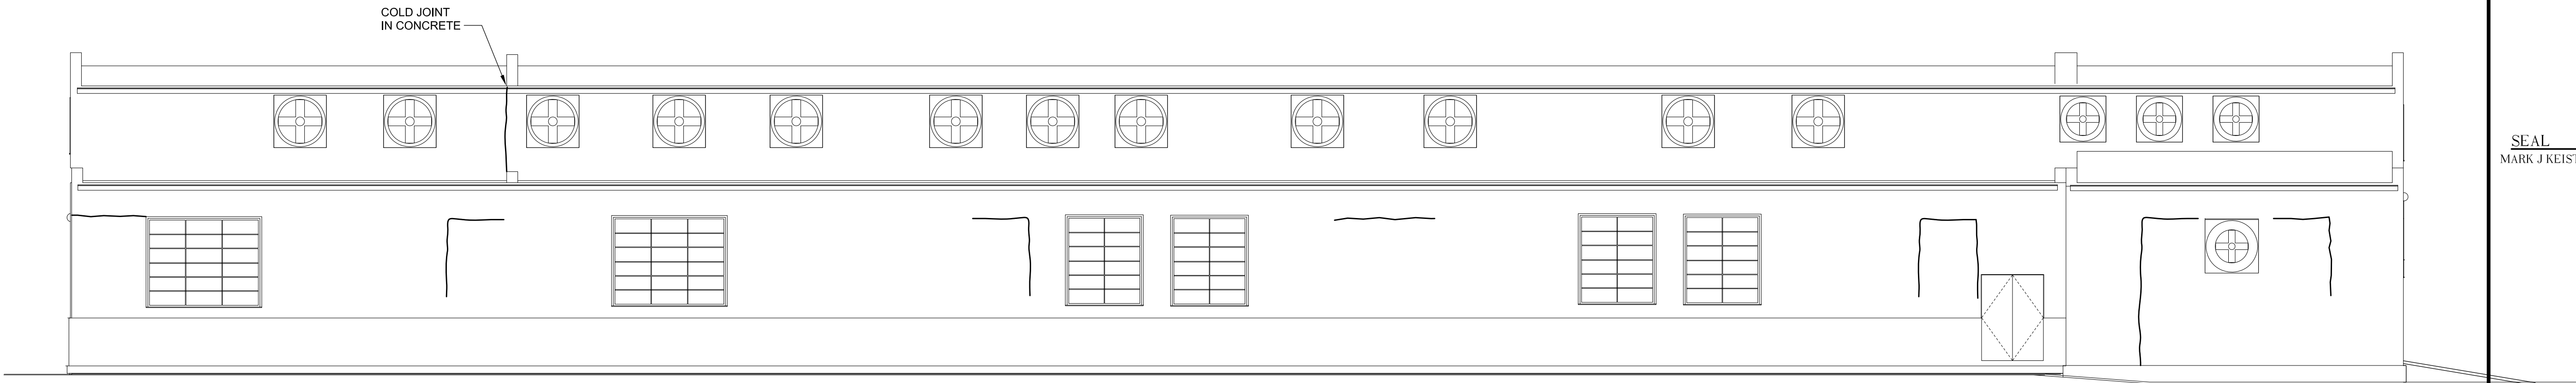
NORTH ELEVATION
SCALE: 1/8" = 1'-0"
STUCCO CRACKS

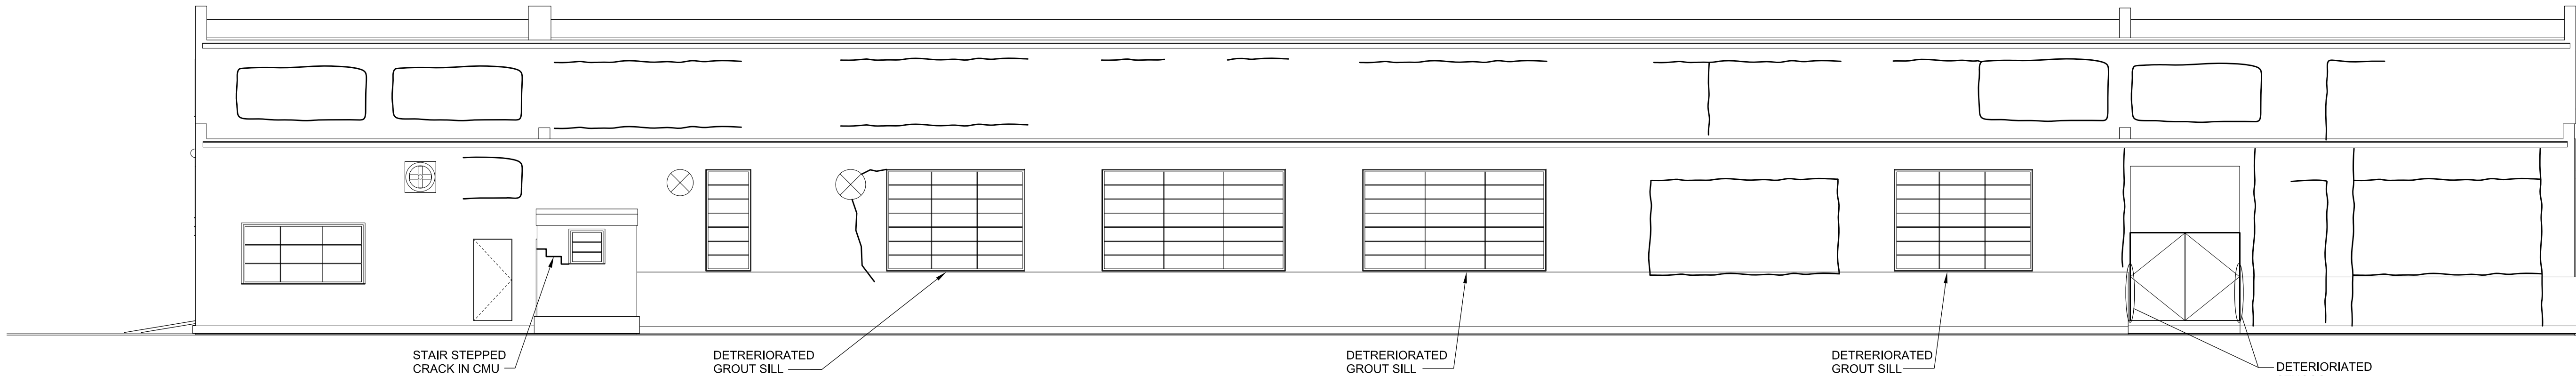
SOUTH ELEVATION
SCALE: 1/8" = 1'-0"
STUCCO CRACKS
