CITY OF KEY WEST

POST-HURRICANE IRMA
SEAWALL CONDITION ASSESSMENT
AQUARIUM BASIN SEAWALL

**Subject: Post-Hurricane Irma Condition Assessment
Key West Aquarium Basin Seawall**

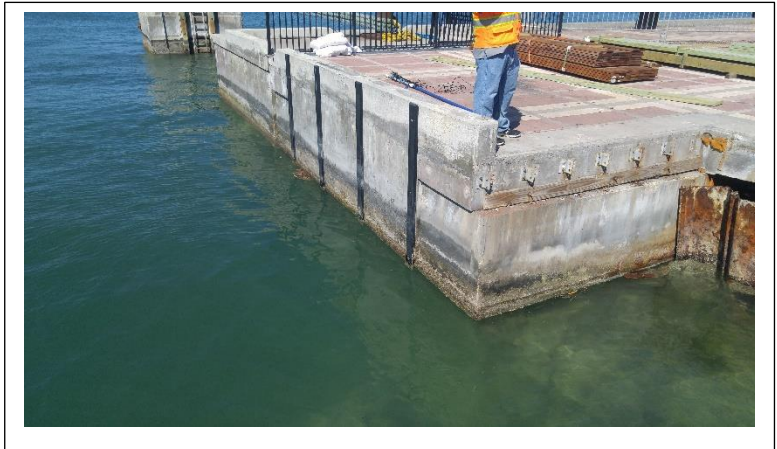
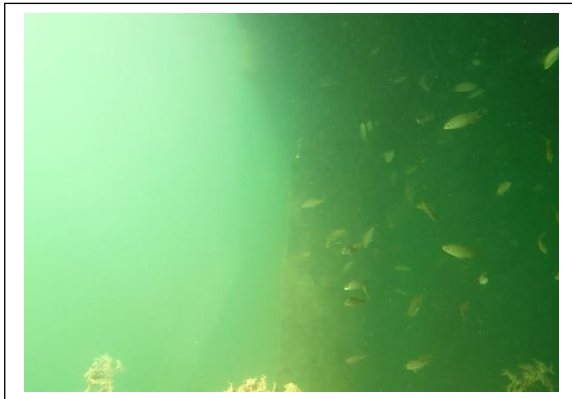
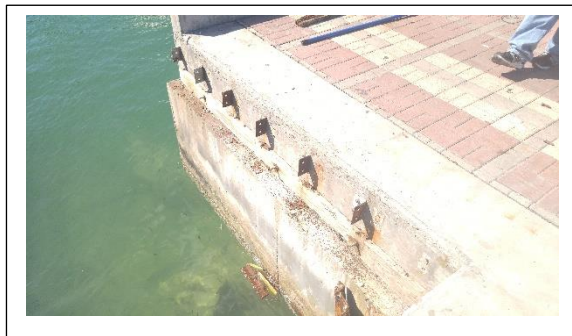
Figure 4: STA 0+00 to STA 30+00 from Bridge

Figure 5: STA 0+10, looking West

Figure 6: STA 0+30, looking South

Description	Baseline A (STA 0+00 to 30+00)
Condition Index	GOOD, no repairs required
Service Life	40-50 years
Age of Structure	10-15 Years

Condition: The seawall through Baseline A is a pile supported cast-in-place concrete cap of relatively recent construction. There is open access beneath the cap and between piles to the open air and water area beneath the Mallory Square Pier. The cap and piles appear to be in good condition, although there is construction debris and a broken piling found at the base of the supporting pilings. The adjoining deck along the east boundary was damaged during Hurricane Irma, and is in the process of being replaced as of this writing. The overall condition of this area is good.

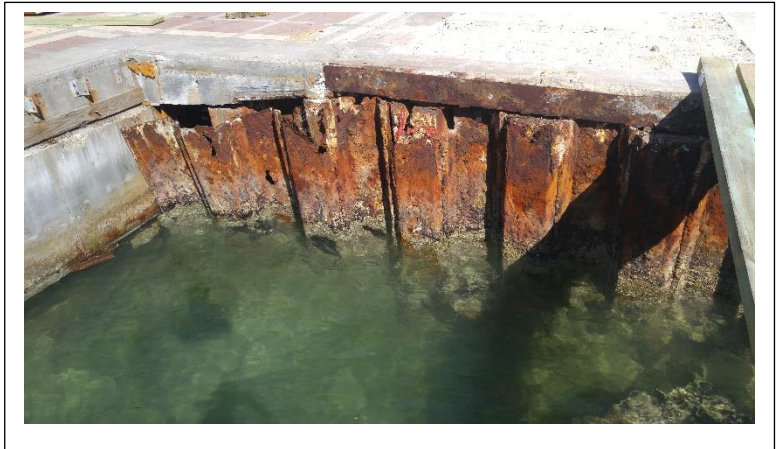
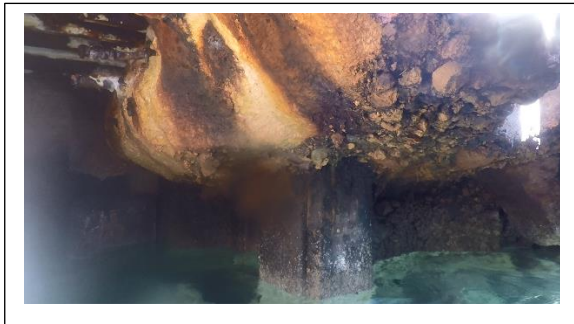
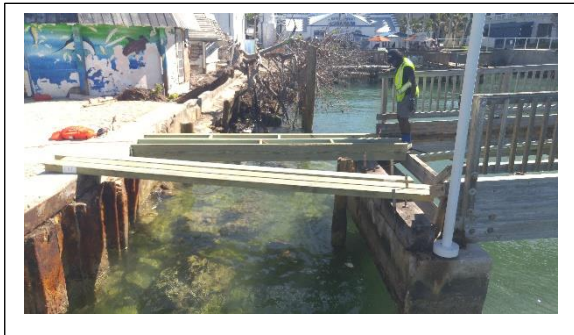
Figure 8: STA 0+00 to STA 0+18 beneath Bridge

Figure 9: View of soil loss behind wall

Figure 10: STA 0+00, looking East

Description	Baseline B (STA 0+00 to 0+18)
Condition Index	FAILED: Replacement Required
Service Life	25 years
Age of Structure	>30 Years

Condition: The first portion of Baseline B is a severely corroded steel sheet pile wall for a length of 18 feet. The wall has several holes of 1 foot diameter, pitting, severe corrosion, and loss of substantial soil and rock from behind the wall. The western end of the sheets is unattached, and moves freely with wave action. Subsidence was noted in the adjacent upland area, but had been filled at the time of inspection to facilitate restoration of the bridge. Large coquina stones and concrete debris have broken through the wall underwater, and remnants of a concrete pour beneath the deck may be seen floating freely where it had been previously poured at grade. The overall condition of this area is failed, and a replacement is required.

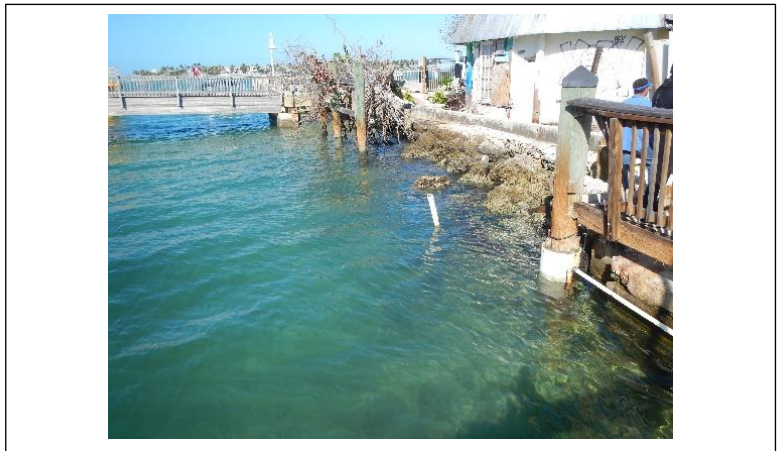
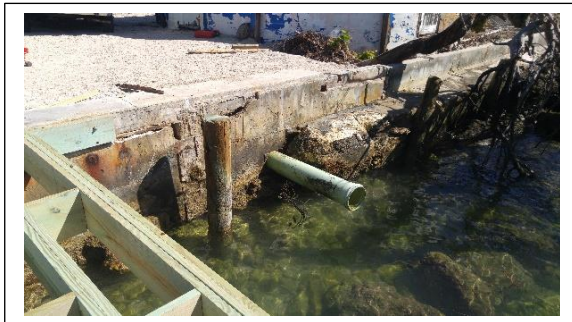
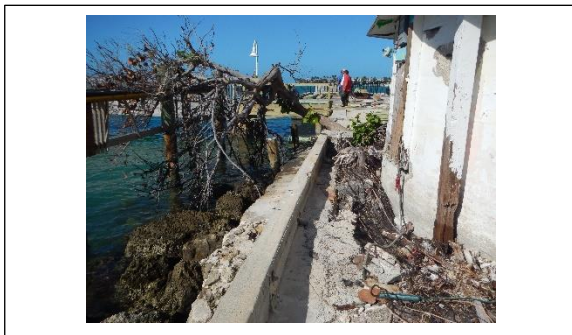
Figure 12: STA 1+00 looking West

Figure 13: STA 0+18 looking Northeast

Figure 14: STA 0+60, looking West

Description	Baseline B (STA 0+18 to 1+00)
Condition Index	Fair to Poor, Should be Replaced
Service Life	25 years
Age of Structure	>50 Years

Condition: The second portion of Baseline B is a combination of cast-in-place concrete and mortar-bonded native coquina stone. A parapet wall was constructed atop the cap for soil retention. On the waterside of the wall is 8-10 feet of rubble riprap, obscuring much of the wall face from view. However, the upland area adjacent to the wall shows signs of soil subsidence, likely due to tidal soil migration through the wall. This area is in close proximity to the historically designated cable huts. The area as noted includes a mortared rubble return wall that extends 10' into the water at the east end. The overall condition of this area is fair to poor.

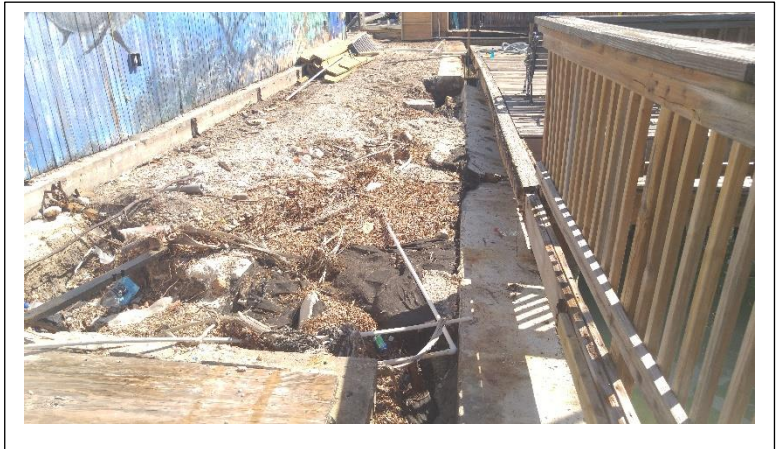
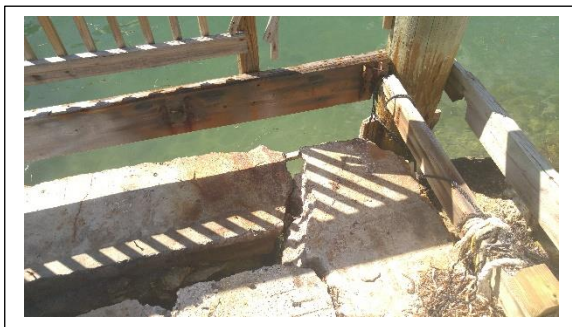
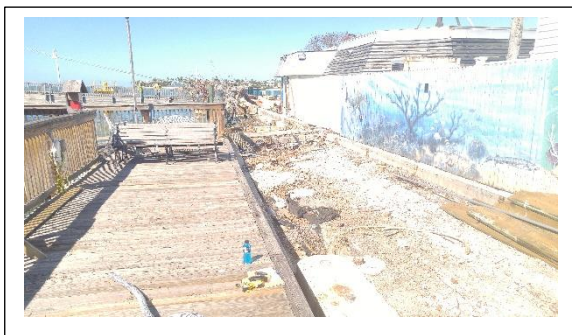
Figure 16: STA 1+00 looking East

Figure 17: View of STA 1+00

Figure 18: STA 1+60, looking West

Description	Baseline B (STA 1+00 to 1+62)
Condition Index	FAILED: Replacement Required
Service Life	25 years
Age of Structure	>50 Years

Condition: The third portion of Baseline B is a mortared native stone wall with a cast-in-place concrete cap. Approximately 42 linear feet of the wall has collapsed as a result of Hurricane Irma, having rotated forward. The collapsed wall is currently supported only by the timber pilings for the adjacent dock. Remnants of a previous seawall may be seen behind the collapsed wall. The eastern portion of the wall is still standing, though being of similar vintage and construction, it is considered to be in hazardous condition. This wall segment has failed and requires replacement.

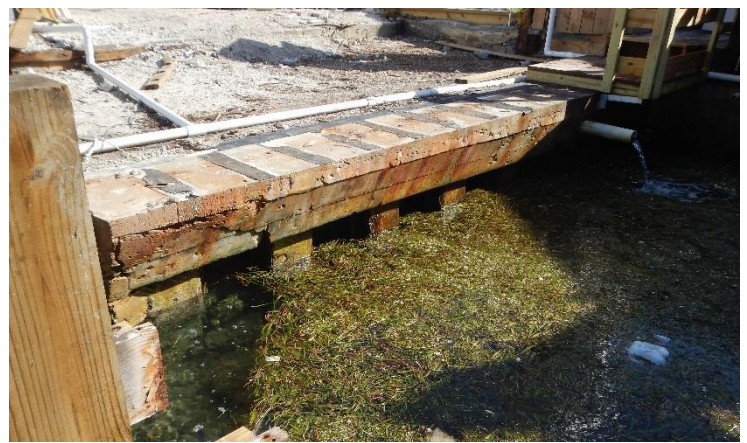
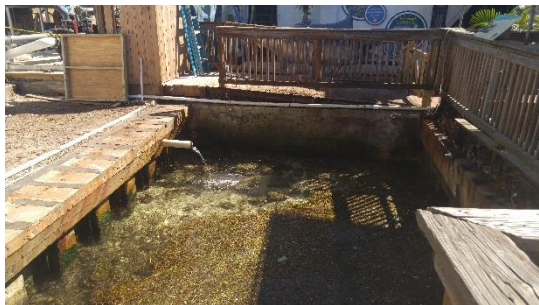
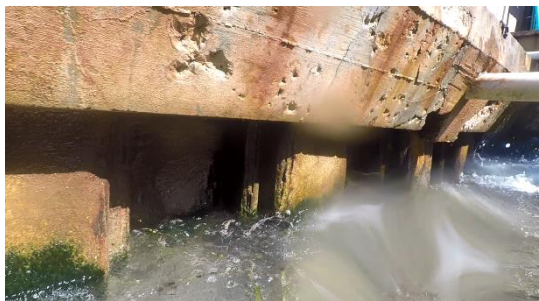
Figure 20: STA 1+60 looking East

Figure 21: View of East Wall

Figure 22: STA 1+60 looking East

Description	Baseline B (STA 1+62 to 1+80)
Condition Index	Fair
Service Life	25 years
Age of Structure	>35 Years

Condition: The fourth portion of Baseline B is a steel sheet pile wall. The cap is pitted, and cracked with spalled rust from exposed rebar. The steel sheets show signs of corrosion at their seams. While the steel portion does not exhibit any signs of soil loss or rotation, it is of short enough span that a seawall project on the aforementioned segments should include it to provide for a complete system. The overall condition of this area is fair.

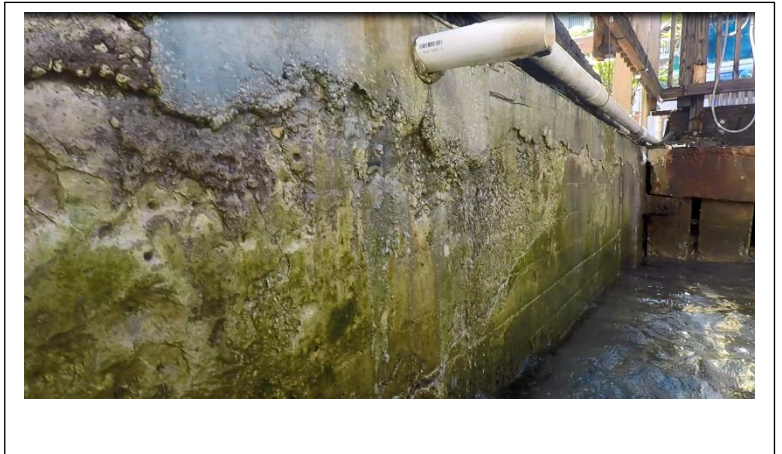
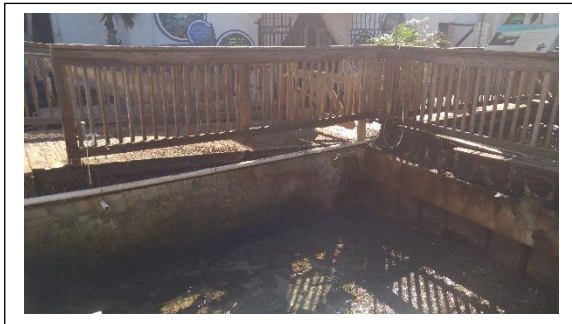
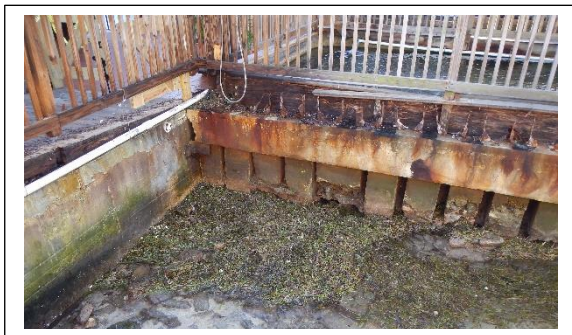
Figure 24: East Wall Face

Figure 25: View of East Wall

Figure 26: View of pile supported turtle enclosure

Description	Baseline B (STA 1+80 to 2+27)
Condition Index	Fair
Service Life	50 years
Age of Structure	>50 Years

Condition: The fifth and final portion of Baseline B is a cast-in-place concrete wall that is visible only for the northern 15 feet. There is surficial cracking, pitting and delamination of concrete with exposed aggregate along the visible length. Several structural cracks are visible within the visible portion of the wall. The remaining 32 feet of wall are blocked from view behind concrete pile supported turtle enclosures, and as such could not be observed during the inspection. The overall condition of this wall section is fair.

Should the City elect to only replace the north wall, it's advisable that the east wall be monitored on a yearly interval for signs of degradation and future repairs or replacement.
