ORDER TO REPAIR, ALTER, OR IMPROVE BUILDINGS

Structural Condition Assessment Key West Diesel Plant Key West, Florida

AES Project No. 316-048
August 3, 2016

Re: Structural Condition Assessment
Key West Diesel Plant
Key West, Florida

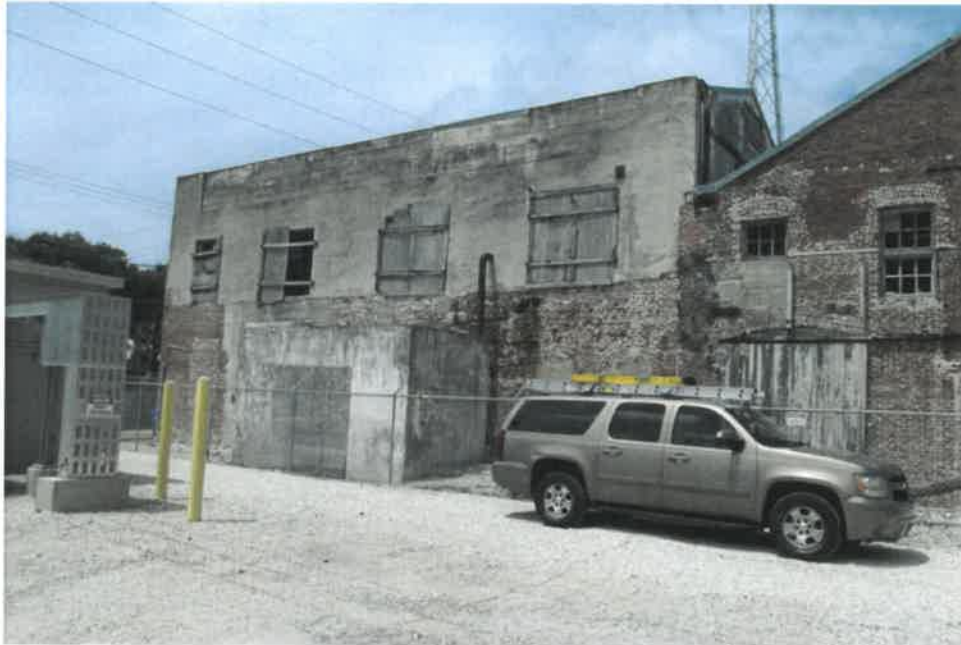
PHOTOGRAPH 5 (BUILDING IV AND V)

The abandoned Diesel Plant consists of four (4) connected one-story, buildings with the three (3) eastern buildings housing four (4) electric dynamos and the southwestern building having a lower roof that probably housed a shop and support spaces. The northernmost eastern building (Building I) houses one (1) dynamo and consists of a high new pre-engineered wood truss framed roof with plywood sheathing and metal roofing supported by perimeter multi-wythe brick walls and interior steel beams and columns (see Photographs 1 and 2). The easternmost center building (Building II) houses two (2) dynamos and consists of metal roofing on plywood sheathing, on wood joists and beams supported by heavy timber trusses and steel beams and columns that support crane beams (see Photographs 3 and 4). The heavy timber roof trusses are supported by perimeter multi-wythe brick walls. The southernmost eastern building (Building IV) houses one (1) dynamo and consists of metal roofing on wood sheathing on wood joists and beams supported by heavy timber trusses, and perimeter low multi-wythe brick walls and upper concrete walls (see Photographs 5 and 6).

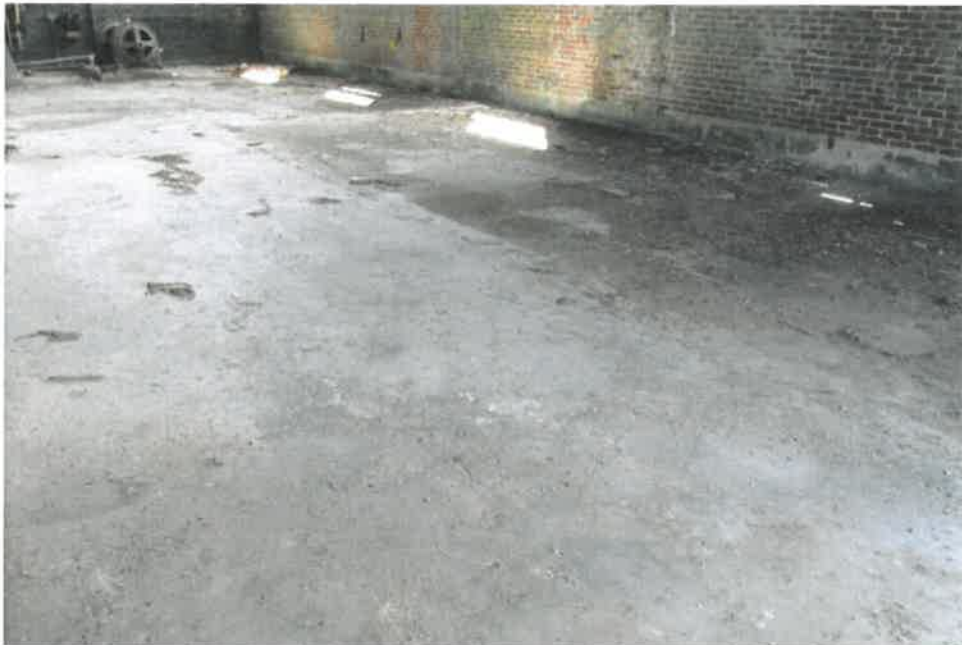
PHOTOGRAPH 14 (BUILDING I)

- I. The northernmost, eastern building (Building I) has been recently re-roofed and the original wood structure supported by the steel beams and trusses have been replaced with plywood sheathing and wood trusses. The new roofing and roof structure is in excellent condition except that the roofing screws are not stainless steel and are corroding (see Photograph 12). The original steel beams, trusses and columns are in good condition with surficial corrosion except for one (1) column, which has a badly corroded base with more than 20% material loss (see Photograph 13). The slab on grade is cracked and uneven and there is a large crack at the interior door to the adjacent building, and several of the western window sills are spalled with corroded reinforcing and the remainder are cracked (see Photographs 14, 15 and 16).

Building I is in good condition with the exterior masonry requiring repair and several window lintels requiring replacement. The steel structure is in good condition with surficial corrosion except for one (1) column that needs reinforcement due to excessive corrosion at its base. All of the steel needs to be cleaned of corrosion and coated with a corrosion inhibiting coating. The slab on grade is cracked and uneven and is due for replacement. The exterior masonry requires repointing and all of the corroded embedments and steel lintels need to be cleaned of corrosion and coated with a corrosion inhibiting coating. The deteriorated face brick needs to be removed and replaced and the vegetation in the wall cracks needs to be removed and the cracks repointed. At the western return metal panel wall, the badly corroded angle purlin needs replacement as well as the wall metal panels. The concrete spall in this wall also requires repair.

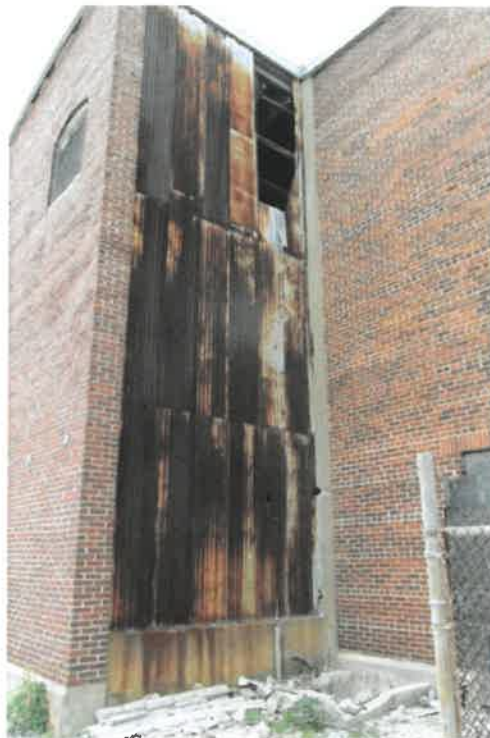
PHOTOGRAPH 27 (BUILDING I)

The exterior masonry walls are in good condition but there are numerous cracks, corroded embedments, deteriorated mortar, corroded lintels, deteriorated face brick, brick cracks with vegetation and random cracks in the concrete water table (see Photographs 17, 18, 19, 20, 21, 22 and 23). At the western return metal panel wall, there is a badly corroded angle purlin and a large column spall with corroded reinforcing and an area of missing metal wall panel (see Photographs 24, 25 and 26). The remaining metal panels are corroded and in poor condition (see Photograph 27).

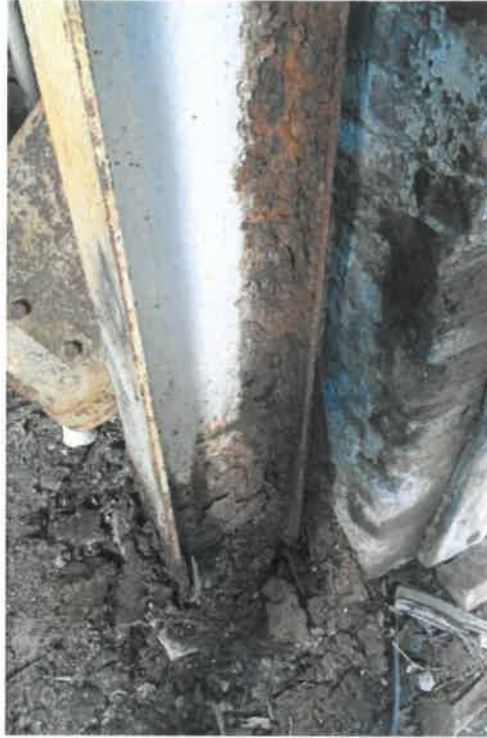
PHOTOGRAPH 29 (BUILDING II)

- II. The eastern center building (Building II) is in much worse condition than the Building I with metal roofing in extremely poor condition with large areas of missing metal roofing and large areas of deteriorated roof decking (see Photograph 28). The roof wood structure is in good condition as well as the steel structure with surficial corrosion except for several badly corroded columns and post bases with more than 20% material loss (see Photographs 29 and 30).

The remainder of the buildings are in worse condition than Building I with Building IV being in the worst condition with a portion of missing roof. These buildings are stable but require new roofs with extensive roof sheathing replacement and some wood structure reinforcement and replacement. At the areas of missing and badly deteriorated roofing, these roofs could sustain significant damage in a severe wind event losing the remainder of their roofing and sheathing. In general, the steel structure is in good condition with surficial corrosion but several columns will need reinforcement due to excessive corrosion at their bases. All of the steel needs to be cleaned of corrosion and coated with a corrosion inhibiting coating. At Building IV, the wall opening with numerous loose and missing bricks and falling bricks needs to be shored or repaired immediately to prevent further deterioration of the wall. The exterior masonry walls are in good condition except for the northwest corner of Building II where there is a large area of missing brick that needs to be rebuilt. The remaining walls need to be repointed, deteriorated face brick removed and replaced and the vegetation in the wall cracks removed and the cracks repointed. Like Building I, all of the corroded embedments and steel lintels need to be cleaned of corrosion and coated with a corrosion inhibiting coating. In many of the arched brick openings, brick has been infilled with no lintel installed. This infill brick is being held in place by the mortar alone and in areas is cracking. This infill brick needs to be removed or steel lintels installed to support it. At Building II, the concrete platform is in poor condition with large spalls and the concrete carbonated to the reinforcing with the concrete containing high levels of chlorides. If it is the owner's desire to rehabilitate this platform when the concrete is repaired, it should be treated with a penetrating corrosion inhibitor or an active cathodic protection system installed. Due to the thickness of the platform walls, both will be expensive, therefore strong consideration should be taken for demolishing this platform. The exterior concrete walls and pits, except for Building V, are in poor condition requiring extensive repair. Like the Building II concrete platform, the concrete contains high levels of chlorides and once repaired, the walls should be treated with a penetrating corrosion inhibitor or an active cathodic protection system installed, and the exterior concrete coated with a penetrating sealer. The exterior pits and chutes are abandoned and should be cleaned of debris, the top of the deteriorated walls demolished to 8" below grade and filled with clean fill or stone. All of the interior trench and pit edge angles are in poor condition and badly corroded. All of the dynamo pits are full of water and breeding mosquitos. When the deteriorated dynamos are removed, the pits need to be pumped empty of water. The pits and trenches need to be dewatered, cleared of debris with the edge angles removed, and the pits and trenches filled with clean fill or stone with a concrete slab on grade placed, drilled and adhesived into the pit and trench walls level with the surrounding concrete slabs on grade. If any of the dynamos are kept for display, their pits should be pumped empty of water and filled and capped as described above.

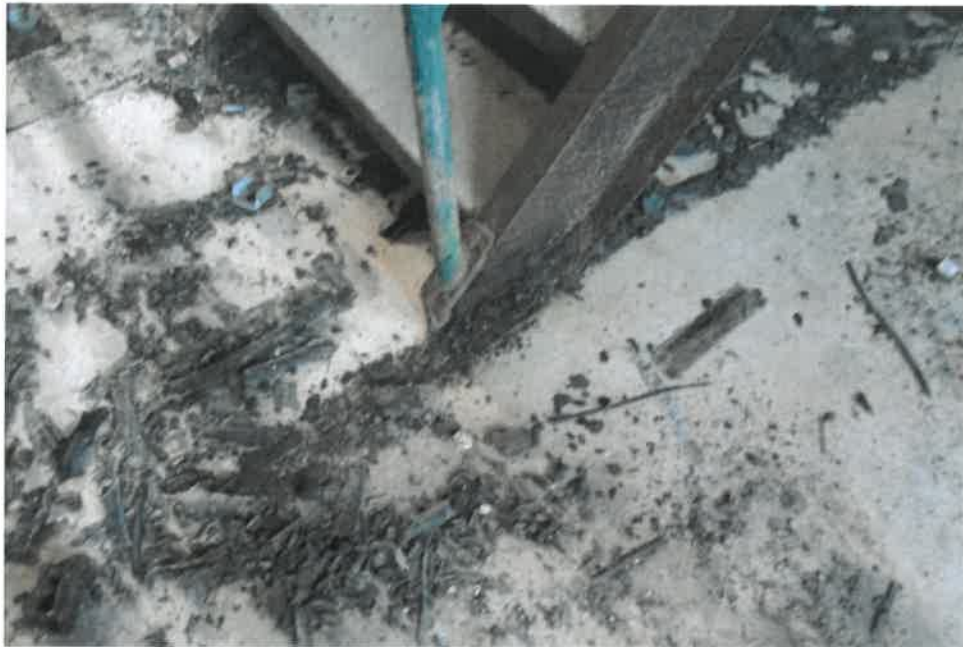
PHOTOGRAPH 31 (BUILDING II)

The stair to the concrete platform has badly corroded stair stringer bases with more than 20% material loss and the concrete platform has extensive large concrete spalls with exposed corroding reinforcing (see Photographs 31, 32 and 33). The exterior masonry walls are in good condition, but there are numerous cracks, corroded embedments, deteriorated mortar, deteriorated face brick, infilled arch brick with no lintel, large areas of missing brick, corroding lintels and brick cracks with vegetation (see Photographs 34, 35, 36, 37, 38 and 39).

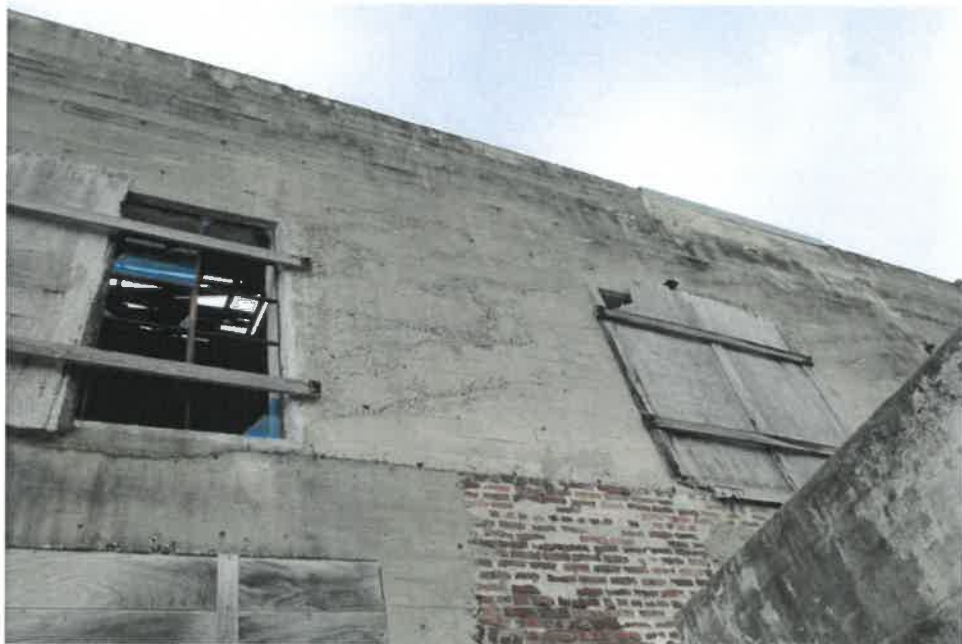
PHOTOGRAPH 44 (BUILDING IV)

- IV. The southernmost eastern building (Building IV) is in worse condition than Building II with a large area of missing metal roofing and wood sheathing, a deteriorated bottom roof truss chord and a wall opening with numerous loose and missing bricks with bricks falling (see Photographs 40, 41 and 42). The wood roof joists are in poor condition but the wood trusses appear in good condition. The steel structure is in good condition with surficial corrosion but many of the steel column bases are severely corroded with more than 20% material loss (see Photograph 43). The exterior masonry walls are in good condition but there are numerous cracks, corroded embedments, deteriorated mortar and loose and missing face brick. The upper concrete walls have large areas of honey combed concrete and an area of spalled concrete with corroded reinforcing (see Photographs 44 and 45).

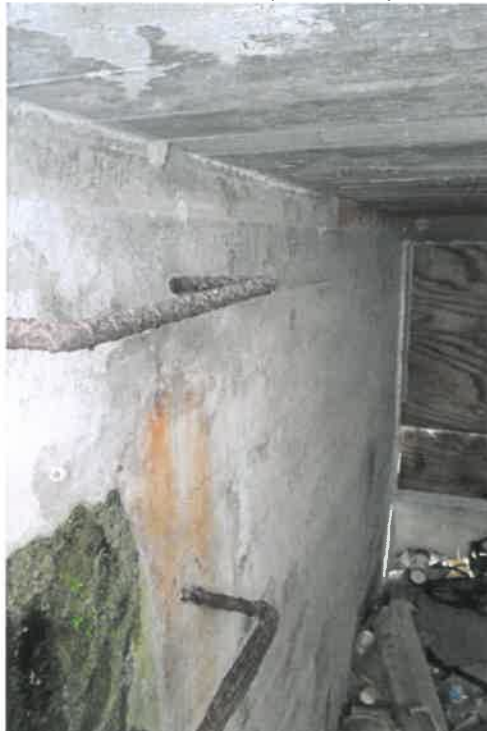
PHOTOGRAPH 50 (BUILDING V)

- V. The concrete exhaust building (Building V) is in good condition with corroded steel ladders; a badly corroded pipe support, a cracked housekeeping pad and a hairline crack in the roof parapet (see Photographs 50, 51, 52 and 53). The exterior pit and chute walls are in poor condition with cracked and spalling concrete with corroding reinforcing (see Photograph 54). All of the interior pits are full of water and breeding mosquitos. The interior trench and pit edge angles are in poor condition and badly corroded (see Photograph 55). All of the dynamos are in poor condition and badly corroded (see Photograph 56).
