**Subject: Seawall Condition Assessment
From Turtle Kraals to William Street
Resolution No. 17-017**

CITY OF KEY WEST
PORT & MARINE SERVICES

SEAWALL CONDITION ASSESSMENT
WATERFRONT MARKET TO TURTLE KRAALS RESTAURANT

RESOLUTION NO. 17-017

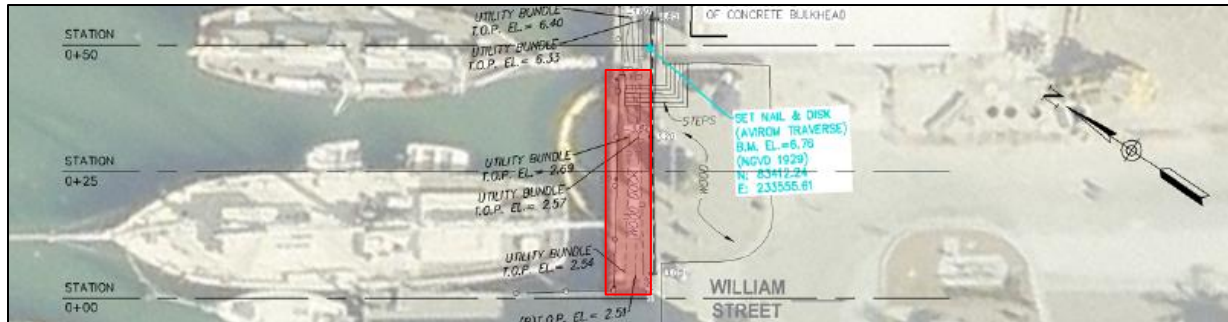
Figure 2: Station Exhibit, 0+00 to 0+50

Condition: The condition of the bulkhead located in front of the William Street/Key West Bight terminus (see Figure 2 above) appears to be in stable condition. However, because the design parameters of this portion of the wall are not known, it is difficult to perform an accurate stability check. The 1995 upland redevelopment plans show a gravity wall with a key wall located below the toe, but no dimensions or specifications were shown. Figure 3 shows the wall above the waterline and Figure 4 shows what appears to be a steel key wall located just below the toe of the wall.

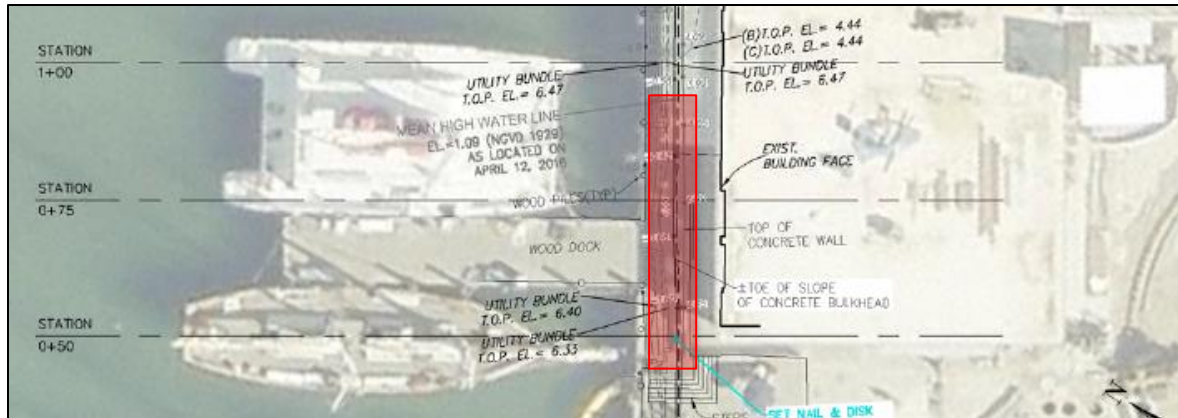
Figure 5: Station Exhibit, 0+40 to 0+89

Condition: The bulkhead located in front of the Waterfront Market & Brewery appears to be in stable condition. The 1995 upland redevelopment plans show a gravity wall with a key wall located below the toe, but no dimensions or specifications were shown. Figure 6 shows the wall above the waterline. Figure 7 shows a previously installed toe wall at the mudline.

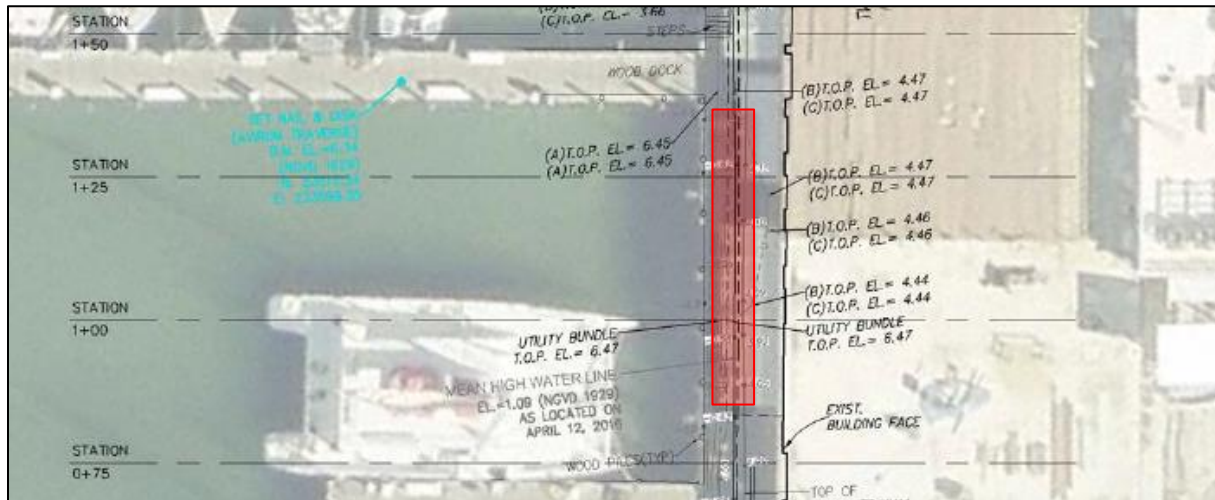
Figure 8: Station Exhibit, 0+82 to 1+32

Condition: The condition of the bulkhead located in front of the Waterfront Brewery appears to be in stable condition. For this approximately 50 foot segment a concrete/steel sheet pile combination wall was installed along the toe of the existing wall, presumably to fill any voids that had developed.

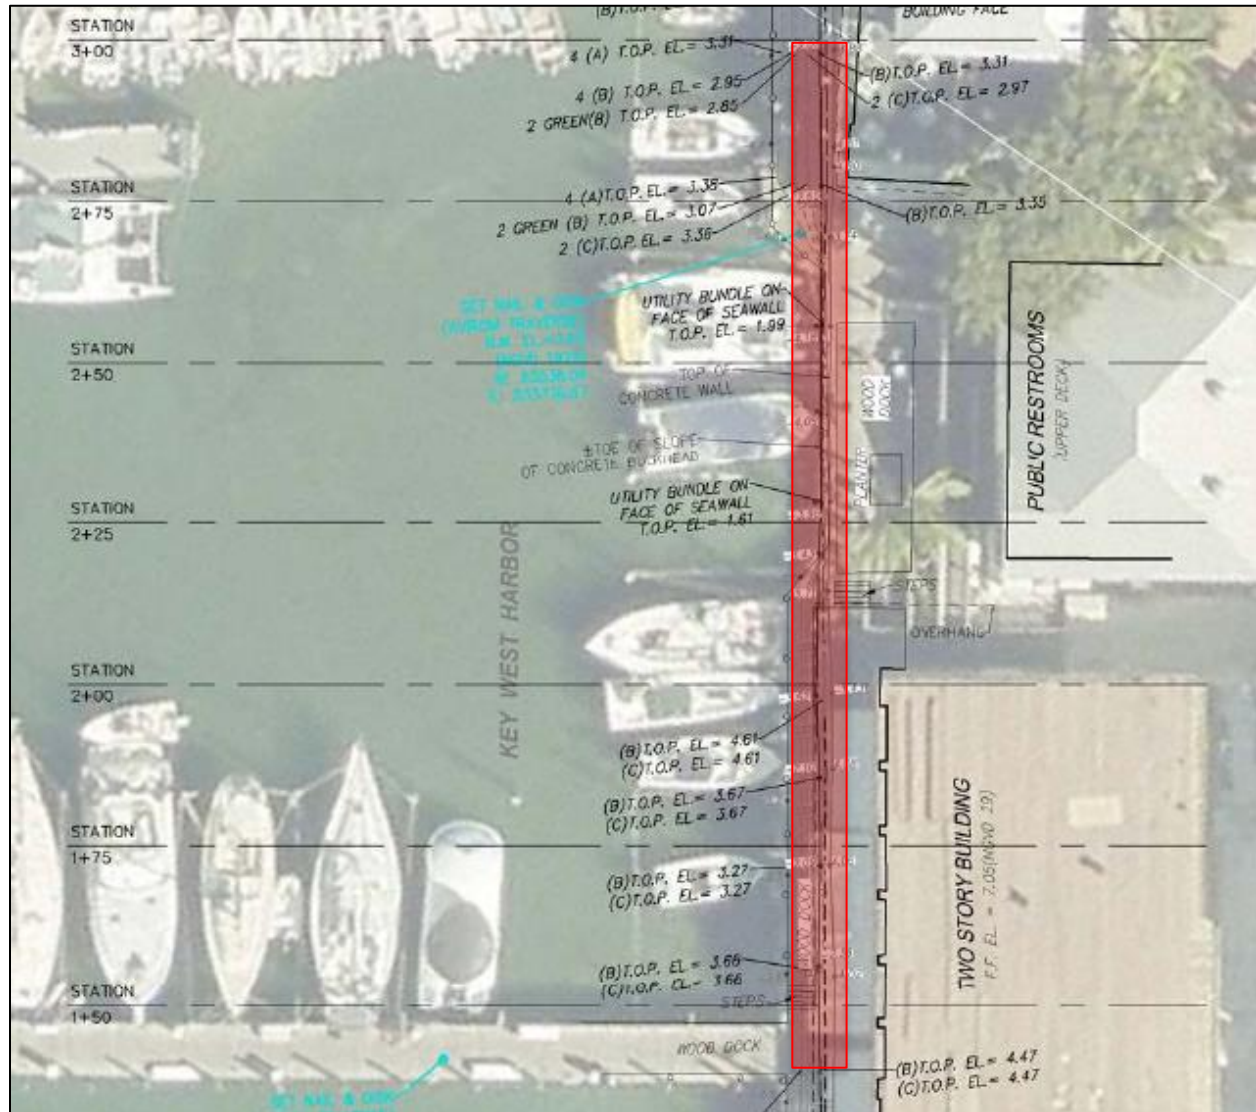
Figure 11: Station Exhibit, 1+31 to 3+00

Condition: The bulkhead located in front of the Waterfront Market & Brewery appears to be in stable condition. There are discontinuous voids in this area but the penetration was nominal. Divers were unable to confirm the presence of a key wall but the depth of the void match those seen in front of Williams Street. It is recommended that this segment of the wall be inspected again in three years to determine if this condition has worsened.

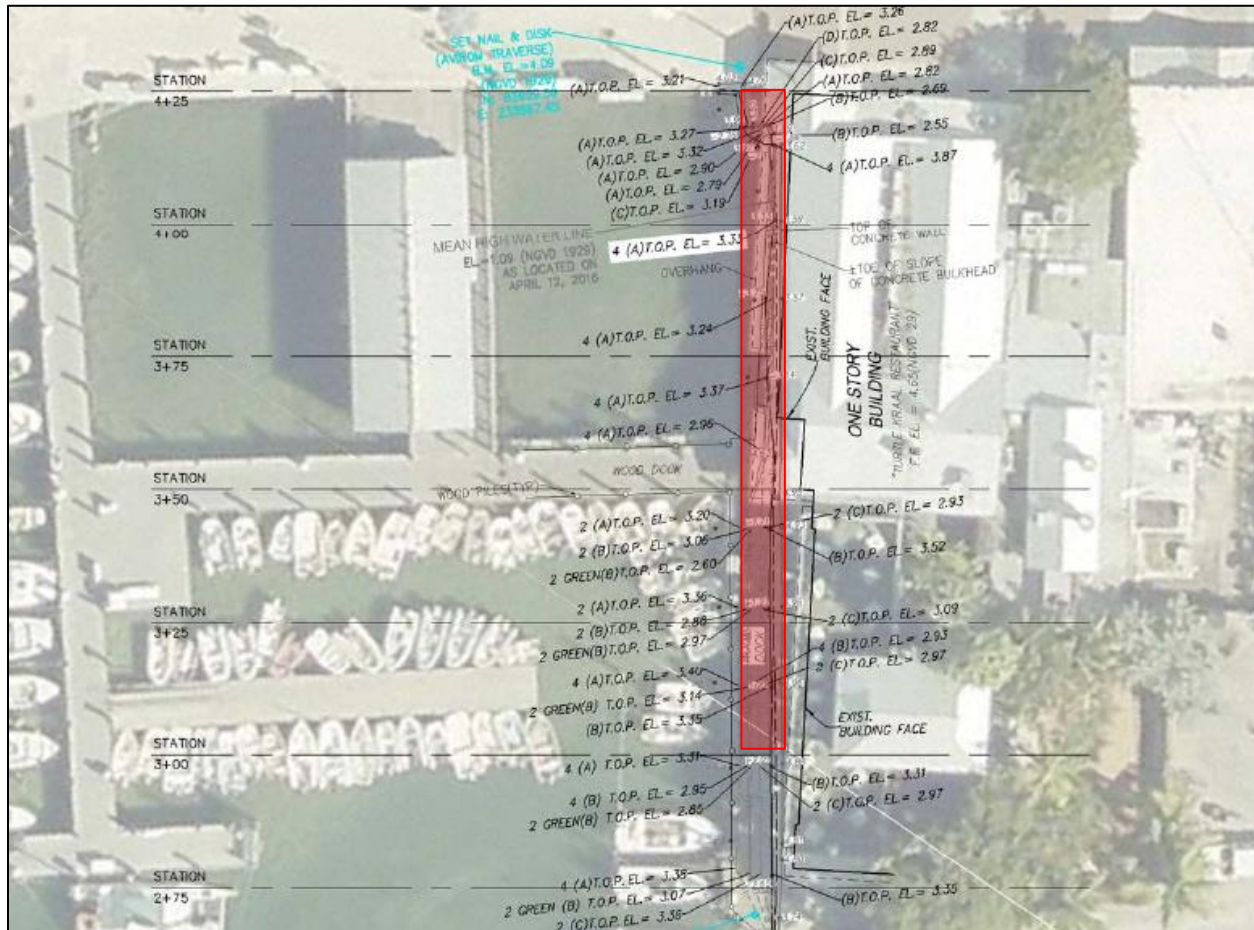
Figure 14: Station Exhibit, 3+00 to 4+40

Condition: The bulkhead located in front of the Waterfront Market & Brewery appears to be in stable condition. The above water line photo (Figure 15) shows a large crack that extends from the mudline to the top of the wall. This crack does not appear to be a construction joint and judging from the condition of concrete in the spalled areas, appears to have been there for a long time. We recommend that this portion of the wall continue to be monitored and re-inspected in three years. We also recommend that this large crack and several others along the face of the wall be sealed during the next phase of construction.

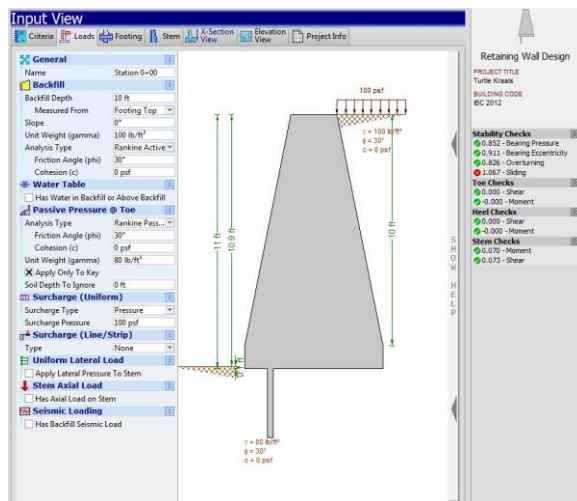
Figure 19 – TK Wall before repair

The most concerning observation was the approximately 40-foot long segment of wall identified as Defect B where the steel key wall was completely exposed. At this location we used the “QuickRWall Version 5.0” design software to perform a basic stability check on the wall. For the computer analysis, we assumed the wall was a monolithic, unreinforced concrete wall set on top of a steel key set just below the toe (as shown in Figure 19). Because of the fractured limestone behind the wall and the various voids and cracks along its face we assumed the passive and active water pressures cancel each other out and no water pressures were applied. This portion of the wall is only loaded by light pedestrian traffic an active surcharge pressure was applied. In other segments of the wall a stem axial load was added to estimate the load from the columns added to the top of the wall that now support the Harbor Walk (Boardwalk).

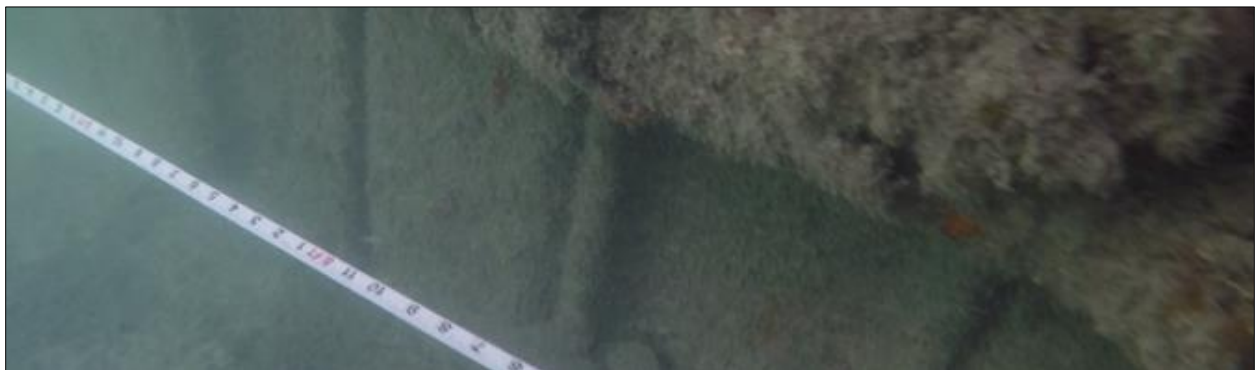
Photo 1: At 5' from start of Phase 2 wall segment beginning at corner of William St.

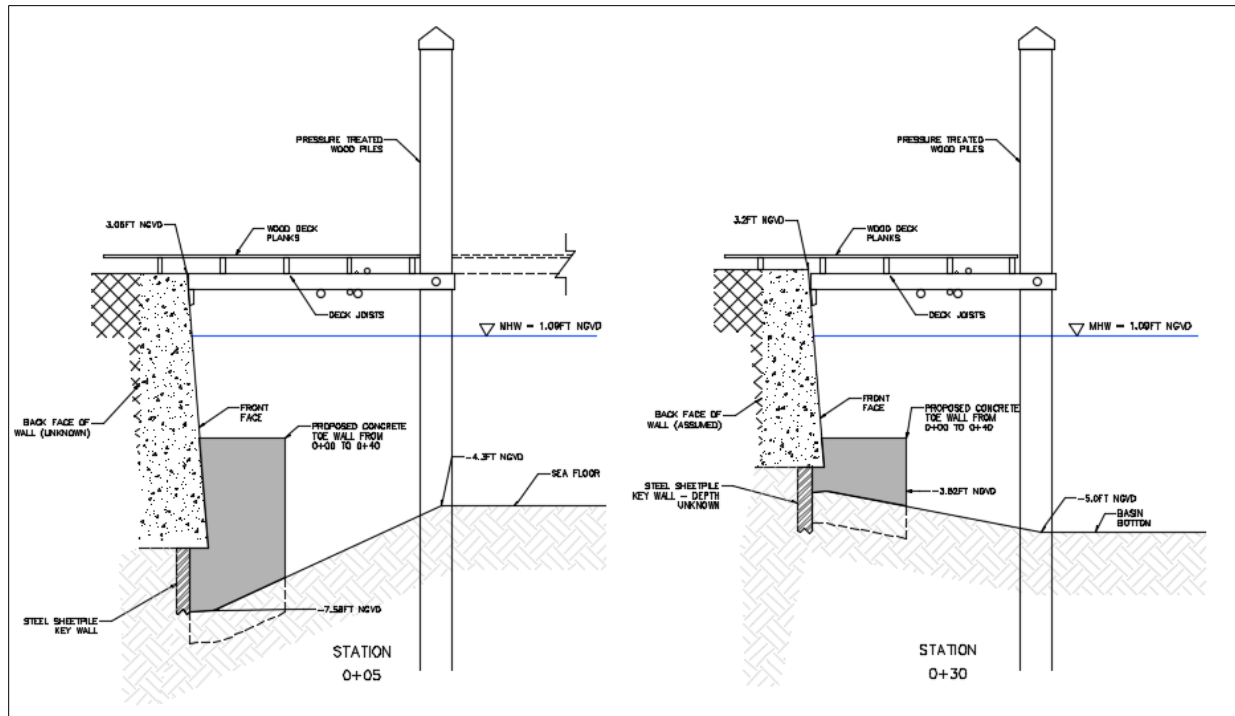
Figure 22 – Cross sections of proposed wall repair

As you can see in Figure 22 below, at (0+05), the elevations captured by the survey show the seafloor sloping down from the basin toward wall face. This is an indication that at some time in the past a large vessel was moored relatively close to wall and it is possible that turbulent prop wash helped to create the scour that is now observed. During the inspection process the sailboat now moored at this location ties up bow first and its prop is over fifty feet from the wall face. At 0+30 in the same Figure 22, the seafloor is shown to slope away from the wall and the key is far less exposed.

This portion of the wall is the most exposed and therefore we are proposing a concrete toe wall be installed from station 0+00 to 0+40 feet at the toe of the wall extending from a point approximately two feet above the wall toe (base of the concrete portion of the wall near the top of key) down to the hard bottom of the basin. The basin bottom is now relatively flat at this point and minimal additional scour or limestone degradation is expected in the foreseeable future.

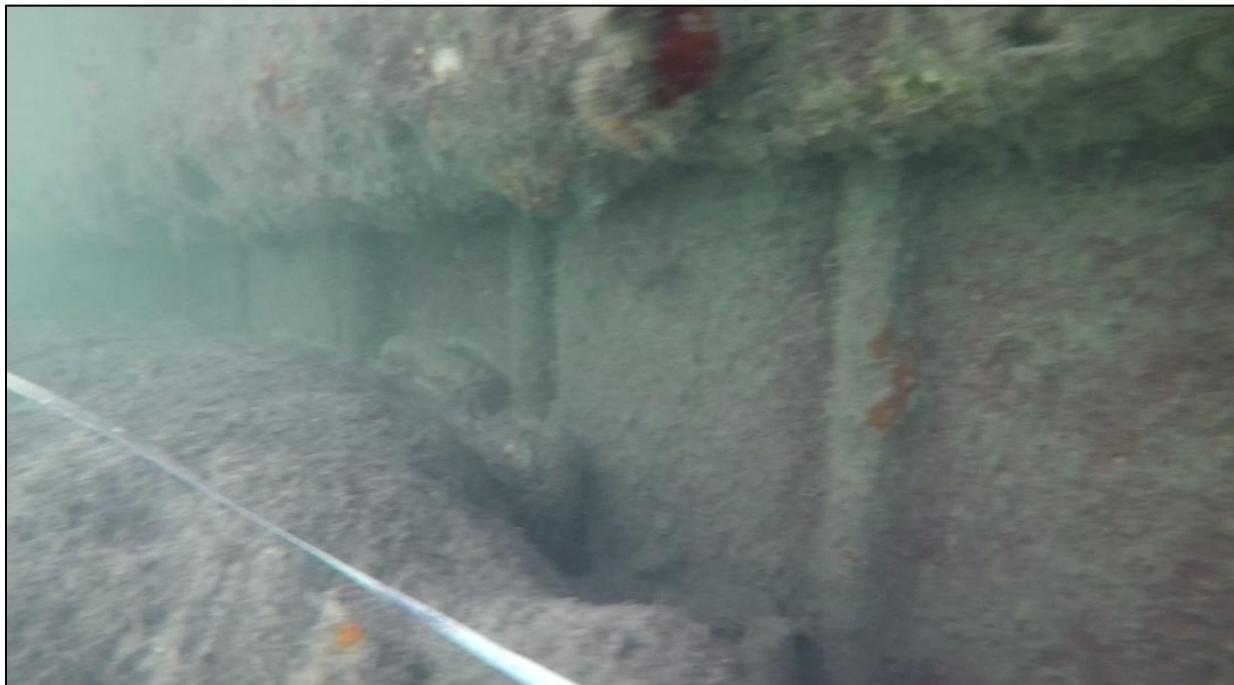
Photo 2: At 30' from the start of Phase 2 wall segment beginning at the corner of Williams St.

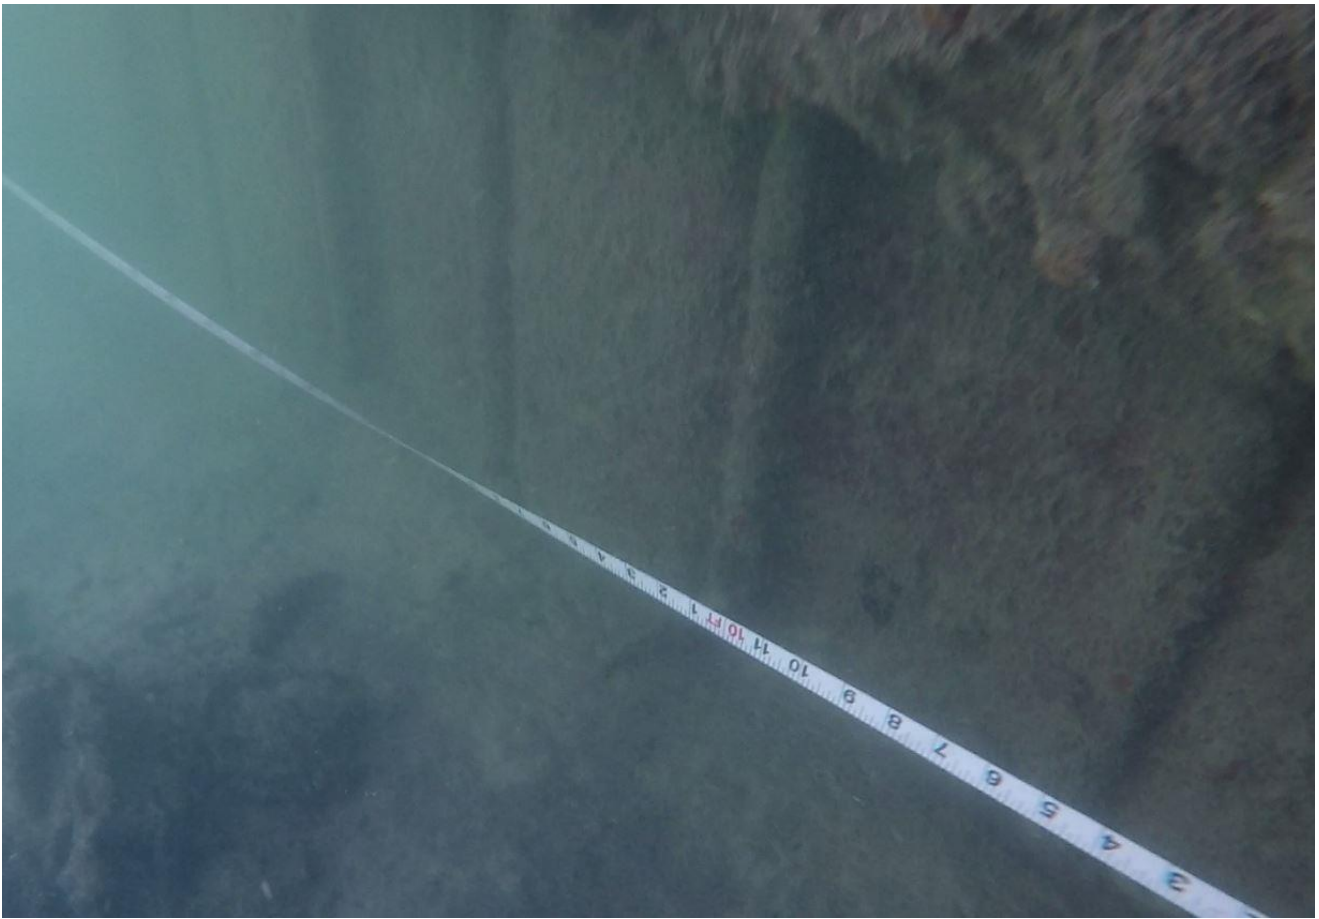
Underwater 3 - at 10ft shows steel sheetpile with concrete cap in good condition

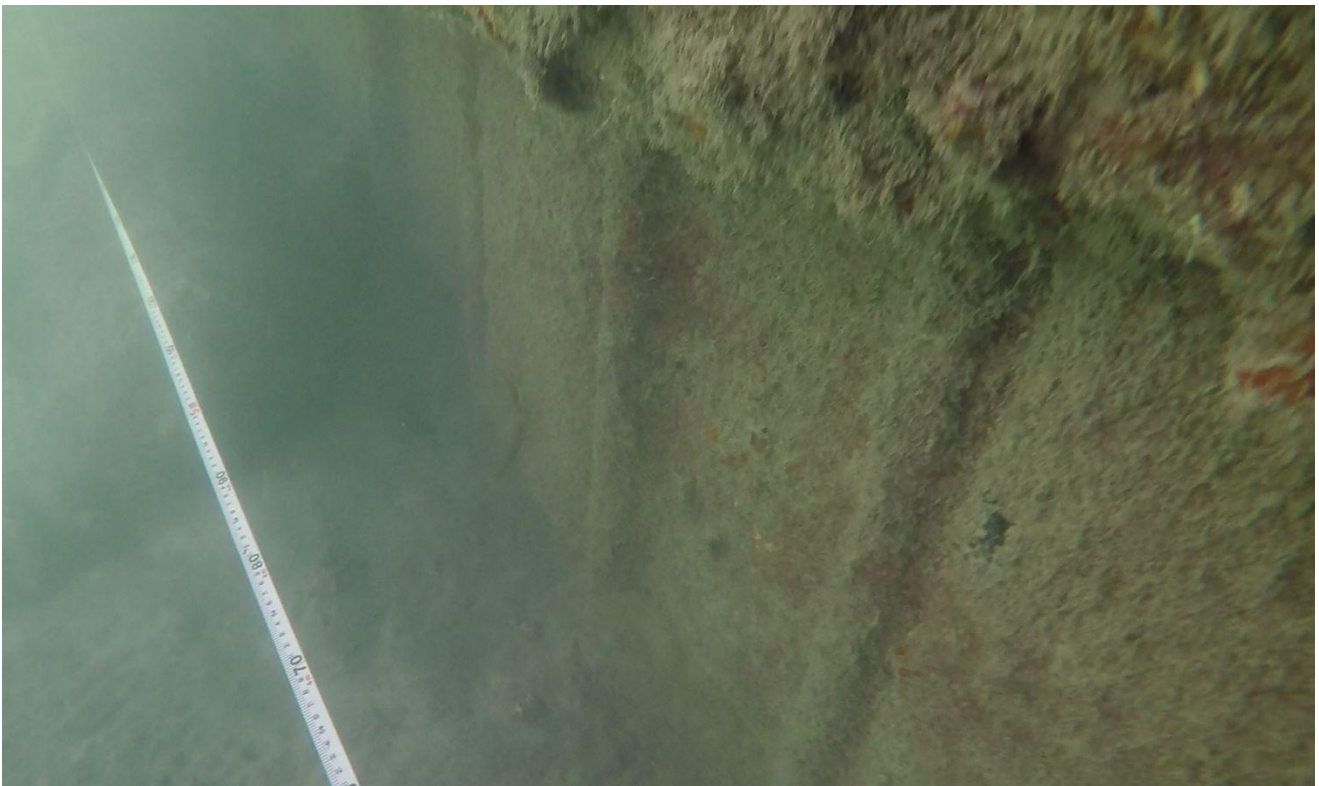
Underwater 4 - at 15ft 8in shows steel sheetpile and concrete cap in good condition

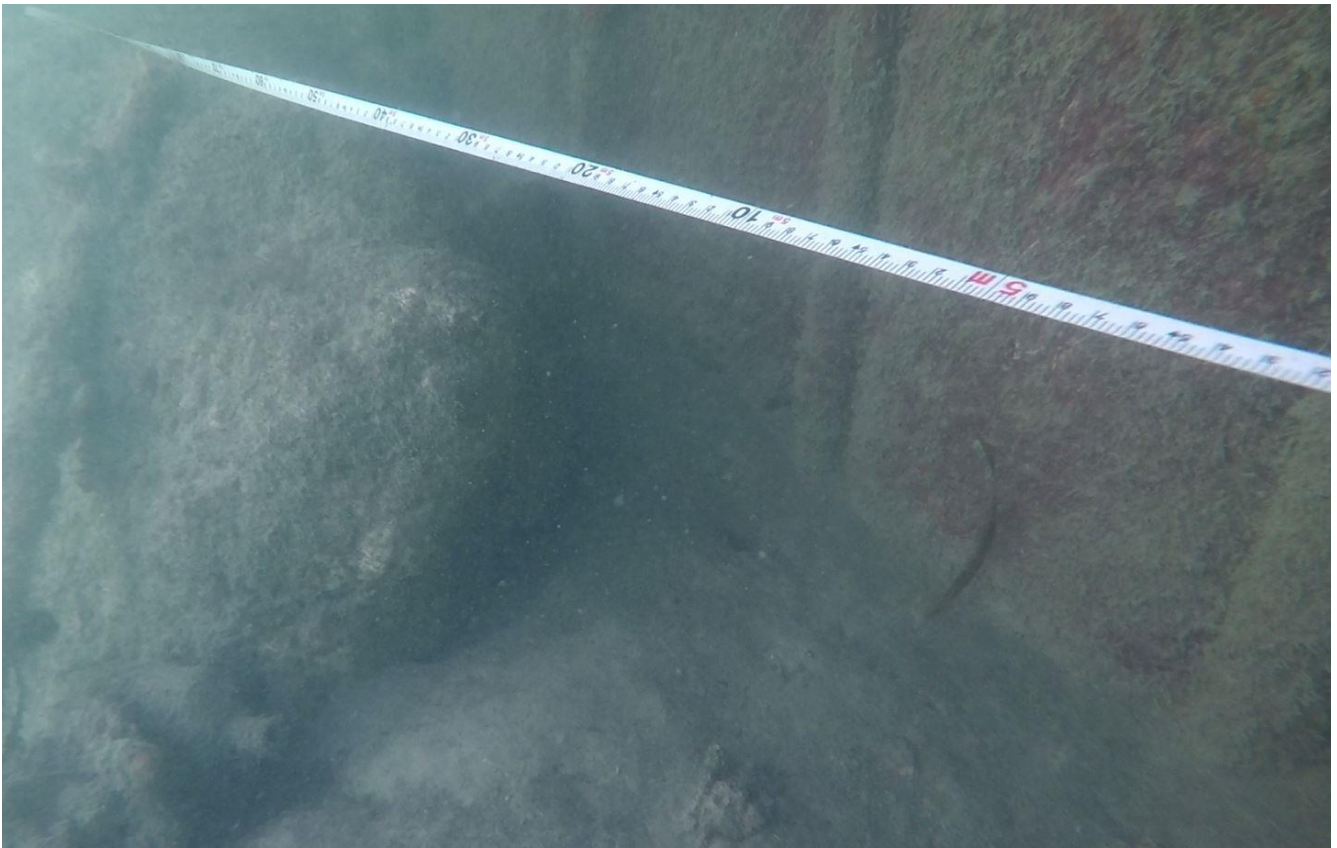
Underwater 5 - at 18ft 0in shows steel sheets driven through rock, rock sheered off left in front of wall

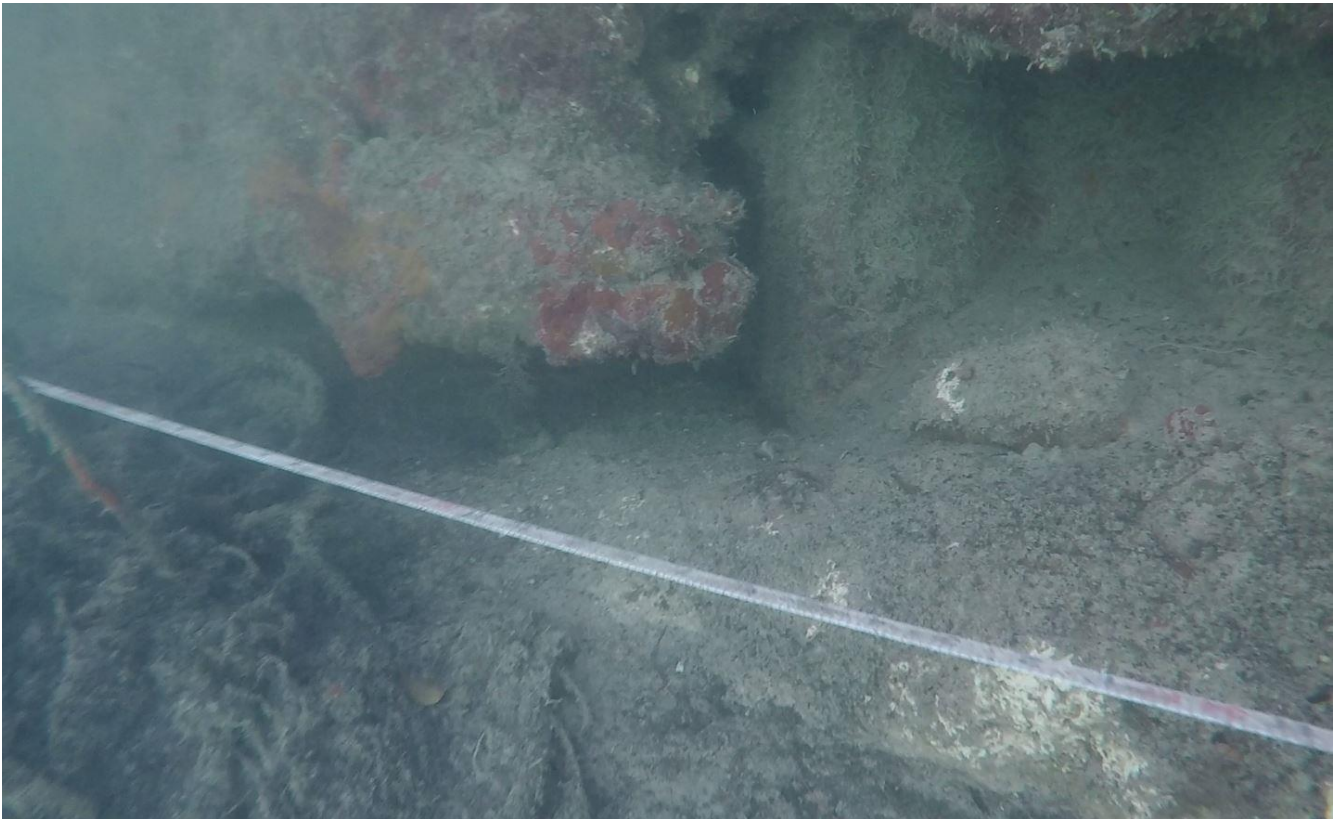
Underwater 6 - at 36ft steel sheet pile seems to have a void but it is only 6in deep at 36ft 8in

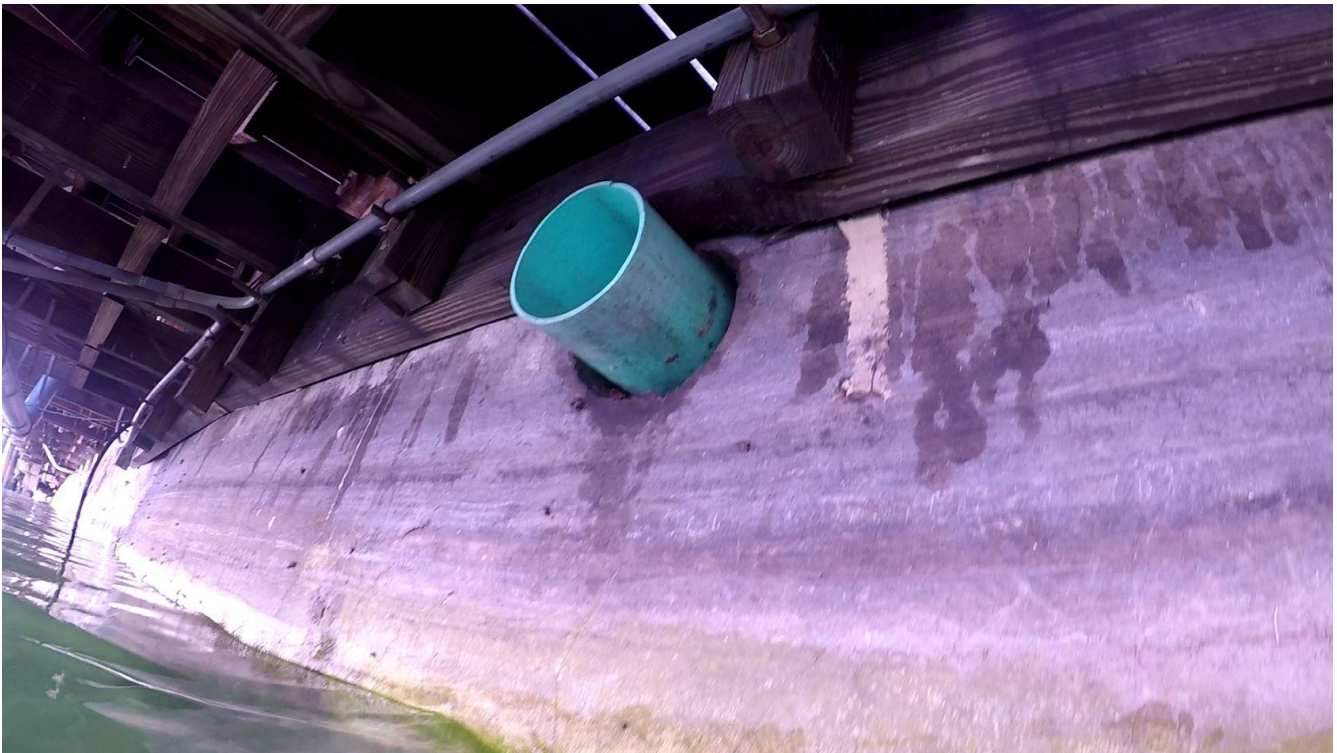
Underwater 8 - at 45ft above waterline looking east shows condition of concrete in good shape

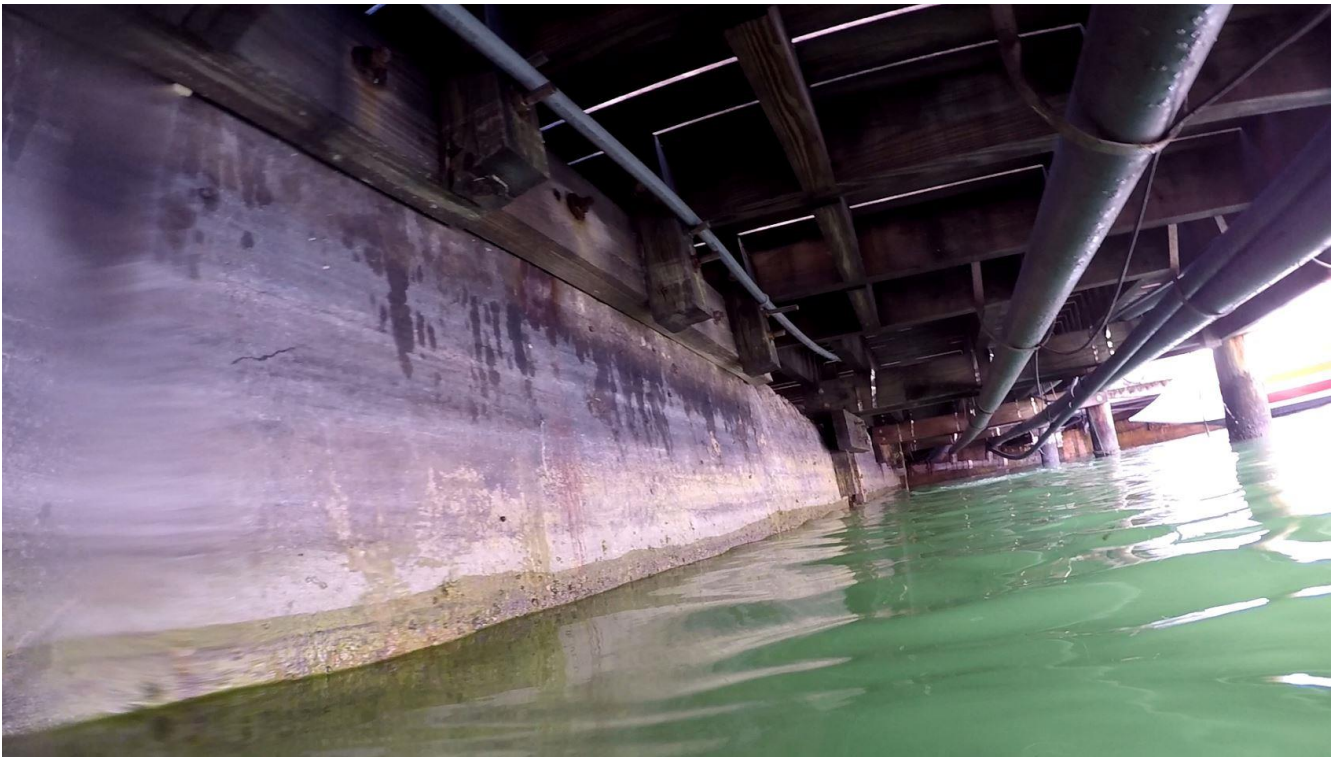
Underwater 9 - at 45ft above waterline looking west shows condition of concrete in good shape

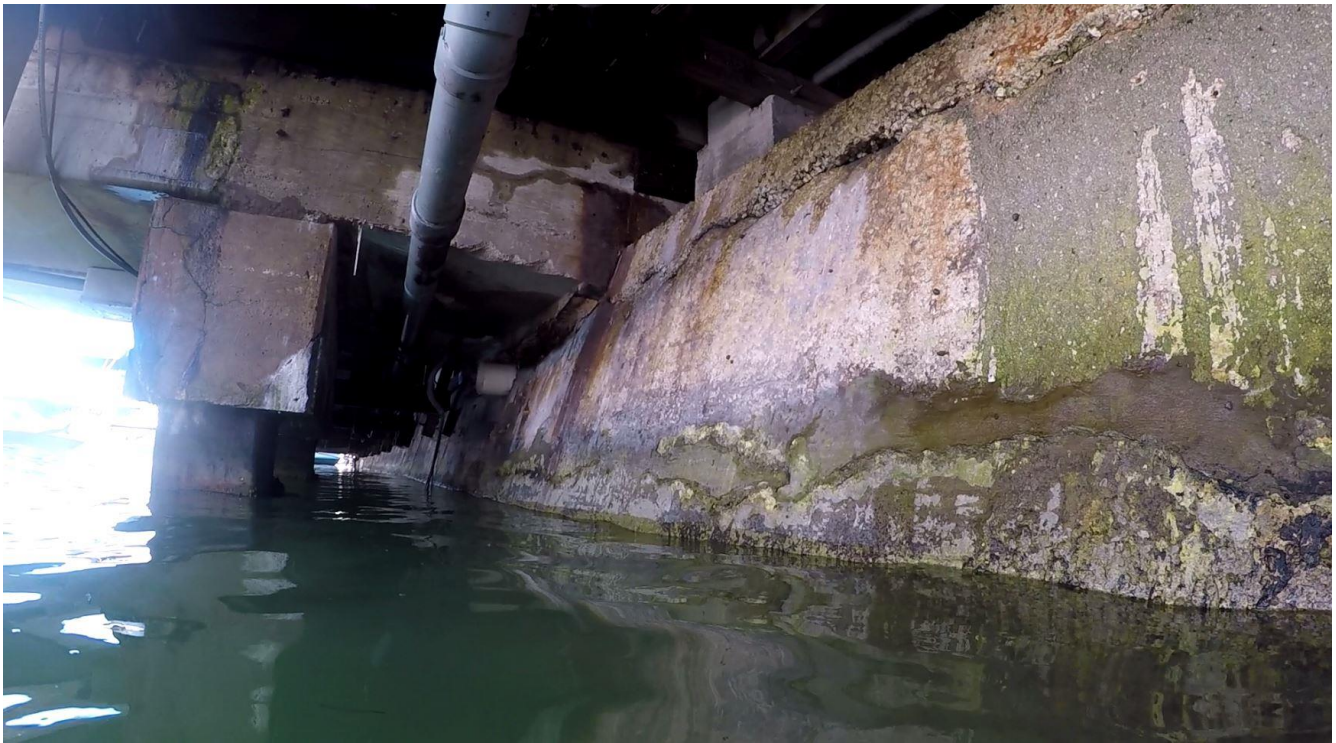
Underwater 17 - at 140ft above waterline looking east shows previous repairs and concrete piles supporting structures above wall

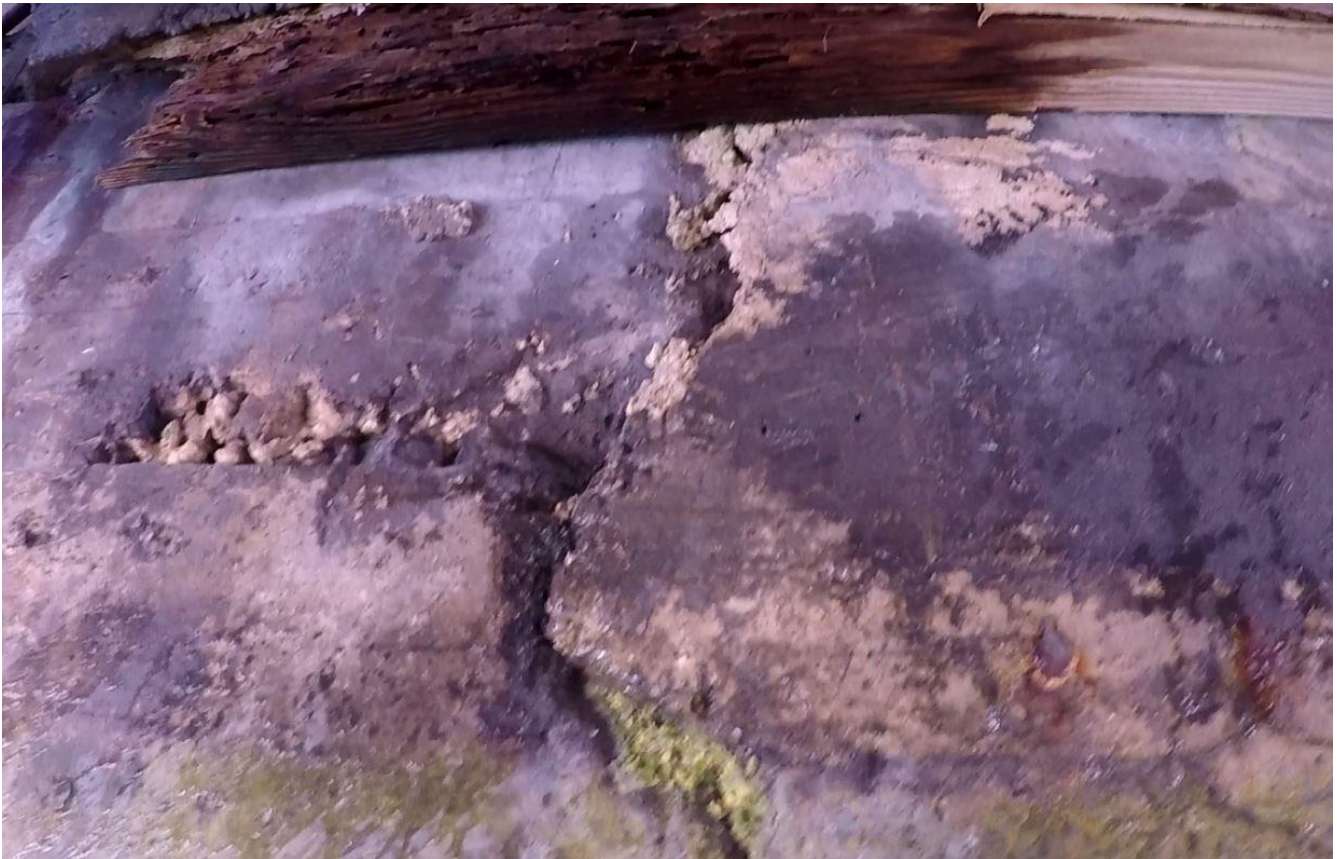
Underwater 20 - at 151ft above waterline shows large vertical crack

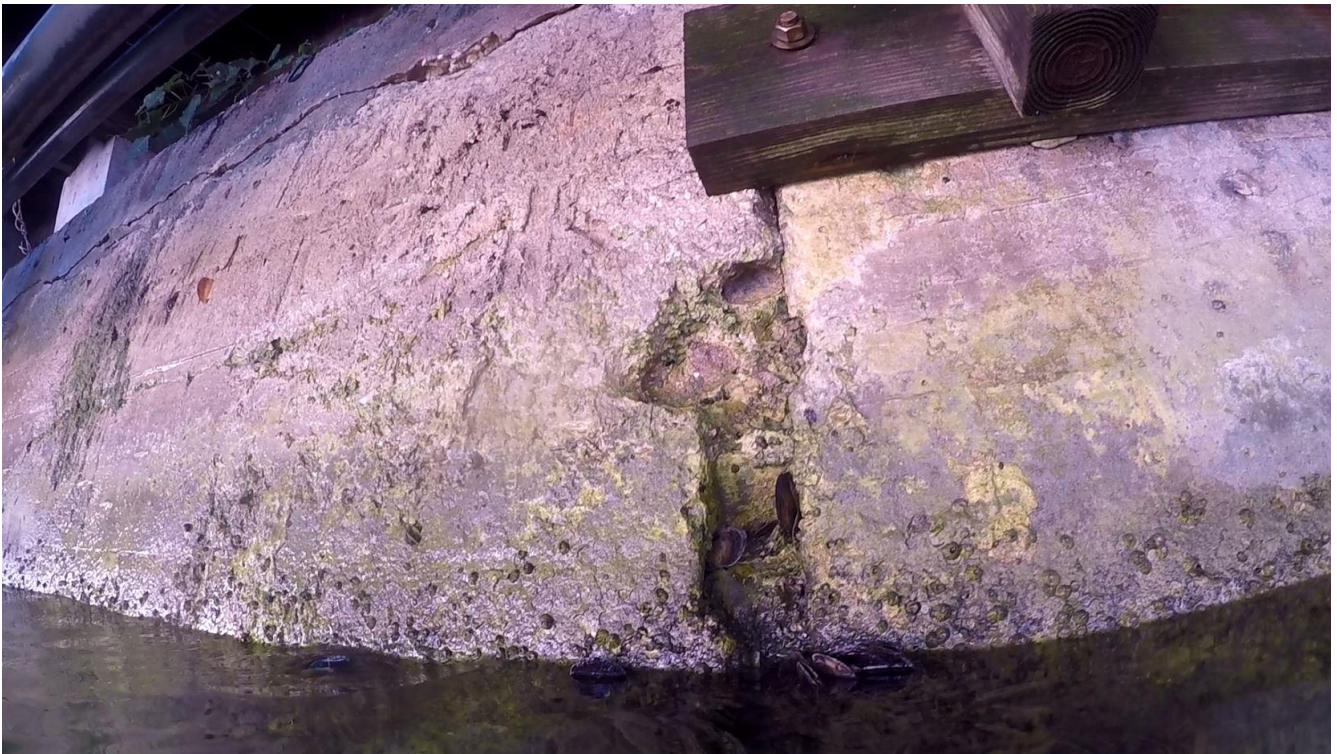
Underwater 24 - at 204ft shows old construction joint and spalling above the waterline

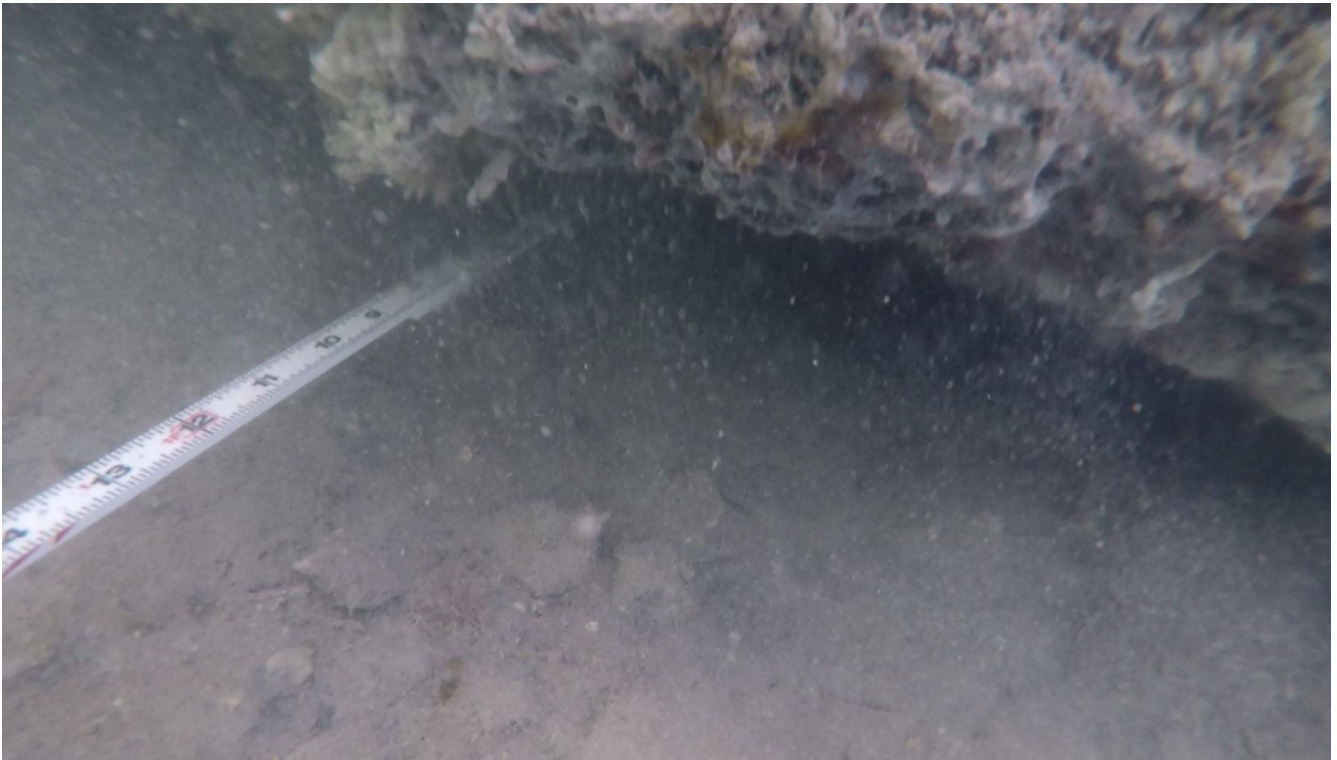
Underwater 25 - at 233ft shows 10ft long 8in deep void at toe of wall

The water depths along the face of the wall continued to shallow for the remaining portions of the wall from 1+32 to 4+40 with several cracks and voids along the mudline. The voids were discontinuous and relatively small and should be scheduled for re-inspection in 3-5 years.

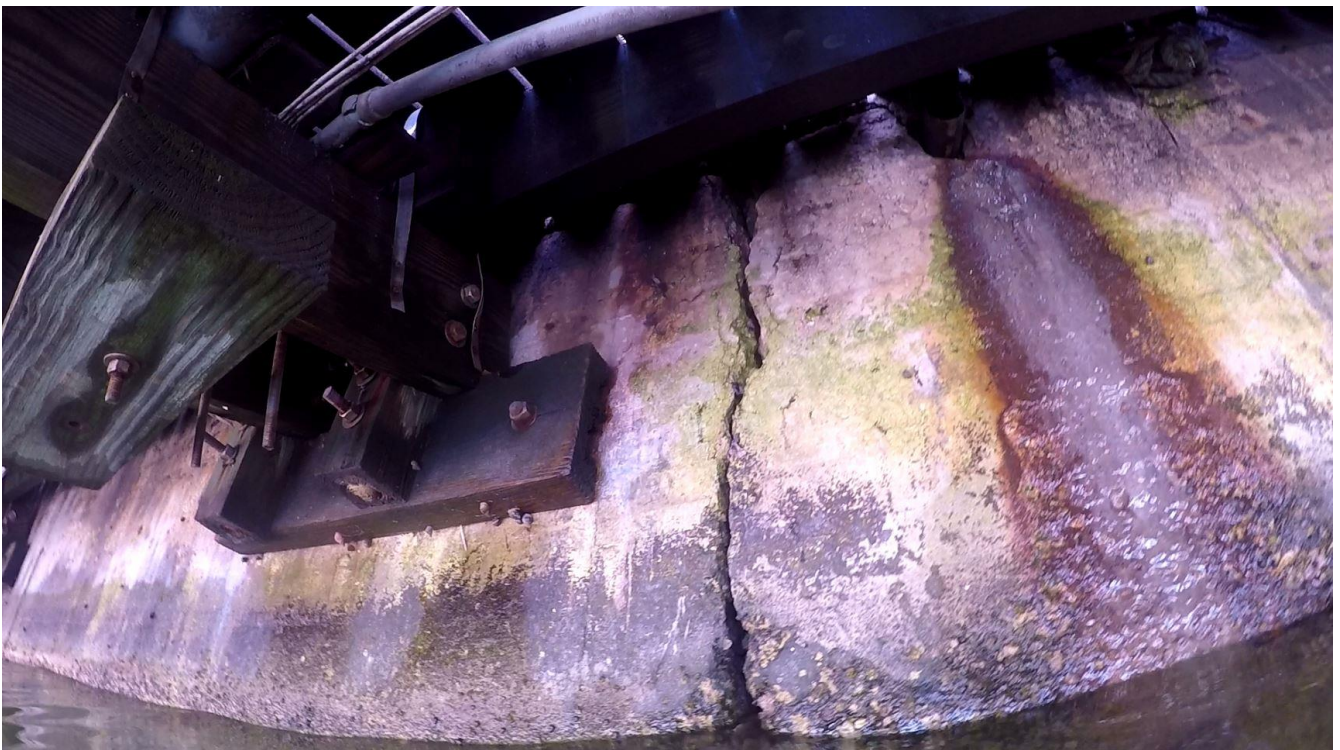
Underwater 32 - at 318ft above water shows large crack from top off wall all the way to the bottom

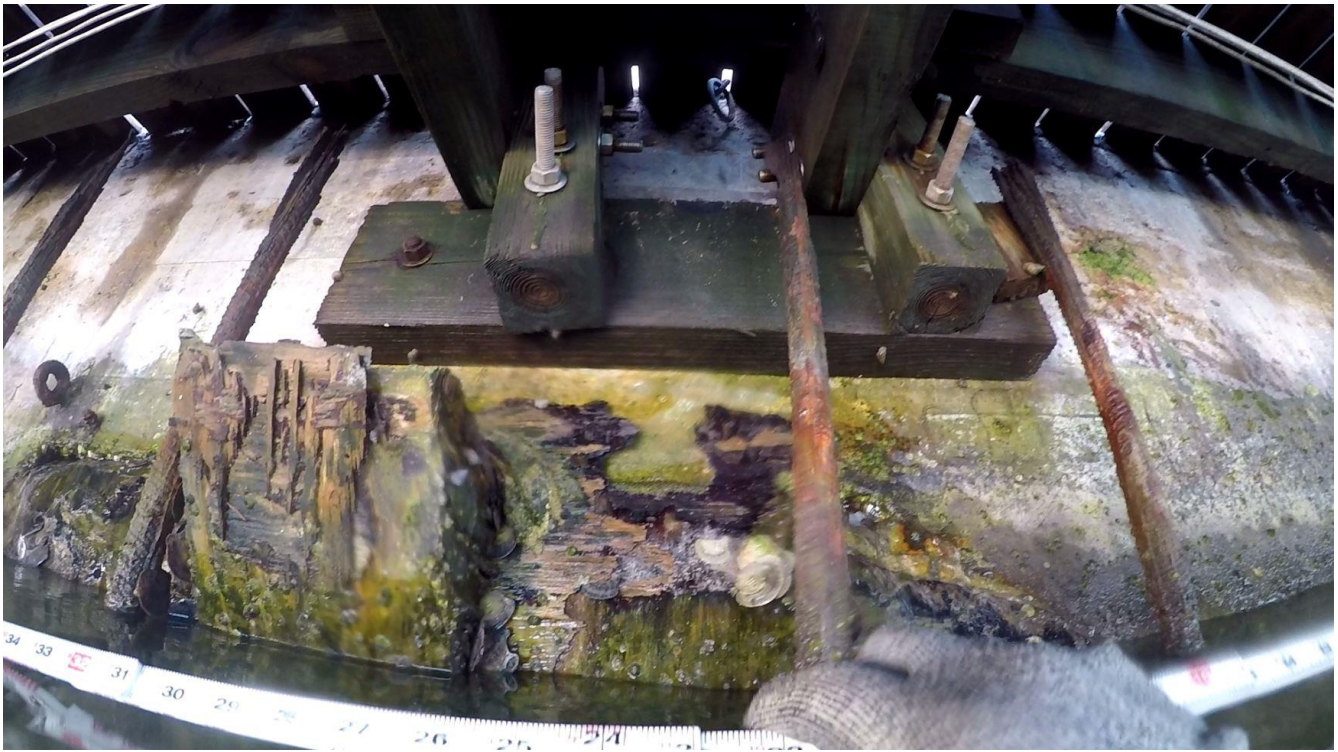
Underwater 35 - at 339ft shows a plug of some kind, with water leaking on both sides at top

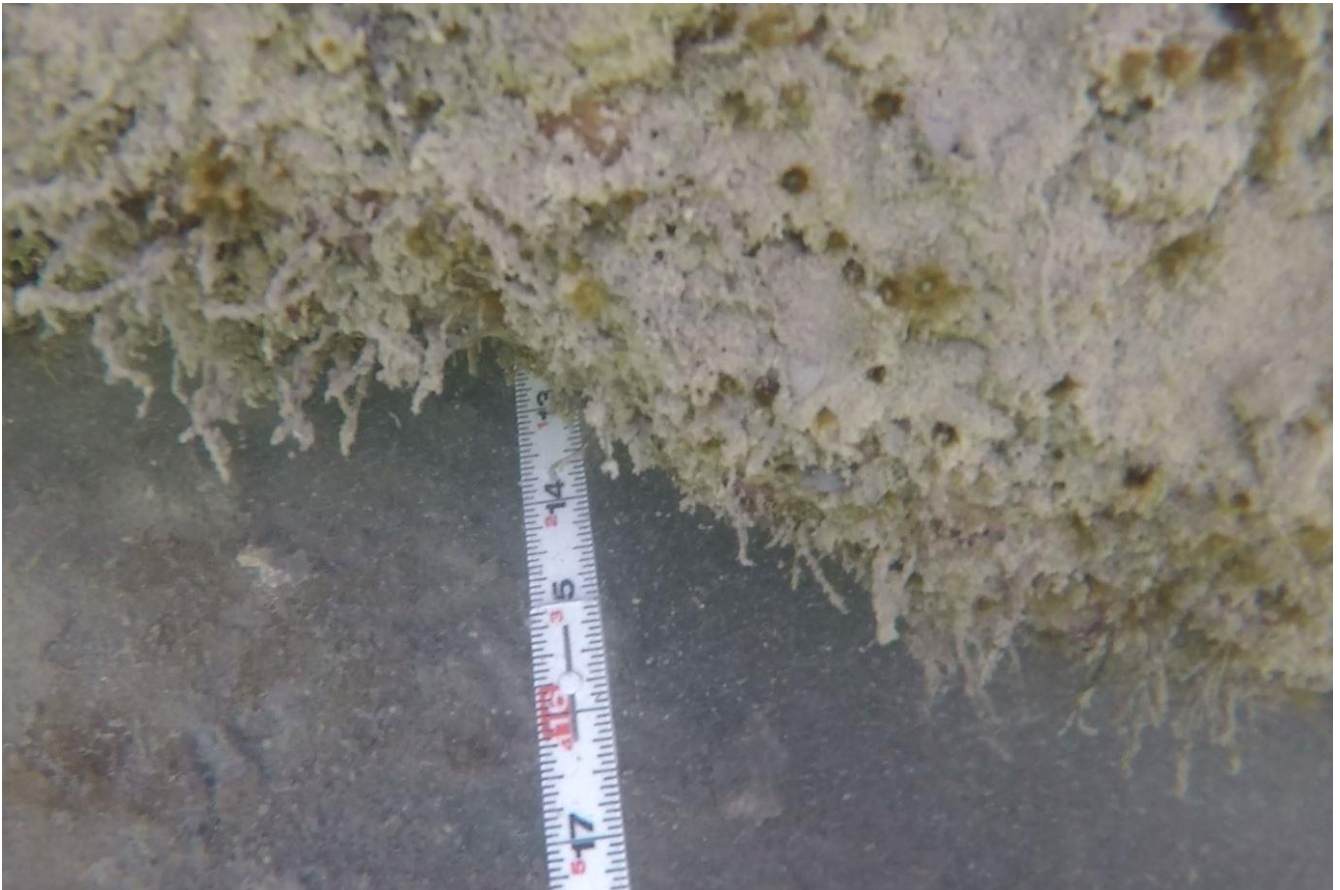
Underwater 43 - at 405ft shows 16in void
