CITY OF KEY WEST  
PORT AND MARINE SERVICES

KEY WEST BIGHT SEAWALL INVESTIGATION  
PHASE III  
SCHOONER WHARF TO CONCH REPUBLIC

SUBMITTED: February 5, 2018  
REVISED: May 10, 2018

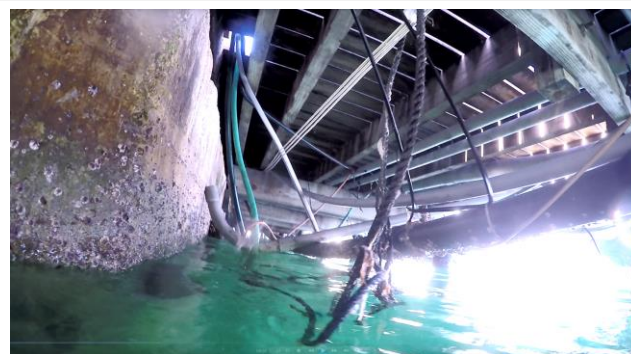
Figure 7: A-A, STA 0+47, Submerged Conduits

**Condition:** There is an 8" diameter, 6" deep hole in the concrete cap at STA 0+03, which should be grouted to prevent soil loss. Most of the sheets appear to be intact, although they are covered with marine growth, and due to the suspected age exhibit some minor corrosion and swelling at the knuckle joints. Some pitting is evident in the cap, typically 1/4"-1/2" diameter, and 1/2" deep on 50% of the surface. The overall condition of the wall is good, but most concerning in this area are the submerged utilities at the corner with Baseline B. These utilities should be re-connected to the dock walkway overhead to prevent breaks in the PVC housing conduits and exposure of utilities to salt water.

Location	Item	Condition Index	Recommendation
Baseline A STA 0+00 to 0+47	Overall Wall Condition	Good	Monitor Every 2-3 Years for signs of degradation to sheet piles/cap
STA 0+03	Isolated Hole (8" Dia)	Poor	Fill with Tremie or Pressure Grout
STA 0+47	Submerged Conduits	Poor	Install new hanger hardware

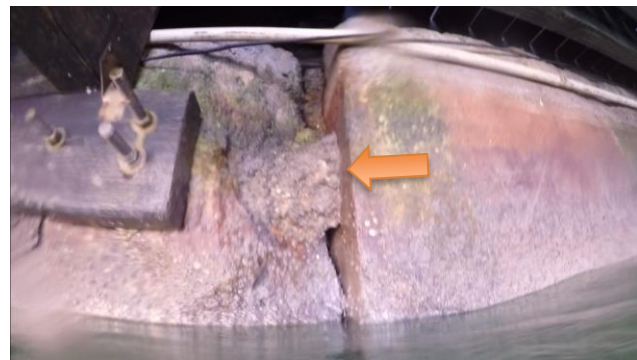
Figure 10: B-B, STA 0+50, Degraded Cold Joint

**Condition:** There is a man-made 14" x 14" hole 4 in deep penetration in the top of the sheet pile, immediately beneath the cap. It appears the sheet was cut off at this location. Unless there is a reason for this defect (for drainage or other purposes) it should be pressure grouted to prevent soil loss from behind the wall. A cold joint is present at STA 0+50, which had previously been epoxy coated, but it appears to be degrading. This area should be epoxy coated again. The remaining sheets appear to be intact. The cap exhibits moderate pitting (>1/4" deep). The overall condition of the wall is good, but as with the prior note, there are submerged utilities at the corner with Baseline A. These utilities should be re-connected to the dock walkway overhead to prevent breaks in the PVC housing conduits and exposure of utilities to salt water.

Location	Item	Condition Index	Recommendation
Baseline B STA 0+00 to 0+80	Overall Wall Condition	Good	Monitor Every 2-3 Years for signs of degradation to sheet piles/cap
STA 0+35	Isolated Hole (14"x14")	Poor	Fill with Tremie or Pressure Grout
STA 0+50	Isolated Cold Joint	Poor	Epoxy coat

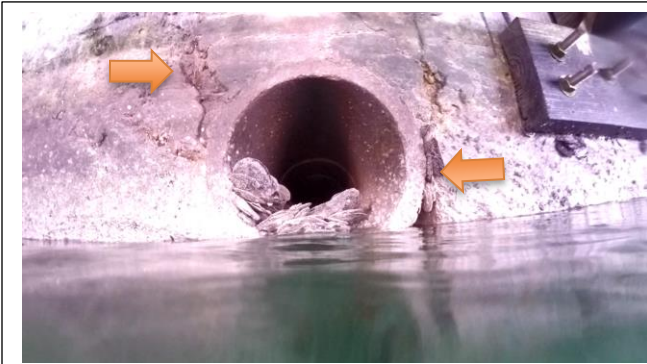
Figure 12: B-B, STA 0+87, Pipe Penetration w/ Cracking

**Condition:** A 12" diameter drainage pipe exits the wall at STA 0+87. Emanating from that penetration are a number of significant cracks, each measuring several feet in length, and approximately 1/2" wide. The steel sheets beneath appear to be separating due to section loss at the joint. A ficus tree at STA 1+00 (the entrance to Schooner Wharf) has roots overhanging the seawall, and while no notable damage appears to be present, ficus roots can be notoriously harmful to infrastructure. The relative significance of this tree to the establishment should be taken into consideration, but in terms of impacts to the seawall, it would be better to remove it, or at least trim the roots back periodically. A second set of roots is found overhanging the wall at STA 1+22. There is a 3" diameter punctured penetration in the sheet pile at 1+26, which is minor but should be patched. A disconnected utility line appears to be present at STA 1+30, although it appears to be devoid of any cable connections.

The overall condition of the wall is fair, and there is increased concern about the structural integrity of the wall due to the corroded sheet pile joints beneath the pipe.

Location	Item	Condition Index	Recommendation
Baseline B STA 0+80 to 1+60	Overall Wall Condition	Fair	Consider replacement. At a minimum, monitor Every 2-3 Years for full replacement.
STA 0+87	Cracks from Pipe Penetration	Poor	Epoxy coat all cracks, monitor for signs of joint degradation at 1 year intervals.
STA 1+00 and 1+22	Roots overgrowing seawall	Poor	Consider removing vegetation or trimming roots periodically
STA 1+26	Puncture Hole	Poor - Minor	Grout or epoxy-fill

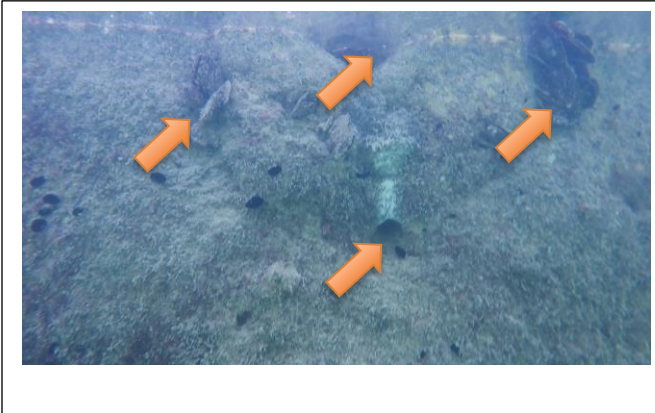
Figure 18: B-B, STA 1+71, Several 3" Dia. holes in cap

**Condition:** This section of wall is in overall good condition. There are a few isolated areas of concern. At STA 1+71, there are three to four small penetrations in the cap that appear to be drain lines. The cap along this section is broken and cracked from approximately STA 1+60 to STA 2+10, contributing to a potential trip hazard. Some exposed rebar can be found in the spalled portions. At STA 2+81 there is a large piece of concrete debris and nearby at STA 2+86 there is a 4 in diameter hole in the sheet pile with a void extending approximately 25" behind it.

Location	Item	Condition Index	Recommendation
Baseline B STA 1+60 to 3+36	Overall Wall Condition	Good	Monitor Every 2-3 Years for signs of degradation to sheet piles/cap
STA 1+71	Isolated Holes (3-4 @ 3" Dia)	Fair - Minor	Determine if functional outfalls. If not, fill with Tremie or Pressure Grout
STA 1+60 to 2+10	Broken Concrete Cap	Poor	Demolish cap and reconstruct
STA 2+86	Hole in sheet with void	Poor	Fill with Tremie or Pressure Grout

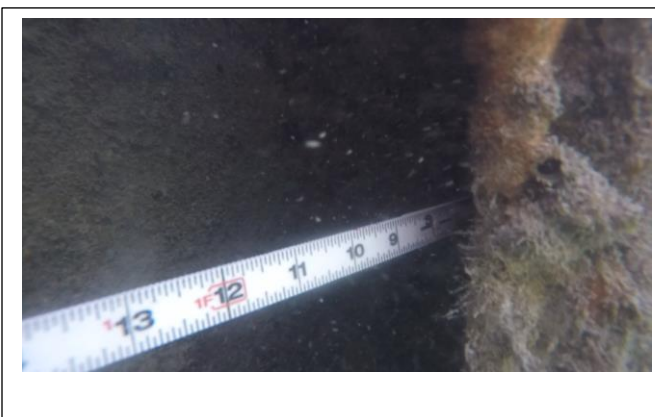
Figure 22: C-C, STA 0+07, Begin steel sheet piling

**Condition:** This section of wall is in overall poor condition. The most apparent change in the transition from Baseline B-B to Baseline C-C is the emergence of a more severely corroded sheet pile throughout the limits of C-C. The sheets are corroded and swollen at the corners and along the joints, indicating a higher degree of corrosion. In many cases, these corroded locations have become long fissures. Isolated cases of defects are distributed throughout, but on account of the loss of structural integrity to the sheets, this wall must be considered to be in poor condition and is a candidate for replacement.

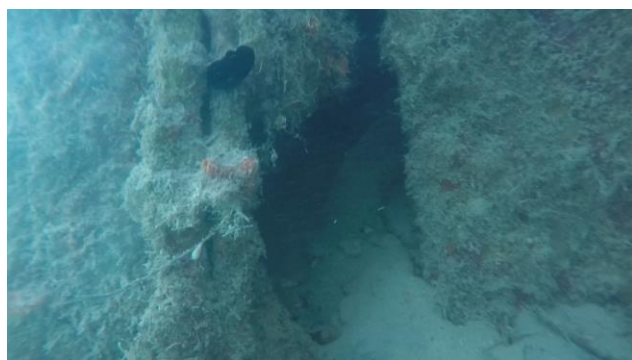
Figure 26: C-C, STA 1+36, Separation of sheets (View 1)

**Condition:** This section of wall is in overall poor condition. Consistent with the first segment of Section C-C, this wall also exhibits signs of severe corrosion of the sheet piles. In one instance, at STA 1+36, the sheets have separated and a void space of 20" may be found behind the wall. This sheet appears to have "toed out", a mode of failure indicative of insufficient penetration of the sheet pile.

Location	Item	Condition Index	Recommendation
Baseline C STA 0+80 to 1+60	Overall Wall Condition	Poor	Replacement
STA 1+36	Separation of sheets	Poor	Replacement due to overall condition
STA 1+57	Cracked cap	Poor	Replacement due to overall condition

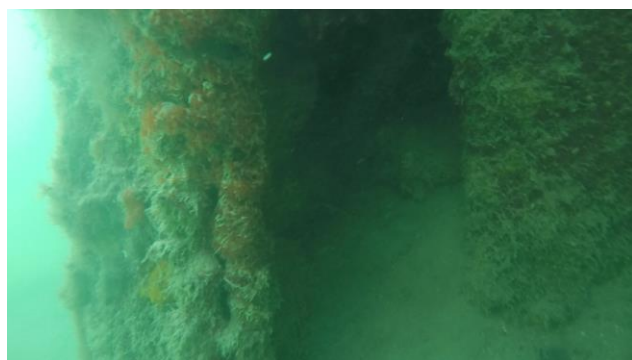
Figure 30: C-C, STA 1+69, Separation of sheets (View 1)

**Condition:** This section of wall is in overall poor condition. Consistent with the prior two segment of Section C-C, this wall also exhibits signs of severe corrosion of the sheet piles. As had been the case at STA 1+36, the sheets have separated again at STA 1+69, with a “toe-out” failure mode present, indicating insufficient penetration of the sheet pile. In Figures 32 & 33, there are large spall areas with exposed rebar.

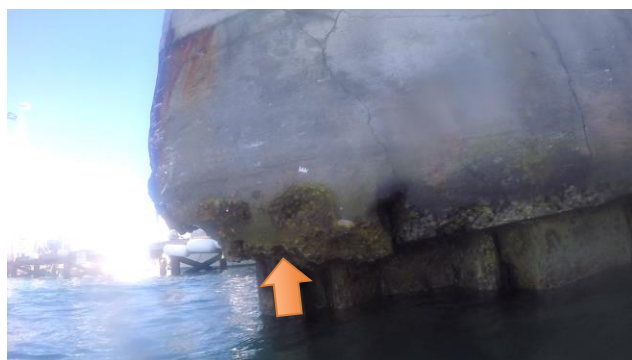
Figure 34: D-D, STA 0+00, Spalled cap at corner

**Condition:** This section of wall is in overall poor condition. Consistent with Baseline C, the wall exhibits similar levels of corrosion on the sheets. Although this is a shorter run of wall, the need to replace Baseline C should incorporate Baseline D to provide a homogenous interlocking wall for increased stability to the adjacent uplands.
