Structural Evaluation Report  
for existing one-story ground level commercial building

Property Address:  
**"Piano Shop"**  
**907 Caroline St,**  
**Key West, FL 33040**

AD Job#: 1804-15  
City of Key West P.O.: 086088

Artibus Design  
April 2018

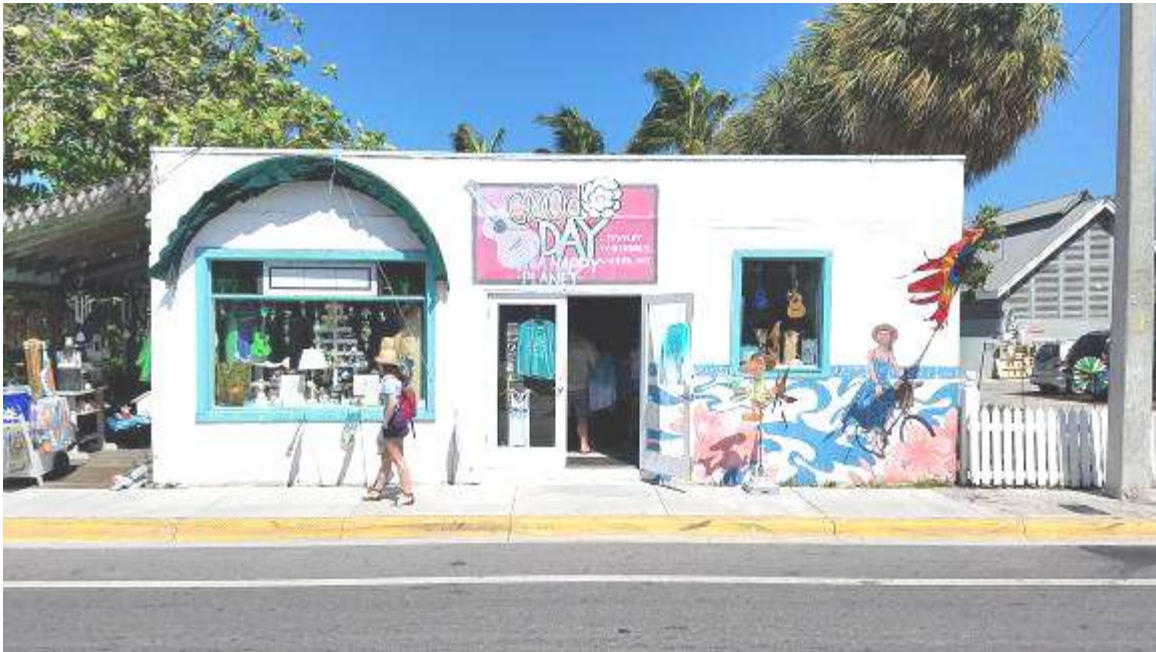
Figure 3. Front Elevation. Visible concrete damage – cracks along tie-beam above windows.

In my professional opinion overall condition of the building is poor. Concrete tie-beam around entire building perimeter needs to be replaced together with the parapet wall above. All roof rafters are currently supported by the embedment into the concrete which will have to be removed. New ledger will be required around the building perimeter and all rafters shall be sistered with PT wood lumber since so many locations of heavy damage were discovered – it is likely that all rafters are termite damaged to some extent.

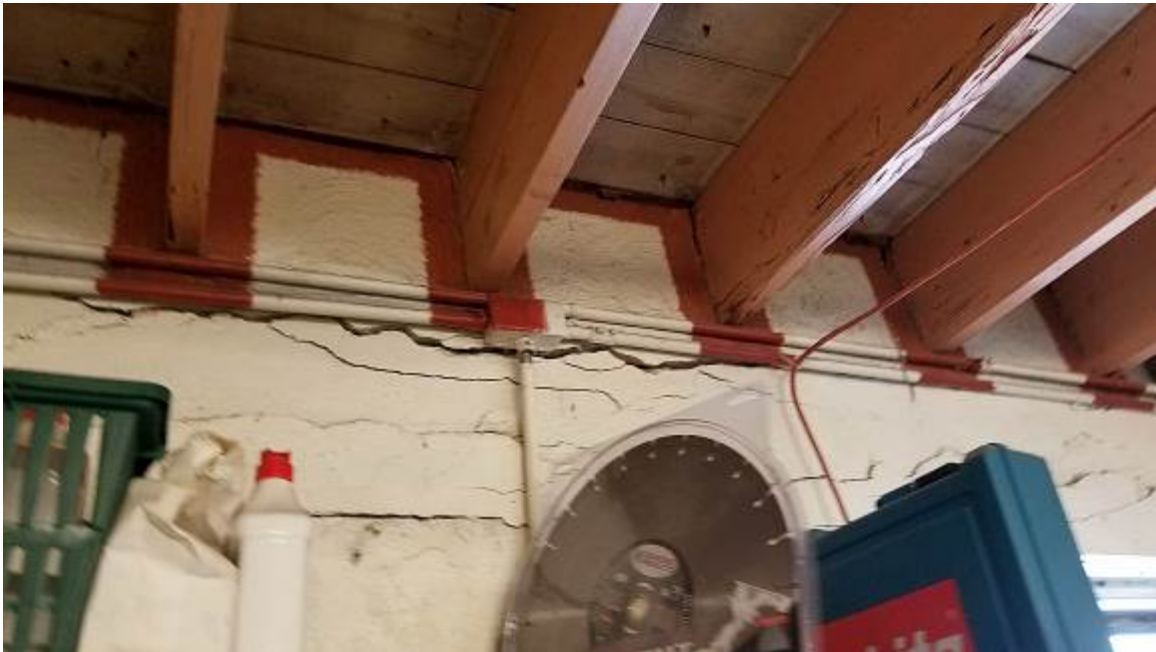
Figure 11. Same as above. Heavy concrete damage, damaged rafters and more electrical conduits.

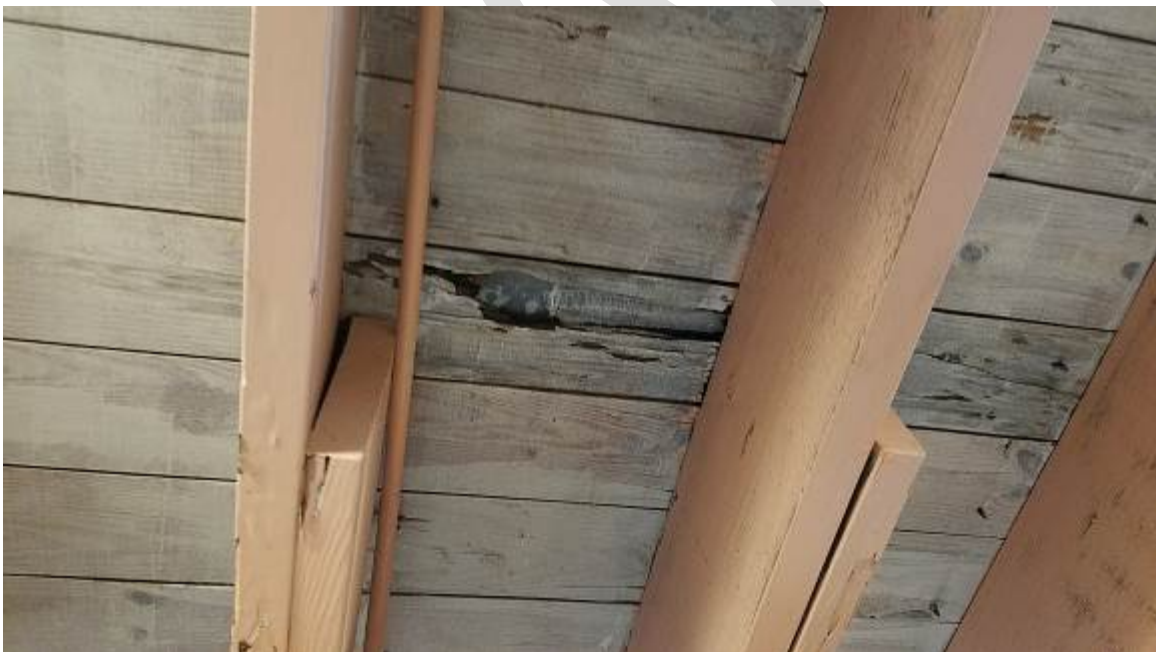
Figure 12. Roofing deck with hole demonstrating heavy termite damage to deck boards in some locations.

In my professional opinion up to 30% of the roof decking board require replacement, which will require new roofing system to be installed (replacement of the parapet wall would require such work as well).

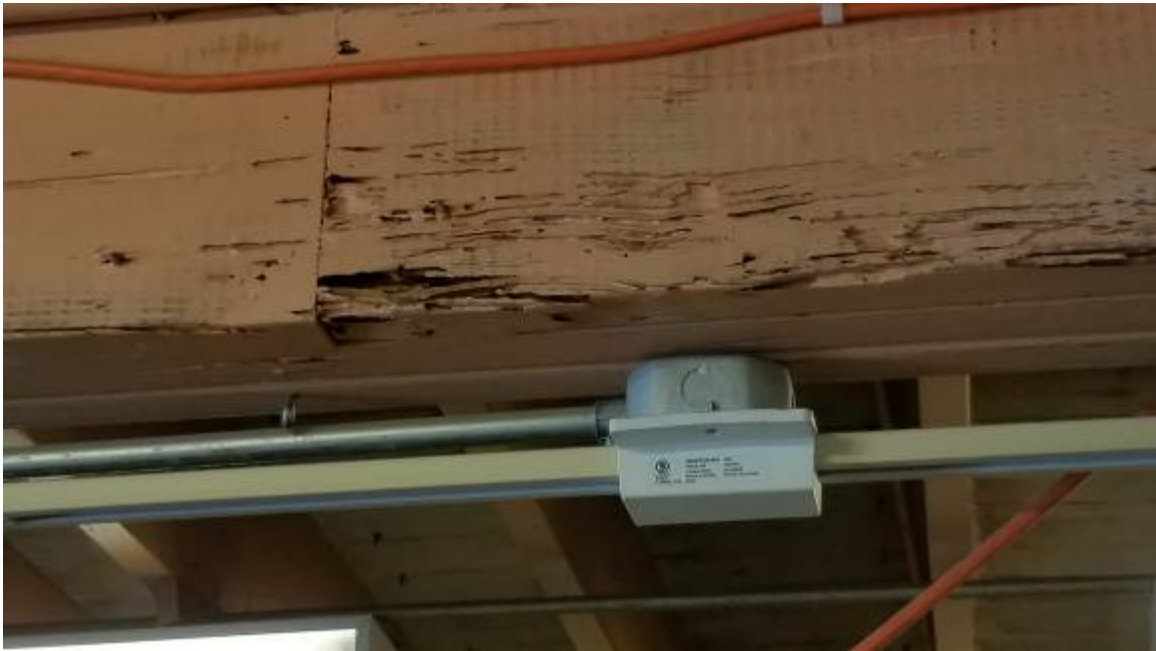
Figure 13. Termite damage to the middle roof beam and attached electrical components.

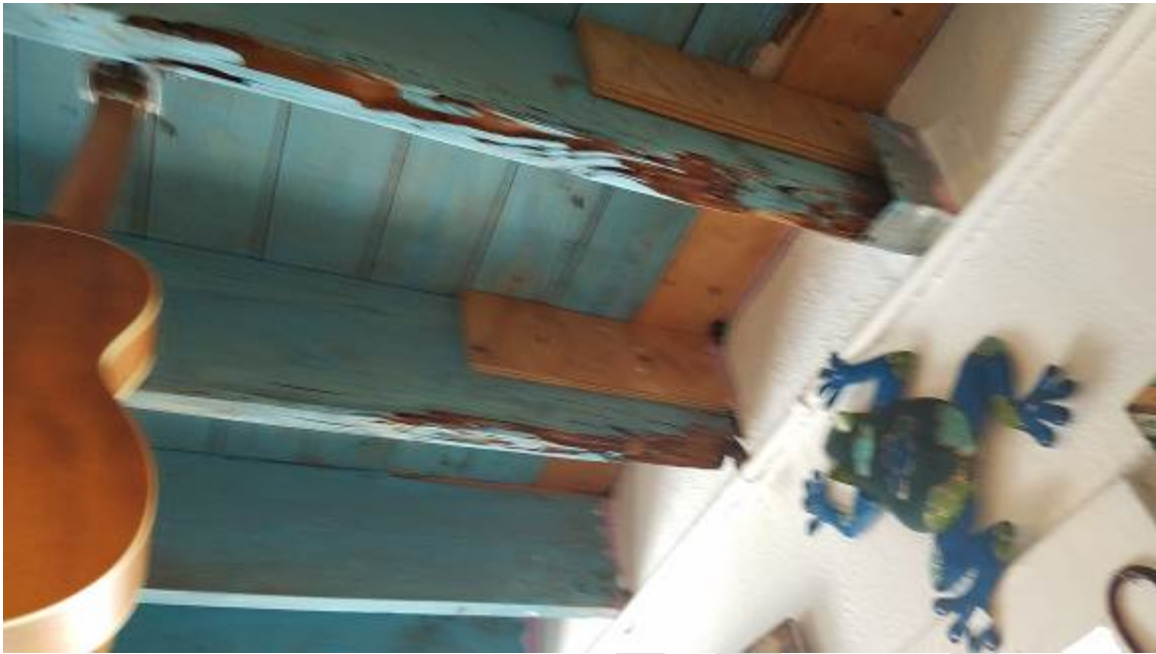
Figure 15. Heavy termite damage to the rafters (interior of the gift shop).
