Structural Evaluation Report
for existing one-story ground level commercial building

Property Address:
"Piano Shop"
907 Caroline St,
Key West, FL 33040

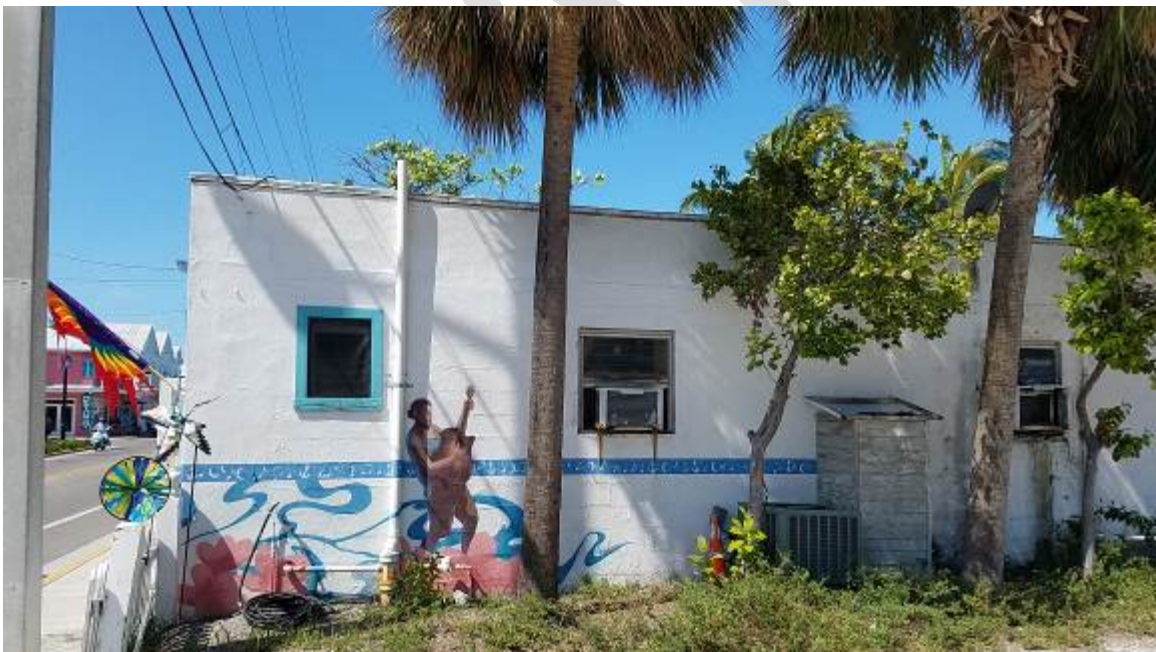
Figure 4. Partial right side elevation. More cracks in the tie-beam. Damaged jalousie style glazing with window a/c units.

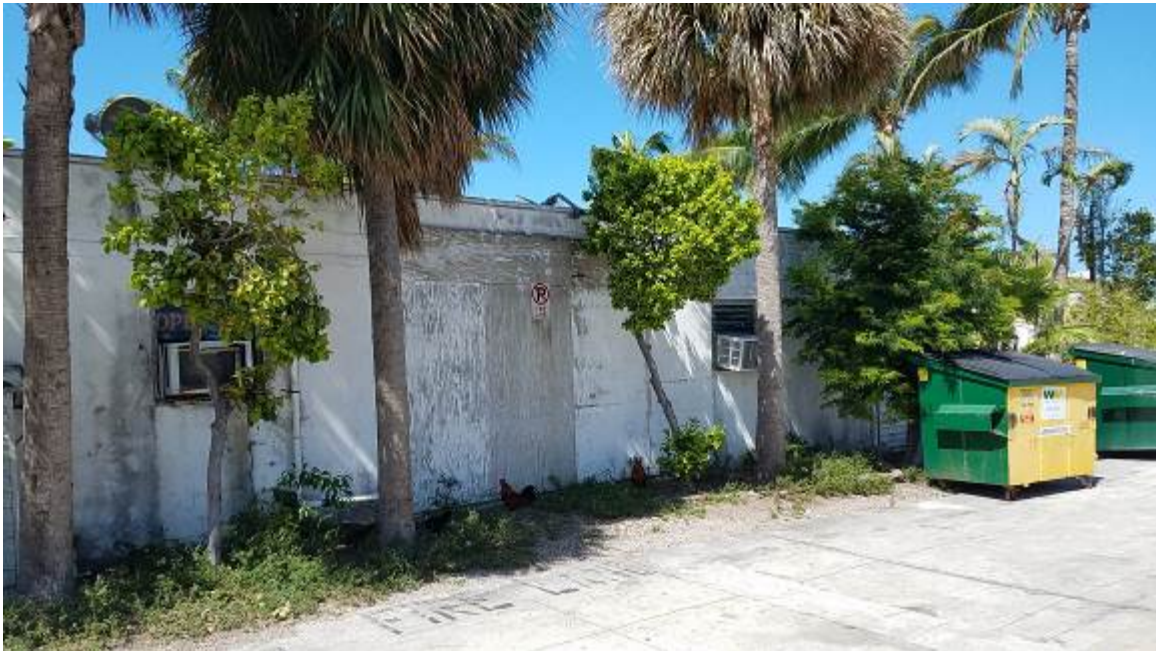
Figure 5. Partial right side elevation (middle of building). Large area covered with plywood which prevents damaged concrete debris from falling. Old paint and more damaged windows.

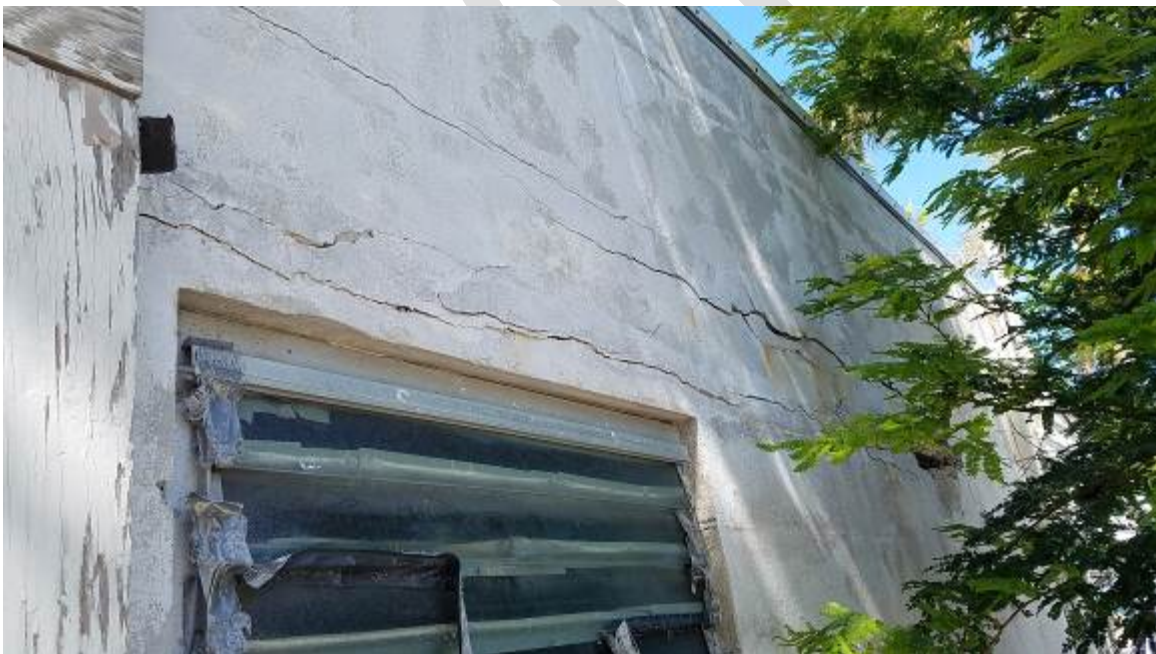
Figure 6. Same as above. Close-up view. Tie-beam with extensive damage and window sealed with duck tape.

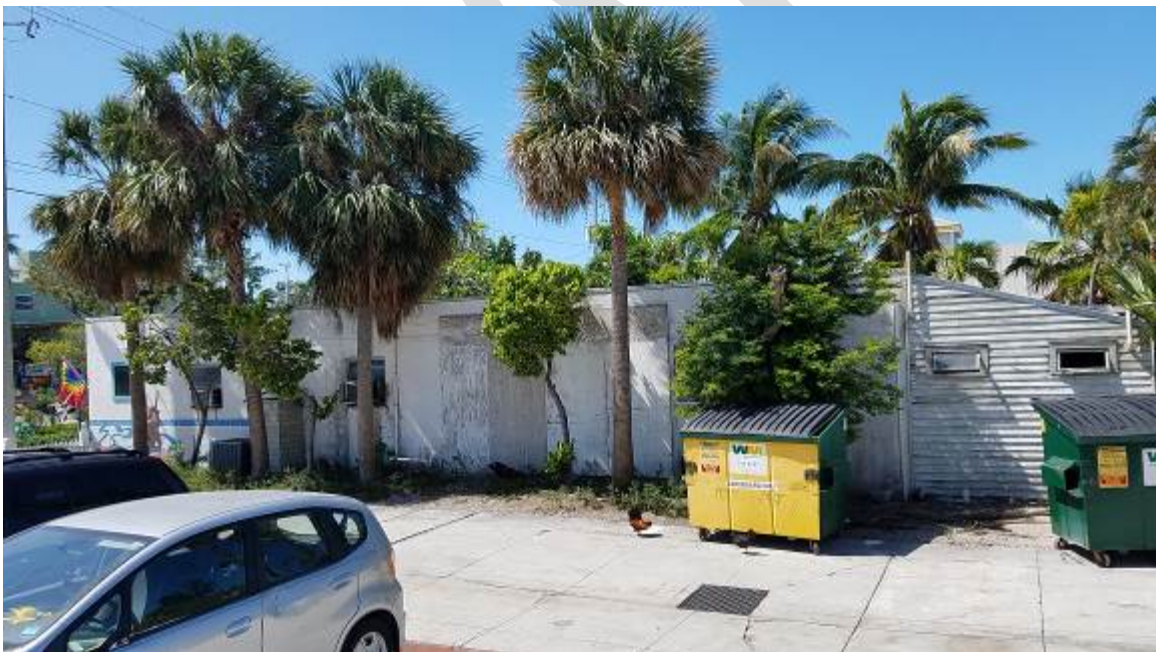
Figure 8. Overall right side elevation with rear wood frame shed.

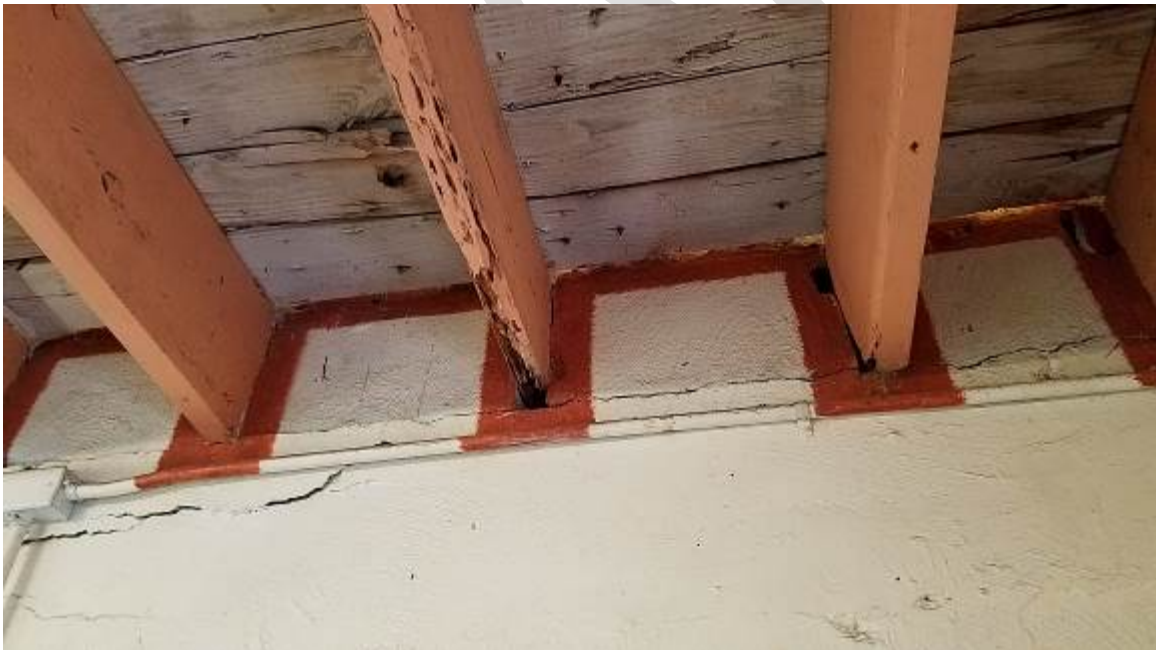
Figure 10. Maintenance shop - Interior view with damaged top of tie-beam and heavily damaged roof rafter. Damaged wood roofing deck. Please note electrical conduits along the tie-beam.

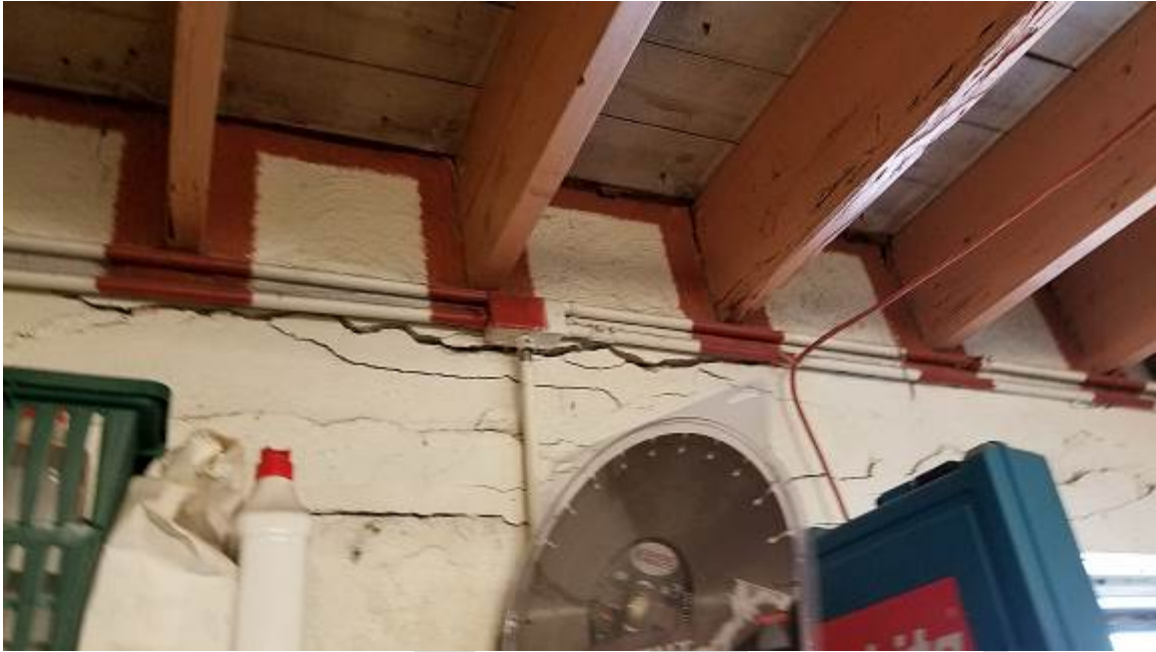
Figure 11. Same as above. Heavy concrete damage, damaged rafters and more electrical conduits.

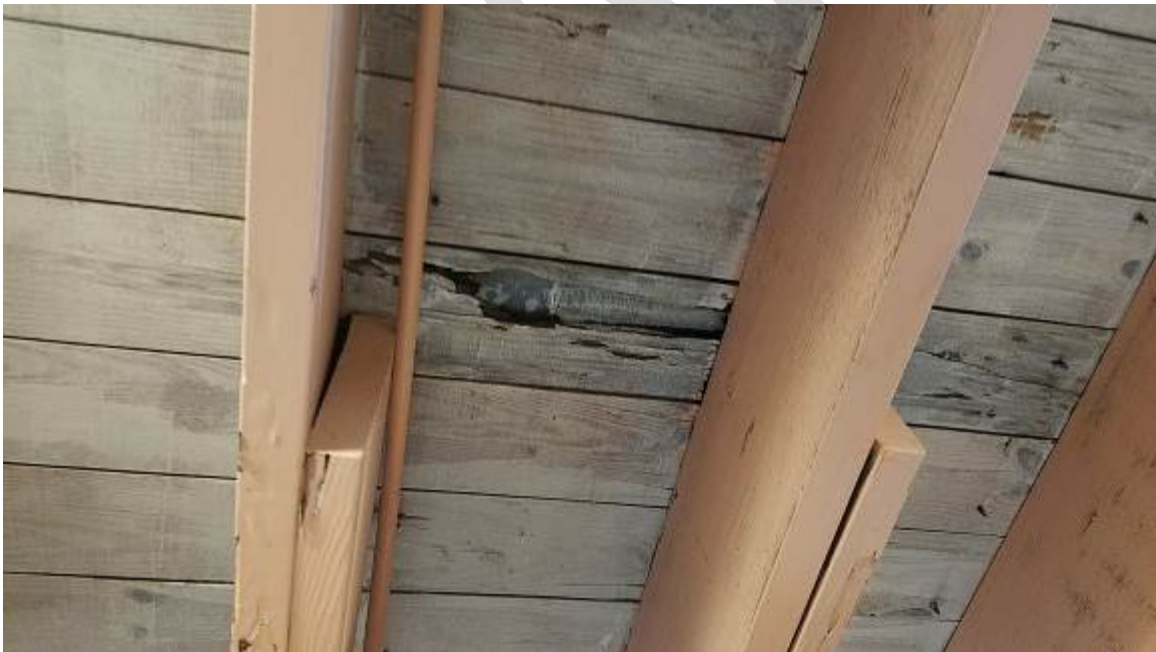
Figure 12. Roofing deck with hole demonstrating heavy termite damage to deck boards in some locations.

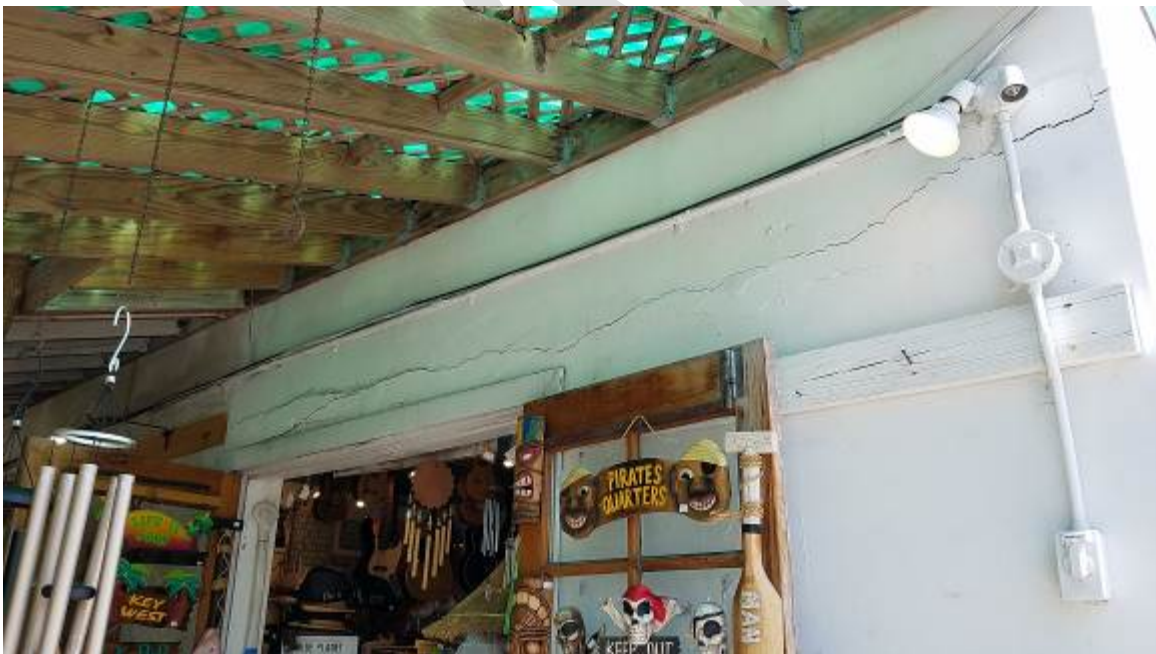
Figure 14. Heavy spalling damage above the side entrance into the gift shop. Large sections of concrete debris are unsecured and may fall creating life & health safety hazard. Roofing above with a patchwork of non-conforming improvements. More electrical components in the way of repairs.

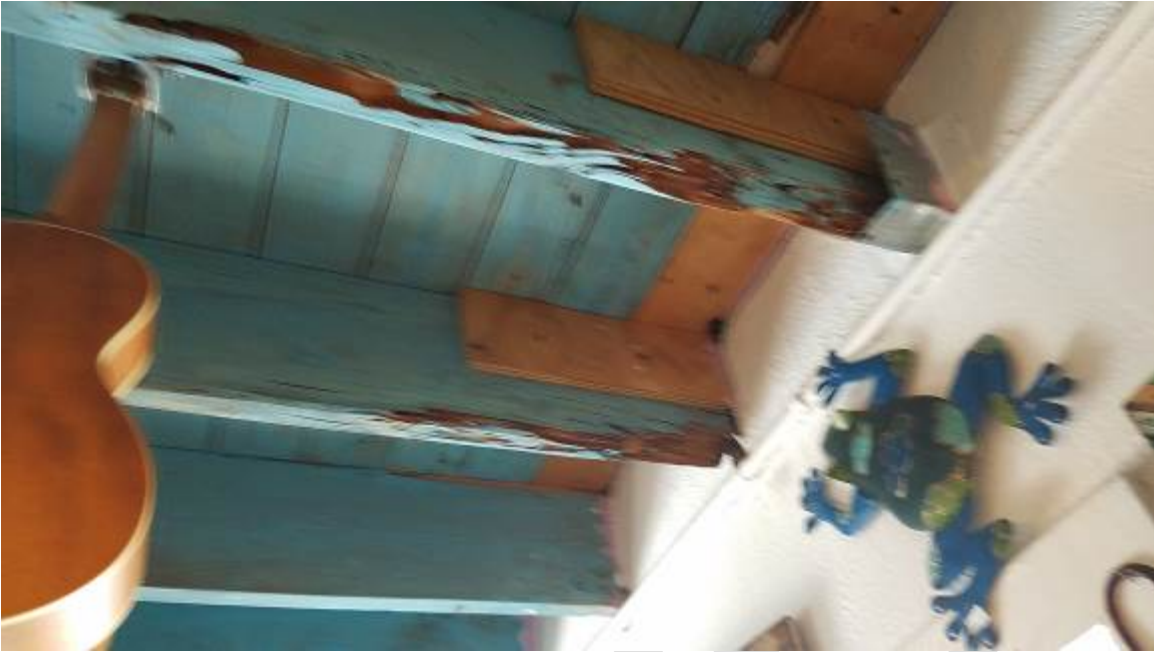
Figure 15. Heavy termite damage to the rafters (interior of the gift shop).

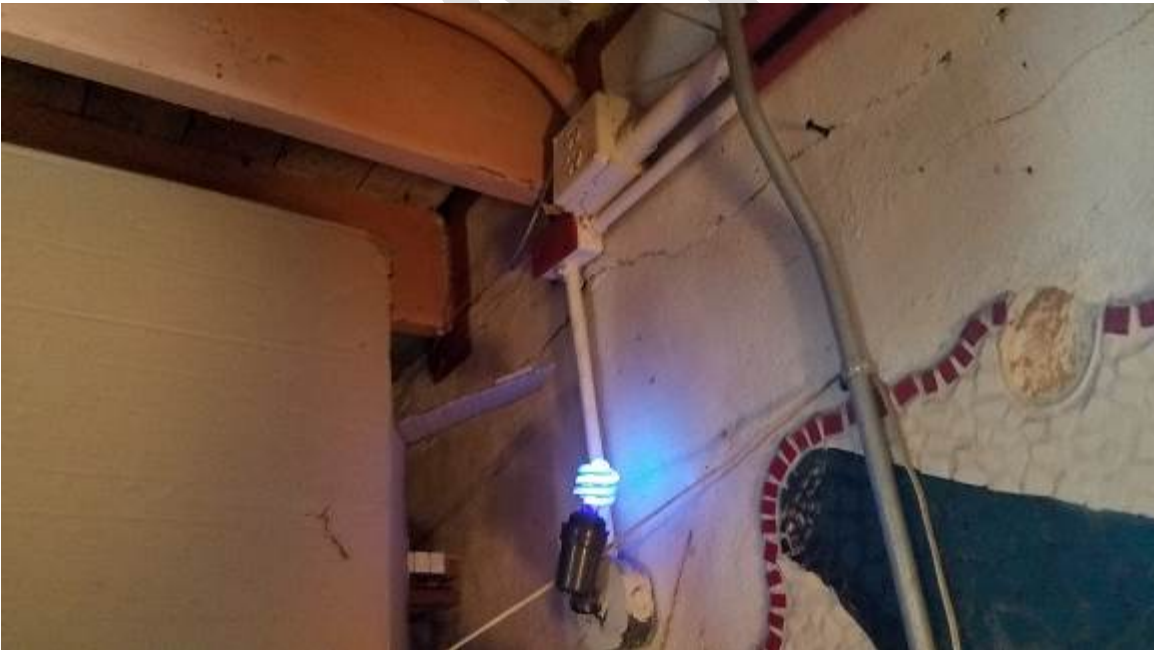
Figure 16. More electrical conduits, outlets and lights at the level of tie-beam and roof rafters requiring repairs.
