## MEMORANDUM

DATE: April 5, 2019

RE: 2023 Flagler Avenue

FROM: Karen DeMaria, Urban Forestry Manager, City of Key West

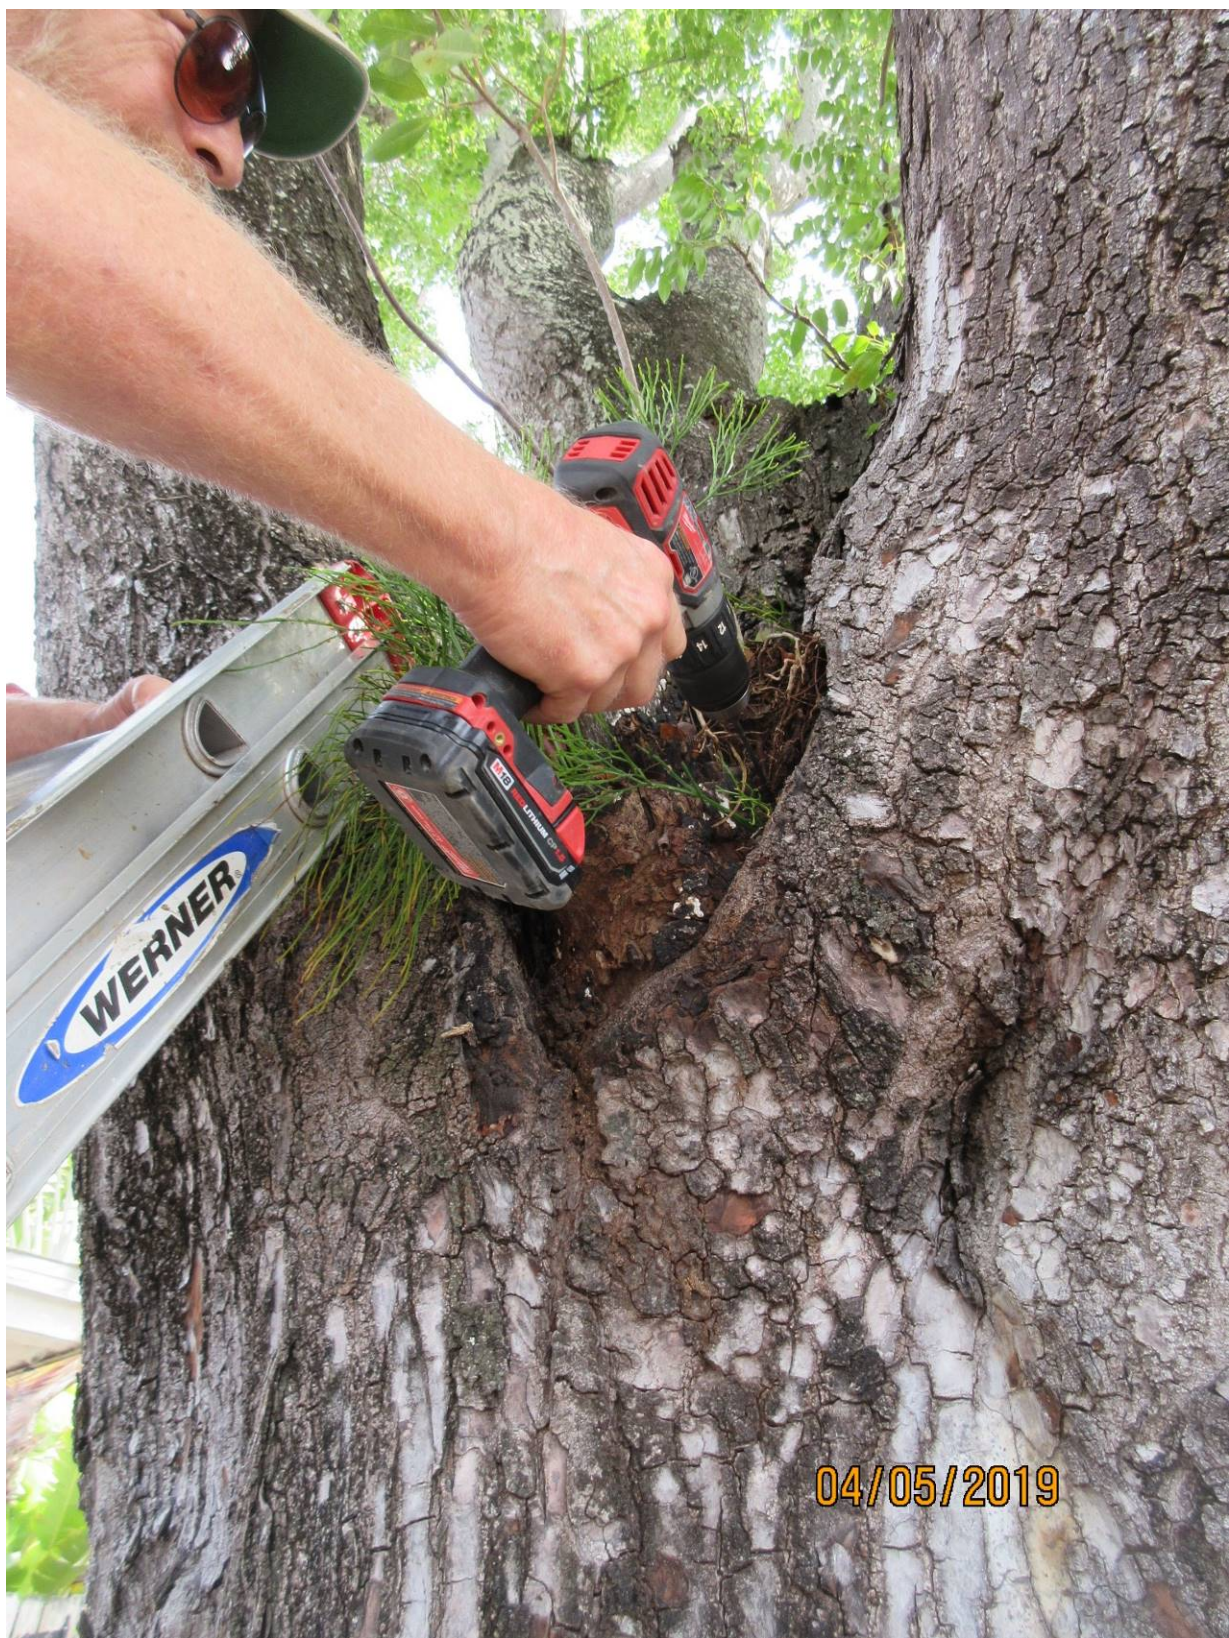
Drill location above-drill bit easily into trunk-10" soft wood.

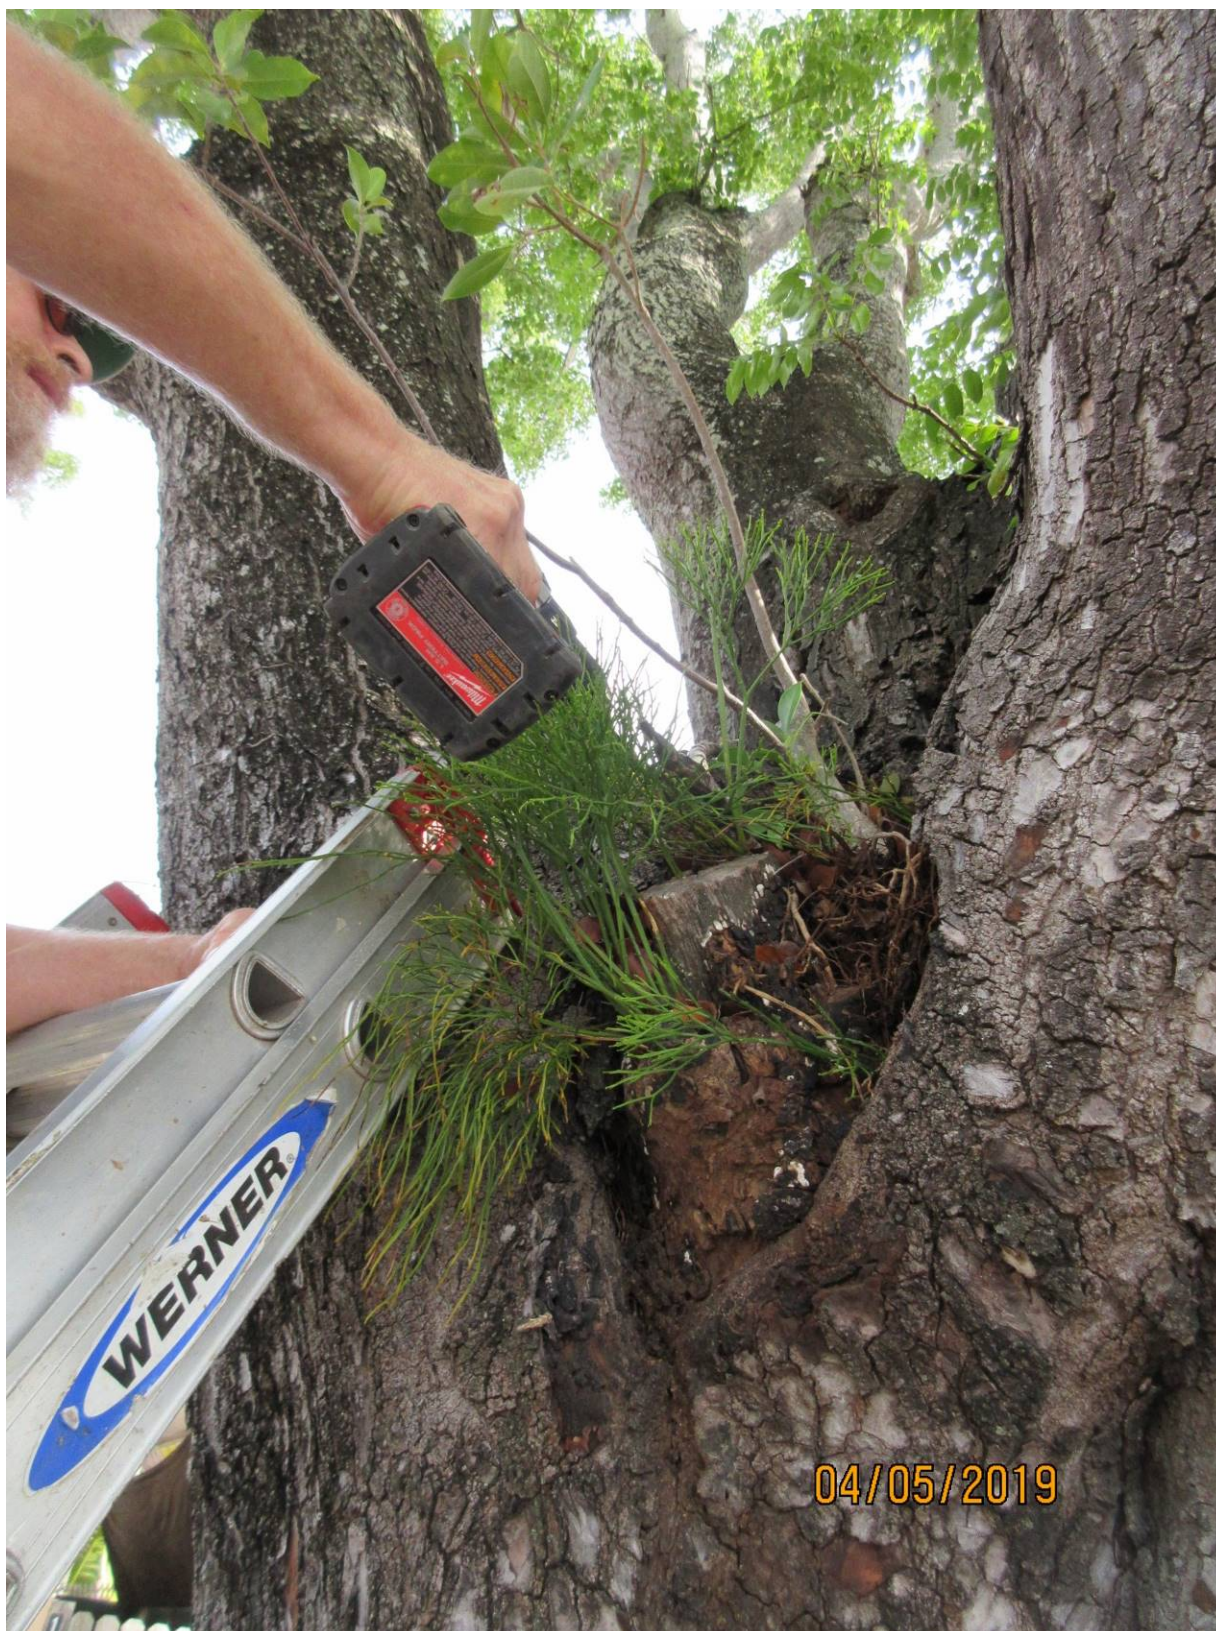
Drill location above: drill bit easily into the wood-10" soft wood

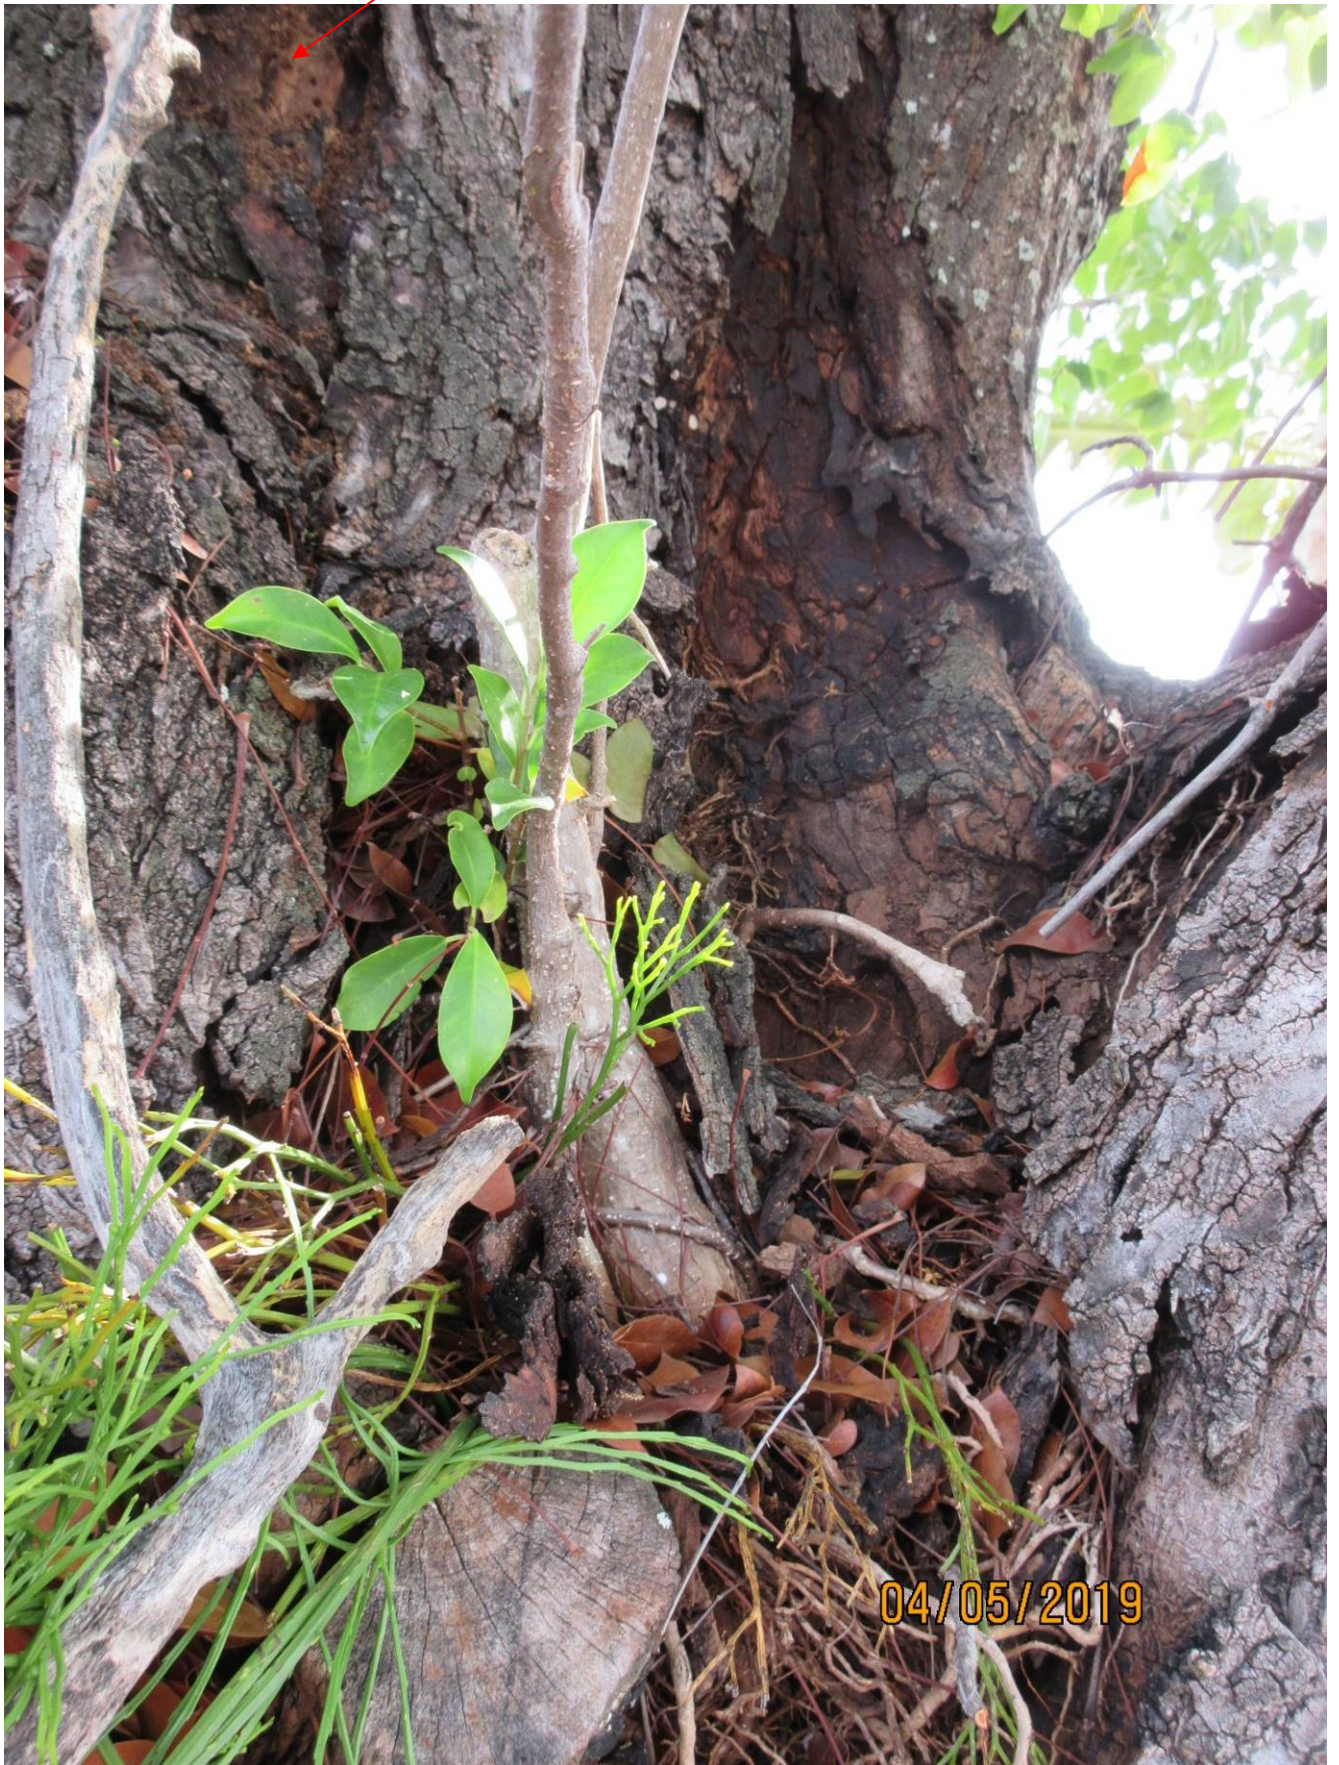
Close up of ant/decay area
