FLORIDA DEPARTMENT OF Environmental Protection

Re: Compliance Assistance Offer
Stock Island Landfill-Closed
WACS 97636
Monroe County

**Florida Department of
Environmental Protection
Inspection Checklist**

Facility Name: STOCK ISLAND LF (SOUTHERNMOST WTE & KEY WEST LF)

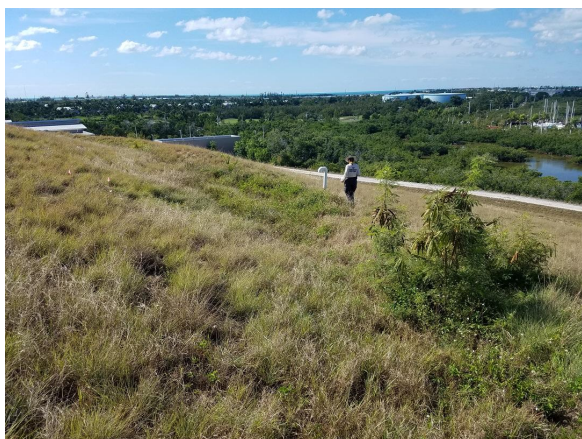
Explanation: Along the uppermost bench on the west side and the northwest corner of the landfill, there was some low points that could retain stormwater and accelerate erosion.

The cover in the low area on the west step is greener than the surrounding cover, which could indicate that stormwater is accumulating in that area.

Low point on west step

Corrective Action: Restore bench to original grade and stabilize with vegetation.

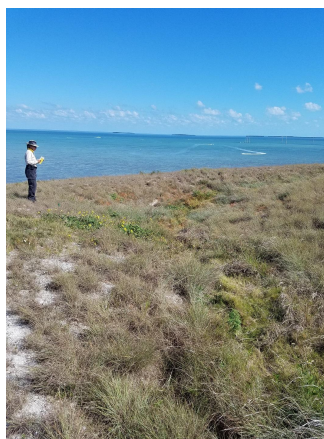
Low area on northwest corner step

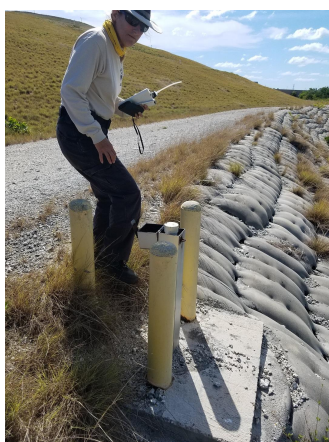
Explanation: No locks were observed on the monitoring wells. Department staff were able to open the well cover.

Unsecured monitoring well.

Monitoring well (MW) #2 was examined. Neither the well housing, nor the well cap were locked to prevent tampering.

Corrective Action: Appropriately lock and secure monitoring wells.

The LTC Report does not mention monitoring well security. However, if the wells are to remain in place they should be secured from tampering as required in 62-701.510(2)(d)5. F.A.C.

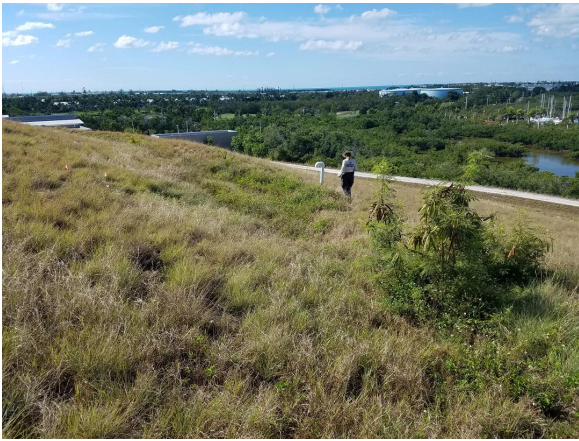
Explanation: The landfill cover does not show signs of recent mowing. Mr. Castro stated he does not remember when the last mowing event occurred. He further stated that the city's mower is not in operation at this time.

Overgrown plant on cover

Corrective Action: The city is supposed to mow the landfill cover six times a year. Mr. Castro stated that he is looking at getting a contractor to maintain the cover.
