STAFF REPORT

RE: 916 Elizabeth Street (permit application # T2019-0412)

FROM: Karen DeMaria, City of Key West Urban Forestry Manager

RE: Update to Certified Arborist Tree Risk and Viability Assessment, Chelsea House Hotel

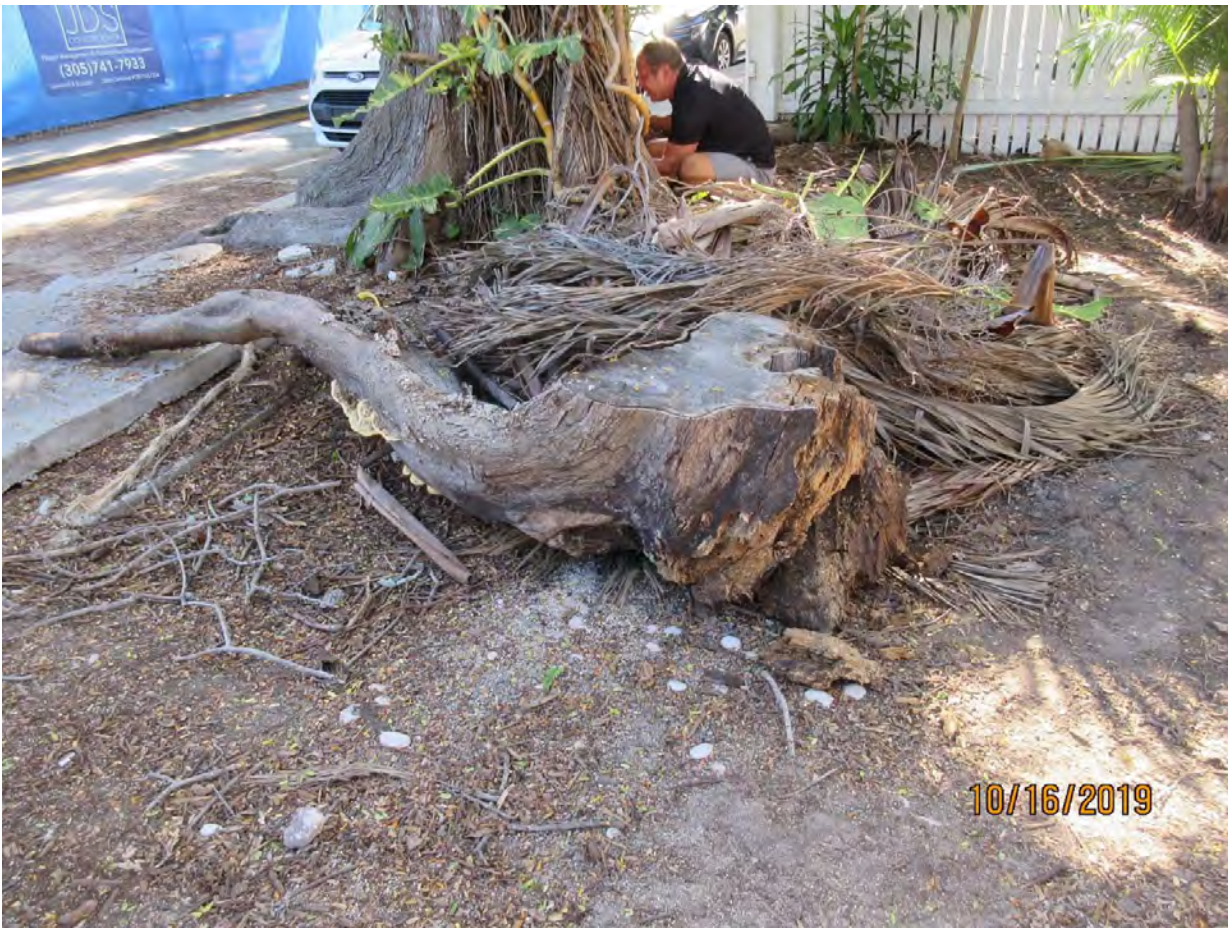
Photo showing old stump area that easily removed during clean up of area.

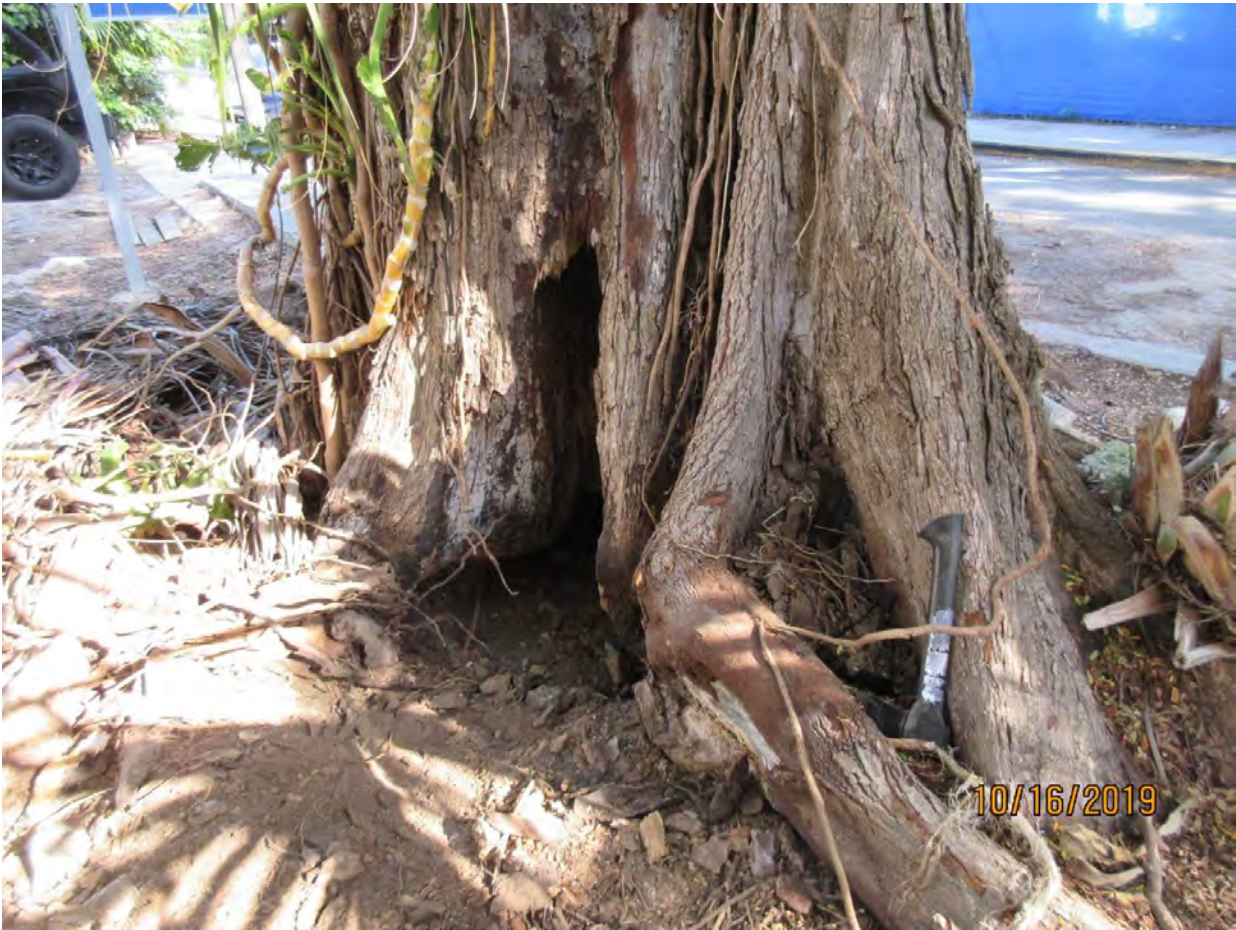
Photo of the base of the tree, cleaned up, showing decay/hole area.

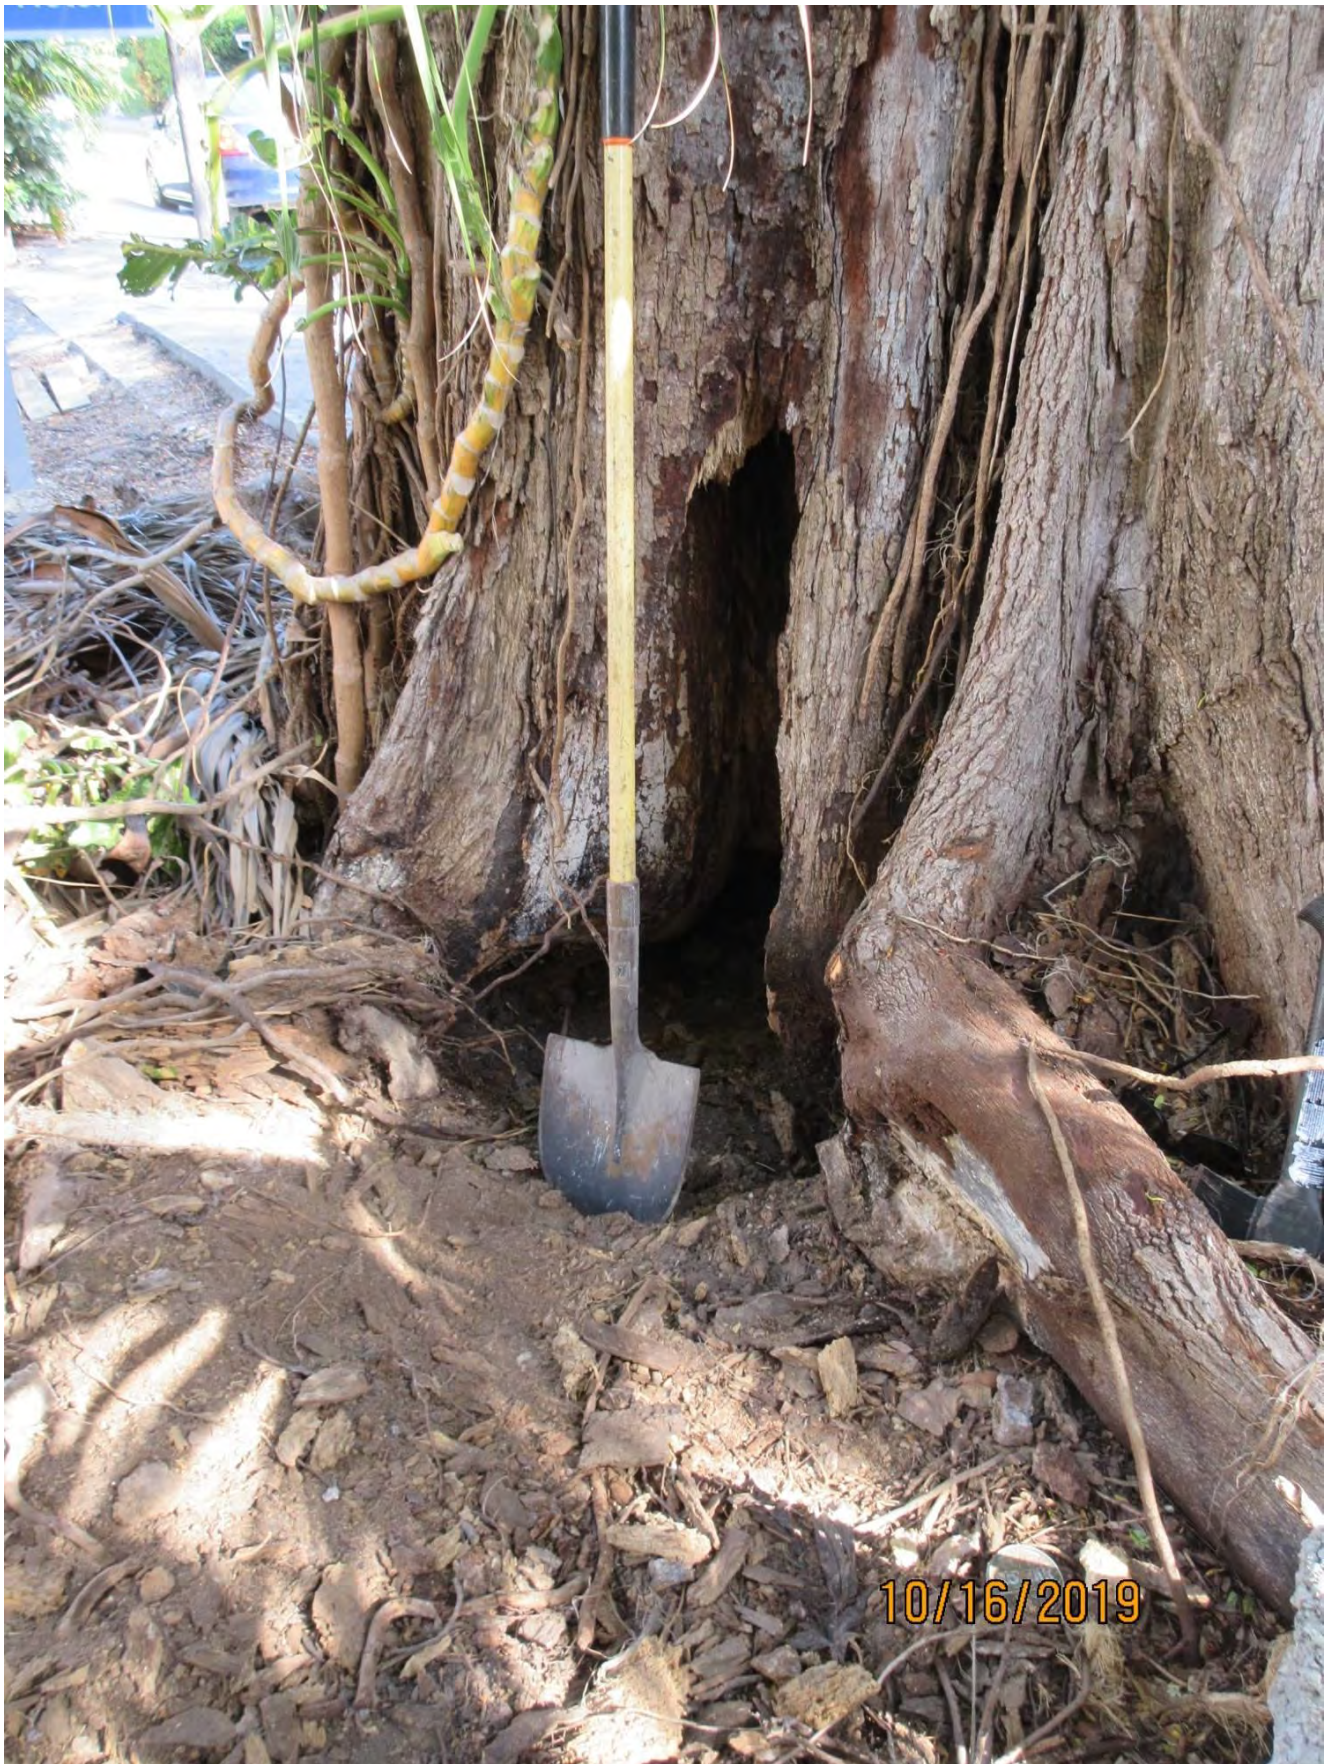
Photo showing base of tree hole area with a shovel to show size of area.

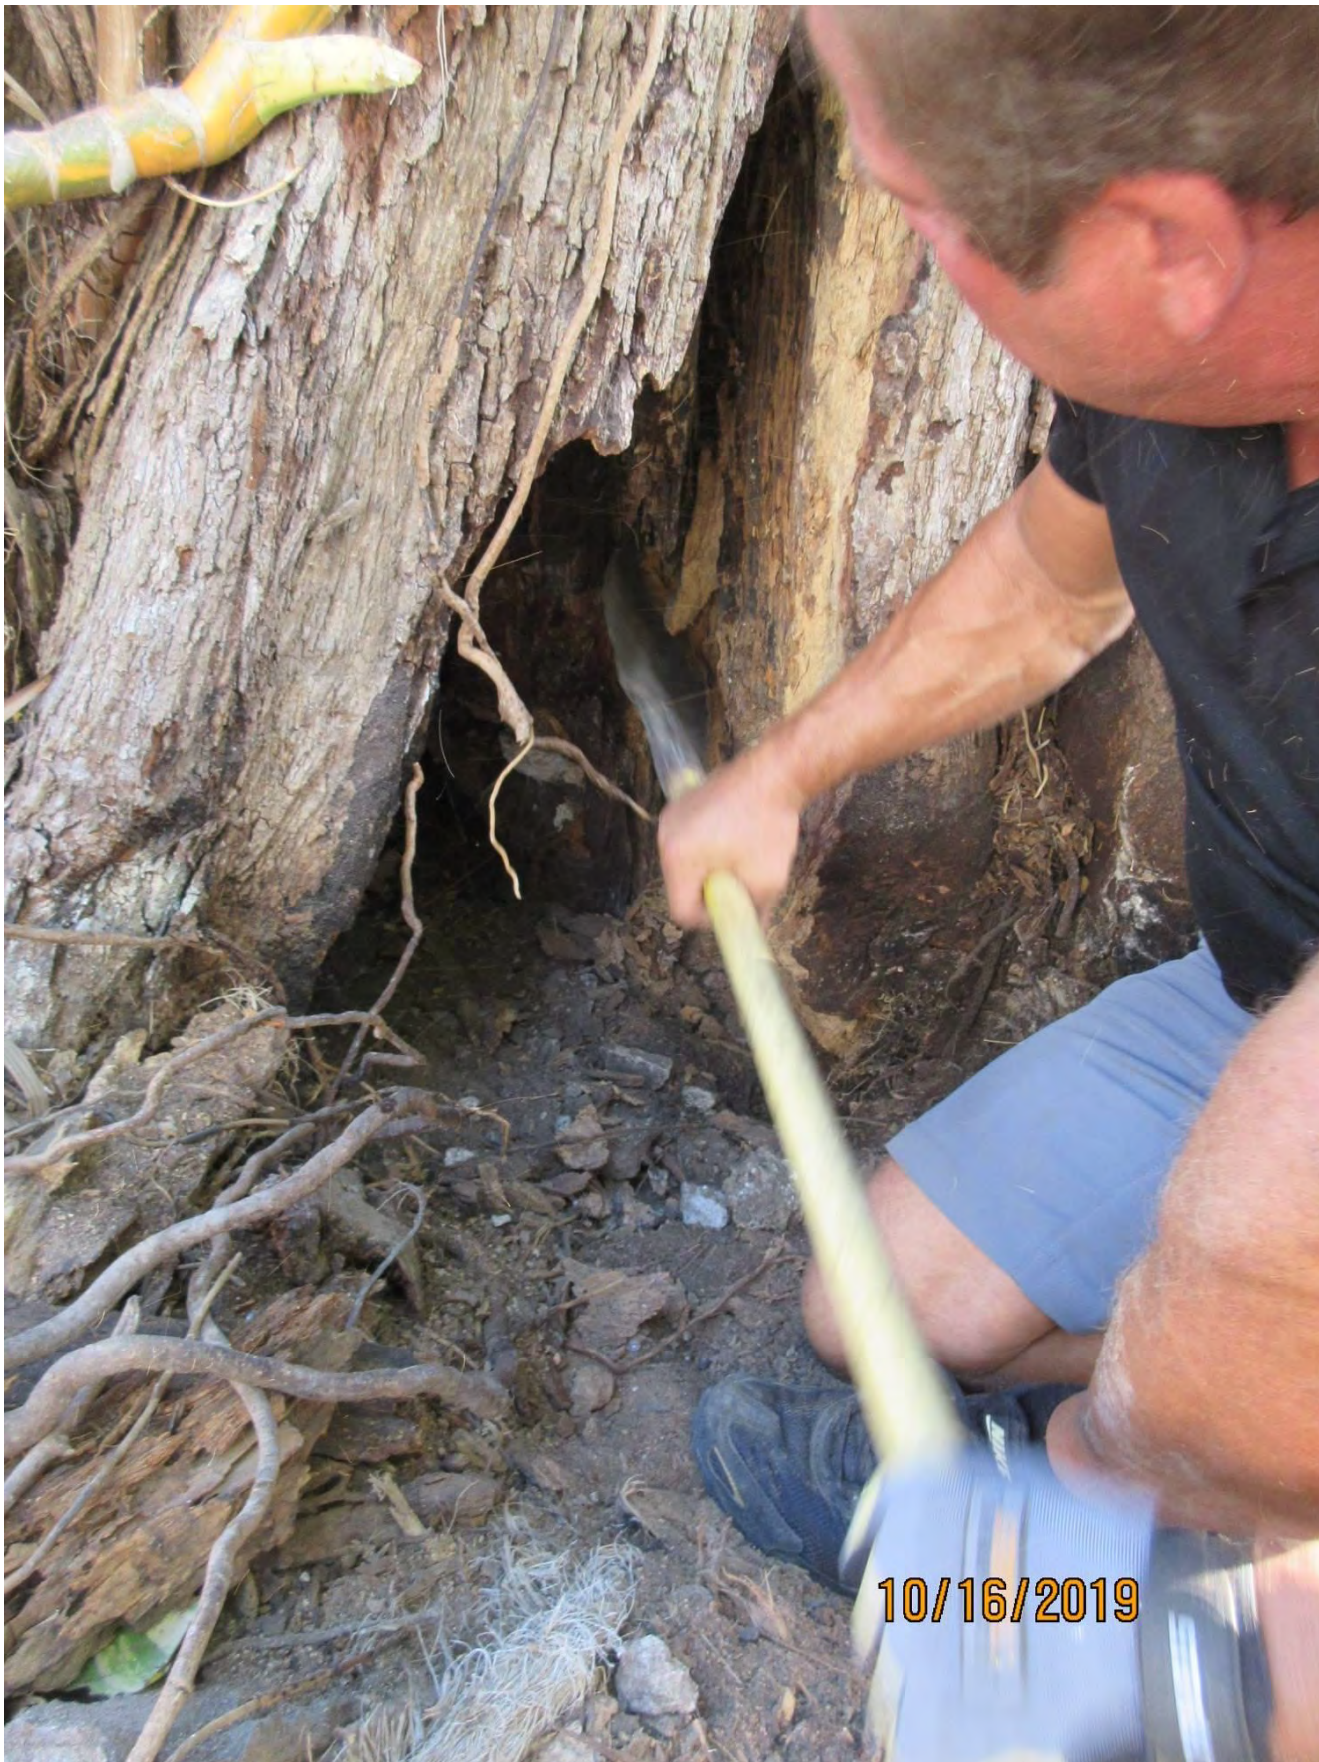
Photo showing the interior decay. Shovel would tap the wood and it would fall off easily.

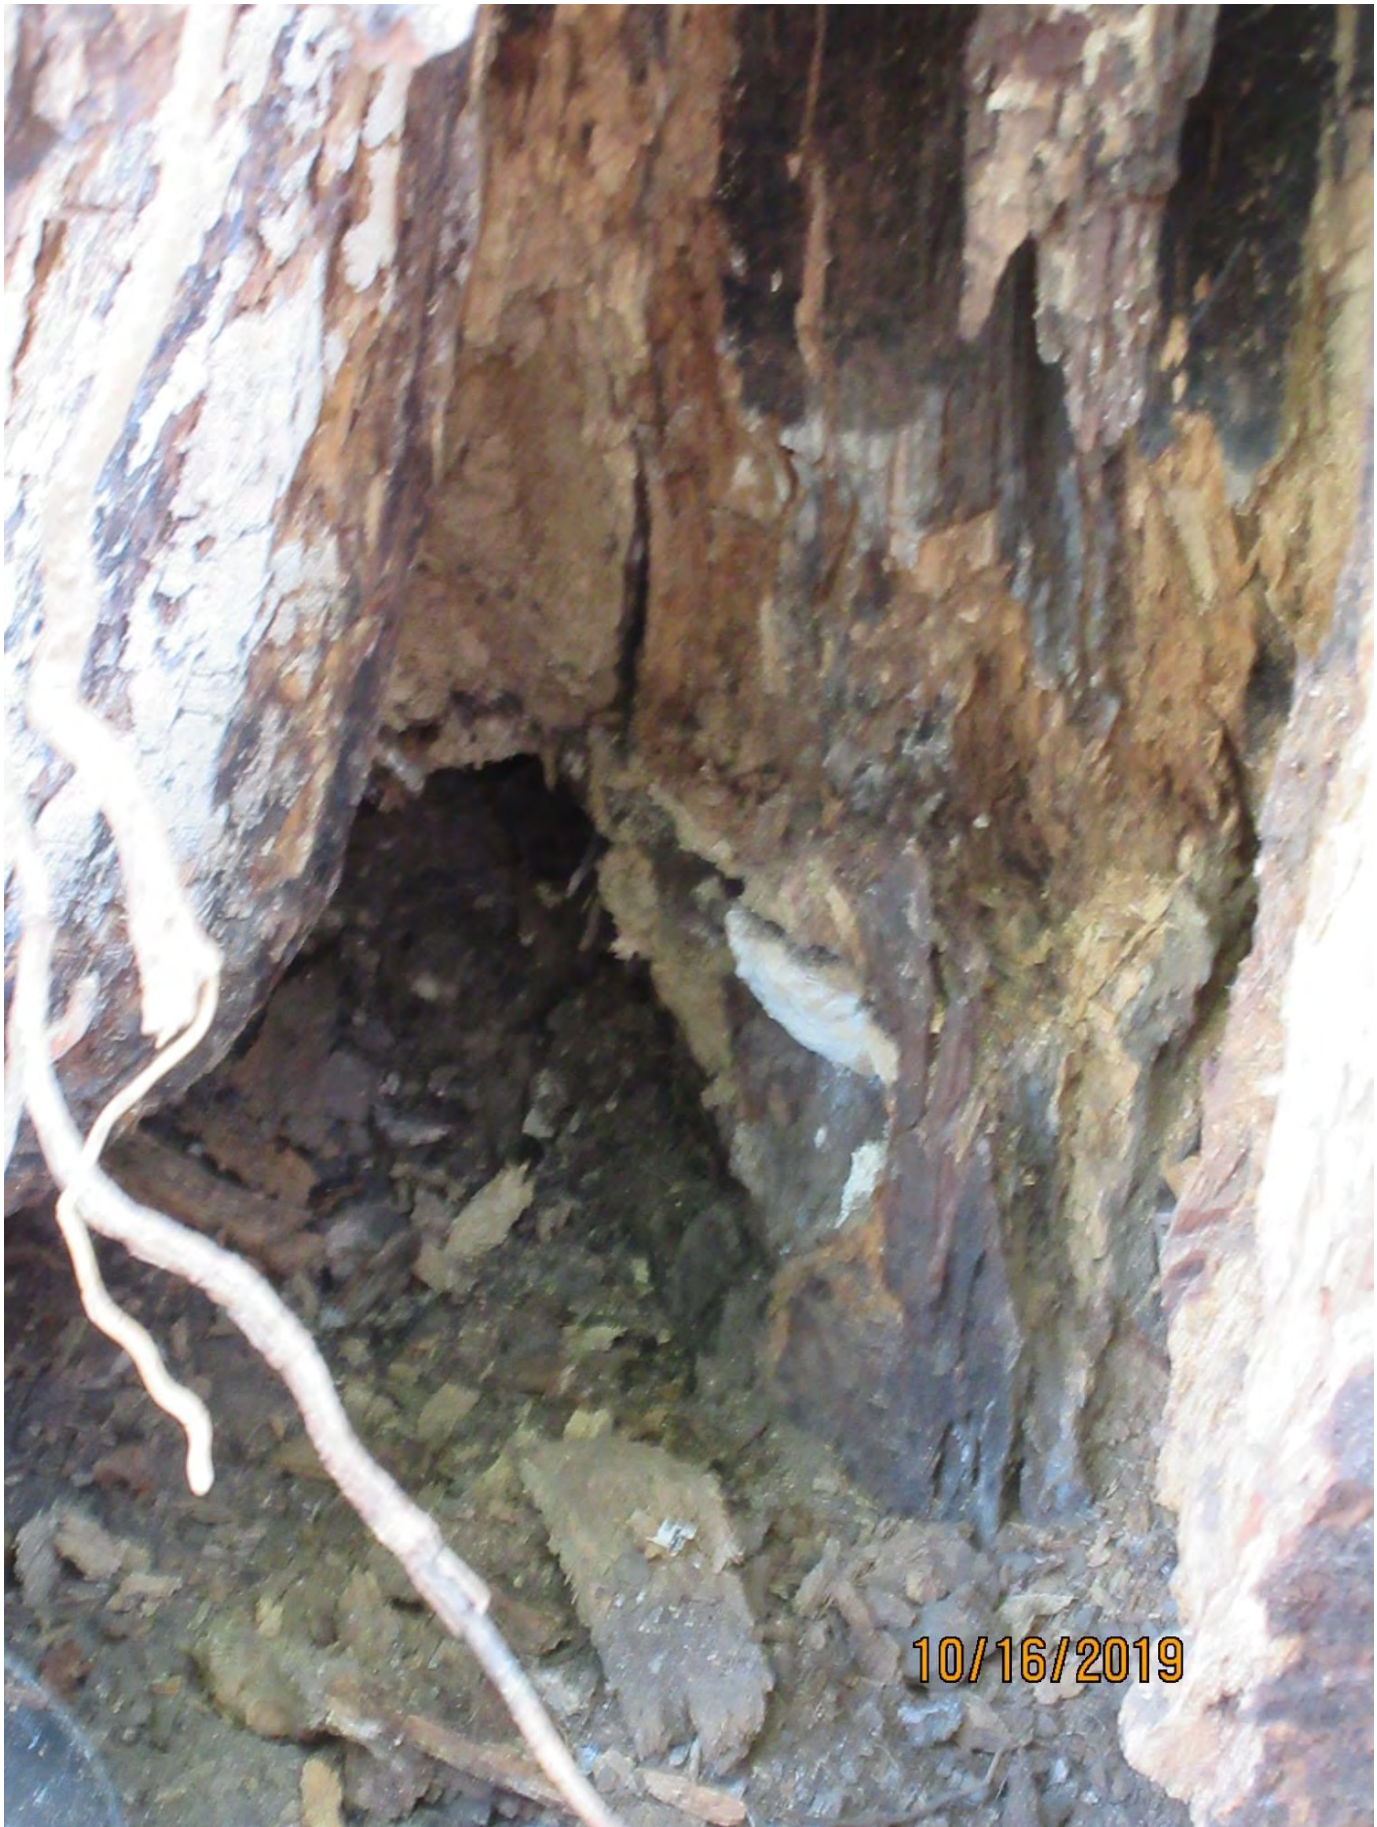
Close up photo of hole/decay area, view 1.

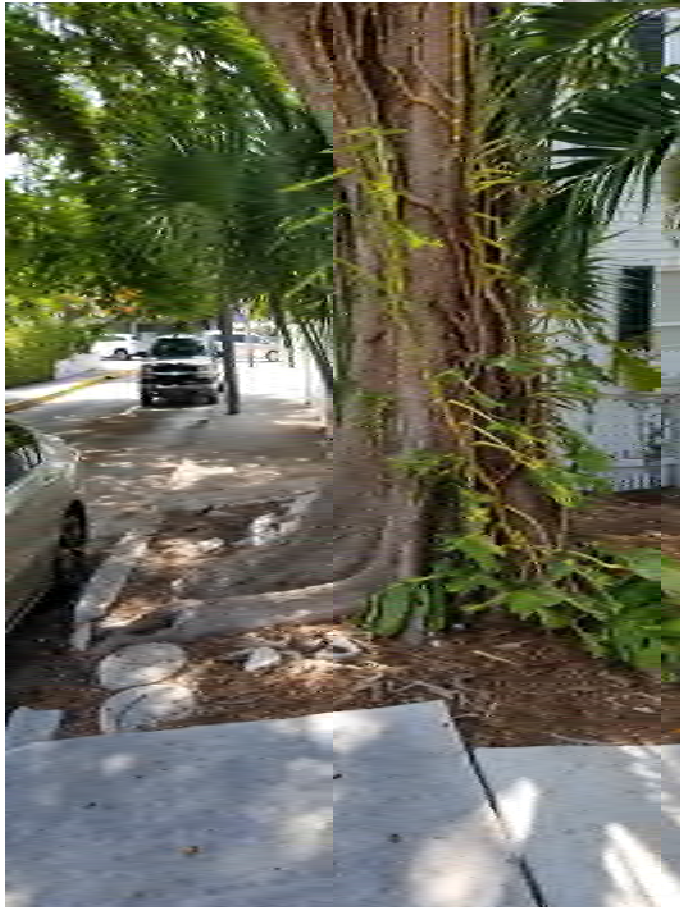
- There is currently no continuation of paving from one side of the tree to the other, and the roots have also dislodged a portion of the roadside curb, and the adjacent segment of sidewalk.

Photo 2. View of tree from north. Sidewalk is missing, adjacent pavers and curb broken.

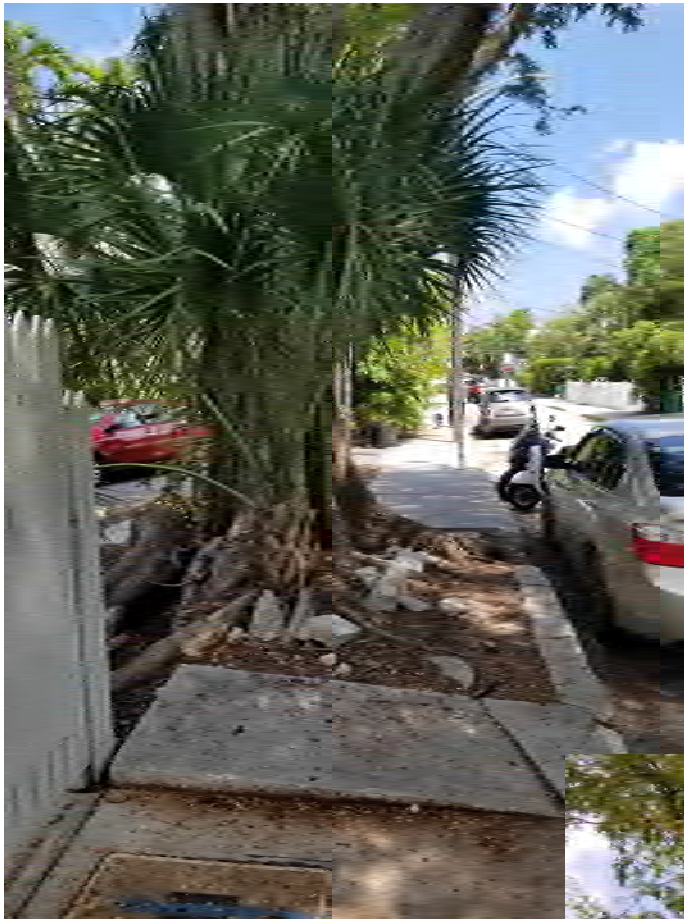
Photo 3. View of base of tree from the south.

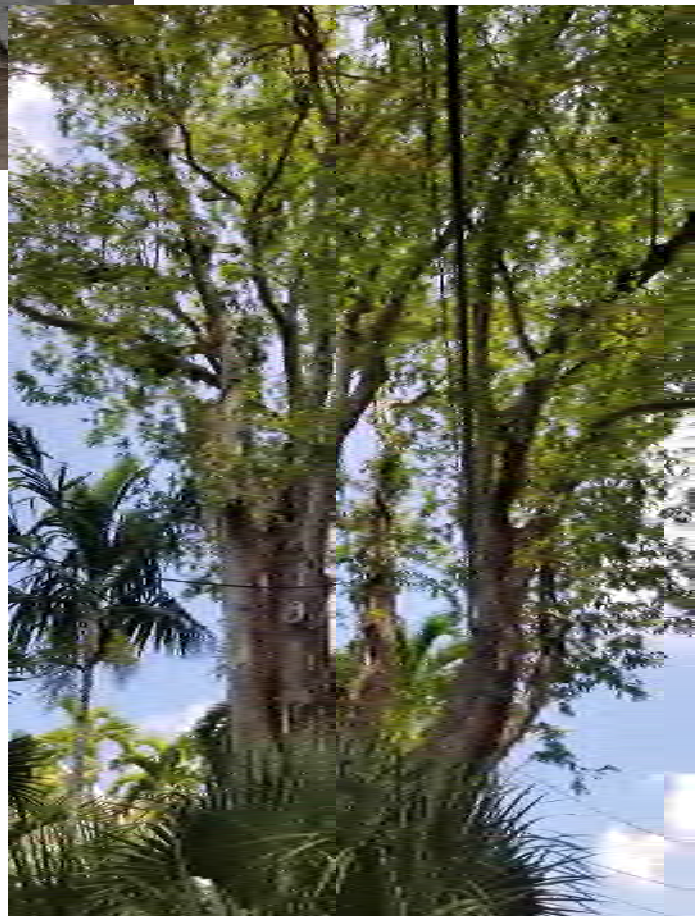
- Overhead utility lines pass through the middle of the canopy, and branches are in contact with and pressing against the lines.
- The base of the trunk has a cavity approximately three feet in diameter. The cavity is cone shaped, with the top extending upwards up to approximately four feet. The inside edges of the cavity all exhibit significant signs of decay, with 2-3 inches of completely friable/loose wood fragments prior to sound wood. The decay is a white rot, which causes greater structural damage than brown rot. The decay is likely caused by an aggressive fungal pathogen. Based on the fungal conchs on the (formerly) adjacent stump, the fungus is likely to be a variety of *Ganoderma*, which is a very destructive pathogen that is difficult to control.

Photo 4. View of canopy and utility lines

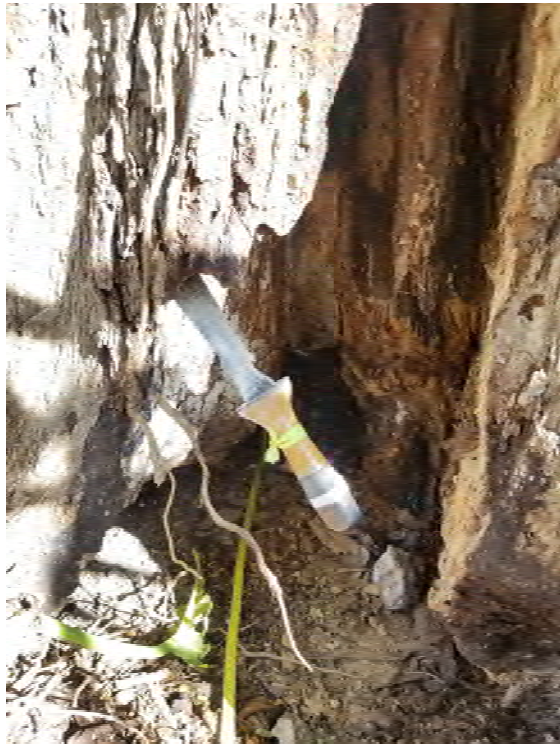
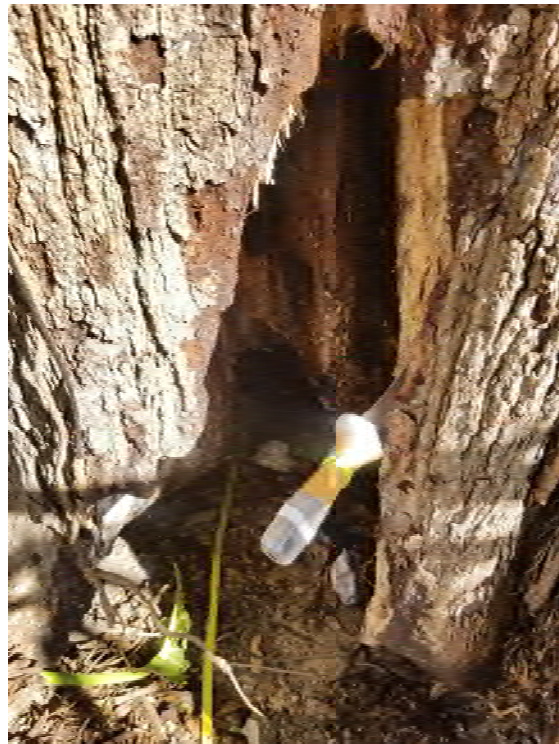
Photos 5 & 6. View of cavity on southwest side of tree. Soil knife inserted into white rot to a depth of approximately three inches on both sides.

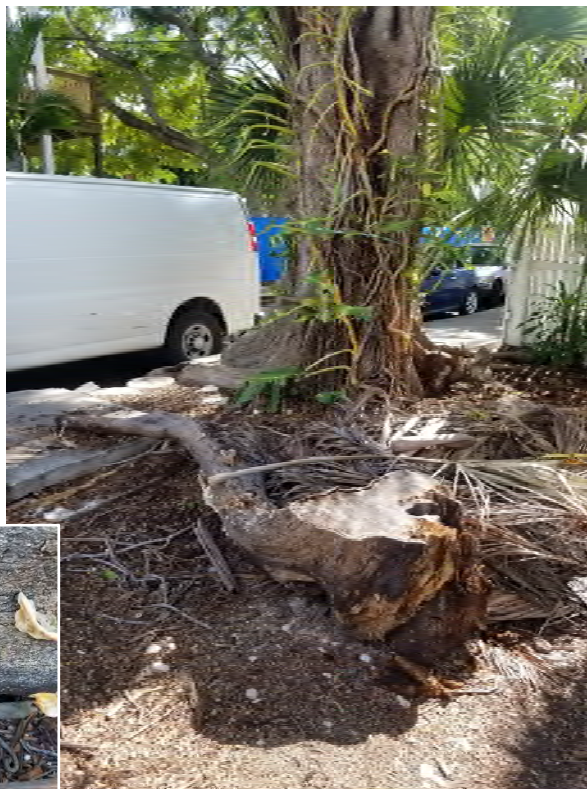
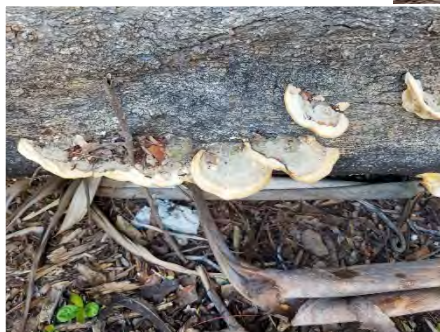
Photos 7 & 8. View of stump removed from southwest side of tree. White rot visible on right side of stump, fungal conchs visible on main root (larger view on inset).

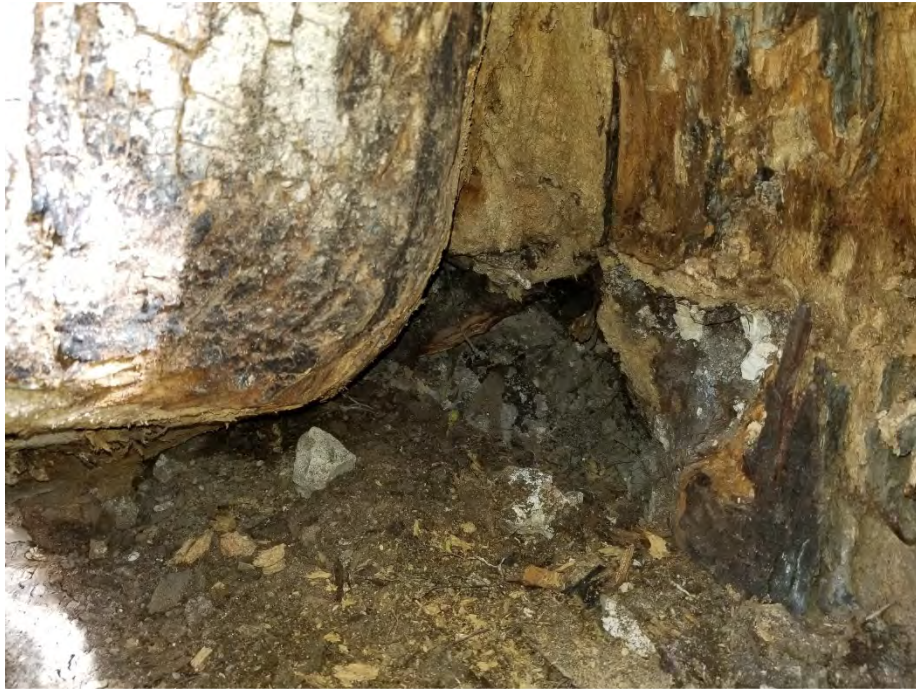
- The removal of the dead stump from the tree that was abutting the tamarind allowed for viewing beneath the base of the tamarind tree. Owing to the space occupied by the formerly abutting tree, the tamarind tree has no roots (or any wood mass) directly under the tree, and no roots/root

flair on the southwest side. Noting that the roots on the opposite (northeast) side are truncated by the curb (and may be further impacted through curb/sidewalk reconstruction), the tree has a significantly increased risk of failure in either direction.

Photo 9. View within center cavity of tree, no roots or woody mass beneath the tree (root flair curving out is visible).
