STAFF REPORT

RE: 916 Elizabeth Street (permit application # T2019-0412)

FROM: Karen DeMaria, City of Key West Urban Forestry Manager

RE: Update to Certified Arborist Tree Risk and Viability Assessment, Chelsea House Hotel

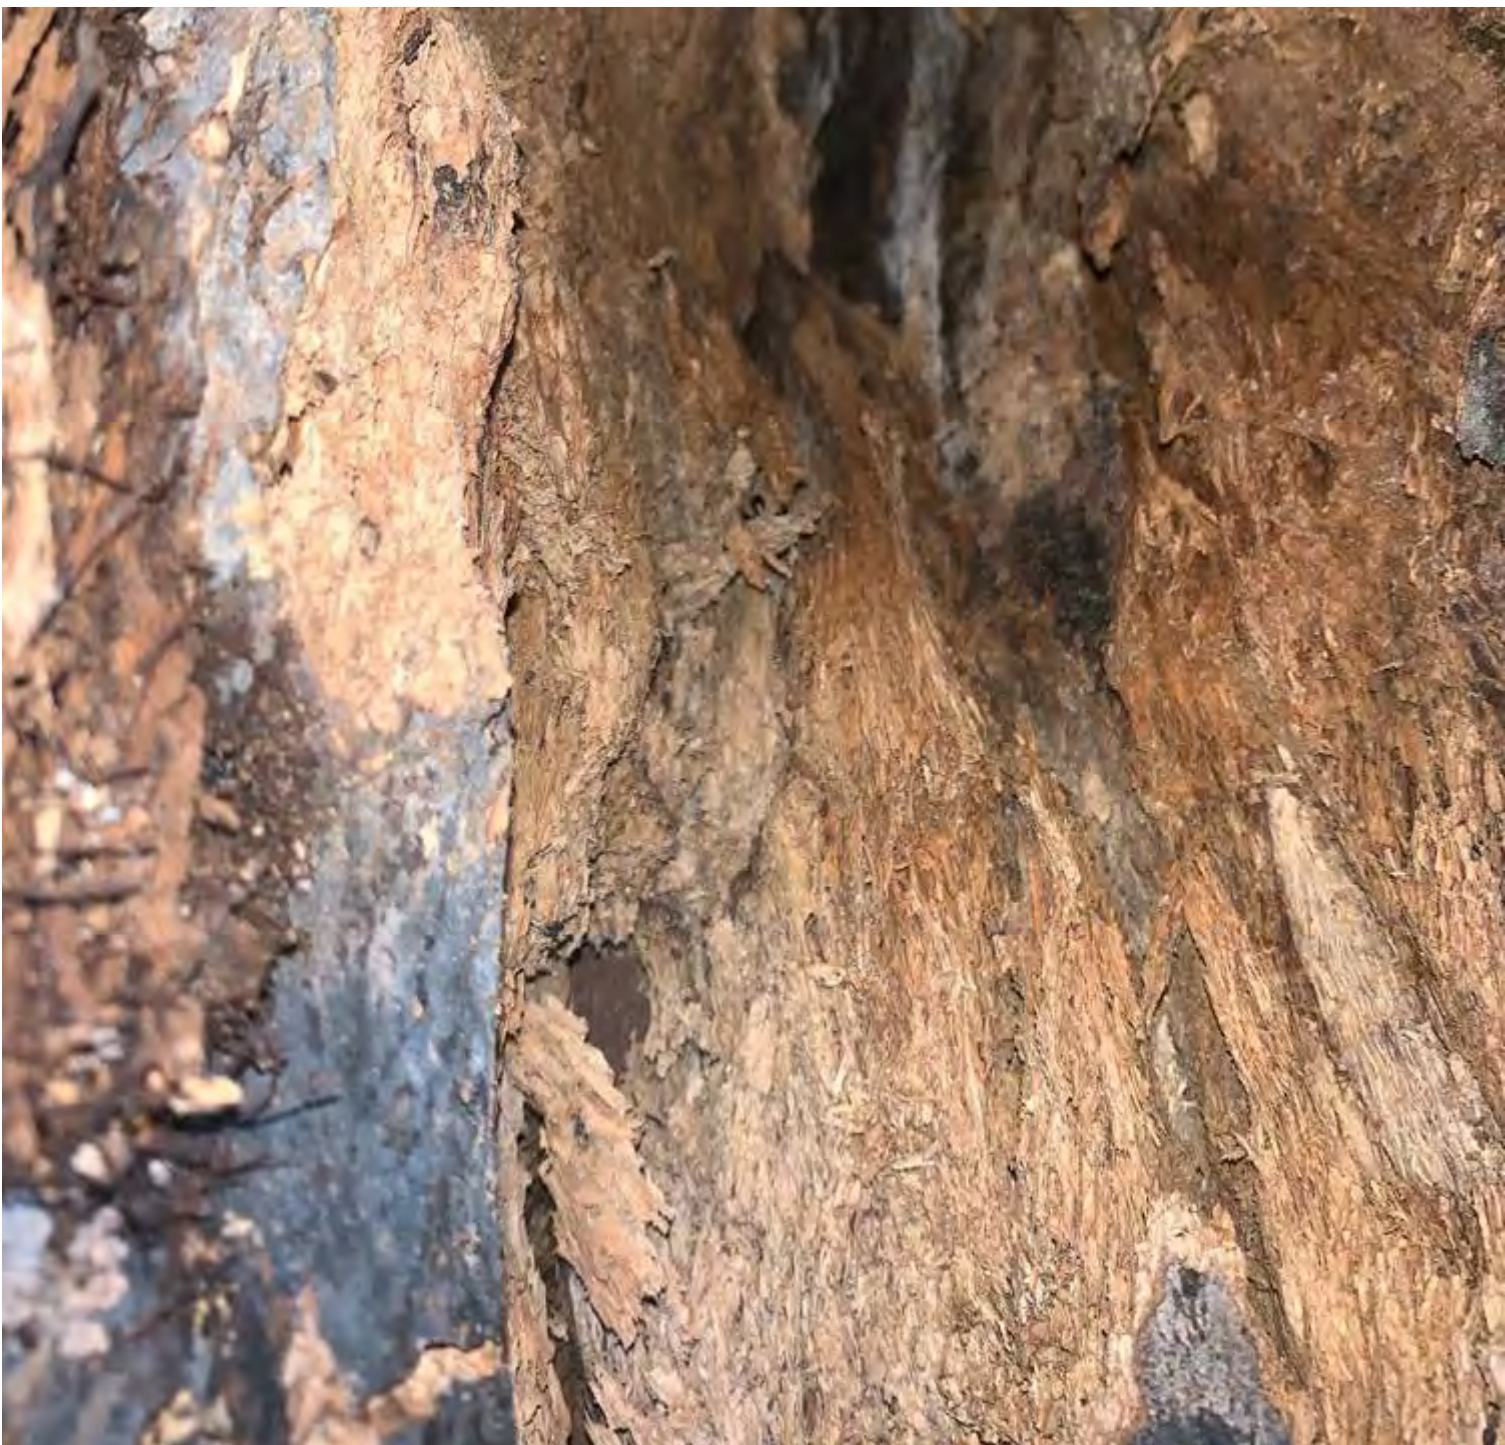
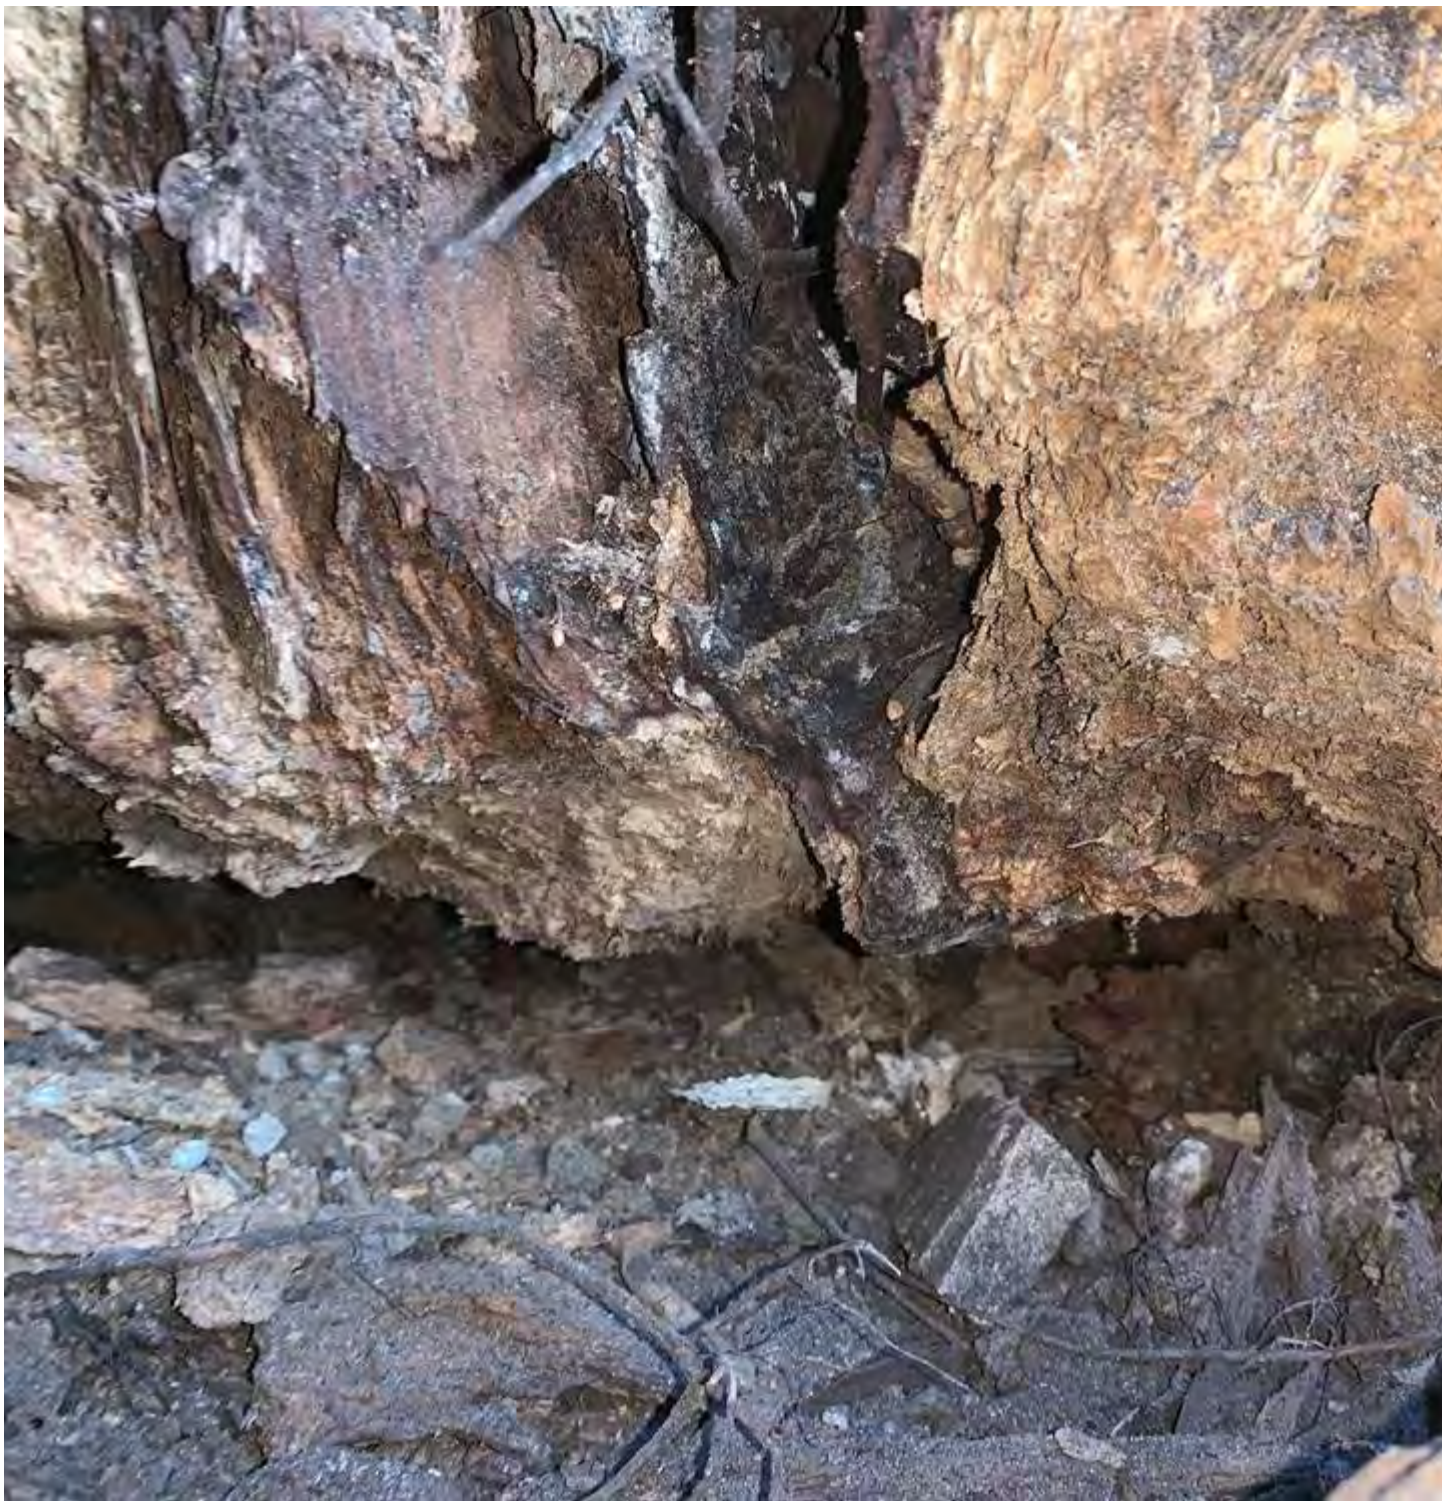
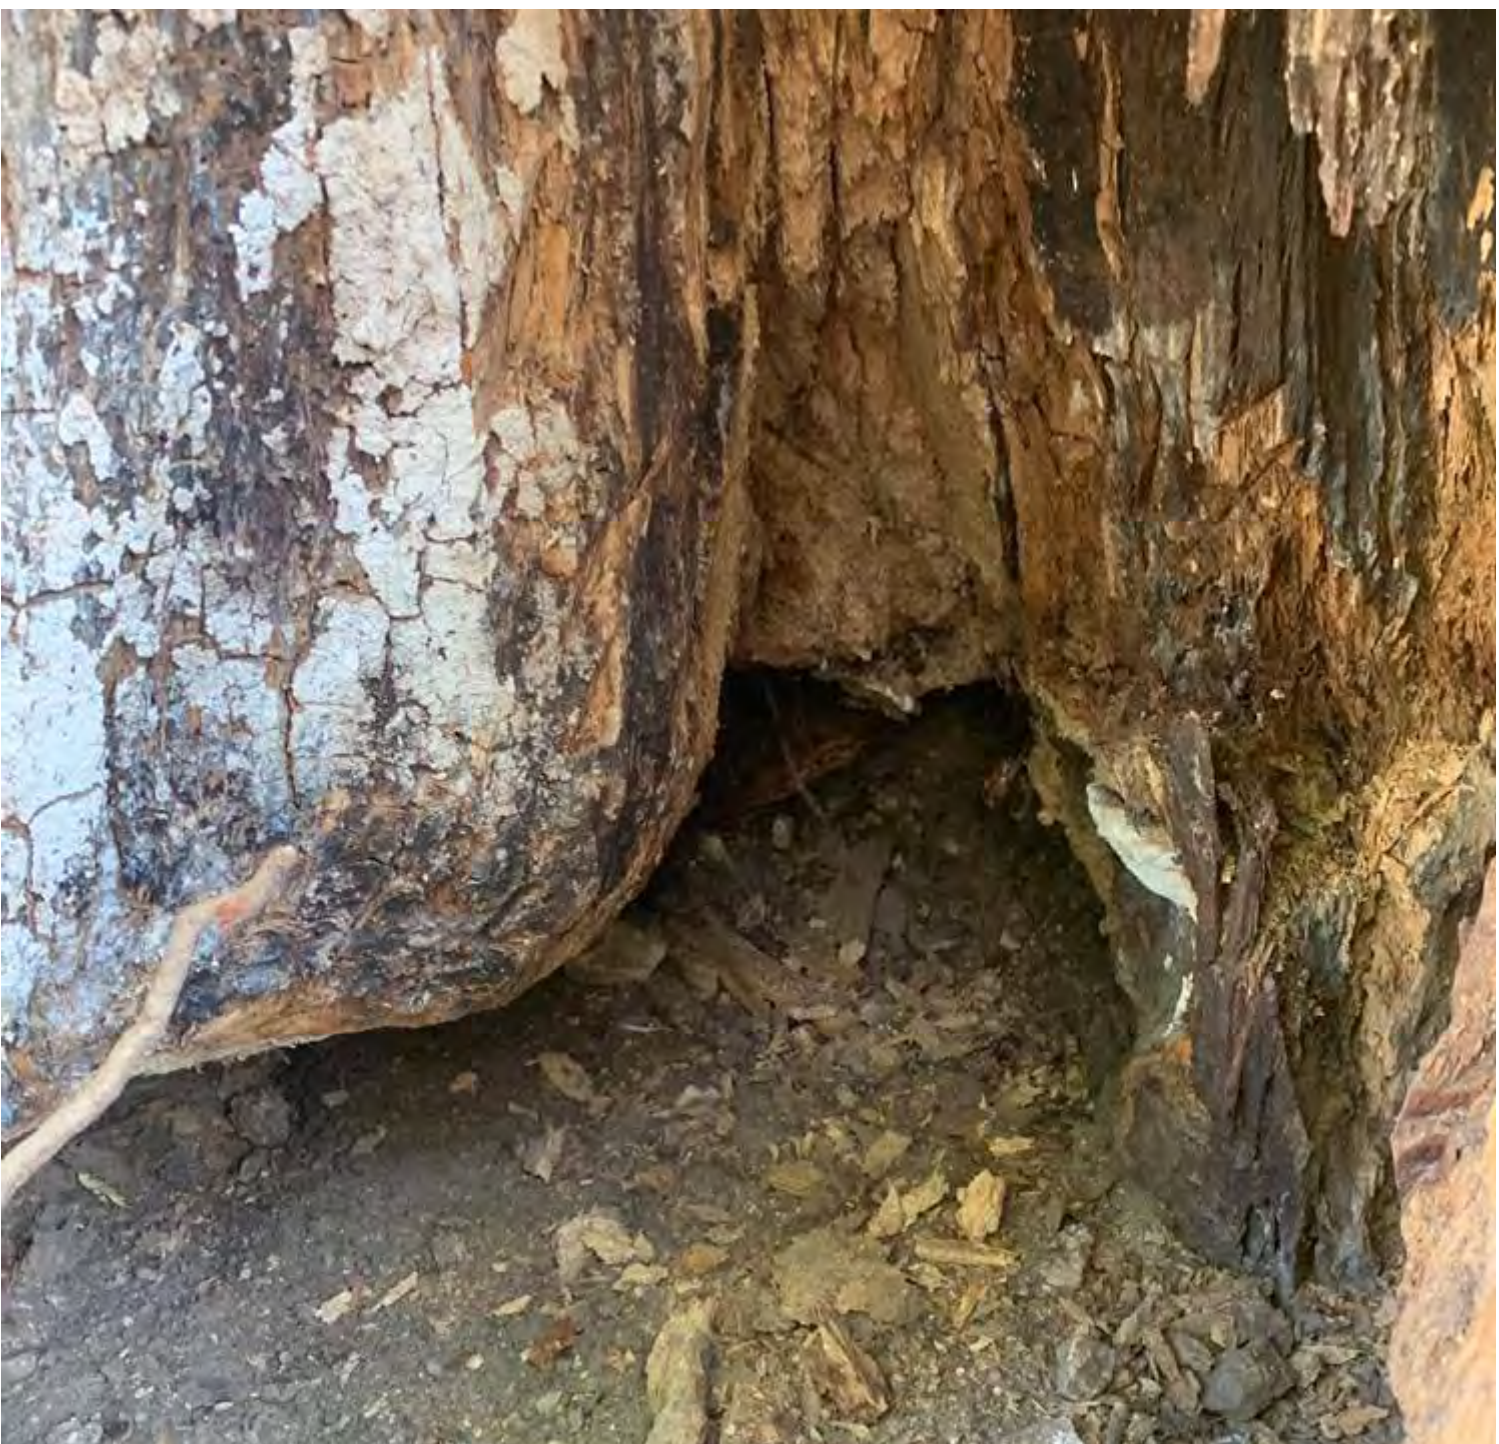
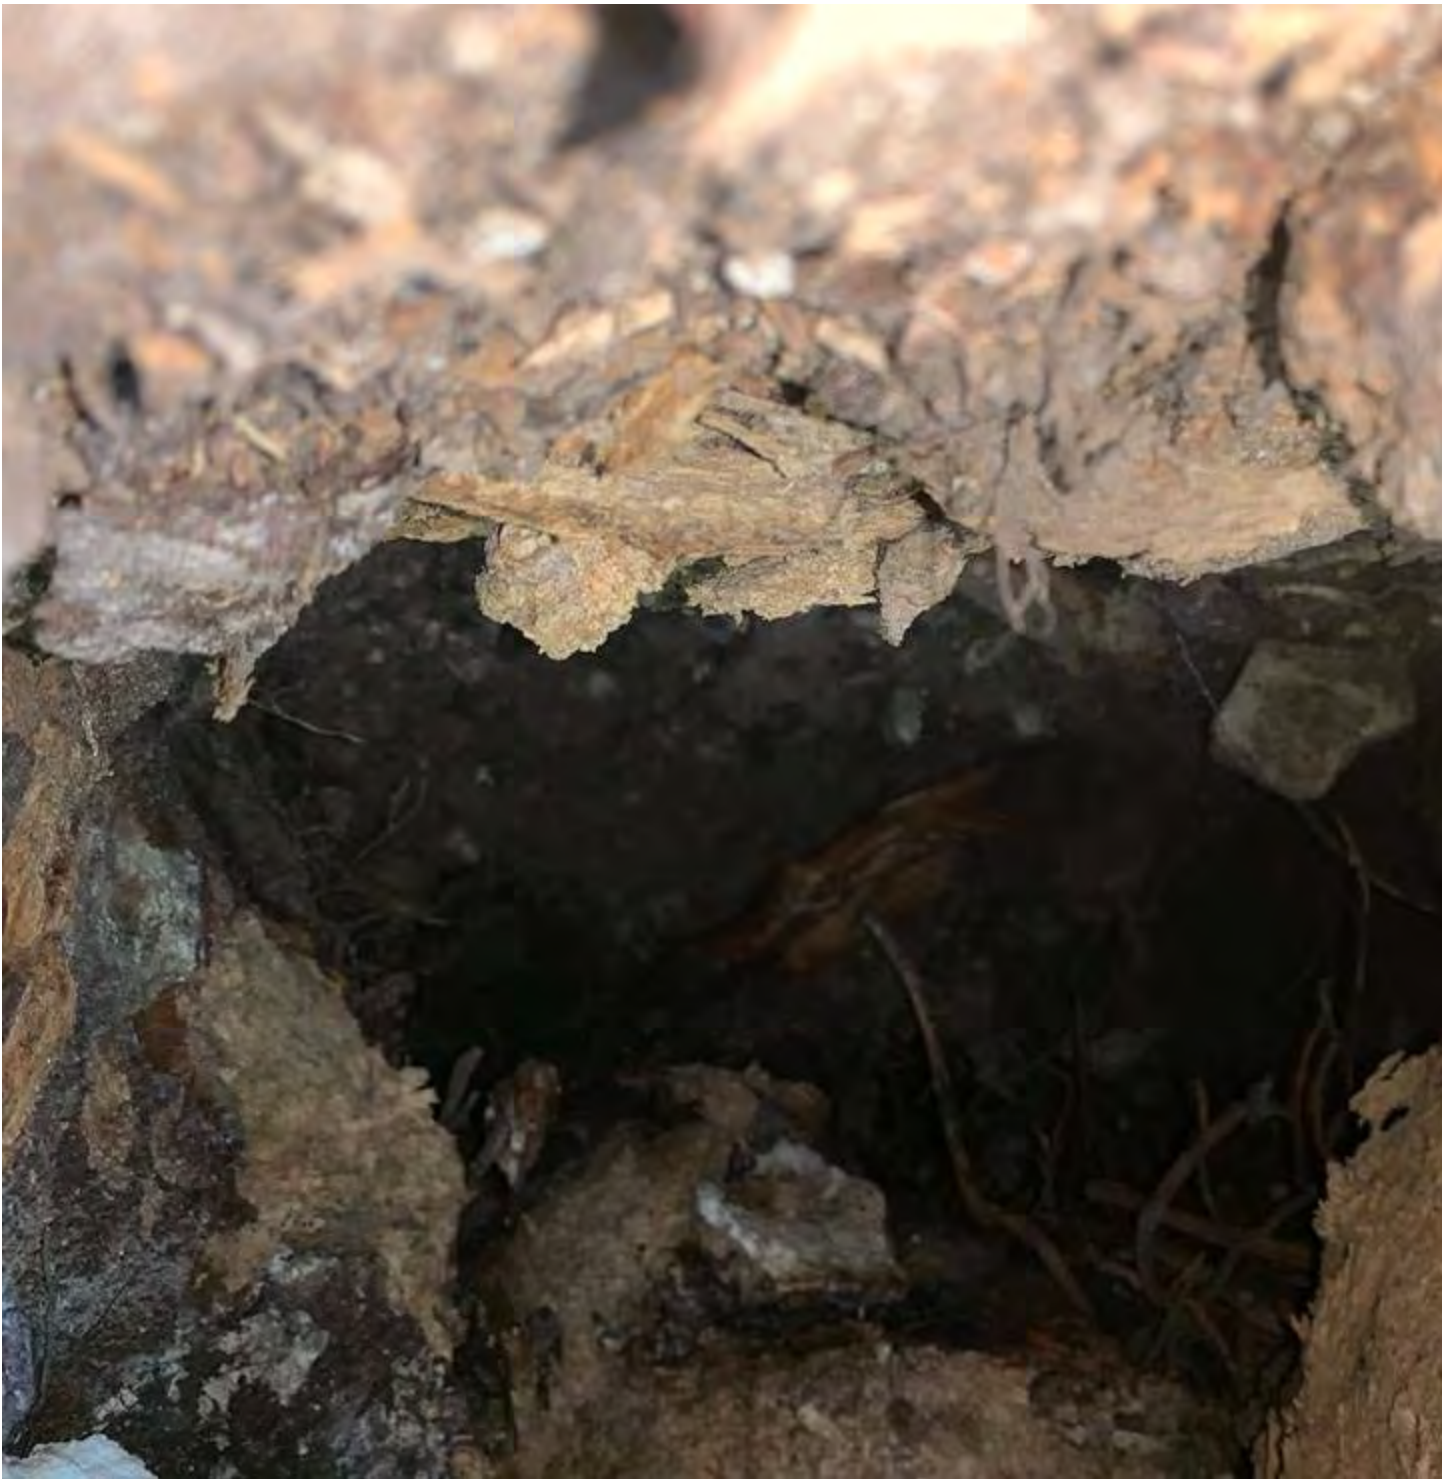
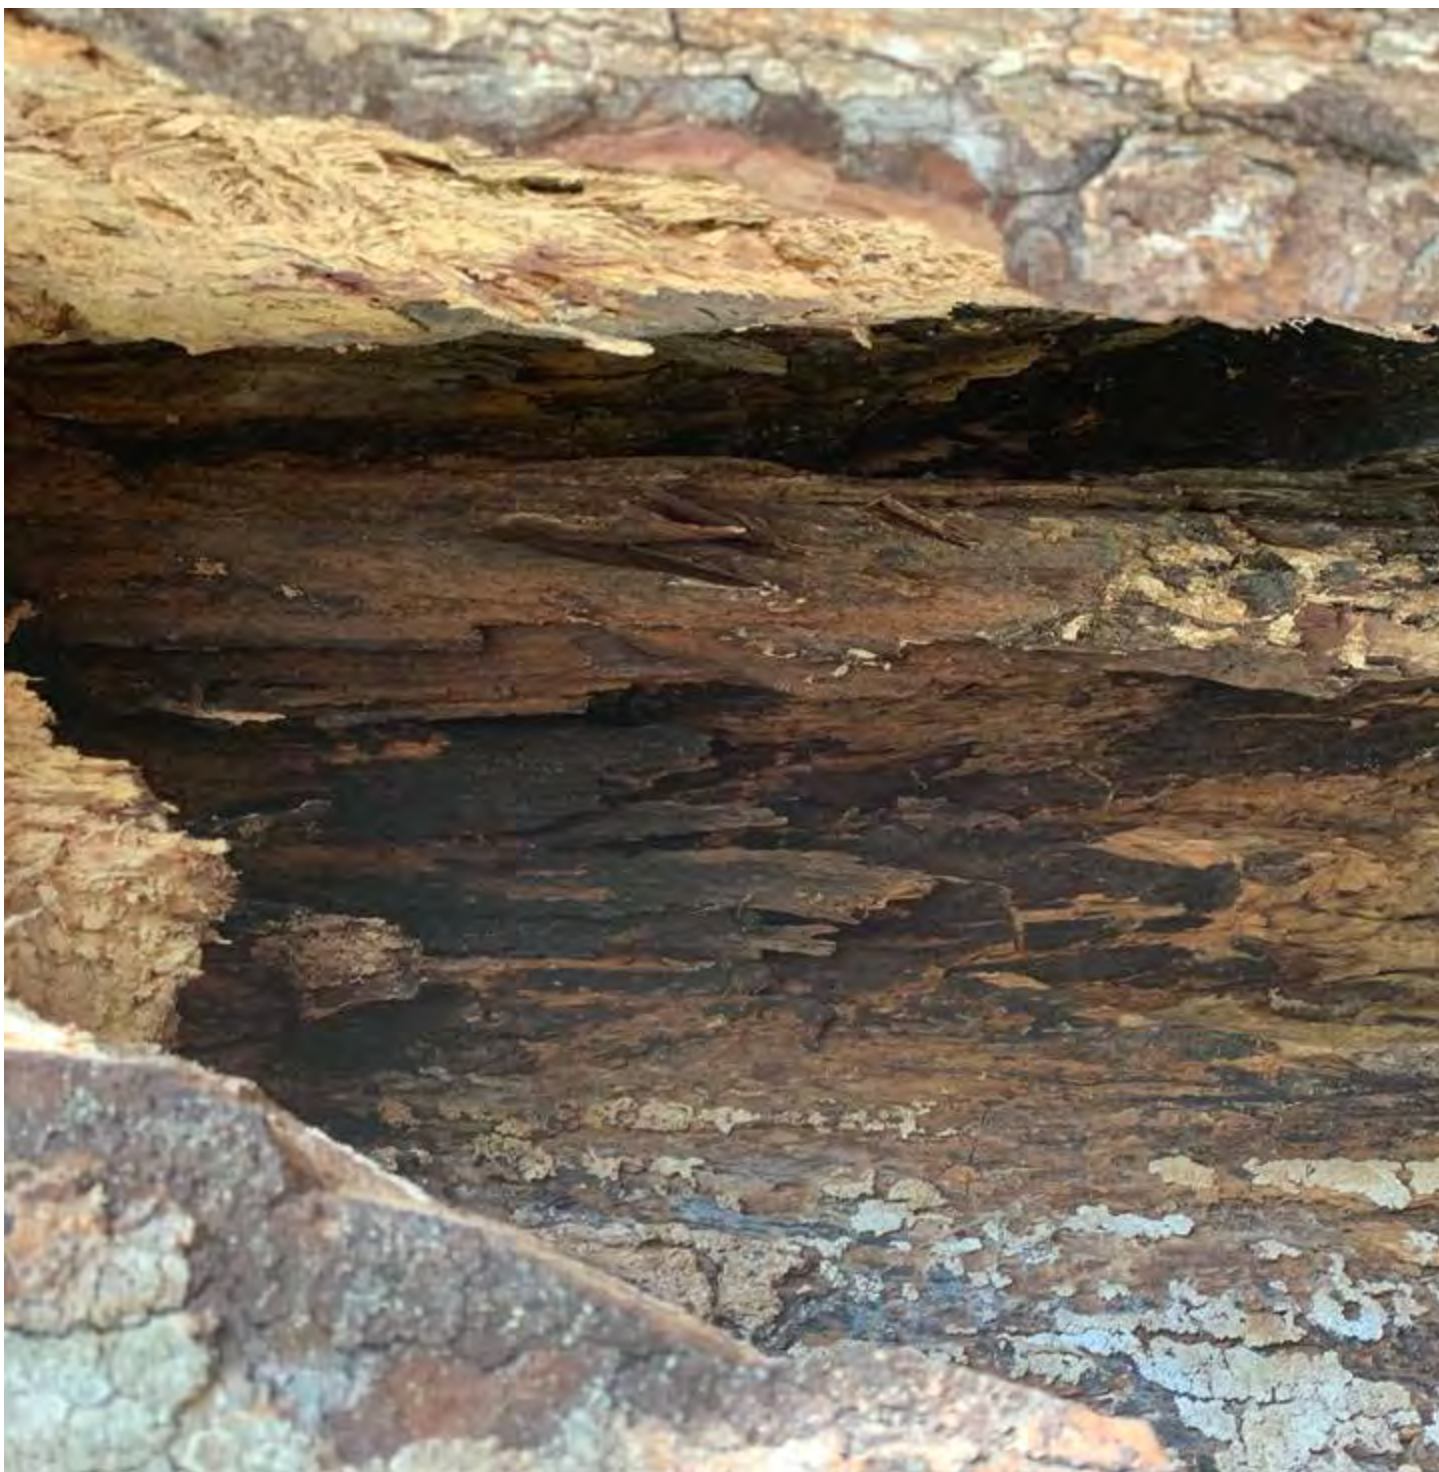
Karen, I was brought in by JDS Construction to examine the Indian Tamirind Tree. After extensive examination of the cavity on the western base of the tree. I have found that there is a cavity opening with advanced decay throughout the heartwood approximately 52" from the soil level extending upwards. I noted extensive decay and fungi development in the remaining support roots. With the amount of rot and decay it is at high risk of structural failure supporting this large canopy. (Please see attached photos)

It's my professional opinion and with over 30 years in the field of arboriculture that our options for public safety and to prevent property damage are limited to complete Tree removal and replacement.
